**ENVIRONMENTAL COMPLIANCE MONITORING**

**Final Summary Report**

Project: Verizon Wireless Palmer Pond CT Facility  
 Address: 53 Gallup Road, Voluntown, Connecticut

APT Project #: CT1411060

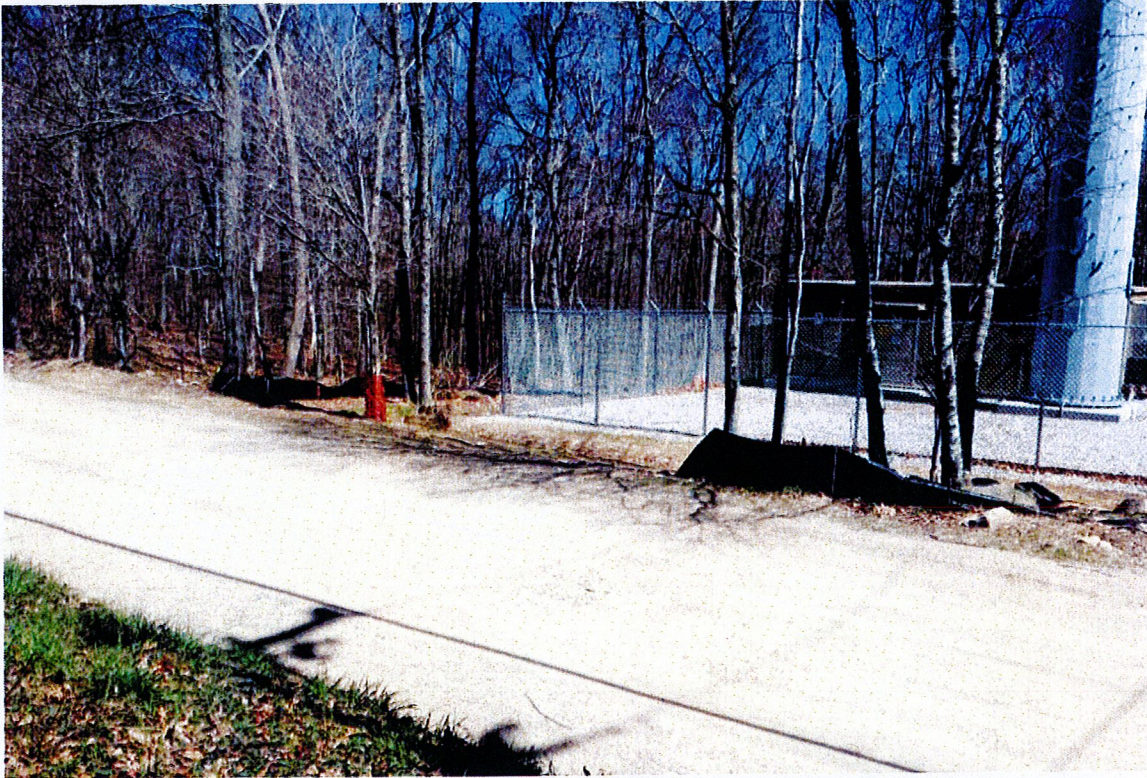
DESCRIPTION OF OBSERVED ACTIVITY	
Compliance Level:	
Communication <input checked="" type="checkbox"/> Acceptable <input type="checkbox"/> Problem Area <input checked="" type="checkbox"/> <ul style="list-style-type: none"> <li><input checked="" type="checkbox"/> Minor Exclusion Fencing Repair</li> <li><input type="checkbox"/> Additional Exclusion Fencing Required</li> <li><input type="checkbox"/> Sediment release into upland habitat without risk of resource impact</li> </ul> Non-Compliance <input type="checkbox"/> <ul style="list-style-type: none"> <li><input type="checkbox"/> Sediment release into upland habitat with risk of resource impact</li> <li><input type="checkbox"/> Sediment release into wetland habitat</li> <li><input type="checkbox"/> Sediment release into watercourse</li> </ul>	
Issues Requiring Corrective Action	Corrective Action Implemented
None	N/A
Correction Area #1 – areas of silt fencing sagging or broken and needing repair	5/13/2015

Photo 1: View of Facility with broken silt fence line looking northeast.

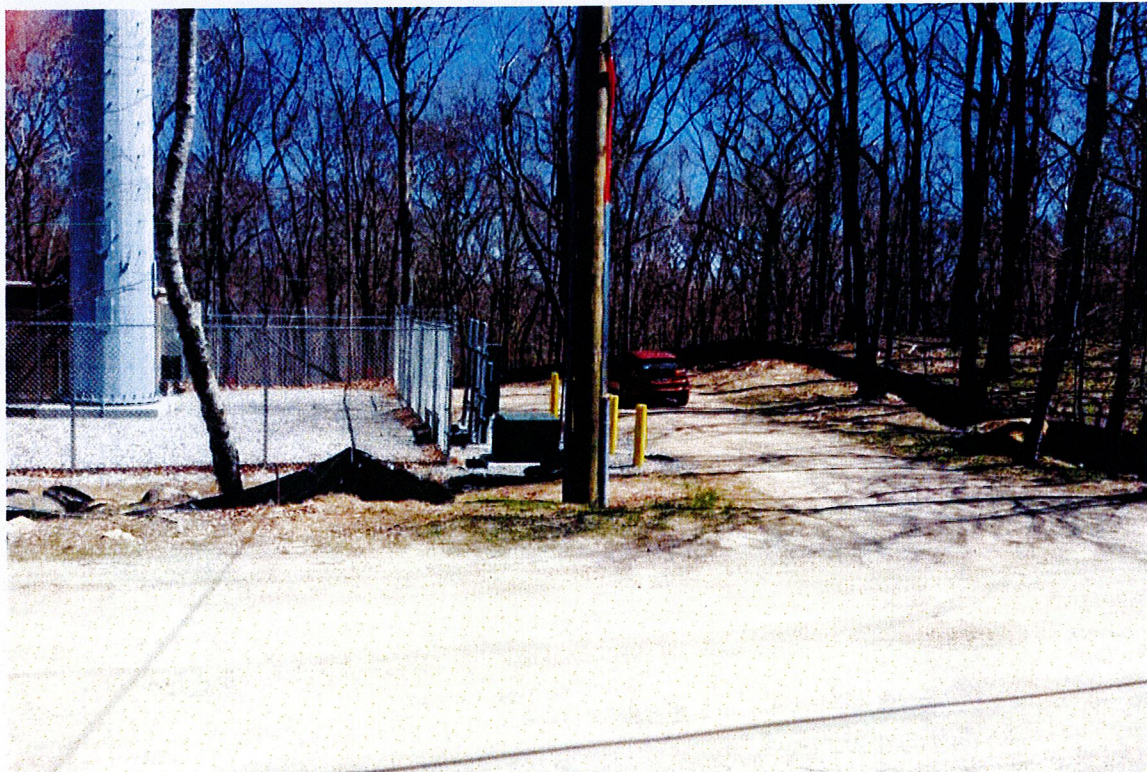
Correction Area #2 – Entrance is entirely open to migration	5/13/2015
Project Modification Requested:	
Extra Work Space Requested <input type="checkbox"/> Change to Work Area <input type="checkbox"/> Description of Modification: N/A

Photo 2: View of access entrance with open silt fencing looking east.

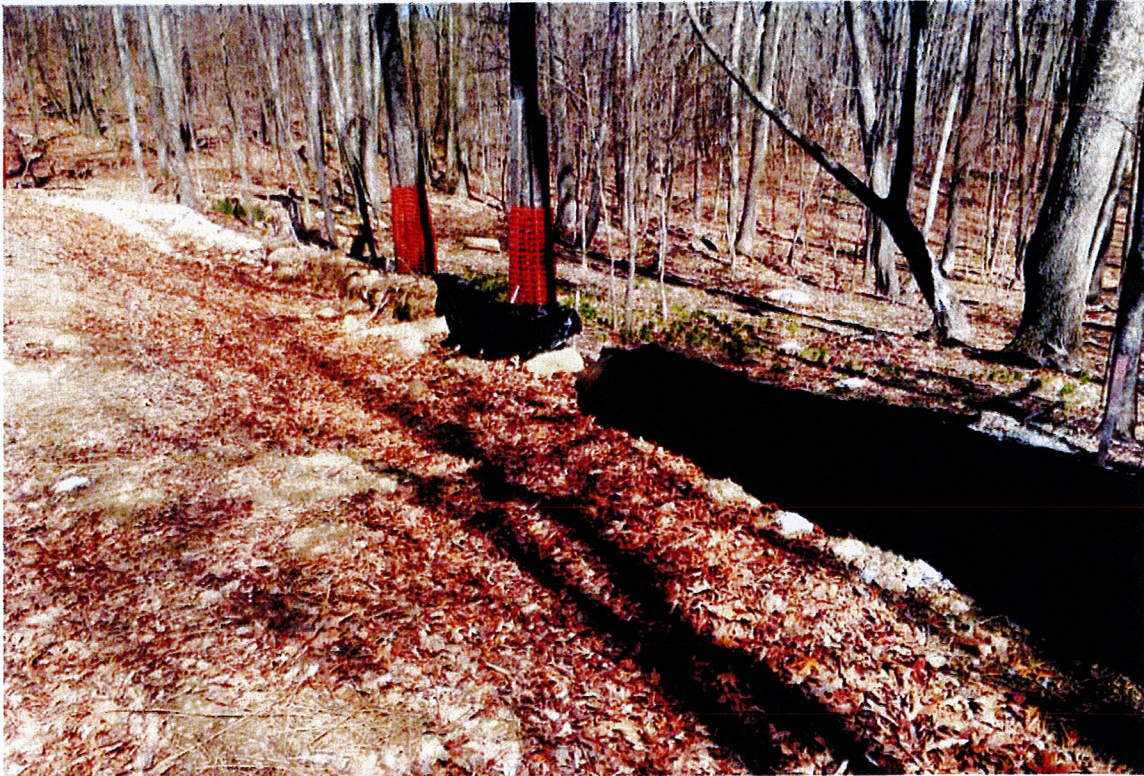
Photo 3: View of broken silt fencing looking north.

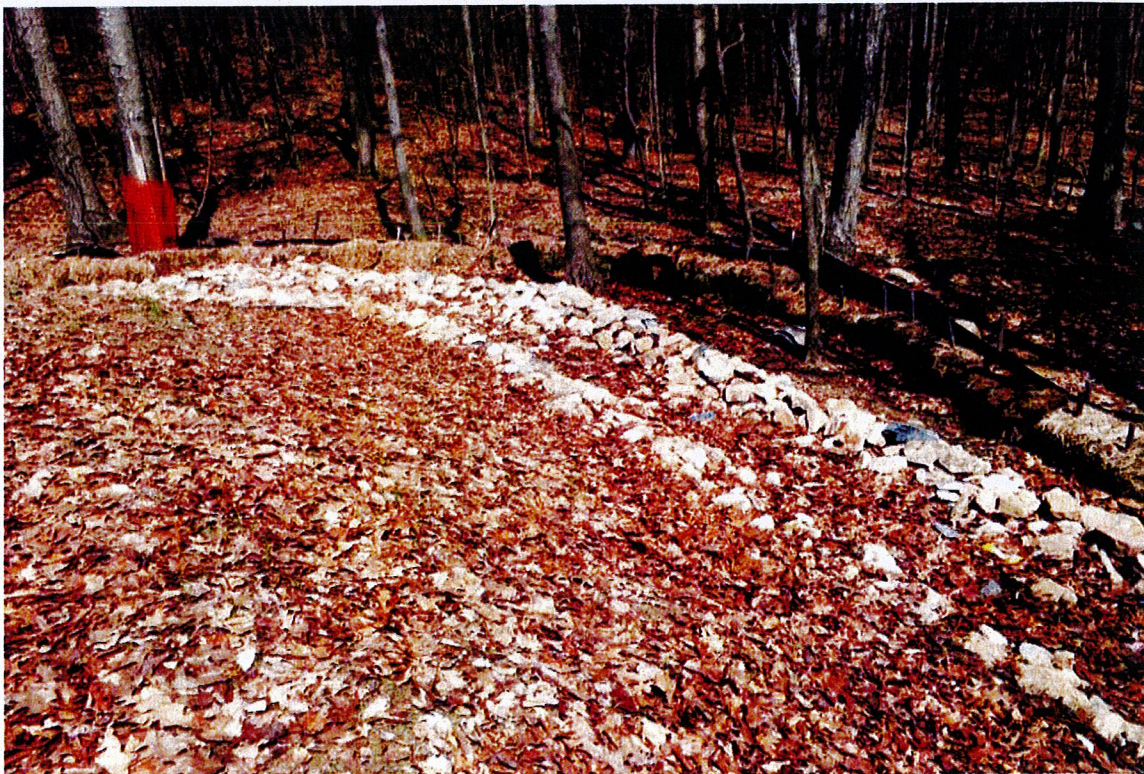
Photo 4: View of constructed rip rap drainage swale looking northeast.

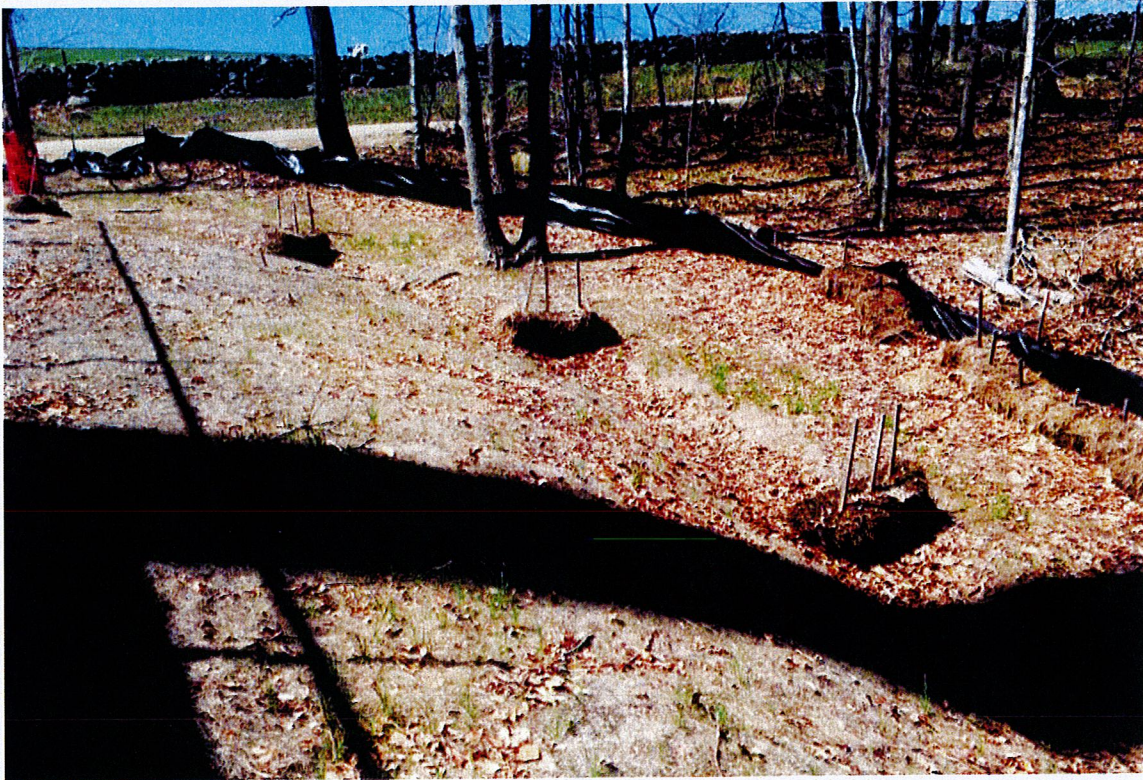
Photo 5: View of drainage swale and straw bale check dams looking northwest.

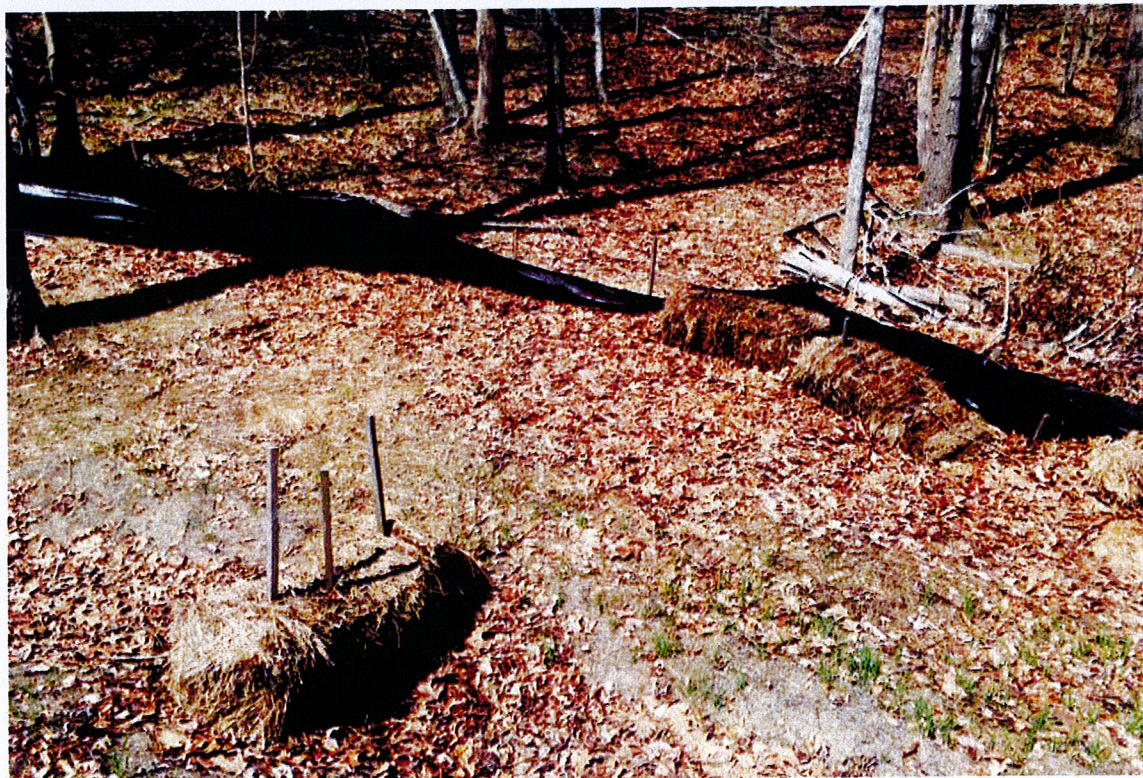
Photo 6: View of broken silt fencing looking north.

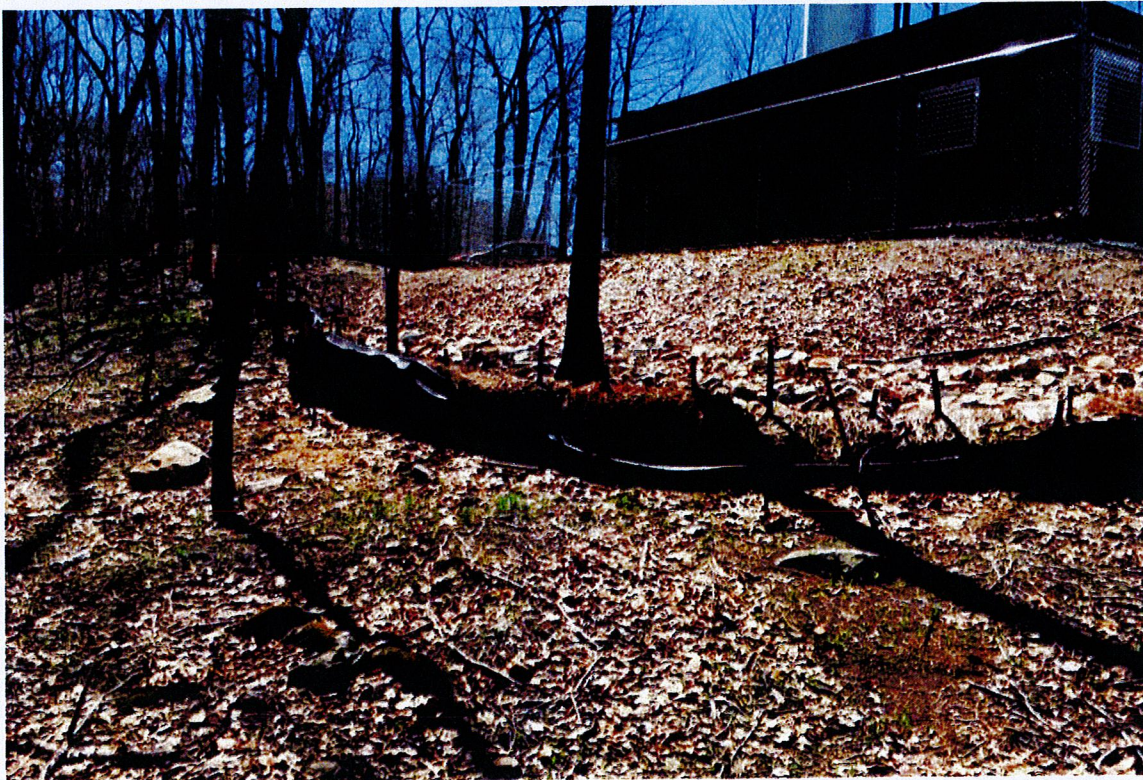
Photo 7: View of broken silt fencing looking southwest.

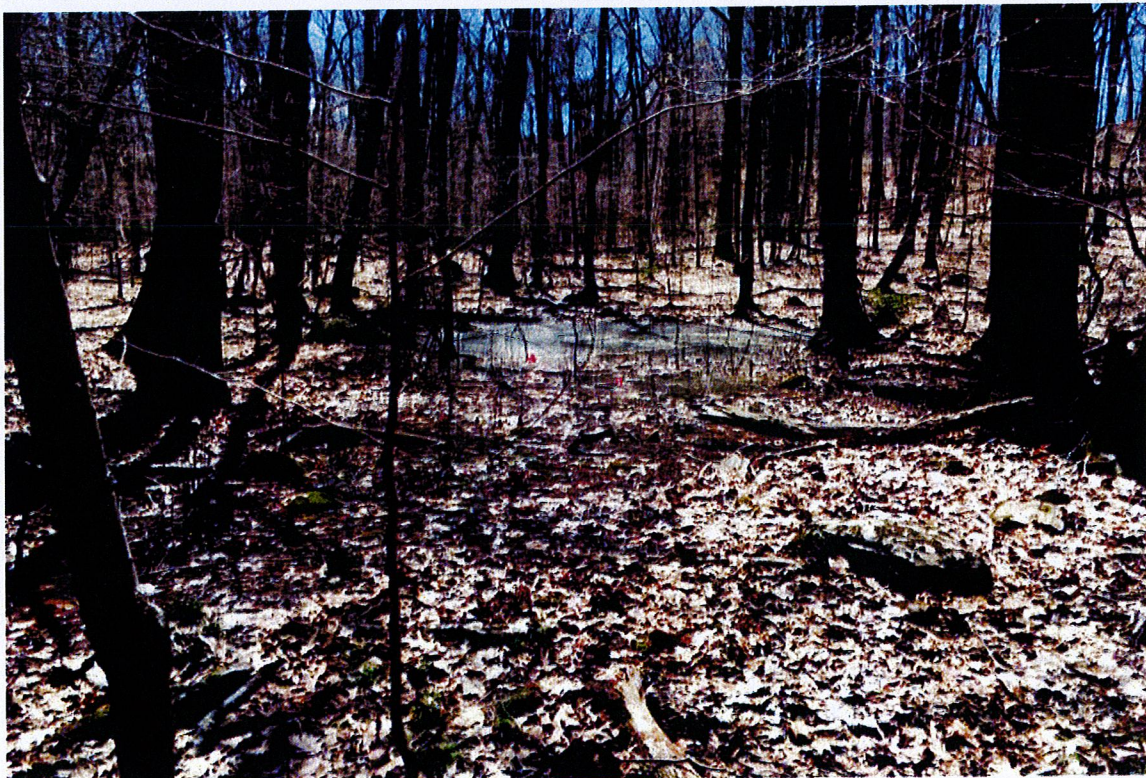
Photo 8: View of vernal pool looking southwest.

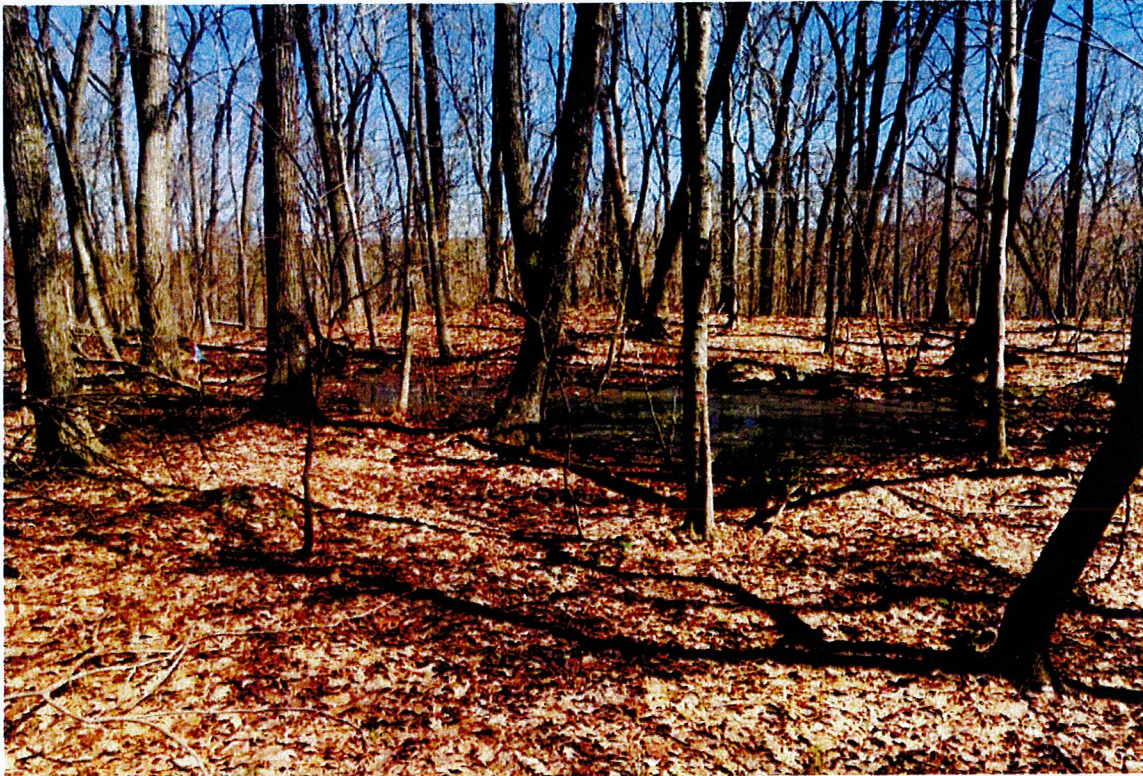
Photo 9: View of vernal pool with approximately 10 inches of inundation looking northeast.

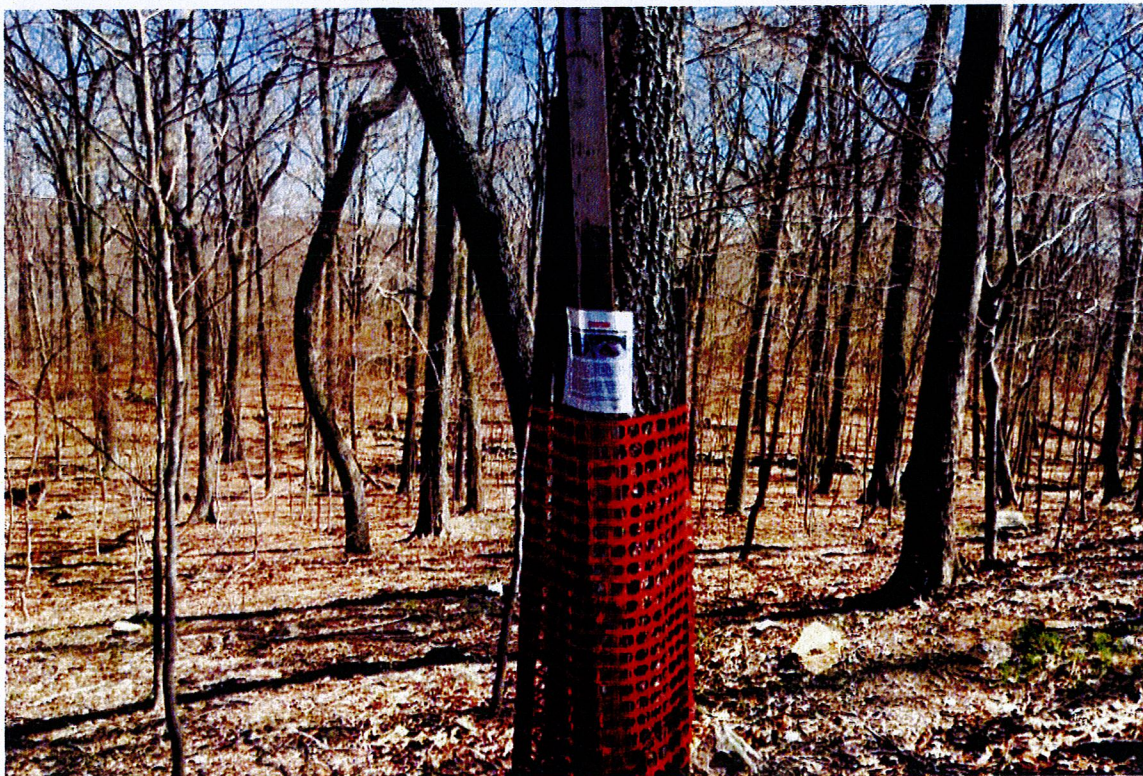
Photo 10: View of signage posted.

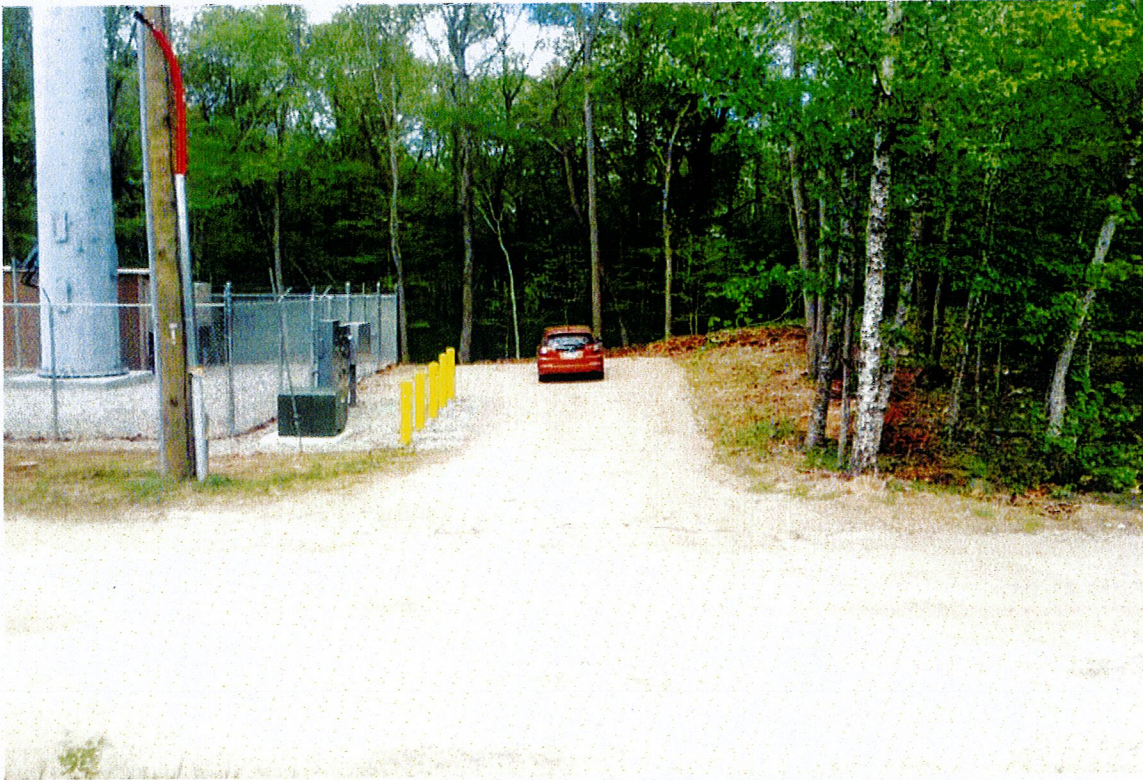
Photo 1: View of access road entrance looking northeast.

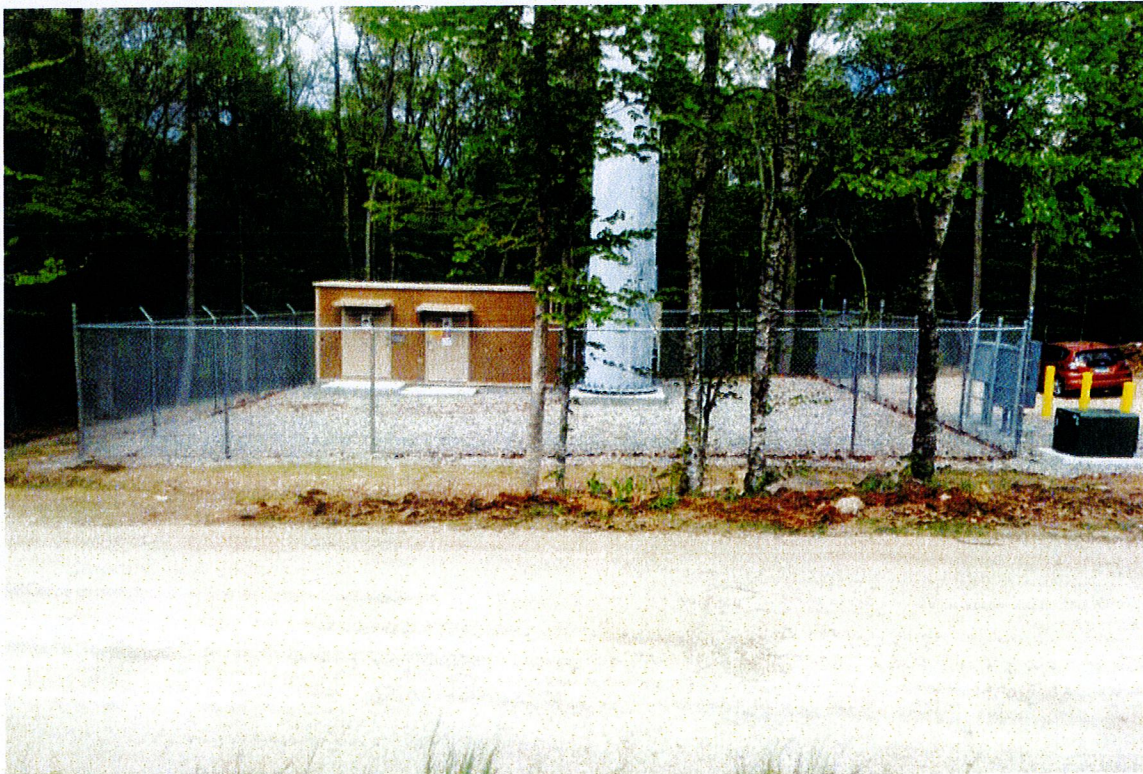
Photo 2: View of facility looking northeast.

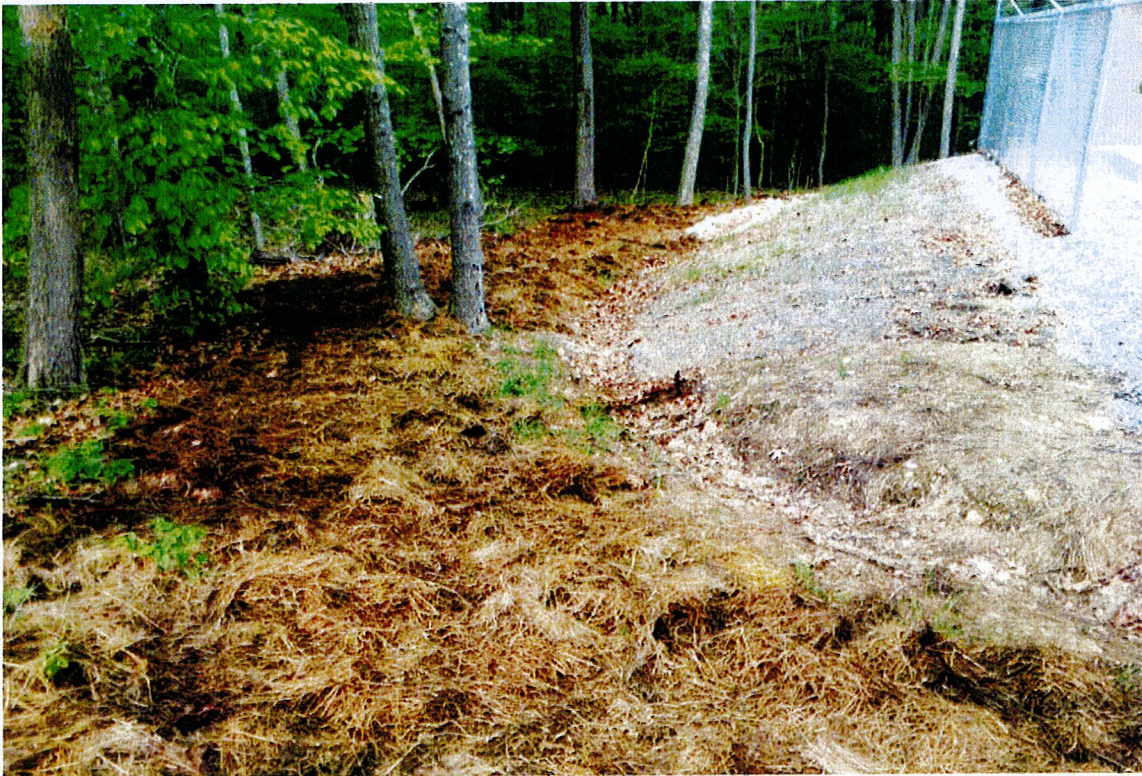
Photo 3: View of north side of compound looking northeast.

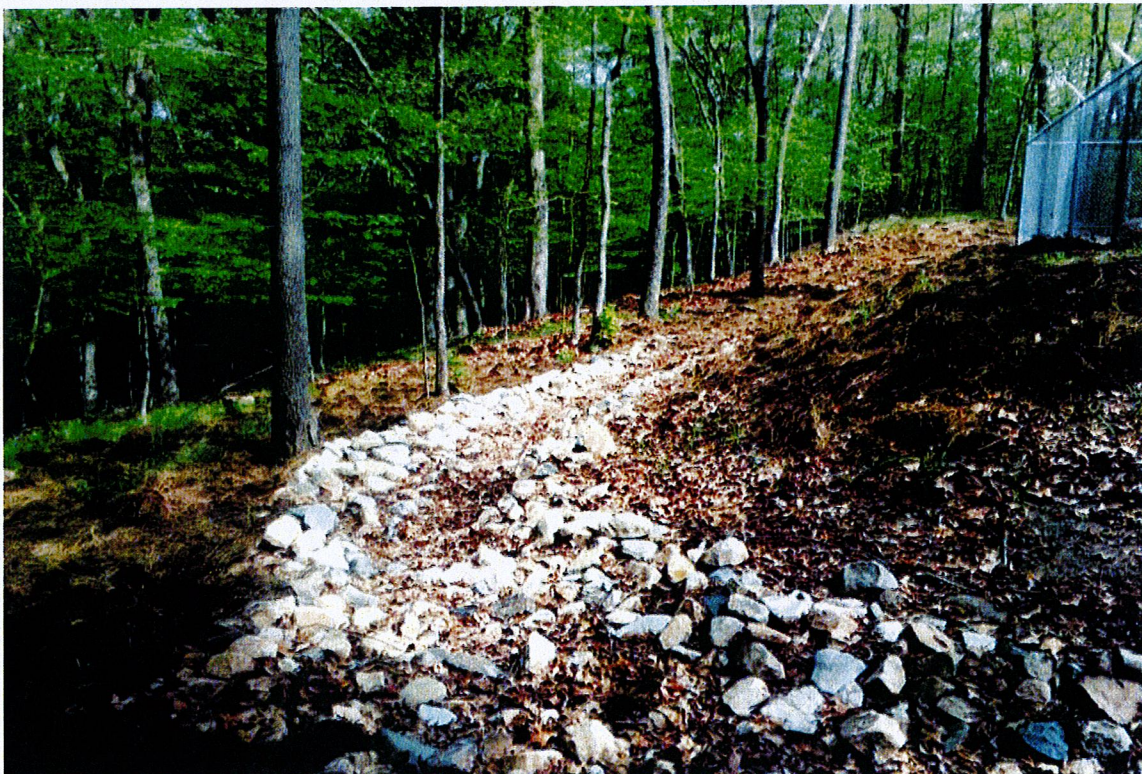
Photo 4: View of eastern side of compound looking southeast.

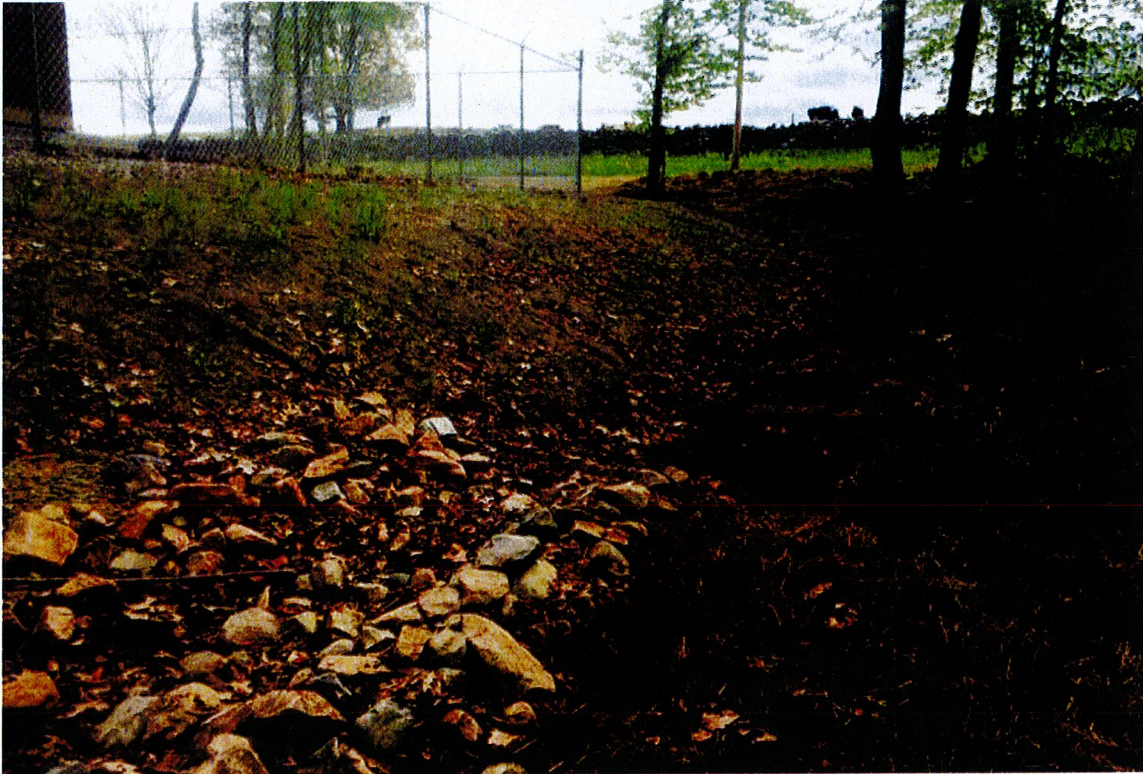
Photo 5: View of northern side slope to compound looking southwest.

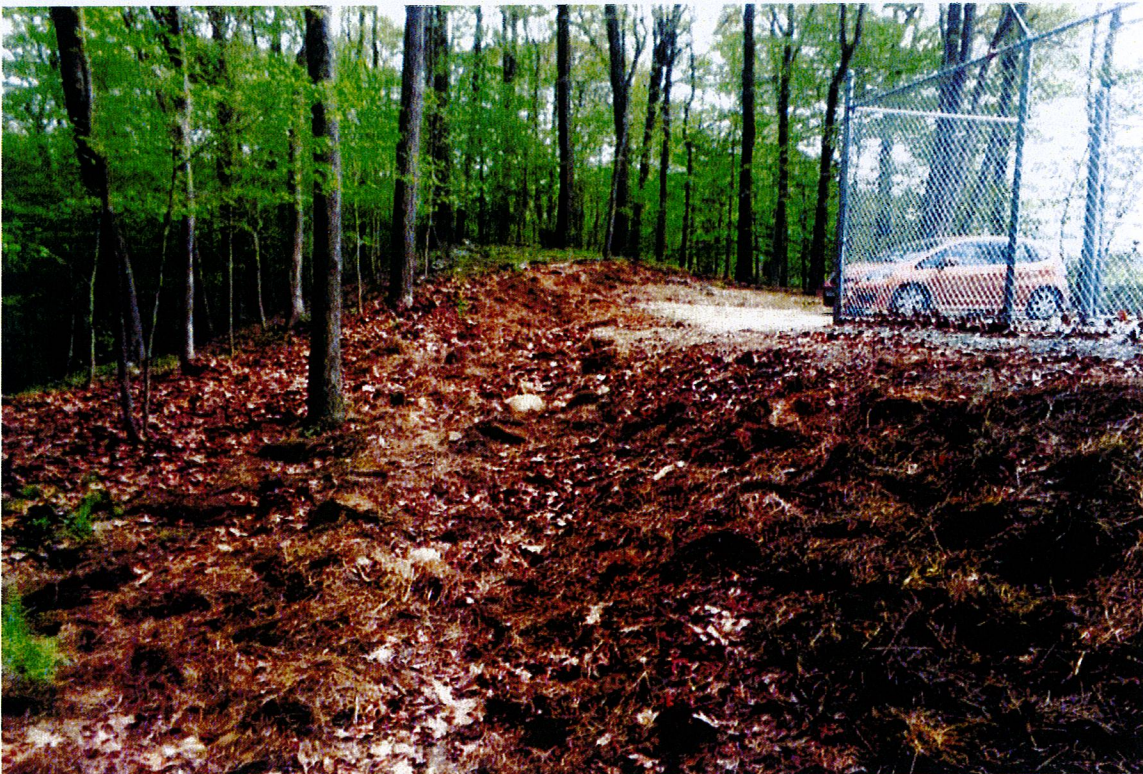
Photo 6: View of dispersed straw bales looking southeast.

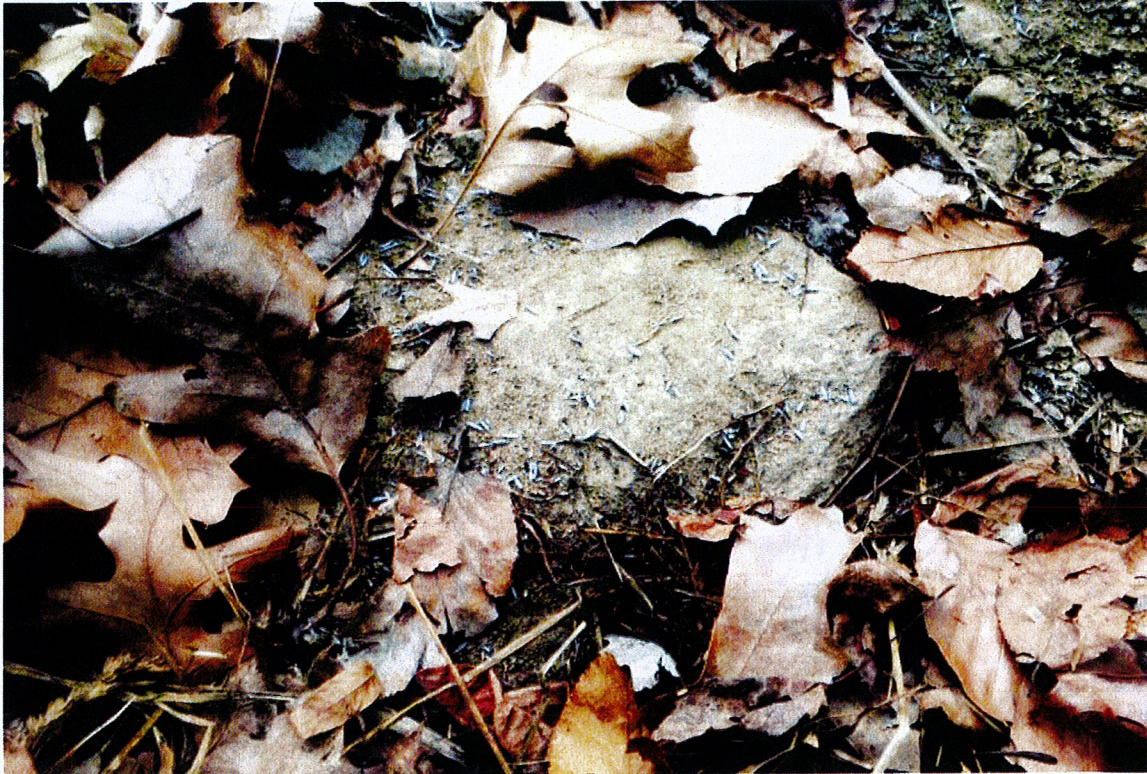
Photo 7: View of the seed mix disbursed.
