ENVIRONMENTAL MONITORING
DAILY SITE OBSERVATION FORM

Report No. 3

Project: Verizon Wireless Plymouth West Relo Facility
 Address: 33 Keegan Road, Plymouth, Connecticut

APT Project #: CT1412030

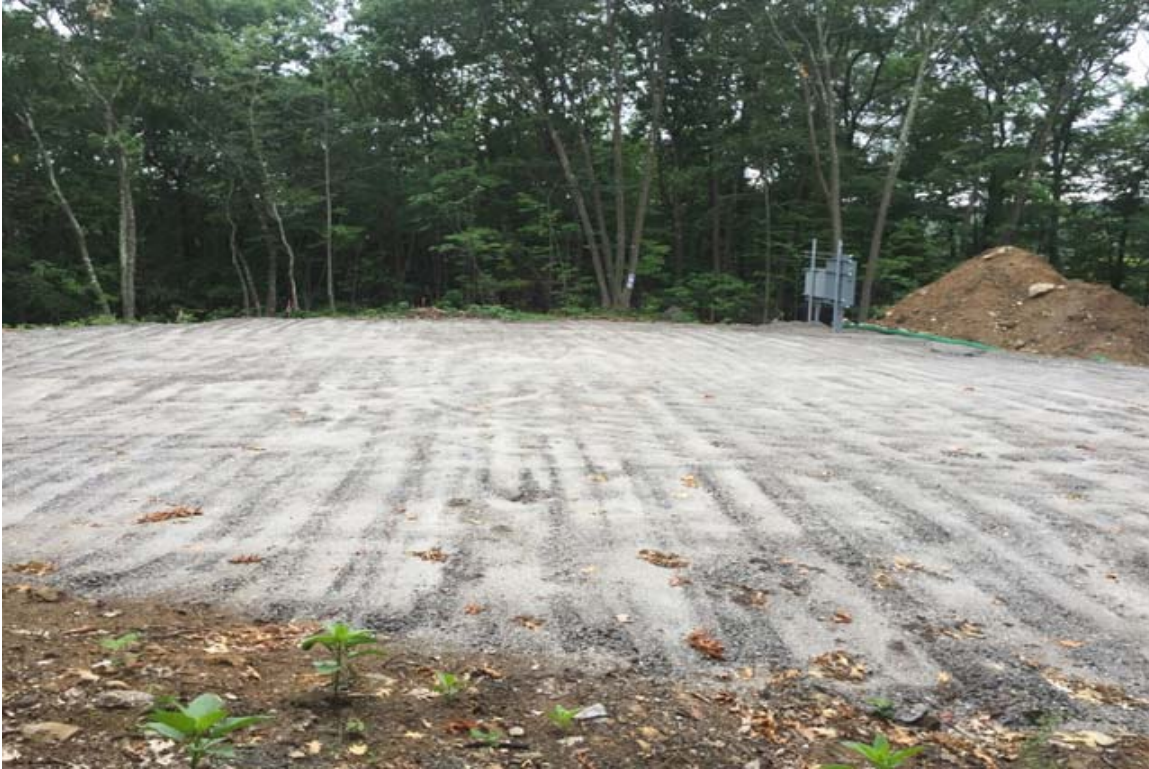
Photo 1: View of compound looking south.

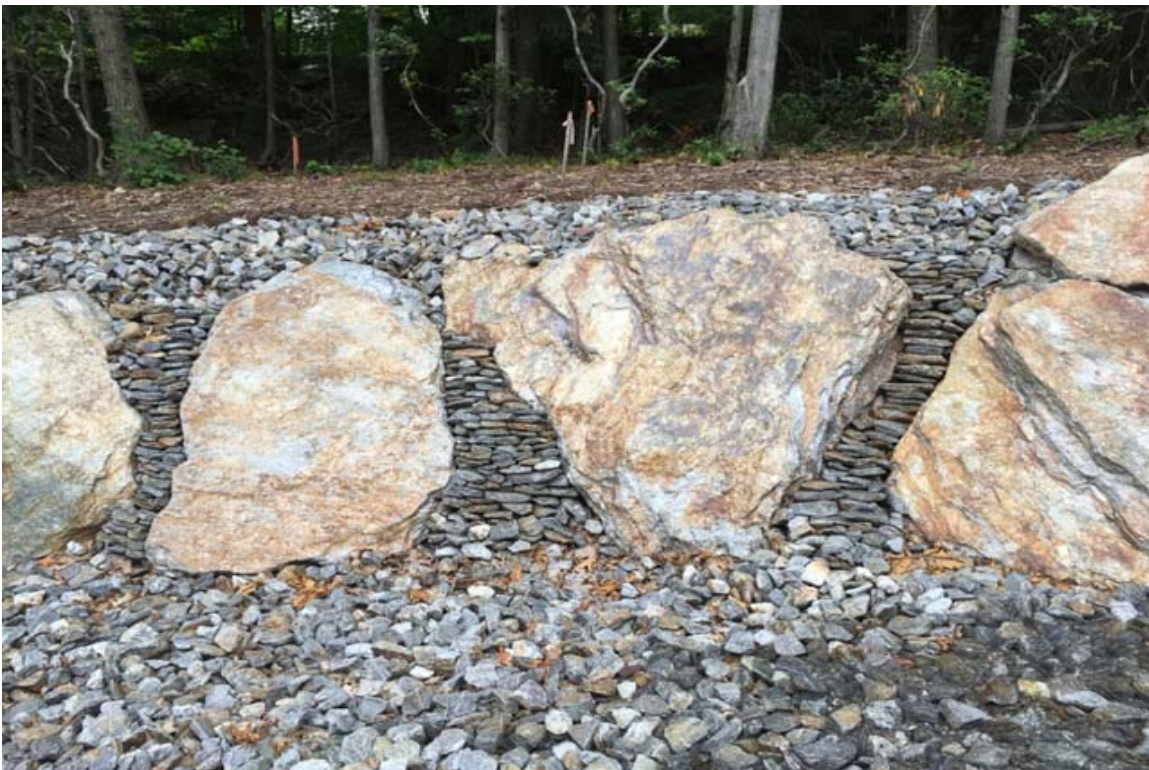
Photo 2: View of drainage swale and stone retaining wall on north side of access.

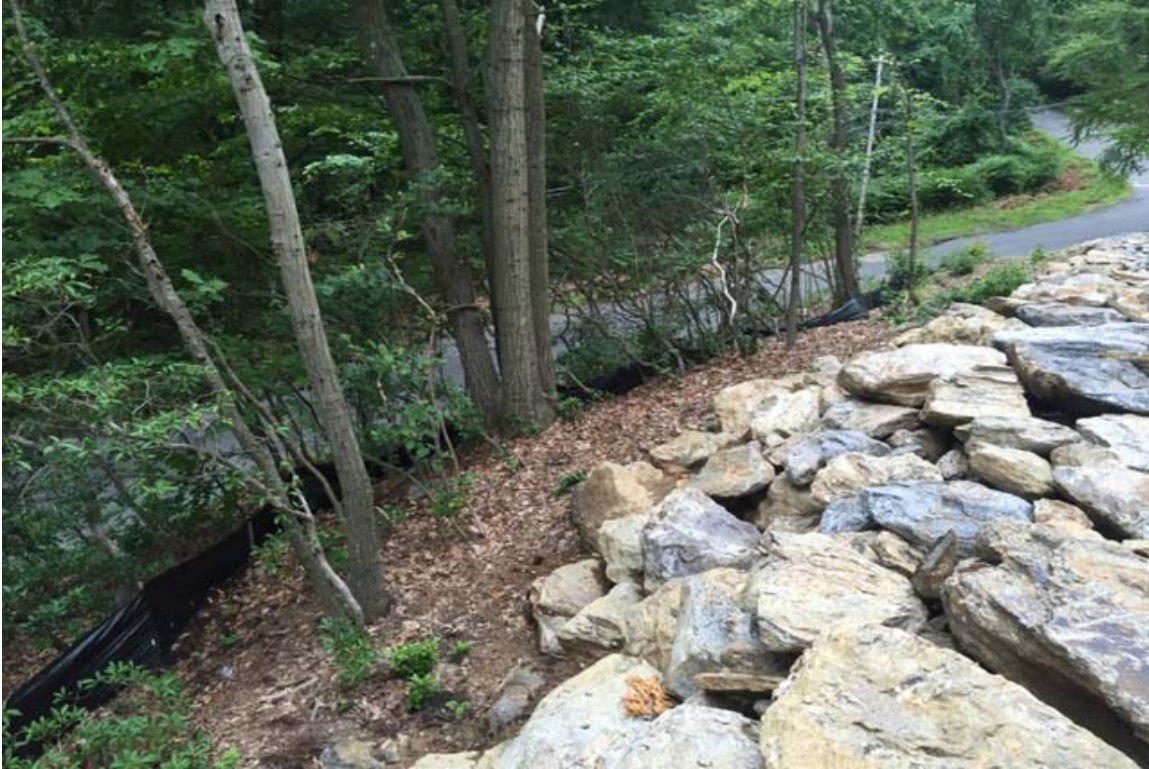
Photo 3: View of silt fence along west of access road entrance in good condition.
CA #1 implemented.

DESCRIPTION OF OBSERVED ACTIVITY	
Compliance Level:	
Communication <input type="checkbox"/> Acceptable <input type="checkbox"/> Problem Area <input checked="" type="checkbox"/> <ul style="list-style-type: none"> <input checked="" type="checkbox"/> Minor Exclusion Fencing Repair <input checked="" type="checkbox"/> Additional Exclusion Fencing Required <input checked="" type="checkbox"/> Sediment release into upland habitat without risk of resource impact Non-Compliance <input type="checkbox"/> <ul style="list-style-type: none"> <input type="checkbox"/> Sediment release into upland habitat with risk of resource impact <input type="checkbox"/> Sediment release into wetland habitat <input type="checkbox"/> Sediment release into watercourse 	
Issues Requiring Corrective Action ("CA")	Corrective Action Implemented
CA #1- silt fence install along west side of access road entrance (only compost filter sock installed) per site plan C-1	4/8/16

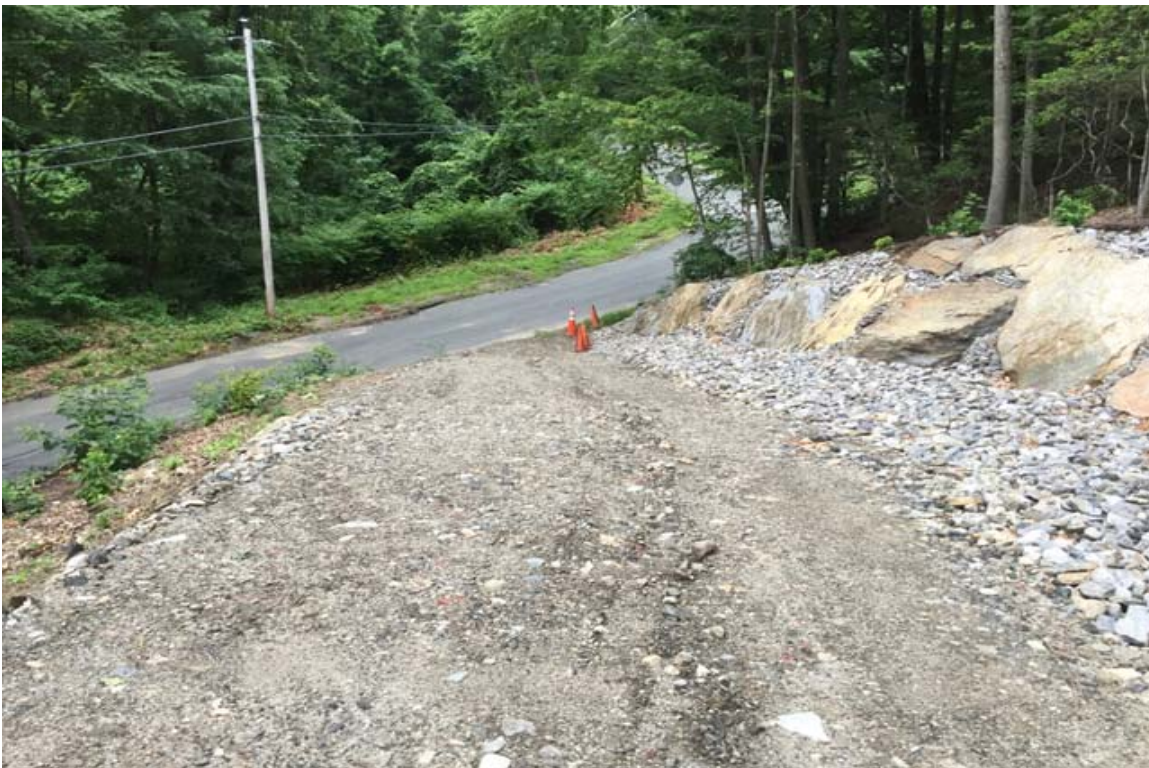
Photo 4: View of drainage swale along north side of access road preventing siltation onto Keegan Road. CA #2 implemented.

CA #2 – controls to prevent siltation out on Keegan Rd needed (temp swale providing some control – no releases noted)	4/8/16
CA #3 – E&S control along west side of compound required per site plans C-1; minor erosion observed	4/8/16
CA #4 – west side of soil stockpile, remove sediment build up and temporary seed stockpile	
CA #5 – west side of compound south of access road – add perimeter control for runoff and sediment discharge from rill erosion on west compound slope	
CA #6 – access road entrance – repair silt fence at south end	
CA #7 – east catch basin on Keegan Road – clean out clogged silt sock	
Project Modification Requested:	
Extra Work Space Requested <input type="checkbox"/> Change to Work Area <input type="checkbox"/> Description of Modification: N/A	
Notes:

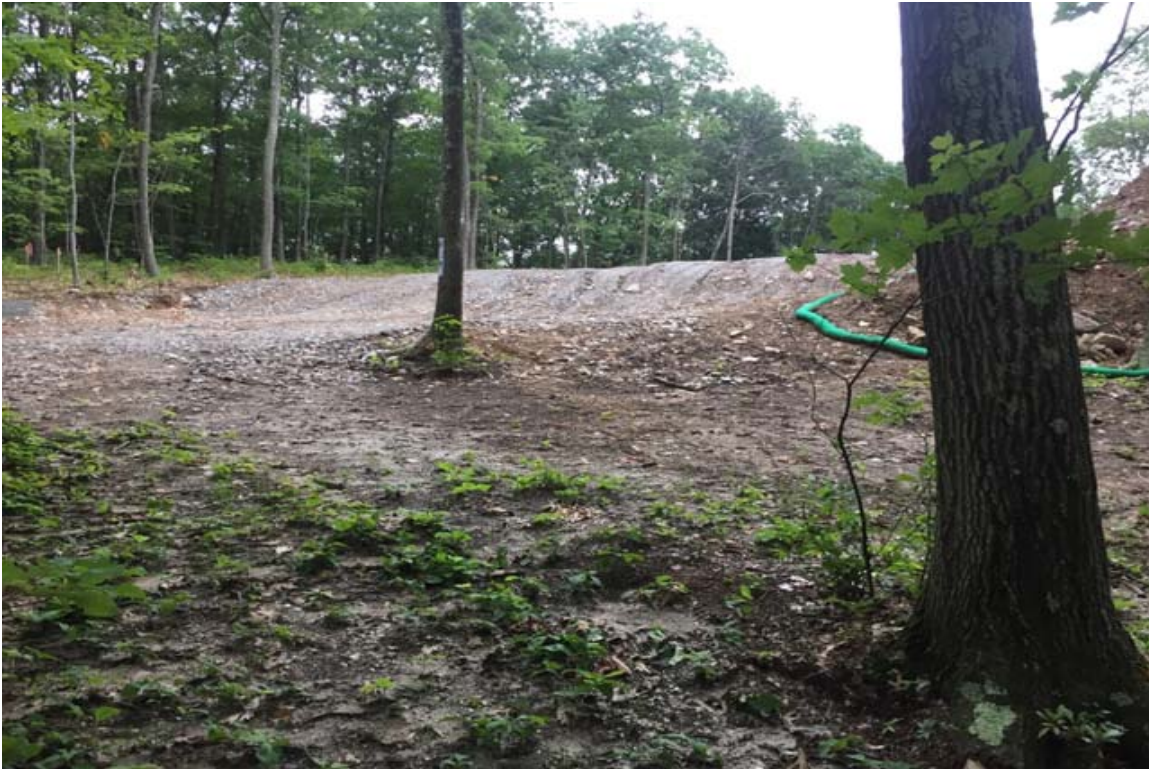
Photo 5: View of compost filter sock along portion of west side of compound. CA#3 implemented. Perimeter control needs to extend further to north to control rill erosion - CA#5.

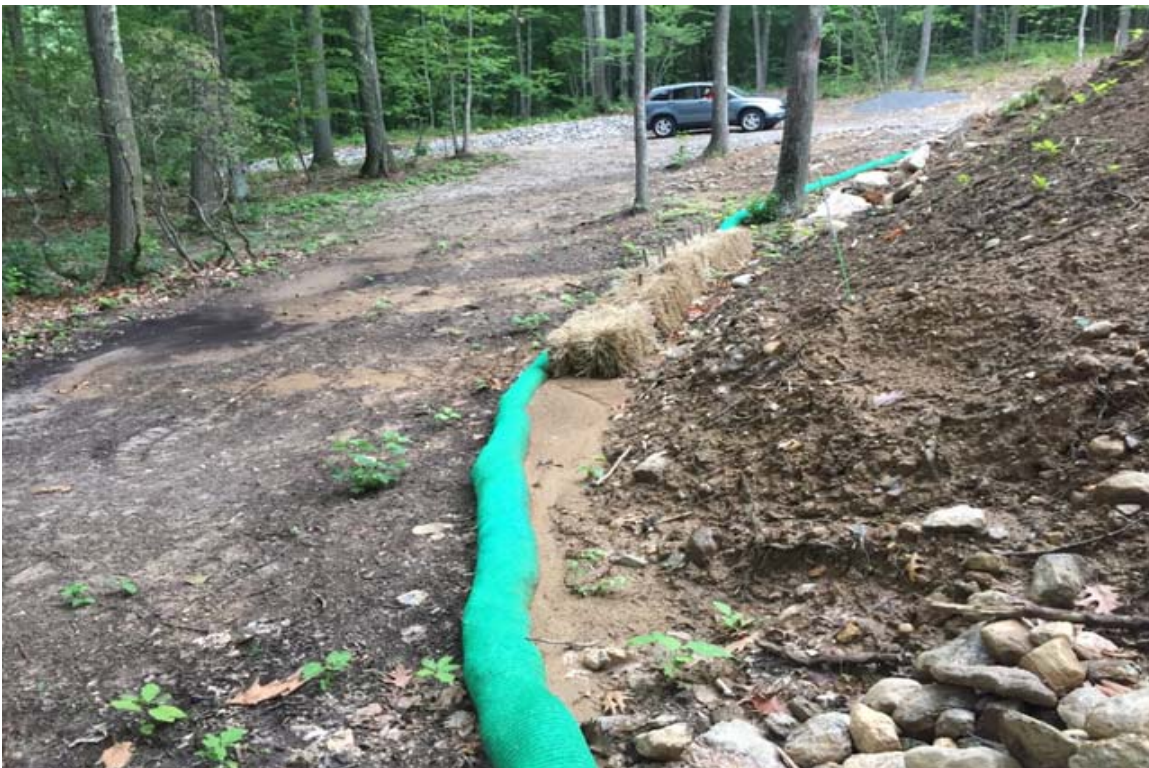
Photo 6: Clean out sediment buildup around west side soil stockpile and temporary seed stockpile looking north – CA #4.

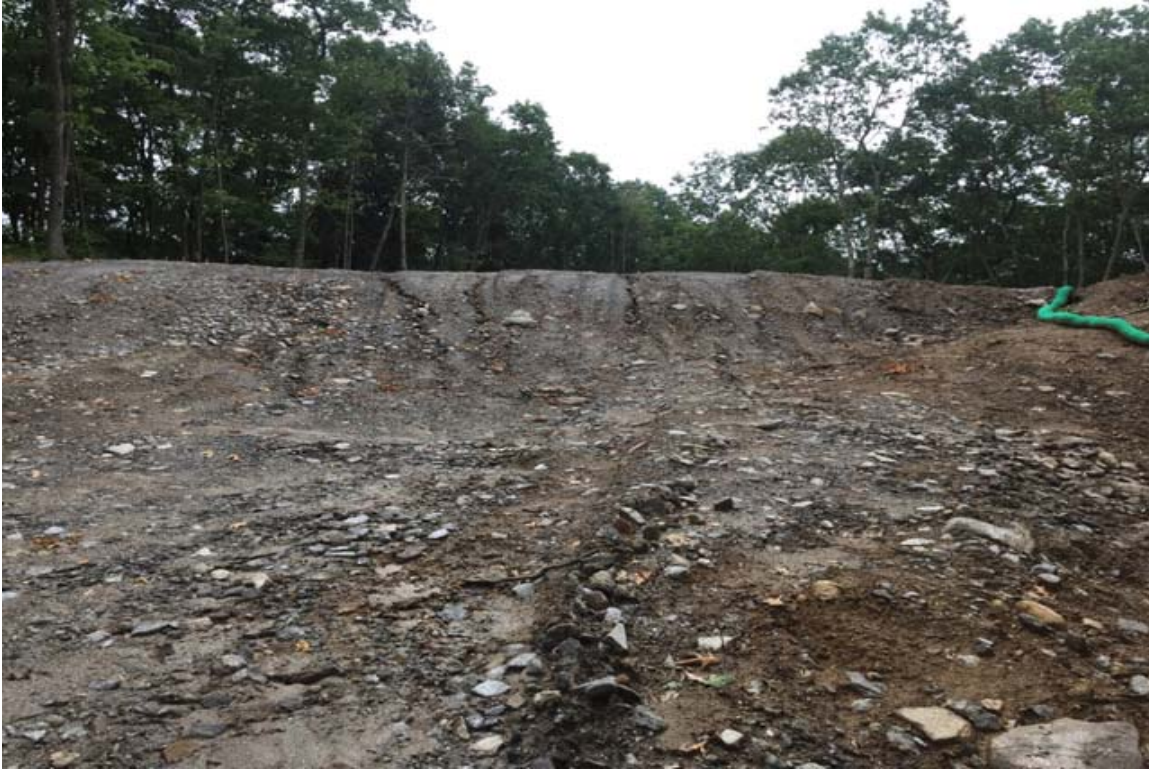
Photo 7: View of minor rill erosion along west side of compound, south of access road
- add perimeter control – CA #5.

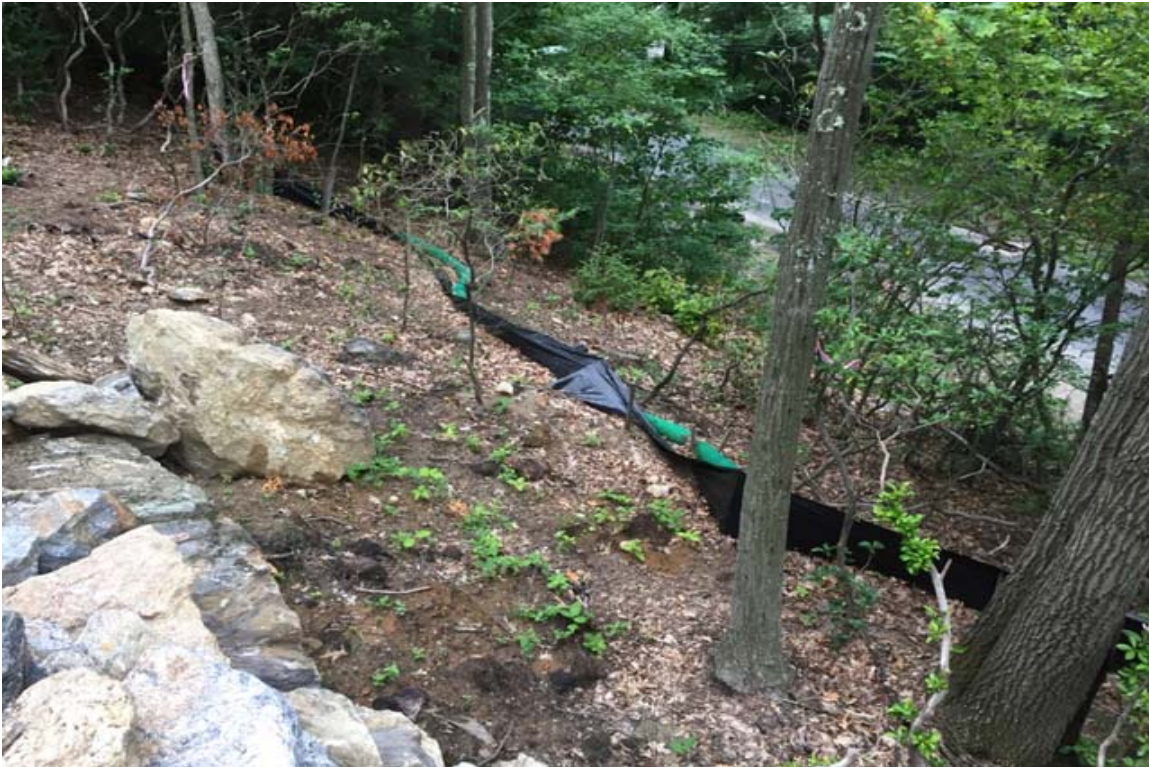
Photo 8: Repair silt fence along access road entrance perimeter control south end, looking southwest with Keegan Road in background.

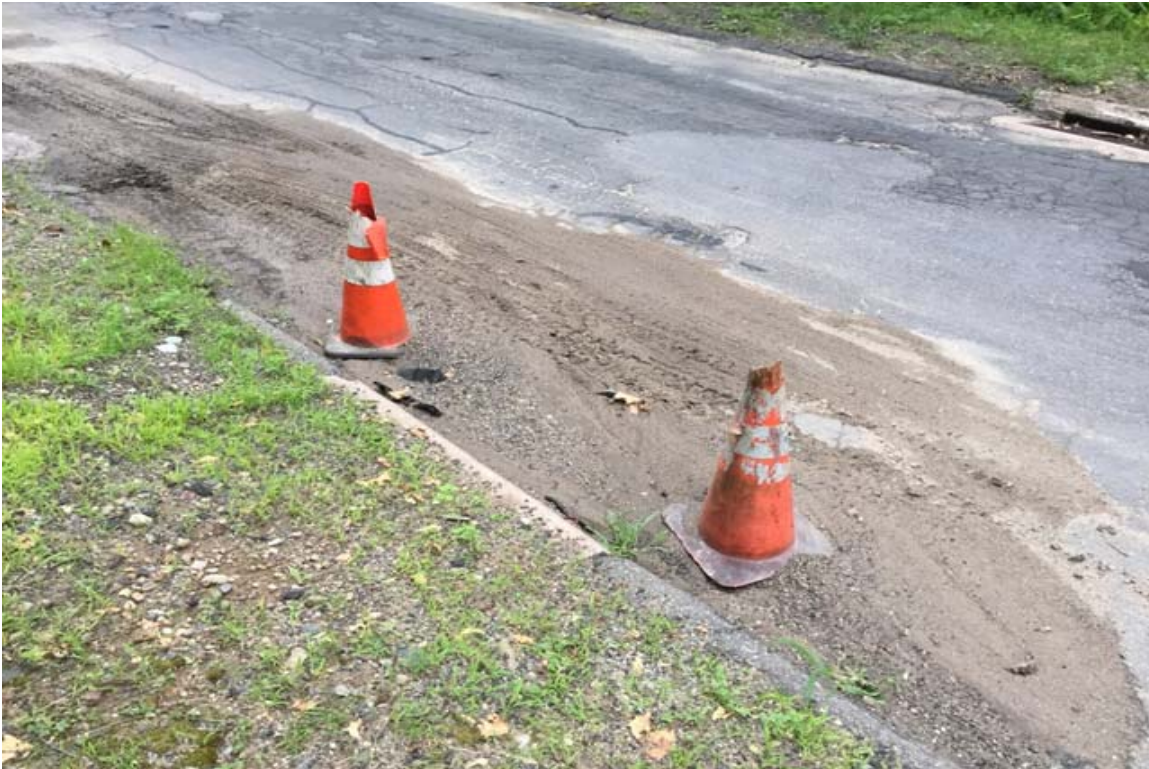
Photo 9: Clean out sediment clogged catch basin silt sock – CA #7.

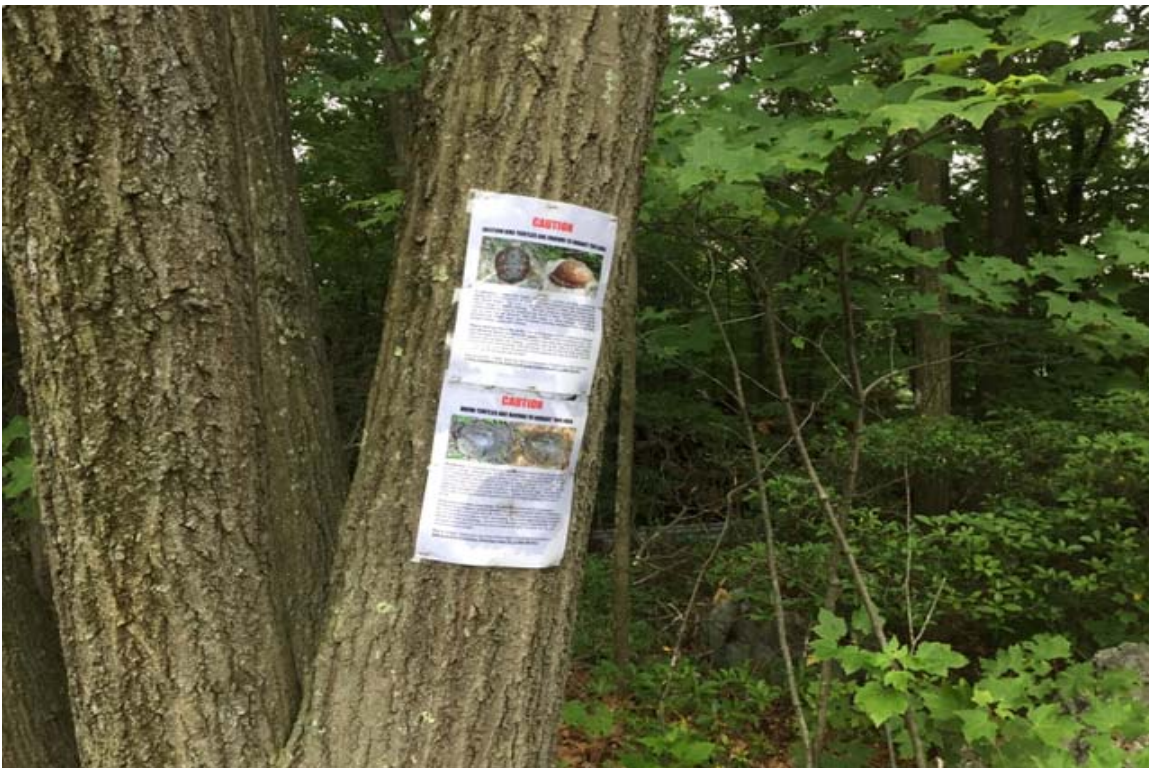
Photo 10: View of turtle protection signs at compound looking southeast.
