Re: **Docket No. 462 – Cellco Partnership d/b/a Verizon Wireless
15 Great Pasture Road, Danbury, Connecticut
Environmental Monitoring Daily Site Observation Form – Report No. 2**

**ENVIRONMENTAL MONITORING
DAILY SITE OBSERVATION FORM**

Report No. 2

Project: Verizon Wireless Bethel West 2 CT Facility
Address: 15 Great Pasture Road, Danbury, Connecticut

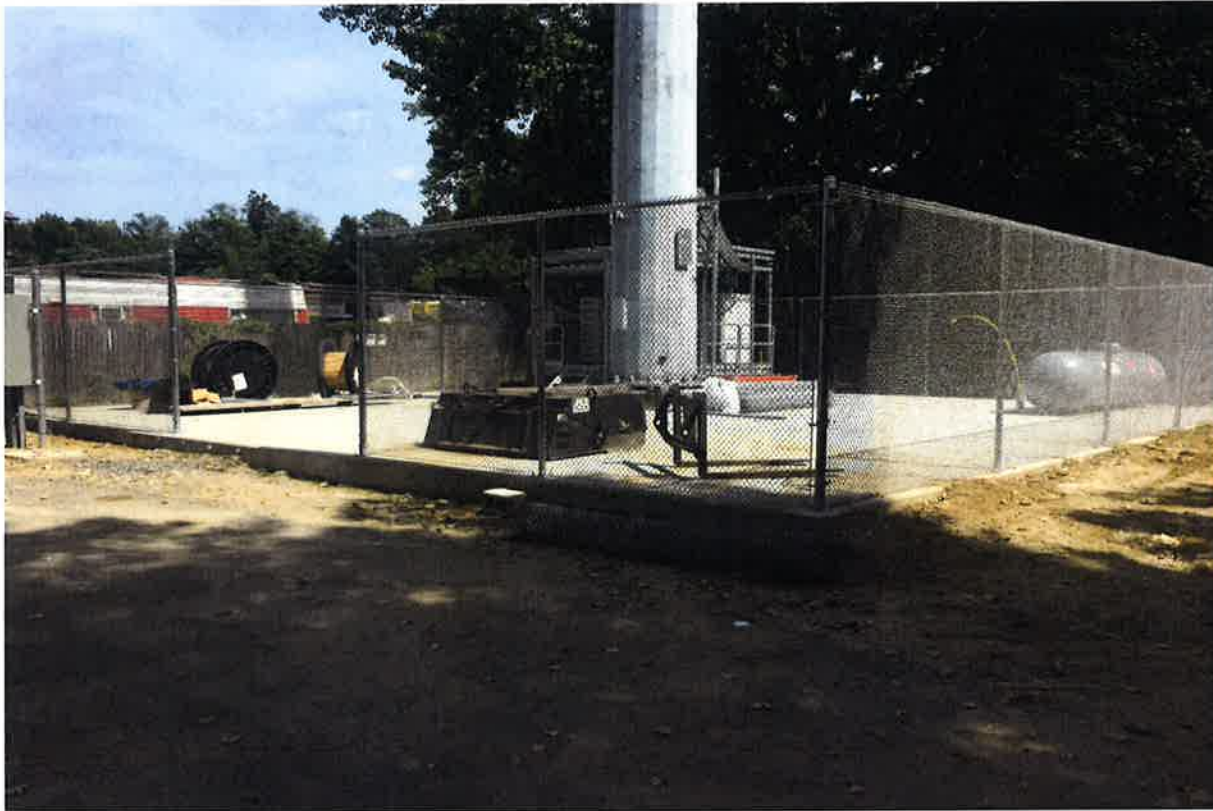
Photo 1: View of compound area looking south.

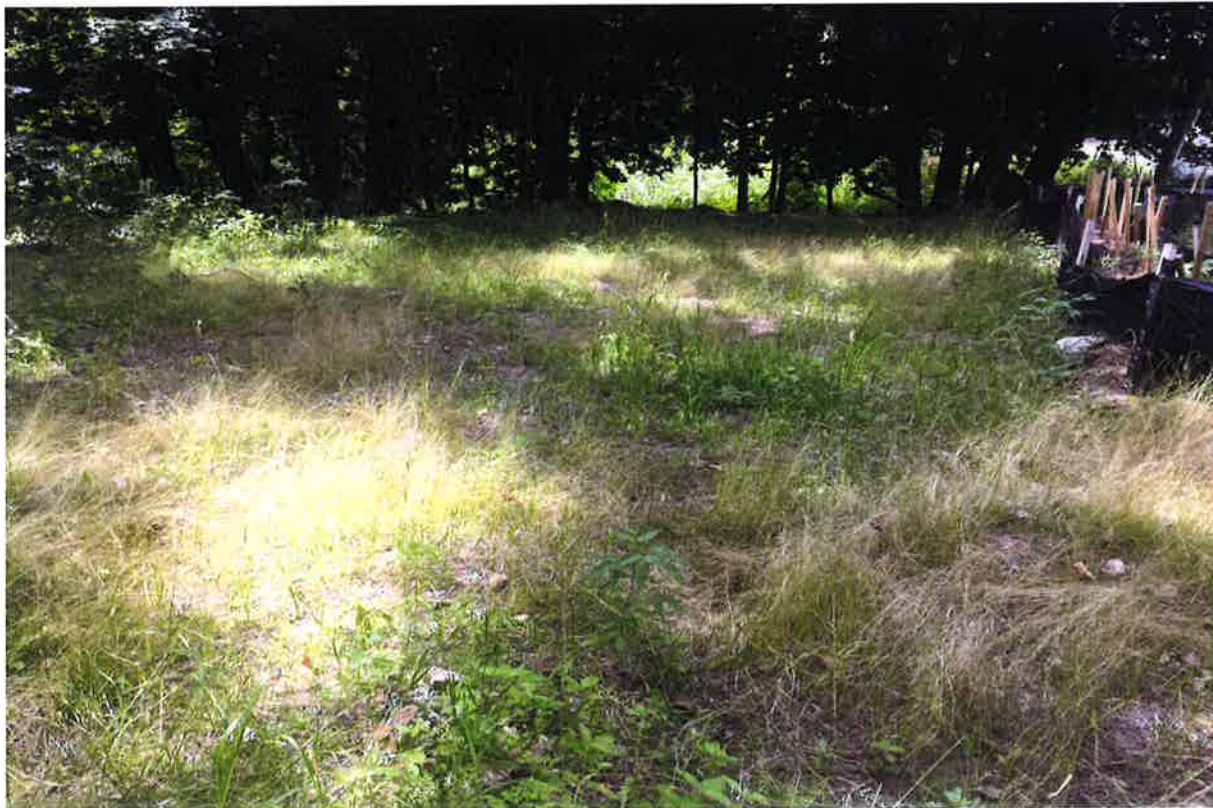
Photo 2: View of stabilized areas outside silt fence (completed CA #3) looking north.

CA #1 – close gap at east end against wooden stockade fence	4/11/17
CA #2 – add haybales at east end of erosion controls	4/11/17
CA #3 – seed and mulch exposed soils outside of silt fence	4/11/17
CA #4 – add haybales at west end of erosion controls	4/11/17
CA #5 – silt fence and haybales knocked over at west end - need repair	
Project Modification Requested:	
Extra work space requested <input type="checkbox"/> Change to work area <input type="checkbox"/> Change to stormwater feature <input type="checkbox"/> Description of Modification: N/A	
Notes:	
<p>4/3/17 – Silt fence/haybale erosion controls inspected with minor issues noted (CA #1-#4). All corrective actions were completed by 4/11/17. Construction activities and earthwork may commence.</p> <p>7/21/17 – Tower has been erected and antenna installed. The compound is under construction with good seed germination outside perimeter controls, no release of sediment noted.</p>

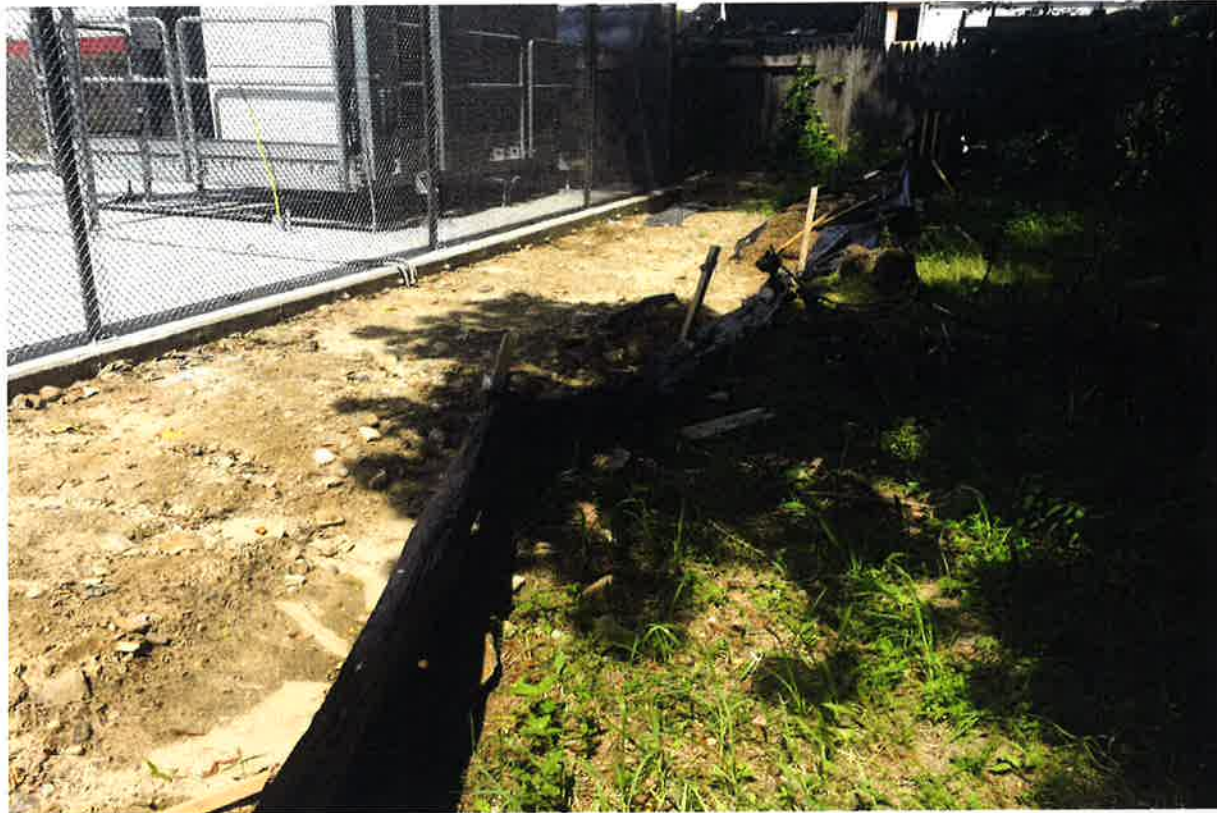
Photo 3: View of CA #5, repair perimeter controls, looking west.

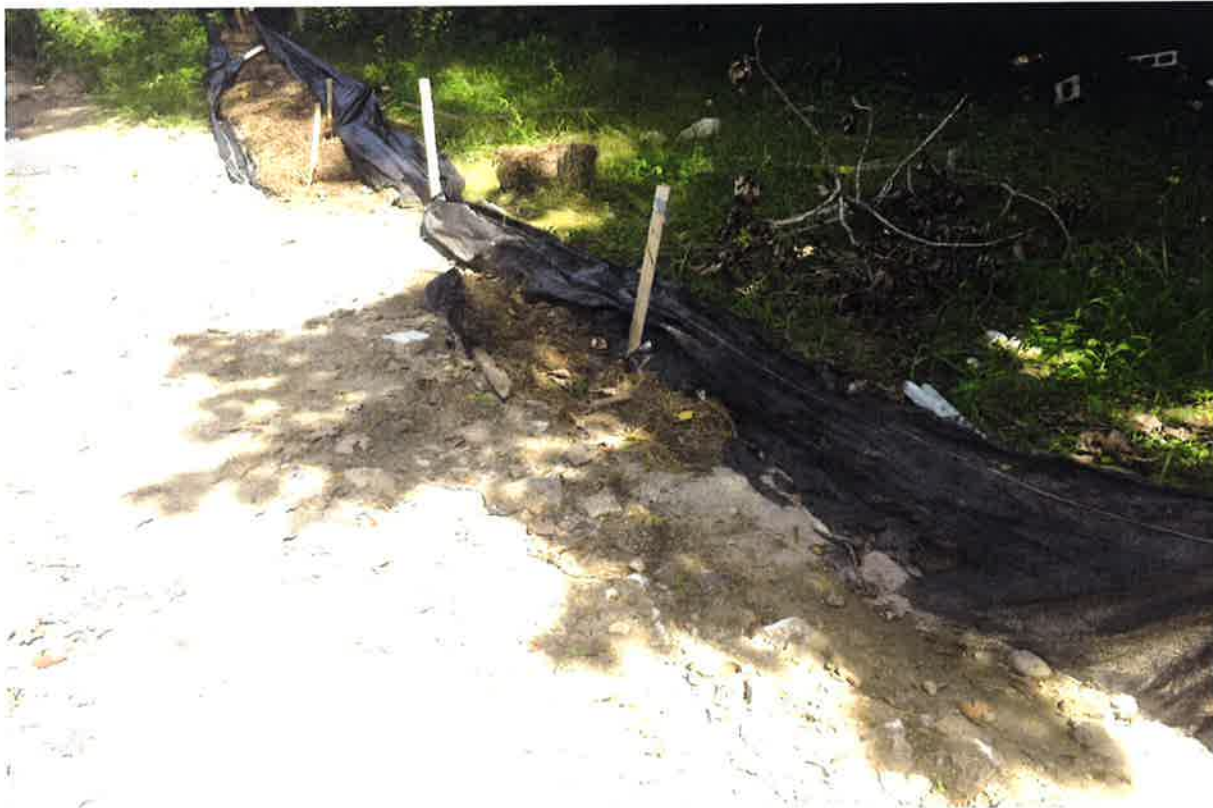
Photo 4: View of CA #5, repair perimeter controls, looking west.

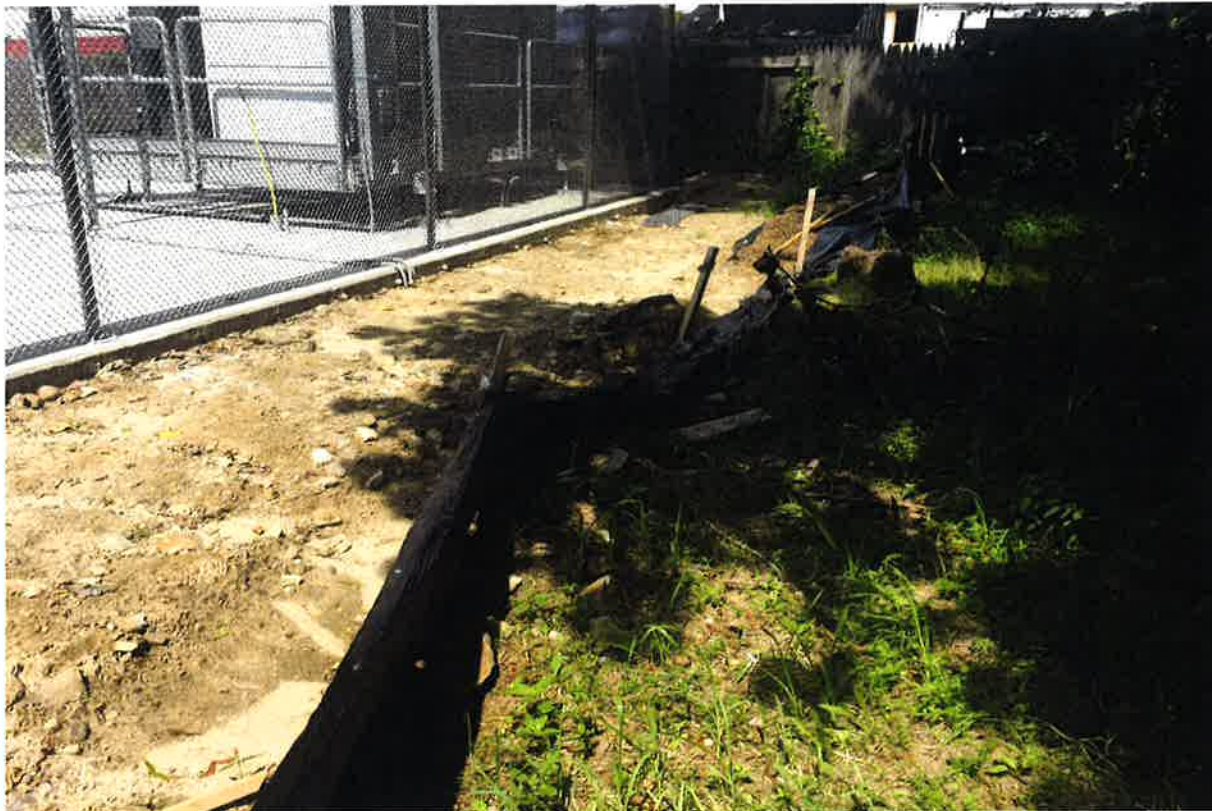
Photo 5: View of CA #5, repair perimeter controls, looking west.

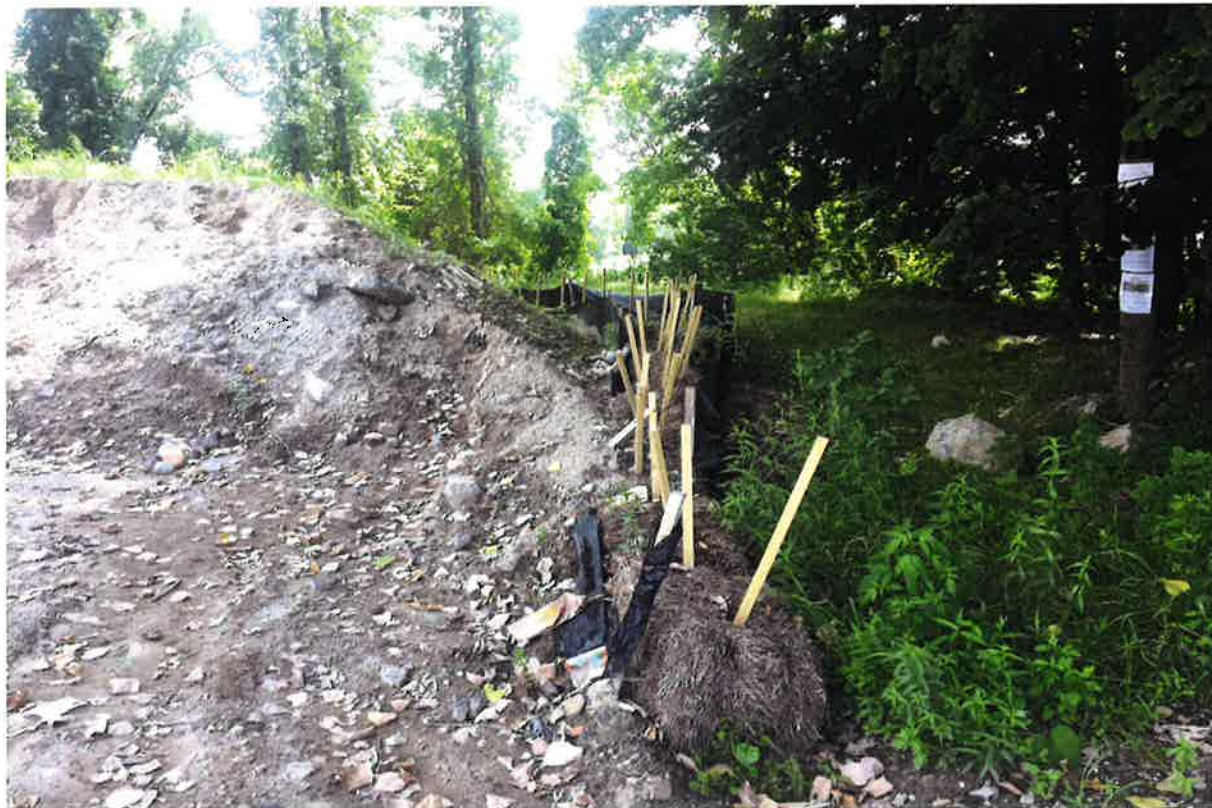
Photo 6: View of haybales added at west end of silt fence (completed CA #5) looking south.
