**Subject: Docket No. 466, Frost Bridge to Campville 115-kV Project
Decision and Order Condition #4 – Independent Environmental Inspector Report**

Please find enclosed the Biweekly Independent Environmental Inspector Report, Report #30, for the **January 19th** and **January 26th, 2018**, inspection events for the construction of the Eversource Frost Bridge to Campville 115-kV Project.

Docket No. 466- Development and Management Plan Inspection

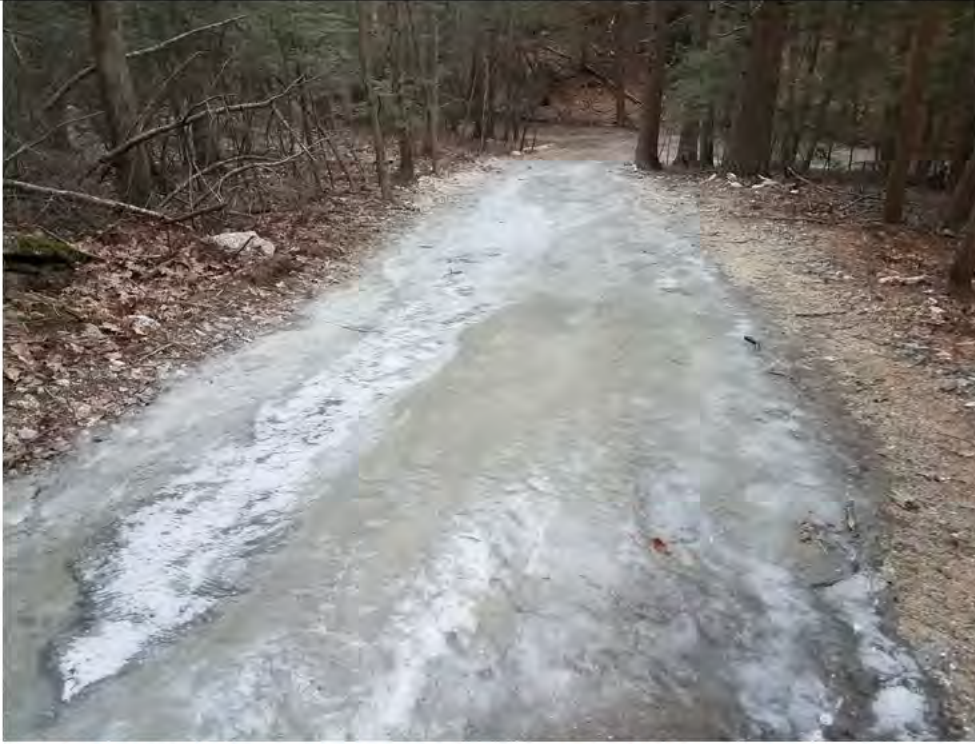
Areas of Inspection		Observation:	Recommended Action/s:	Corrected Action/s:
Access Roads and Adjacent Roadways	Interim Week	N/A	N/A	
	Bi-Week	Ice covering portions of access roads. The most severe condition is on the access road between Str44 and Str45, ice is covering the full width and more than 200-feet in length (see photo 1). ↓	Make area safe. State Designated Recreation Trail abuts the access road. The trail, pedestrian access, and vehicle ROW access are impacted.	PENDING
Vegetative Clearing Limits (Including trees to save or danger trees noted.	Interim Week	CONTINUED FROM ABOVE SECTION- The access road below Str73 down to W-E2 is ice covered and rills are visible (see photo 2). Surface water flow from upland drainage and non-stabilized Str73 pad area. Water flow was observed flowing below the ice sheet at the time of this inspection.		
	Bi-Week	N/A	N/A

Photo 1: 01/26/2018, Watertown: Map 15, ice sheet on the access road between Str44 and Str45.

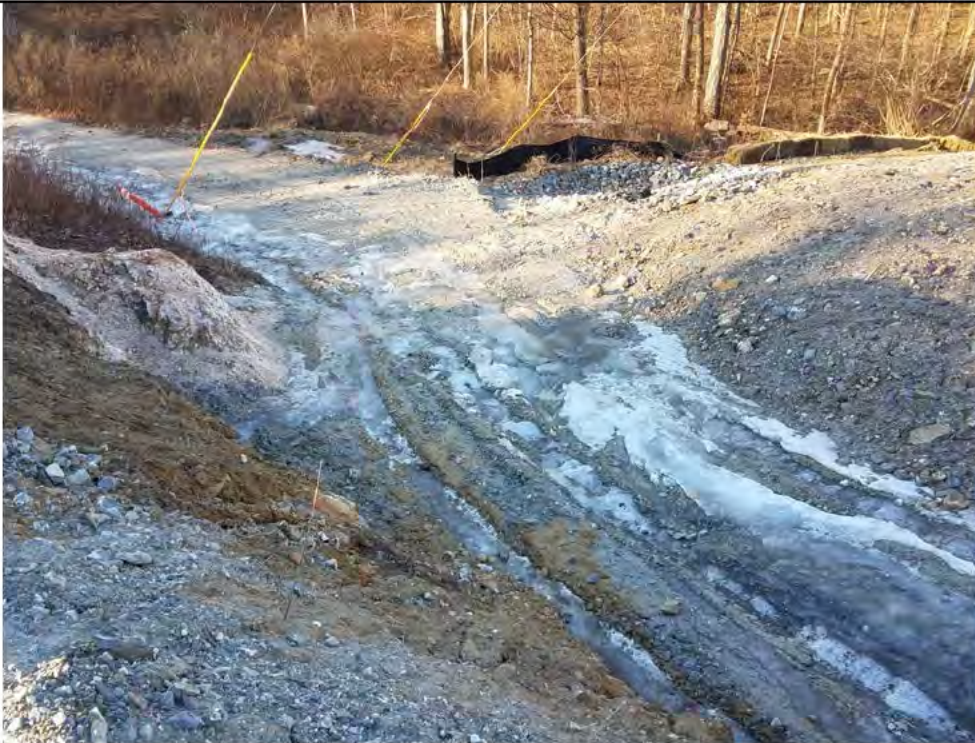
Photo 2: 01/26/2018, Litchfield: Map 26, ice sheet and visible rills on the access road below Str73 down to wetland W-E2, runoff from upland drainage and from the pad for structure Str73.

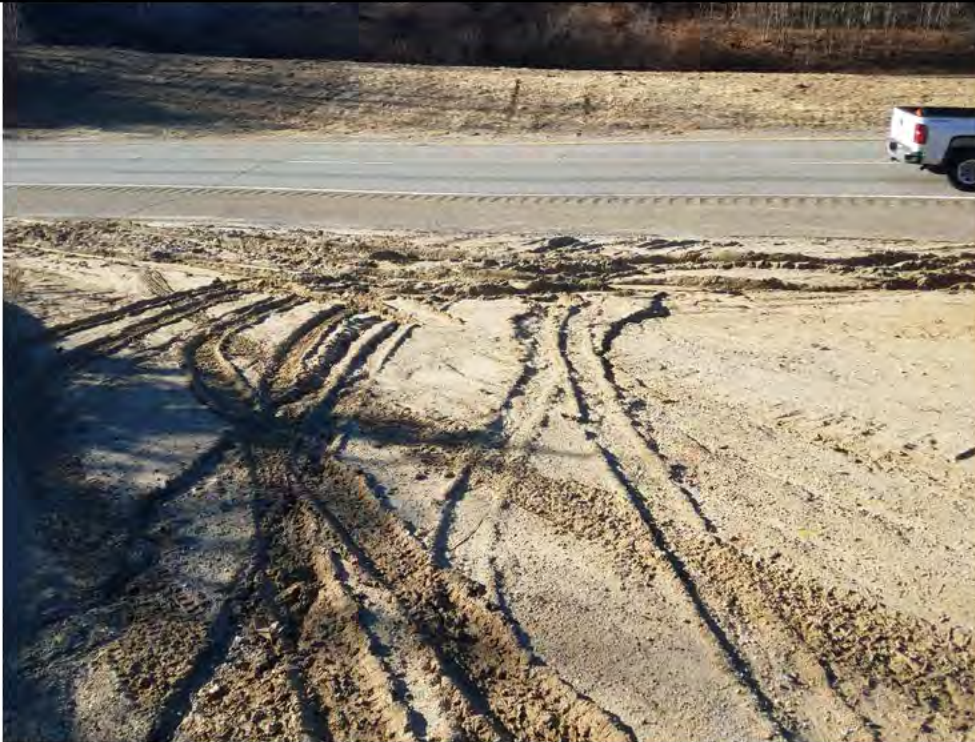
Erosion and Sedimentation Controls	Interim Week	N/A	N/A	
	Bi-Week	Silt fence failure was observed at Str1A and Str2 (see photos 5 & 6). Additional E&S controls should be addressed at Str85 (pad and slope stabilization, and tracking pad or stabilization on the access road at Rt. 8. see photos 3 & 7). Surface water flow conditions at Str27-Str28 (area should be regraded so that flow is directed to swale) →	(see photo 4). Surface water flow over the access roads below Str44 (between Str44 and Str45), and in the area below Str73 down to W-E2 (see photos 1 and 2), should be diverted and controlled (water bars and sediment traps upland of condition).	PENDING
Inland Wetland & Watercourse encroachment & mitigation	Interim Week	N/A	N/A	
	Bi-Week

Photo 3: 01/26/2018, Litchfield: Map 31, access road to Str85 of Route 8 north, visible tire ruts and sedimentation.

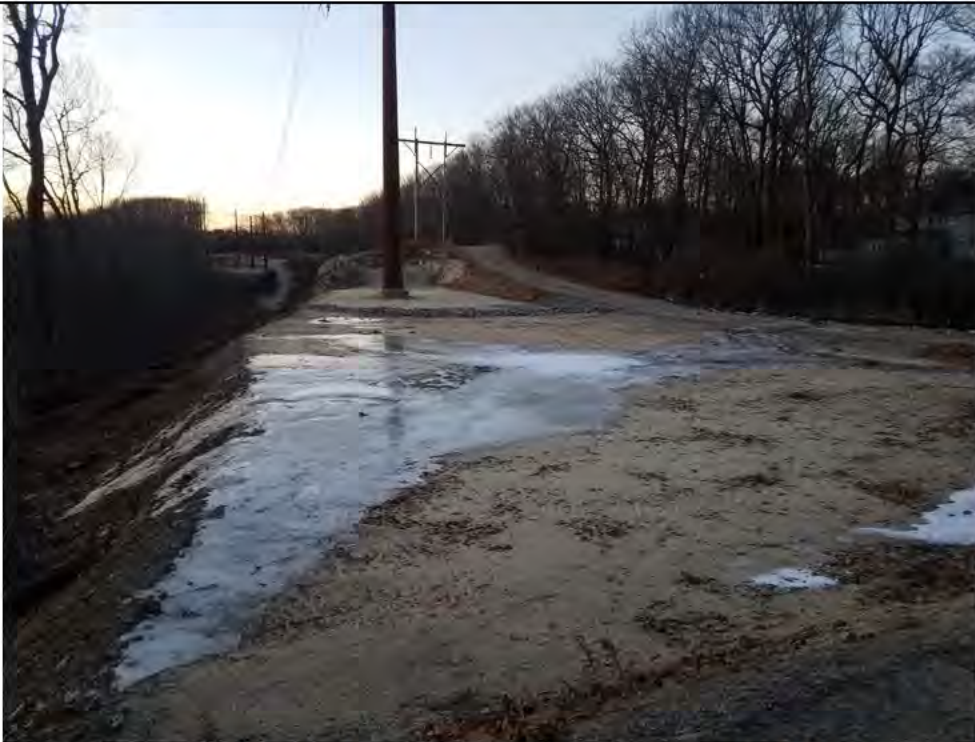
Photo 4: 01/26/2018, Watertown: Map 26, ice sheet and minor slope erosion at Str27-Str28, caused by drainage from W-C3 across the access road and over the pad for Str28. Due to surface grades the drainage is not getting to the rip rap swale that runs through the middle of the combined Str27-Str28 pad (swale can be seen in the photo in distance past the ice sheet).

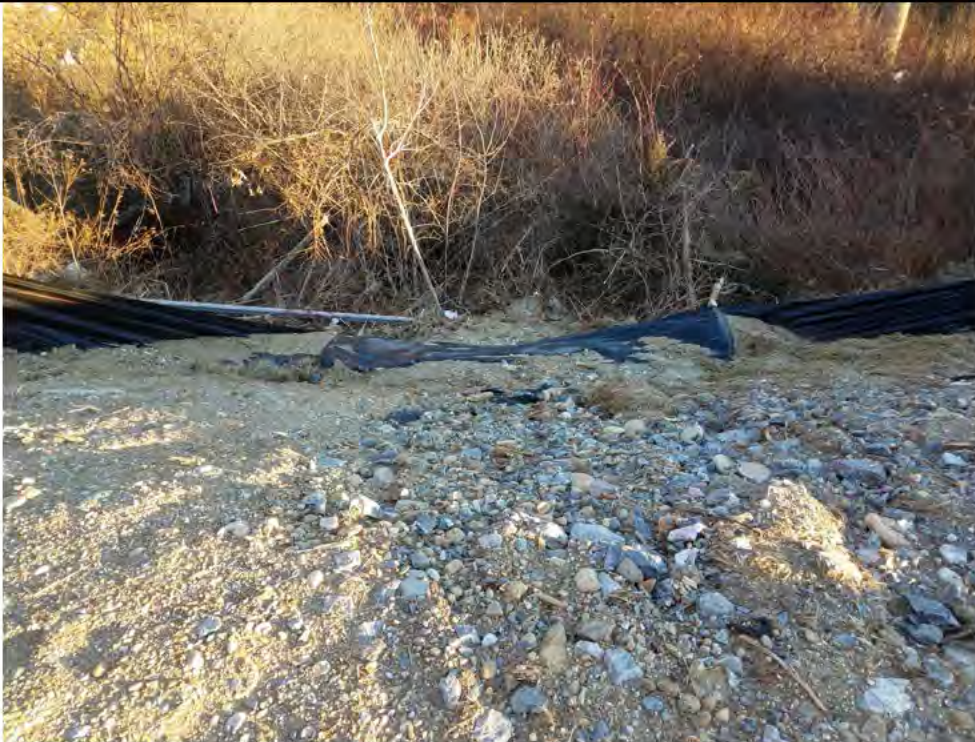
Photo 5: 01/26/2018, Watertown: Map 01, Str2 pad, failed silt fence at toe of slope abutting S-A1 and sedimentation into watercourse, non-stabilized slope and pad.

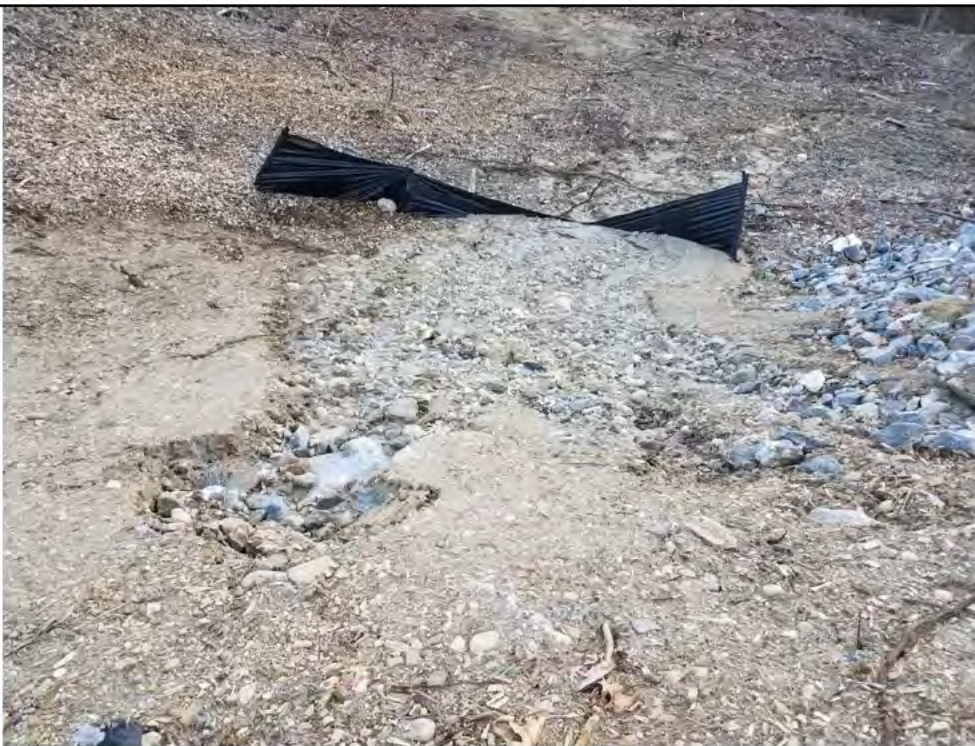
Photo 6: 01/26/2018, Watertown: Map 01, Str1A pad, failed silt fence at toe of slope, significant rills for a great distance down gradient towards Connecticut Designated Wetland Area.

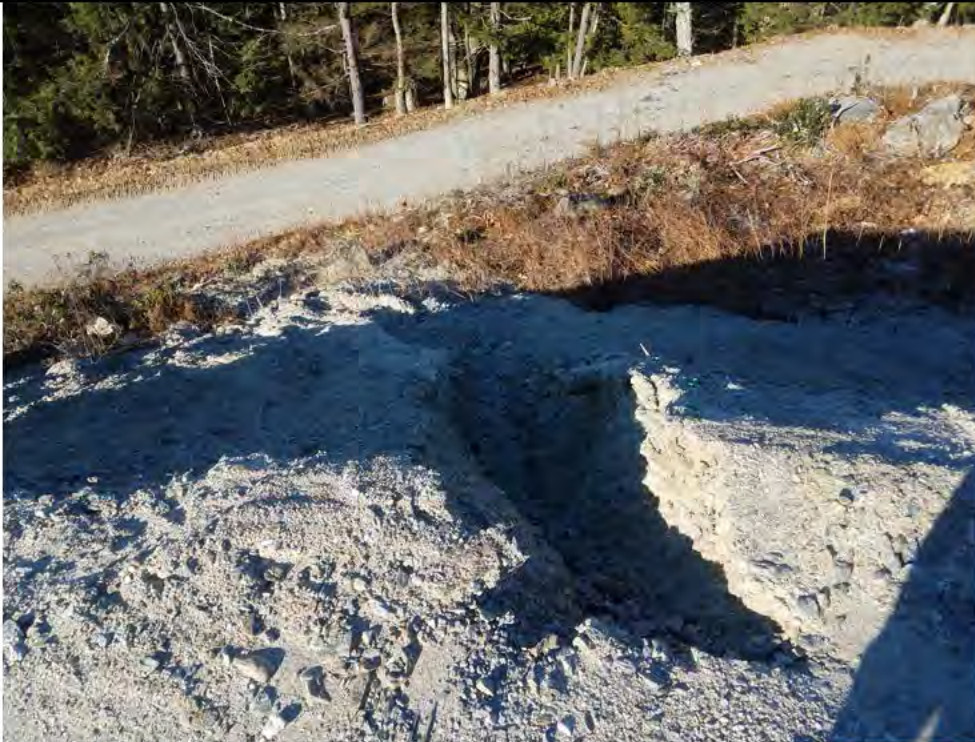
Photo 7: 01/26/2018, Litchfield: Map 30, Str85, significant rill formed and slope erosion visible, non-stabilized pad and slope.
