**Subject: Docket No. 466, Frost Bridge to Campville 115-kV Project
Decision and Order Condition #4 – Independent Environmental Inspector Report**

Please find enclosed the Biweekly Independent Environmental Inspector Report, Report #35, for the **March 29th** and **April 5th, 2018**, inspection events for the construction of the Eversource Frost Bridge to Campville 115-kV Project.

Docket No. 466- Development and Management Plan Inspection

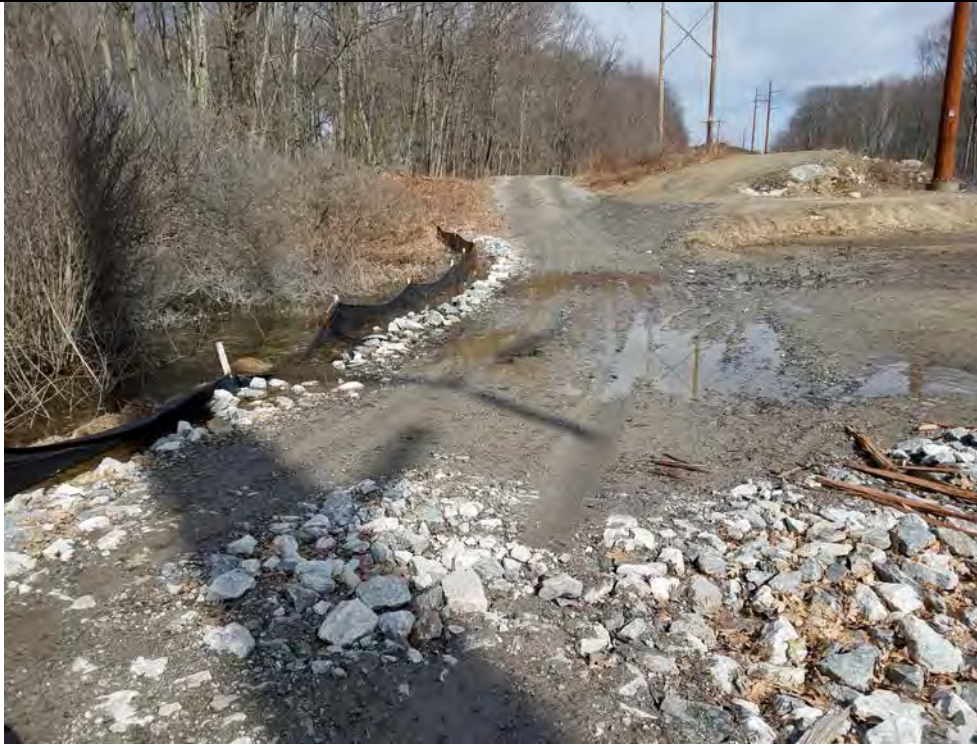
Photo 1: 04/05/2018, Watertown: Map 10, combined work pads Str27-Str28, the access road and work pad grading is such that surface water does not drain properly to the stone filled swale, rather it ponds and either drains to wetland W-C3 or to low elevation points in the pad and then freely drains off the eastern slope. The slope has visible rills and water flow from the west side of the pad to the east. No drainage is emitting from the swale or from the work pad (Str27) south of the swale. Photo taken facing north along the access road, Str27 and Str28 work pads to the right (east).

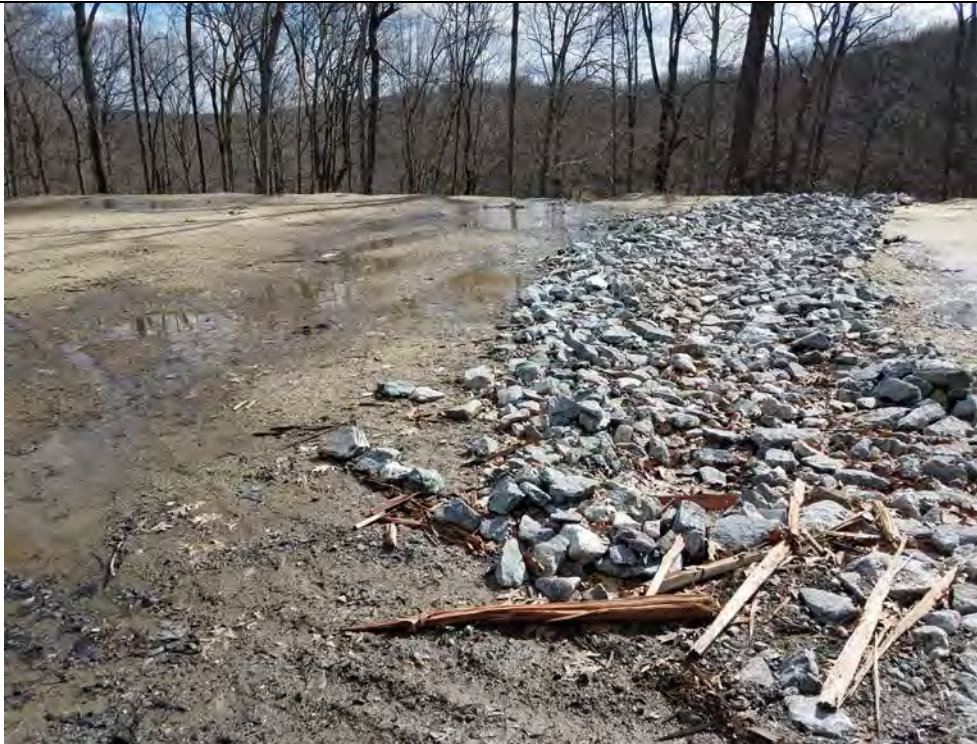
Photo 2: 04/05/2018, Watertown: Map 10, additional view of Photo 1 conditions, Str27 work pad is the right (south) of the rock filled swale and Str28 is to the left (north) of the swale. .
