**Subject: Docket No. 466, Frost Bridge to Campville 115-kV Project
Decision and Order Condition #4 – Independent Environmental Inspector Report**

Please find enclosed the Biweekly Independent Environmental Inspector Report, Report #38, for the **May 11th** and **May 18th, 2018**, inspection events for the construction of the Eversource Frost Bridge to Campville 115-kV Project.

Photograph Log Frost Bridge to Campville 115kV Project

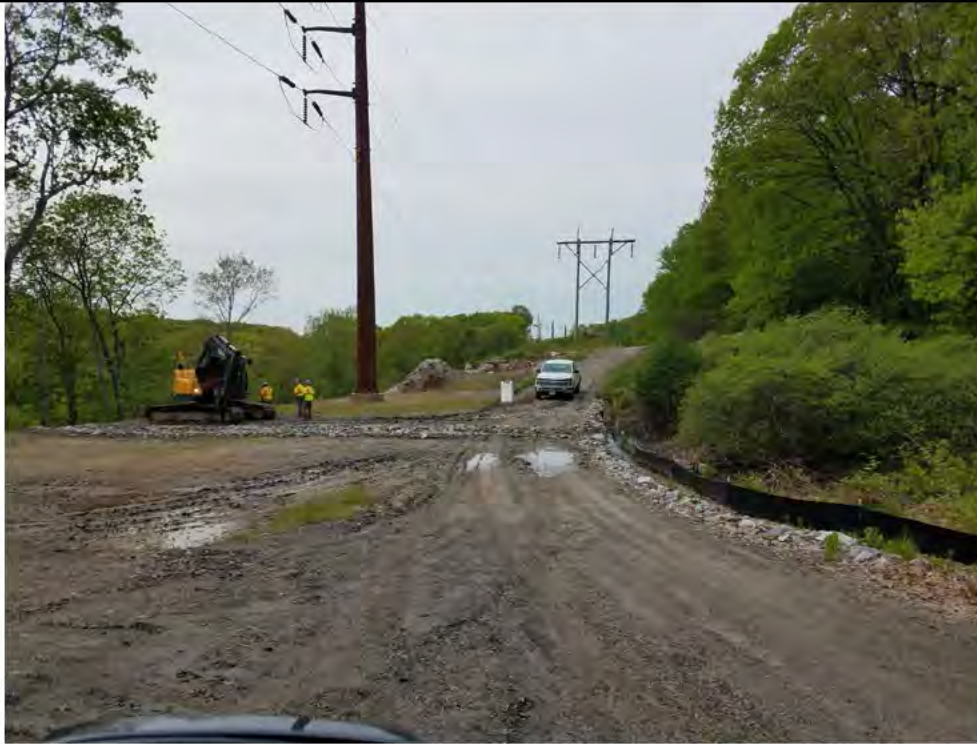
Photo 1: 05/18/2018, Watertown: Map 10, combined work pads Str27-Str28, BluRoc setting up to resume stabilization/restoration work. Photo taken facing south along the access road, Str27 in the distance.

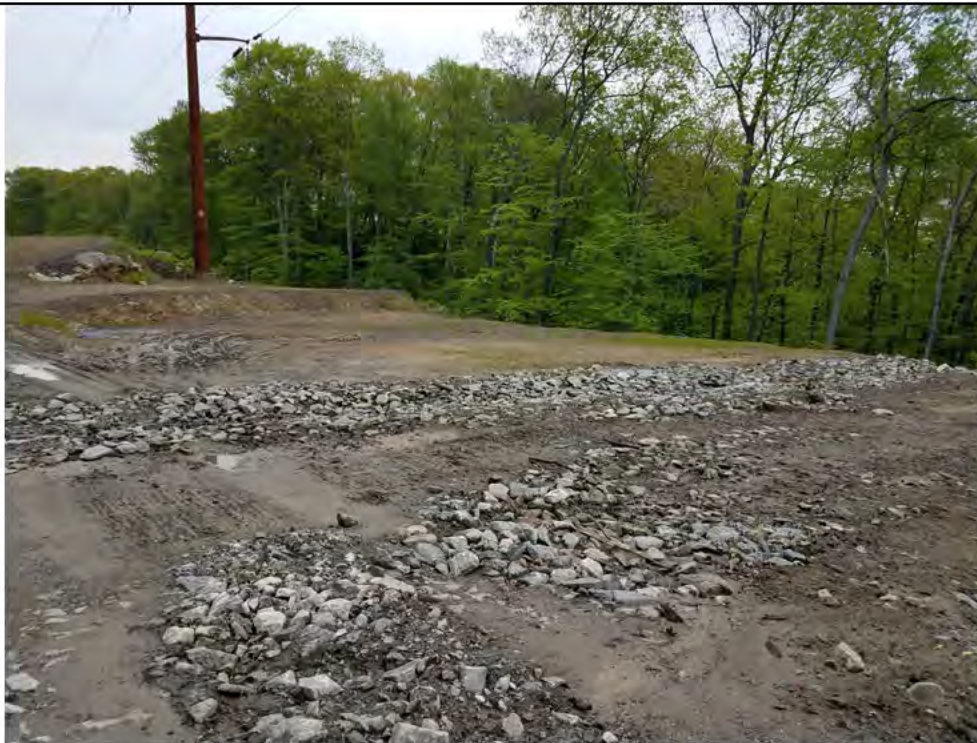
Photo 2: 05/18/2018, Watertown: Map 10, combined work pads Str27-Str28, area regraded and the rock filled swale reconstructed. Photo taken facing north along the access road, Str28 in the distance.

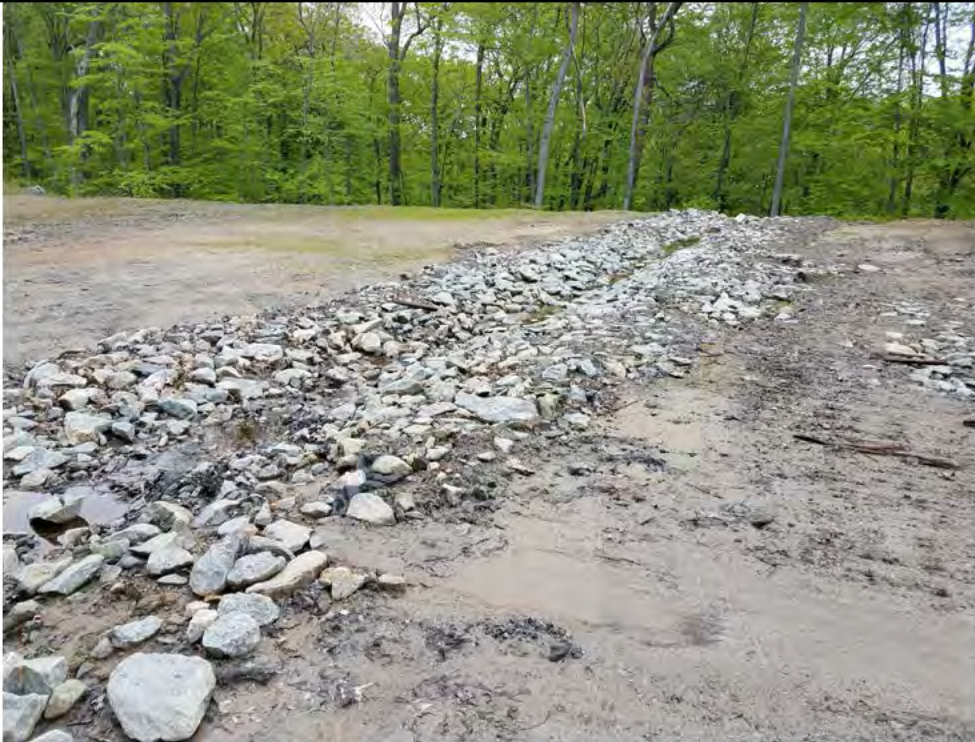
Photo 3: 05/18/2018, Watertown: Map 10, combined work pads Str27-Str28, area has been regraded and the rock filled swale reconstructed. Photo taken facing east across the pad.

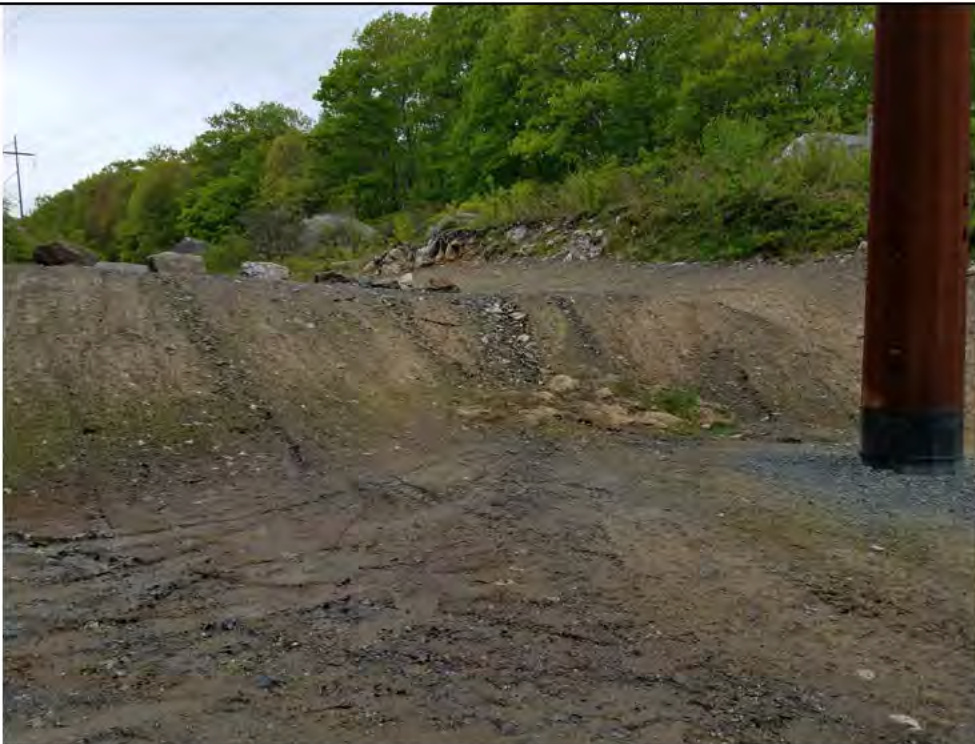
Photo 4: 05/18/2018, Watertown: Map 11, Str32 upland slope and pad not stabilized, visible erosion of the slope and lower pad is occurring. Photo taken facing south from the access road.

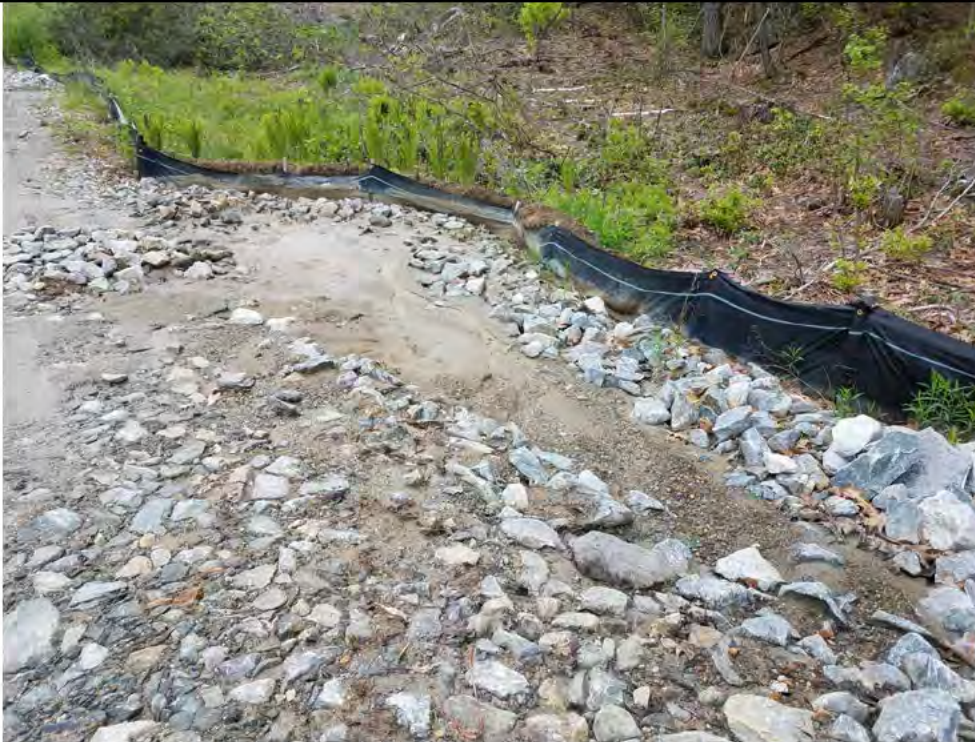
Photo 5: 05/18/2018, Watertown: Map 11, north of Str32 sediment trap filled to capacity and failing silt fence and degraded hay bales. Photo taken facing north along the east side of the access road.

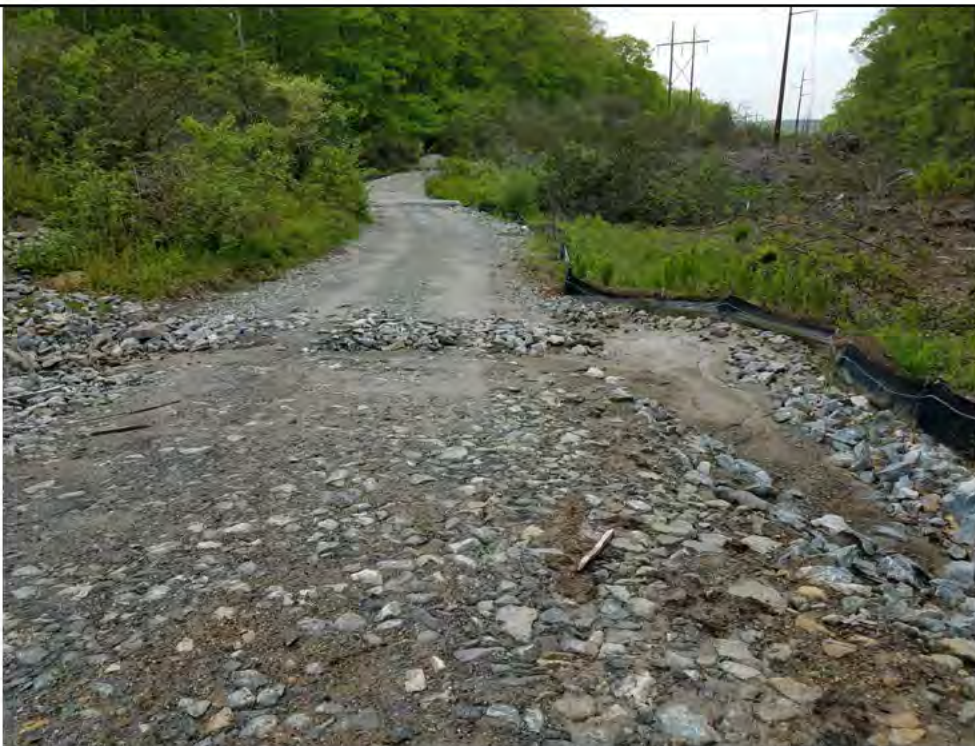
Photo 6: 05/18/2018, Watertown: Map 11, north of Str32 sediment trap filled to capacity, failing silt fence and degraded hay bales, stone filled water bar packed with sediment. Photo taken facing north along the access road in the direction of Str33.

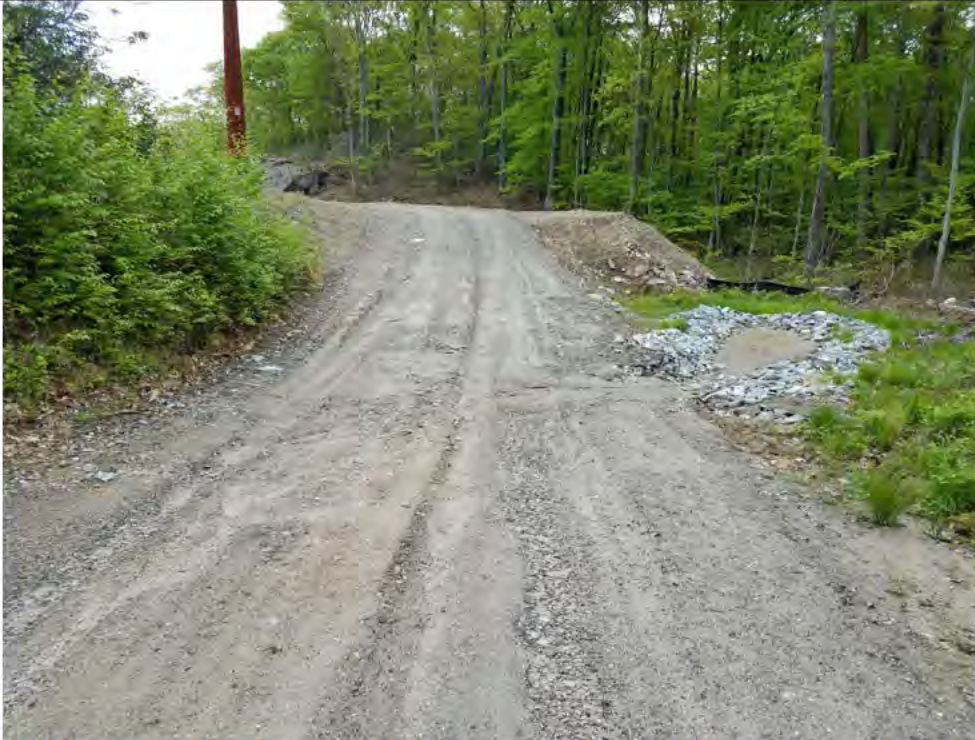
Photo 7: 05/18/2018, Watertown: Map 12, south of Str33 sediment trap filled to capacity and visible access road erosion (rills). Photo taken facing north along the access road, Str33 in the distance.

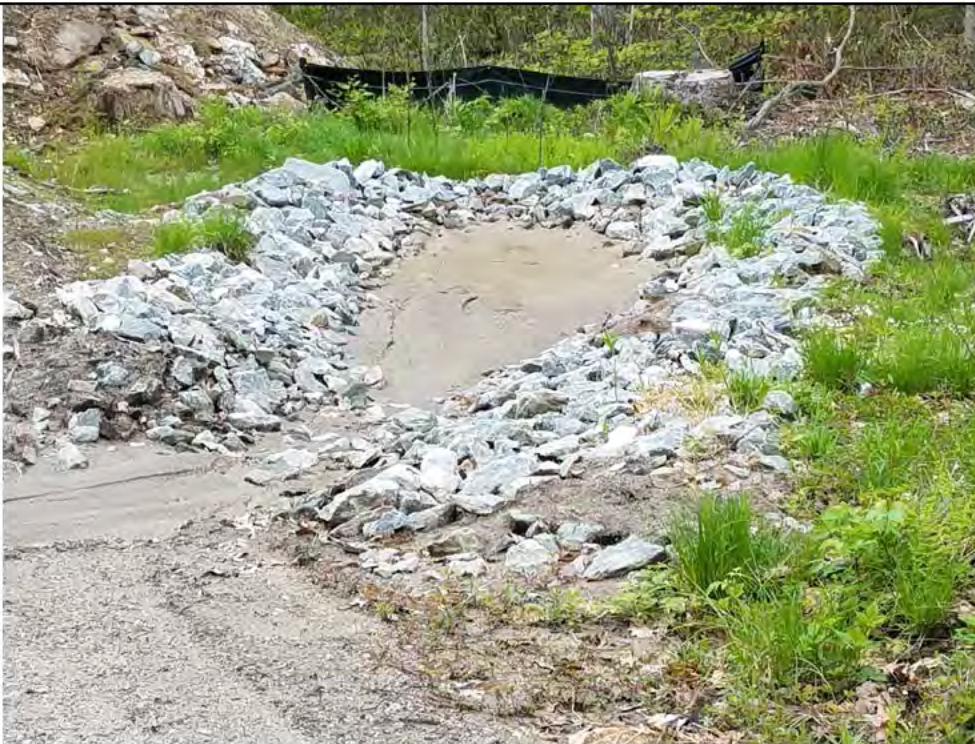
Photo 8: 05/18/2018, Watertown: Map 12, south of Str33 sediment trap filled to capacity. Photo taken facing east along the east side of the access road to Str33.

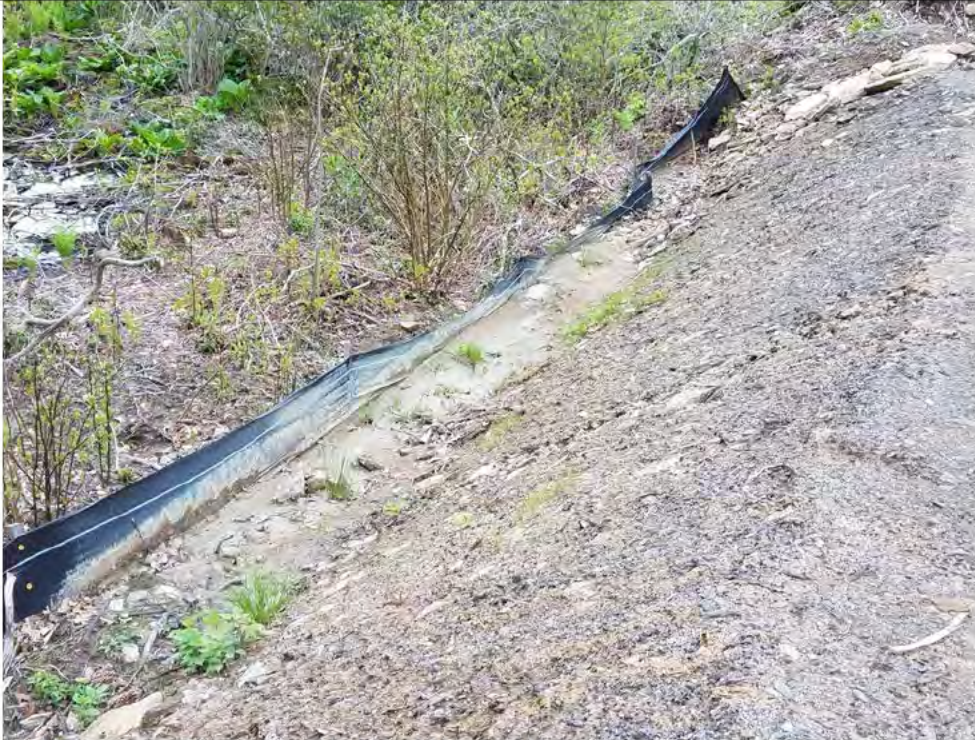
Photo 9: 05/18/2018, Watertown: Map 12, east side of the Str35 work pad, failing silt fence, excessive sediment buildup on silt fence, visible slope erosion (rills), and no pad stabilization measures. Photo taken facing southeast from the pad toward the abutting wetland (W-C15).

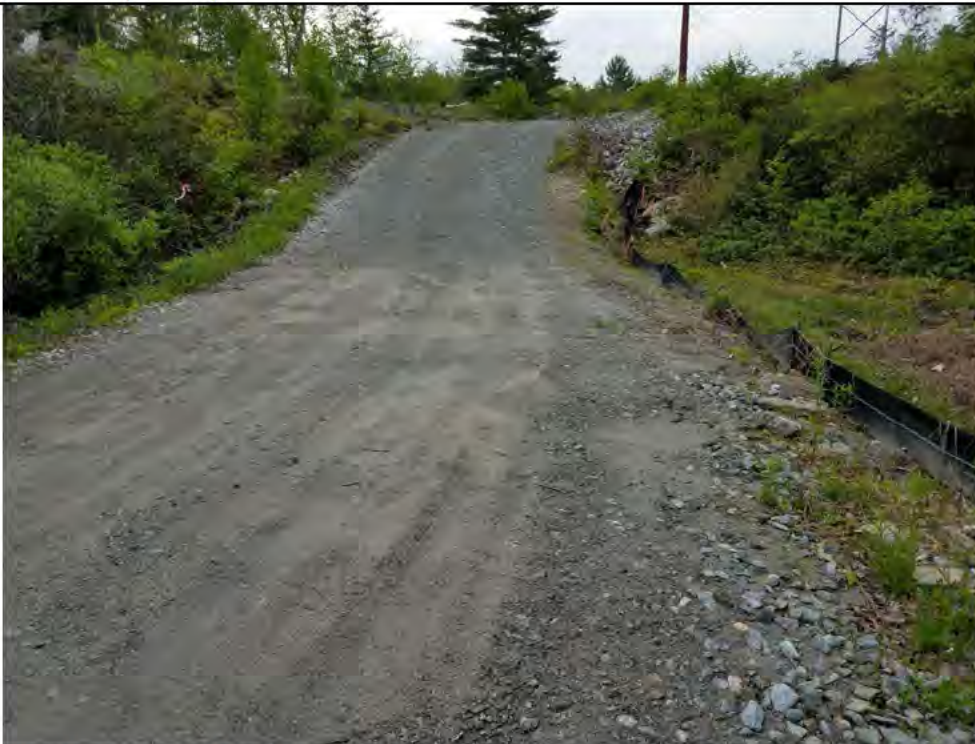
Photo 10: 05/18/2018, Watertown: Map 13, access road south of Str36, failing silt fence abutting wetland W-C15. Photo taken facing north along the access road toward Str36.

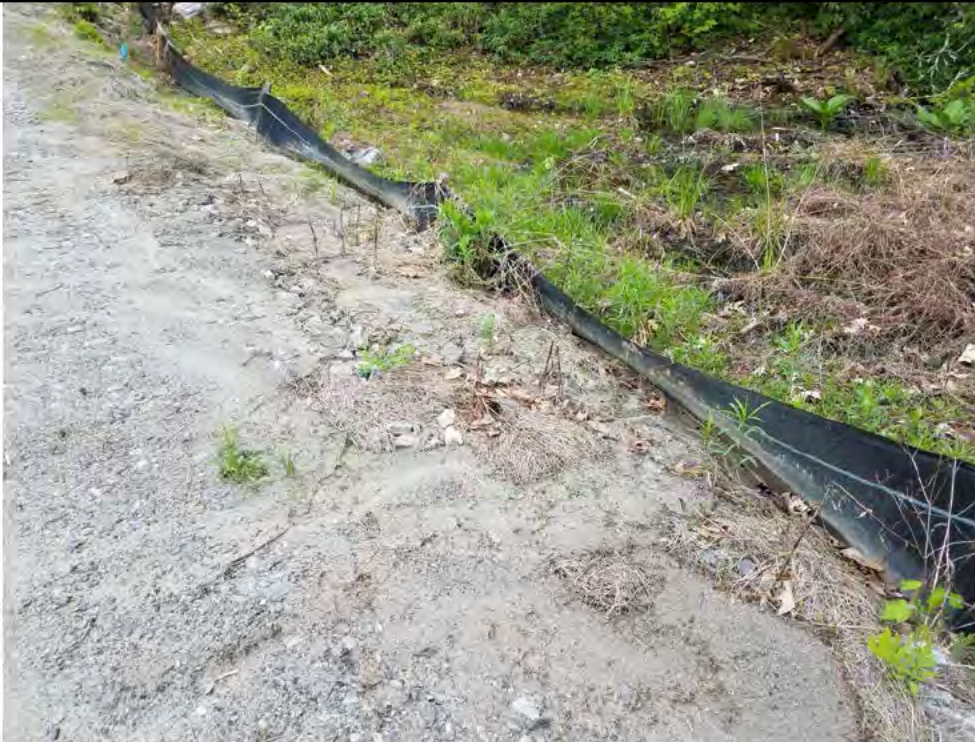
Photo 11: 05/18/2018, Watertown: Map 13, access road south of Str36, failing silt fence abutting wetland W-C15 and access road erosion. Photo taken facing east along the access road toward Wetland W-C15.

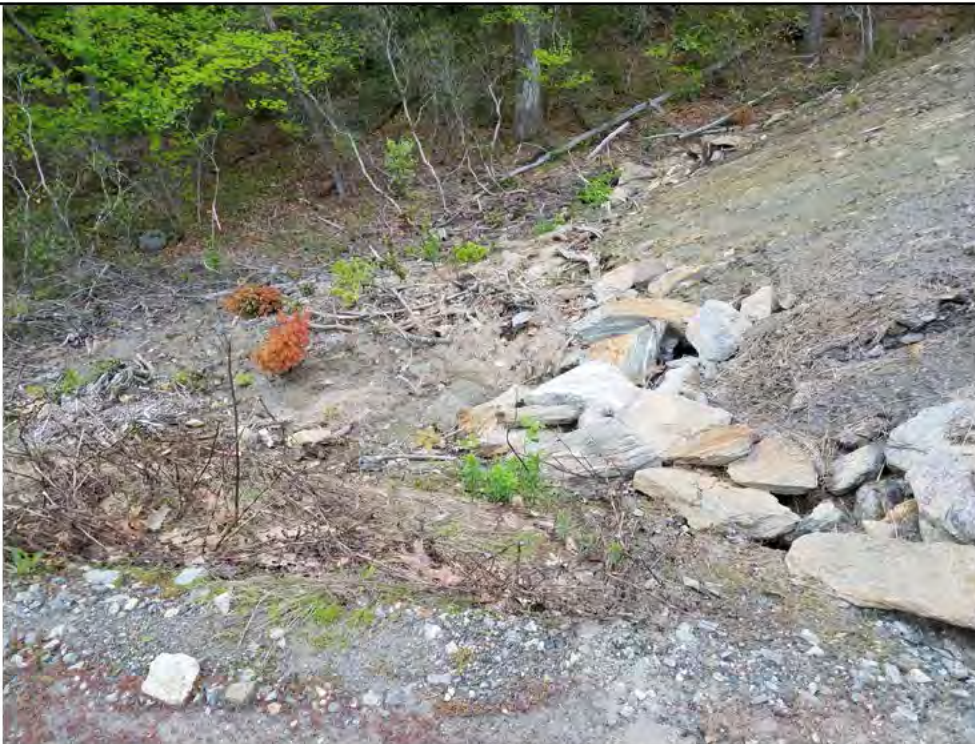
Photo 12: 05/18/2018, Watertown: Map 13, northwest corner of the Str38 work pad, pad and slope erosion. Photo taken facing northeast off the access road and down the pad slope.

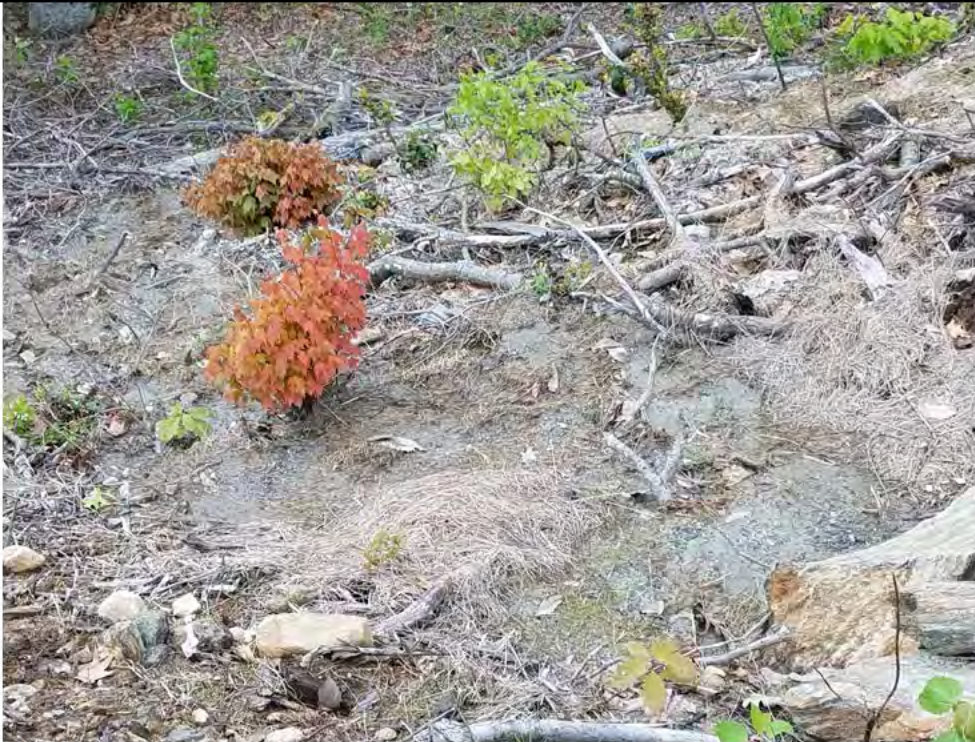
Photo 13: 05/18/2018, Watertown: Map 13, northwest corner of the Str38 work pad, pad and slope erosion. Photo taken facing northeast off the access road and down the pad slope.

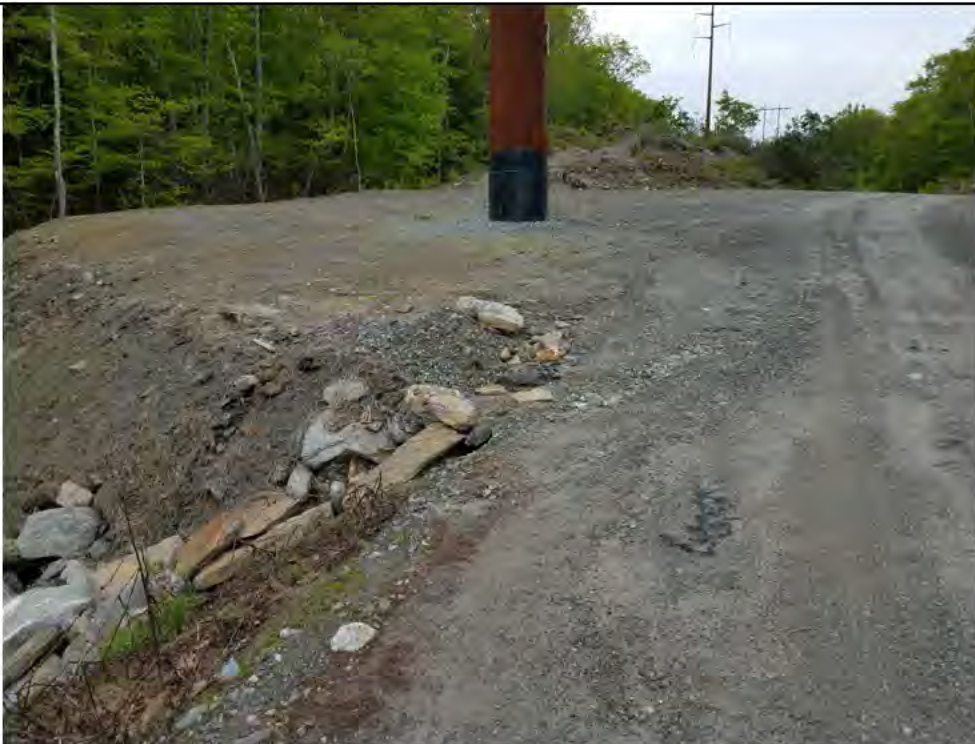
Photo 14: 05/18/2018, Watertown: Map 13, northwest corner of the Str38 work pad, pad and slope erosion, pad stabilization measures (seeded last fall) failed. Photo taken facing south along the access road and work pad.

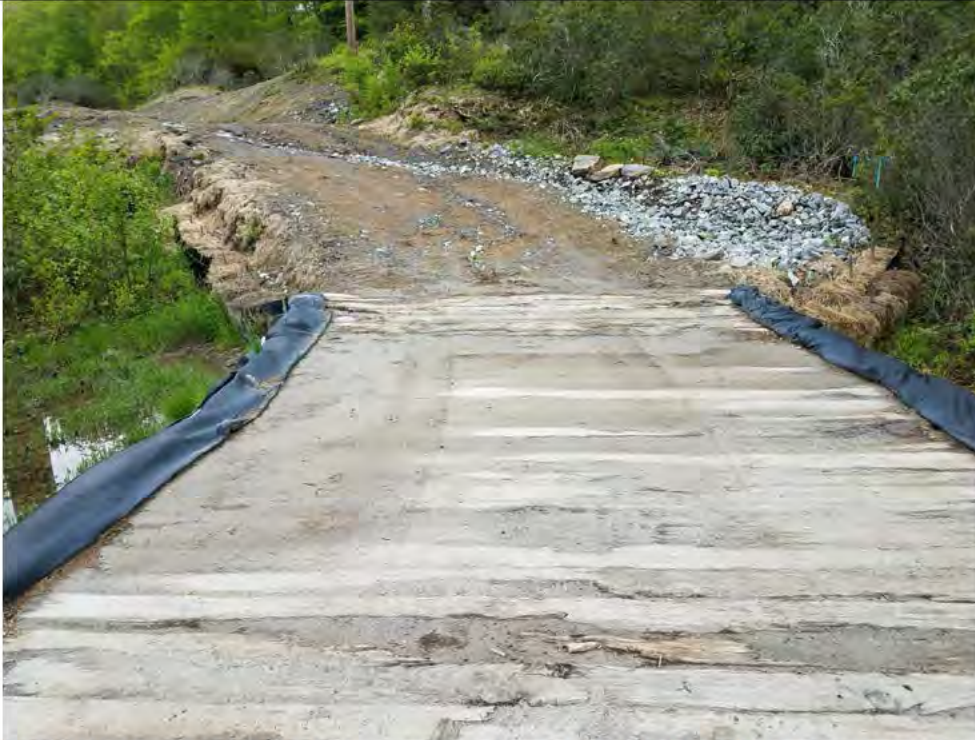
Photo 15: 05/18/2018, Watertown: Map 14, timber mat crossing at W-C20/VP-C20-1, access road erosion, water bar failure, heavy sedimentation on timber mats, and visible impacts to surrounding area (w-C20/VP-C20-1). Photo taken facing south toward Str39.

Water Crossings	Interim Week	<p>No changes in conditions since the previous inspection. Areas that need to be addressed as part of restoration have been reported to the project inspectors and contractor. Site restoration and stabilization is in progress at this time. Areas will continue to be monitored until deemed closed out by the Project inspectors/Project Managers.</p>	N/A	
	Bi-Week	<p>Timber mats in the area of Wetland W-20/VP-C20-1 have significant buildup sediments. Sediment impacts to W-20/VP-C20-1 was observed (see Photo 15).</p>	<p>Install/repair existing E&S controls, stabilize upland sediments, clean or remove timber mats, and restore W-20/VP-C20-1.</p>

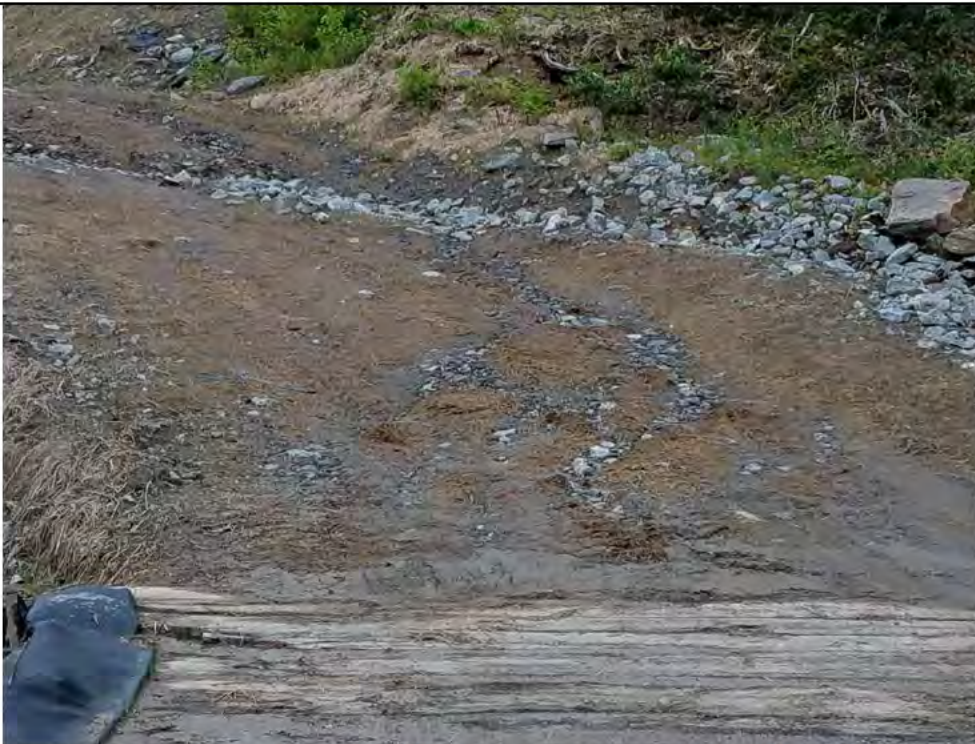
Photo 16: 05/18/2018, Watertown: Map 14, south of timber mat crossing at W-C20/VP-C20-1, access road erosion, water bar failure, causing heavy sedimentation on timber mats, and visible impacts to surrounding area (w-C20/VP-C20-1). Stabilization measures were in place last fall but were not maintained throughout the winter months.

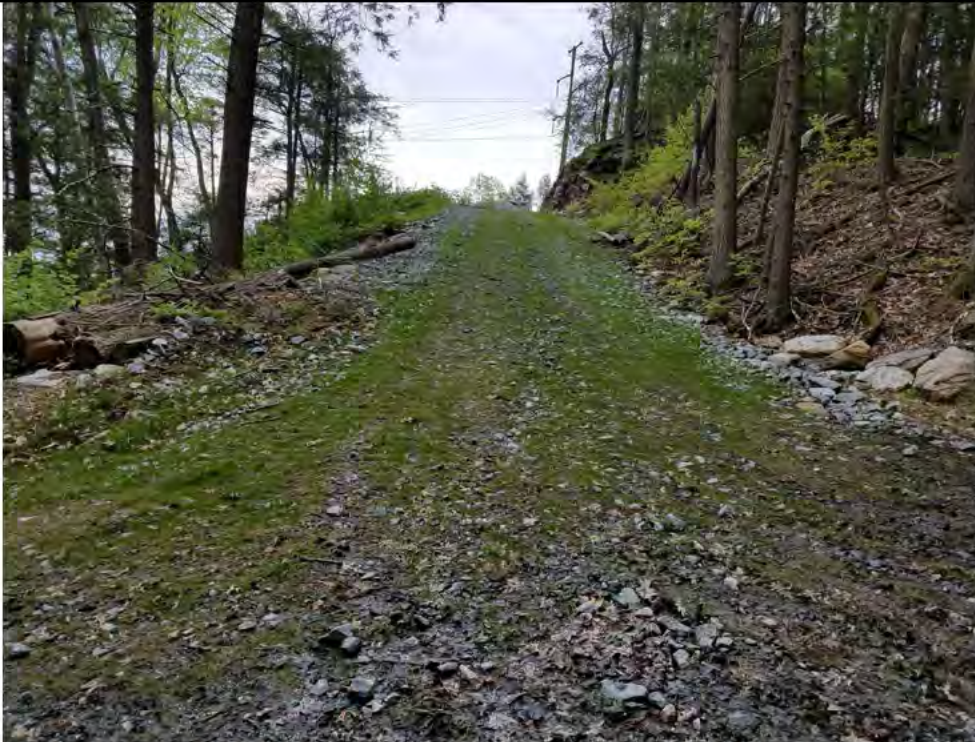
Photo 17: 05/18/2018, Watertown: Map 16, access road to Str45, stabilized last fall with hydro seed applications. Good growth at this time, no visible erosion. Photo taken facing upland, southeast toward Str45.
