**Subject: Docket No. 466, Frost Bridge to Campville 115-kV Project
Decision and Order Condition #4 – Independent Environmental Inspector Report**

Please find enclosed the Biweekly Independent Environmental Inspector Report, Report #39, for the **May 25**, and **June 1, 2018**, inspection events for the construction of the Eversource Frost Bridge to Campville 115-kV Project.

Docket No. 466- Development and Management Plan Inspection

Frost Bridge to Campville 115kV Project

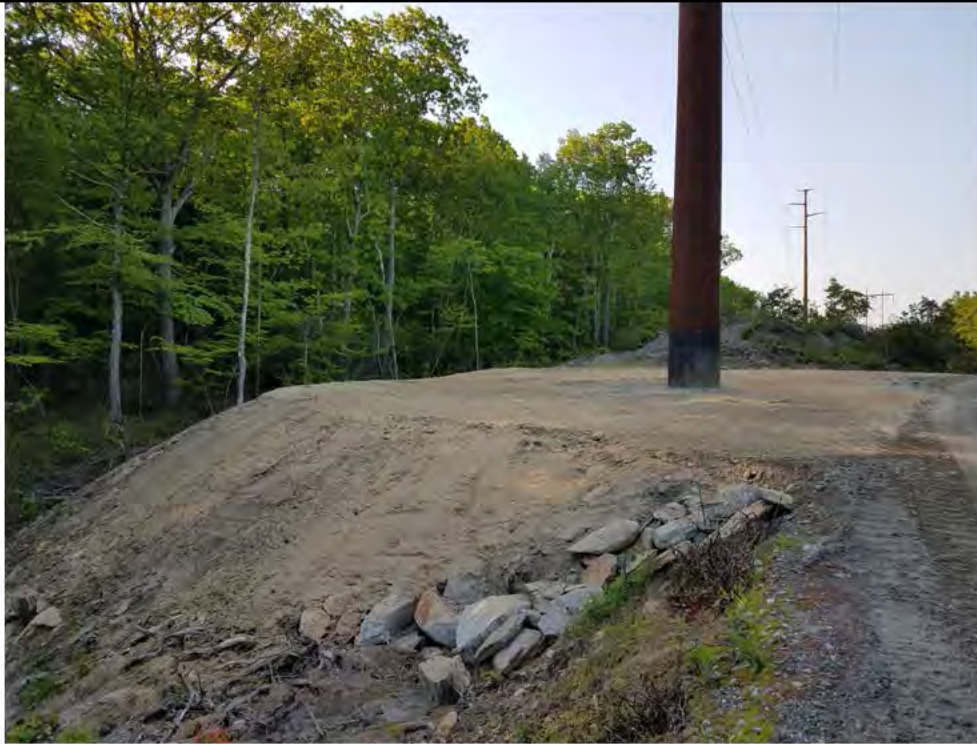
Photo 1: 05/25/2018, Watertown: Map 13, Str38, pad stabilization measures (graded and hydro seeded). Photo taken facing south along the access road and work pad.

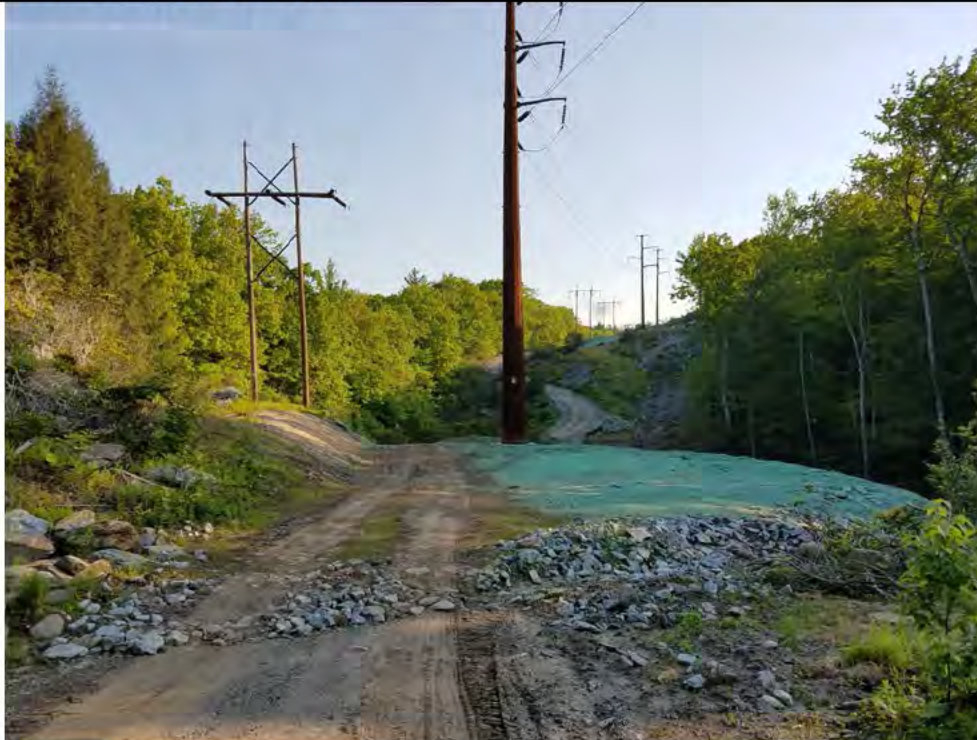
Photo 2: 05/25/2018, Watertown: Map 14, Str39, pad stabilization measures (graded and hydro seeded). Photo taken facing north along the access road and work pad.

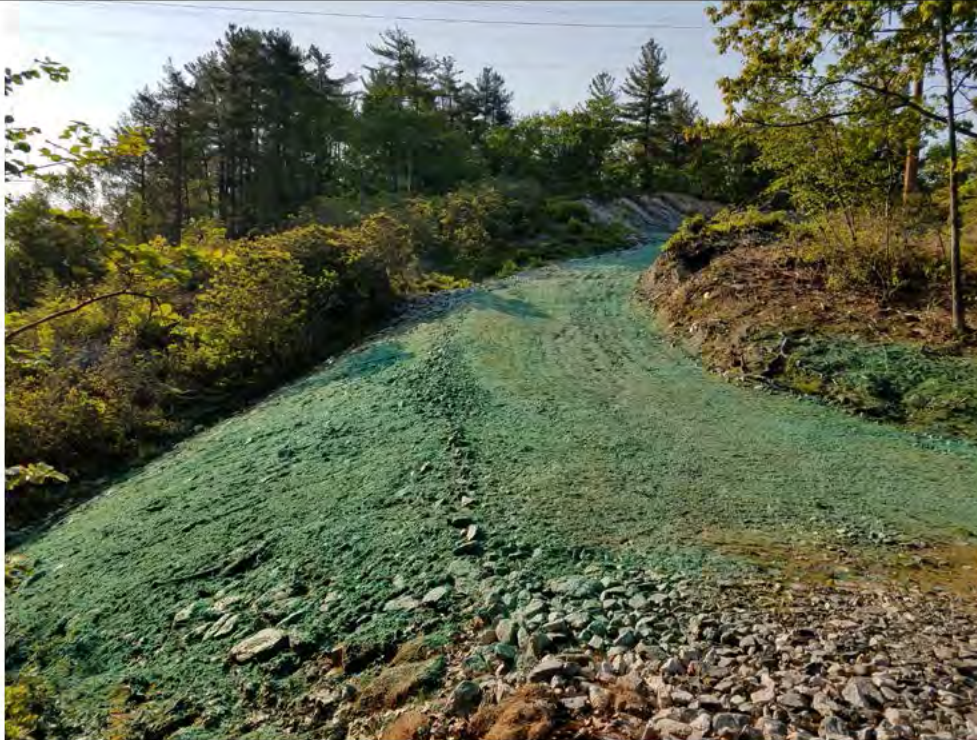
Photo 3: 05/25/2018, Watertown: Map 14, Str41, pad stabilization measures (graded and hydro seeded). Photo taken facing east along the access road to the work pad upland.

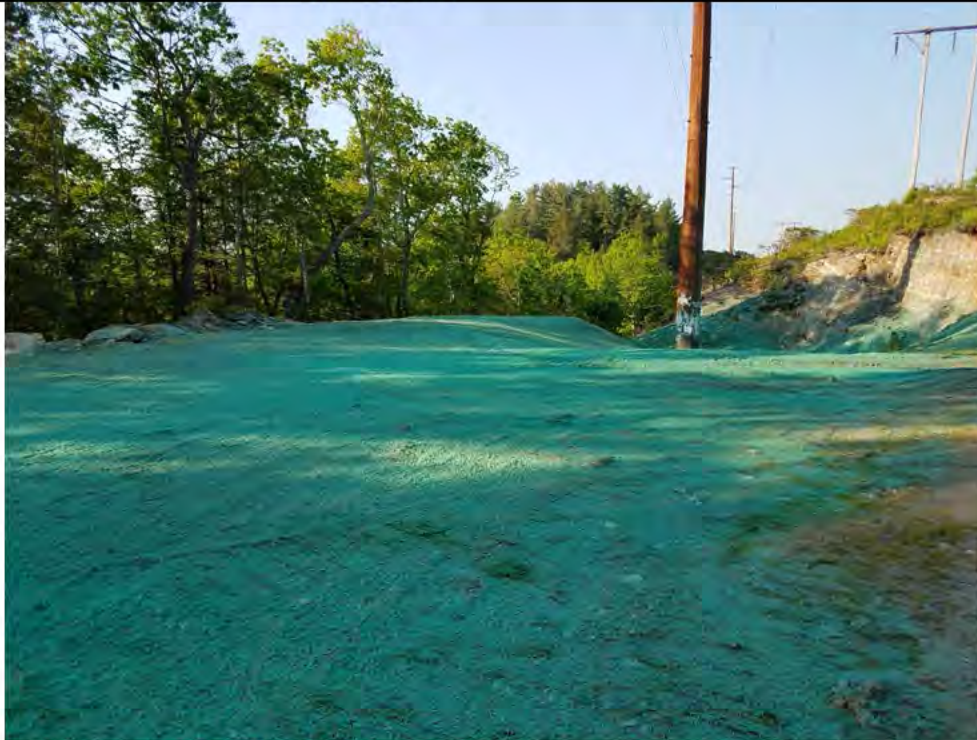
Photo 4: 05/25/2018, Watertown: Map 15, Str42, pad stabilization measures (graded and hydro seeded). Photo taken facing south along the access road and work pad, Str42 in the distance.

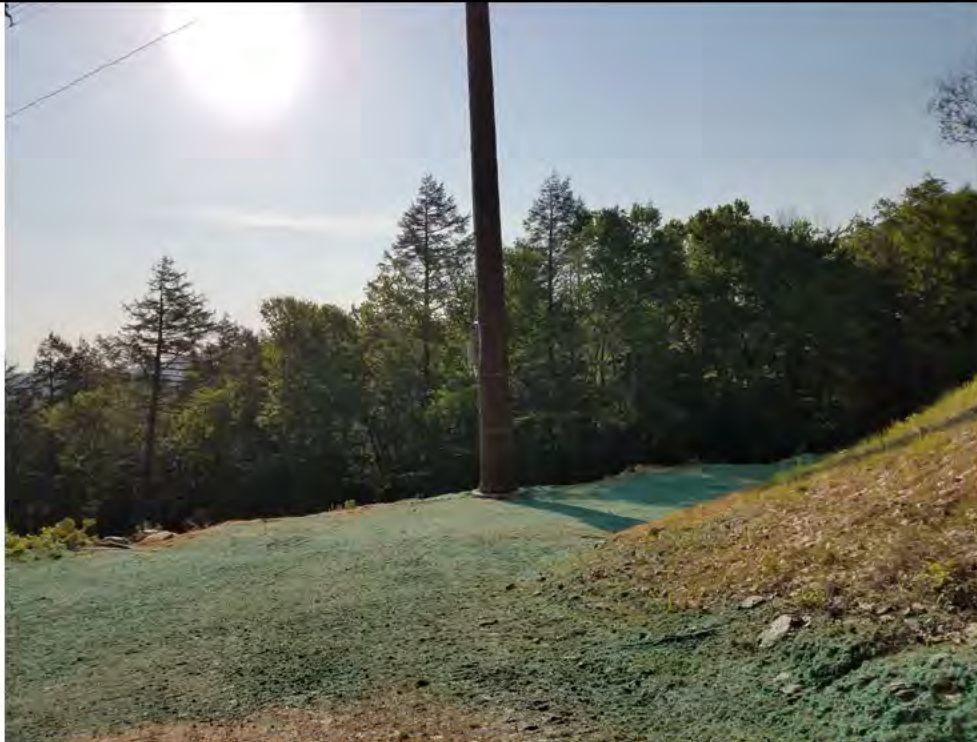
Photo 5: 05/25/2018, Watertown: Map 16, Str46, pad stabilization measures (graded and hydro seeded). Photo taken facing south along the access road and work pad.

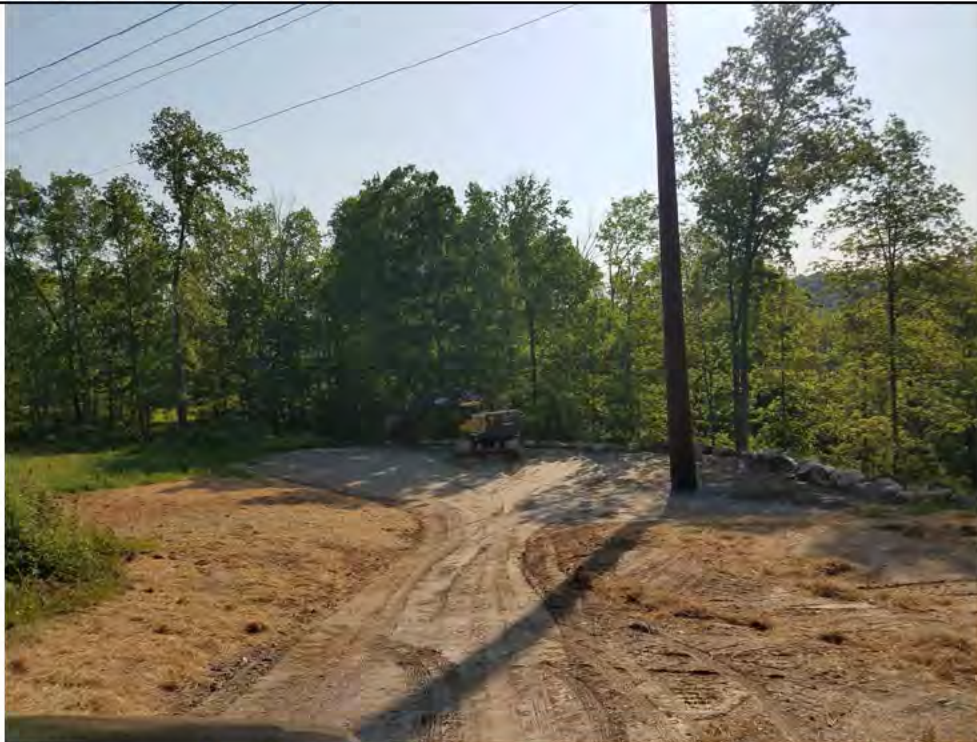
Photo 6: 05/25/2018, Watertown: Map 23, Str65, pad stabilization measures in progress. Photo taken facing east along the access road and work pad.

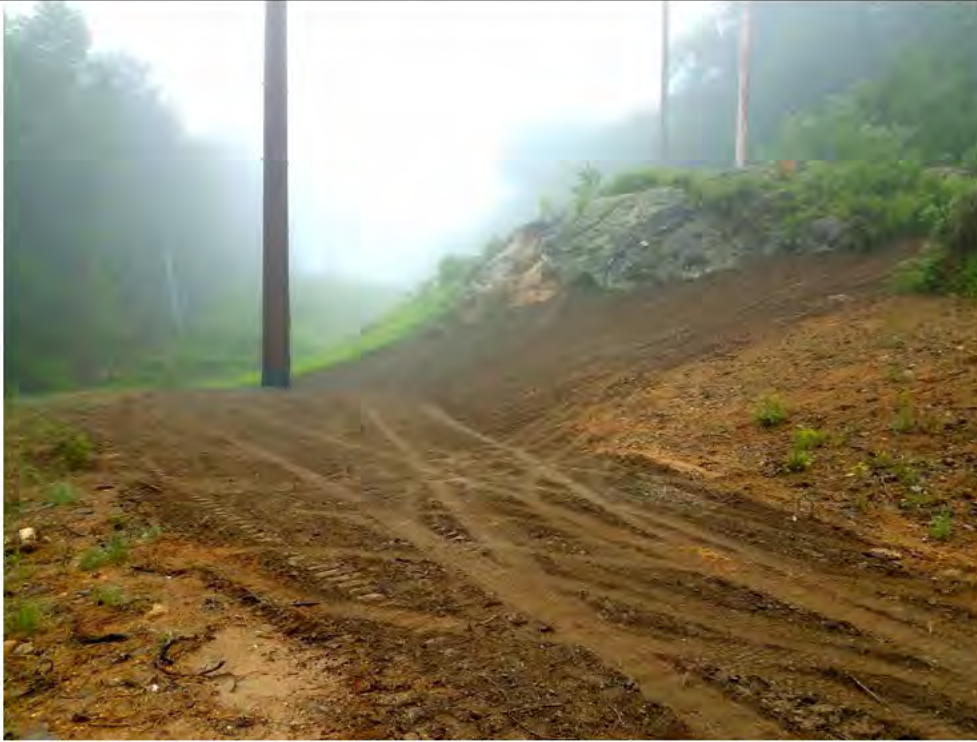
At the request of a homeowner abutting the ROW near Str60, the grade at the base of a rock outcrop was raised and sloped which after initial construction/installation of the structure was a vertical cut. Eversource instructed the contractor to raise the grade and create a gentle slope away from the outcrop (see Photos 7).

Photo 7: 06/01/2018, Thomaston: Map 21, Str60, grade at base of rock outcrop raised approximately 8 to 10 feet (up from top grade of structure base) and gently sloped away from the rock face to match surrounding slope and grades.
