**Subject: Docket No. 466, Frost Bridge to Campville 115-kV Project
Decision and Order Condition #4 – Independent Environmental Inspector Report**

Please find enclosed the Biweekly Independent Environmental Inspector Report, Report #42, for the **July 6th** and **July 13th, 2018** inspection events for the construction of the Eversource Frost Bridge to Campville 115-kV Project.

Docket No. 466- Development and Management Plan Inspection

Frost Bridge to Campville 115kV Project

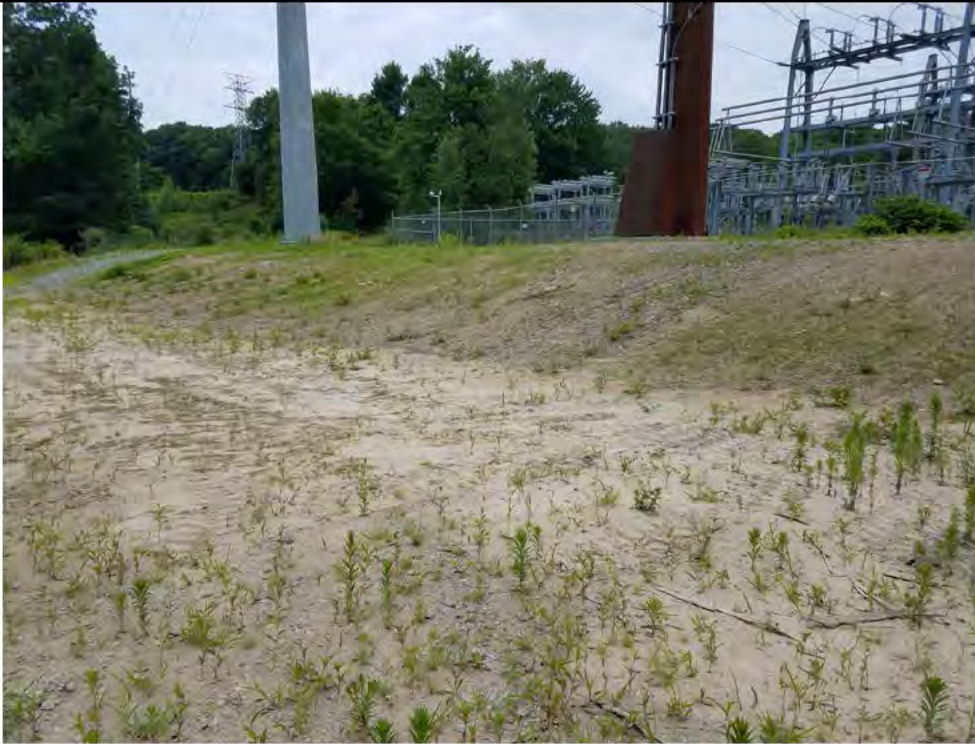
Photo 1: 07/06/2018, Watertown: Map 01, Str1A pad and pad slope erosion, minimal vegetation cover. Photo taken facing southeast toward Str1A.

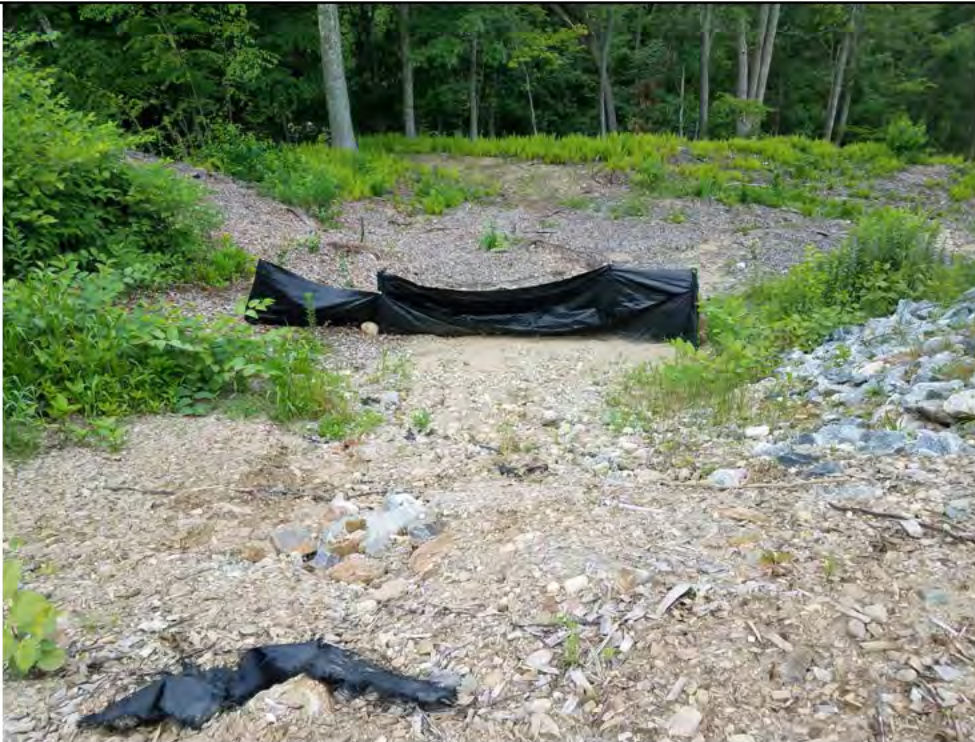
Photo 2: 07/06/2018, Watertown: Map 01, Str1A pad slope erosion, no stabilization. Photo taken facing north CT wetland.

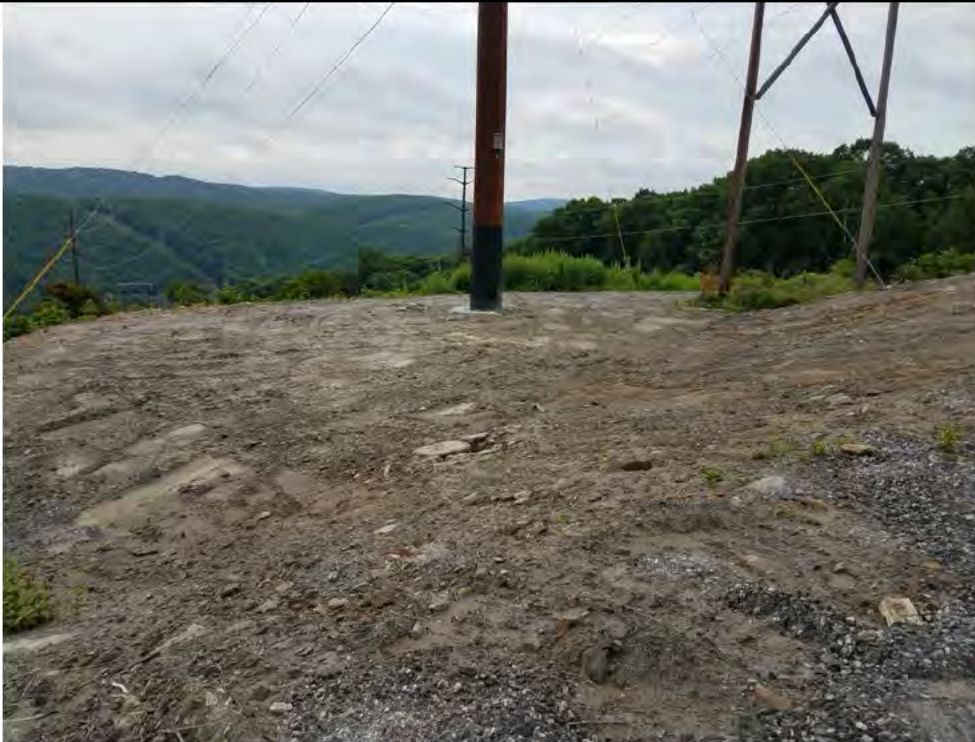
Photo 3: 07/06/2018, Watertown: Map 04, Str05 slope erosion, fine sediments continue to wash out of exposed, unstabilized/unvegetated soils during rain events. Photo taken facing north.

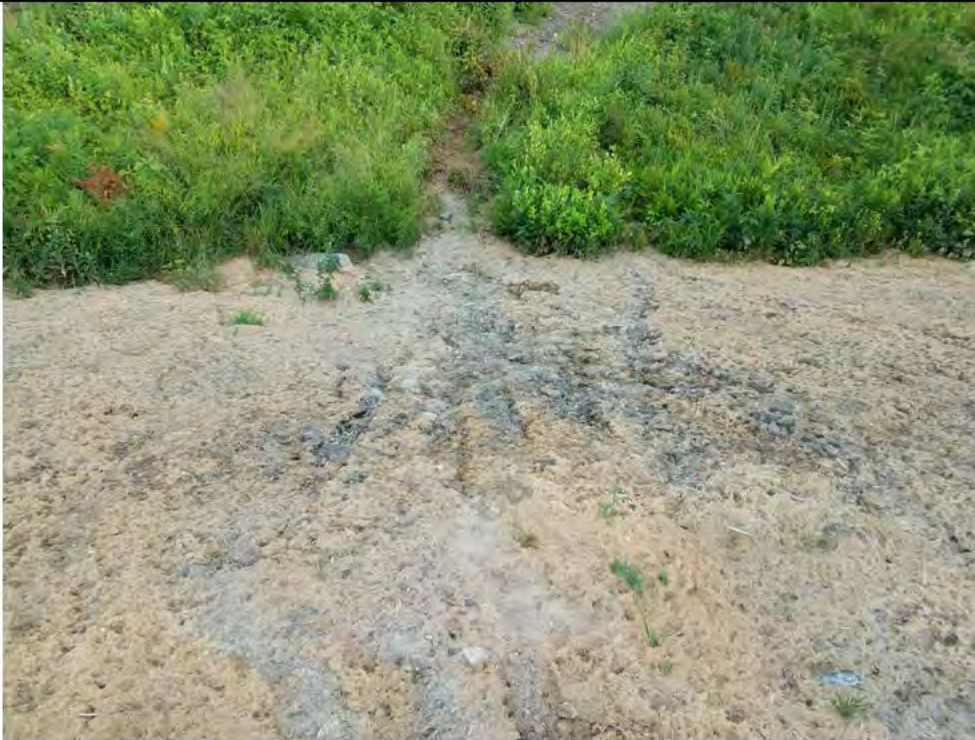
Photo 4: 07/06/2018, Watertown: Map 03, Str05 slope erosion, no stabilization. Photo taken facing north.

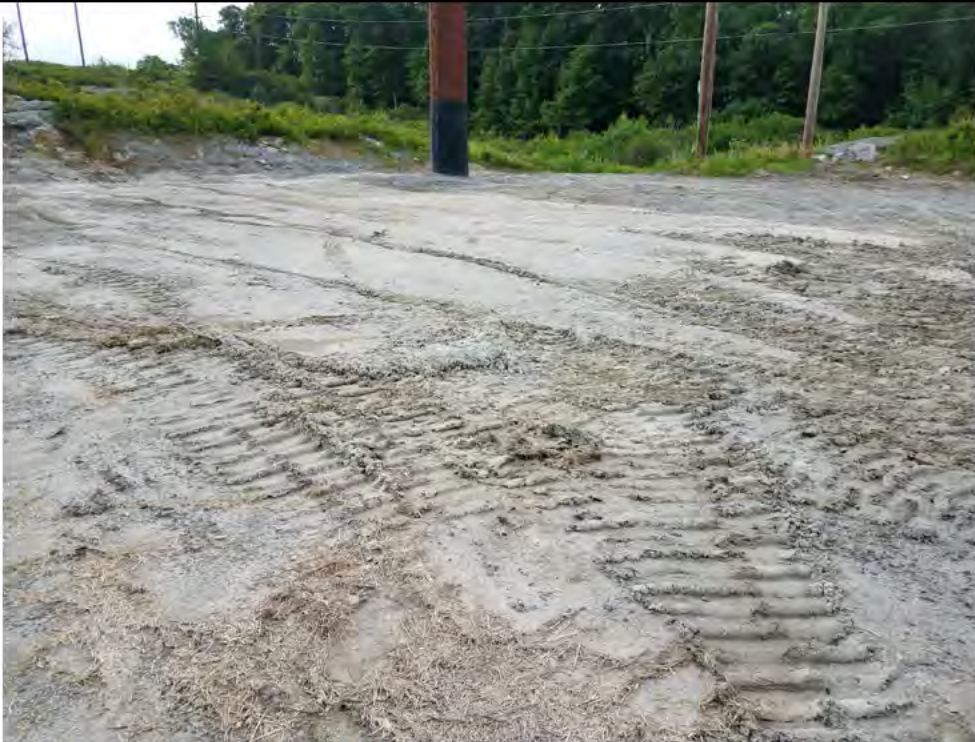
Photo 5: 07/06/2018, Watertown: Map 03, Str07, fine sediments continue to wash out of exposed, unstabilized/unvegetated soils during rain events. Photo taken facing northeast.

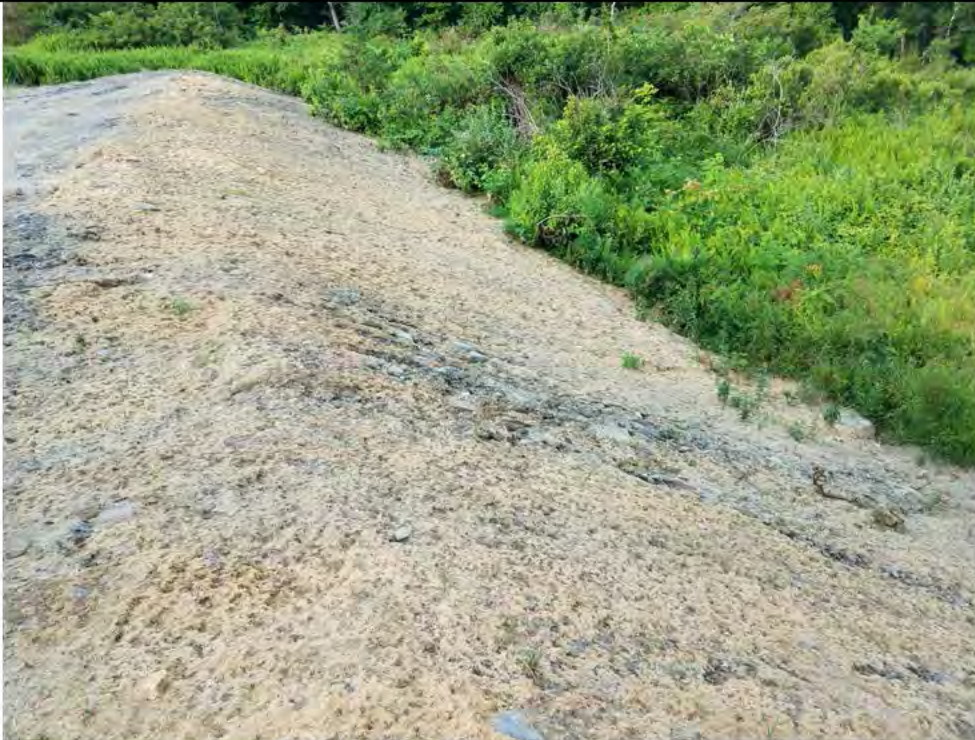
Photo 6: 07/06/2018, Watertown: Map 03, Str07 slope erosion, hydro seed application last fall, no visible growth. Photo taken facing east off of the south slope of pad.

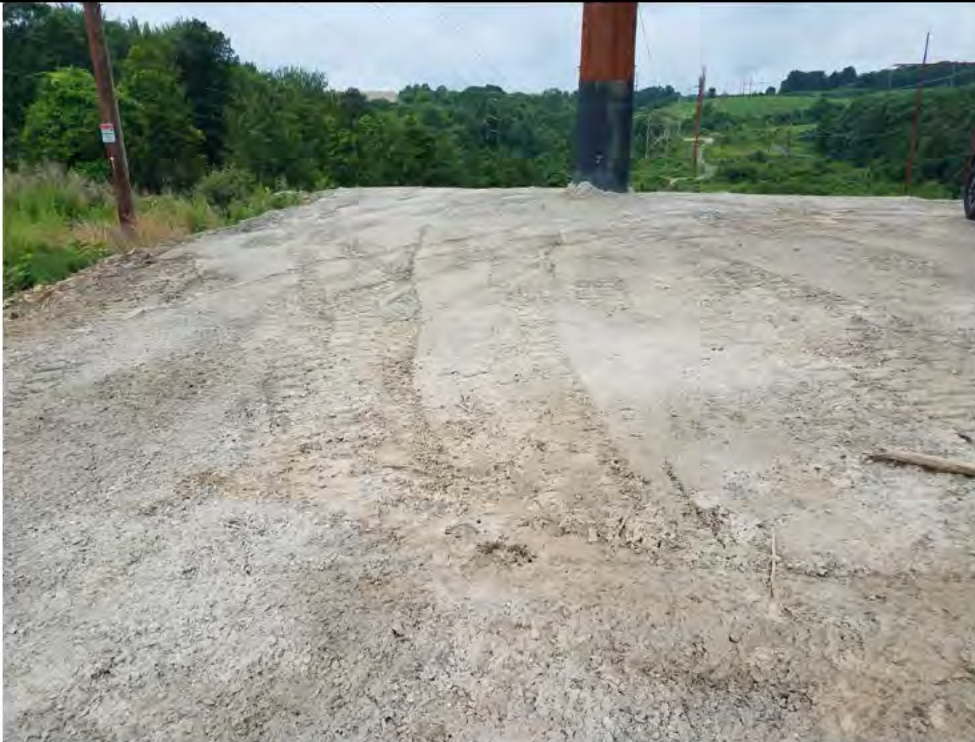
Photo 7: 07/06/2018, Watertown: Map 04, Str08, fine sediments continue to wash out of exposed, unstabilized/unvegetated soils during rain events. Photo taken facing west.

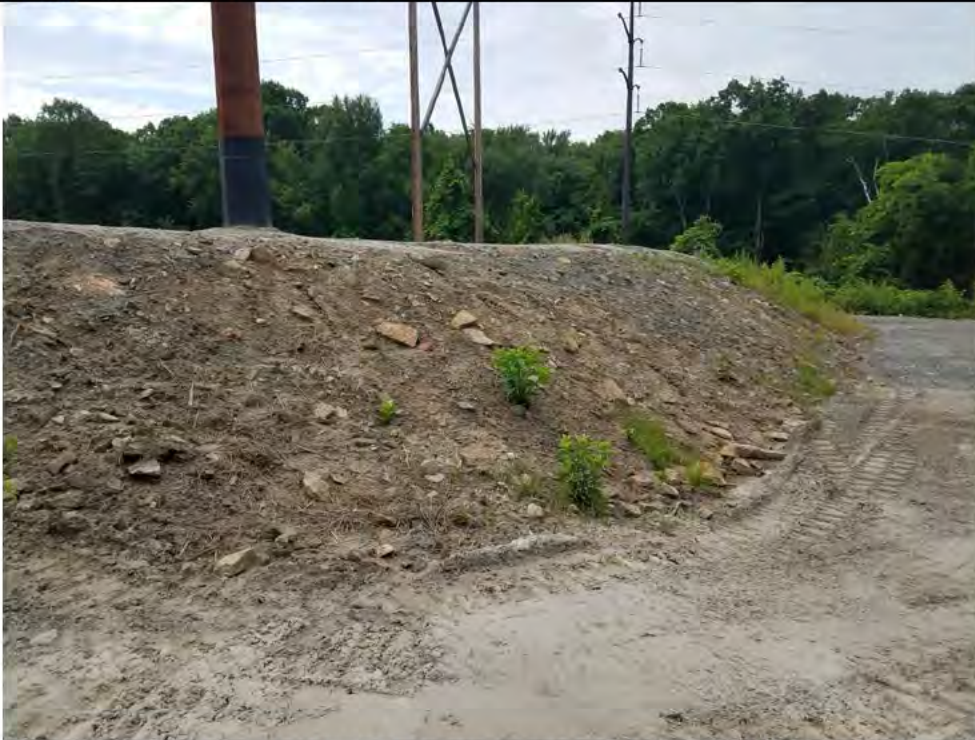
Photo 8: 07/06/2018, Watertown: Map 04, Str08, slope erosion, no stabilization. Photo taken facing northwest.

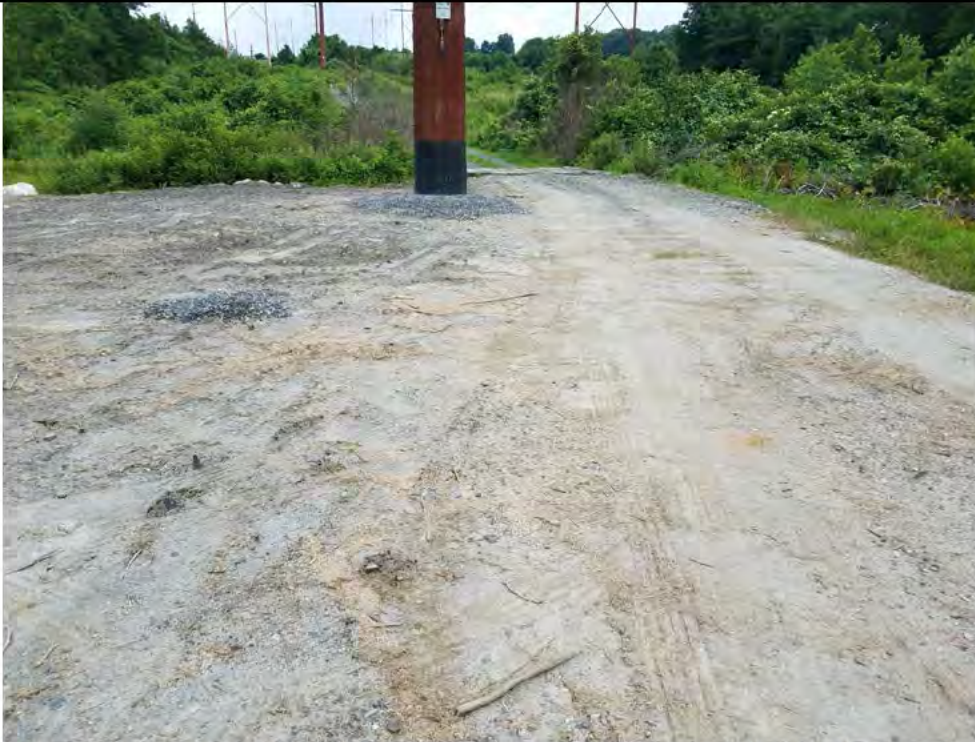
Photo 9: 07/06/2018, Watertown: Map 04, Str09, fine sediments continue to wash out of exposed, unstabilized/unvegetated soils during rain events. Photo taken facing west.

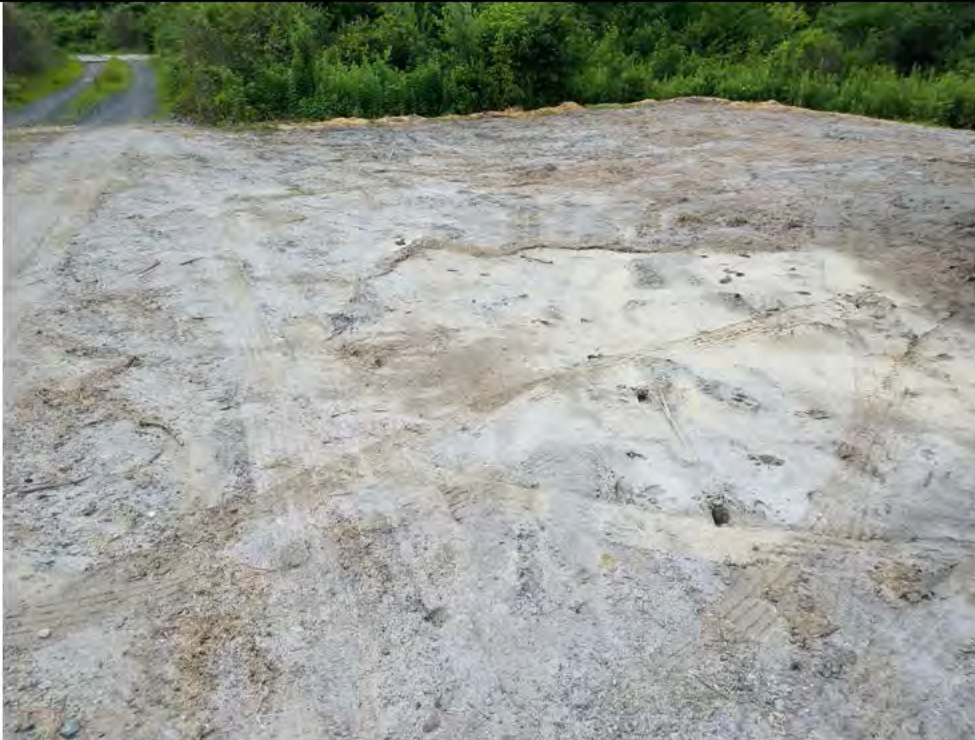
Photo 10: 07/06/2018, Watertown: Map 04, Str09, fine sediments continue to wash out of exposed, unstabilized/unvegetated soils during rain events. Photo taken facing east.

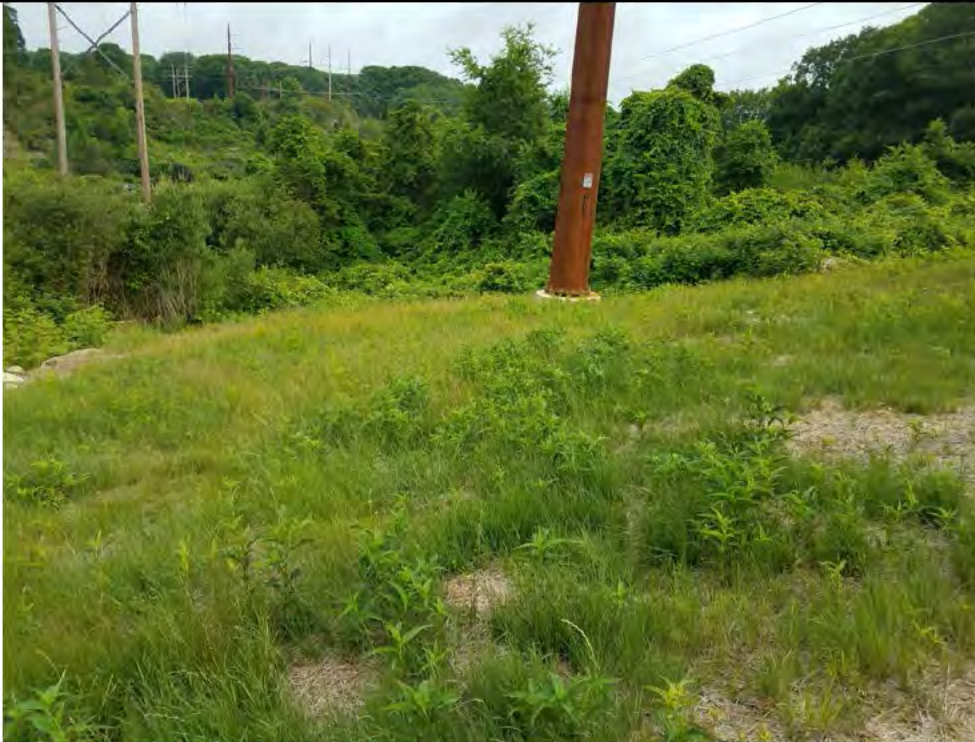
At the time of this inspection disturbed ground areas appeared dry and dusty conditions were observed in various areas inspected. Most areas inspected today have yet to be stabilized or restored. Ground surfaces that were disturbed during project construction, as well as access roads and structure/pull pads that are not constructed of gravel or stabilized with gravel, exhibited varying degrees of prolonged and/or recent soil erosion (see Photos 1-18). In areas where stabilization measures have been successful such as at Str23 (Photos 11-12) and to a lesser degree Str81(Photo 19), no erosion is occurring at this time.

Photo 11: 07/06/2018, Watertown: Map 09, Str23 pad stabilization. Photo taken facing north.

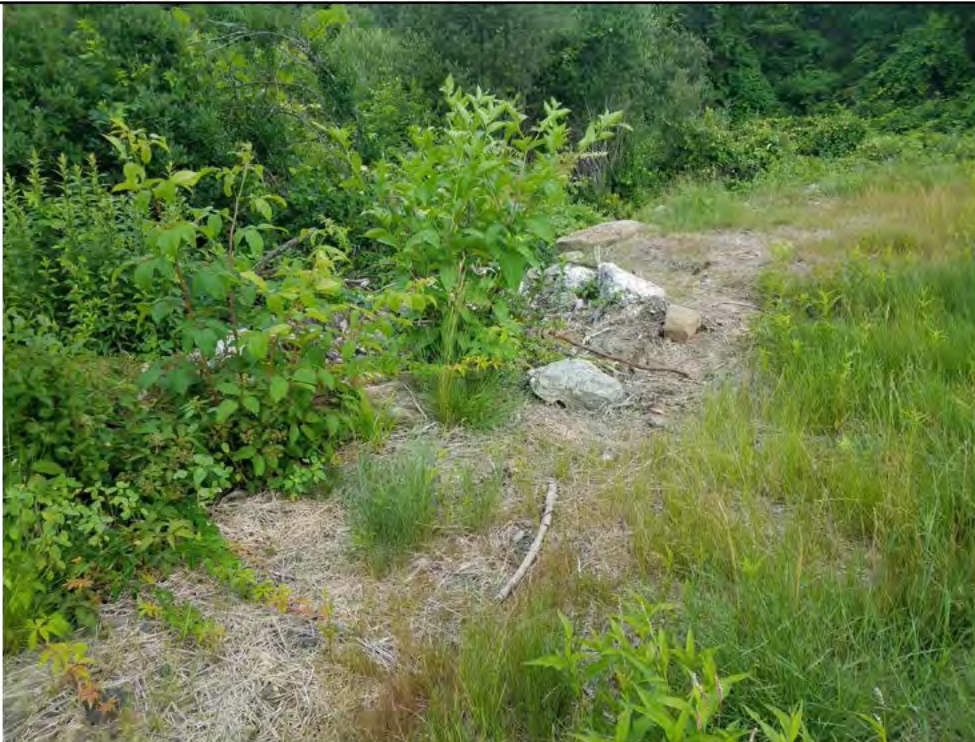
Photo 12: 07/06/2018, Watertown: Map 09, Str23 pad stabilization. Photo taken facing north.

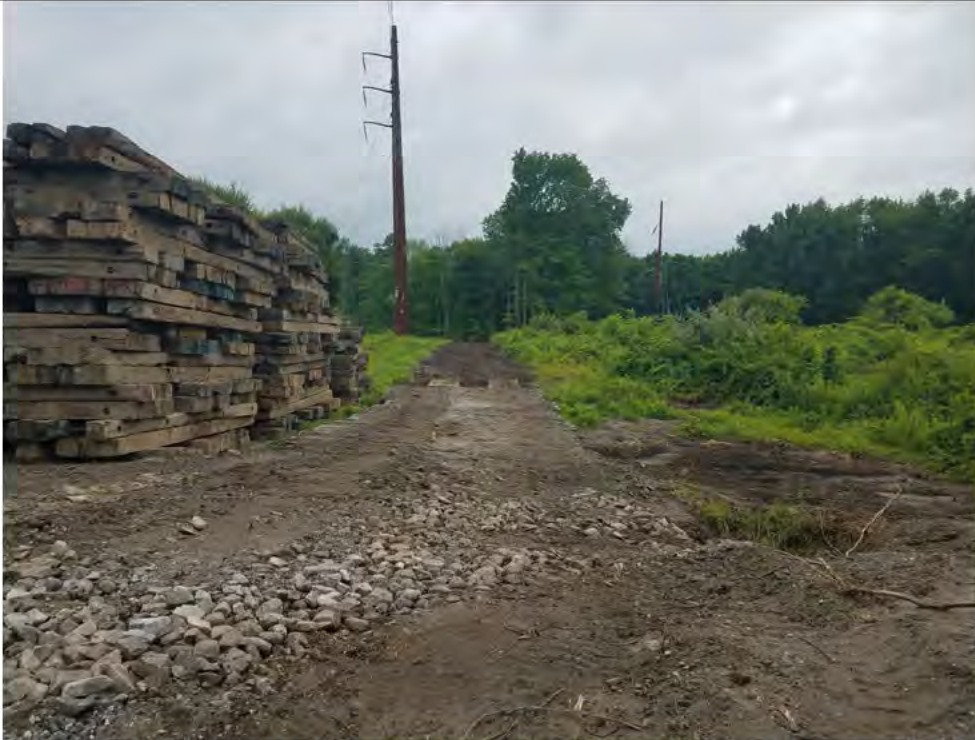
Photo 13: 07/06/2018, Thomaston: Map 22, Str63-Str64 timber mats being removed. Photo taken facing north from Walnut Hill Road access.

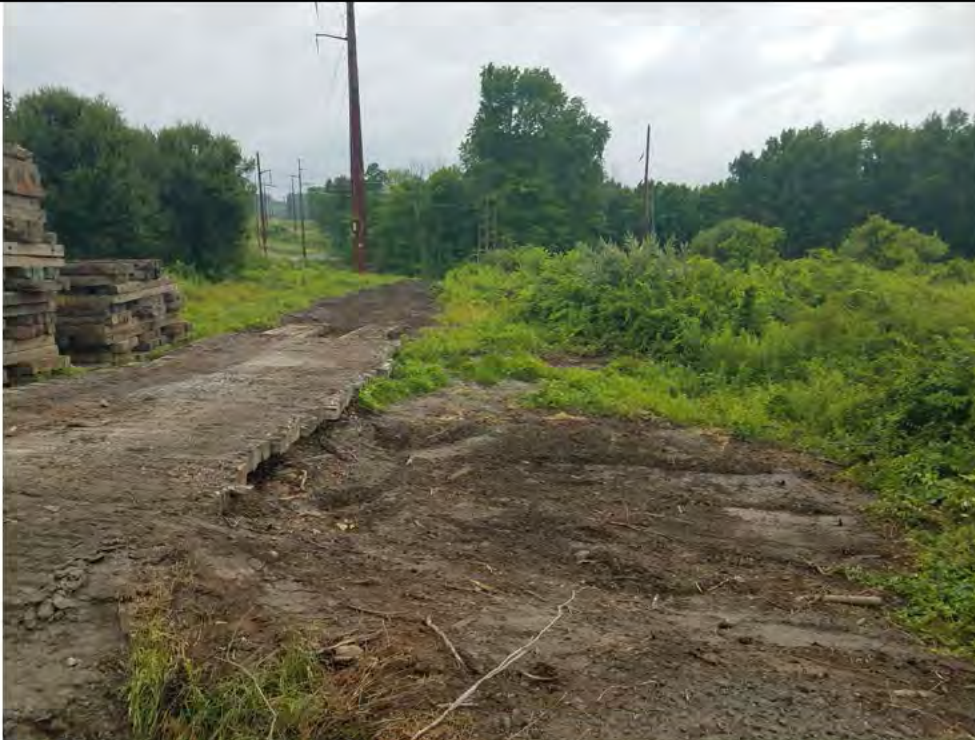
Photo 14: 07/06/2018, Thomaston: Map 22, Str63-Str64 timber mats being removed. Photo taken facing north from Walnut Hill Road access.

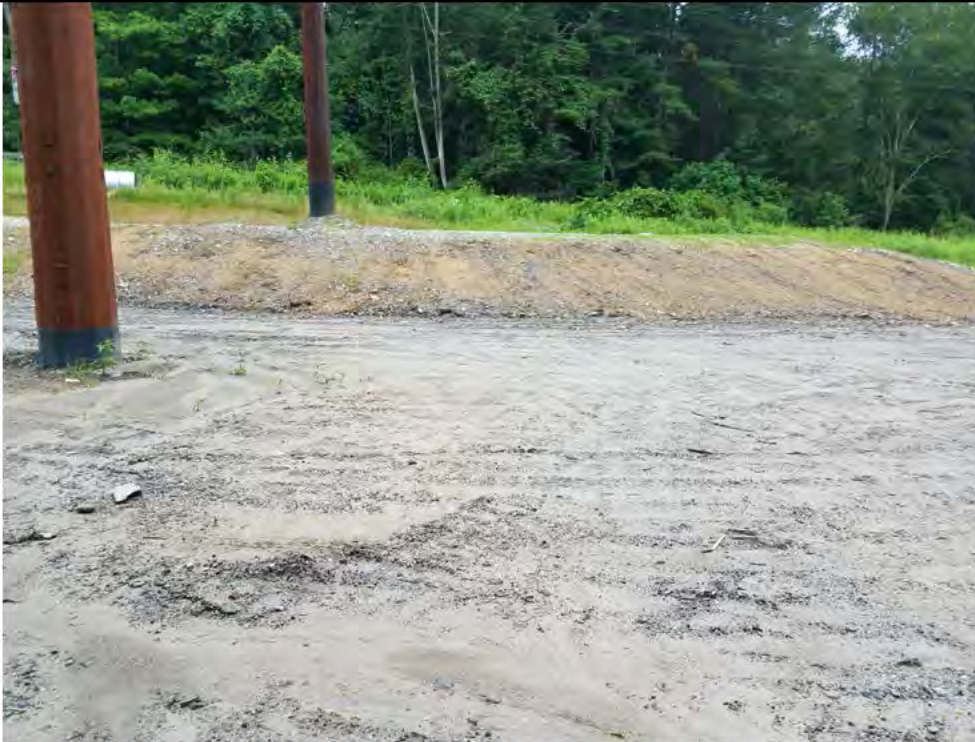
Photo 15: 07/06/2018, Litchfield: Map 29, Str83, fine sediments continue to wash out of exposed, unstabilized/unvegetated soils during rain events. Photo taken facing west.

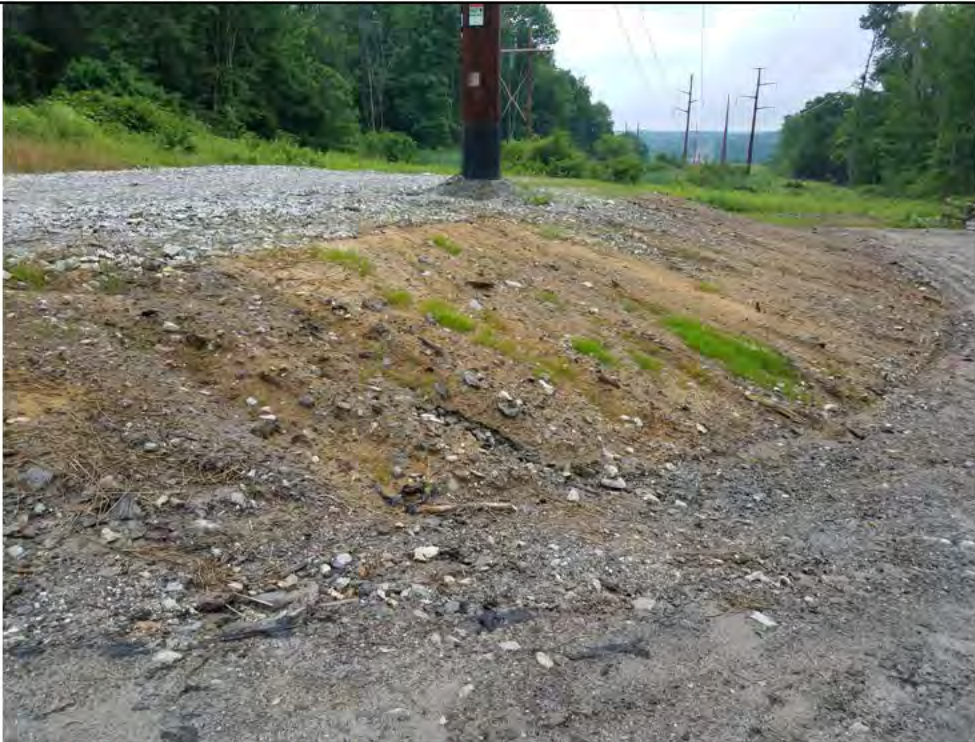
Photo 16: 07/06/2018, Litchfield: Map 29, Str83 Pad and upland slope erosion, no stabilization. Photo taken facing north.

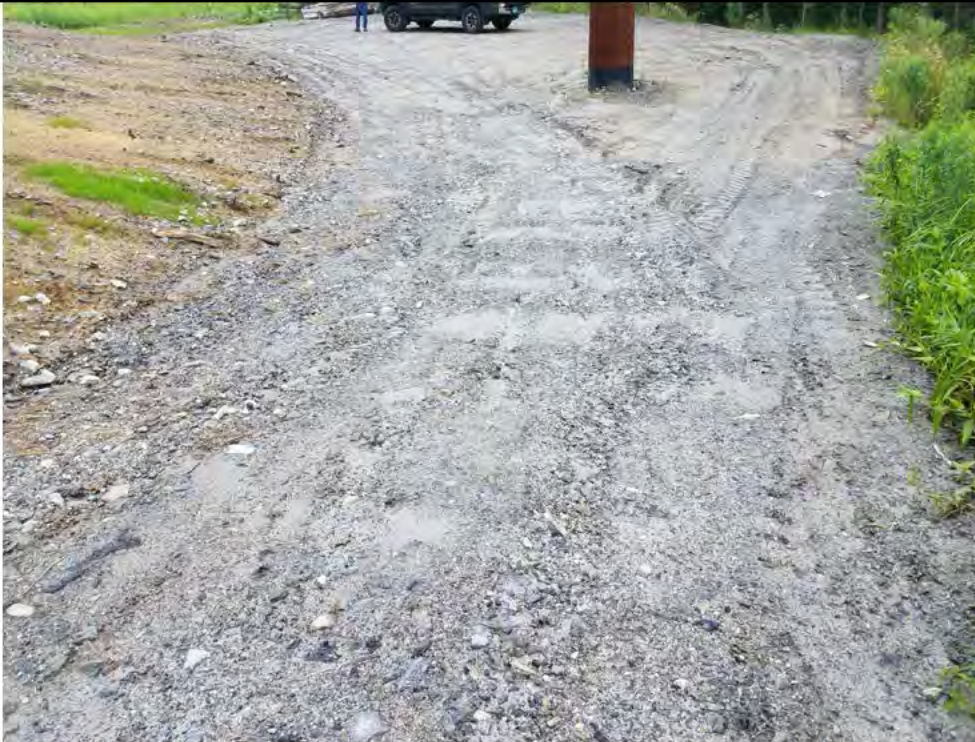
Photo 17: 07/06/2018, Litchfield: Map 29, Str83, fine sediments continue to wash out of exposed, unstabilized/unvegetated soils during rain events and access road erosion due to uncontrolled surface water flow from upland areas. Photo taken facing east.

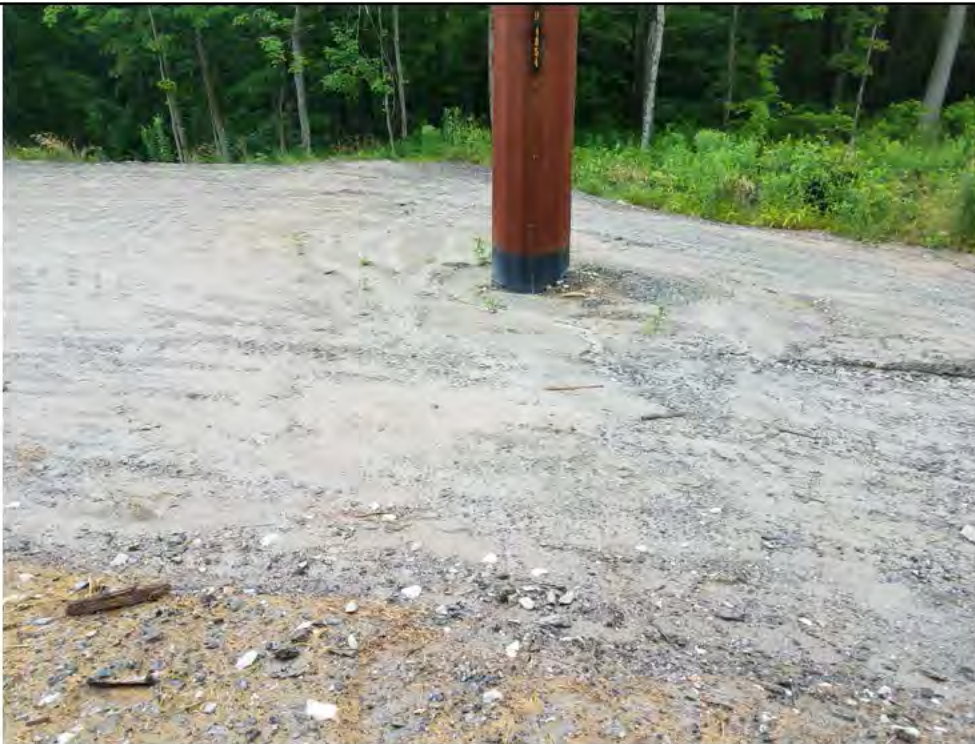
Photo 18: 07/06/2018, Litchfield: Map 29, Str83, fine sediments continue to wash out of exposed, unstabilized/unvegetated soils during rain events. Photo taken facing east.

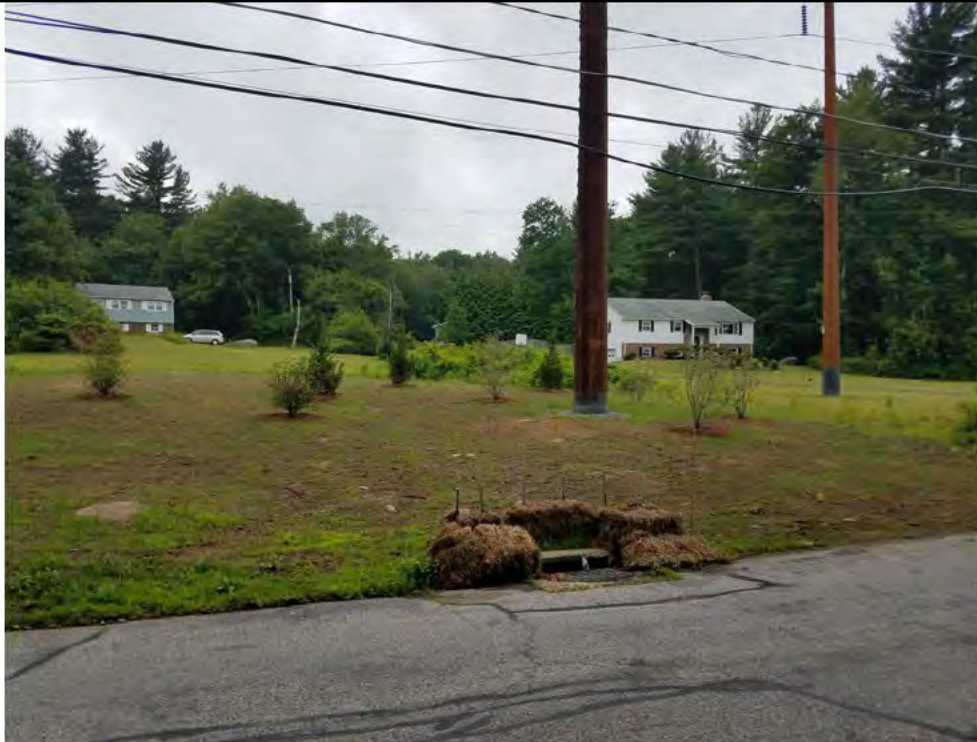
Photo 19: 07/06/2018, Litchfield: Map 29, Str81 Pad stabilization. Photo taken facing west from Campville Road.

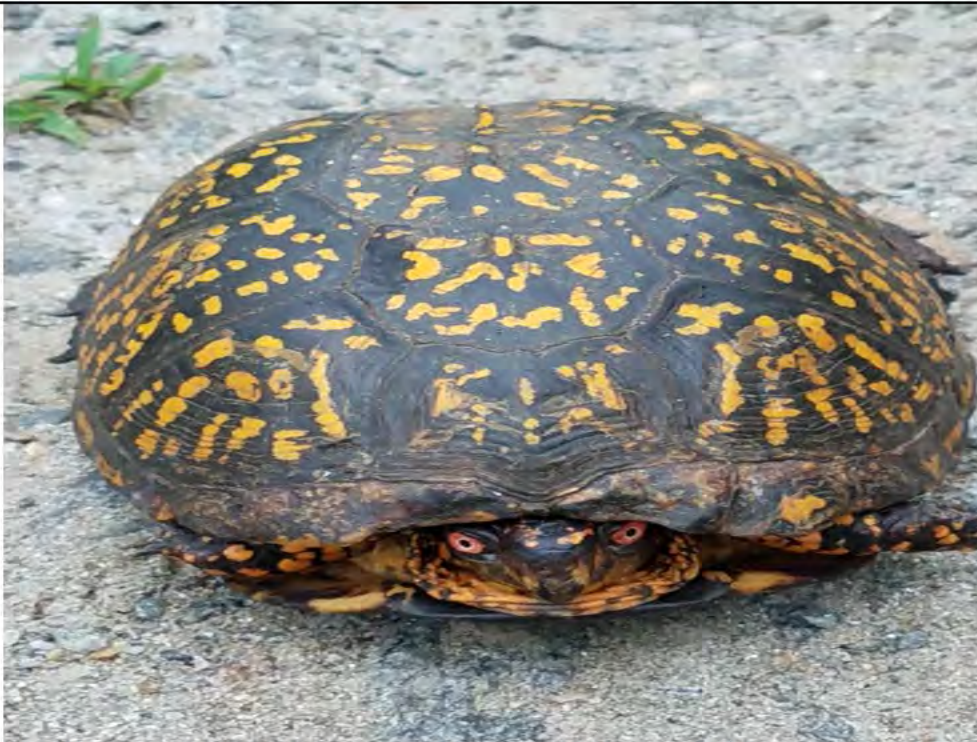
Rare, Threatened, and Endangered Species	Interim Week	Although not on the rare, threatened, or endangered species list for this project, an Eastern Box Turtle was observed during this inspection on the access road between Str7 and Str8. Because of the population decline in CT, the box turtle was added to the state's List of Endangered, Threatened, and Special Concern Species List, revised in 1998.	Turtle was photographed (Photos 19 & 20) and then moved several feet off to the side of the access road.	
	Bi-Week	None observed.	N/A

Photo 20: 07/06/2018, Watertown: Map 04, access road between Str08 and Str09, Eastern Box Turtle relocated off of the access road area.

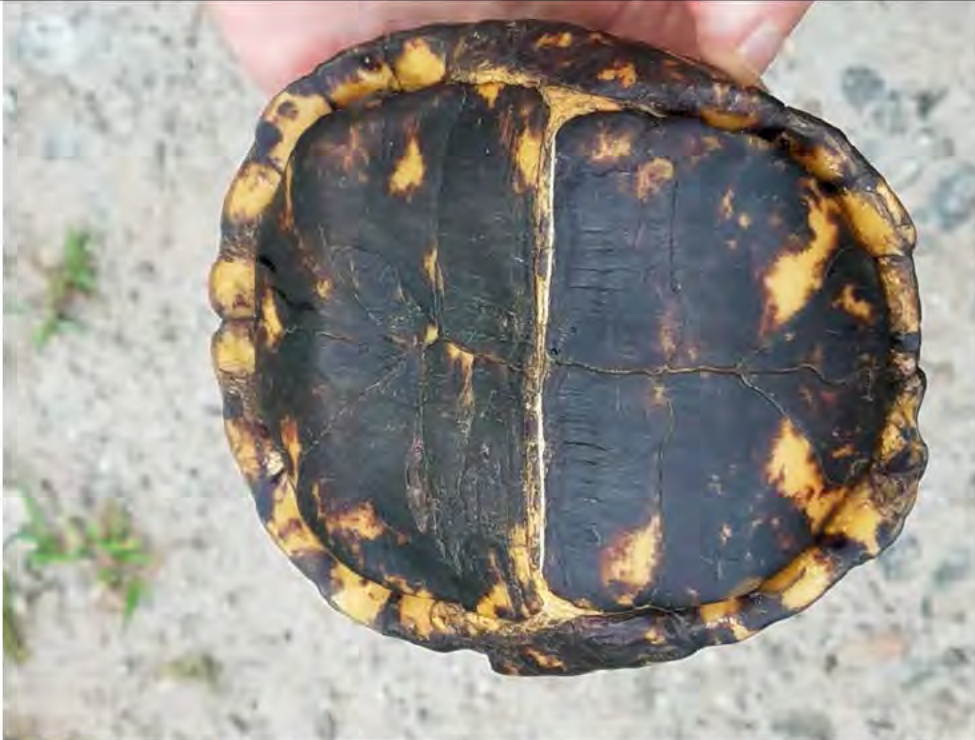
Photo 21: 07/06/2018, Watertown: Map 04, access road between Str08 and Str09, Eastern Box Turtle relocated off of the access road area.

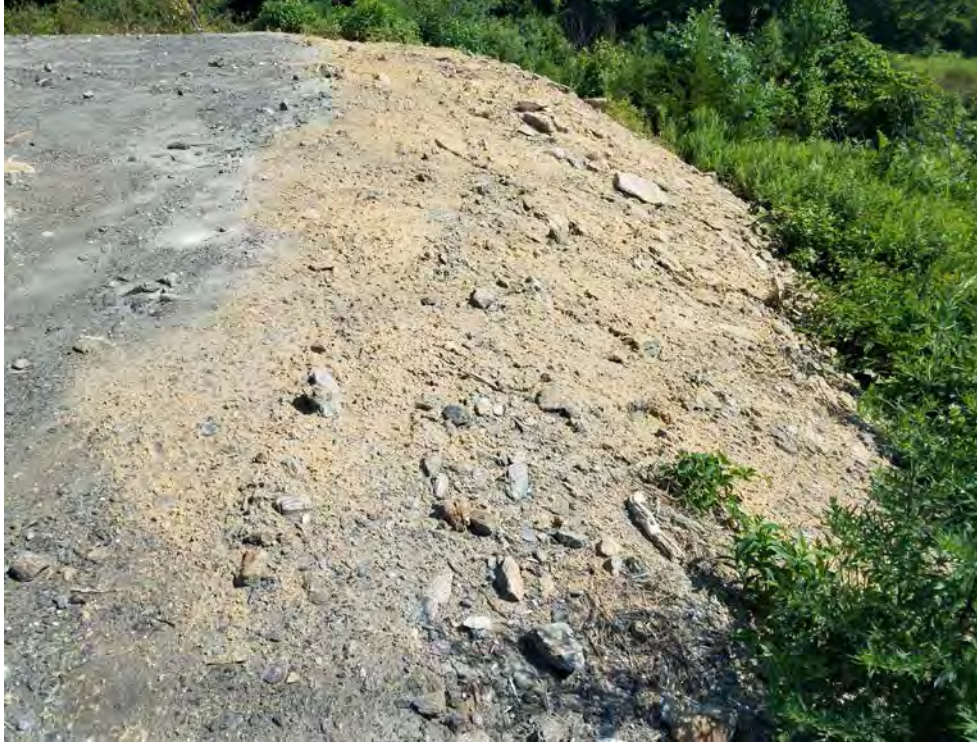
Photo 22: 07/13/2018, Watertown: Map 04, Str05 slope stabilization. Hydro seed applied to the down gradient slope.

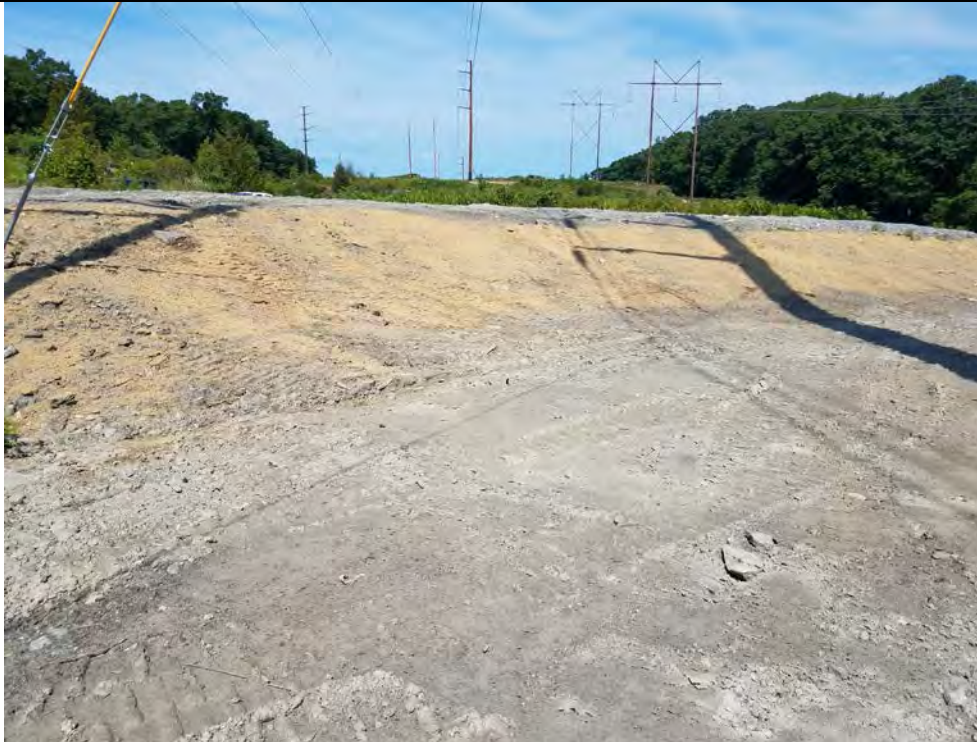
Photo 23: 07/13/2018, Watertown: Map 04, Str05 slope stabilization. Hydro seed applied to the upland slope, erosion area shown previously in Photo #3. Photo taken facing south (opposite view of Photo 3).

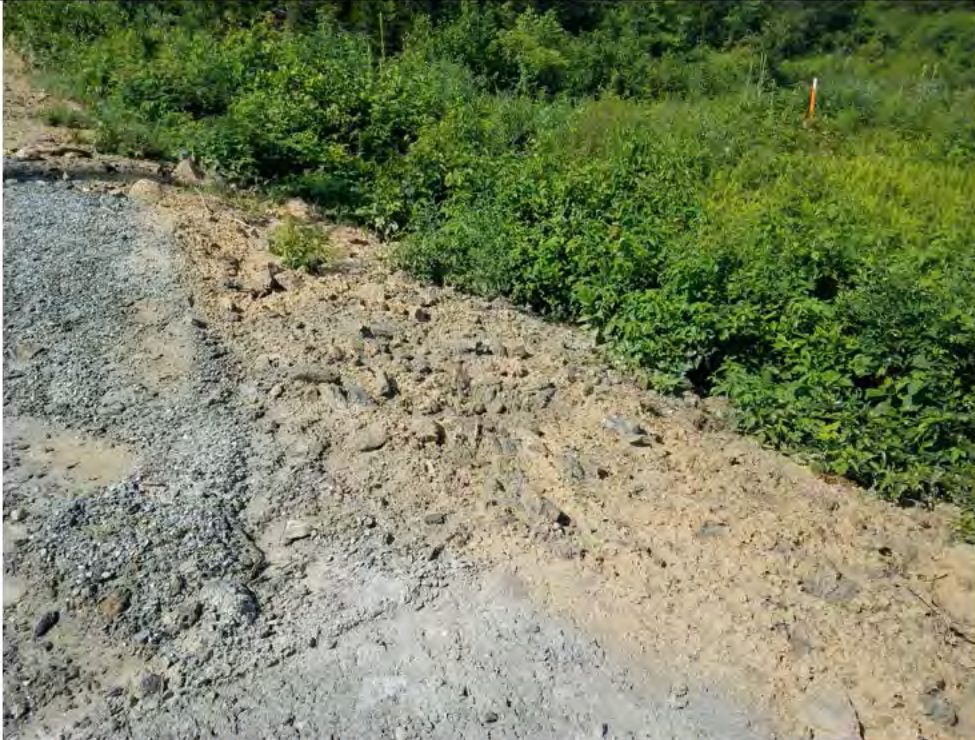
Photo 24: 07/13/2018, Watertown: Map 04, Str05 slope stabilization. Hydro seed applied to the pad slope, erosion area shown previously in Photo #4. Photo taken facing northwest.

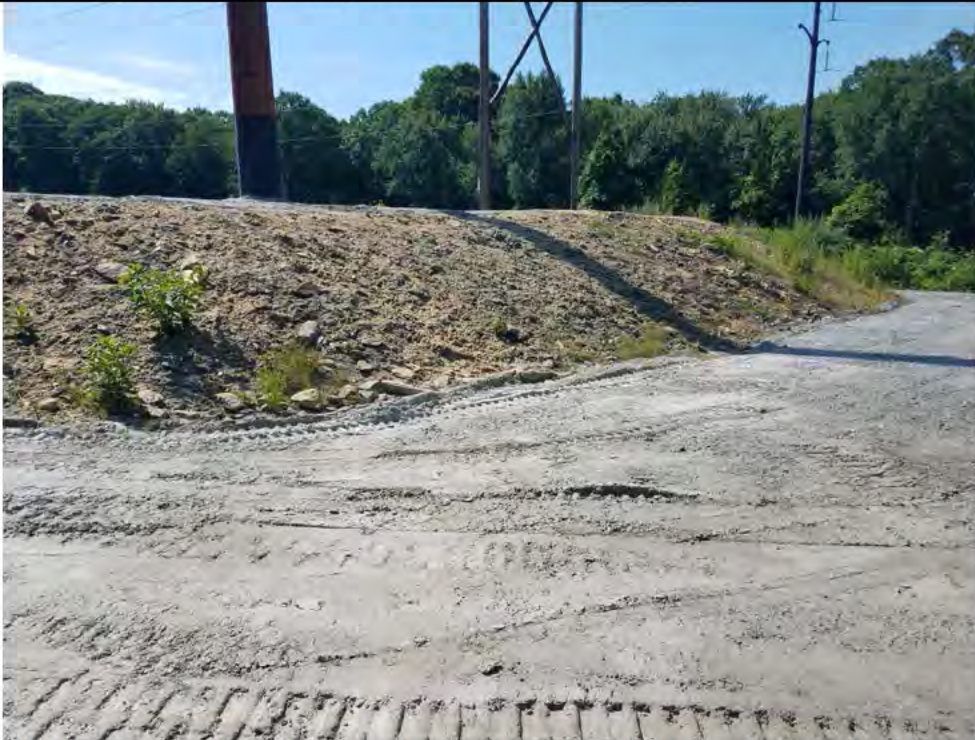
Photo 25: 07/13/2018, Watertown: Map 04, Str08, slope stabilization. Hydro seed applied to the pad slope, erosion area shown previously in Photo #8.

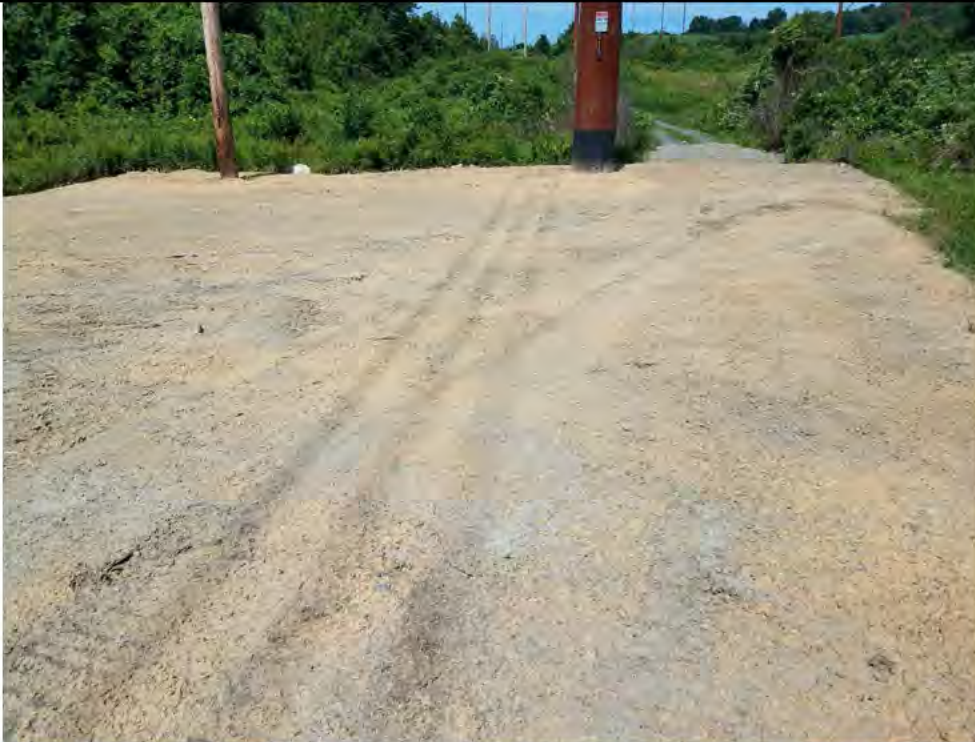
Photo 26: 07/13/2018, Watertown: Map 04, Str09, work pad and access hydro seeded. Area previously shown in Photo #9. Photo taken facing west toward S-A5.

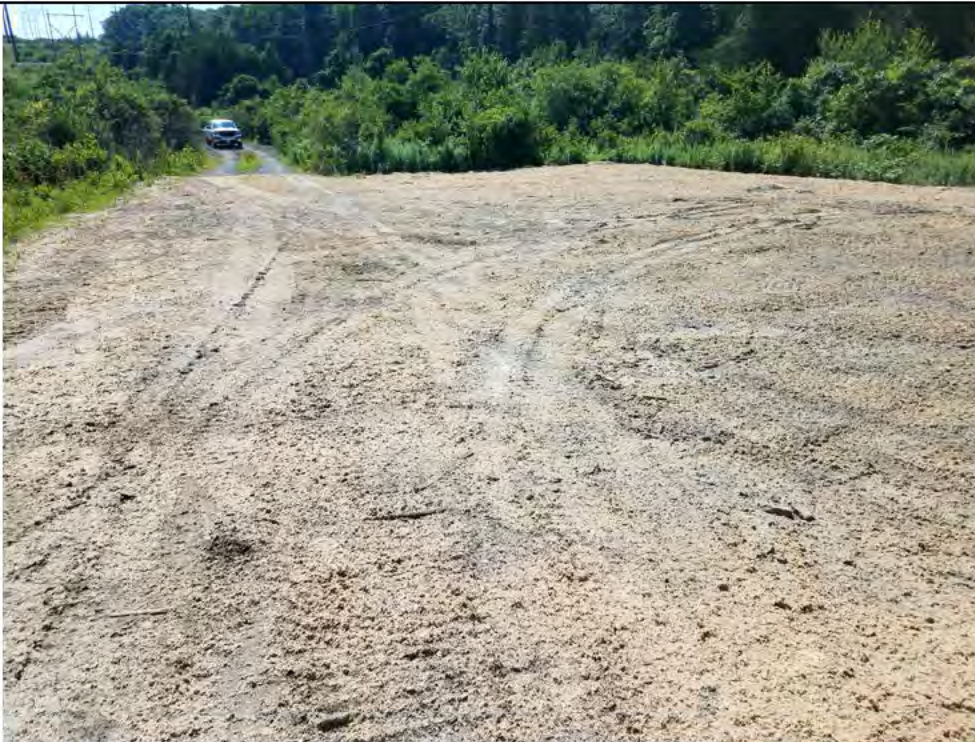
Photo 27: 07/13/2018, Watertown: Map 04, Str09, work pad and access hydro seeded. Area previously shown in Photo #10. Photo taken facing east.

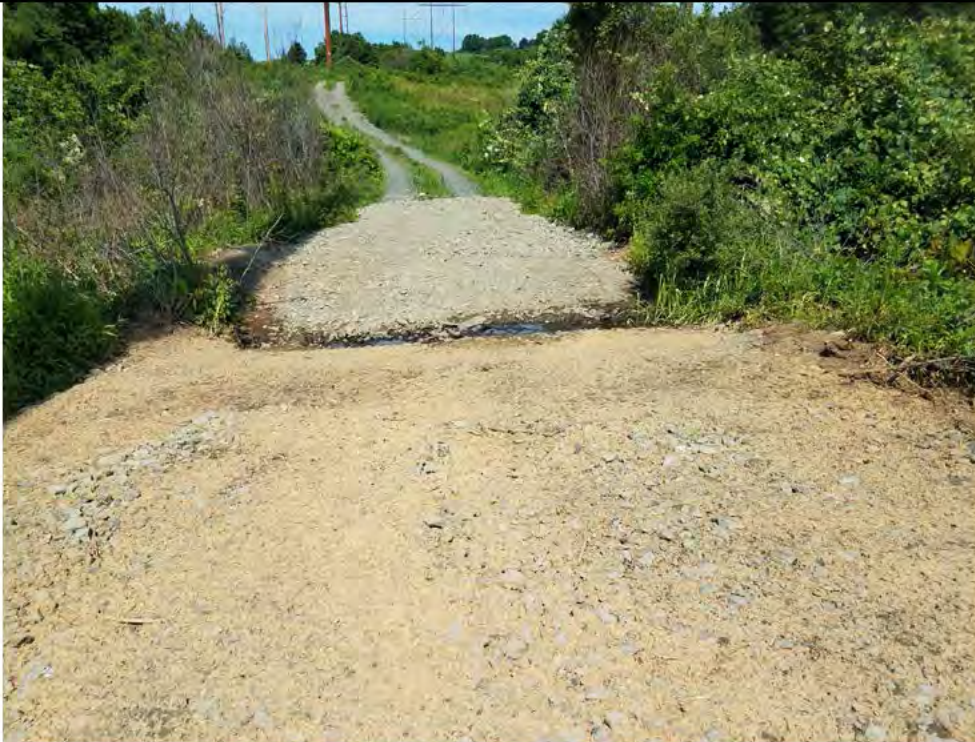
Photo 28: 07/13/2018, Watertown: Map 04, Str09 and S-A5, timber mat crossing removed, access road hydro seeded, stream crossing graded and improved. Photo taken facing west toward S-A5 from west end of Str09.

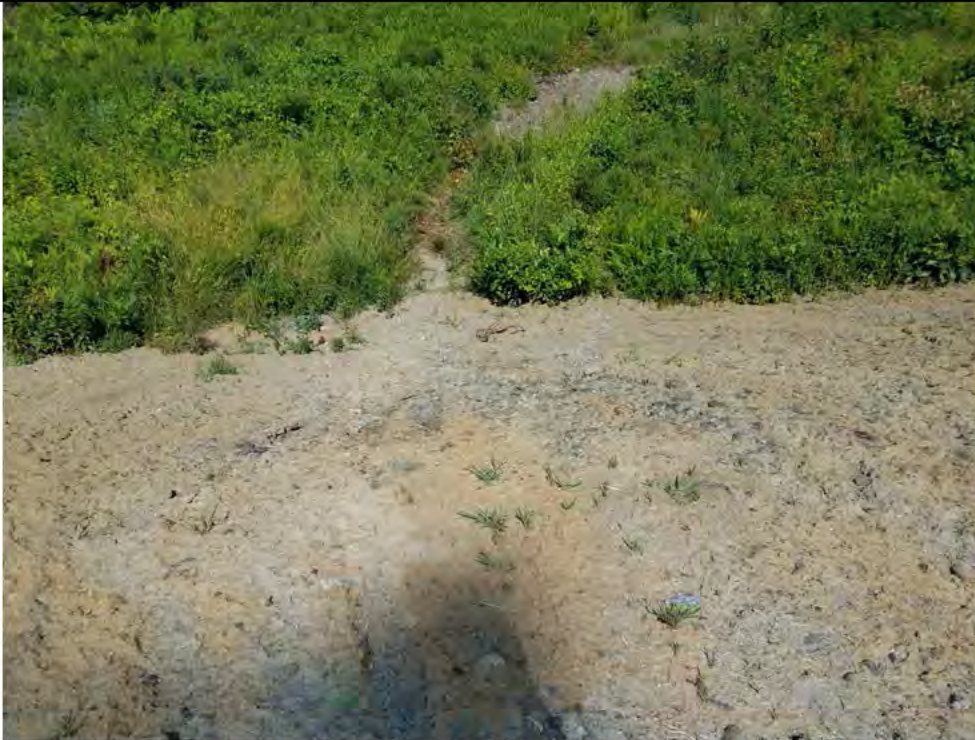
Photo 29: 07/13/2018, Watertown: Map 03, Str07 slope stabilization. Hydro seed applied to the pad slope, erosion area shown previously in Photo #6. Photo taken north off of the top of the work pad.
