**Subject: Docket No. 466, Frost Bridge to Campville 115-kV Project
Decision and Order Condition #4 – Independent Environmental Inspector Report**

Please find enclosed the Biweekly Independent Environmental Inspector Report, Report #42, for the **July 6th** and **July 13th, 2018** inspection events for the construction of the Eversource Frost Bridge to Campville 115-kV Project.

Docket No. 466- Development and Management Plan Inspection

Frost Bridge to Campville 115kV Project

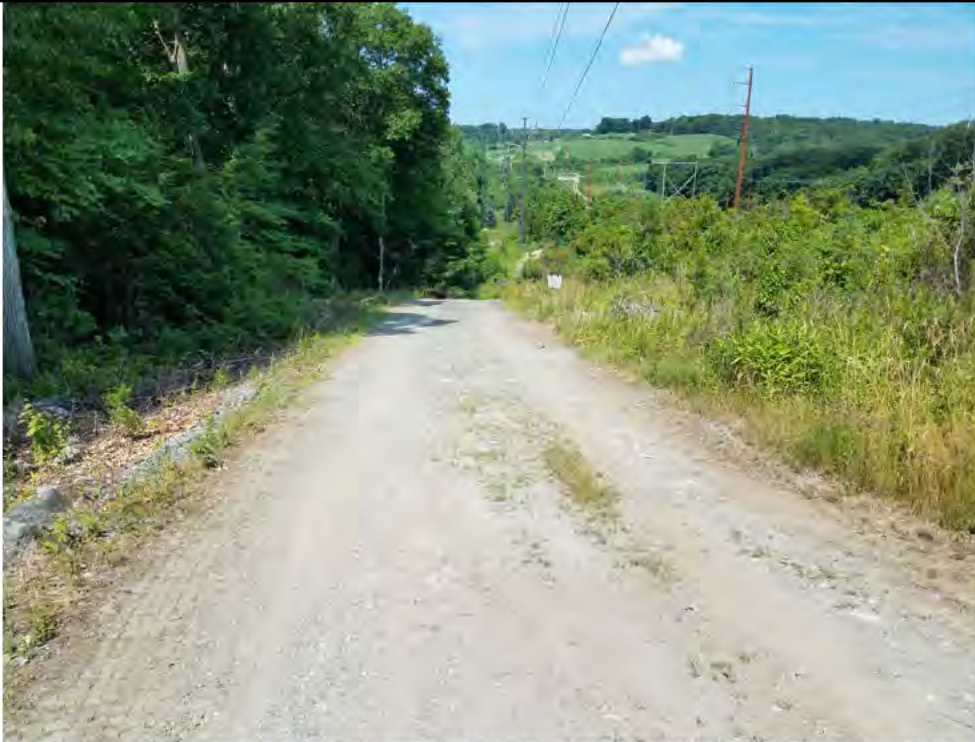
Photo 30: 07/13/2018, Watertown: Map 03, access road between Str07 and Str08, water bars and sediment basin will be installed to help control surface water flow. Photo taken facing north, from Str7 towards Str8.

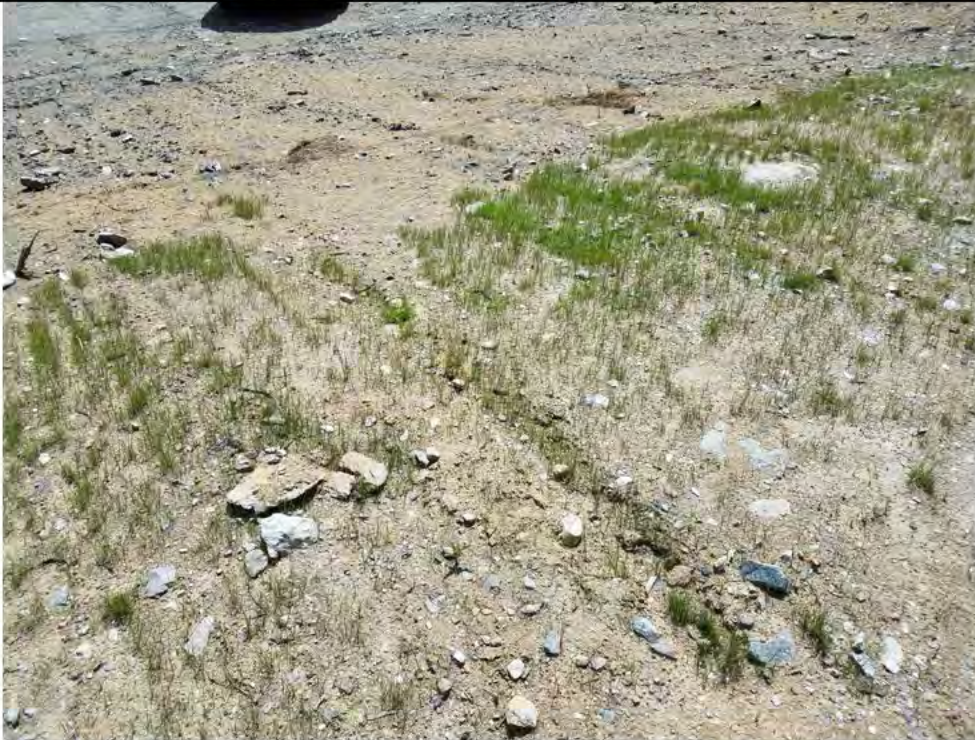
Photo 31: 07/13/2018, Litchfield: Map 29, Str83, upland slope facing down to the Str83 work pad, minimal vegetation growth from previous stabilization measures, erosion visible. Area previously shown in Photo 16. Photo taken facing east, down the upland slope.

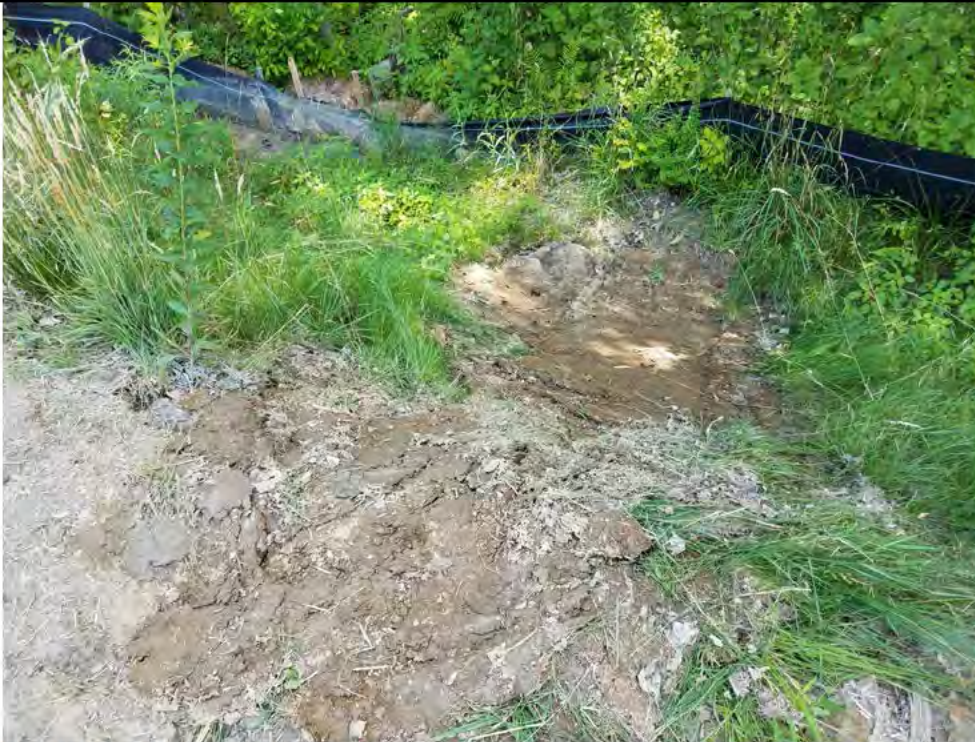
Photo 32: 07/13/2018, Litchfield: Map 29, Str83, erosion area graded but not stabilized on the down gradient slope (east side of work pad). Photo taken facing east towards W-F4 from the Str8 work pad.

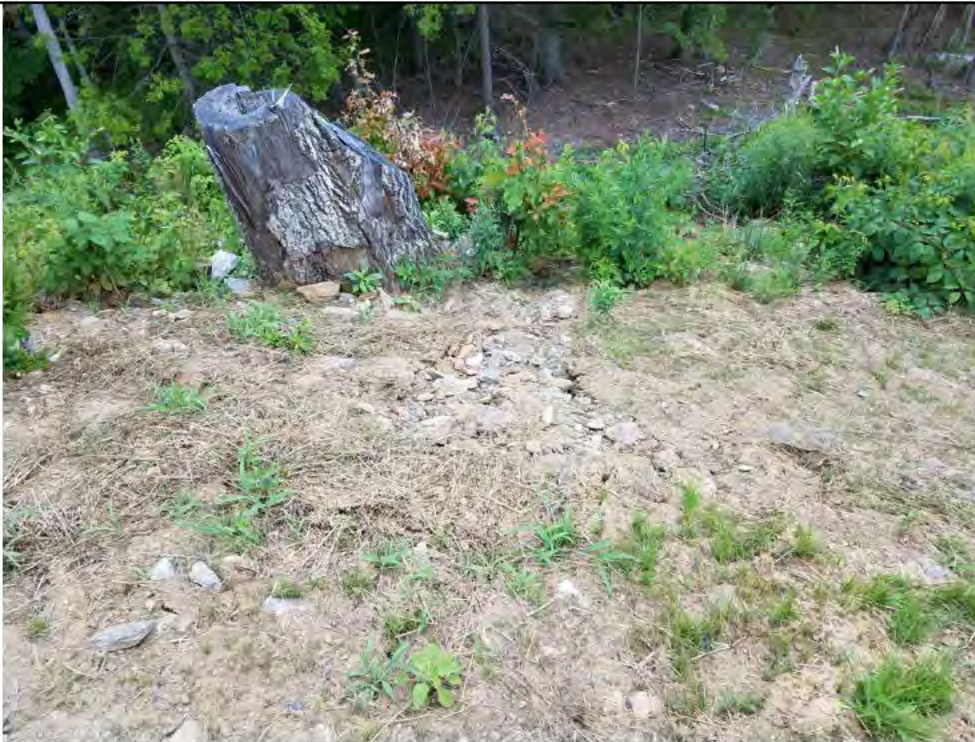
Photo 33: 07/13/2018, Harwinton: Map 32, Str88 eastern slope, visible erosion occurring.

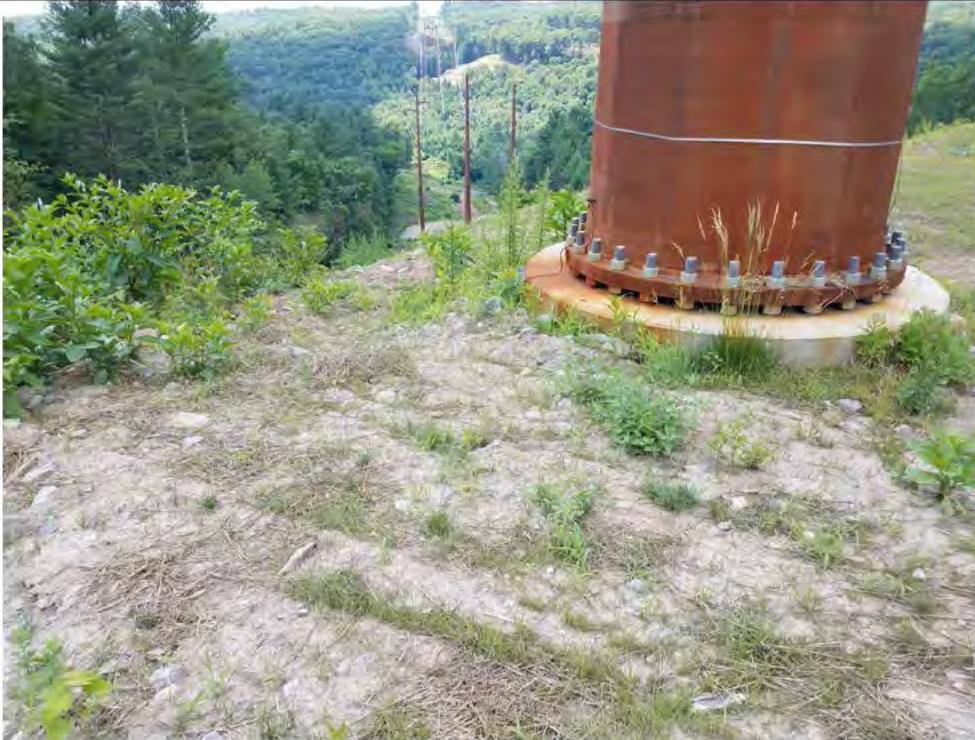
Photo 34: 07/13/2018, Harwinton: Map 32, Str88 work pad, visible erosion occurring on pad and down north slope. Light vegetation growth from previous stabilization measures.
