**Subject: Docket No. 466, Frost Bridge to Campville 115-kV Project  
Decision and Order Condition #4 – Independent Environmental Inspector Report**

Please find enclosed the Biweekly Independent Environmental Inspector Report, Report #43, for the **July 20<sup>th</sup>** and **July 27<sup>th</sup>, 2018** inspection events for the construction of the Eversource Frost Bridge to Campville 115-kV Project.

**Docket No. 466- Development and Management Plan Inspection**

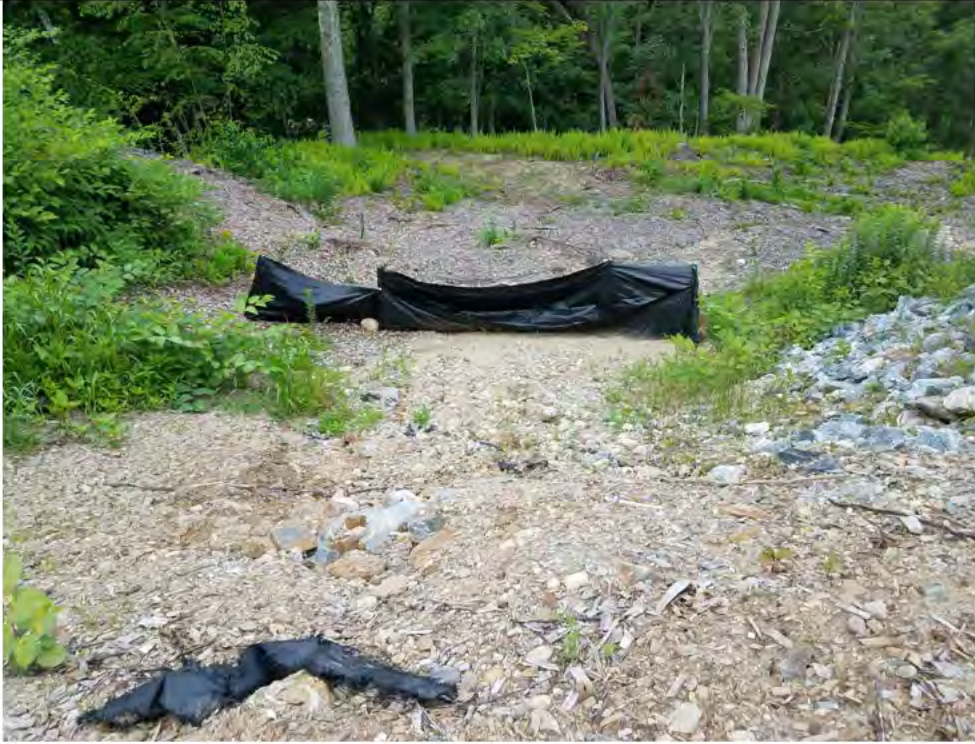
Photo 1: Interim Report # 42, Photo 2: 07/06/2018, Watertown: Map 01, Str1A pad slope erosion, no stabilization. Photo taken facing north CT wetland. **SEE PHOTO 1A and 1B FOR CORRECTIVE ACTIONS, PERMANENT BMPs.**

Photo 1A: 07/20/2018, Watertown: Map 01, Str1A, **CORRECTIVE ACTION**- Rip rap armored slope in erosion area shown in Photo 1, cleared sediment buildup on silt fence and reset silt fence.

Photo 1B: 07/20/2018, Watertown: Map 01, Str1A, **CORRECTIVE ACTION**- Constructed berm at edge of pad upland of slope erosion area shown in Photos 1 and 1A.

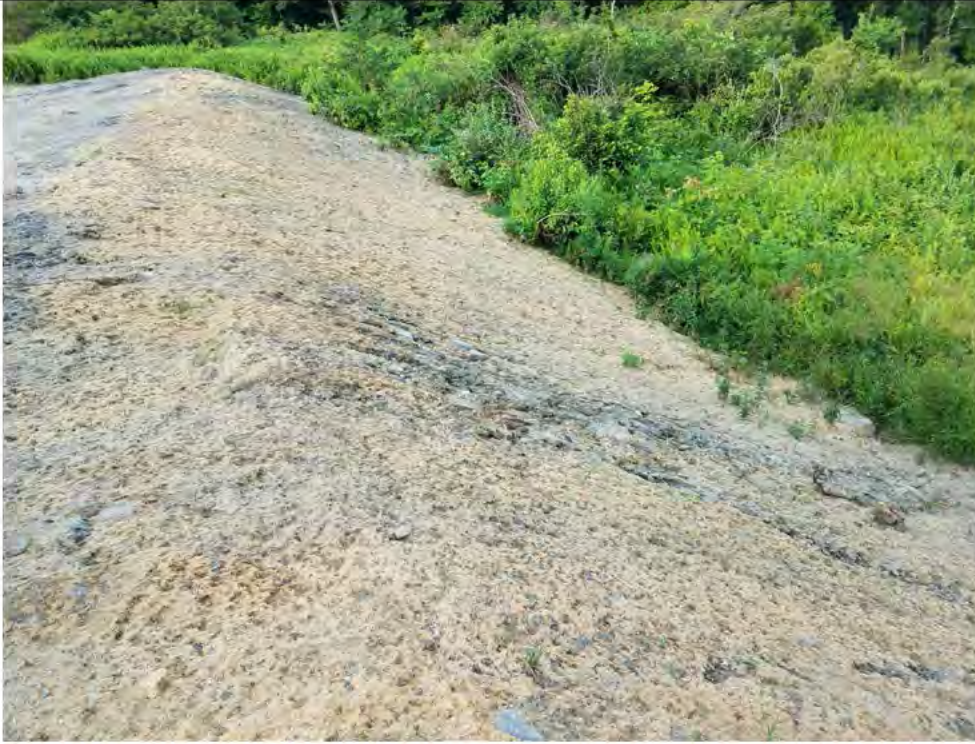
Photo 2: Interim Report # 42, Photo 6: 07/06/2018, Watertown: Map 03, Str07 pad and slope erosion, hydro seed application last fall, no visible growth. Photo taken facing east off of the south slope of pad.  
**SEE PHOTOS 2A, 2B, 2C, and 2D FOR CORRECTIVE ACTIONS, PERMANENT BMPs.**

Photo 2A: 07/20/2018, Watertown: Map 03, Str07, **CORRECTIVE ACTION**- Rip rap armored slope in areas of slope erosion as shown in Photo 2.

Photo 2C: 07/20/2018, Watertown: Map 03, Str07, **CORRECTIVE ACTION**- Rip rap armored slope in areas of slope erosion as shown in Photos 2 and 2B.

Photo 2D: 07/20/2018, Watertown: Map 03, Str07, **CORRECTIVE ACTION**- Rip rap berm along top of pad, upland of slope erosion shown in Photos 2 and 2B.

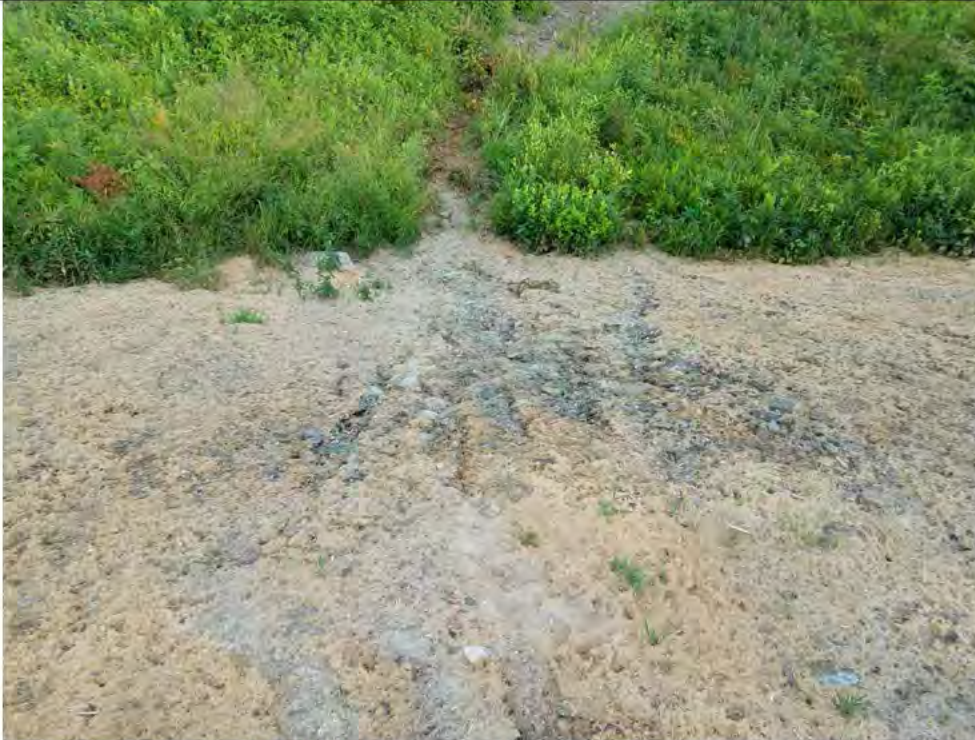
Photo 2B: Interim Report # 42, Photo 4: 07/06/2018, Watertown: Map 03, Str05 pad and slope erosion, no stabilization. Photo taken facing north.

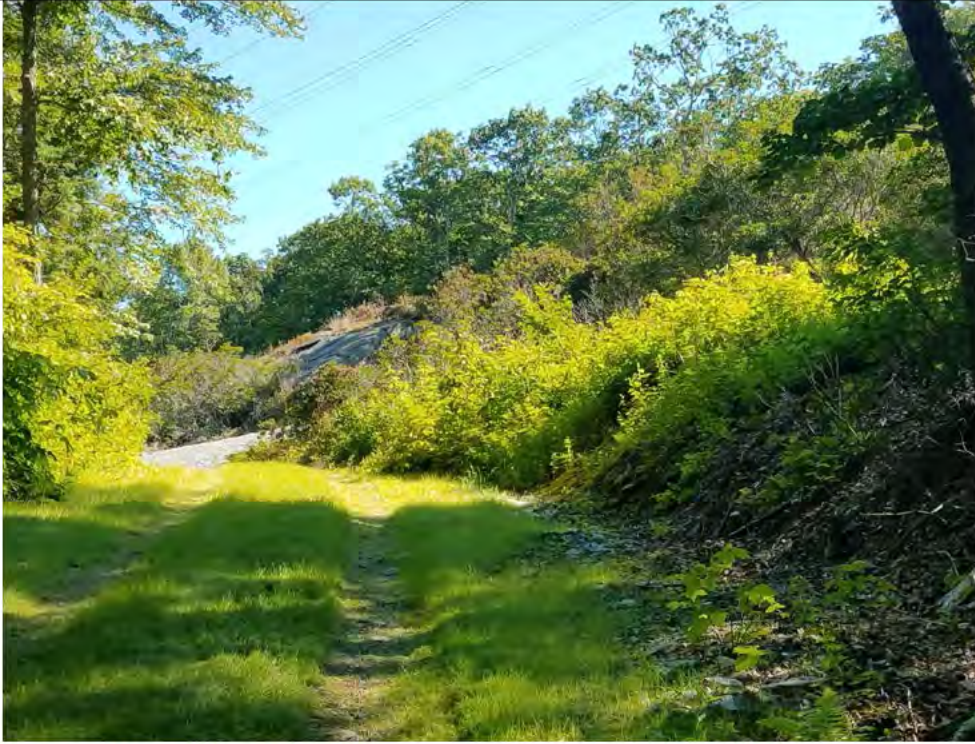
Photo 3: 07/20/2018, Watertown: Maps 11-13, access roads between Str32 and Str38, observed multiple stretches of the access road with varying degrees of vegetation (grass) growth.

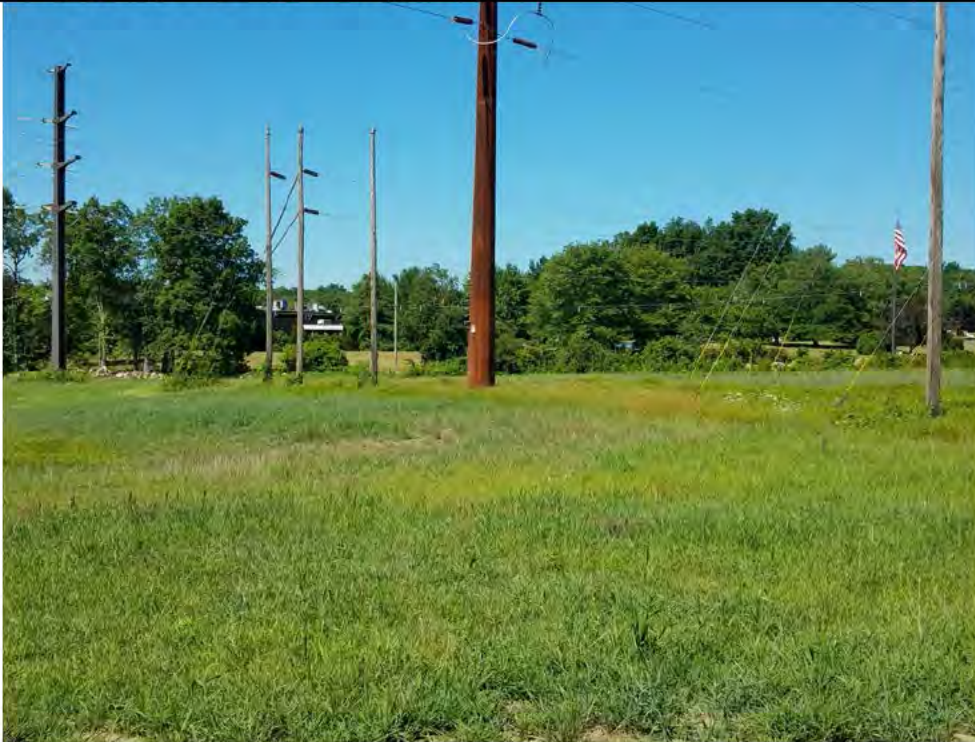
Photo 4: 07/20/2018, Watertown: Map 06, Str14, stabilization measures successful, no erosion visible.

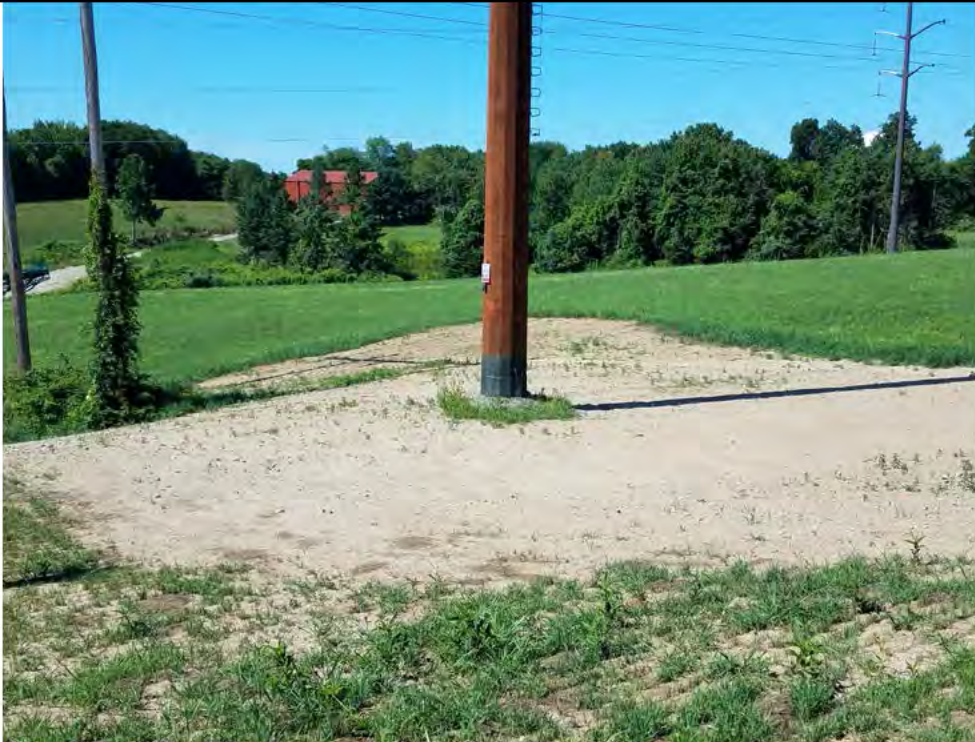
Photo 5: 07/20/2018, Watertown: Map 05, Str13, property owner interference with initial restoration/stabilization measures. This area is reportedly not going to be restored by the project.

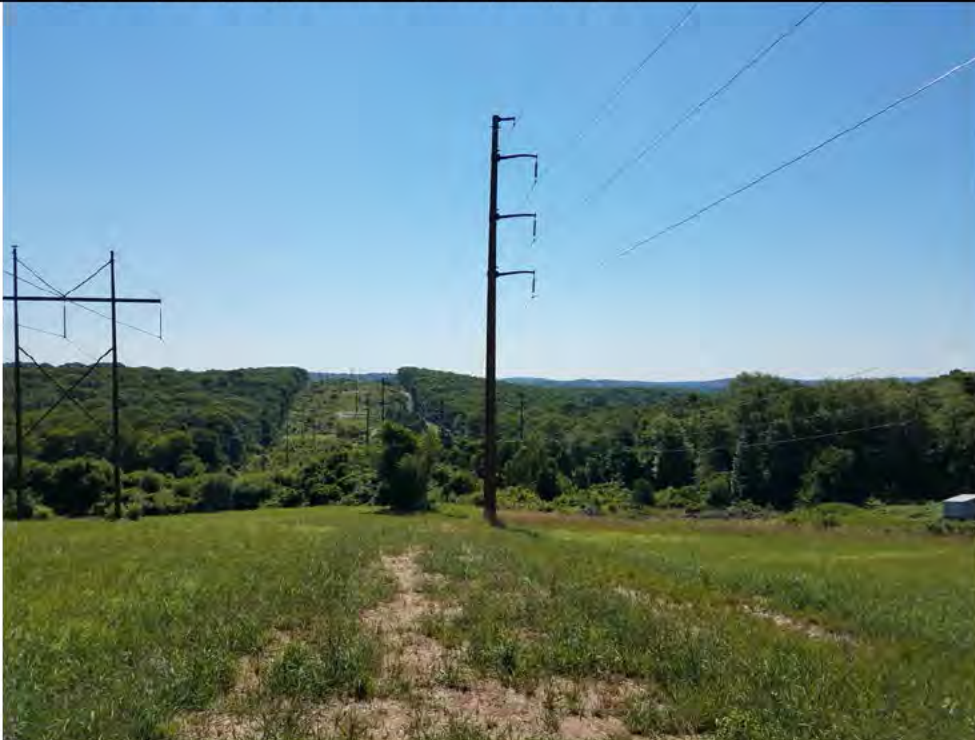
Photo 6: 07/20/2018, Watertown: Map 02, Str12, stabilization measures in progress, no erosion visible.

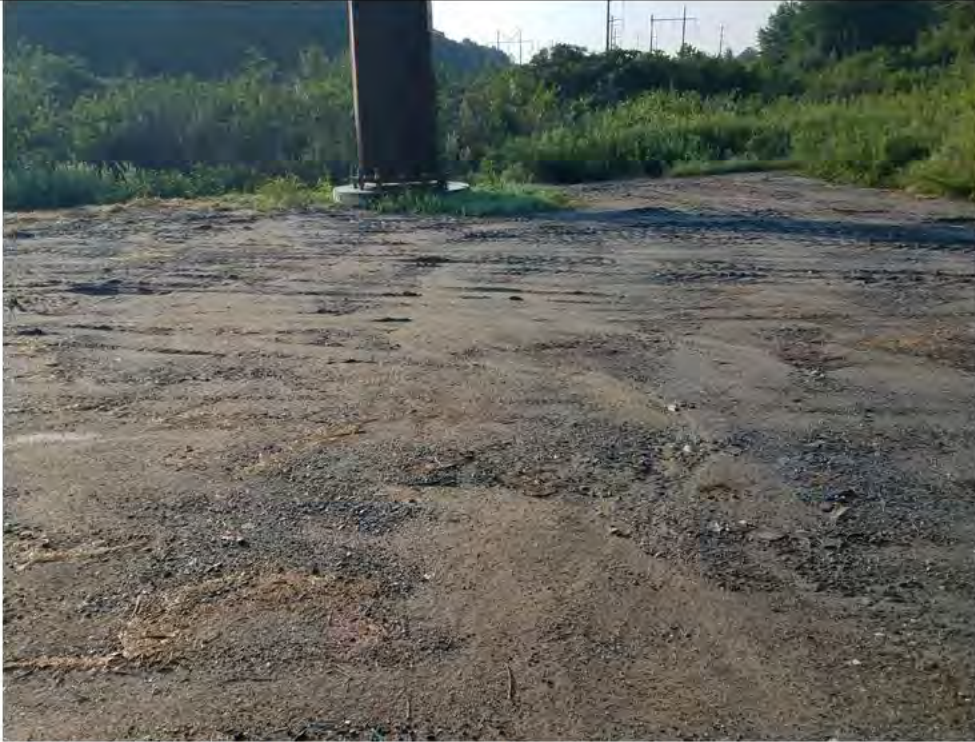
Photo 7: 07/27/2018, Watertown: Map 07, Str18 work pad, fine sediments continue to wash out of exposed non-stabilized/non-vegetated soils during rain events. Sediments are moving to the southeast toward the abutting wetland (W-B6). Photo taken facing southeast. **Photos 8-12 are additional views of conditions at Str18.**

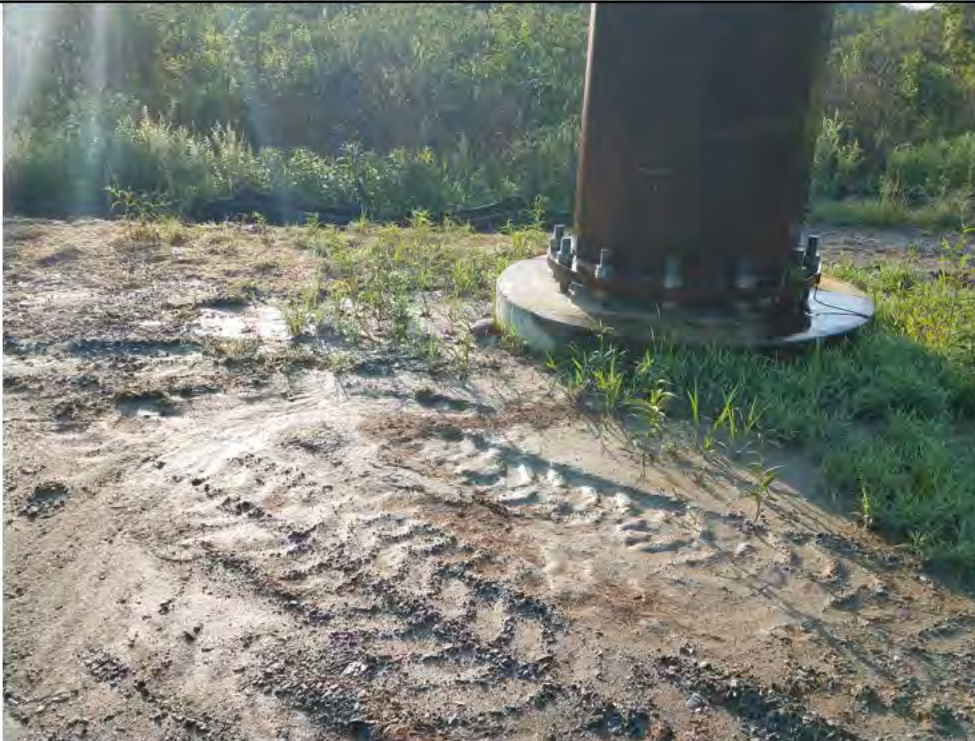
Photo 8: 07/27/2018, Watertown: Map 07, Str18 work pad, fine sediments continue to wash out of exposed non-stabilized/non-vegetated soils during rain events. Sediments appear to be accumulating on the upland side of the structure foundation. Photo taken facing southeast.

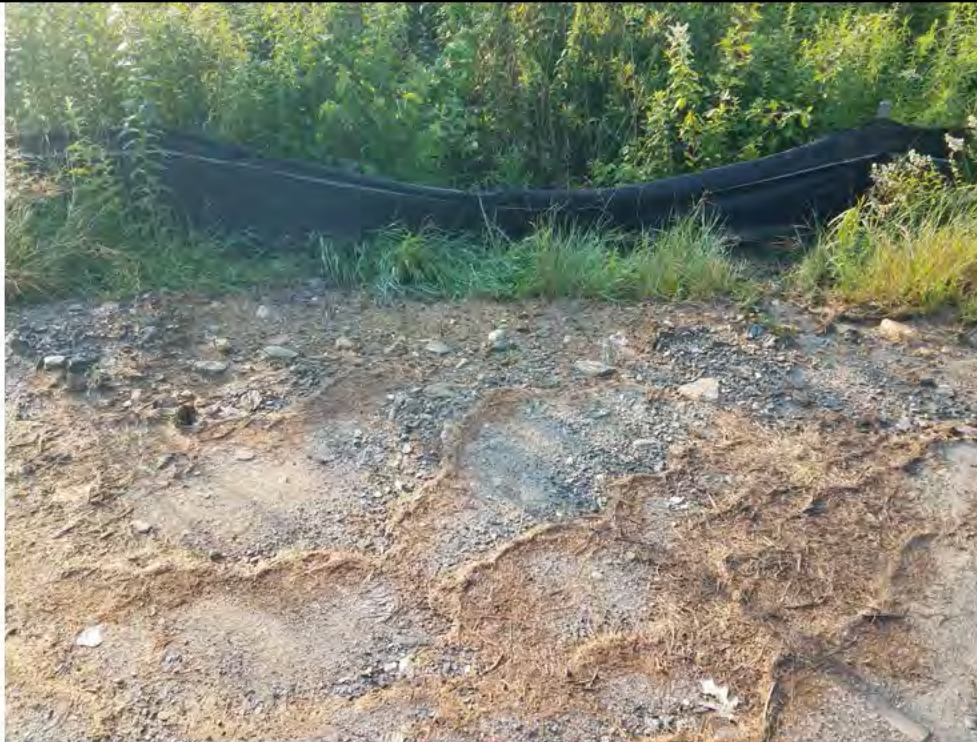
Photo 9: 07/27/2018, Watertown: Map 07, Str18 work pad, fine sediments continue to wash out of exposed non-stabilized/non-vegetated soils and slope erosion is occurring. Observed failing E&S with sediments passing under/through silt fence (see Photo 10). Silt fence maintenance is needed per the BMPs.

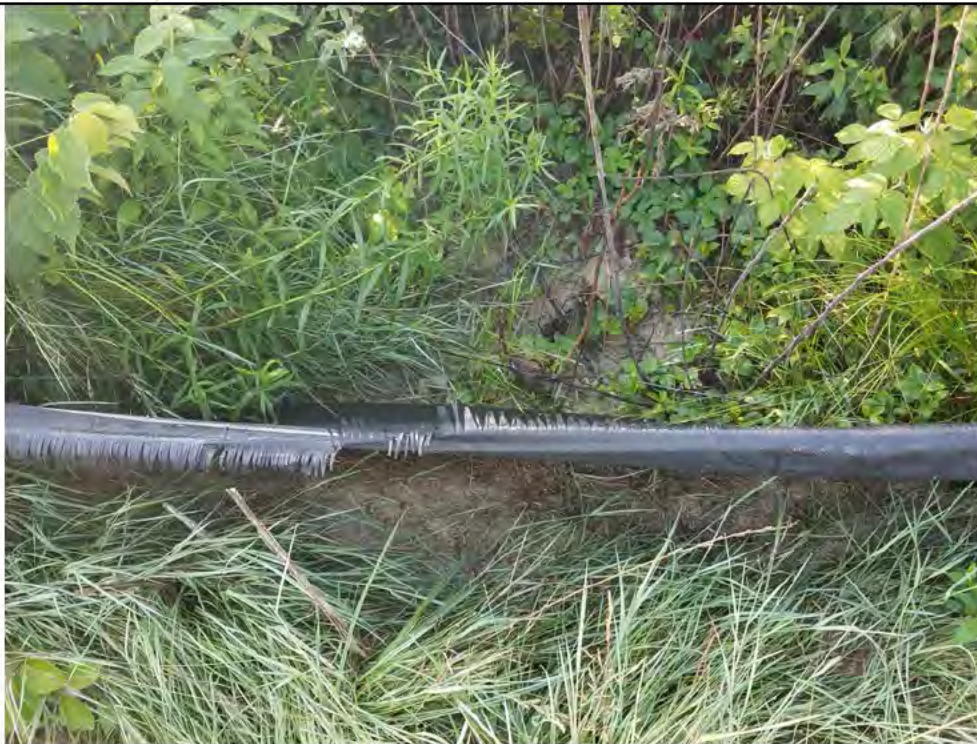
Photo 10: 07/27/2018, Watertown: Map 07, Str18, failing E&S and sediments passing under/through silt fence near or into wetland W-B6. Silt fence maintenance needed per the BMPs. Photo taken facing southeast.

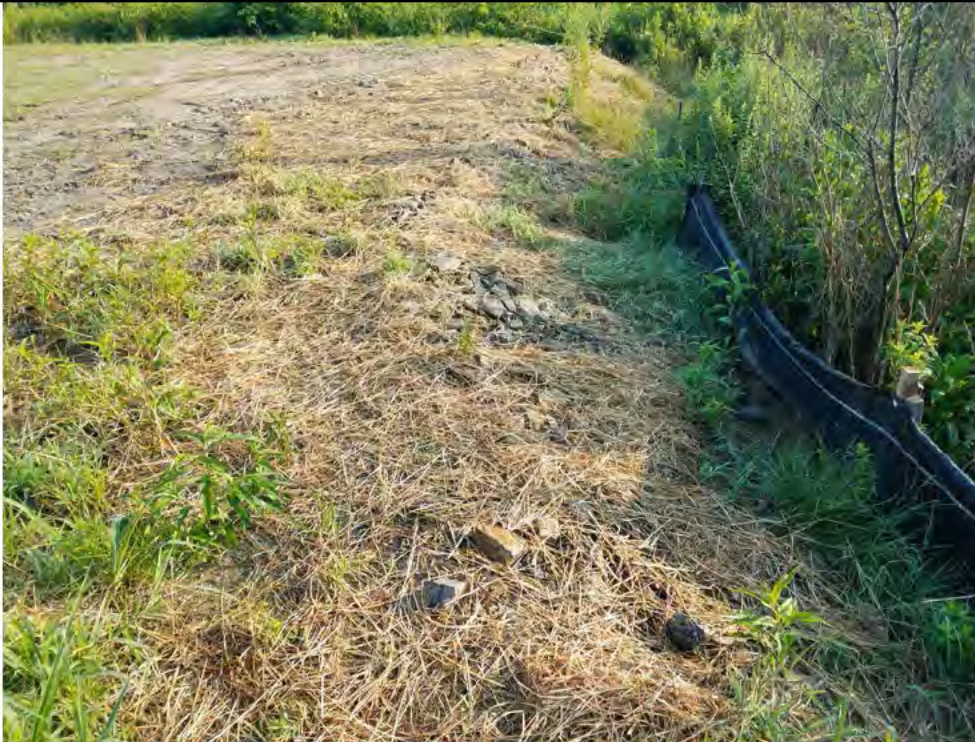
Photo 11: 07/27/2018, Watertown: Map 07, Str18 work pad and slope, slope erosion occurring, silt fence maintenance needed (tattered and sagging due to sediment buildup). Stabilization measures in place consists of a single layer of stone (inconsistently placed with areas of exposed soils) and straw mulch placed on slope (no grass seed applied to pad slopes). Sediments have accumulated at the toe of the slope due to recent heavy rainfall events. Photo taken facing east. See Photo 12 for additional view.

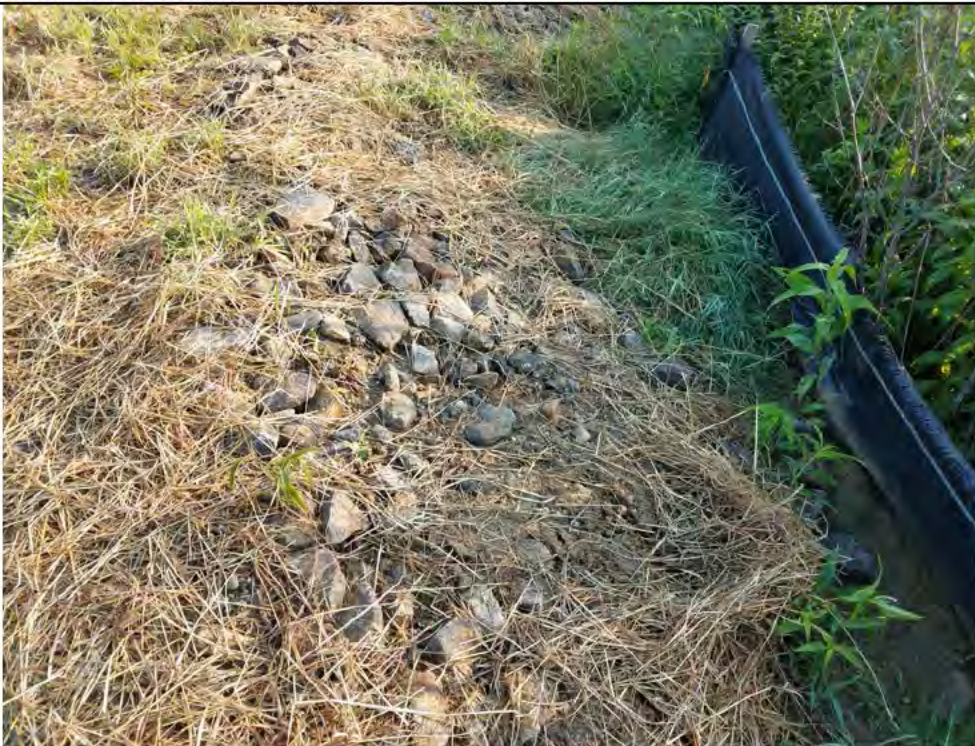
Photo 12: 07/27/2018, Watertown: Map 07, Str18 work pad and slope, close up view of area as shown in Photo 11.

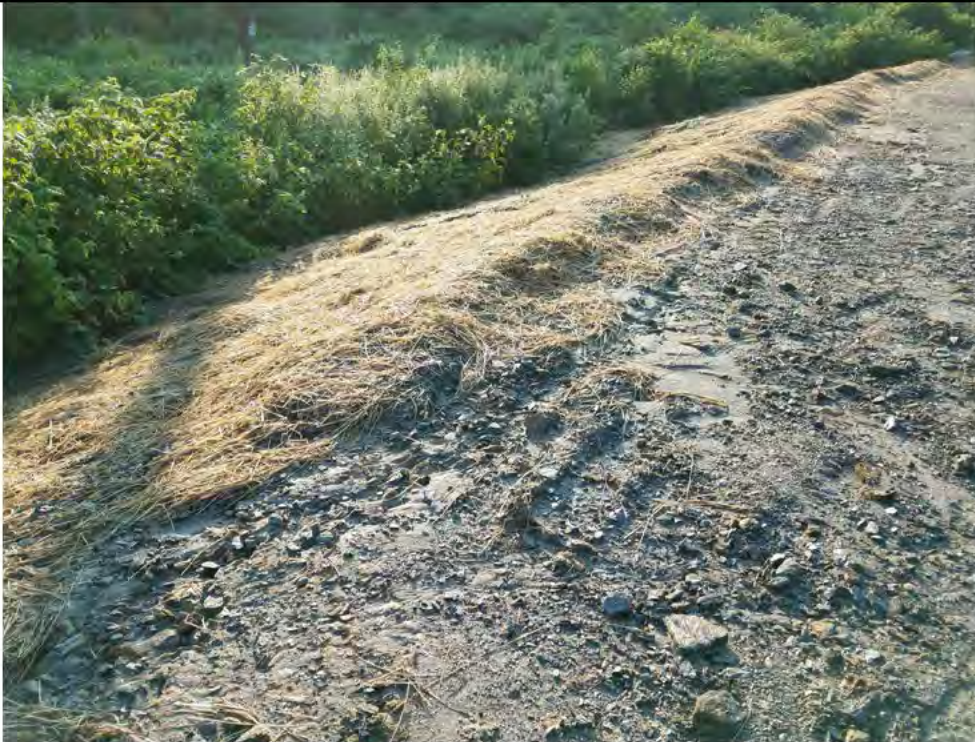
Photo 13: 07/27/2018, Watertown: Map 08, Str20 pad and slope area, erosion off end of berm area (north to east corner of work pad). Photos 13-16 are additional views of conditions at Str20.

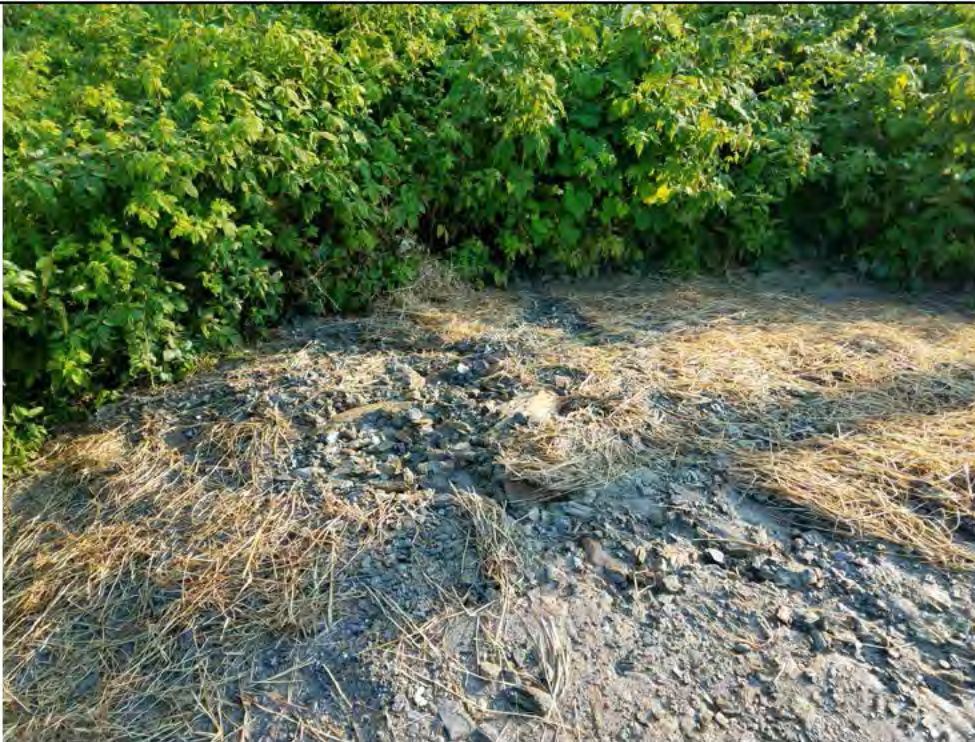
Photo 14: 07/27/2018, Watertown: Map 08, Str20 pad and slope area, slope erosion at north corner of pad. Straw mulch placed on slope surfaces, no seeding of slope.

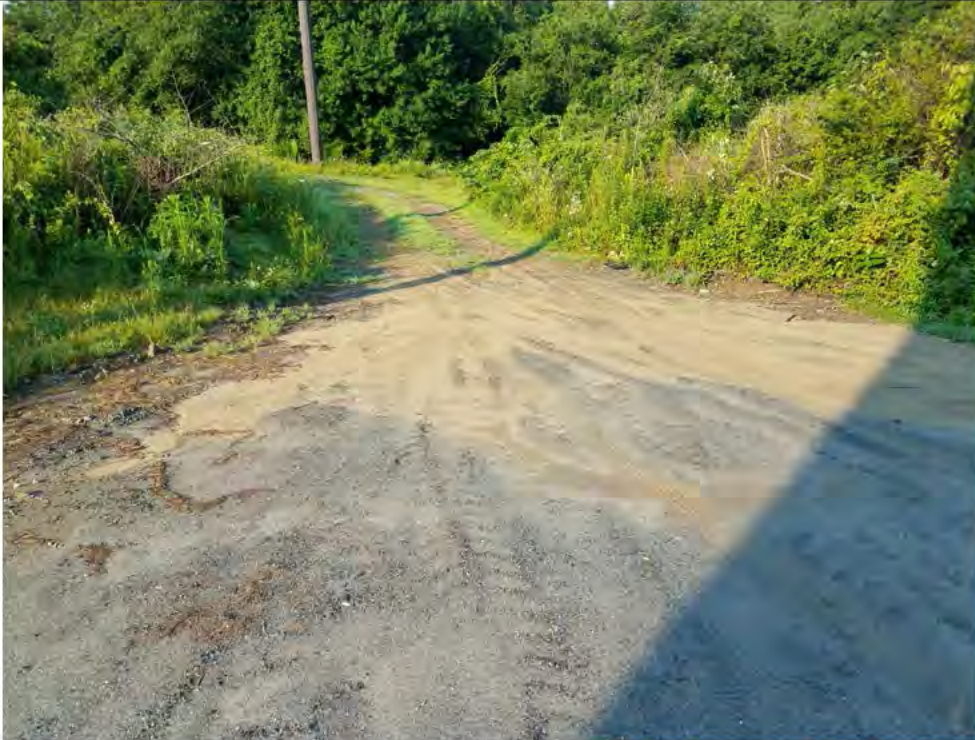
Photo 15: 07/27/2018, Watertown: Map 08, Str20 access road erosion onto the work pad and off of the south corner of the pad (see Photo 16).

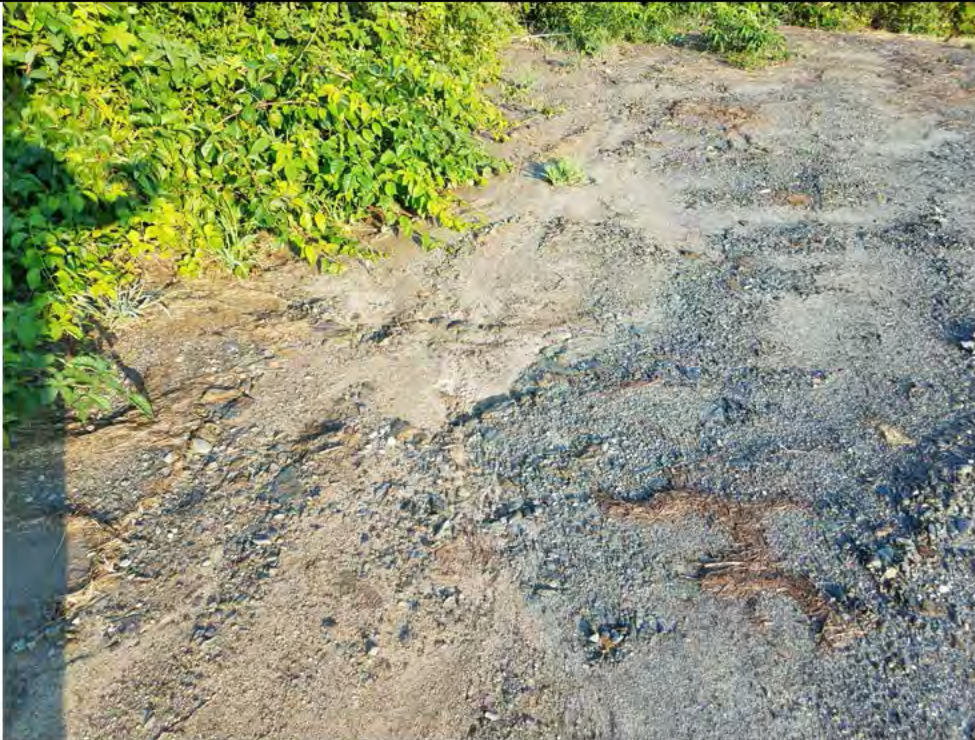
Photo 16: 07/27/2018, Watertown: Map 08, Str20 access road erosion (as shown in Photo 15), fines moving off of south corner of work pad.

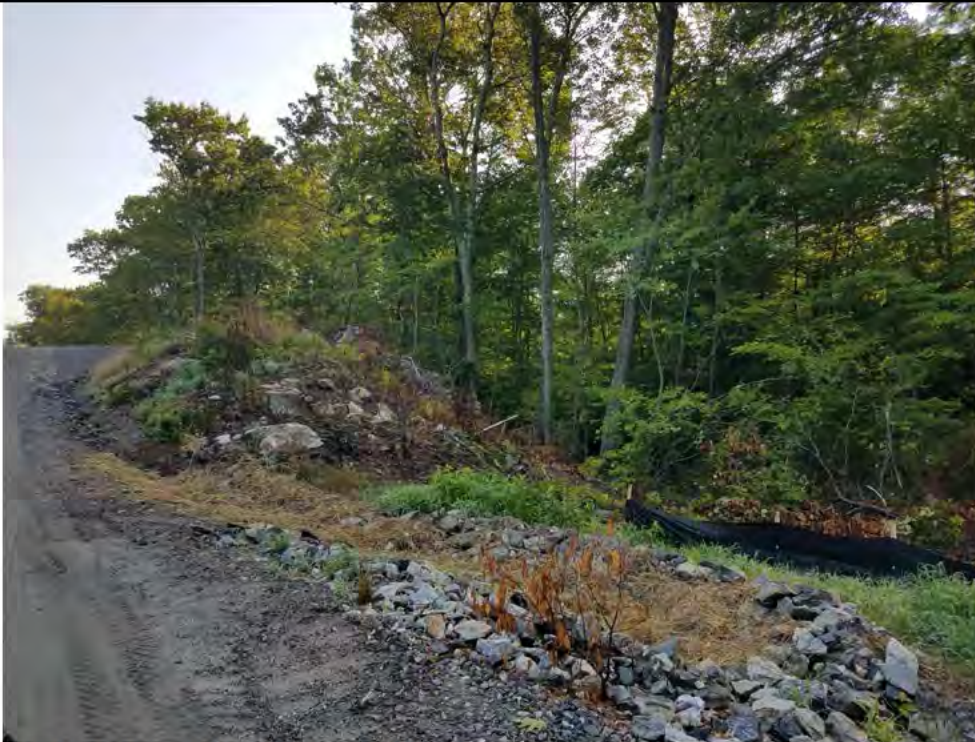
Photo 17: 07/27/2018, Watertown: Map 11, south of Str30, access road erosion into constructed rip rap swale and sediment trap. Photo taken facing north toward Str30. See Photo 18 for additional view.

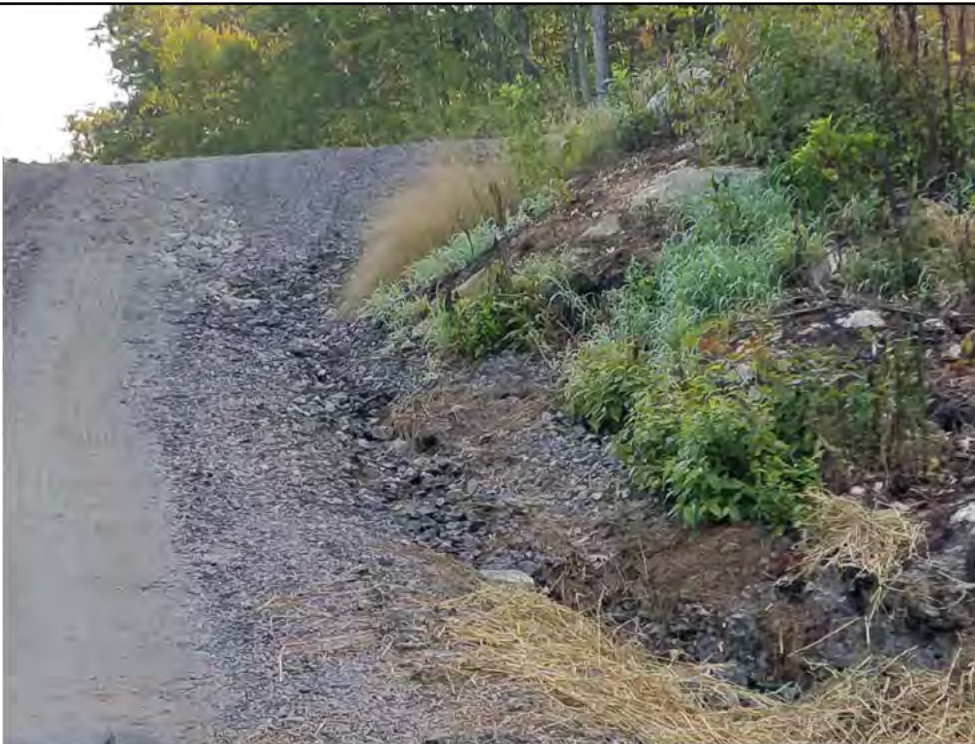
Photo 18: 07/27/2018, Watertown: Map 11, south of Str30, access road erosion immediately upland of constructed rip rap swale and sediment trap (as shown in Photo 17).

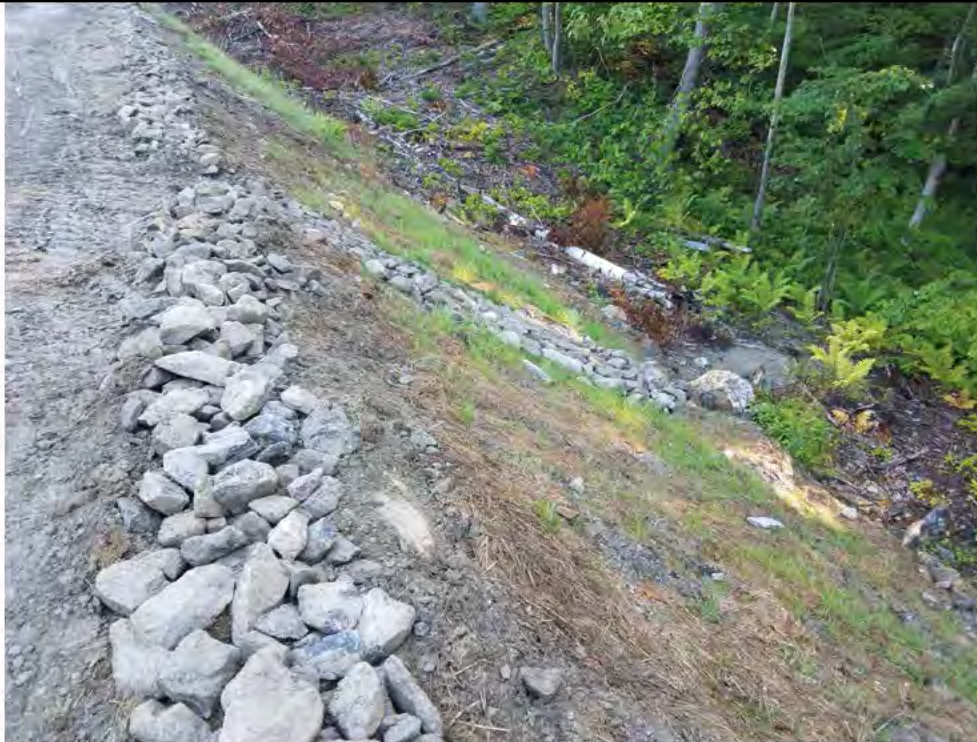
Photo 19: 07/27/2018, Watertown: Map 12, Str33 pad and slope, rip rap berm and leak offs constructed along east side of work pad. Washed out sediments observed off of the pad/slope. See Photo 20 for additional view.

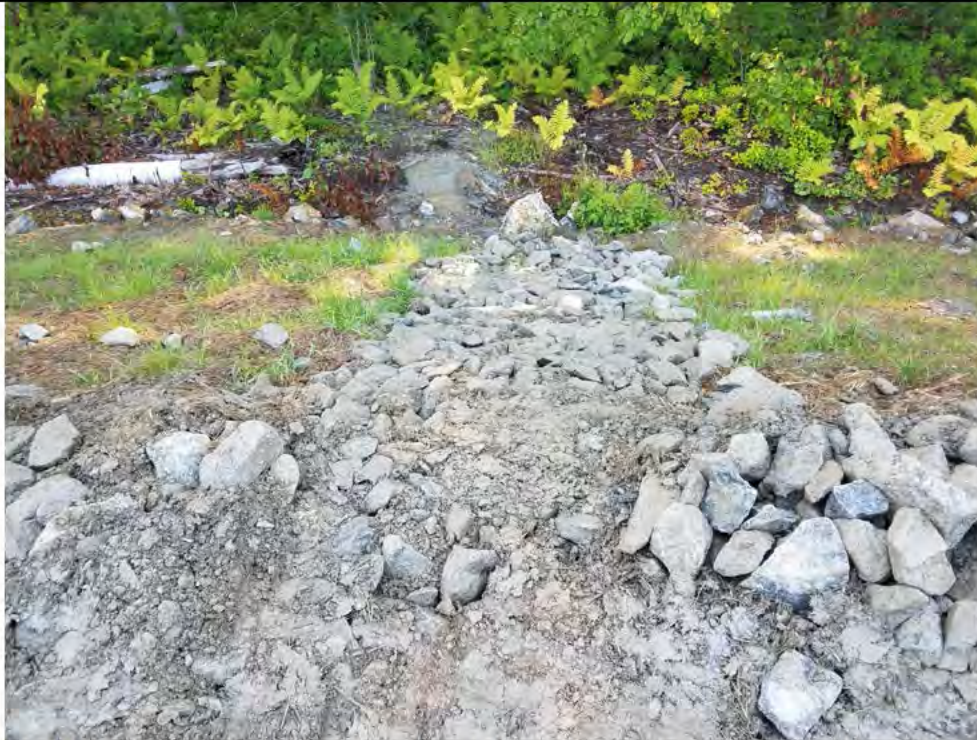
Photo 20: 07/27/2018, Watertown: Map 12, Str33 pad and slope, rip rap berm and leak offs constructed. Stone dust and fines washed out of the rip rap and travelled off the pad. No impacts to wetlands or watercourse in this area.

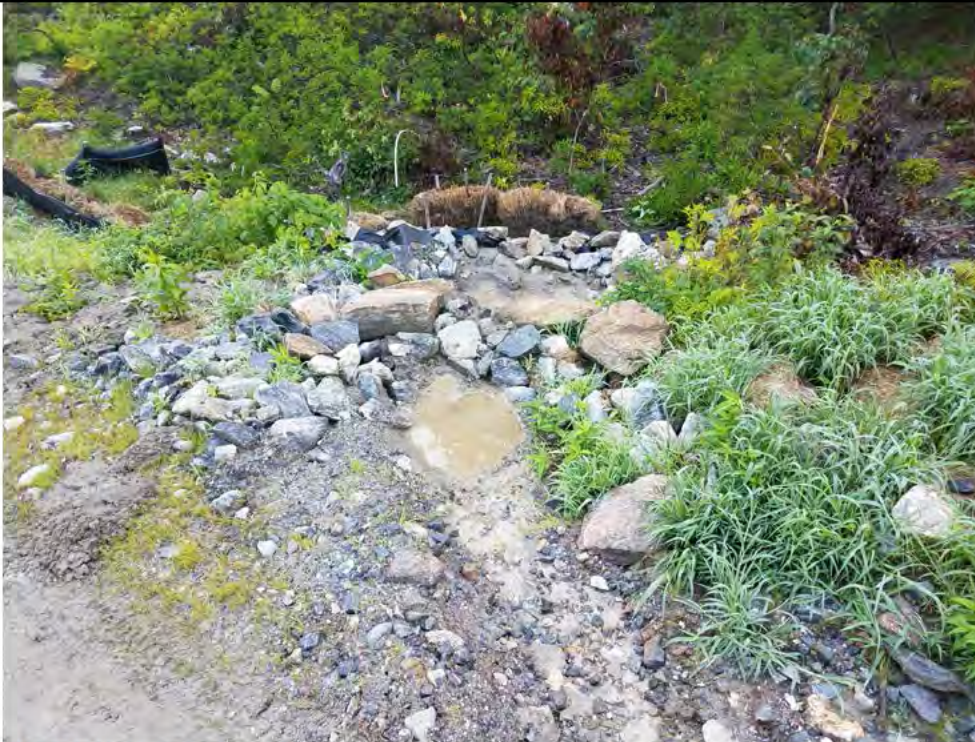
Photo 21: 07/27/2018, Watertown: Map 12, access road between Str34 and Str35, water bar and sediment trap, overloaded with fines, failing silt fence and degraded straw bales, sediments breaking through and moving toward wetland W-C15. See Photo 22 for additional view.

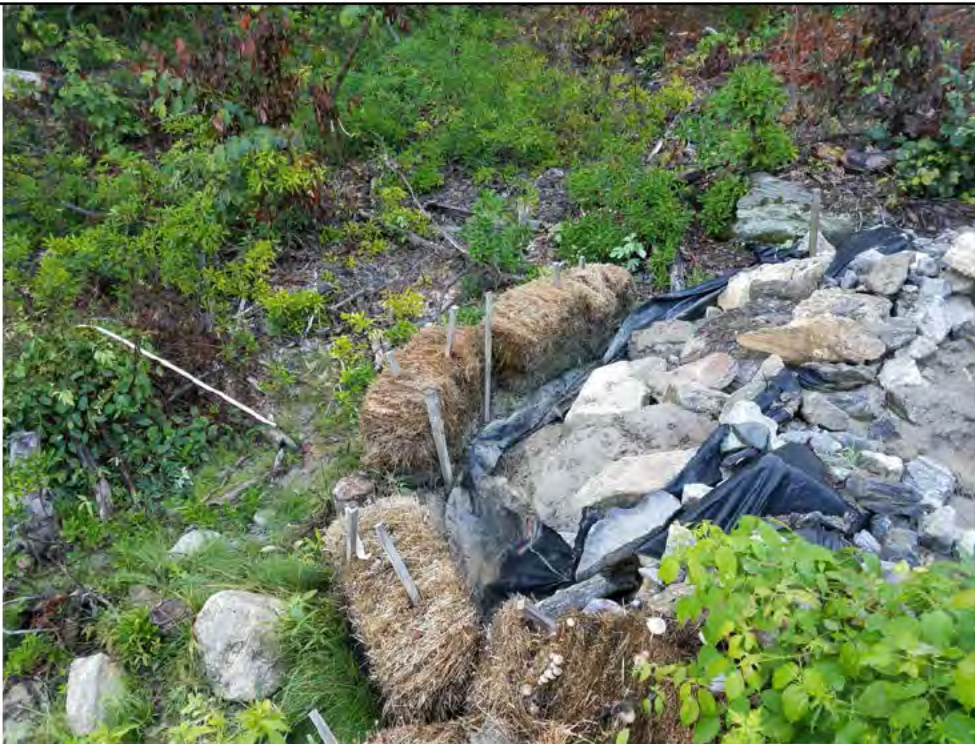
Photo 22: 07/27/2018, Watertown: Map 12, access road between Str34 and Str35, water bar and sediment trap, overloaded with fines, failing silt fence and degraded straw bales, sediments breaking through and moving toward wetland W-C15.

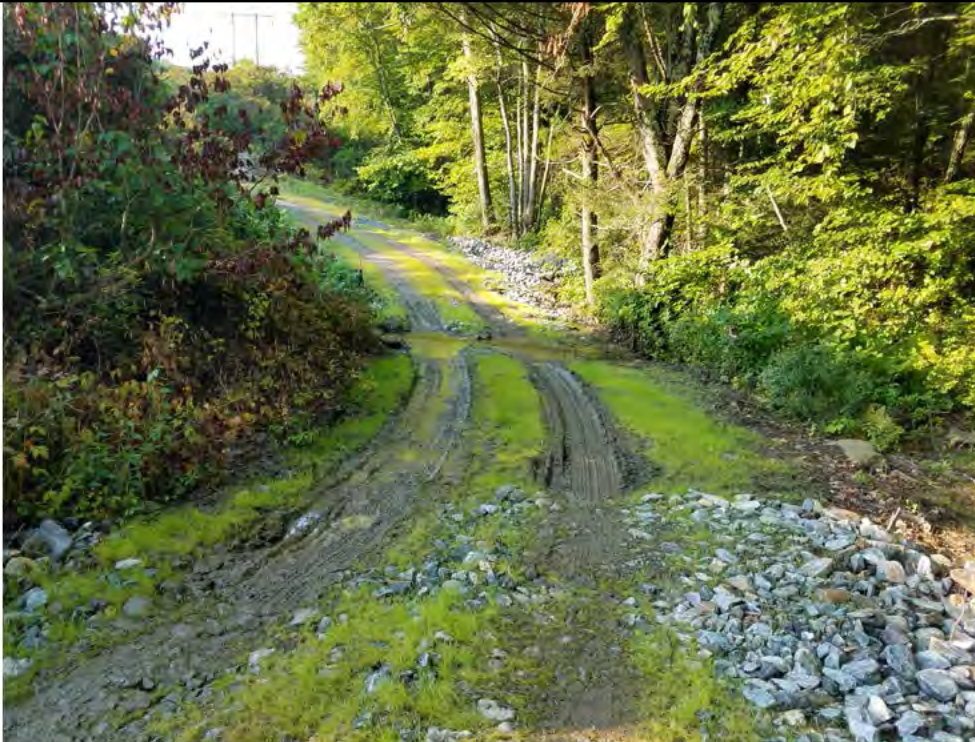
<p><b>Inland Wetland and Watercourse encroachment and mitigation (Continued from previous page)</b></p>	<p><b>Bi-Week</b></p>	<p>See comments in Water Crossing section, Page 3. Specifically, impacts to S-C4 and W-C20/VP-C20-1 (Photos 23-24 and 31-34).</p>	<p>Restore and stabilize areas, install E&amp;S controls in accordance with BMPs to prevent impacts to wetlands and watercourse.                  Continue to monitor the stabilization of disturbed ground surfaces and access road erosion during storm events and surface water runoff from upland areas.</p>	
<p><b>Spills and Material Storage</b></p>	<p><b>Interim-Week</b></p>	<p>None observed, none reported.</p>	<p>N/A</p>	
	<p><b>Bi-Week</b></p>	<p>None observed, none reported.</p>	<p>N/A</p>

Photo 23: 07/27/2018, Watertown: Map 12, access road between Str34 and Str35 at watercourse/wetland S-C4/W-C15, muddy conditions, turbidity at crossing. Photo taken facing south. See Photo 24 for additional view.

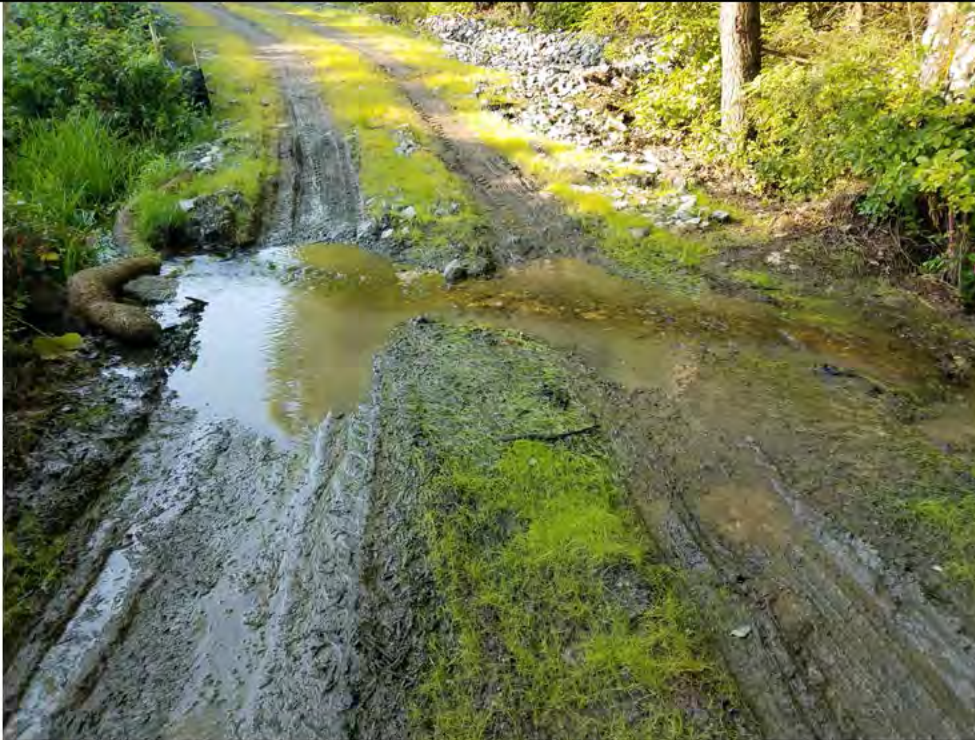
Photo 24: 07/27/2018, Watertown: Map 12, access road between Str34 and Str35 at watercourse/wetland S-C4/W-C15, muddy conditions, turbidity at crossing.

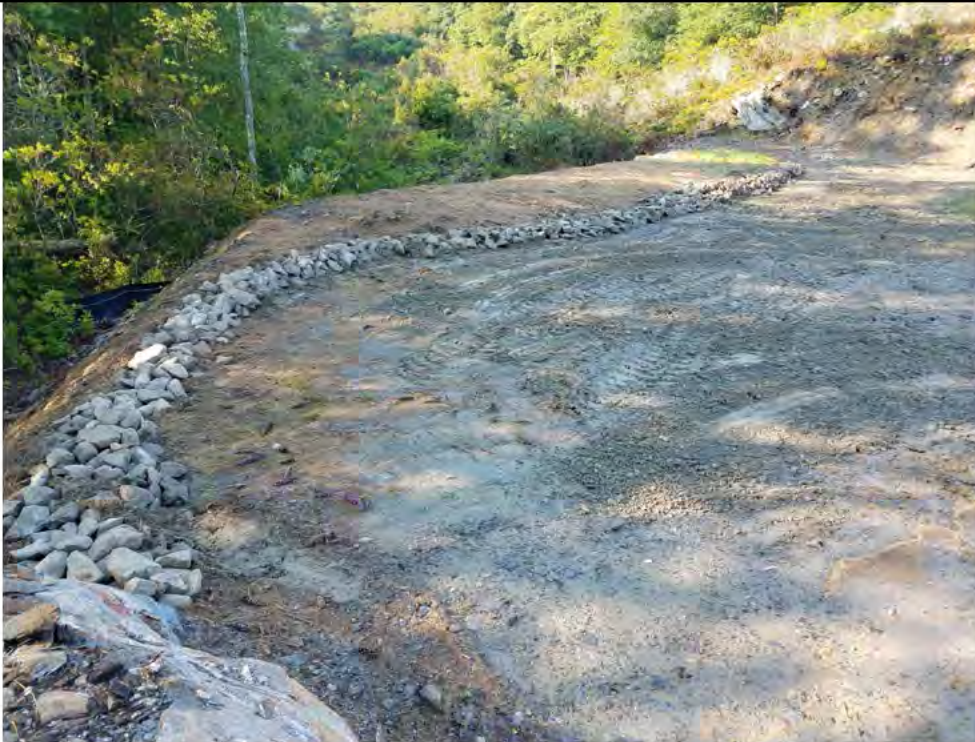
Photo 25: 07/27/2018, Watertown: Map 12, Str35, Permanent BMPs installed at this location. BluRoc constructed a rip rap berm and swale along the south edge of work pad to help prevent slope erosion. See Photo 26 for additional view.

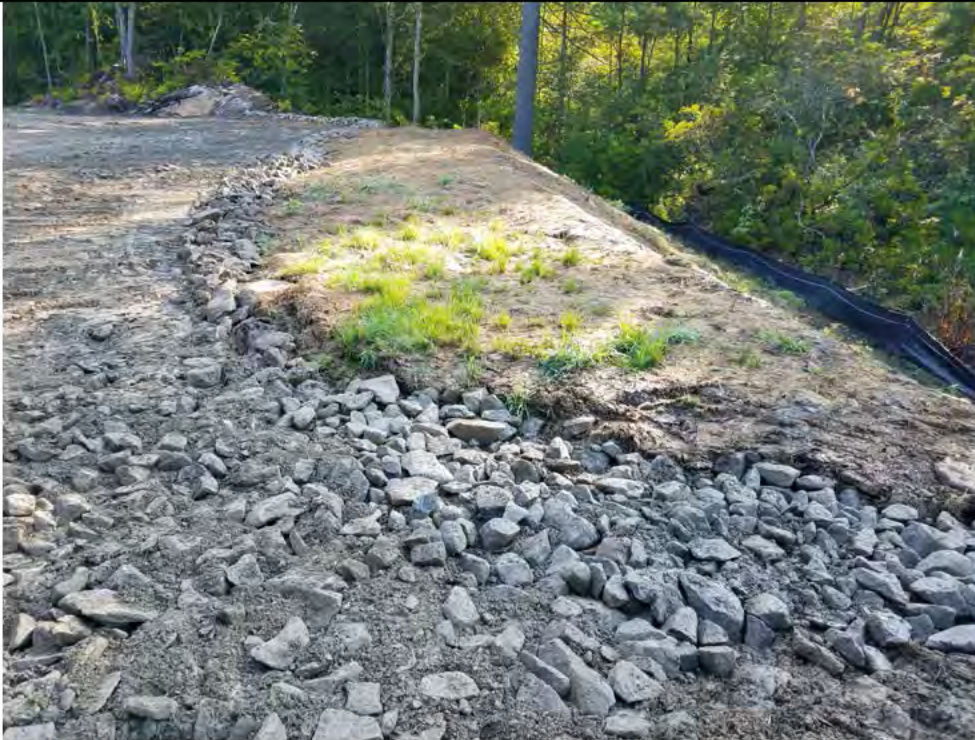
Photo 26: 07/27/2018, Watertown: Map 12, Str35 rip rap berm and swale constructed along south edge of work pad. Photo taken facing northeast. Area appeared to have performed properly during heavy rainfall events.

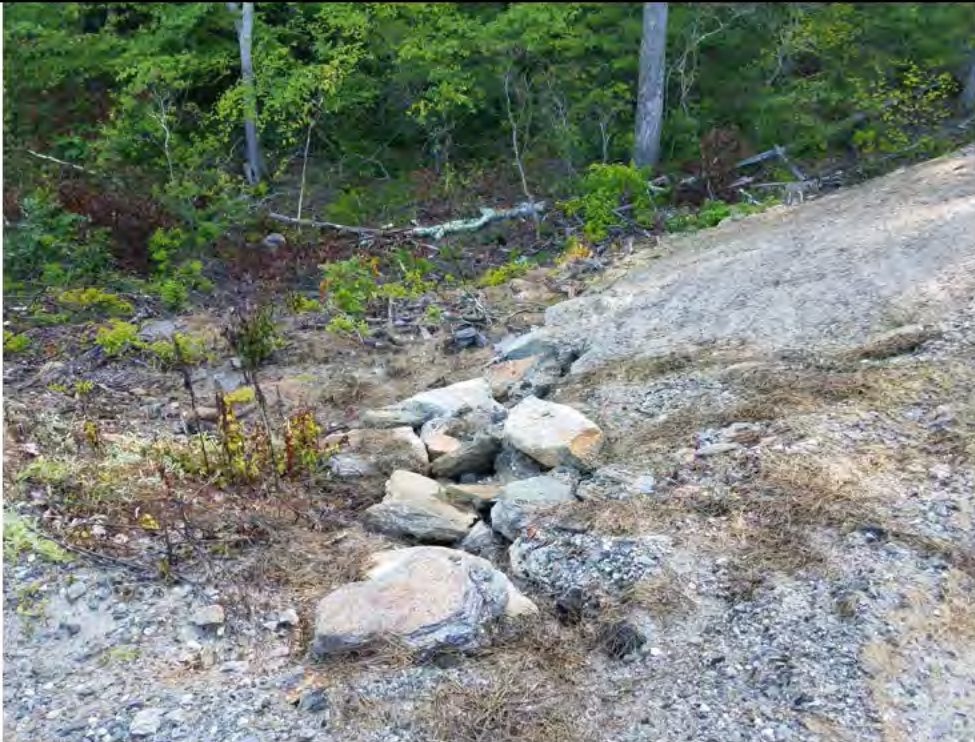
Photo 27: 07/27/2018, Watertown: Map 13, Str38, continued erosion of north slope and sediment buildup at toe of slope. Photo taken facing east from the access road toward wetland south end of W-C20. See Photo 28 for additional view.
