**Subject: Docket No. 466, Frost Bridge to Campville 115-kV Project  
Decision and Order Condition #4 – Independent Environmental Inspector Report**

Please find enclosed the Biweekly Independent Environmental Inspector Report, Report #43, for the **July 20<sup>th</sup>** and **July 27<sup>th</sup>, 2018** inspection events for the construction of the Eversource Frost Bridge to Campville 115-kV Project.

**Docket No. 466- Development and Management Plan Inspection**

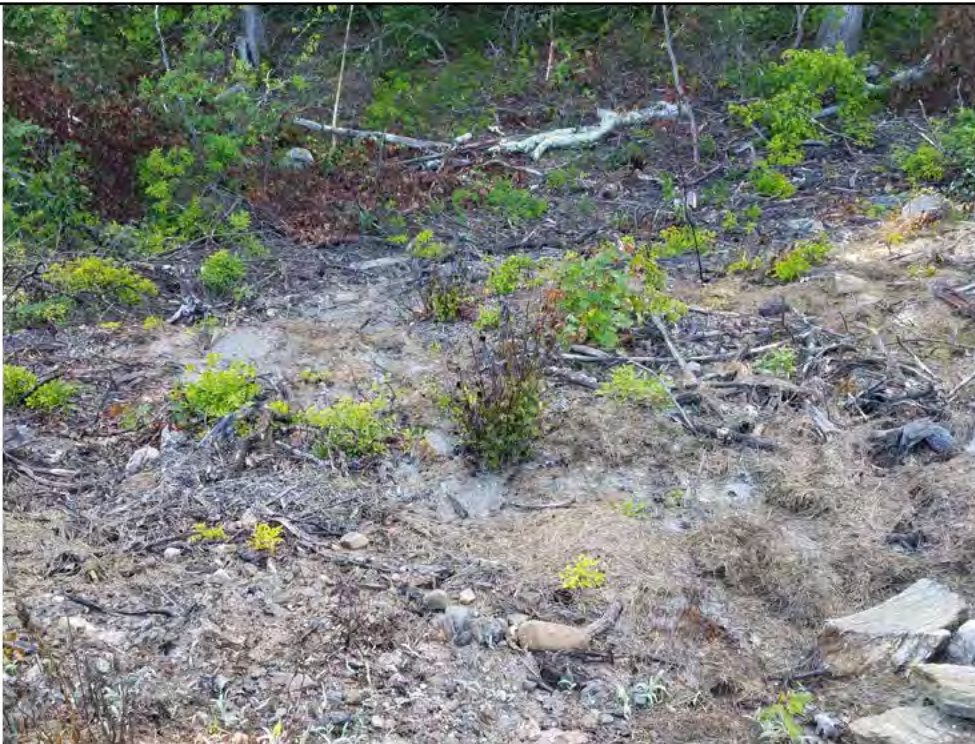
Photo 28: 07/27/2018, Watertown: Map 13, Str38, continued erosion of north slope with buildup of sediments at toe of slope.

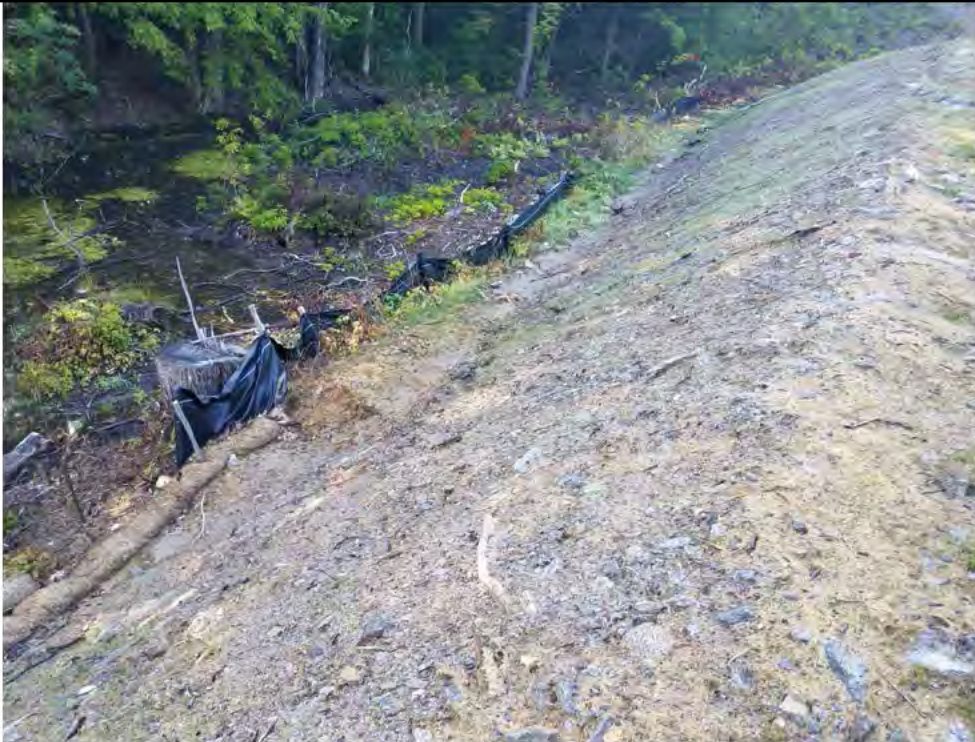
Photo 29: 07/27/2018, Watertown: Map 14, Str39, continued erosion of east slope abutting wetland/vernal pool W-C20/VP-C20-1. Photo taken facing east. Silt Fence Maintenance is needed per the BMPs. See Photo 30 for additional view.

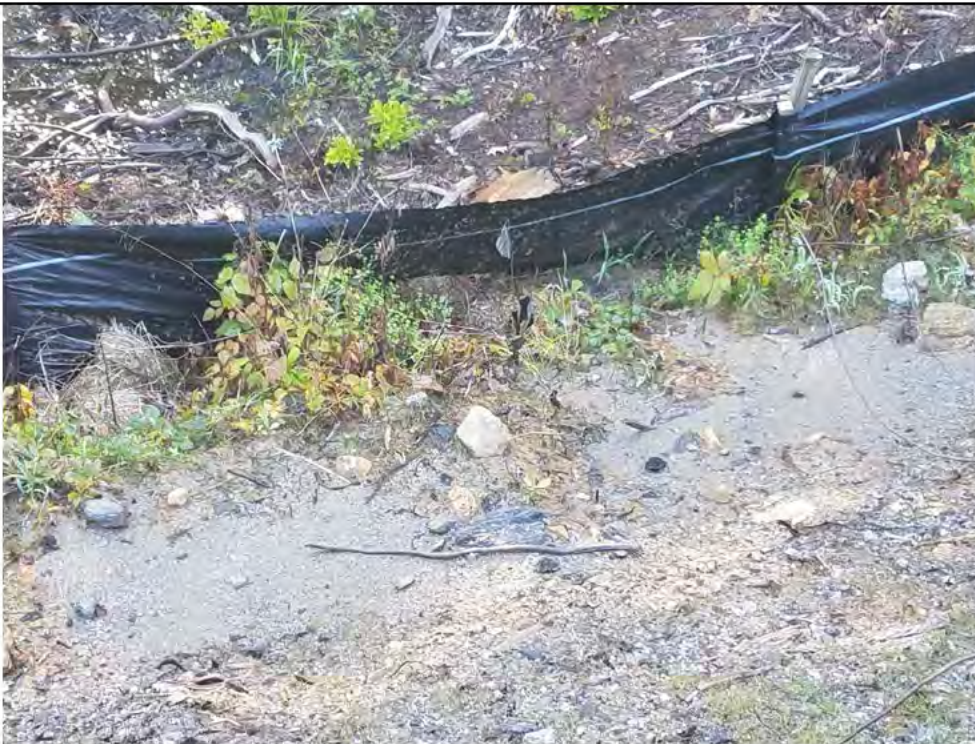
Photo 30: 07/27/2018, Watertown: Map 14, Str39, continued erosion of east slope abutting wetland/vernal pool W-C20/VP-C20-1. Sediment buildup at toe of slope against silt fence abutting wetland/vernal pool.

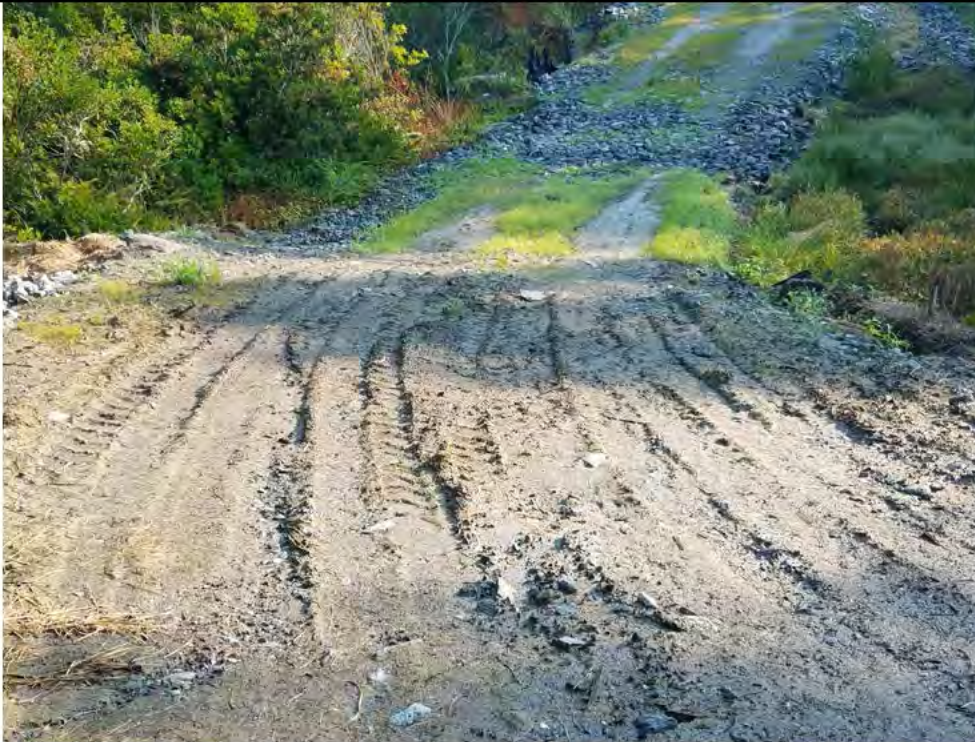
<p><b>Inland Wetland and Watercourse encroachment and mitigation (Continued from previous page)</b></p>	<p><b>Bi-Week</b></p>	<p>See comments in Water Crossing section, Page 3. Specifically, impacts to S-C4 and W-C20/VP-C20-1 (Photos 23-24 and 31-34).</p>	<p>Restore and stabilize areas, install E&amp;S controls in accordance with BMPs to prevent impacts to wetlands and watercourse.                  Continue to monitor the stabilization of disturbed ground surfaces and access road erosion during storm events and surface water runoff from upland areas.</p>	
<p><b>Spills and Material Storage</b></p>	<p><b>Interim-Week</b></p>	<p>None observed, none reported.</p>	<p>N/A</p>	
	<p><b>Bi-Week</b></p>	<p>None observed, none reported.</p>	<p>N/A</p>

Photo 31: 07/27/2018, Watertown: Map 14, access road north of Str39 crossing wetland/vernal pool W-C20/VP-C20-1, continued movement of fine during rain events impacting wetland/vernal pool. Photo taken facing northeast. See Photos 32, 33, and 34 for additional views of conditions in this area.

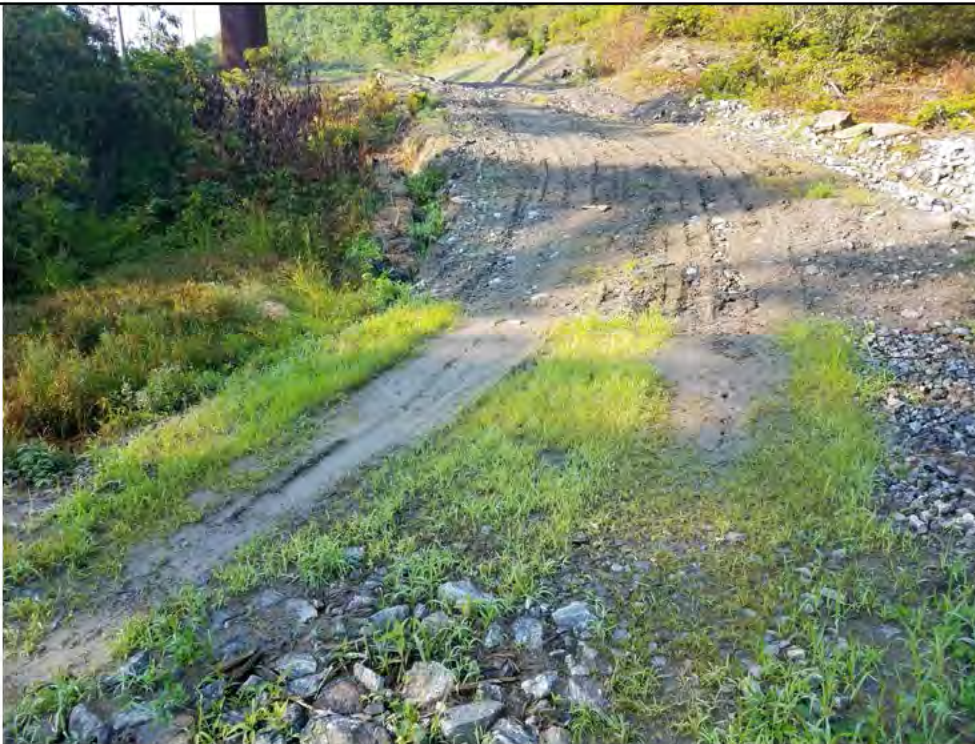
Photo 32: 07/27/2018, Watertown: Map 14, access road north of Str39 crossing wetland/vernal pool W-C20/VP-C20-1, continued movement of fine sediments during rain events impacting wetland/vernal pool. Photo taken facing southwest.

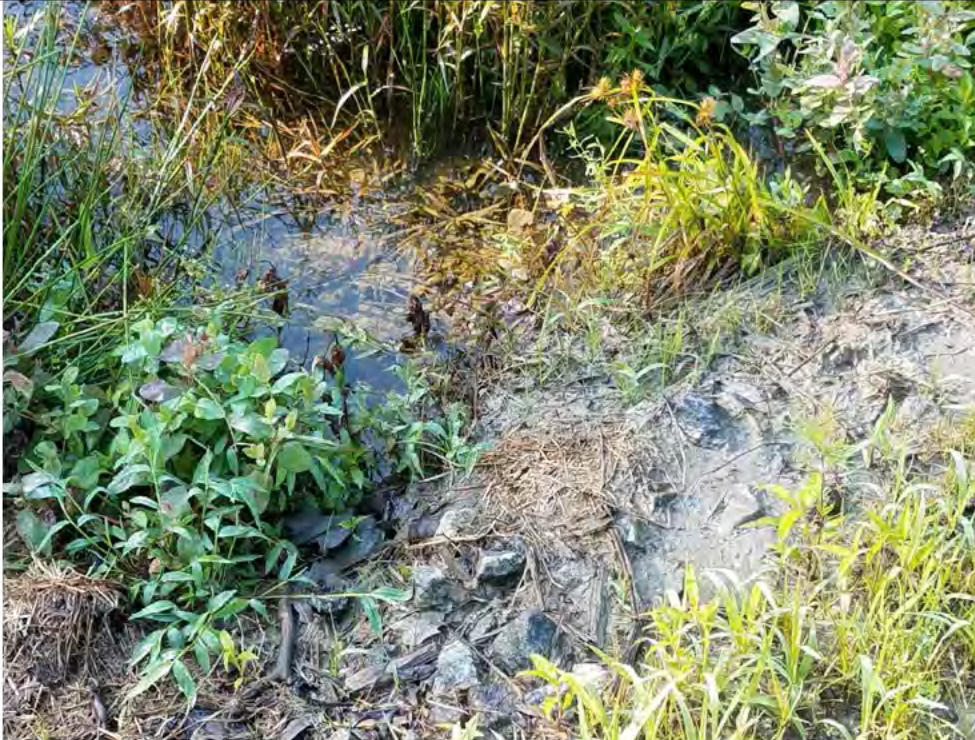
Photo 33: 07/27/2018, Watertown: Map 14, access road north of Str39 crossing wetland/vernal pool W-C20/VP-C20-1, continued movement of fine sediments during rain events impacting wetland/vernal pool. Photo taken facing south into the wetland/vernal pool from the access road.

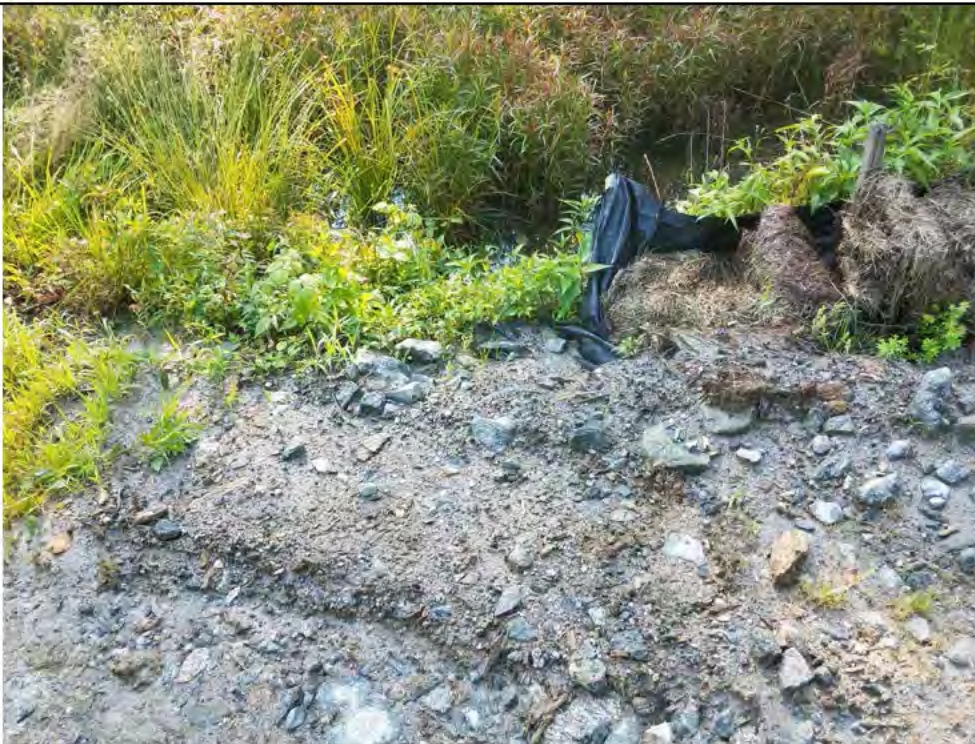
Photo 34: 07/27/2018, Watertown: Map 14, access road north of Str39 crossing wetland/vernal pool W-C20/VP-C20-1, continued movement of fine sediments during rain events impacting wetland/vernal pool. Failing E&S controls. Photo taken facing south into the wetland/vernal pool from the access road.
