**Subject: Docket No. 466, Frost Bridge to Campville 115-kV Project
Decision and Order Condition #4 – Independent Environmental Inspector Report**

Docket No. 466– Development and Management Plan Inspection

ATTACHMENT 1
TRC Final Site Inspection Table

**Photograph Log
Frost Bridge to Campville 115kV Project
FINAL REPORT**

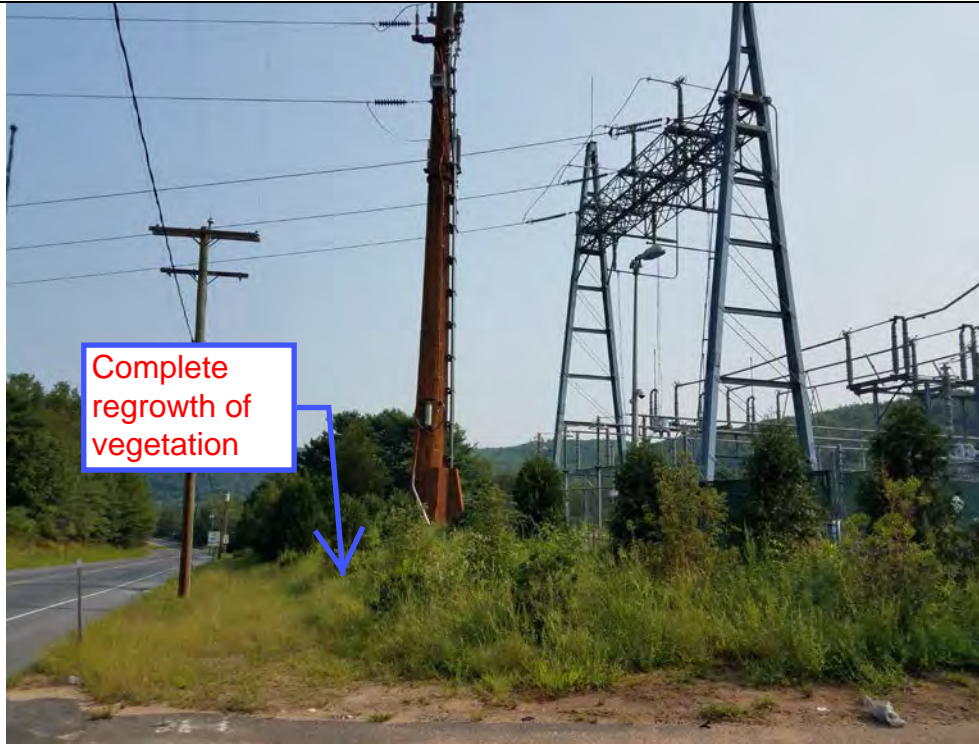
Complete regrowth of vegetation

Photo 1: 08/16/2018: Watertown, Map 01, Structure Str1B, vegetation growth.

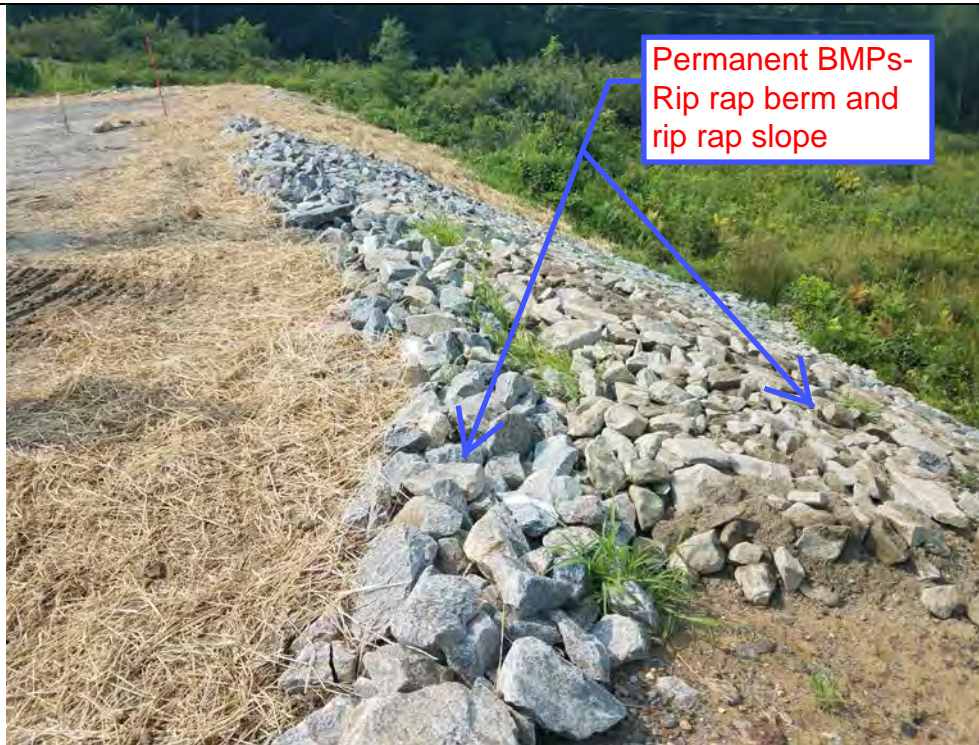
Str 6	Yes		At the time of this final inspection no visible erosion was observed. Aggregate cover on pad. No vegetation on pad. Stabilization efforts are in progress and conditions are being actively monitored.	N/A	
	Str 7	Yes		At the time of this final inspection no visible erosion was observed. In the past, sediment would be suspended in stormwater runoff and travel across the pad surface and down the slope. Fine sediments are on the surface of the pad, little to no aggregate cover present. No vegetation on pad. Stabilization efforts are in progress and conditions are being actively monitored.	A rip rap berm was placed along the west edge of the work pad to slow the flow of uncontrolled surface water flow occurring during significant rainfall events. In addition, sections of slope have been covered with rip rap (west slope) to help prevent slope erosion. The Rip rap has been placed on the slope in areas where erosion was previously observed to have occurred following rainfall events.	Photo 2

Permanent BMPs- Rip rap berm and rip rap slope

Photo 2: 08/16/2018: Watertown, Map 03, Structure Str 7, Permanent BMPs- rip rap berm and rip rap armored slope at point of stormwater runoff.

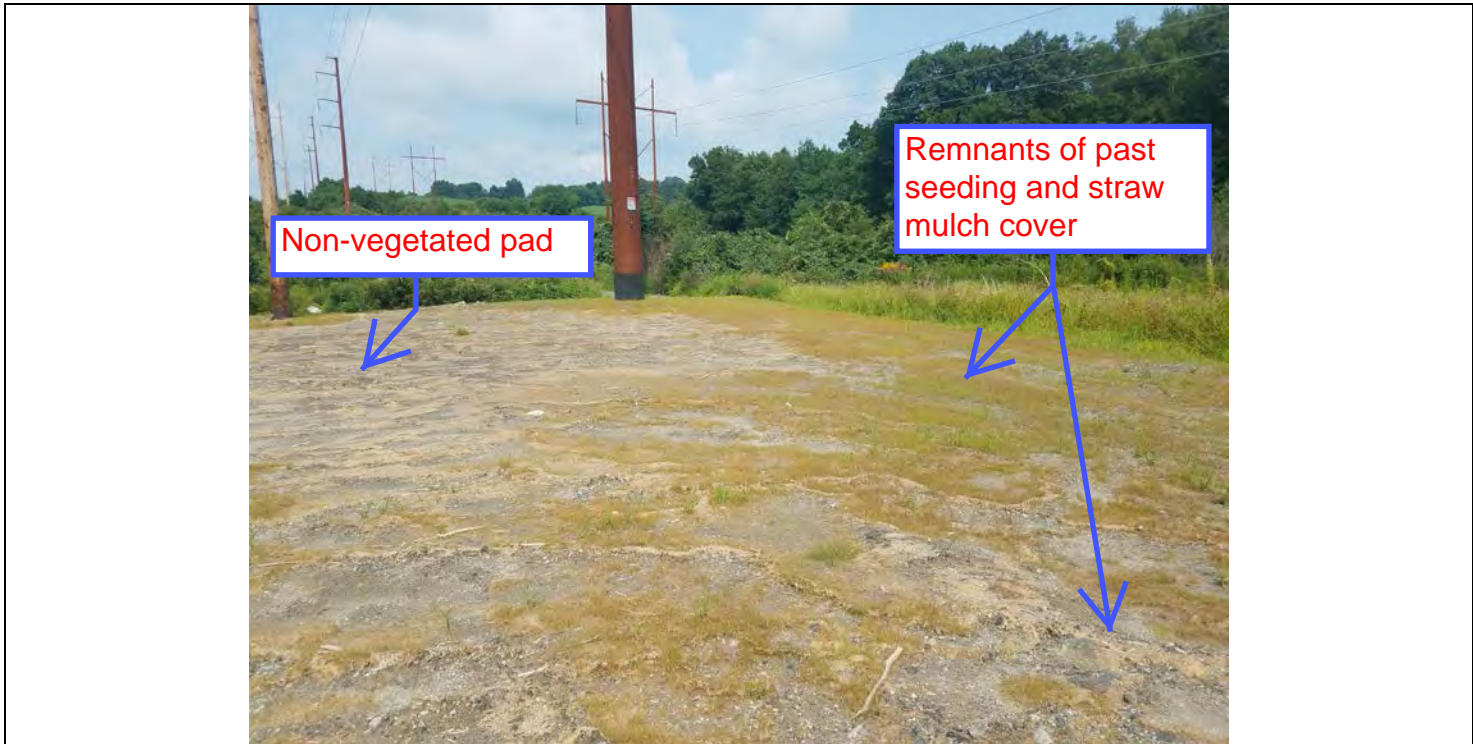
D&M Mapsheet	Structure	Initial Restoration Performed (Yes/No)	Wetland/Watercourse/Vernal Pools (By D&M Mapsheet)	Field Observation at Final Inspection	Permanent BMPs as Corrective Action	Photo Log Reference
4	Str 8	Yes	W-A7, W-A8, W-A9, S-A5, S-A6, S-A7	Visible erosion was observed on the down gradient slope. Fine sediments were washed out on to the lower section of the pad however none of the sediments are leaving the pad surface area. Little to no vegetation on slope and no vegetation on pad. Pad has aggregate cover however fine sediments continue to suspend during rain events and travel to low laying areas of the pad.	Three stone fords along the permanent access road crossings of wetland WA-8/WA-9 (including Turkey Brook [Stream S-A6] and unnamed Stream S-A5.	
	Str 9	Yes		Sediments appear to be moving throughout the pad surface however not leaving the footprint of the pad itself. Some vegetation growth was observed along the access road which passes through the work pad along the north side of Str 9. S-A6 timber mat pads were removed at crossing and stream embankment area is restored.	See above entry.	Photo 3

Photo 3: 08/16/2018: Watertown, Map 04, Structure Str 9, sparse vegetation coverage.

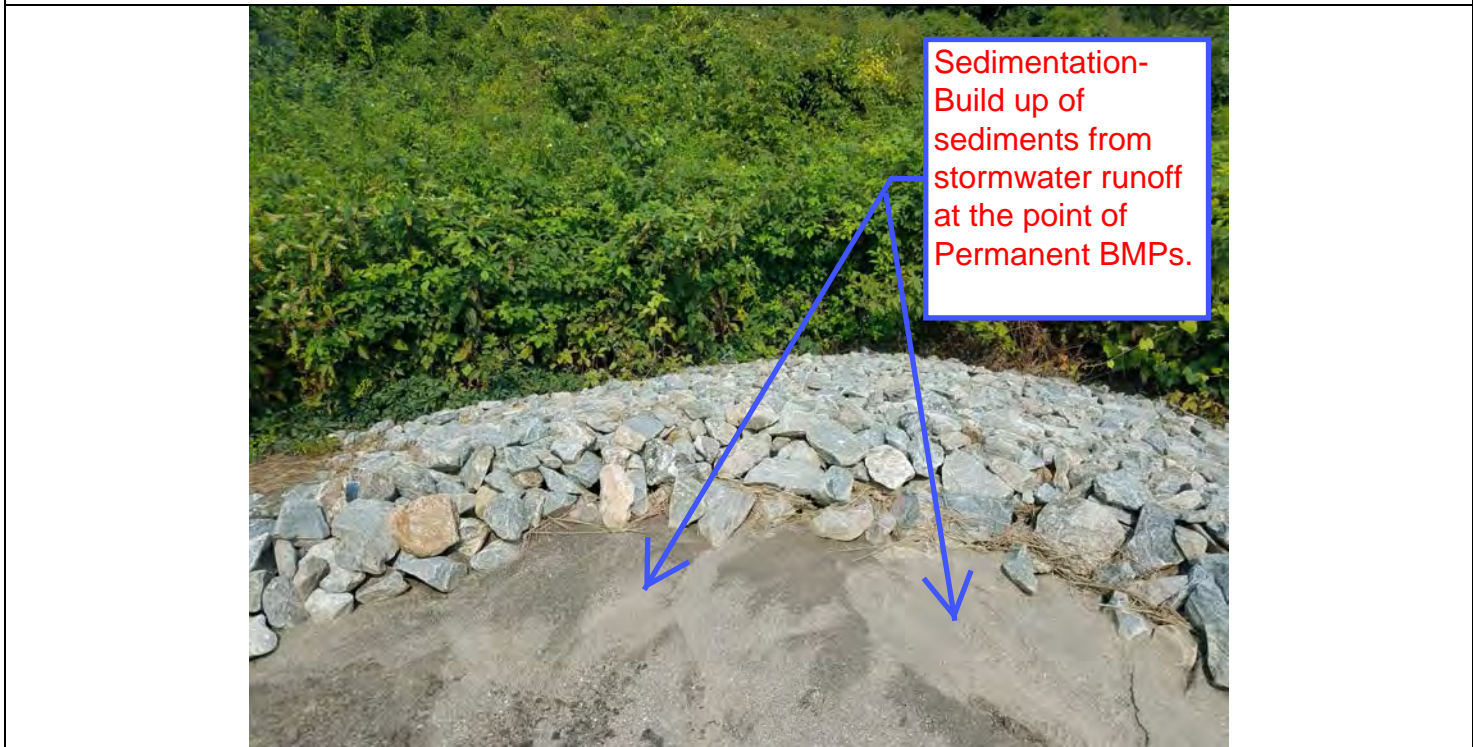
Photo 4: 08/16/2018: Watertown, Map 08, Structure Str 20, sediment build up at corner of pad, Permanent BMPs-rip rap berm and rip rap armored slope at point of stormwater runoff.

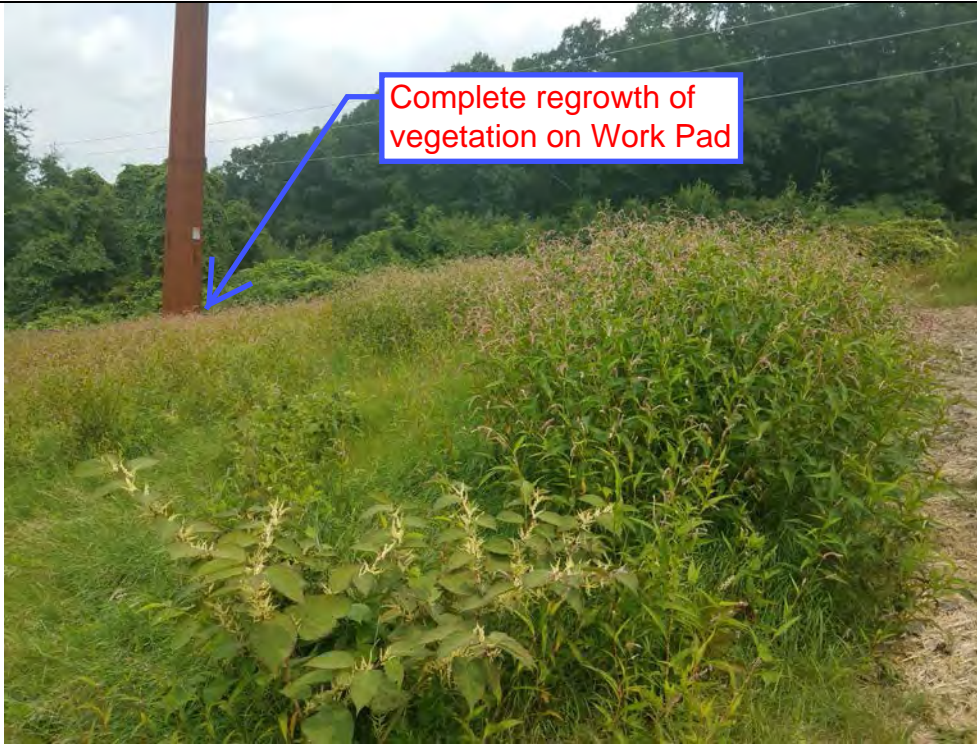
Photo 5: 08/16/2018: Watertown, Map 09, Structure Str 23, vegetation growth.

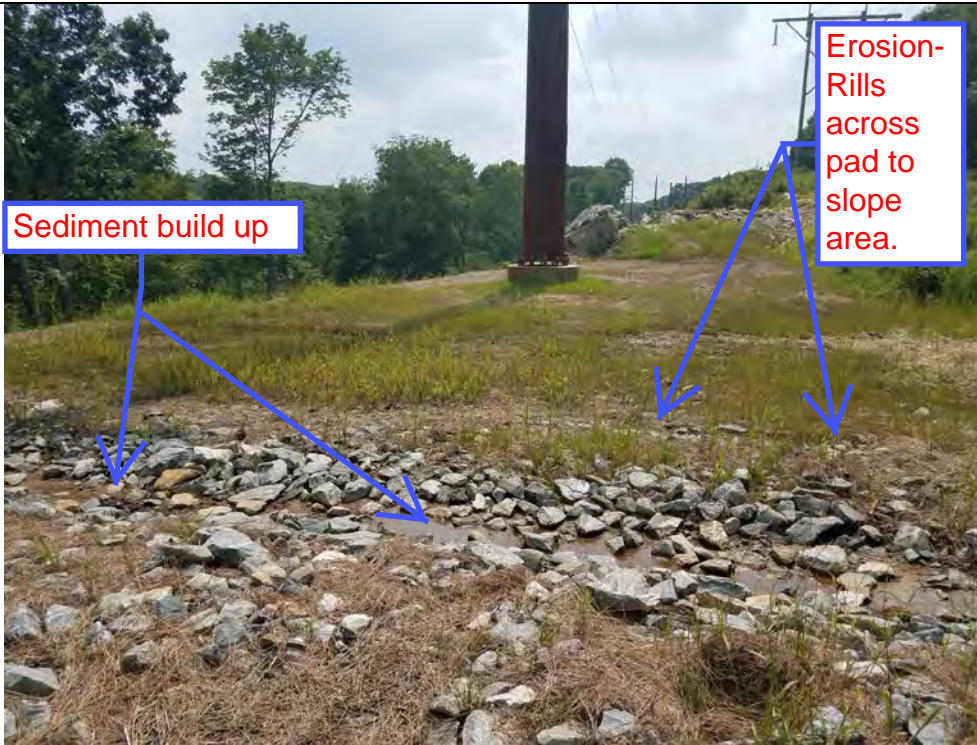
Photo 6: 08/16/2018: Watertown, Map 10, Structure Str 27, erosion sediment buildup in swale, vegetation growth., Permnanent BMP- rip rap lined swale to rip rap armored slope.

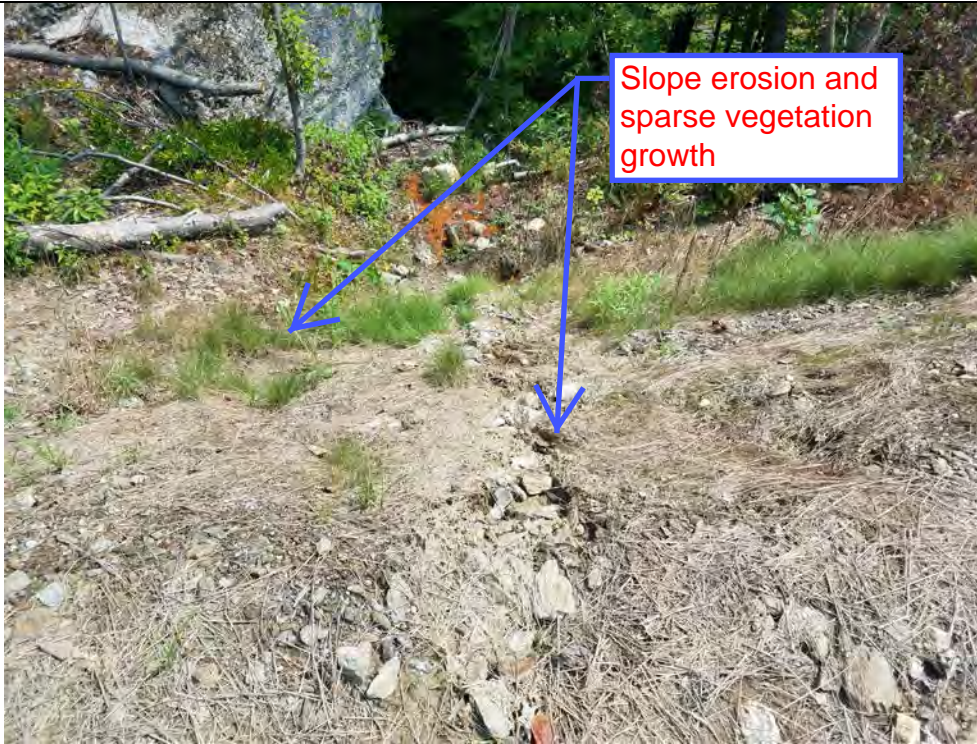
Photo 7: 08/16/2018: Watertown, Map 10, Structure Str 27, slope erosion and sparse vegetation growth.

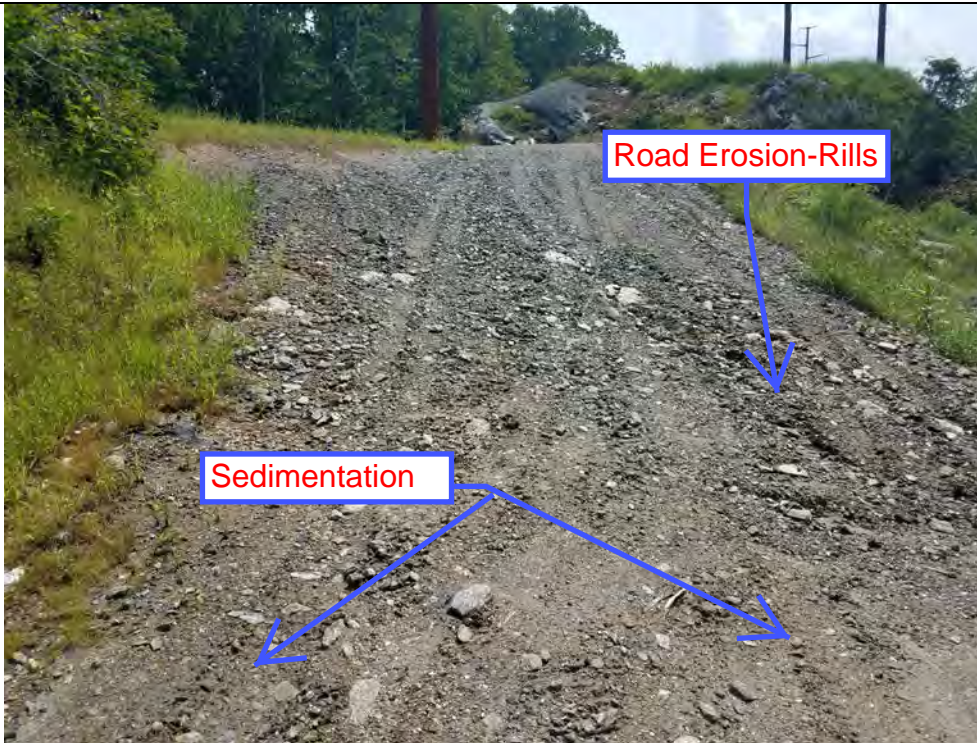
Photo 8: 08/16/2018: Watertown, Map 11, Structure Str 31, access road erosion.

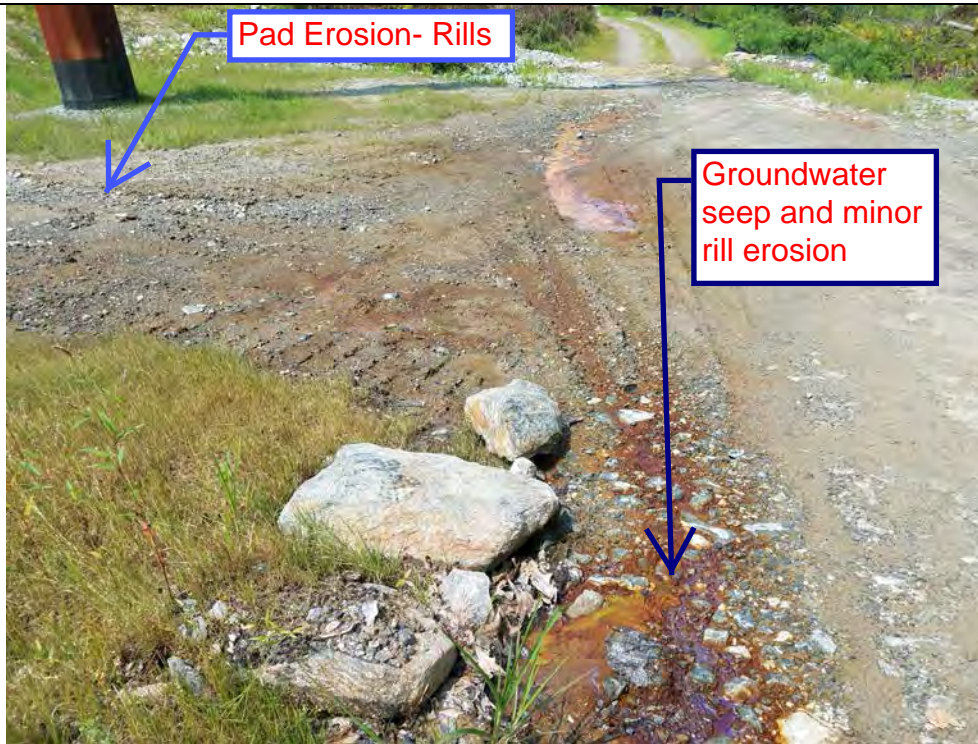
Photo 9: 08/16/2018: Watertown, Map 11, Structure Str 32, active seep, minor access road erosion.

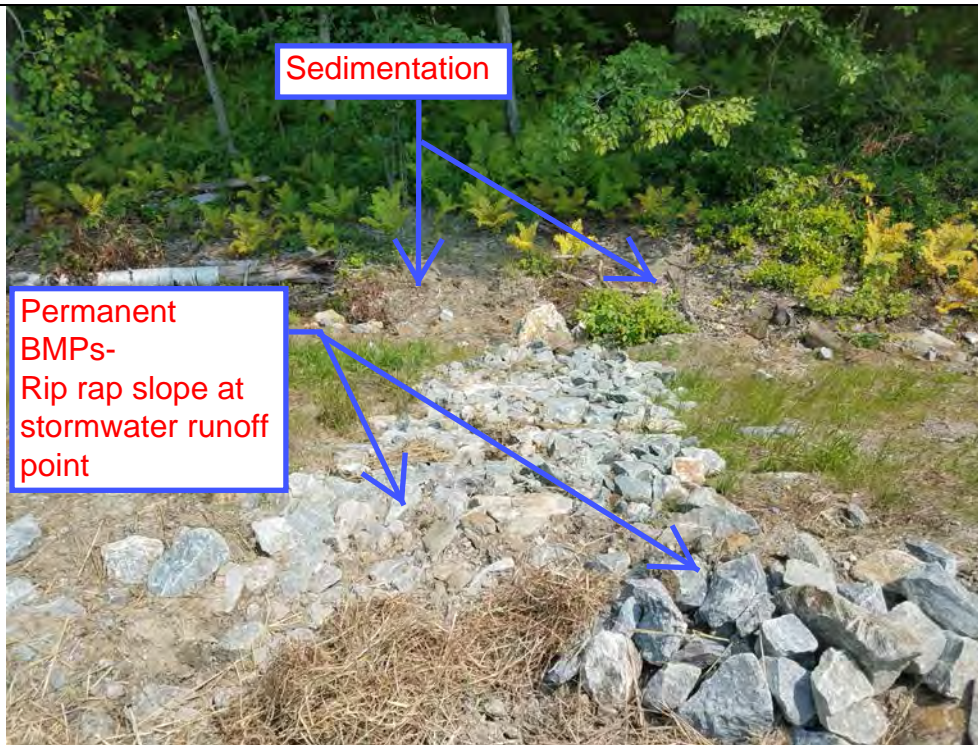
Photo 10: 08/16/2018: Watertown, Map 12, Structure Str 33, continued sedimentation at toe of slope following implementation of Permanent BMPs- rip rap armored slope at point of stormwater runoff .

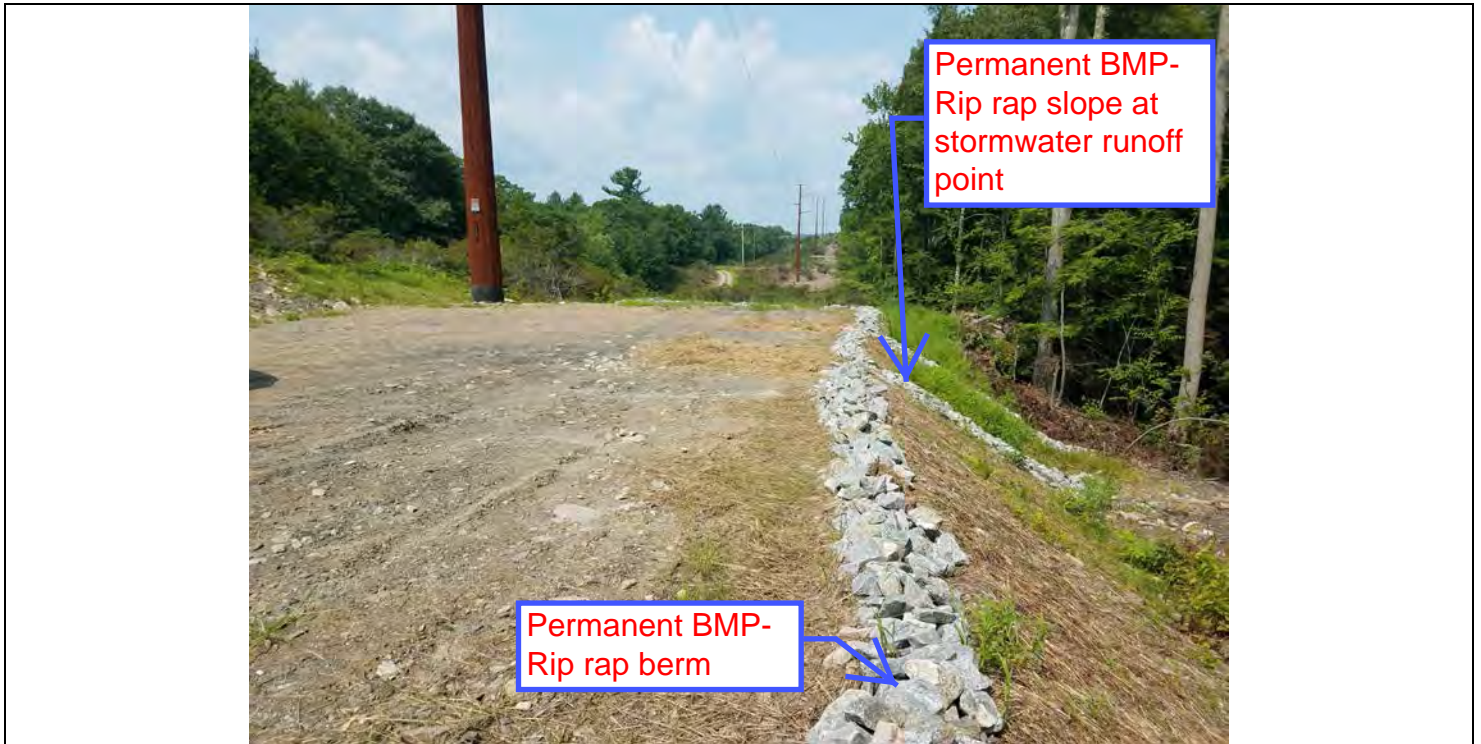
Photo 11: 08/16/2018: Watertown, Map 12, Structure Str 34, implemented Permanent BMPs- rip rap berm and rip rap armored slope at points of stormwater runoff.

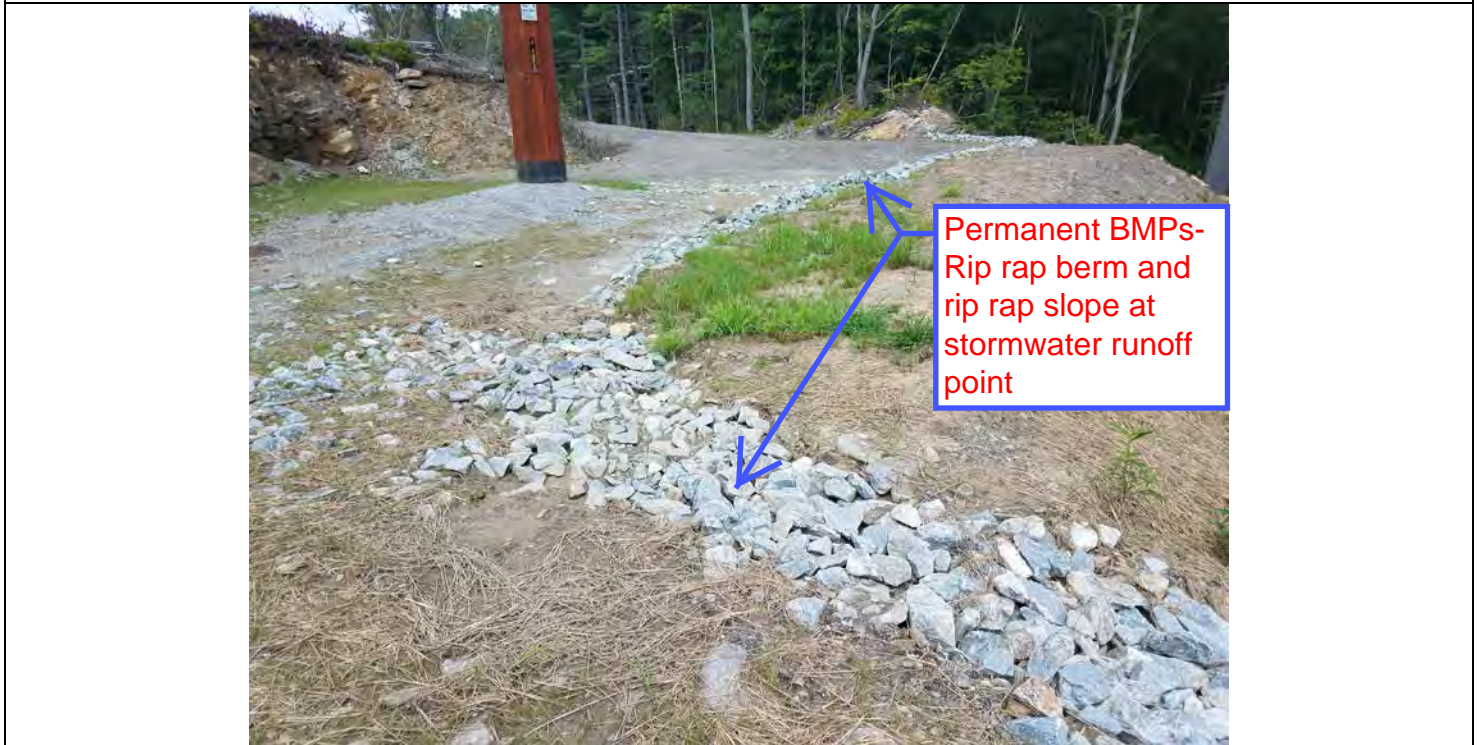
Photo 12: 08/16/2018: Watertown, Map 12, Structure Str 35, implemented Permanent BMPs- rip rap berm and rip rap slope at point of stormwater runoff.

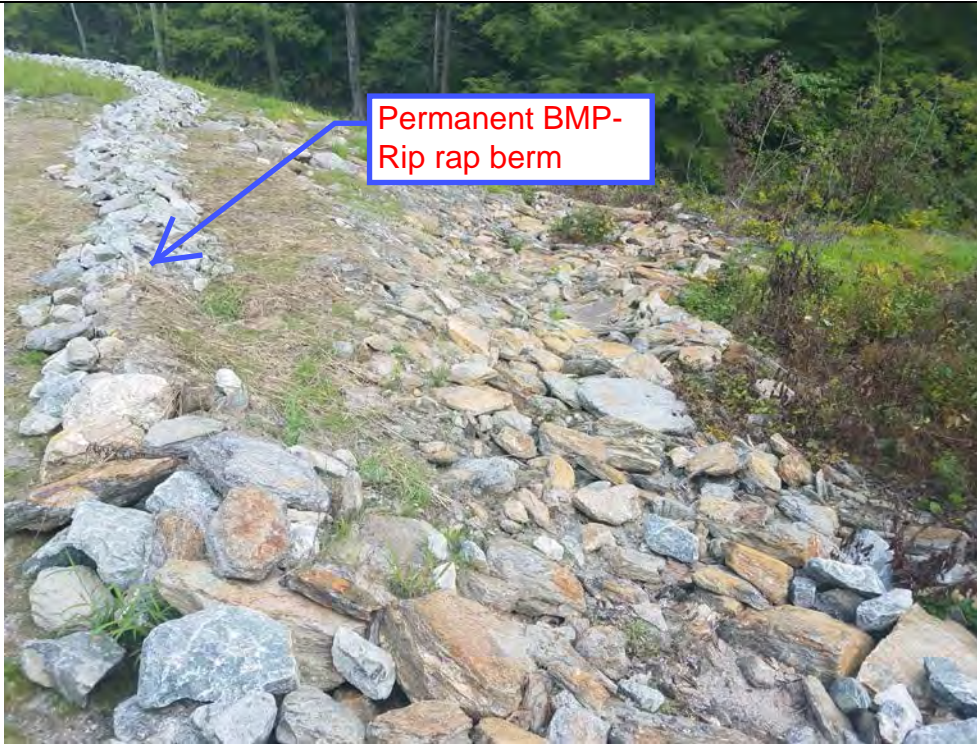
Permanent BMP-
Rip rap berm

Photo 13: 08/16/2018: Watertown, Map 11 Structure, Str 38, implemented Permanent BMPs- rip rap berm.

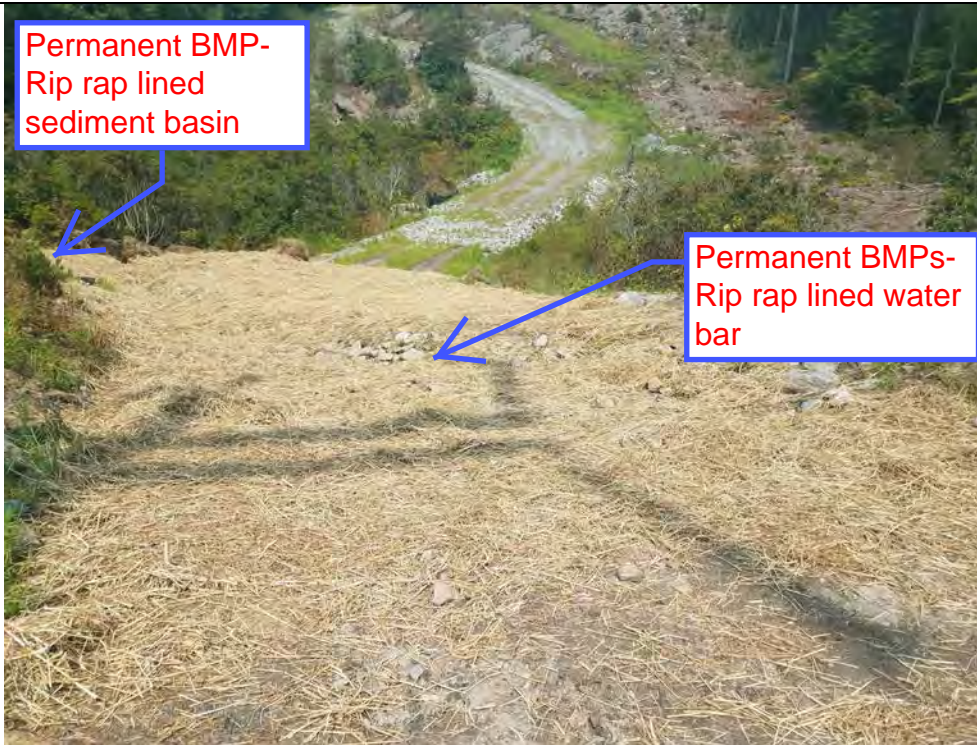
Permanent BMP-
Rip rap lined
sediment basin

Permanent BMPs-
Rip rap lined water
bar

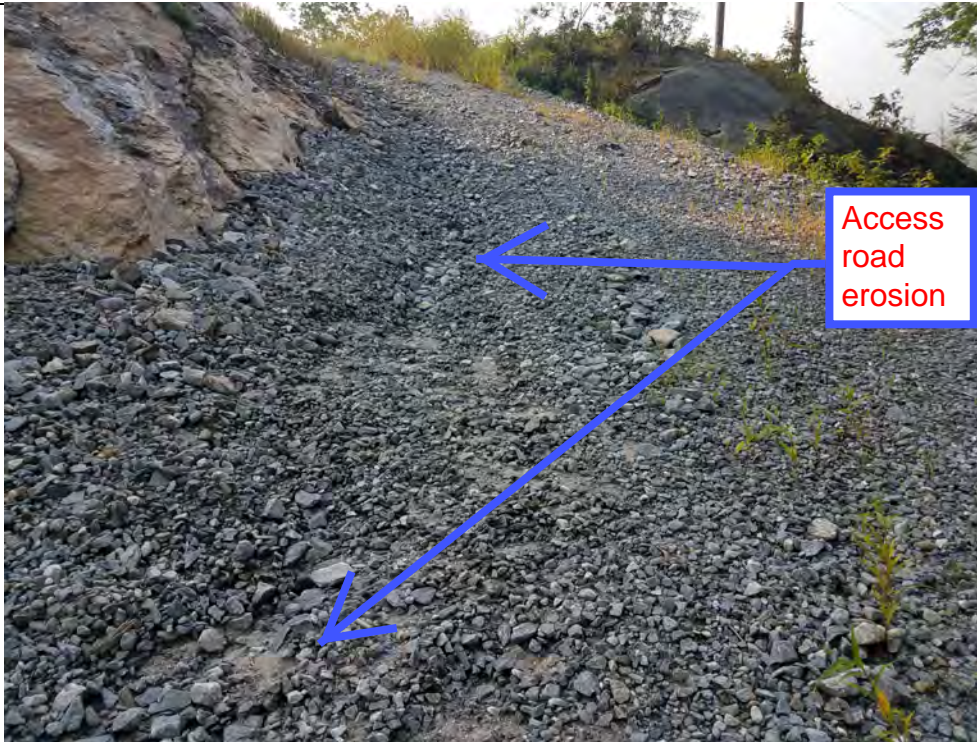
16	Str 45	Yes	W-C22, W-C23, S-C8, S-C9, Branch Brook	Not accessible at the time of the final inspection due to restoration efforts and wet conditions of access roads.	Armored slope along north side of Structure 45 work pad; water bars/dips along access roads to Structures 45 and 46.	
	Str 46	Yes		Not accessible at the time of the final inspection due to restoration efforts and wet conditions of access roads.	Water bar and plunge pool along access road to Structure 46; two berms with natural rock plunge pools across Structure 46 work pad.	
17	Str 47	Yes	W-D1, W-D1A, W-D1B	Visible erosion on access road, sedimentation off of access road slope. Water bar and sediment basin are filled and blow out has occurred. Scattered and sparse veg growth on pad. Pad and access road are constructed of stone.	Four water bars with plunge pools along access road to Structure 47; riprap berm along west side of structure work pad. Gate installed along access road from State Route 109 per CT DOT.	Photo 15 Photo 16

Photo 15: 08/17/2018: Thomaston, Map 17, Structure Str 47, access road erosion and sediment buildup in water bar.

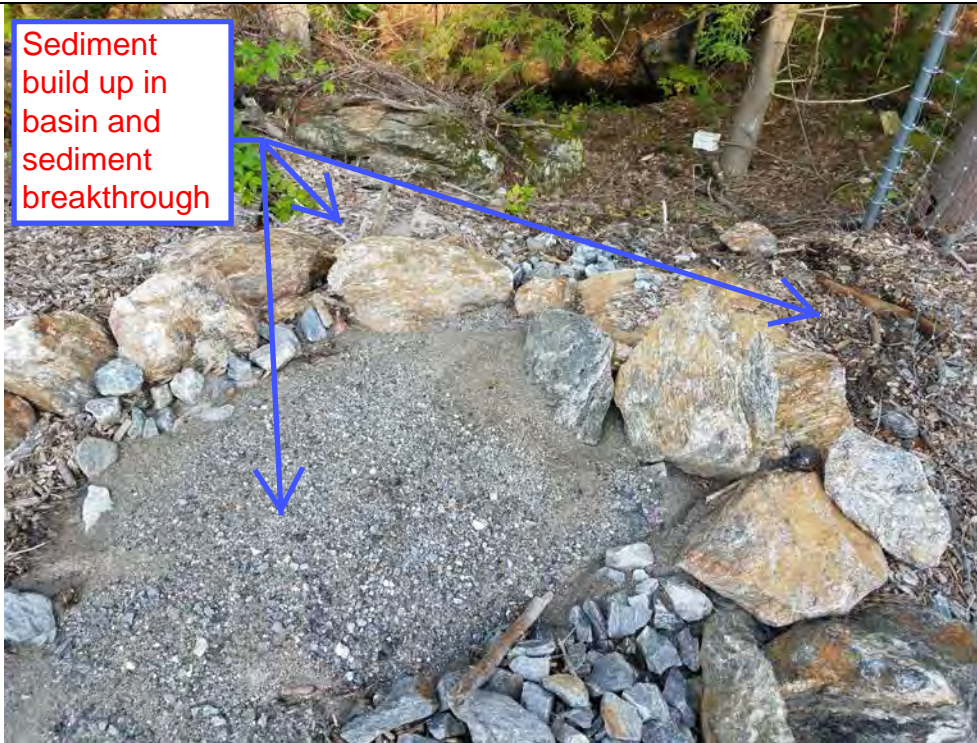
Photo 16: 08/17/2018: Thomaston, Map 17, Structure Str 47, full sediment basin, sediment passing through improperly constructed sediment basin and traveling down gradient.

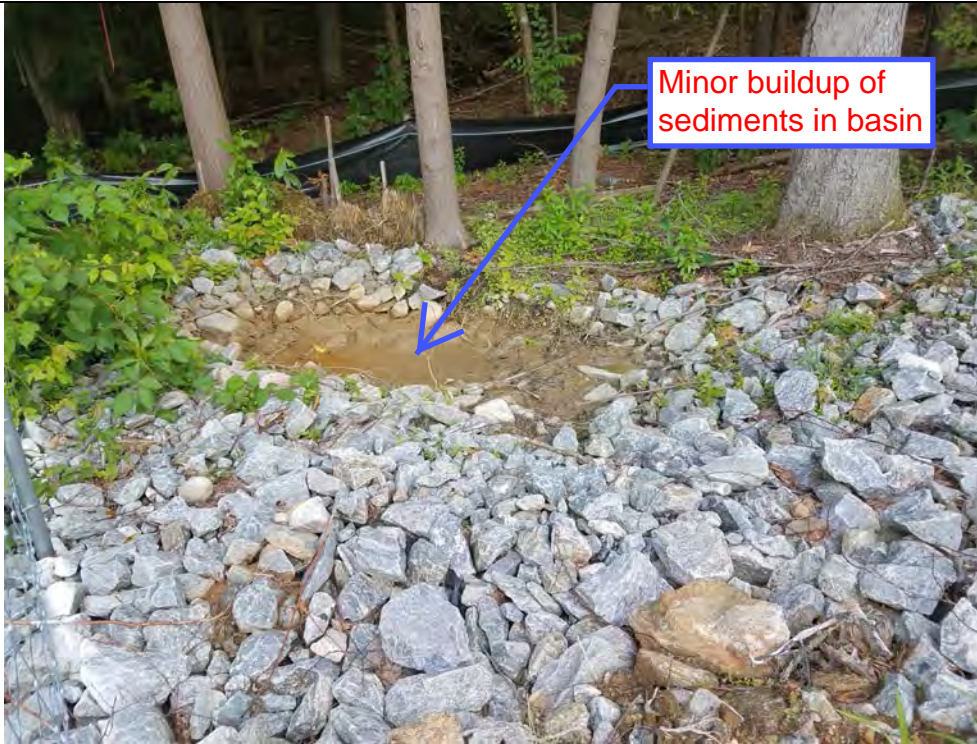
Minor buildup of sediments in basin

Photo 17: 08/17/2018: Thomaston, Map 17, Structure Str 48, sediment basin.

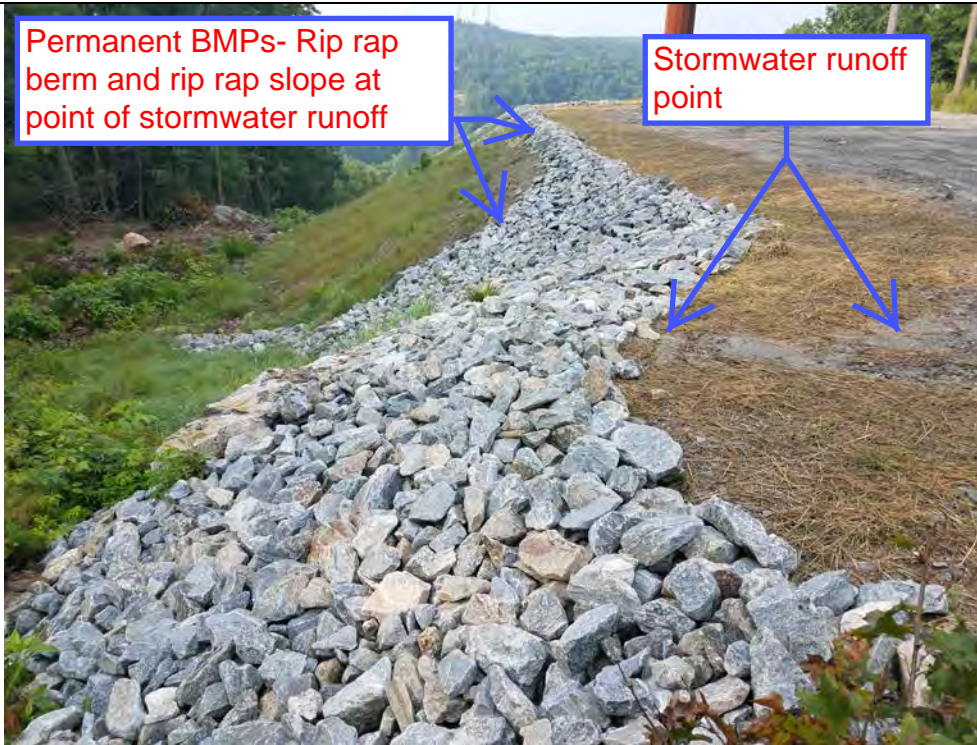
Permanent BMPs- Rip rap berm and rip rap slope at point of stormwater runoff

Stormwater runoff point

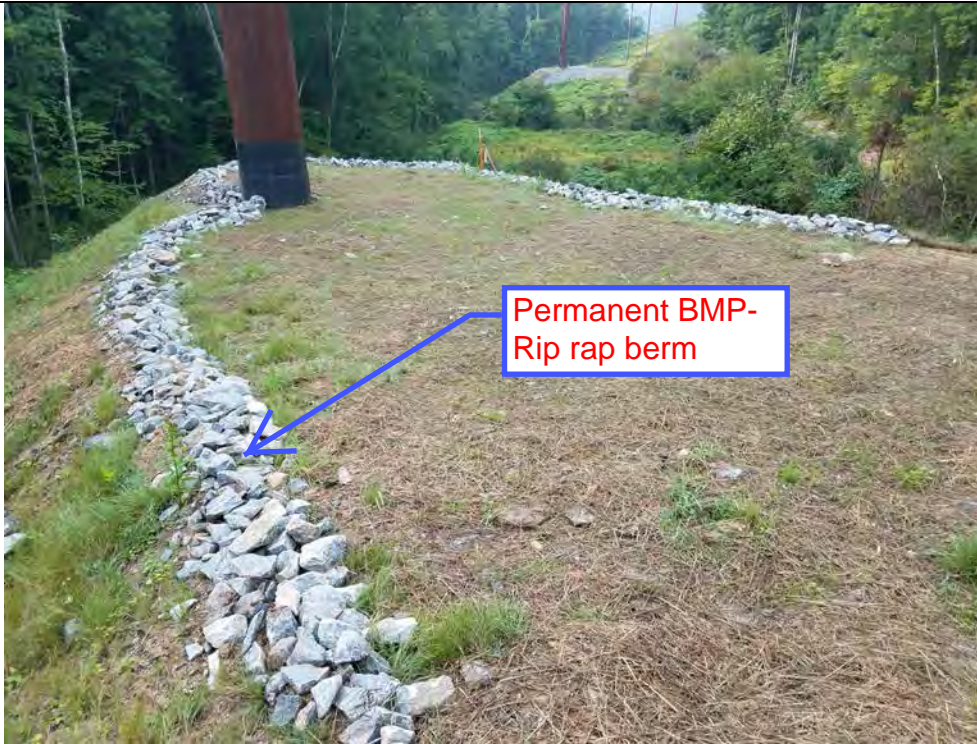
Permanent BMP-
Rip rap berm

Photo 19: 08/17/2018: Thomaston, Map 18, Structure Str 51, permanent BMPs- rip rap berm.

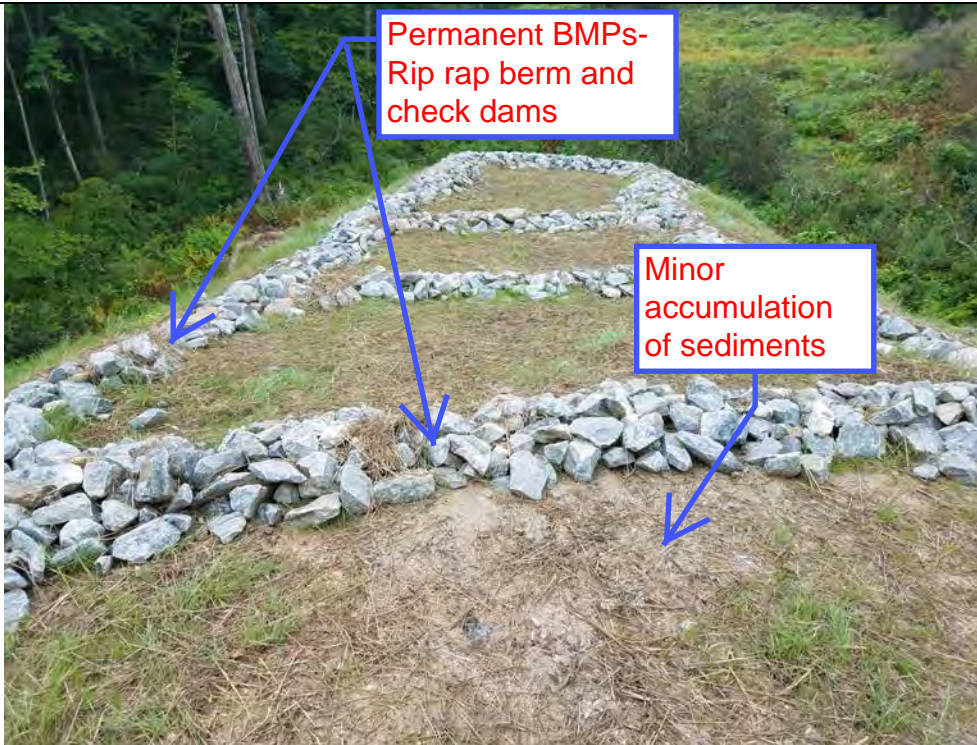
Permanent BMPs-
Rip rap berm and
check dams

Minor
accumulation
of sediments

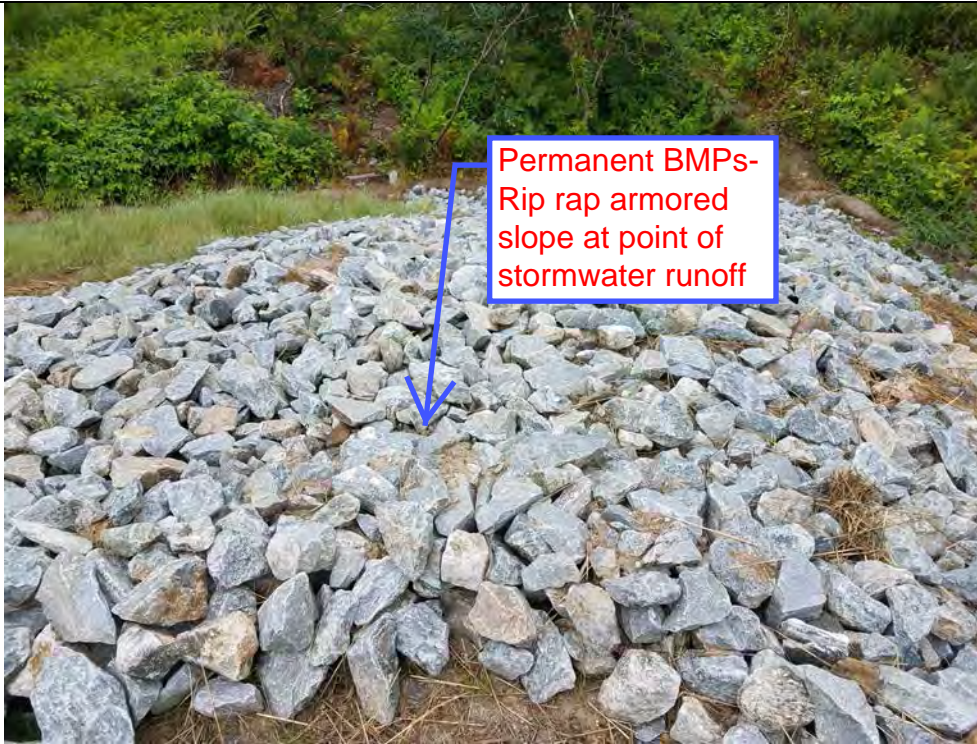
Permanent BMPs-
Rip rap armored
slope at point of
stormwater runoff

Photo 21: 08/17/2018: Thomaston, Map 18, Structure Str 51, Permanent BMPs- rip rap armored slope at point of stormwater runoff.

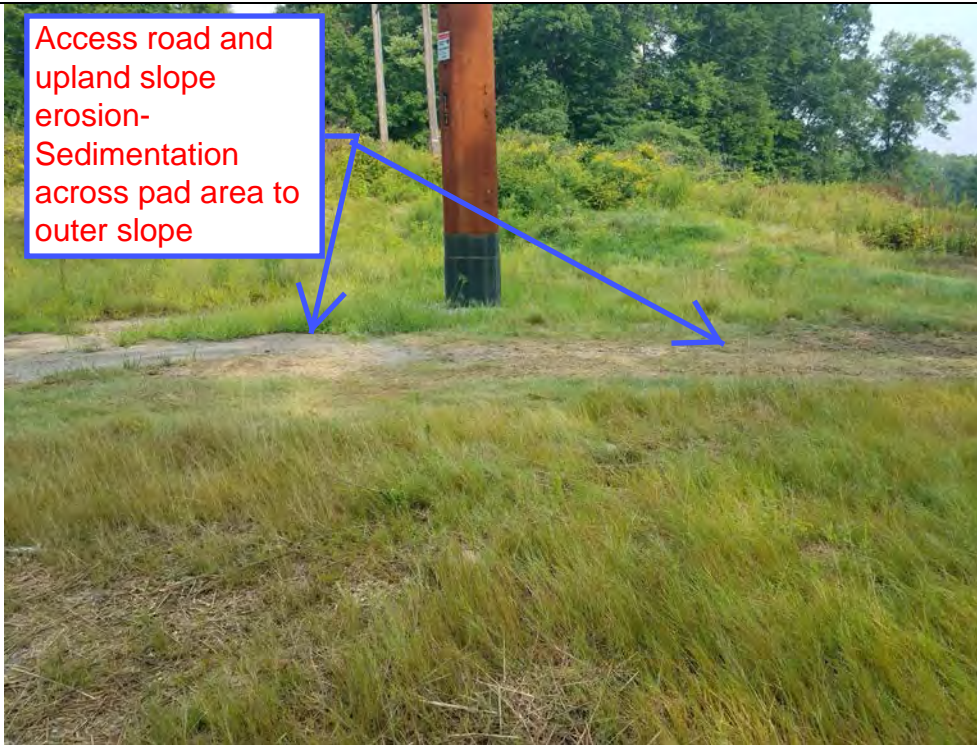
Access road and
upland slope
erosion-
Sedimentation
across pad area to
outer slope

Photo 22: 08/17/2018: Thomaston, Map 20, Structure Str 57, erosion area and vegetation growth on pad, permanent BMP- rip rap slope (not shown) at point of stormwater runoff.

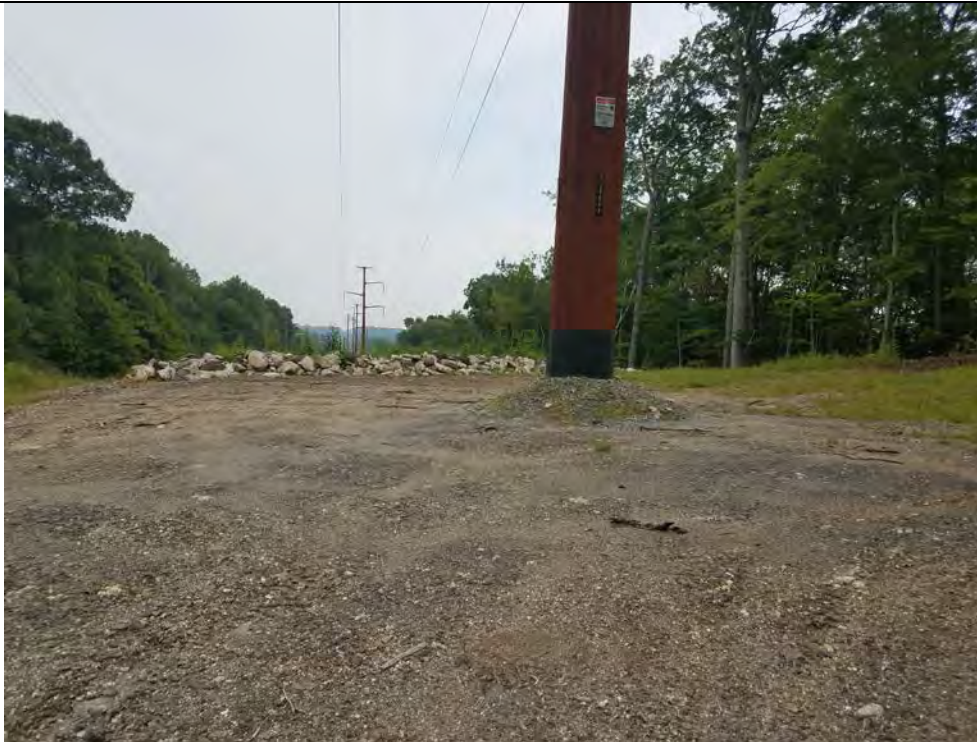
Photo 23: 08/17/2018: Thomaston, Map 20A, Structure Str 59, typical pad construction (native materials) in this area of the ROW.

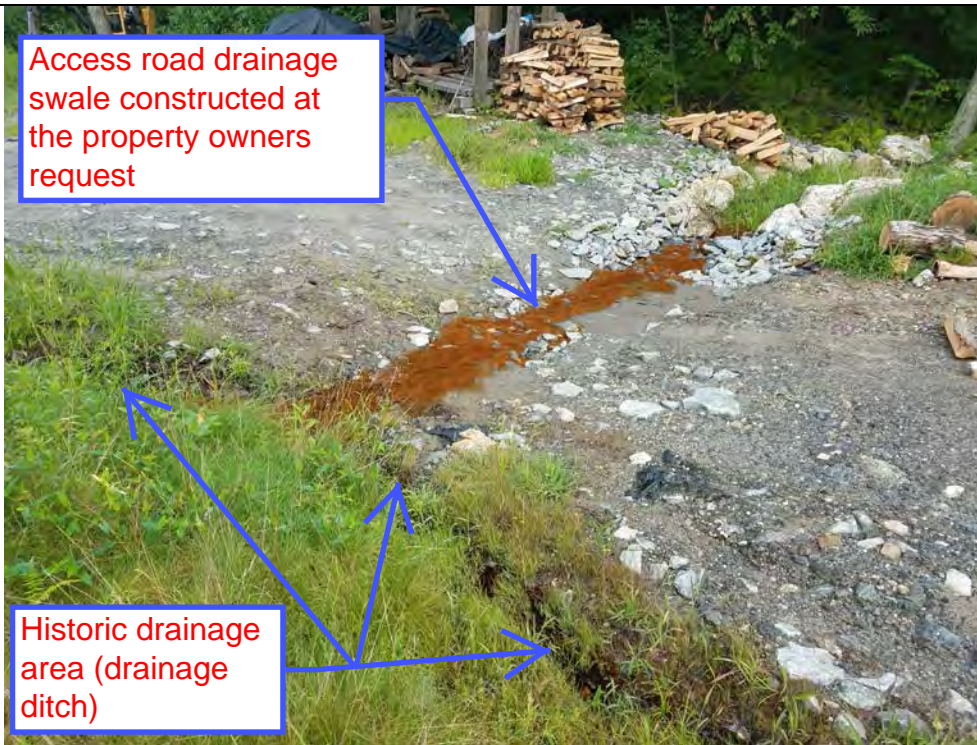
Photo 24: 08/17/2018: Thomaston, Map 20A, Structure Str 59, access road drainage swale.

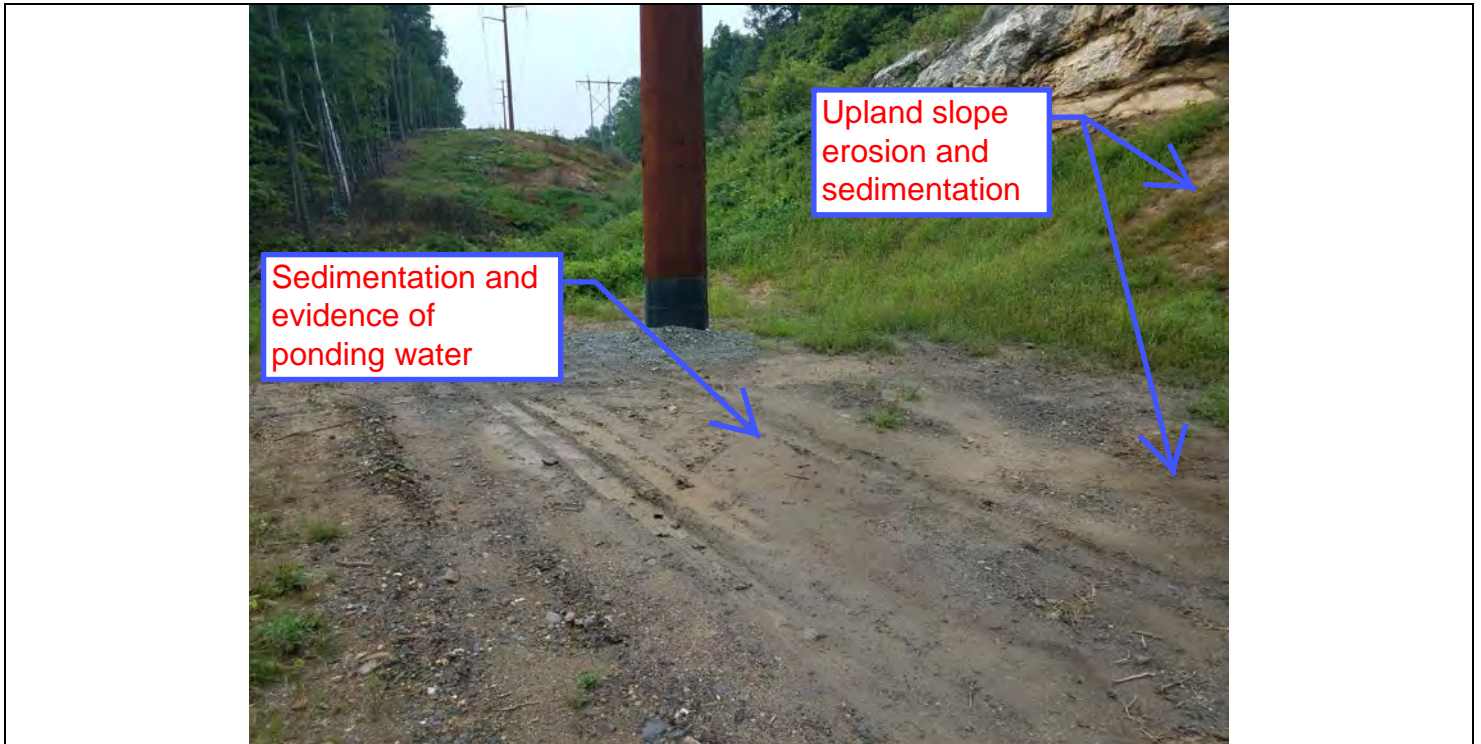
Str 60	Yes		Minor slope erosion (upland and downgradient slopes). Ponding and muddy conditions on access road. Access road and pad are a mixture of pea stone sized aggregate and soils.	Natural rock curtain drain underneath northern portion of Str 60 work pad.	Photo 25 Photo 26
21	Str 58	Yes	W-D7, W-D8, W-D15, S-D5, VP-D15-1	Str 58, SAME AS ABOVE SECTION, MAP PAGE 20A.	N/A	
	Str 59	Yes		Str 59, SAME AS ABOVE SECTION, MAP PAGE 20A.	N/A	
	Str 60	Yes		Str 60, SAME AS ABOVE SECTION, MAP PAGE 20A.	N/A	Photo 25 Photo 26
	Str 61	Yes		Stormwater runoff from pad is causing erosion across the access road and sedimentation off of the down gradient side of the road edge.	N/A

Photo 25: 08/17/2018: Thomaston, Map 20A, Structure Str 60, upland slope erosion and sedimentation and ponding conditions on access road.
