**Subject: Docket No. 466, Frost Bridge to Campville 115-kV Project
Decision and Order Condition #4 – Independent Environmental Inspector Report**

Docket No. 466– Development and Management Plan Inspection

ATTACHMENT 1
TRC Final Site Inspection Table

**Photograph Log
Frost Bridge to Campville 115kV Project
FINAL REPORT**

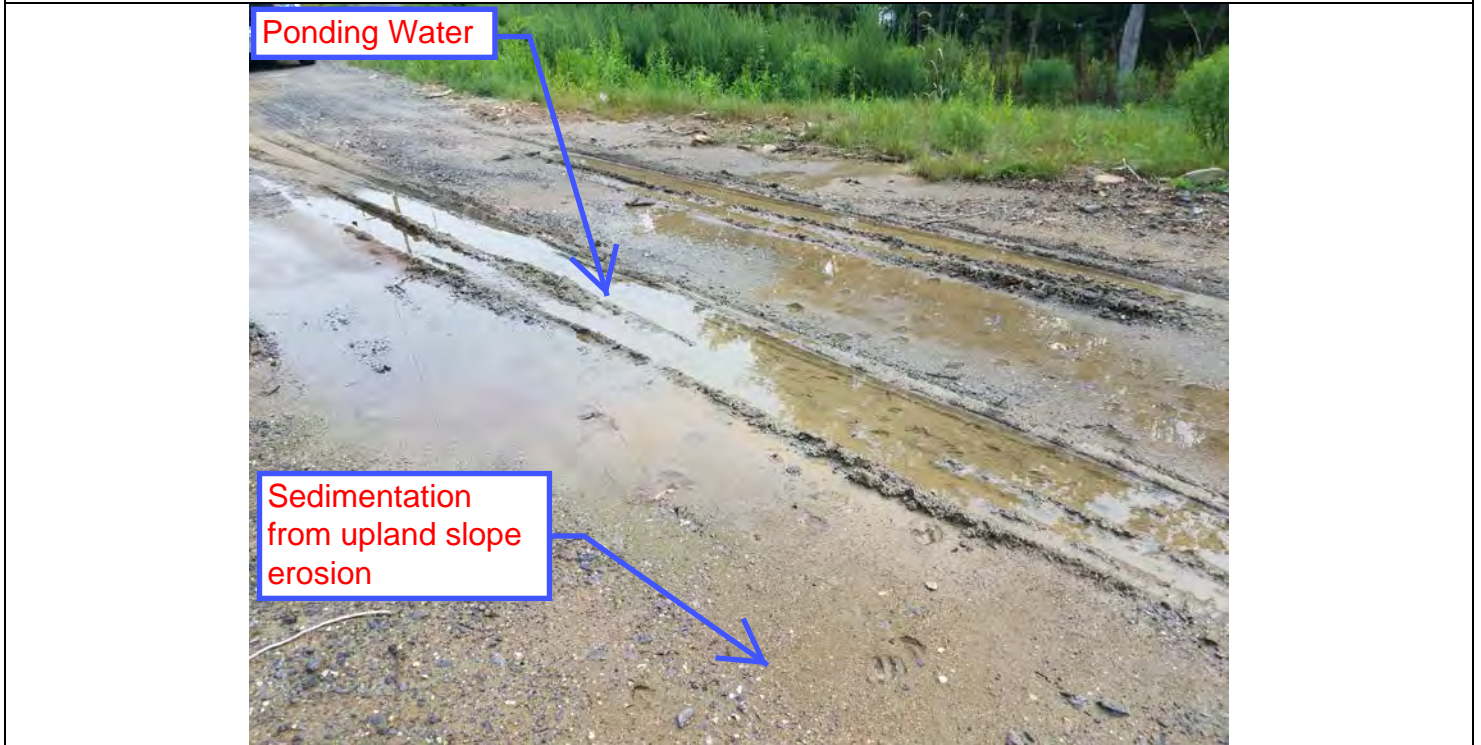
Str 60	Yes		Minor slope erosion (upland and downgradient slopes). Ponding and muddy conditions on access road. Access road and pad are a mixture of pea stone sized aggregate and soils.	Natural rock curtain drain underneath northern portion of Str 60 work pad.	Photo 25 Photo 26
21	Str 58	Yes	W-D7, W-D8, W-D15, S-D5, VP-D15-1	Str 58, SAME AS ABOVE SECTION, MAP PAGE 20A.	N/A	
	Str 59	Yes		Str 59, SAME AS ABOVE SECTION, MAP PAGE 20A.	N/A	
	Str 60	Yes		Str 60, SAME AS ABOVE SECTION, MAP PAGE 20A.	N/A	Photo 25 Photo 26
	Str 61	Yes		Stormwater runoff from pad is causing erosion across the access road and sedimentation off of the down gradient side of the road edge.	N/A

Photo 26: 08/17/2018: Thomaston, Map 20A, Structure Str 60, upland slope erosion and sedimentation and ponding conditions on access road, and leak off of road at the down gradient slope.

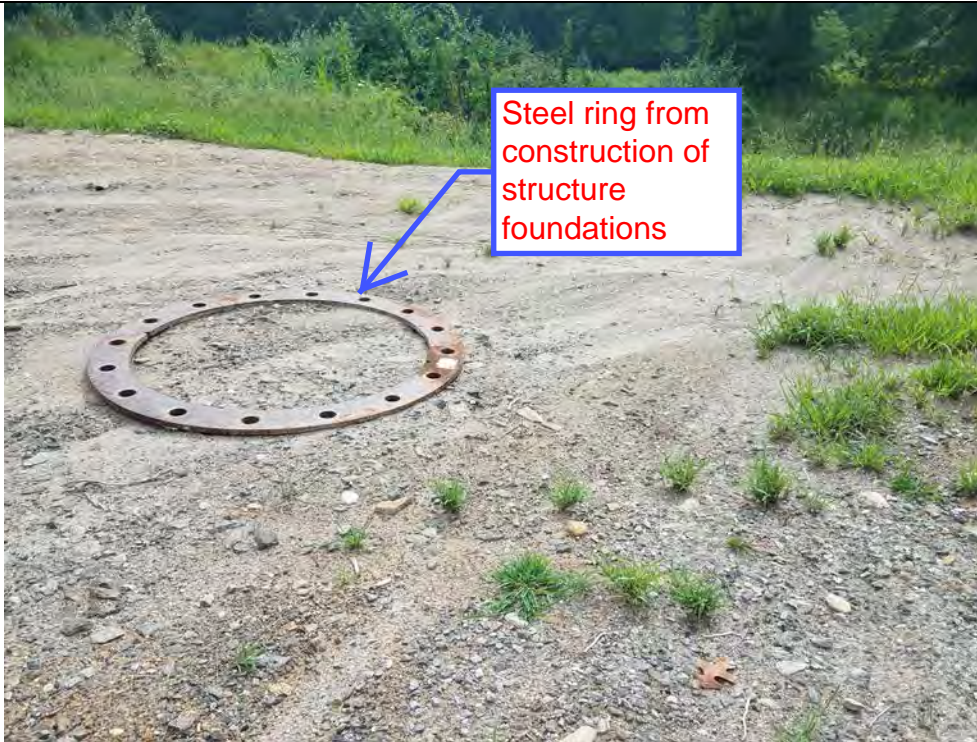
Steel ring from construction of structure foundations

Photo 27: 08/17/2018: Thomaston, Map 23, Structure Str 66, Steel ring left behind following construction activities at the structure.

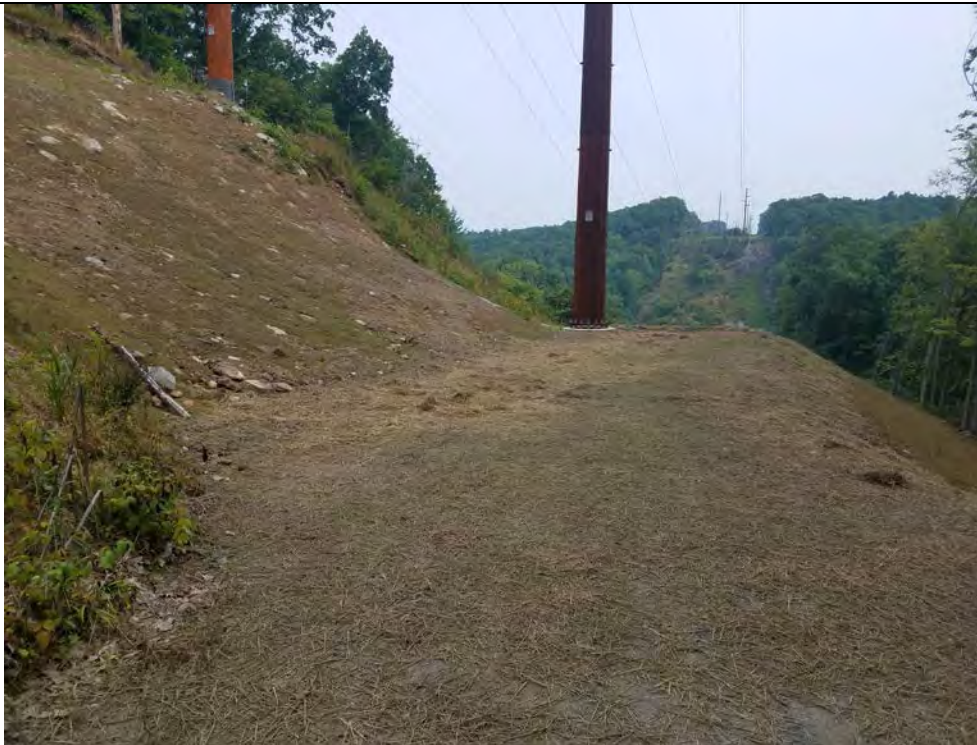
Photo 28: 08/17/2018: Thomaston, Map 24, Structure Str 69, seeding and straw mulch cover on pad.

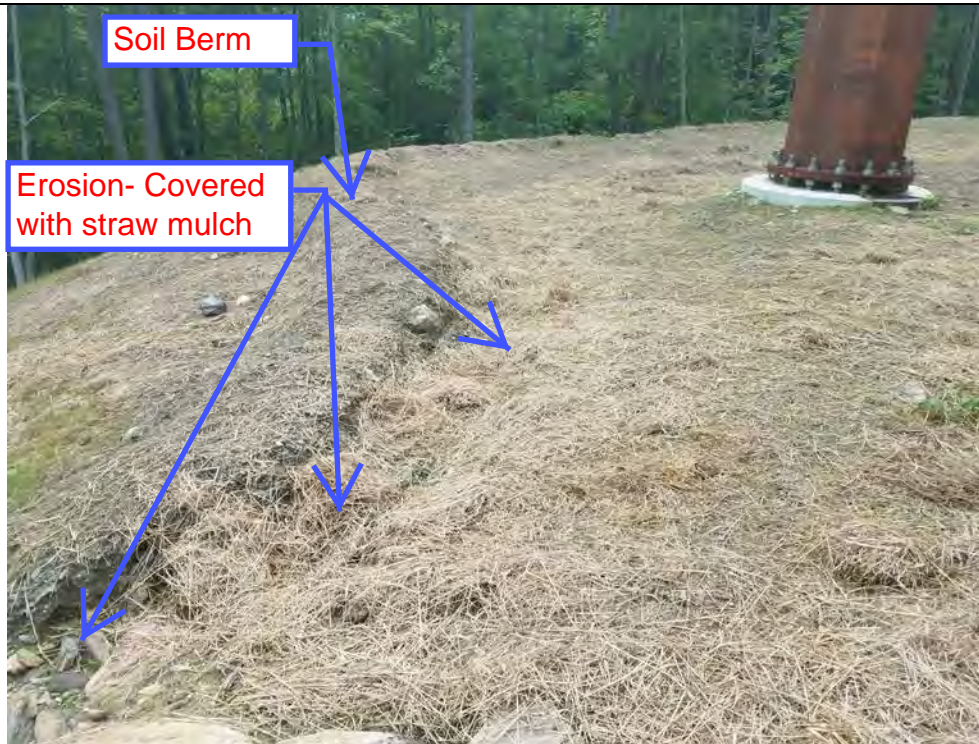
Photo 29: 08/17/2018: Thomaston, Map 24, Structure Str 69, Seeding and straw mulch cover on pad, soil berm constructed along top edge of slope, erosion off and around open edge of slope.

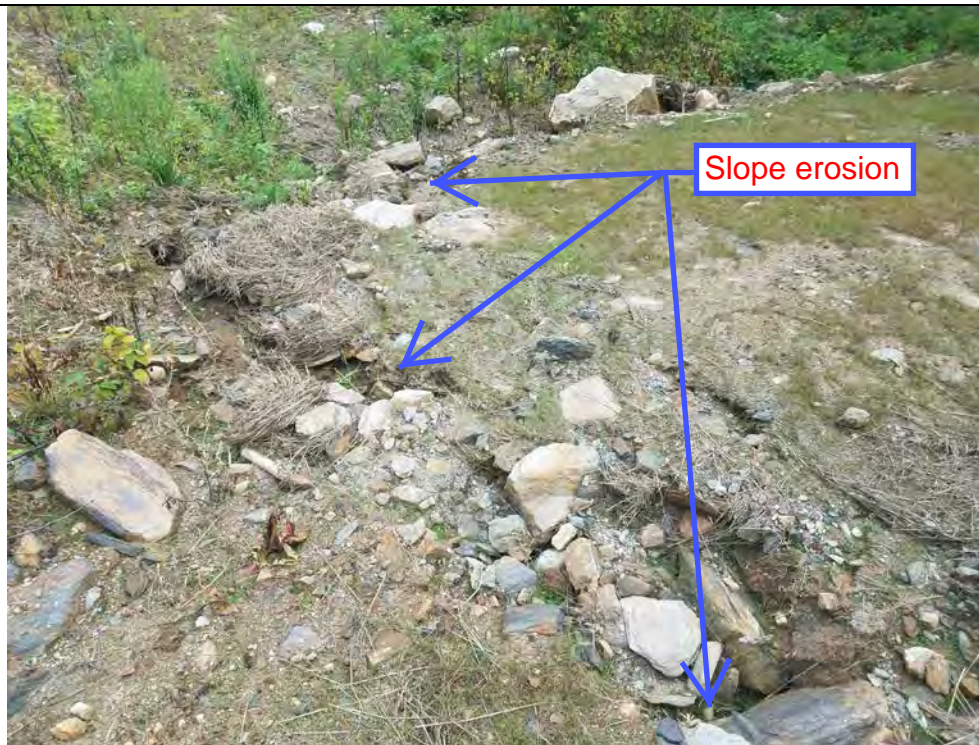
Photo 30: 08/17/2018: Thomaston, Map 24, Structure Str 69, soil berm constructed along top edge of slope, erosion off and down slope.

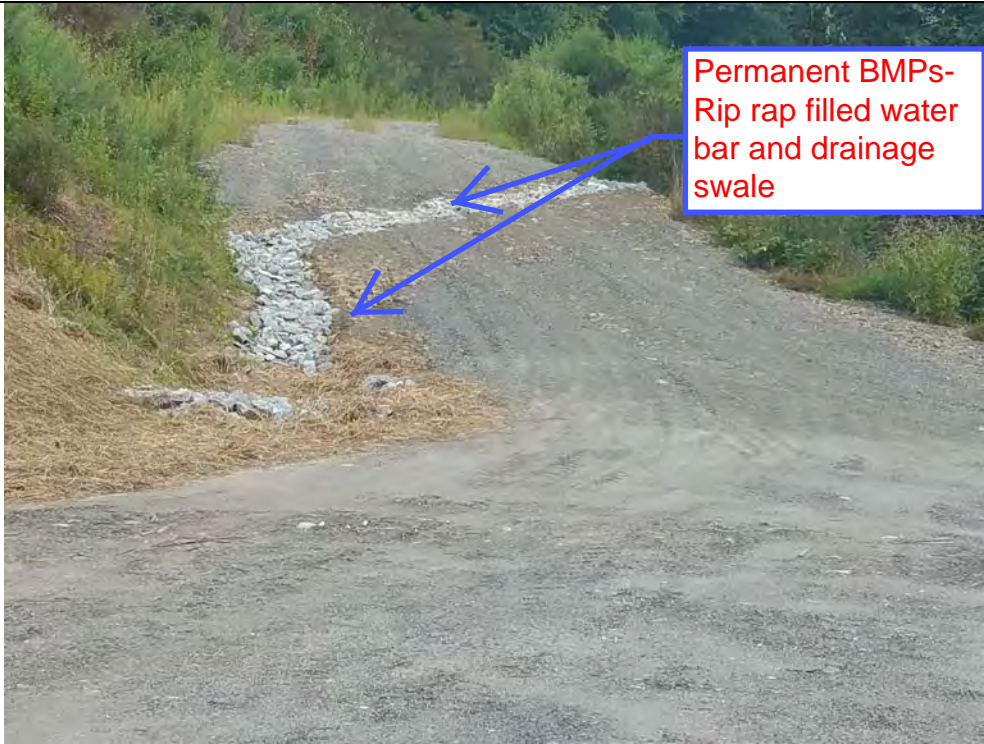
Photo 31: 08/17/2018: Thomaston, Map 25, Structure Str 70, Permanant BMPs- rip rap filled water bar and swale.

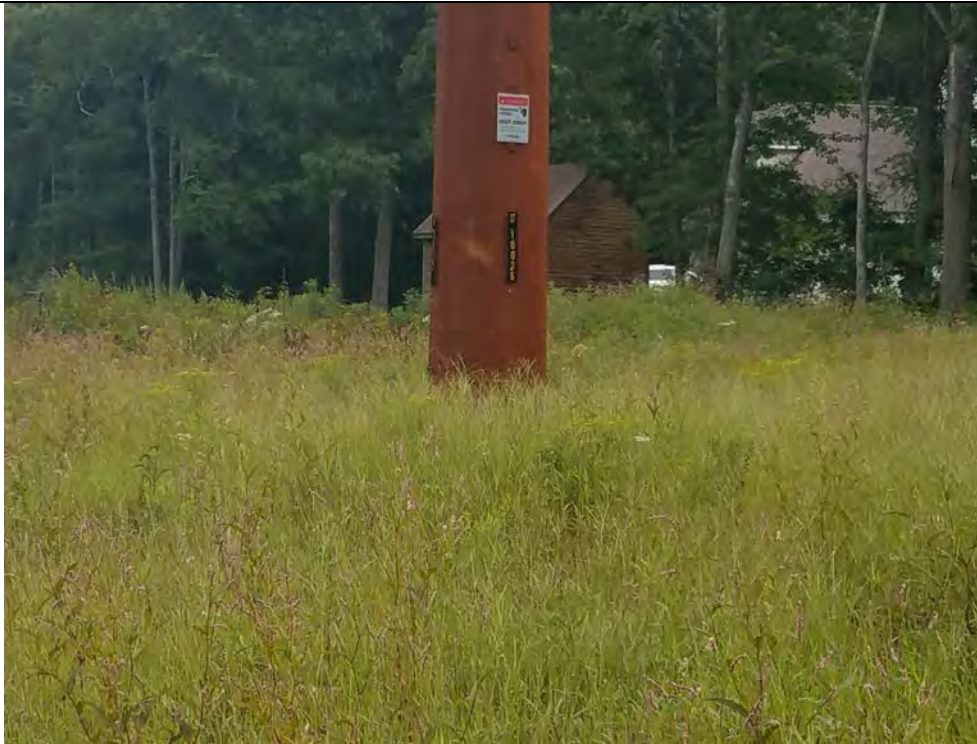
Photo 33: 08/17/2018: Litchfield, Map 27, Structure Str 77, vegetation growth.

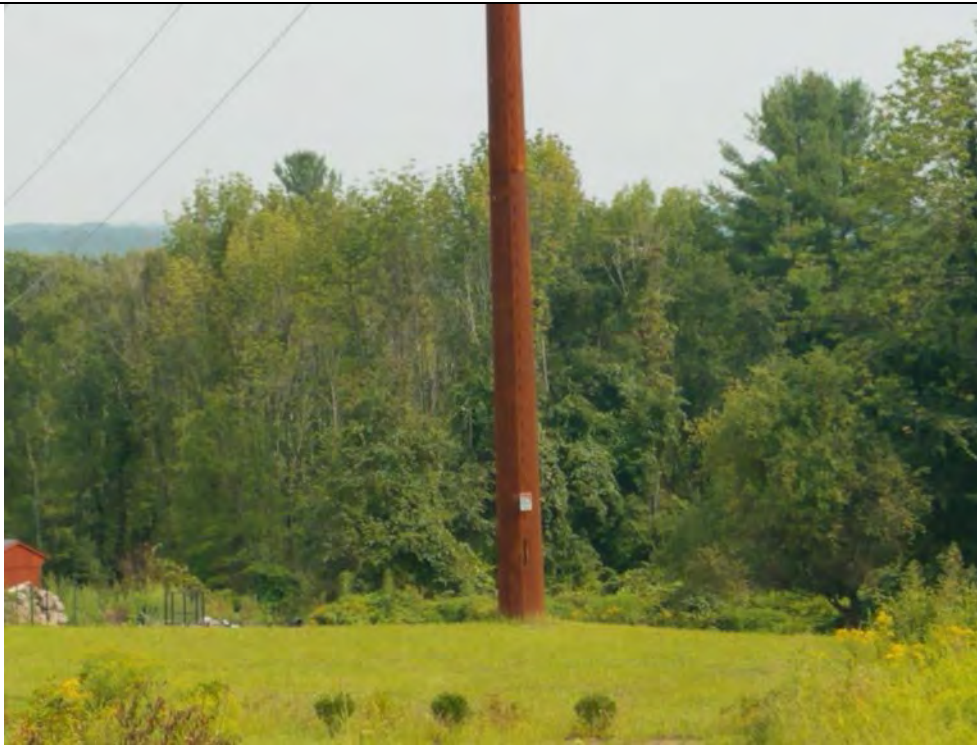
Photo 34: 08/17/2018: Litchfield, Map 29, Structure Str 82, vegetation growth.

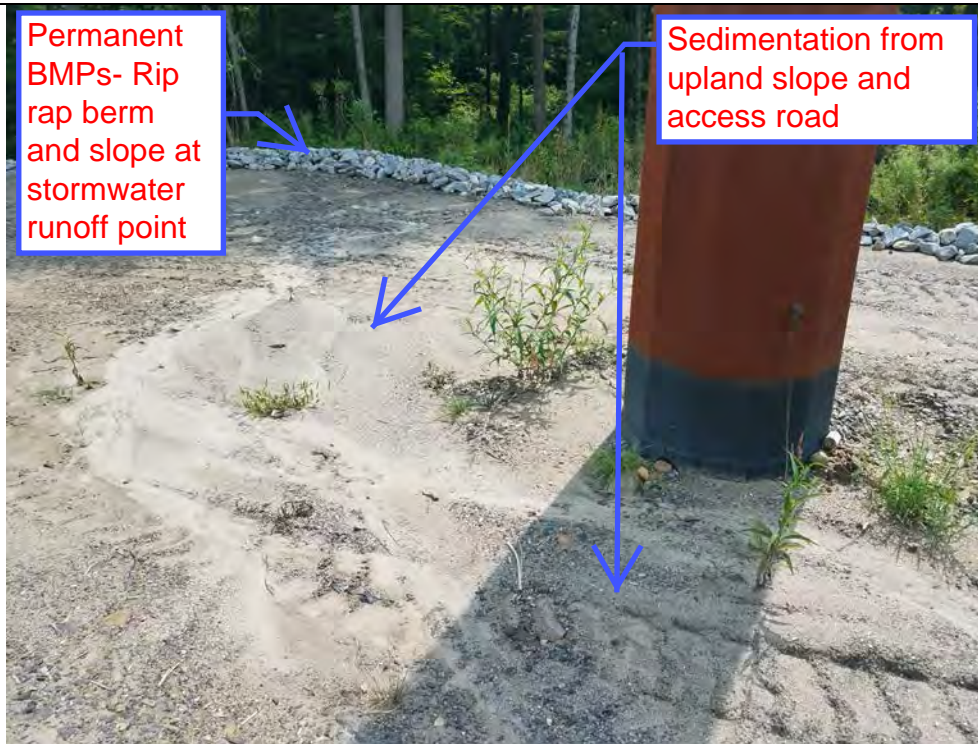
Photo 35: 08/17/2018: Litchfield, Map 29, Structure Str 83, sediment buildup from erosion off of upland slope and sediments moving over pad area during rainfall events, Permanent BMPs- rip rap berm at points of stormwater runoff.

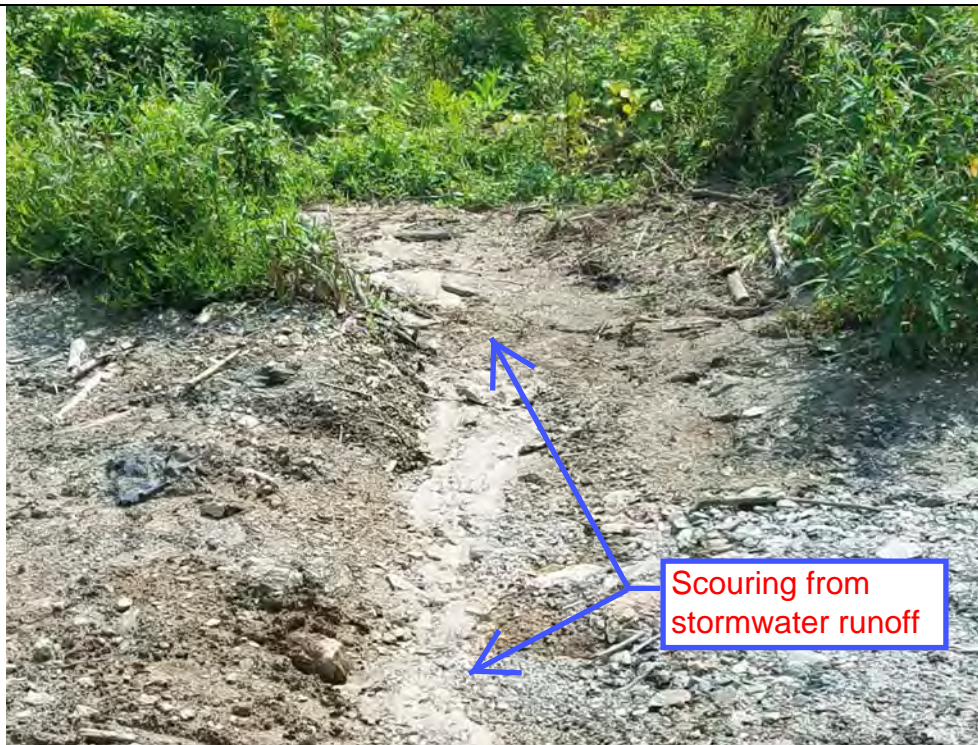
Photo 36: 08/17/2018: Litchfield, Map 29, Structure Str 83, erosion off of pad and access road from non-armored/rip rap lined water bar.

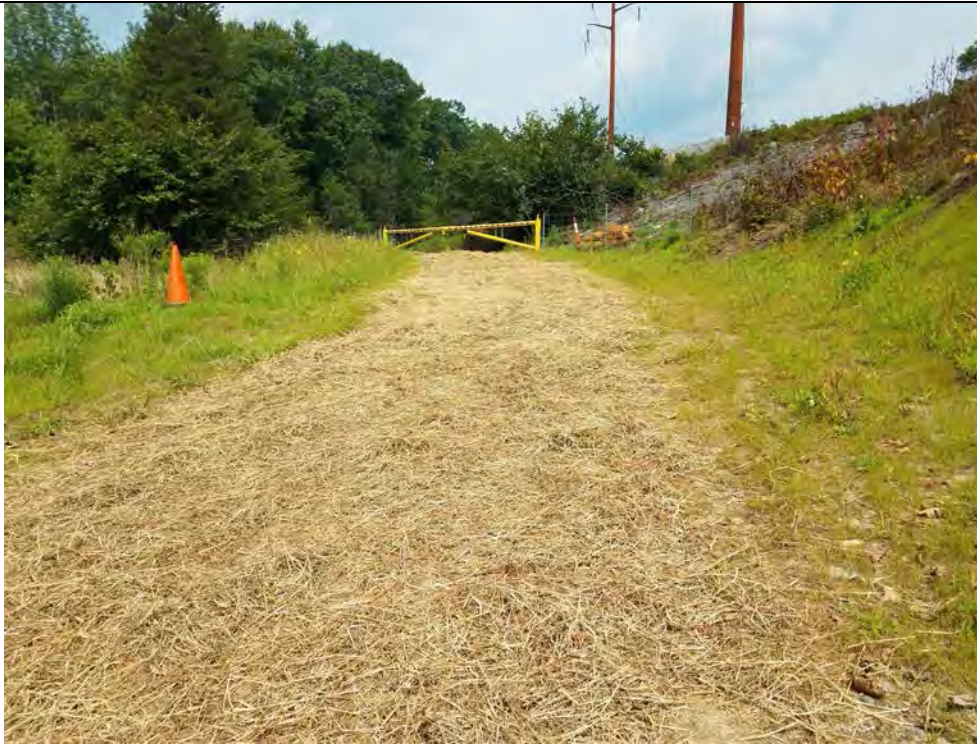
Photo 37: 08/17/2018: Litchfield, Map 30, Structure Str 85, seeding and straw mulch on access road.

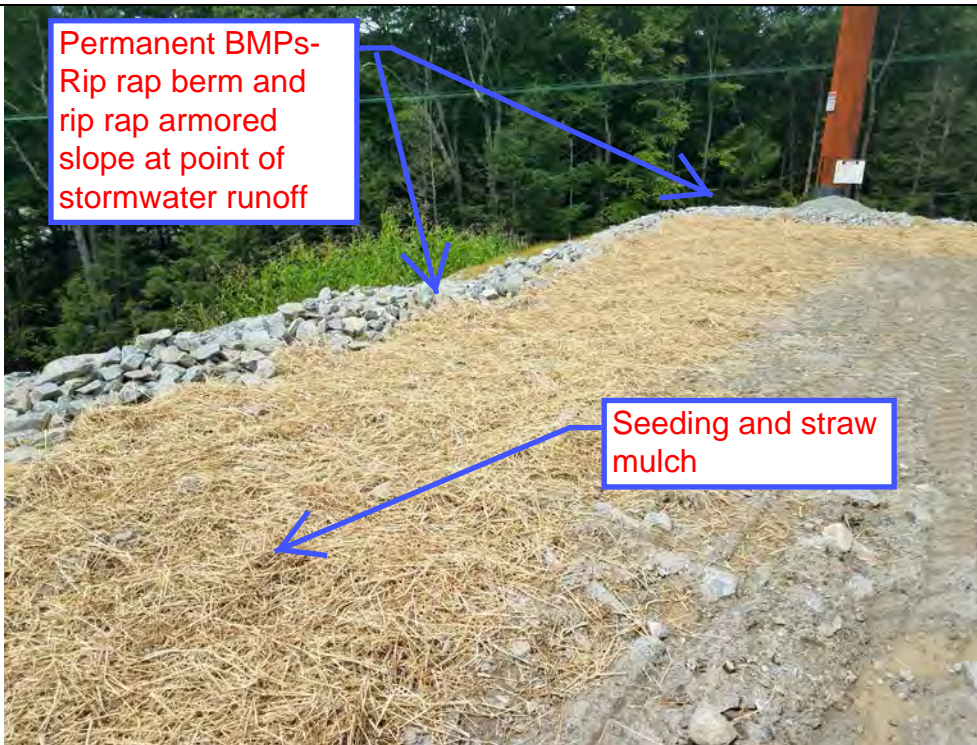
Photo 38: 08/17/2018: Litchfield, Map 30, Structure Str 85, Permanent BMPs- rip rap berm and rip rap slope at points of stormwater runoff, seed and straw mulch.

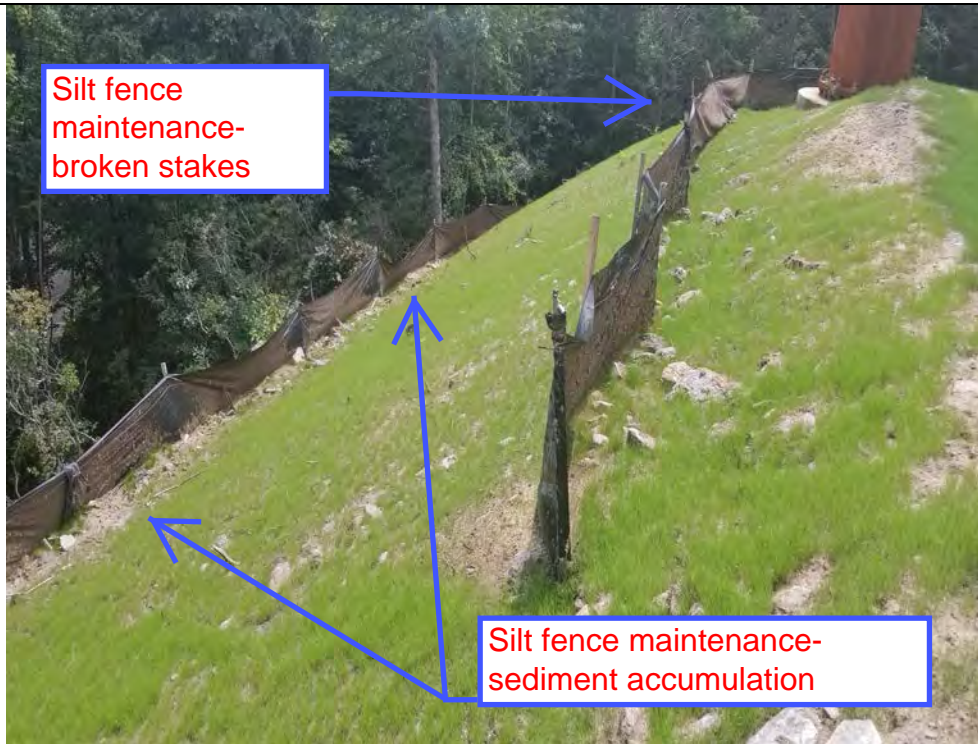
Photo 39: 08/17/2018: Litchfield, Map 31, Structure Str 86, down gradient slope of Str86, vegetation growth, some minor sediment accumulation on lower silt fence and some minor silt fence repairs needed on top silt fence (broken stakes).

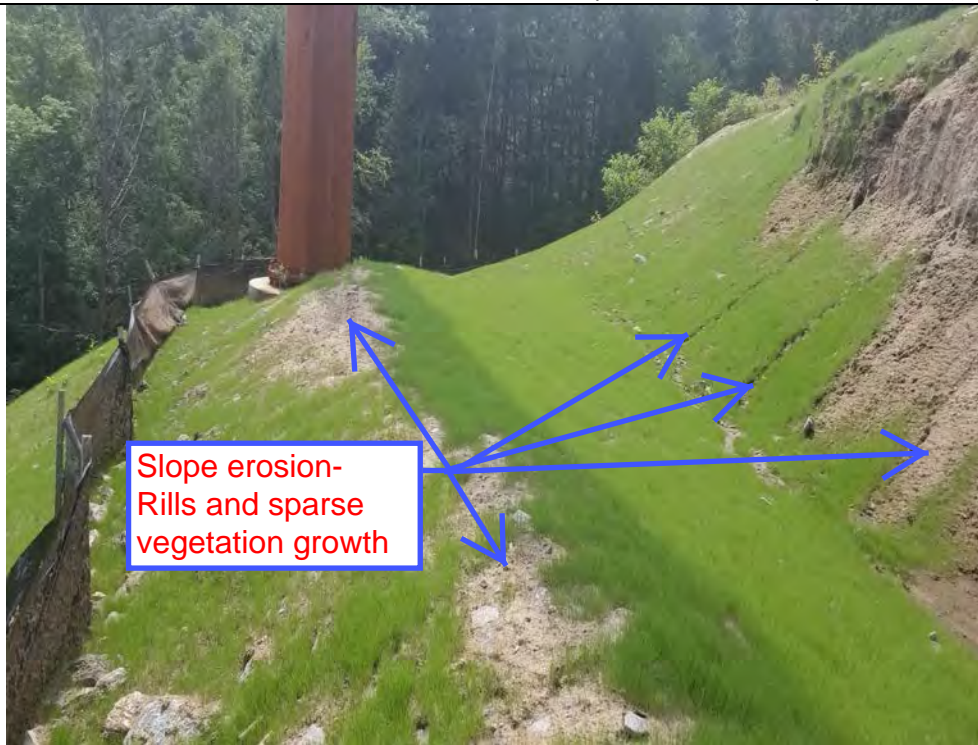
Photo 40: 08/17/2018: Litchfield, Map 31, Str 86, Structure Str 86, down gradient slope, work pad, upland slope of Str86, erosion and bare soil areas, and varying degrees of vegetation growth.

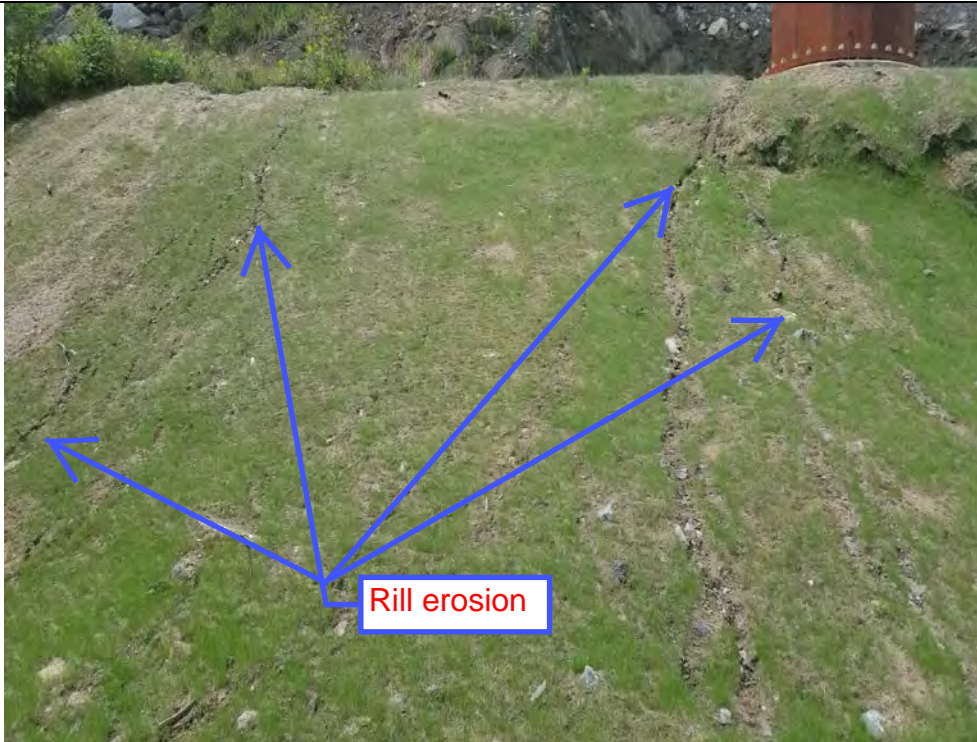
Str 3236	Yes		Work pad is graded such that surface water flows back away from the down gradient slope. Visible erosion on down gradient slope impacting Str 86 work pad. Some visible evidence of sediment movement on the pad and water ponding at the upland side of the pad. Upland slope is bedrock and no erosion was observed.	See above entry.	
	Str 3171	Yes		Work pad is graded such that surface water flows back away from the down gradient slope. Visible erosion on down gradient slope impacting Str 86 work pad. Some visible evidence of sediment movement on the pad and water ponding at the upland side of the pad. Upland slope is bedrock and no erosion was observed. Surface water is flowing off of the southwest corner of the work pad, no visible erosion on slope because it is exposed rock at the edge and further down the slope is native vegetation cover.	See above entry, Str86/Str3236.	
31A	Str 86	Yes	S-F6, CT Wetland	SAME AS ABOVE SECTION, MAP PAGE 31.	See above entry, Str86/Str3236/Str3171.

Photo 41: 08/17/2018: Litchfield, Map 31, Structure Str 3236, down gradient slope, work pad, erosion and bare soils areas, vegetation growth.

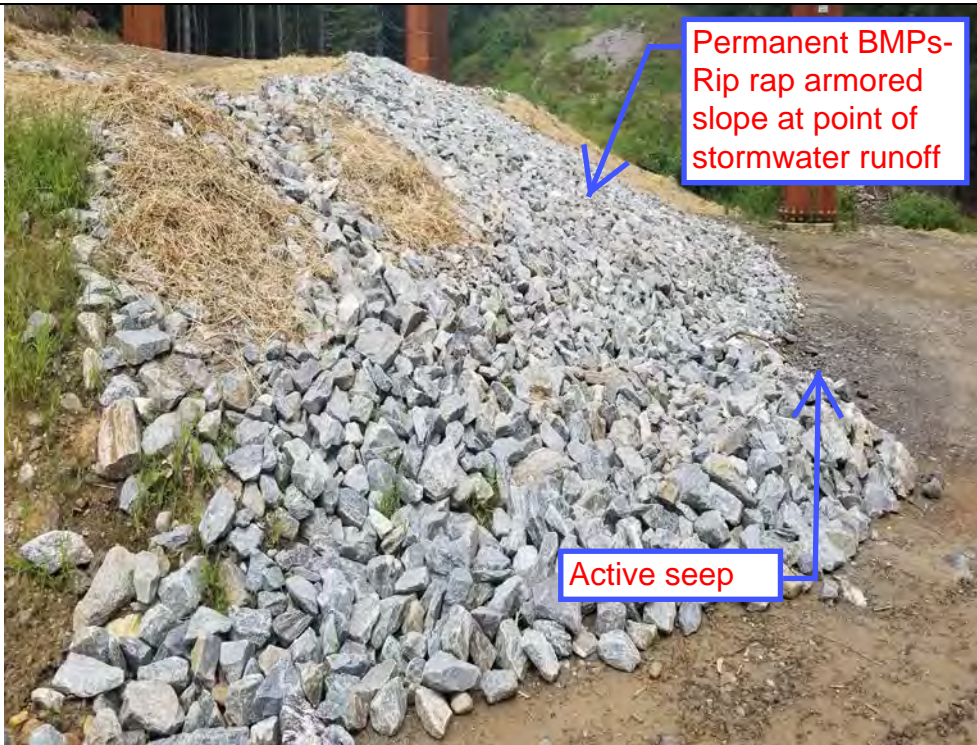
Photo 42: 08/17/2018: Harwinton, Map 32, Structure Str 87, Permanent BMPs- rip rap berm and rip rap armored slopes at points of stormwater runoff, active seep at toe of slope.

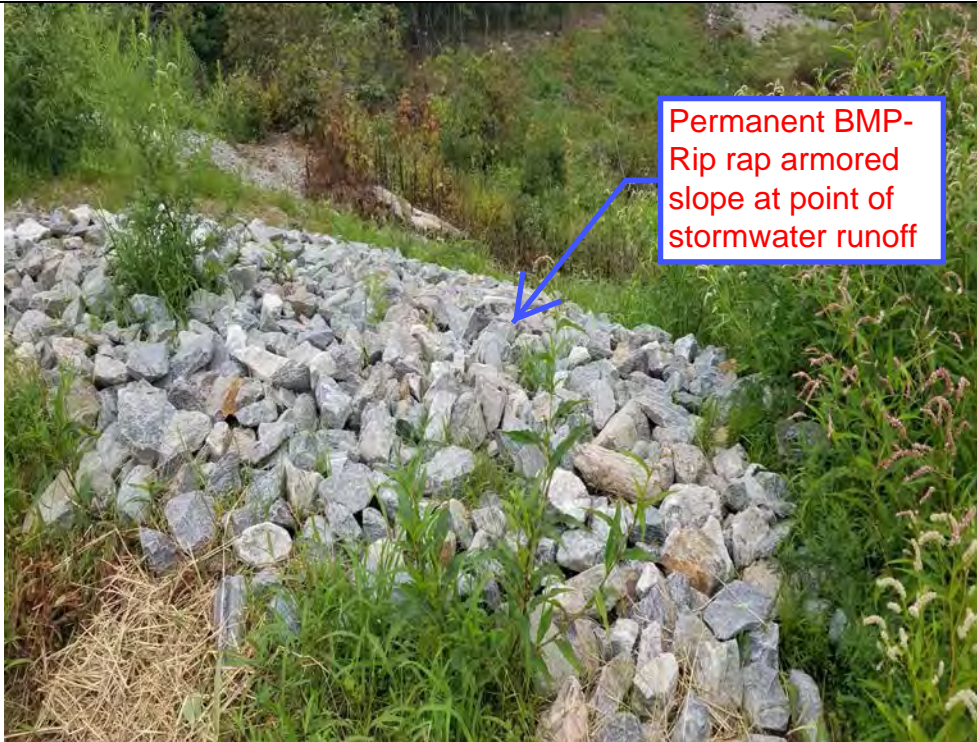
Permanent BMP-
Rip rap armored
slope at point of
stormwater runoff

Photo 43: 08/17/2018: Harwinton, Map 32, Structure Str 88, Permanent BMPs- rip rap armored slope at points of stormwater runoff, vegetation growth.

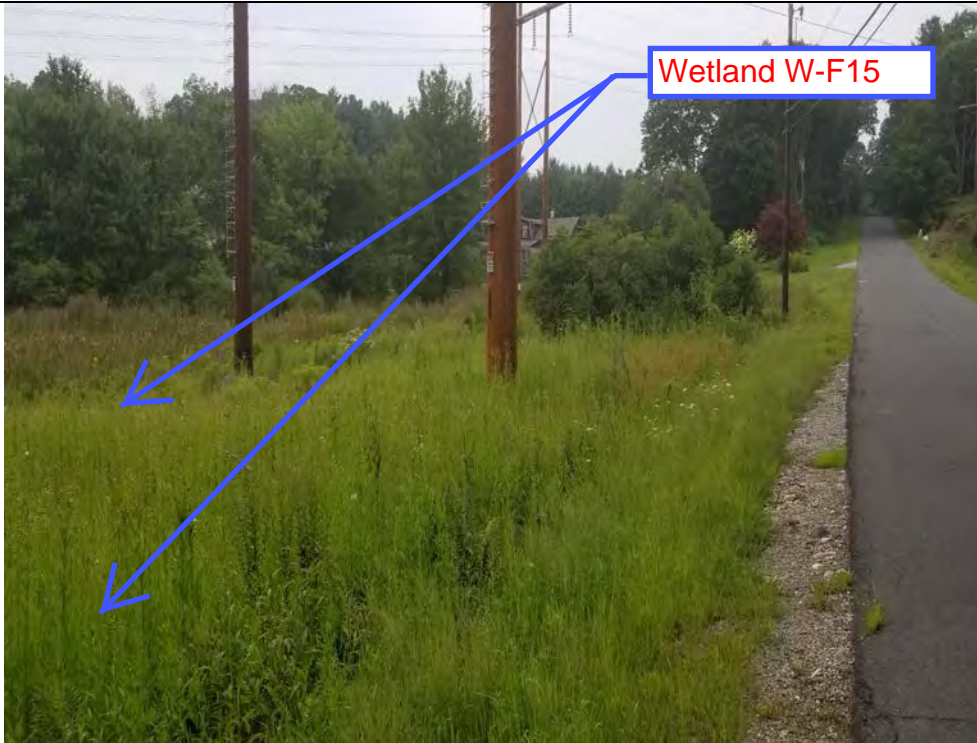
Wetland W-F15

Photo 44: 08/17/2018: Harwinton, Map 35, Structure Str 95 & Wetland W-F15, vegetation growth.

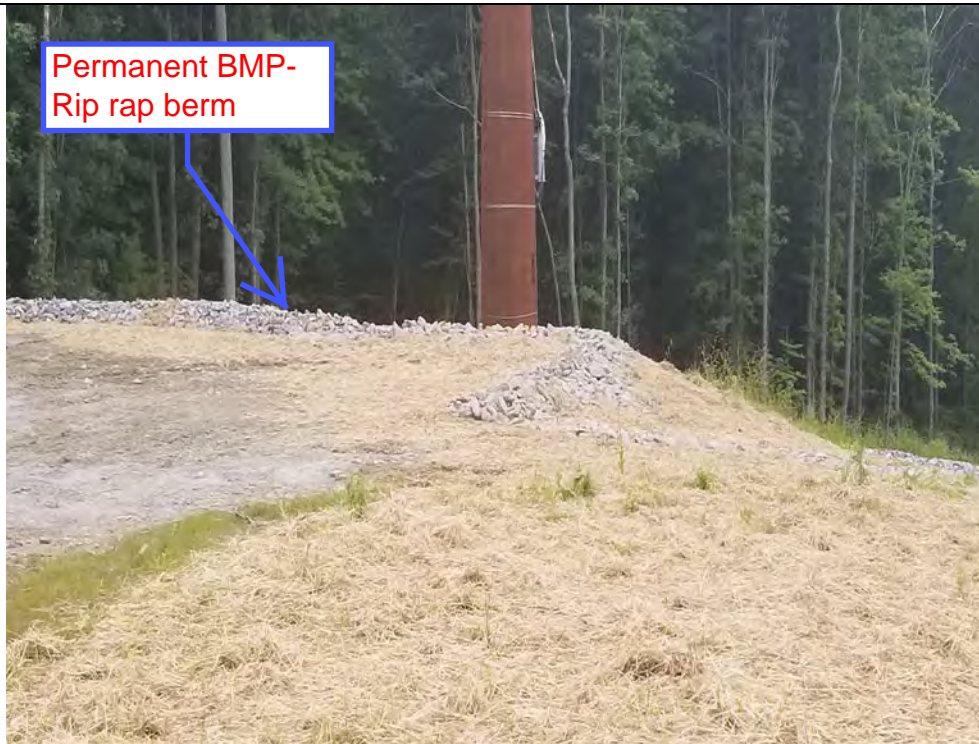
Photo 45: 08/17/2018: Harwinton, Map 35, Structure Str 97, Permanent BMPs- rip rap berm and rip rap armored slopes, drainage swale at points of stormwater runoff, seed and mulch.

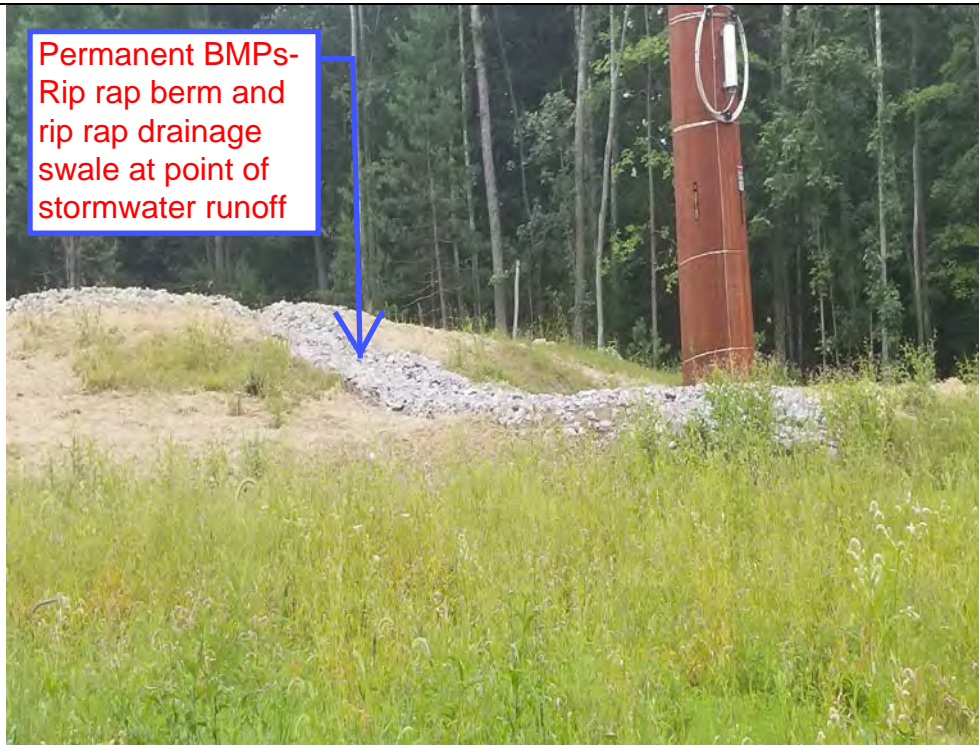
Photo 46: 08/17/2018: Harwinton, Map 35, Structure Str 97, Permanent BMPs-rip rap berm and rip rap armored slopes, drainage swale at points of stormwater runoff, seed and mulch and vegetation growth.
