**Subject: Docket No. 466, Frost Bridge to Campville 115-kV Project
Decision and Order Condition #4 – Independent Environmental Inspector Report**

Please find enclosed the biweekly Independent Environmental Inspector Report, Report #1, for the **December 15th** and **December 21st 2016**, inspection events for the construction of the Eversource Frost Bridge to Campville 115-kV Project.

Docket No. 466- Development and Management Plan Inspection

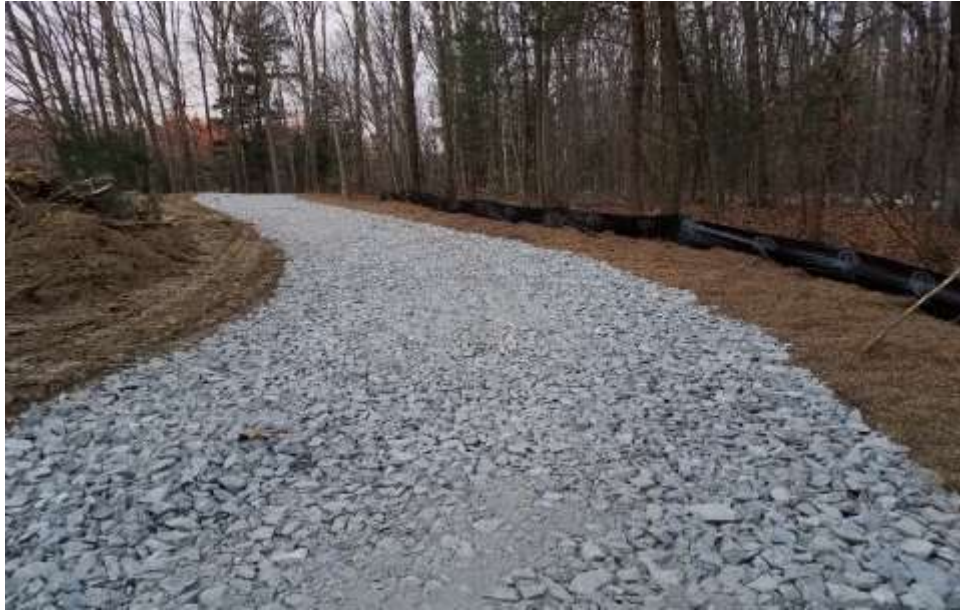
Areas of Inspection		Observation:	Recommended Action:	Corrected Action:
Access Roads and Adjacent Roadways	Interim Week	Temporary access road construction east of the Campville Substation Expansion Area. Stone base construction, appears clean, no sediment buildup, no standing water or ice hazards.	No issue/s observed. Continue to monitor road conditions throughout use.	N/A
	Bi-Week	None observed	N/A	N/A
Vegetative Clearing Limits (Including trees to save or danger trees noted.	Interim Week	Clearing occurred in the areas of the Campville Substation, Str16 through Str23, and Str87. Clearing limits are flagged and visible, no over clearing was observed in the areas listed above. Select areas of vegetation near Str23 were left in place pending further discussion with adjacent property owner. The owner confronted Eversource's Project clearing contractor (Northern Clearing) while they were mowing the area. According to Eversource representatives, the landowner raised questions pertaining to the property owner's fruit bearing trees and greenhouses located within/near the ROW. Encounter discussed at morning tailgate briefing.	No issue/s observed	N/A

Photo #1: 12/15/16-Temporary Access Road construction and installed silt fence east of the Campville Substation Expansion Area, Town of Harwinton.

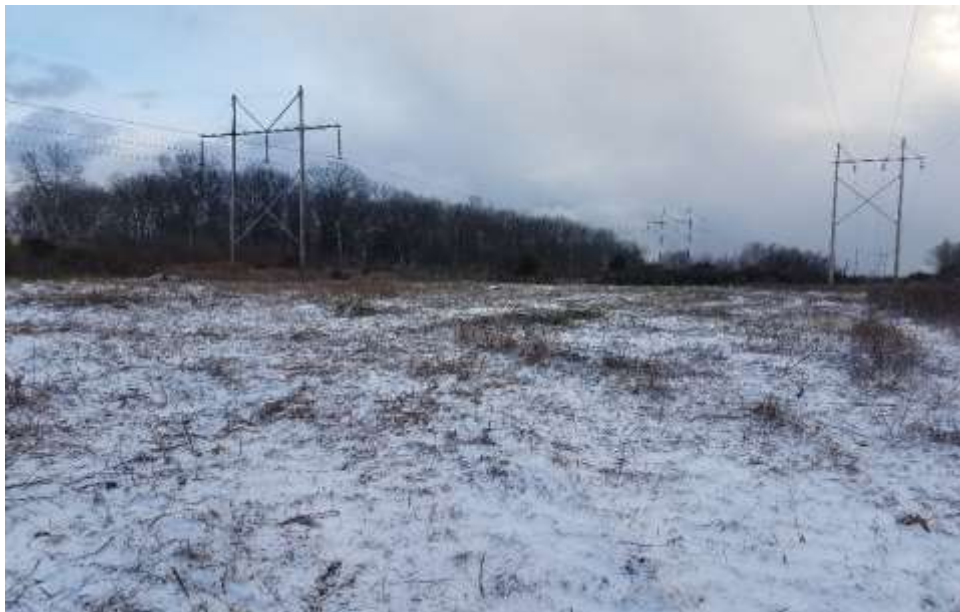
Photo #2: 12/15/16-ROW clearing, area of Str 16 through 18

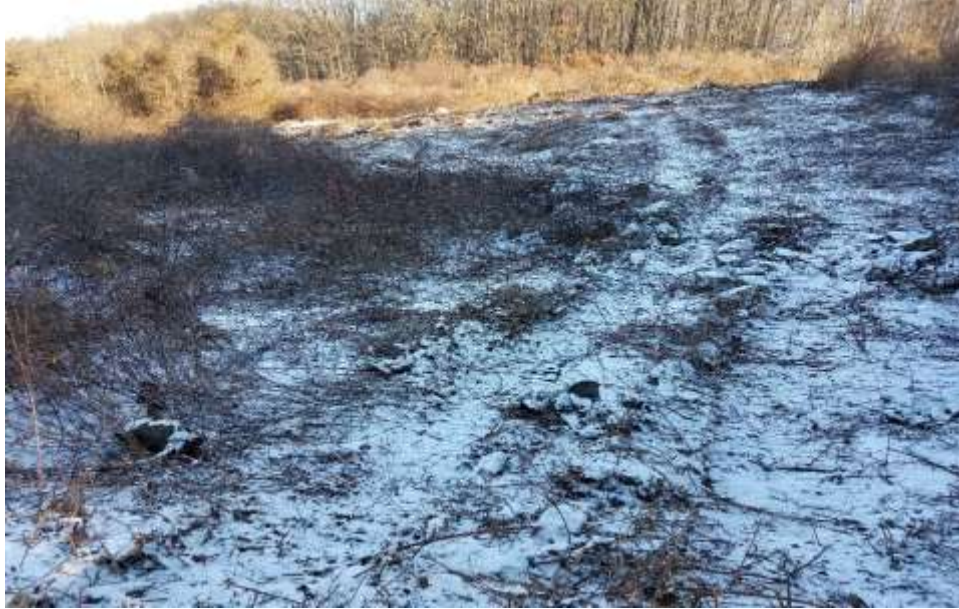
Photo #3: 12/15/16-ROW clearing, area of Str 21 through 23

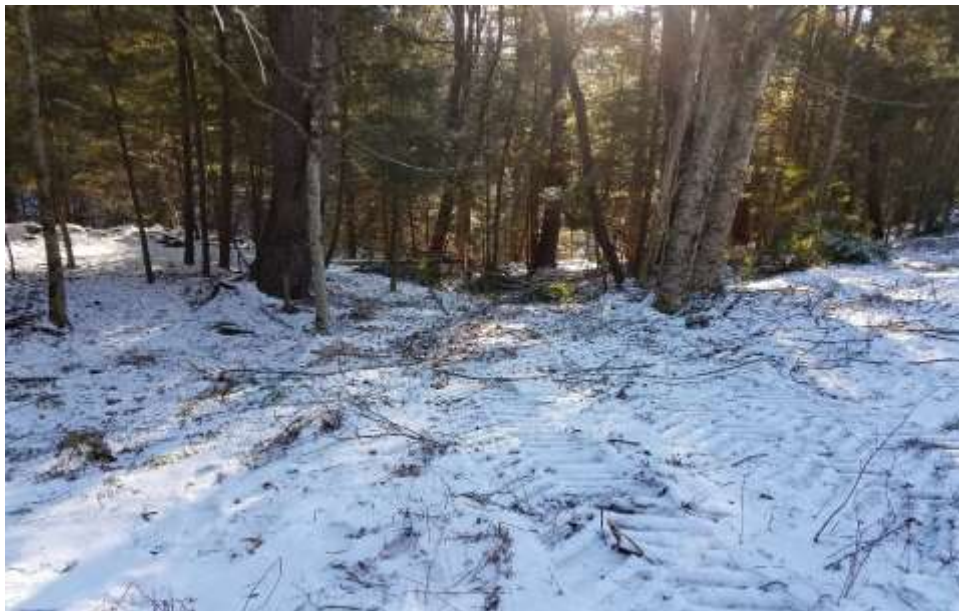
Photo #4: 12/15/16- Ground disturbance (track marks) approaching wetland W-F12

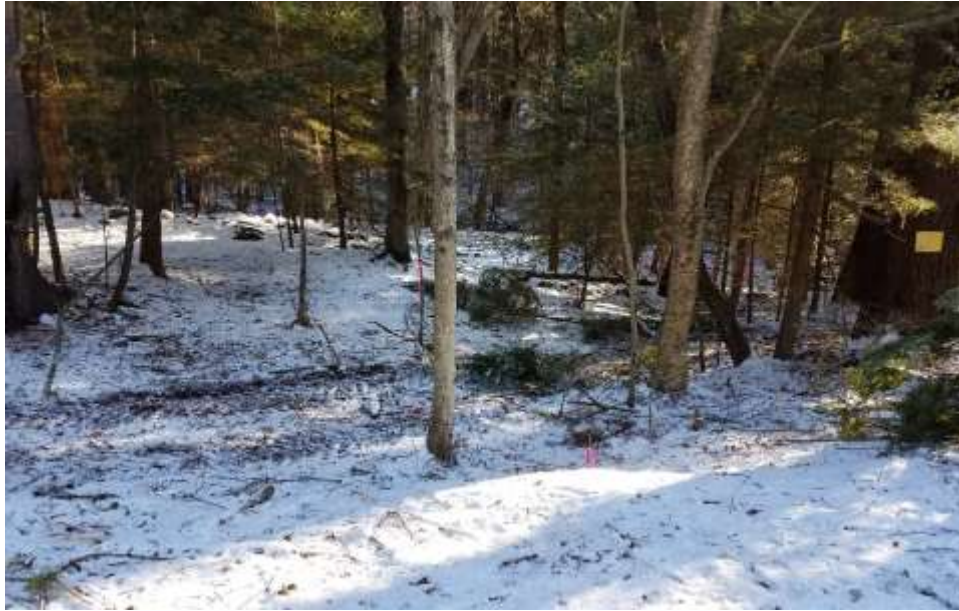
Inland Wetland and Watercourse encroachment and mitigation	Bi-Week	<p>According to Eversource representatives, Terracon had been authorized to access Str. 87 via uplands only to perform geotech surveys, and had received site-specific training on-site to that effect. (Refer to photos 5 and 6 below.)</p>		
Spills and Material Storage	Interim-Week	None observed	N/A	N/A
	Bi-Week	None observed	N/A	N/A

Photo #5:12/15/16- Ground disturbance (track marks) within wetland W-F12, area clearly flagged

Open Items from previous inspections: Ground disturbance within W-F12, restoration pending due to site conditions (snow cover).

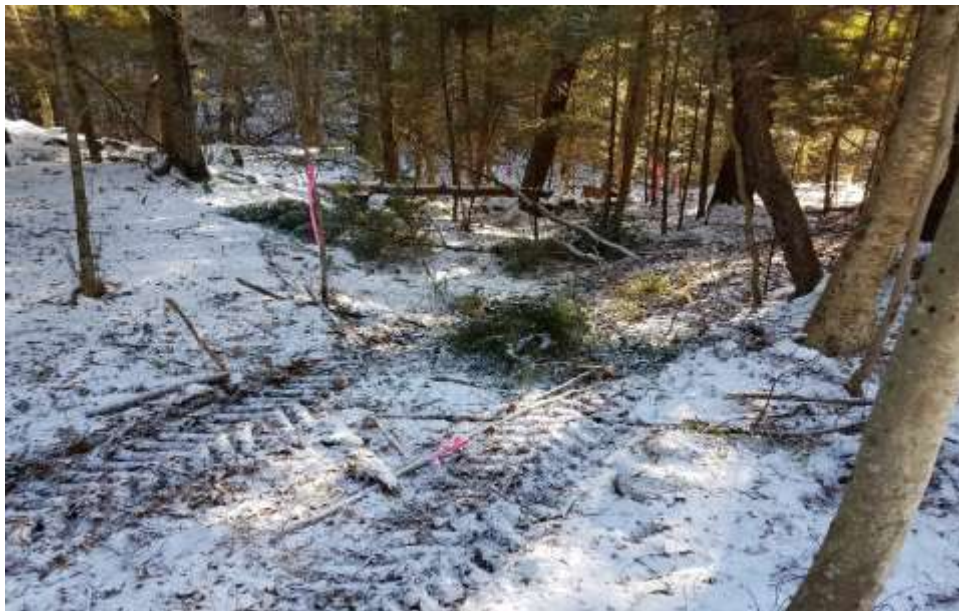
Photo #6: 12/15/16-Ground disturbance (track marks) within wetland W-F12, area clearly flagged

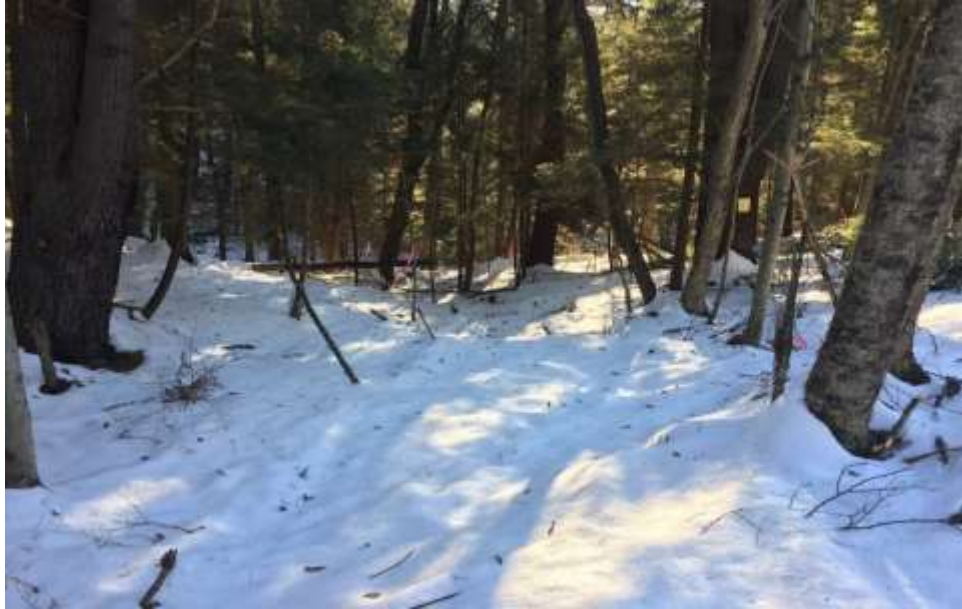
Erosion and Sedimentation Controls	Interim Week	Silt fence was placed east of Campville Substation’s proposed Expansion limits, along eastern edge of the temporary access road (Map Sheet 35). The access road extends beyond the west corner of the substation fence line (Not shown on Map sheet 35). The silt fence is properly installed and effectively placed.	No issue/s observed. Continue to monitor conditions of silt fence and surrounding ground conditions.	N/A
	Bi-Week	Campville Substation expansion area work occurring, silt fence in place and maintained.	No issue/s observed. Continue to monitor conditions of silt fence and surrounding ground conditions.	N/A
Inland Wetland and Watercourse encroachment and mitigation	Interim Week	Flagging was observed and the defined limits identifiable at the following area: W-B2, W-B3, W-B4, W-B5, W-B6, W-B7, W-B8, W-B9, W-B10, W-B11, W-F-11, W-F12, S-F-10, VP-B2-1, and VP-B4-1. During inspection of areas where Northern Clearing was performing vegetation removal in upland areas near Str87, TRC observed ground disturbance (equipment tracks) within a flagged wetland area (W-F12). The track marks were determined to have been caused by a Terracon drill rig, which apparently passed through the south end of W-F12 in a northwest to southeast direction toward the proposed location of a pull pad.	Restoration of disturbed area within W-F12. Suggest providing additional Site orientation/training (Specifically BMP’s) with Terracon personnel. Matt Davison indicated that the area would be hand raked and straw placed over the restored area for stabilization.	Status pending due to existing snow cover from snowfall event on 12/16/16. No erosion concerns at this time. See Photo #7 provided by Matt Davison (Davison Environmental).

Photo #7: Current conditions as of 12/19/16, snow cover preventing restoration activities within wetland W-F12
Photo provided by Matt Davison

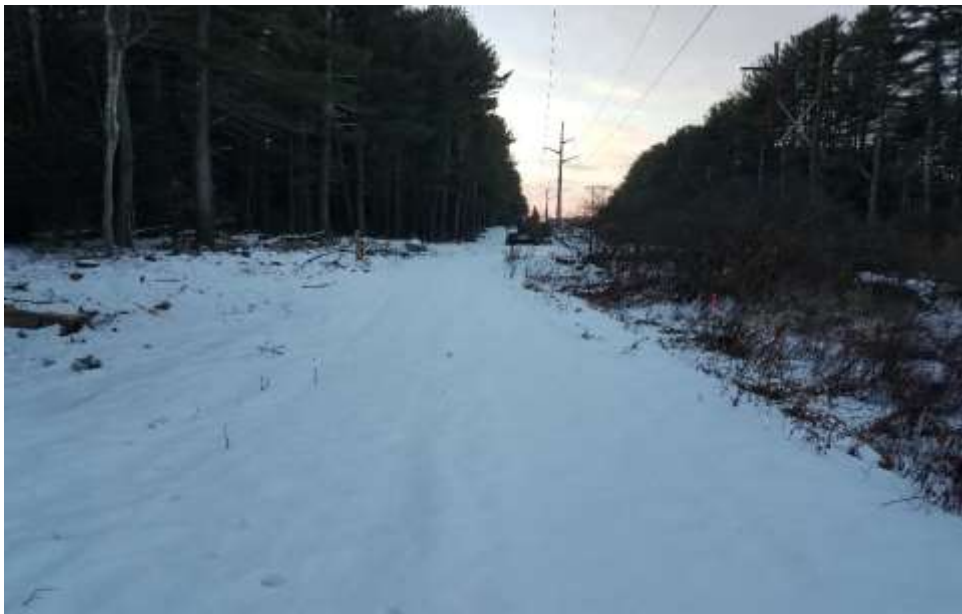
Bi-Week	ROW clearing occurred in the areas of Str92 through Str95. Clearing limits were flagged, wetlands and vernal pools were flagged and visible. The area was snow and/or ice covered at the time of this Site walk.	No issues/s observed	N/A

Photo #8: 12/21/16- ROW clearing, area of Str92 through Str95

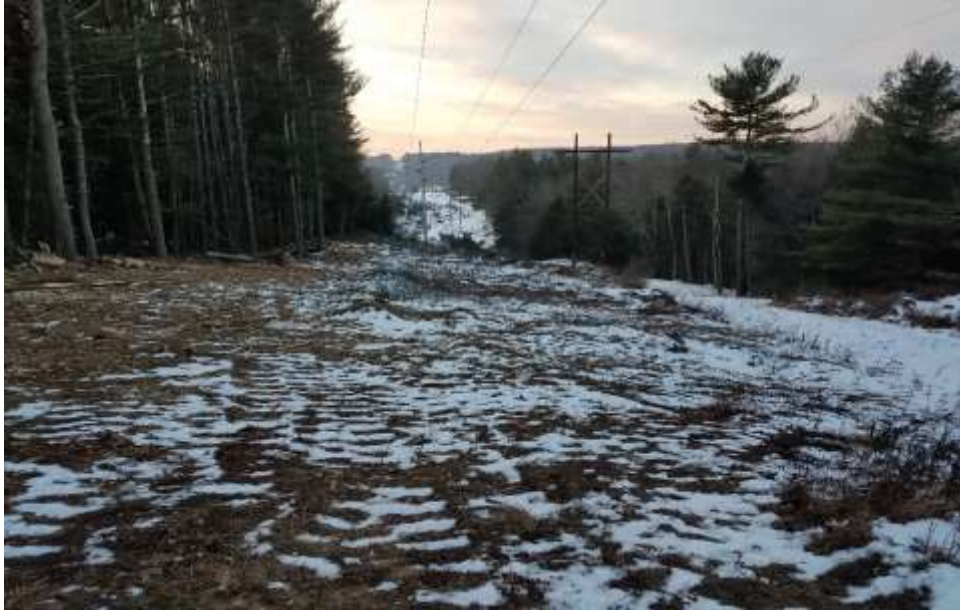
Photo #9: 12/21/16- ROW clearing, area of Str92 through Str95

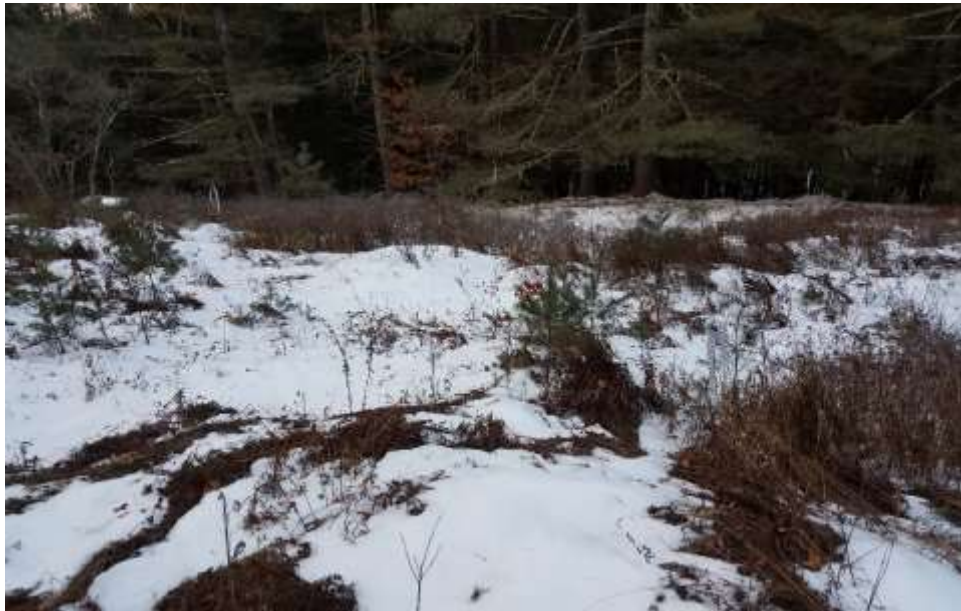
Photo #10: 12/21/16- ROW clearing, area of Str92 through Str95, flagged sensitive area
