**Subject: Docket No. 466, Frost Bridge to Campville 115-kV Project
Decision and Order Condition #4 – Independent Environmental Inspector Report**

Please find enclosed the biweekly Independent Environmental Inspector Report, Report #2, for the **January 5th** and **January 12th 2017**, inspection events for the construction of the Eversource Frost Bridge to Campville 115-kV Project.

Docket No. 466- Development and Management Plan Inspection

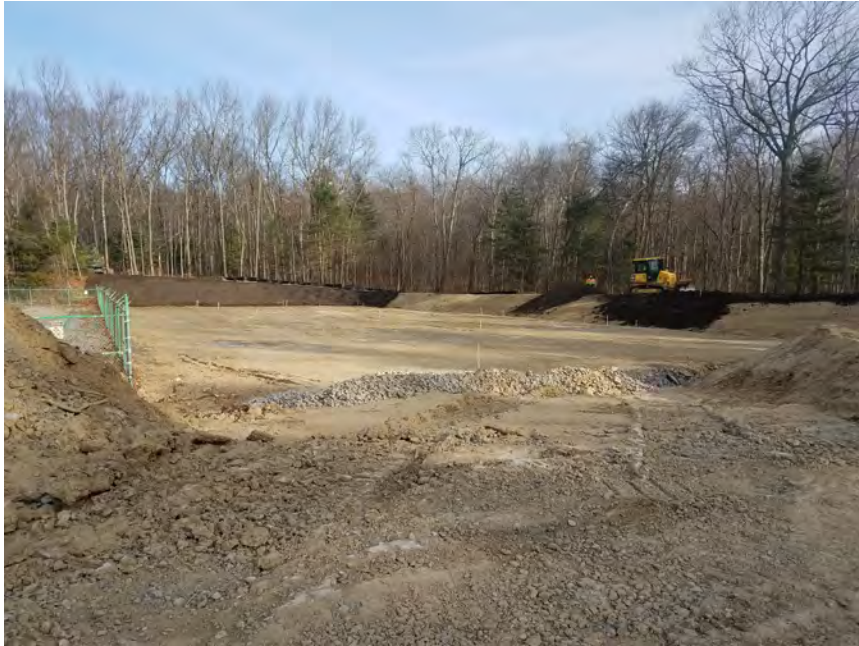
Photo #1: 1/5/17: Harwinton, Map 35, Campville Substation Expansion progress

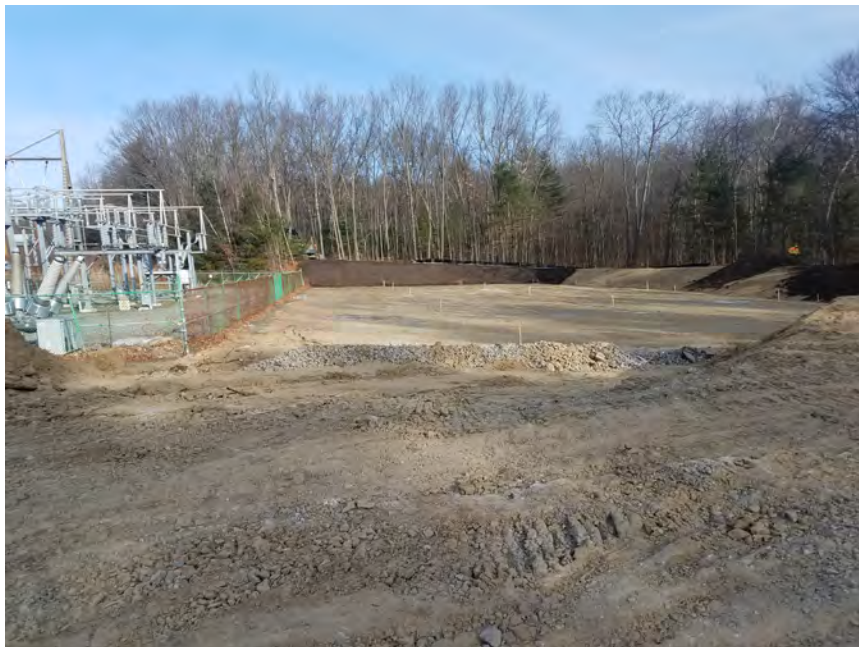
Photo #2: 1/5/2017: Harwinton, Map 35, Campville Substation Expansion progress

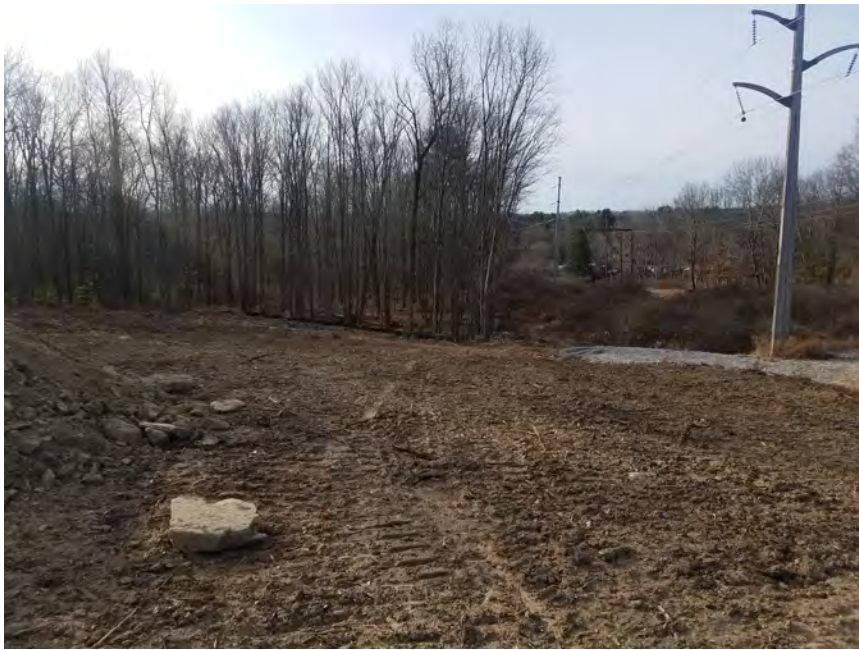
Erosion and Sedimentation Controls	Interim Week	E&S controls (silt fence) in the area of the Campville Substation were maintained and no sediment movement was observed. Silt fence was properly installed down gradient of Str97,	Continue to monitor .	N/A
	Bi-Week	N/A	N/A	N/A
Inland Wetland & Watercourse encroachment & mitigation	Interim Week	Clearing activities have maintained a 25-foot buffer zone from all sensitive areas. No impacts observed.	Continue to monitor.	N/A

Photo #3: 1/5/2017: Harwinton, Map 35, Str97, E&S controls (Silt Fence) installed at tree line

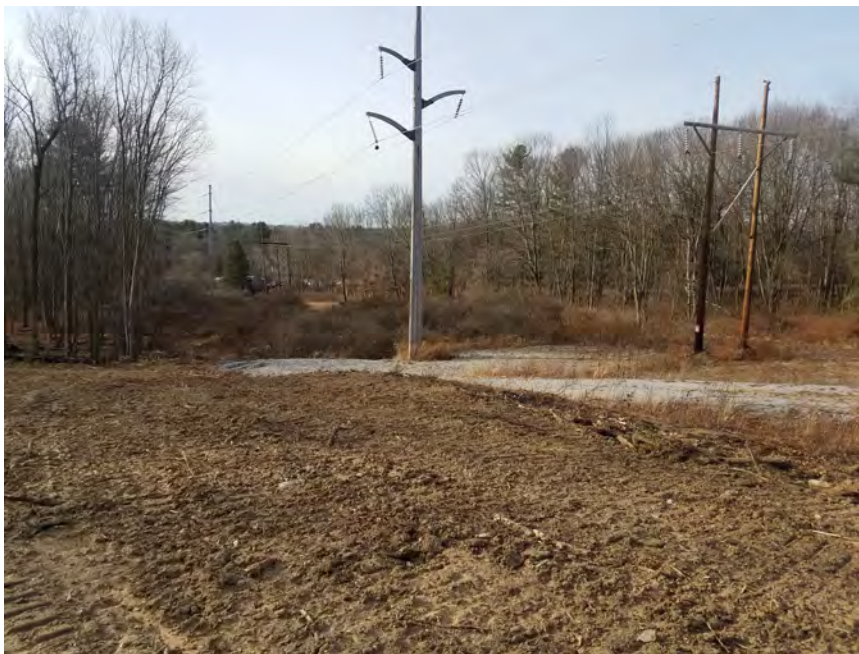
Photo #4: 1/5/2017: Harwinton, Map 35, Str97, partial access road, 25-foot buffer from wetlands W-G1

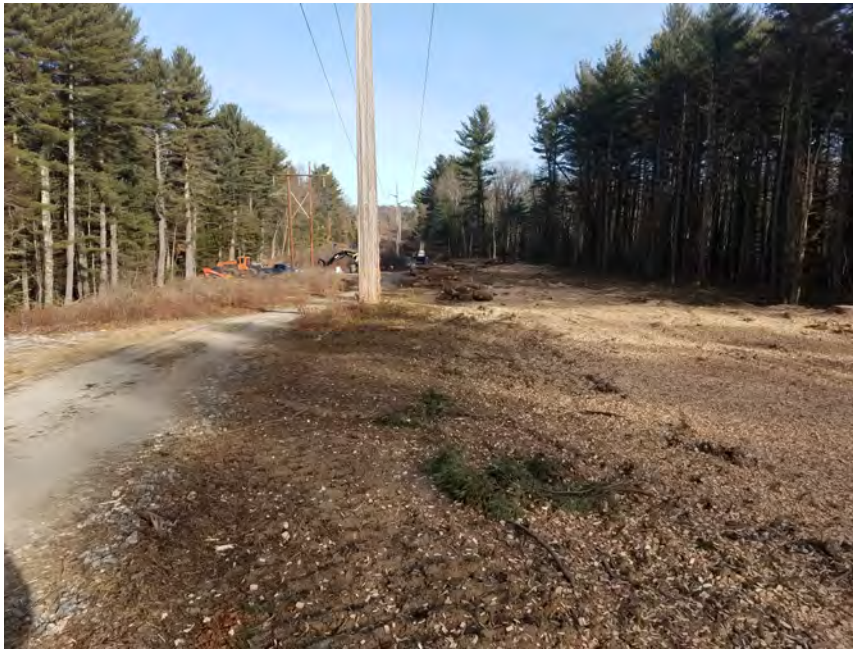
Photo #5: 1/5/2017: Harwinton, Map 33, photo taken facing north from pull pad area toward Str92, Str93 and Str94, clearing and tree removal completed, tree stumps removed, wood chips to stabilize area

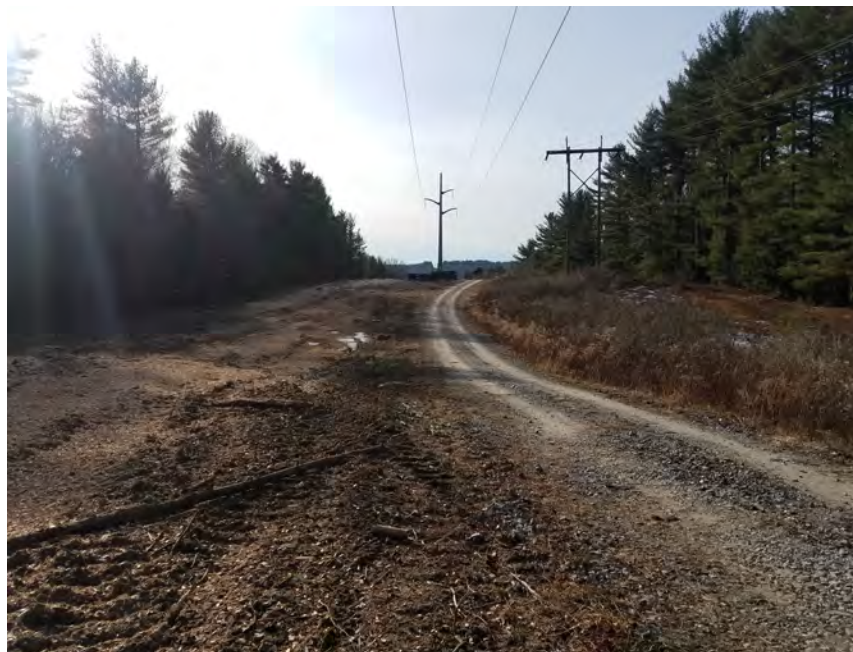
Photo #6: 1/5/2017: Harwinton, Map 33, Photo facing south from pull pad area toward Str91 and Str90, clearing and tree removal completed, wood chips to stabilize area

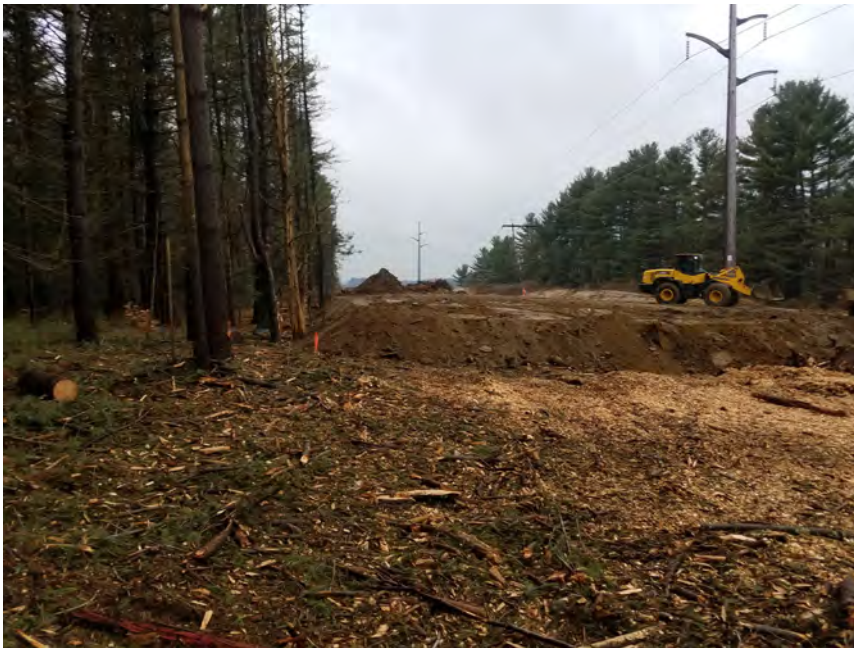
Photo #8: 1/12/2017: Harwinton, Map 33, Str90 pad construction in progress

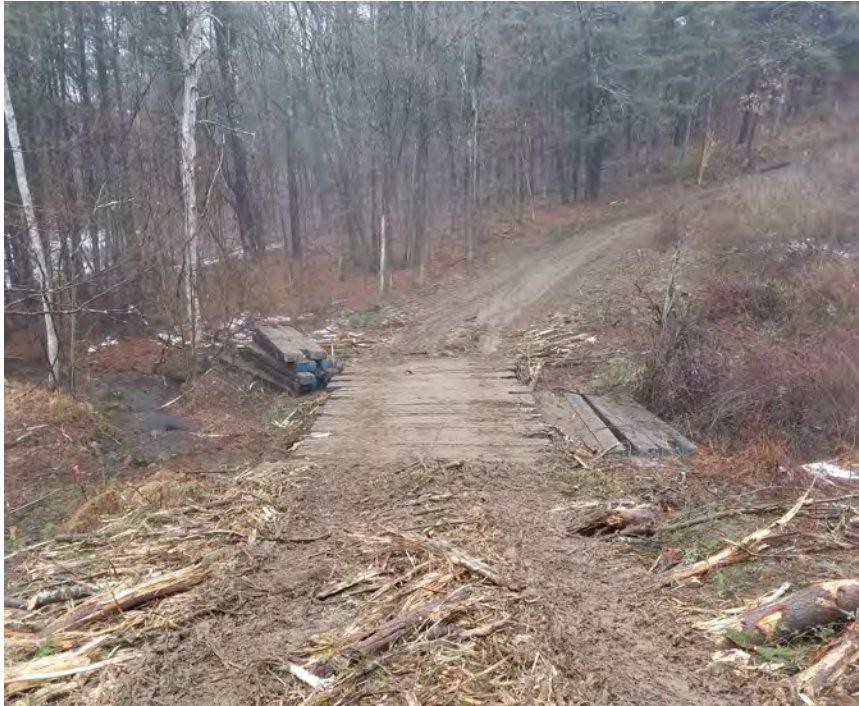
Water Crossings	Interim Week	N/A	N/A	N/A
	Bi-Week	<p>Temporary water crossing constructed in the area of the proposed culvert construction (Harwinton, Map 32), mats maintained and clear of loose debris and mud. No visible impact to stream observed.</p>	<p>Continue to maintain, and clear of excess debris and mud from tracking.</p>	N/A

Photo #9: 1/12/2017: Harwinton, Map 32, temporary water crossing, proposed culvert area

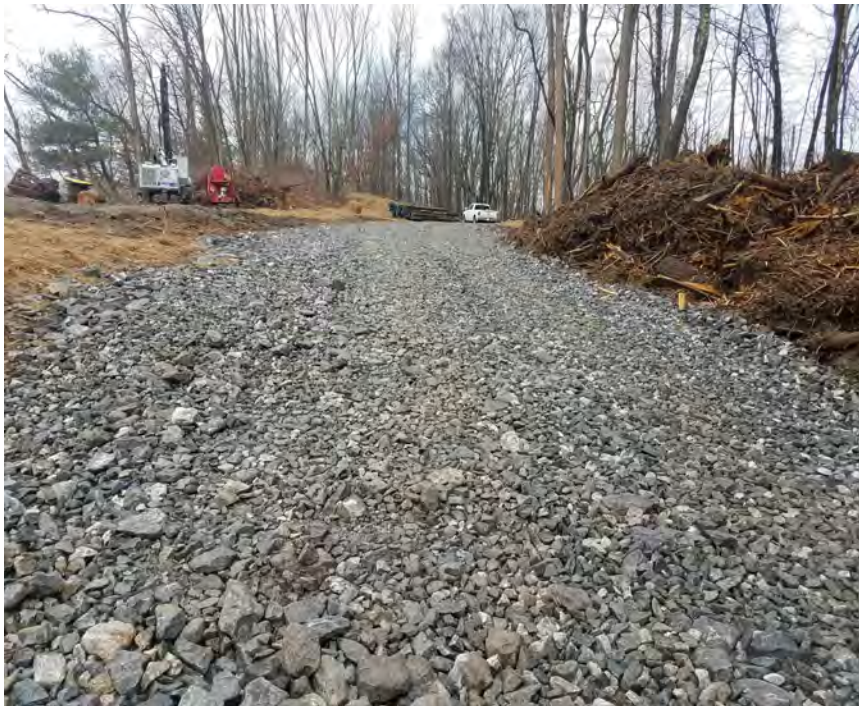
Photo #10: 1/12/2017: Litchfield, Map 31, access road construction to Str86

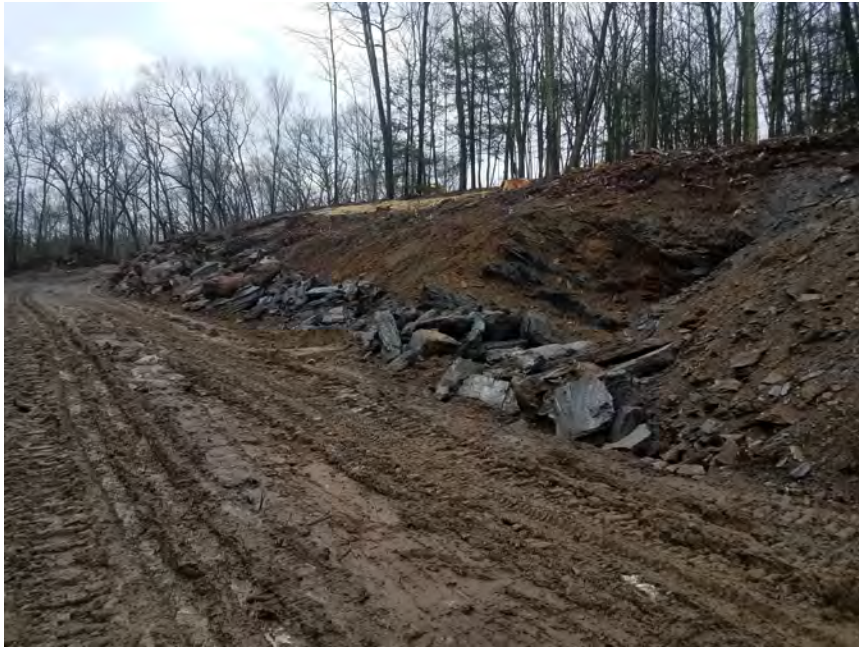
Photo #11: 1/12/2017: Litchfield, Map 31, access road construction to Str86

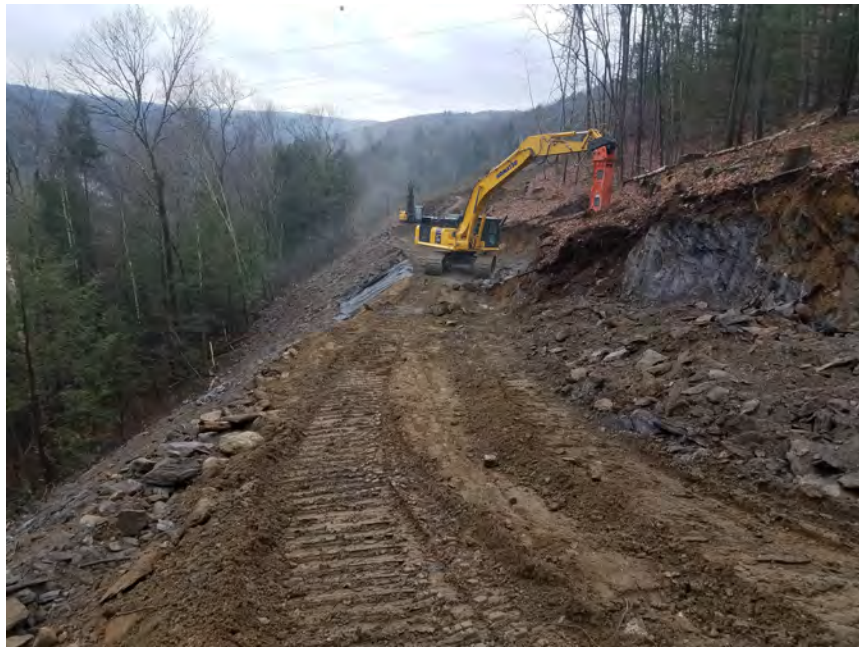
Photo #12: 1/12/2017: Litchfield, Map 31, access road construction to Str86

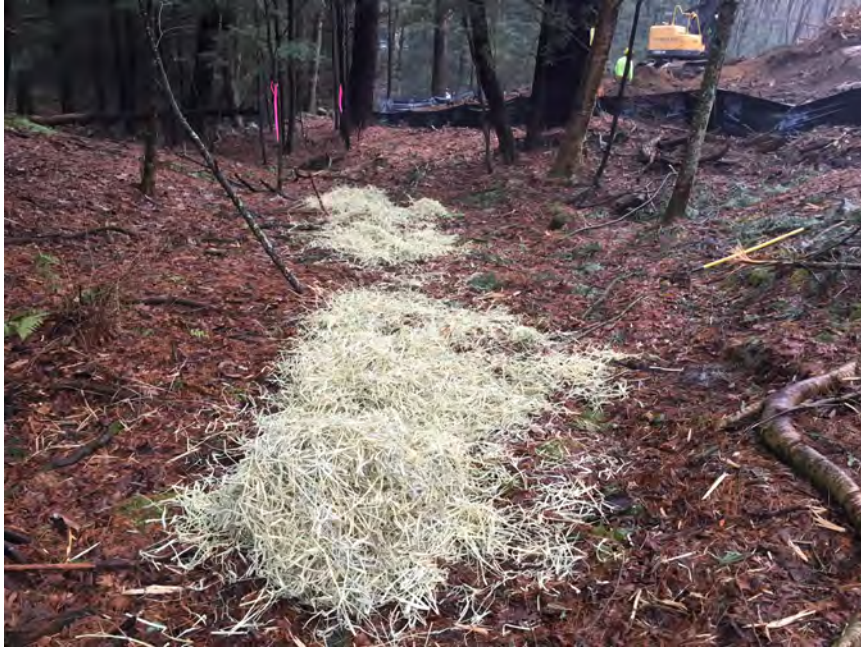
Photo #13: 1/12/2017: Harwinton, Map 32, W-F12/S-F11 ground disturbance restoration

1/12/2017: Harwinton, Map 32, Ground disturbance within W-F12, restoration performed. Drill rig track marks raked out and straw placed to stabilize area of disturbance, see attached photo #13.
