**Subject: Docket No. 466, Frost Bridge to Campville 115-kV Project  
Decision and Order Condition #4 – Independent Environmental Inspector Report**

Please find the enclosed Bi-weekly Independent Environmental Inspector Report, Report #4, for the **February 2<sup>nd</sup>** and **February 10<sup>th</sup>** 2017, inspection events for the construction of the Eversource Frost Bridge to Campville 115-kV Project.

**Docket No. 466– Development and Management Plan Inspection**

### Frost Bridge to Campville 115kV Project

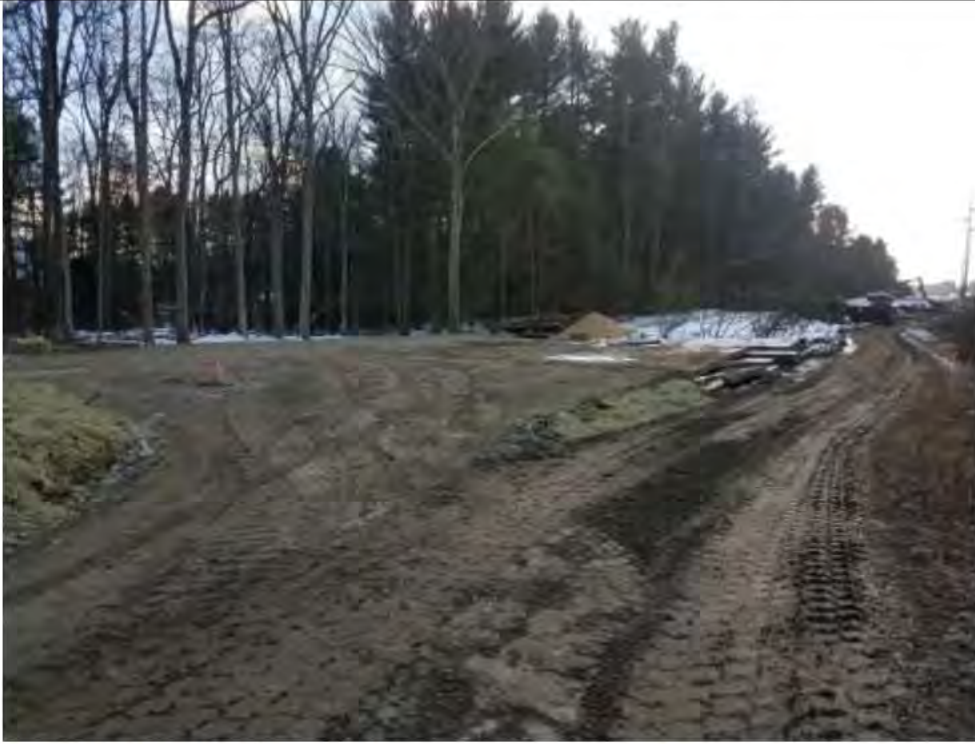
Photo 1: 2/2/2017, Harwinton: Str93 pad construction.

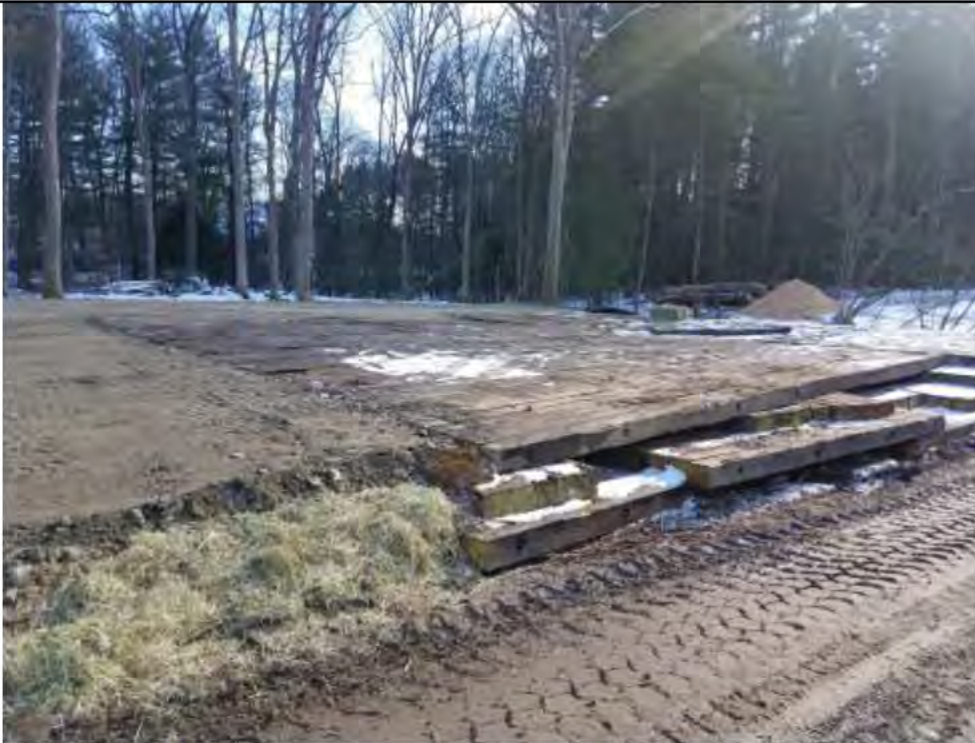
Photo 2: 2/2/2017, Harwinton: Str93 pad construction, timber mats placed over W-F14.

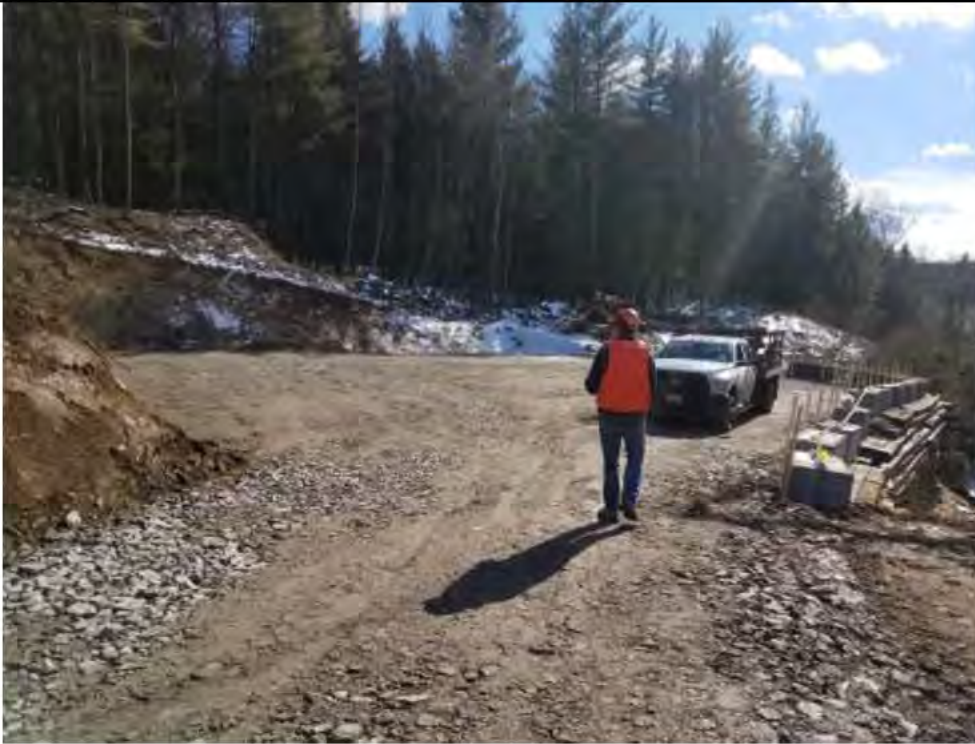
Photo 3: 2/2/2017, Harwinton: Str90 pad construction completed.

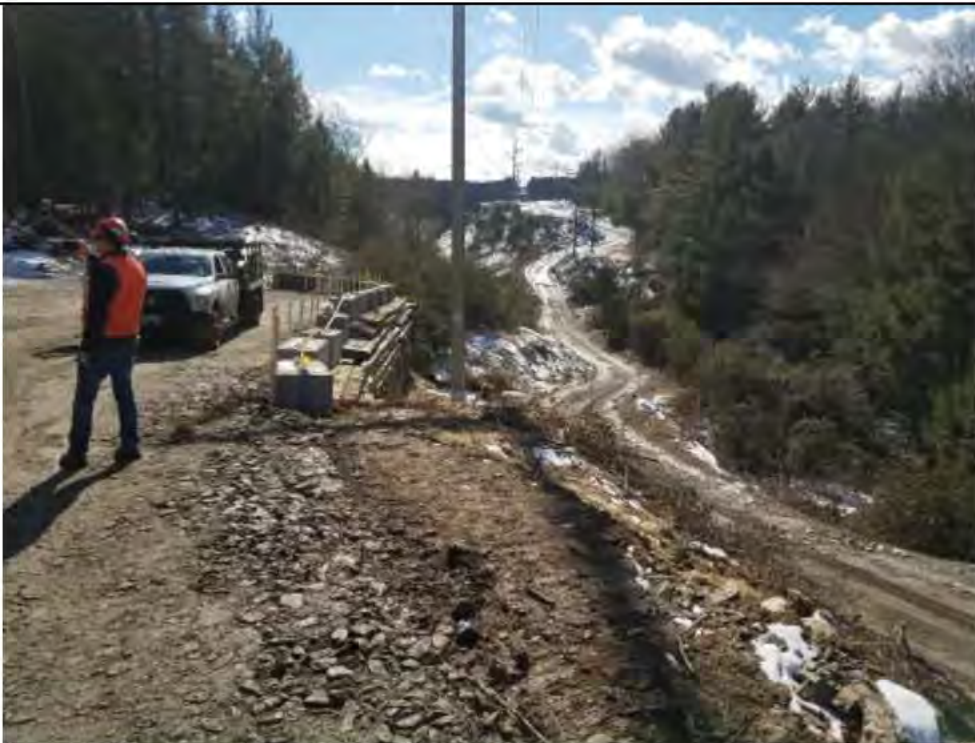
Photo 4: 2/2/2017, Harwinton: Str90 pad construction completed.

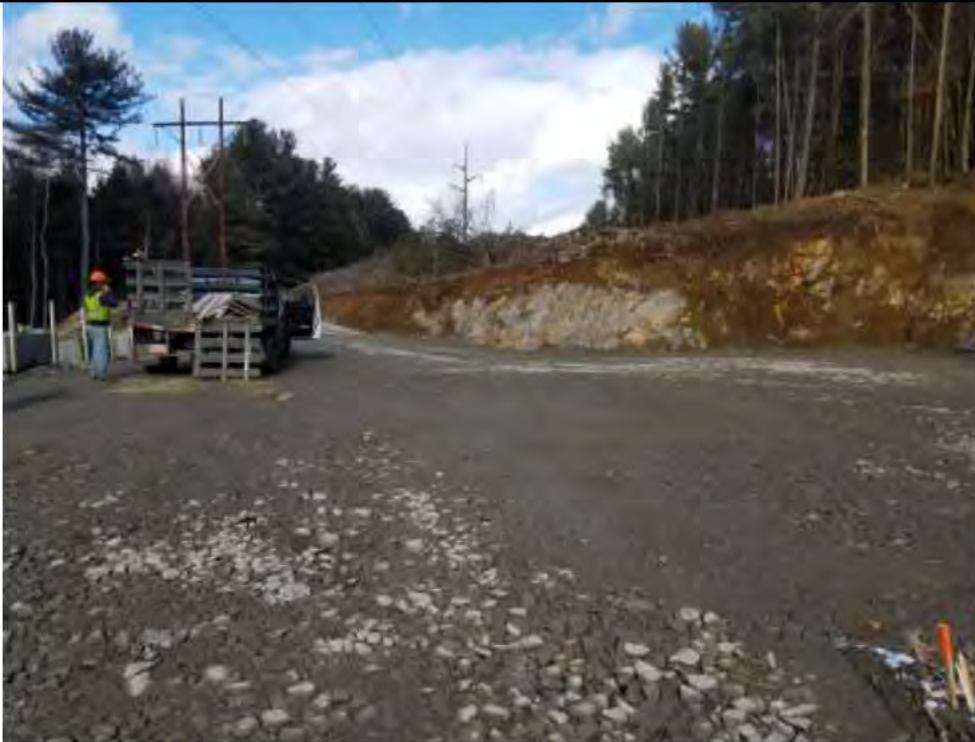
Photo 5: 2/2/2017, Harwinton: Str90 pad construction completed.

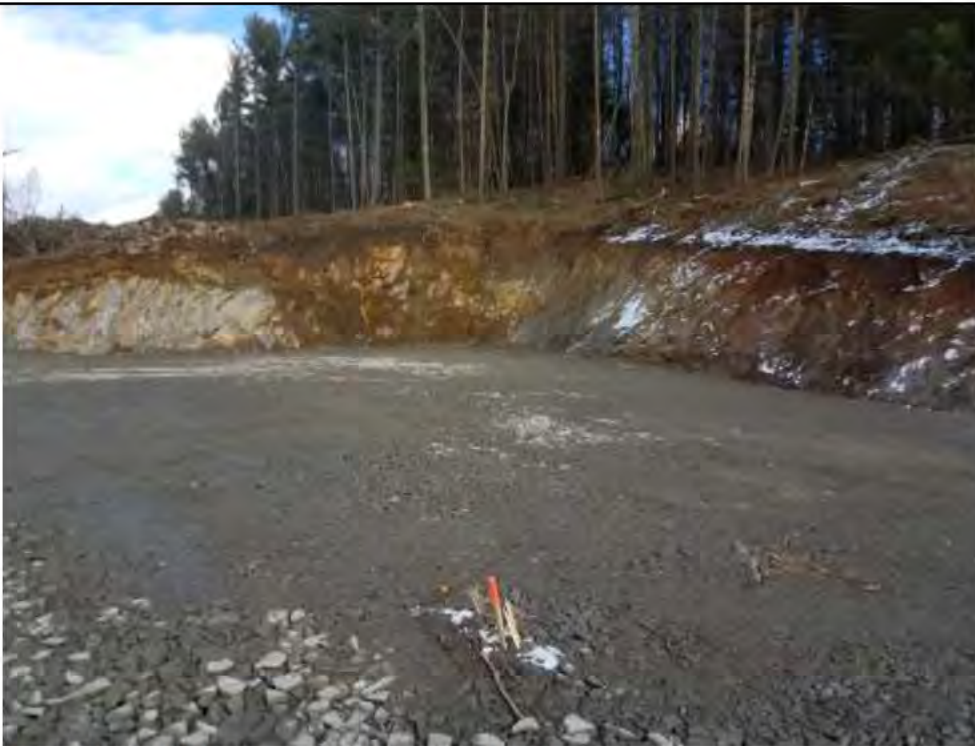
Photo 6: 2/2/2017, Harwinton: Str90 pad construction completed.

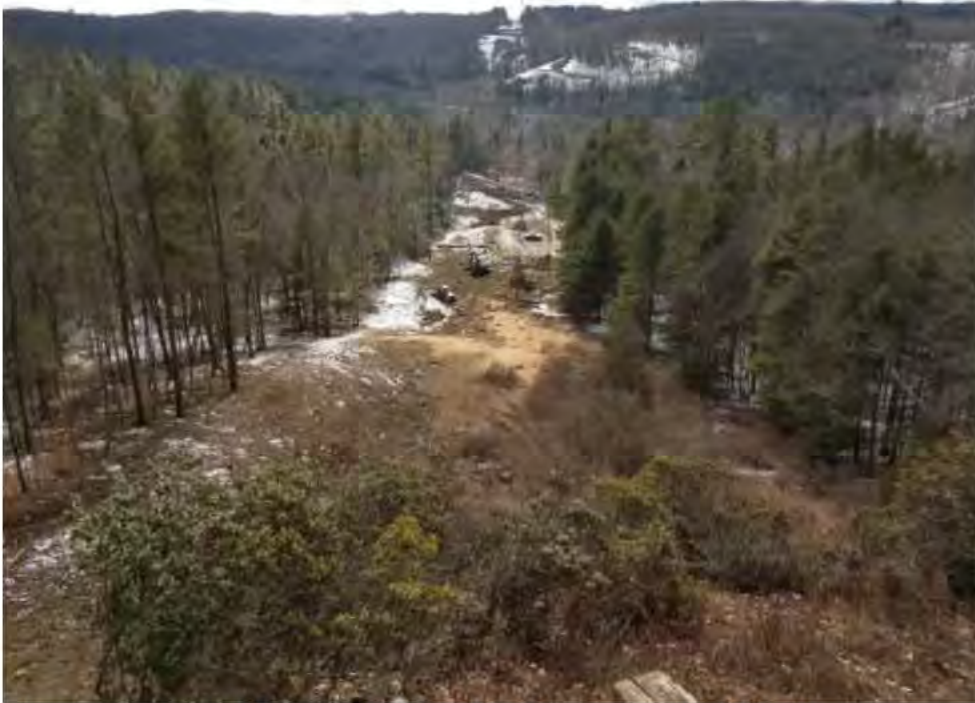
Photo 7: 2/2/2017, Harwinton: Clearing between Str88 and Str87 completed, Str87 in the distance.

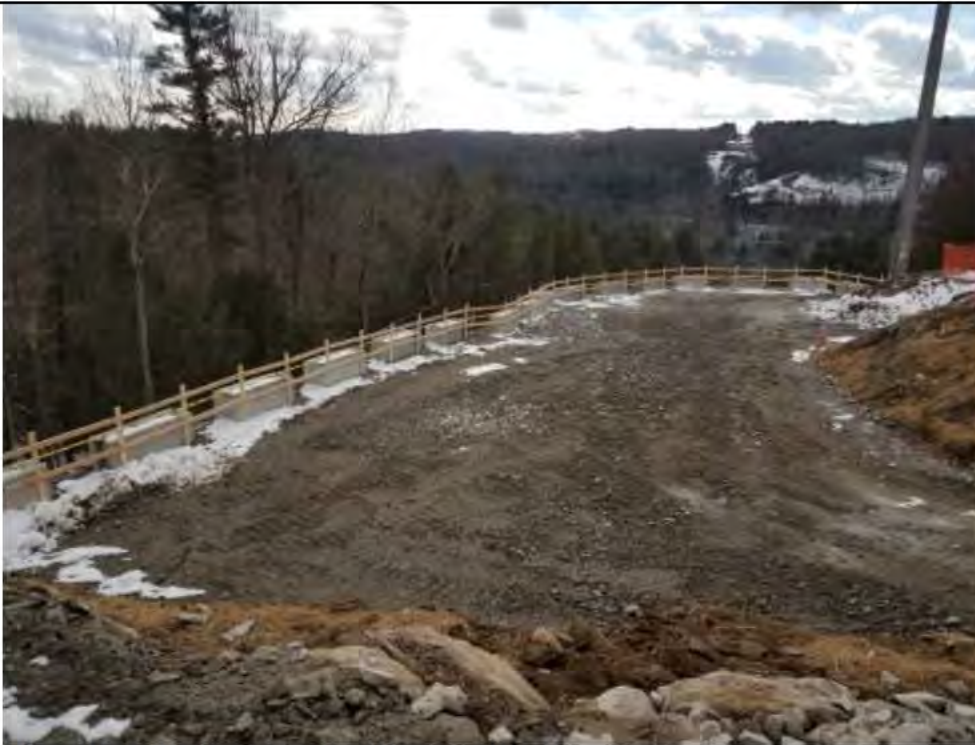
Photo 8: 2/2/2017, Harwinton: Str88 pad construction completed.

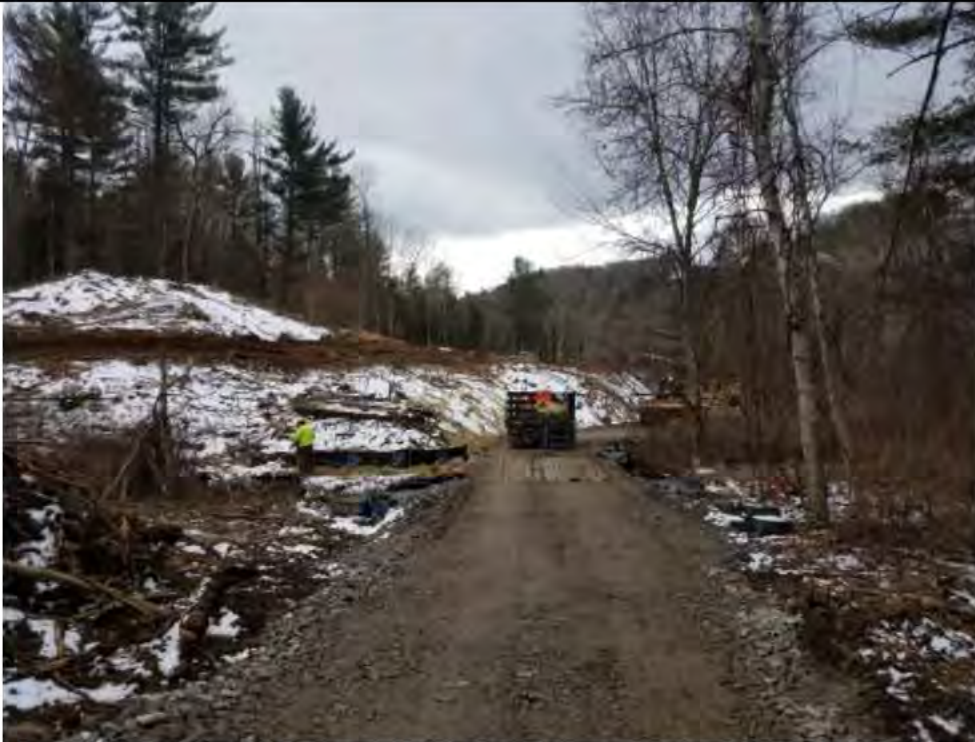
Photo 9: 2/2/2017, Harwinton: Access road construction and watercourse crossing (S-F10) completed.

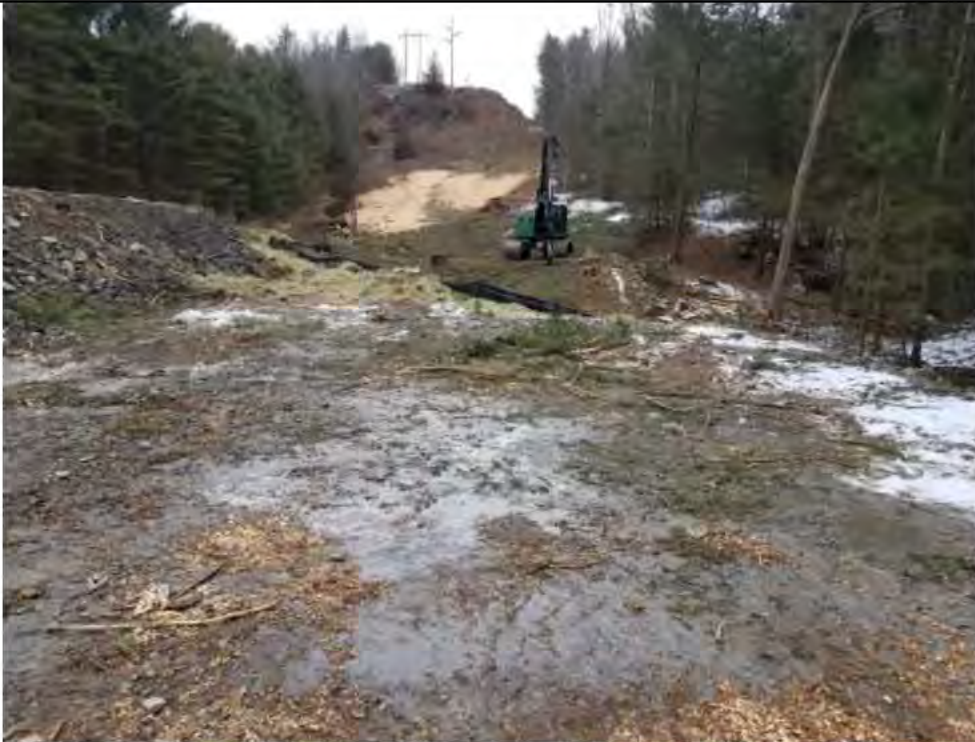
Photo 10: 2/2/2017, Harwinton: Clearing around and through W-F12 completed, equipment staged on timber mats.

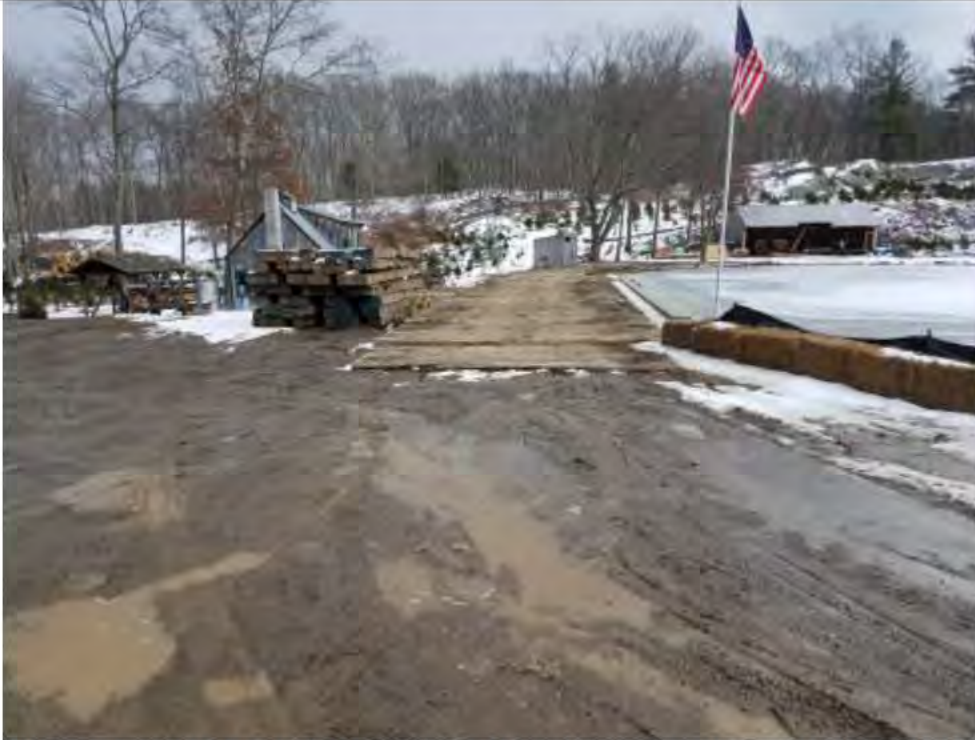
Photo 11: 2/2/2017, Thomaston: Str58 and Str59 access road maintenance, timber mats cleaned of tracked sediments.

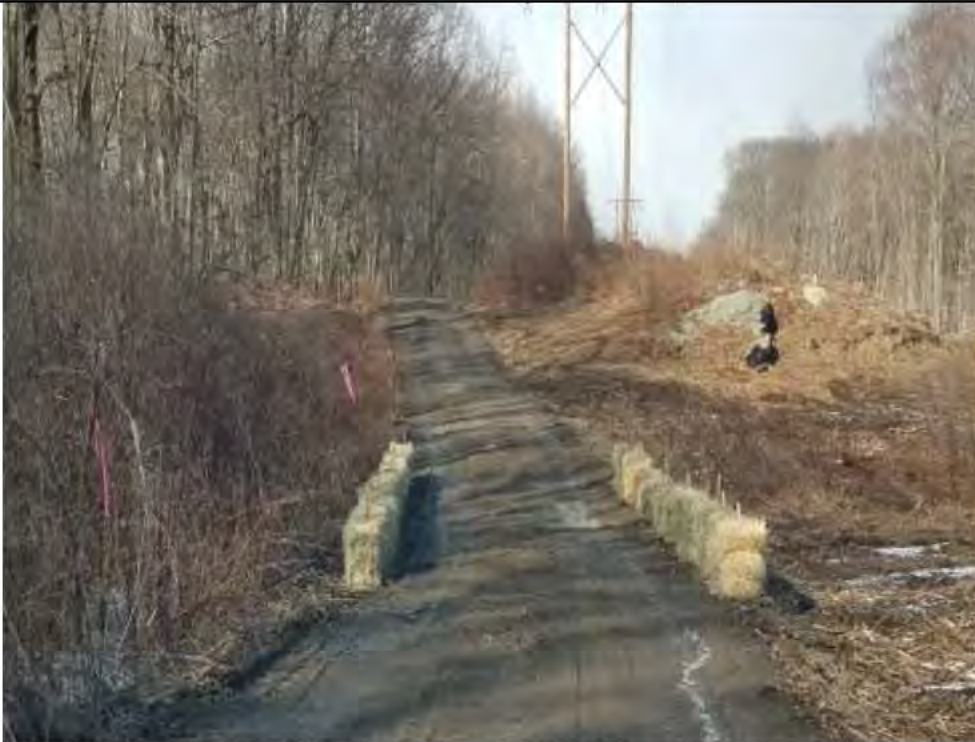
Photo 12: 2/2/2017, Watertown: Access road from Str24 through Str46 E&S controls.

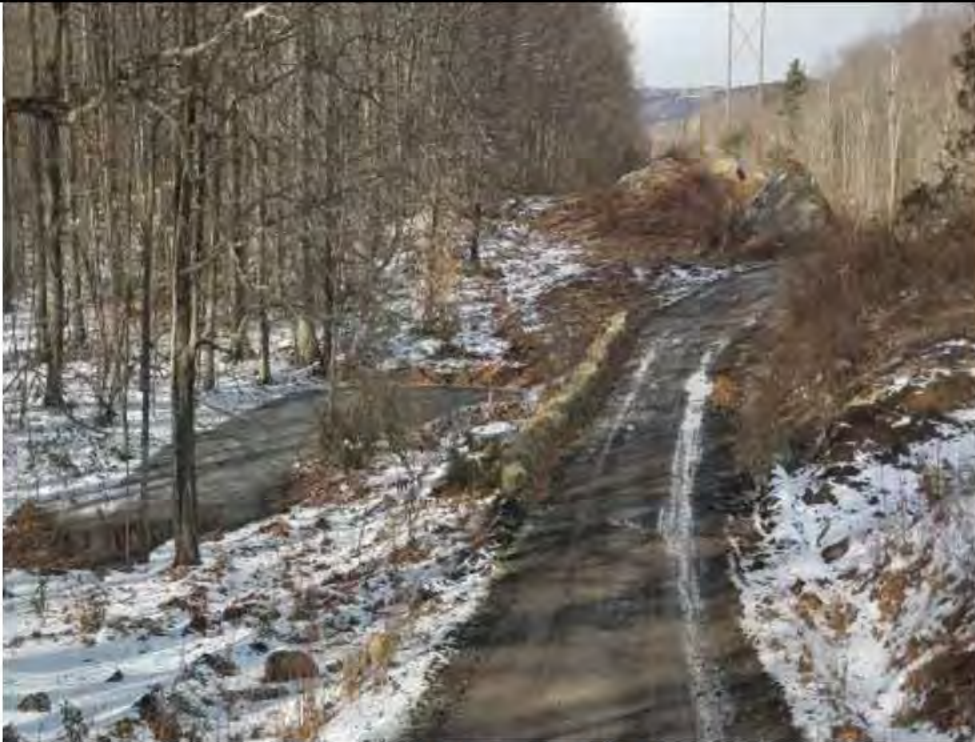
Photo 13: 2/2/2017, Watertown: Access road from Str24 through Str46 E&S controls.

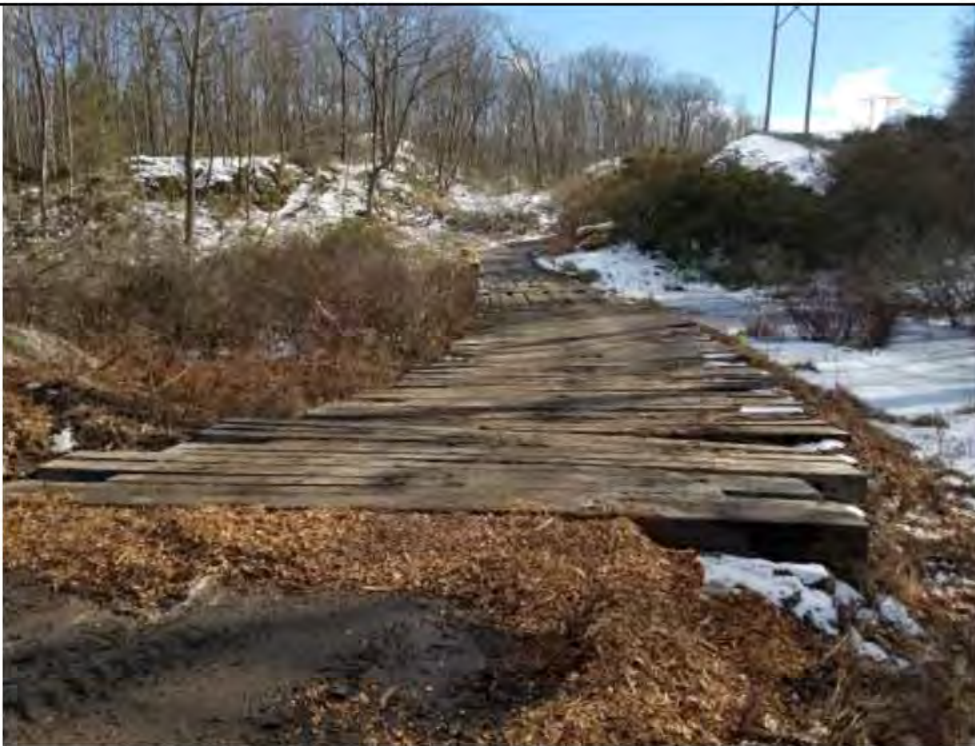
Photo 14: 2/2/2017, Watertown: Timber mats used to stabilize road at C-12-1.

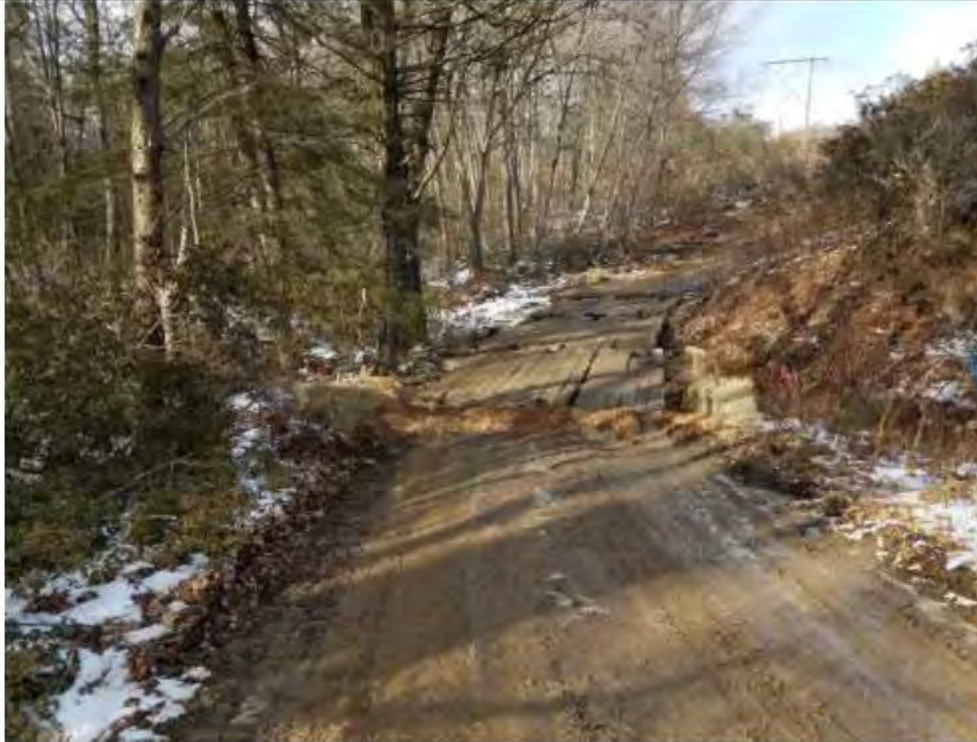
Photo 15: 2/2/2017, Watertown: Timber mats used to stabilize road at C-14.

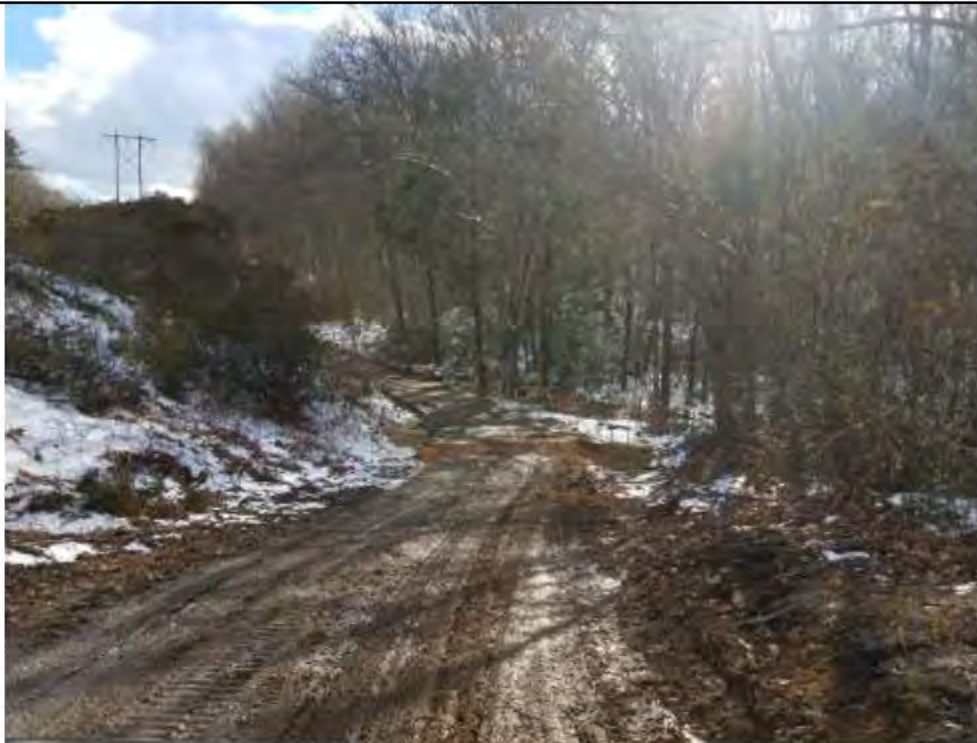
Photo 16: 2/2/2017, Watertown: Access road maintenance performed.

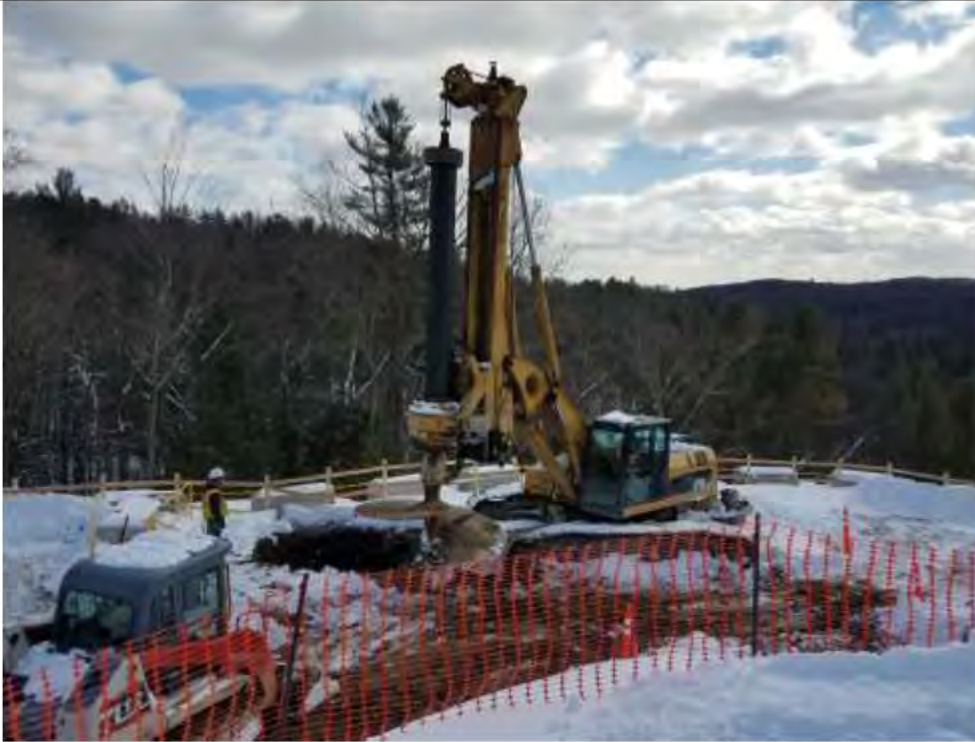
Photo 17: 2/10/2017, Harwinton: Str88 Pad drilling.

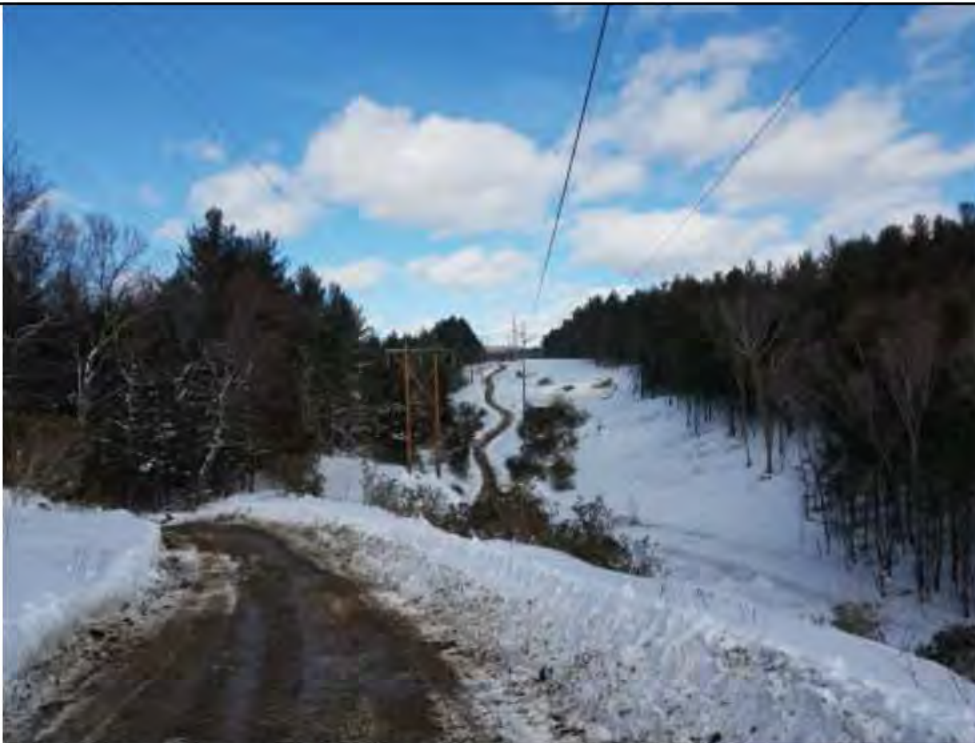
Photo 18: 2/10/2017, Harwinton: Access road snow clearing.

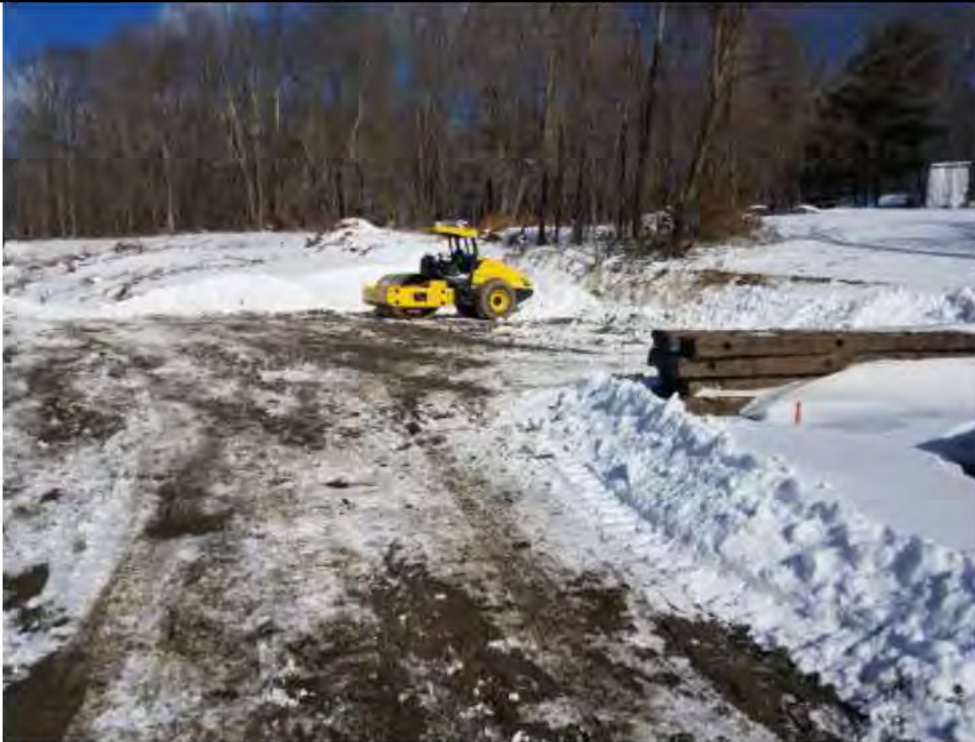
Photo 19: 2/10/2017, Litchfield: Str74 pad and access road snow clearing.
