**Subject: Docket No. 466, Frost Bridge to Campville 115-kV Project
Decision and Order Condition #4 – Independent Environmental Inspector Report**

Please find the enclosed Biweekly Independent Environmental Inspector Report, Report #6, for the **March 3rd** and **March 10th 2017**, inspection events for the construction of the Eversource Frost Bridge to Campville 115-kV Project.

Docket No. 466- Development and Management Plan Inspection

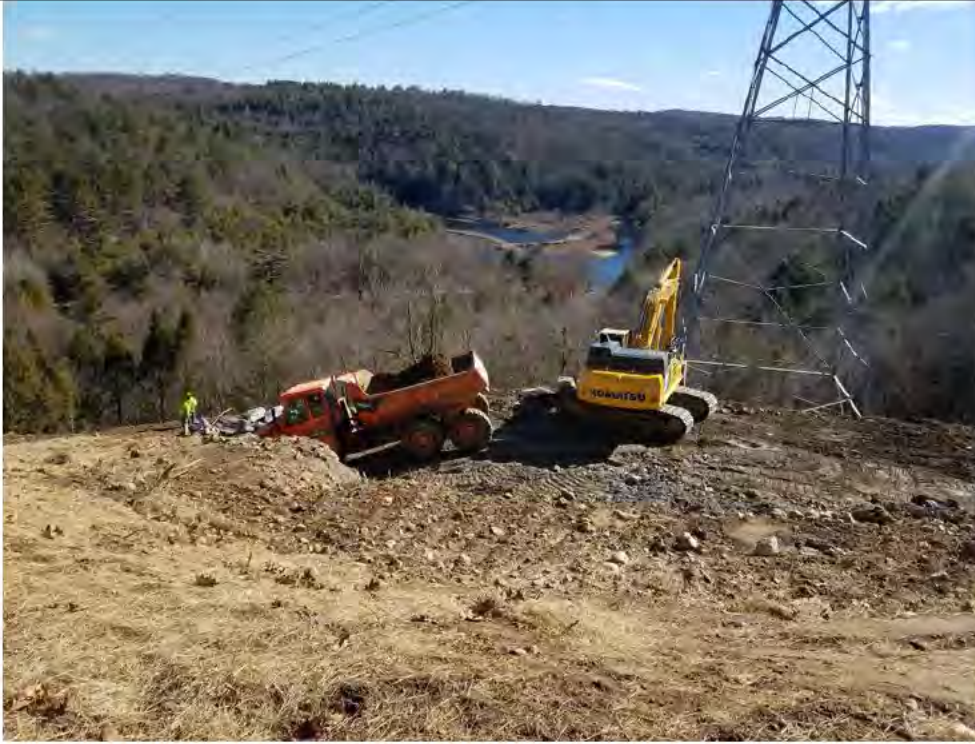
Photo 1: 3/3/2017, Litchfield: Map 31, Pad and access road construction at Str86, Str3171, and Str3231.

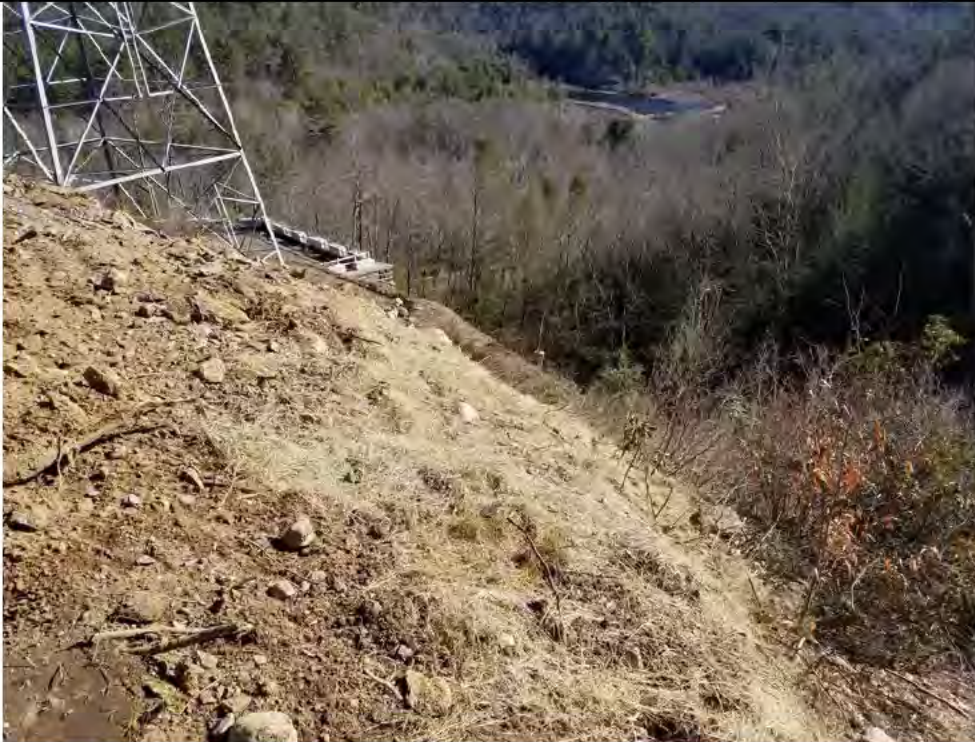
Erosion and Sedimentation Controls	Interim Week	Maintained and functioning (Site wide), and at the time of this inspection blown straw had been placed on south and east facing slopes in the area of Str86, Str3171, Str3231(Map 31).	Monitor and control surface water flow in work areas, divert flow upland of stand alone E&S controls wherever possible. Slope stabilization measures in the area of Str86/Str3171/ Str3231, be monitored closely during rain events to ensure surface water flow is controlled and slope stabilization maintained.	N/A
	Bi-Week	All E&S controls observed during this site visit were installed according to BMPs, maintained, and functioning. Addition of silt fencing in the area of CP-C10-1 installed according to BMPs.	N/A	N/A
Inland Wetland & Watercourse encroachment & mitigation	Interim Week	Timber mat installations (temporary access roads and temporary structure pads) in wetland areas are in accordance with the BMPs as outlined in the D&M.	Continue to follow these procedures. In the area of Str95 and W-F15, exclusion fencing needs to be placed around the timber mat work pad to prevent turtle access according to the D&M plan notes (Map 35).	N/A

Photo 2: 3/3/2017, Litchfield: Map 31, south slopes at Str86, Str3171, and Str3231.

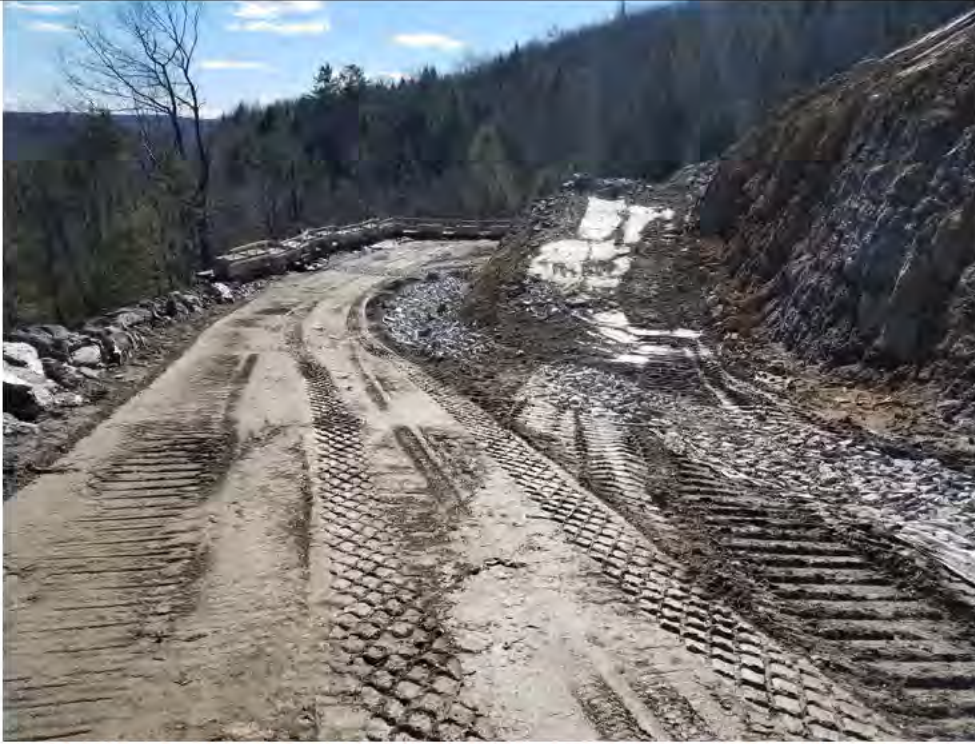
Photo 3: 3/3/2017, Litchfield: Map 31, Pad and access road construction at Str86, Str3171, and Str3231.

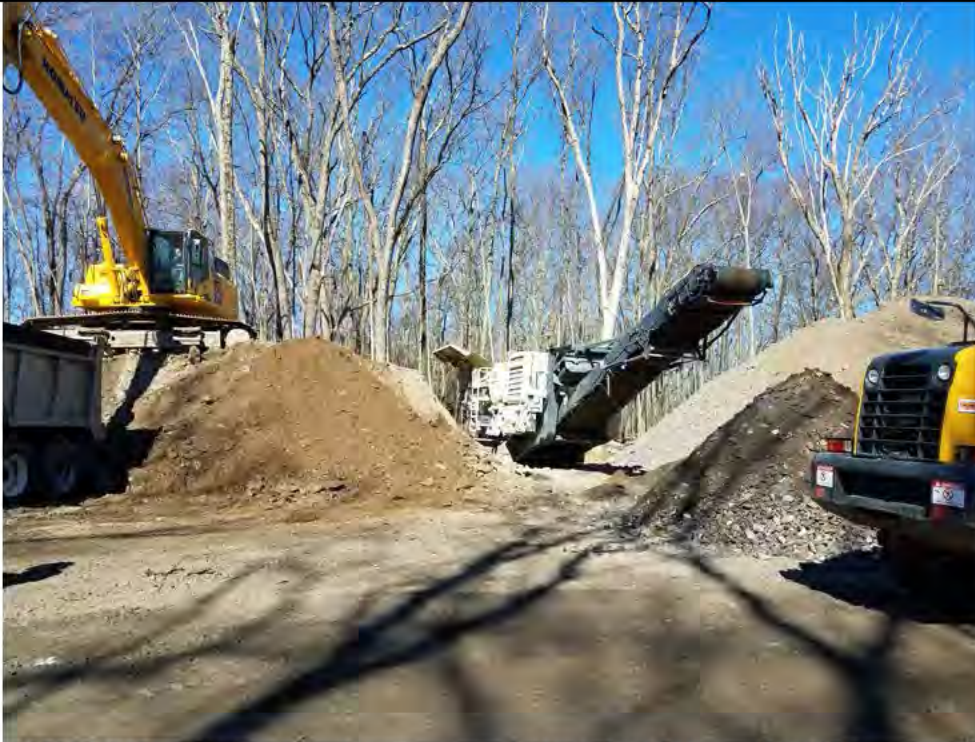
Photo 4: 3/3/2017, Litchfield: Map 31, Rock crushing process at Str86, Str3171, and Str3231.

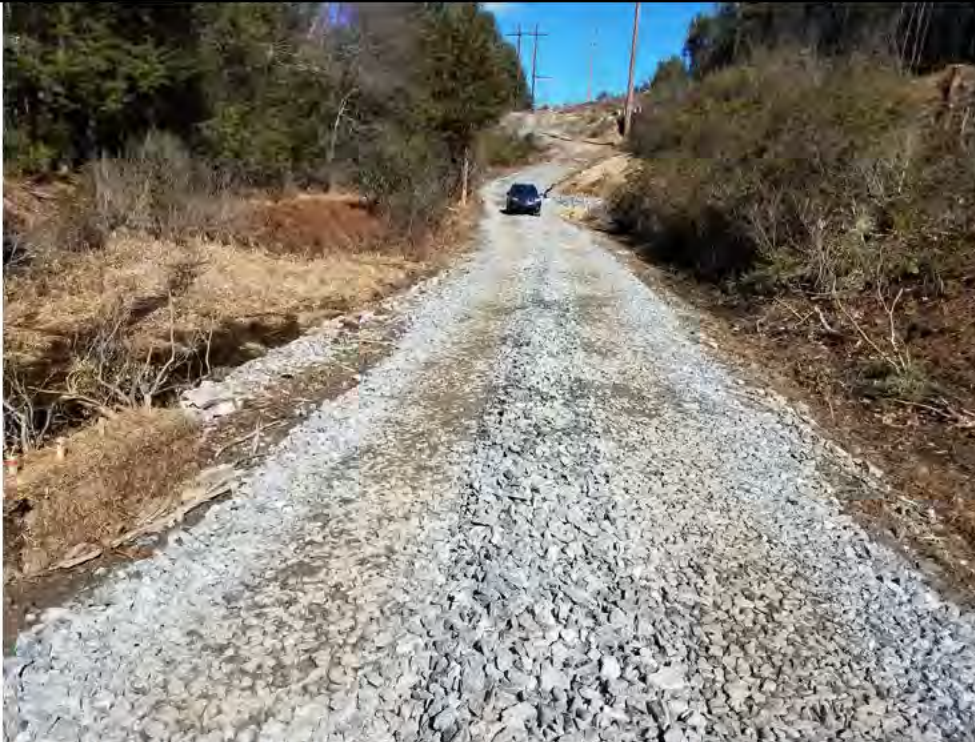
Photo 5: 3/3/2017, Harwinton: Map 32-33, Str88 access road improvements (grading and gravel placement).

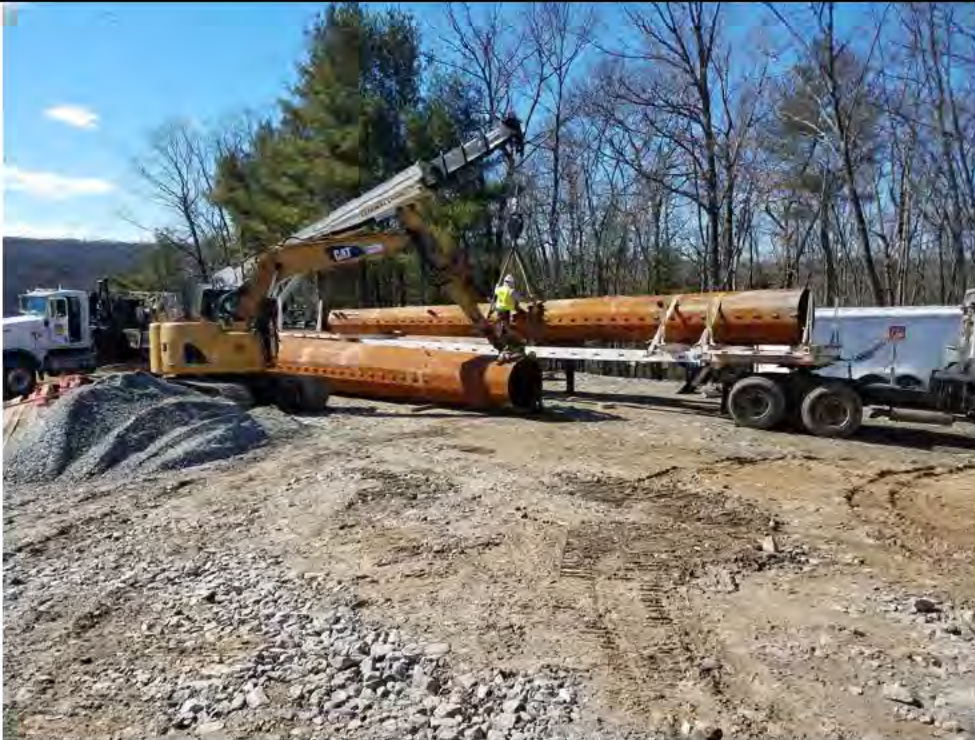
Photo 6: 3/3/2017, Harwinton: Map 32-33, Str88 delivery of typical structures pieces (Vertical Deadend).

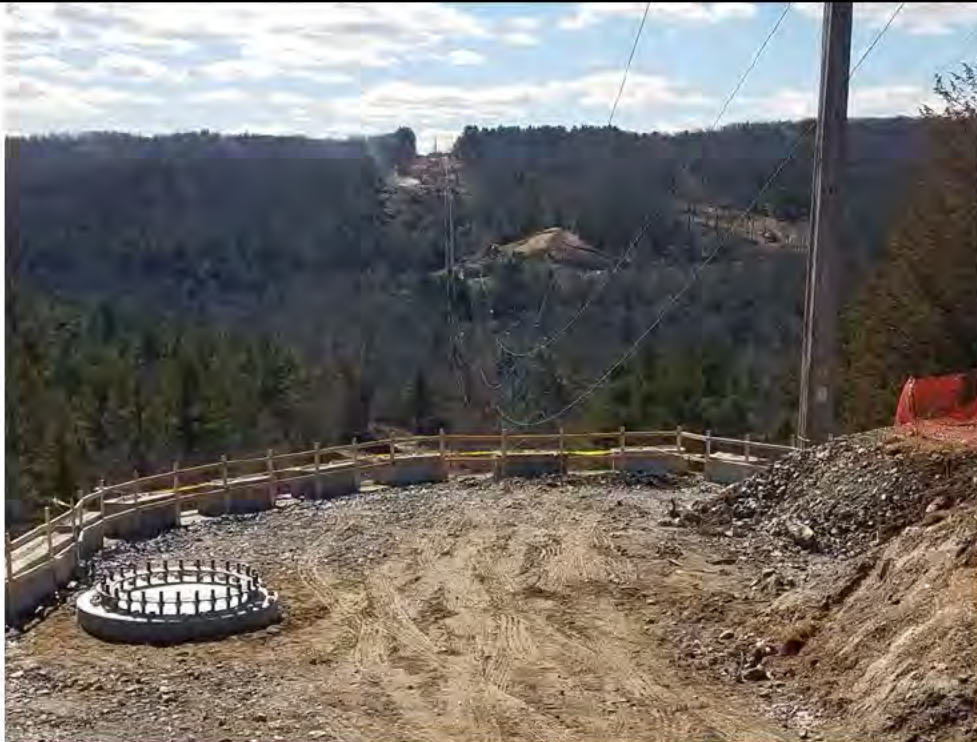
Photo 7: 3/3/2017, Harwinton: Map 32-33, finished Str88 pad and drilled shaft foundation.

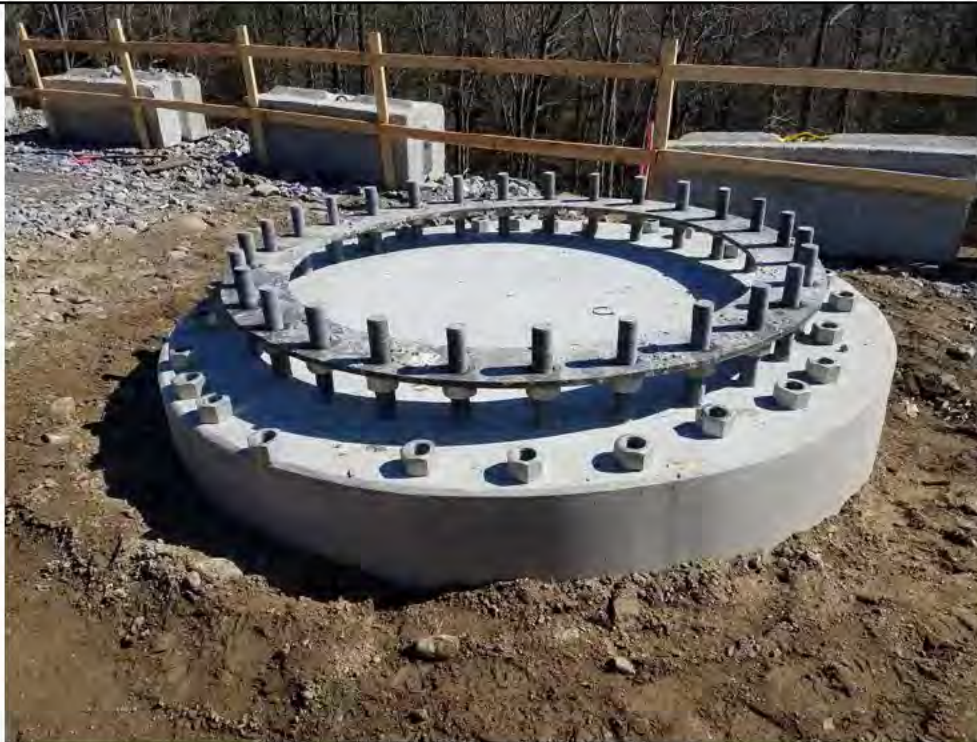
Photo 8: 3/3/2017, Harwinton: Map 32-33, Str88 finished drilled shaft foundation.

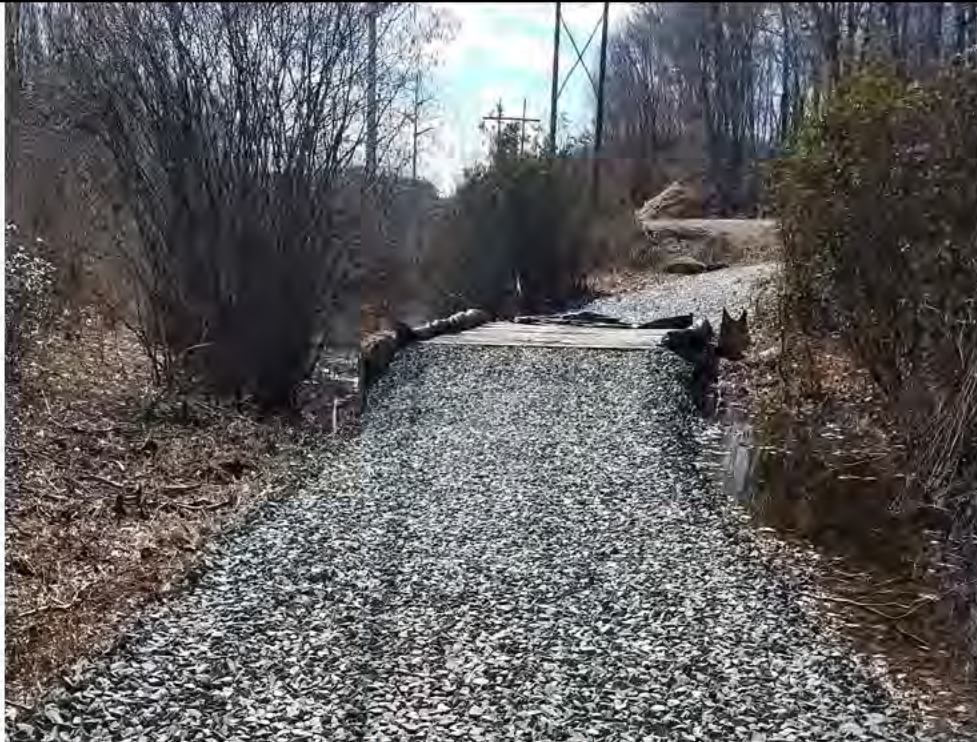
Photo 9: 3/3/2017, Litchfield: Map 25-26, Hard bottom crossing at S-E3

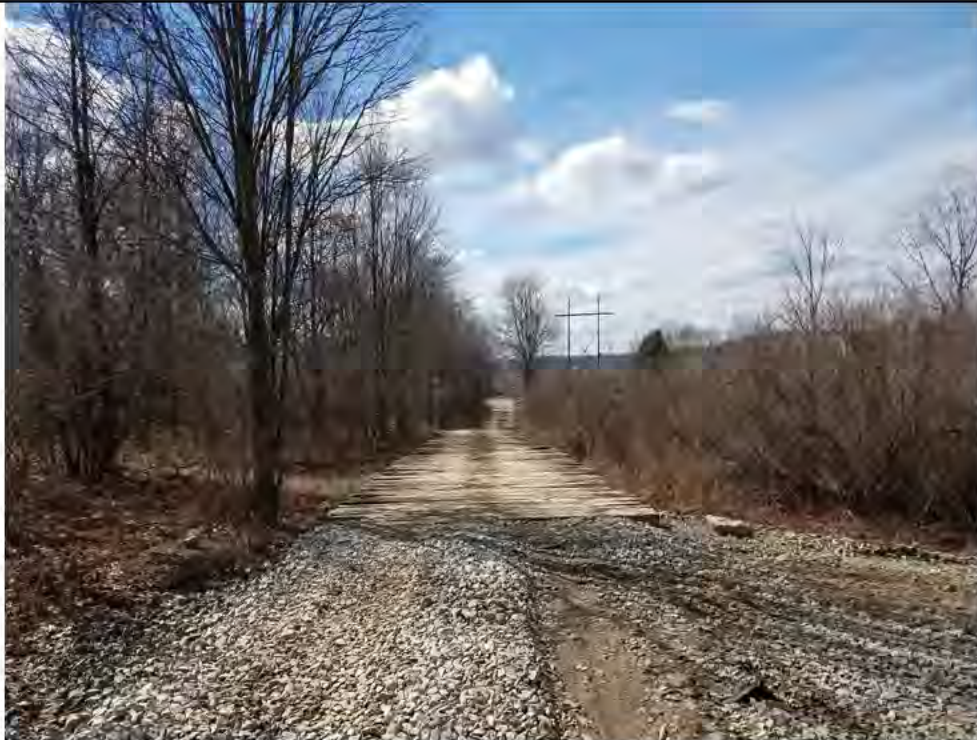
Photo 10: 3/3/2017, Watertown: Maps 09A-11, Access road improvements (timber matted), area of W-C1A and W-C2A.

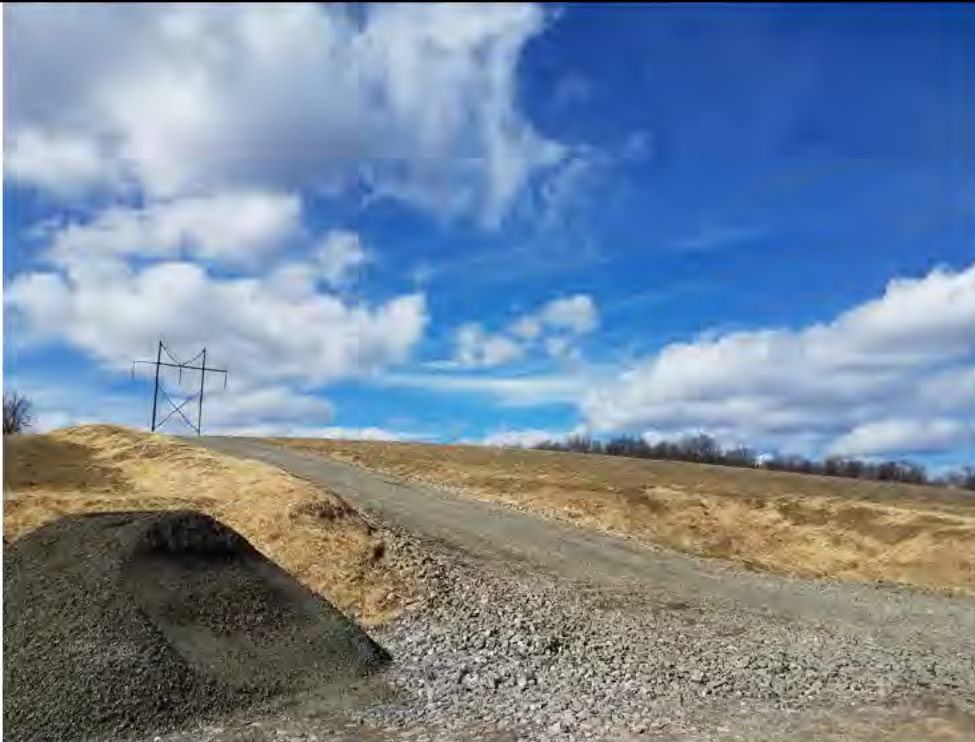
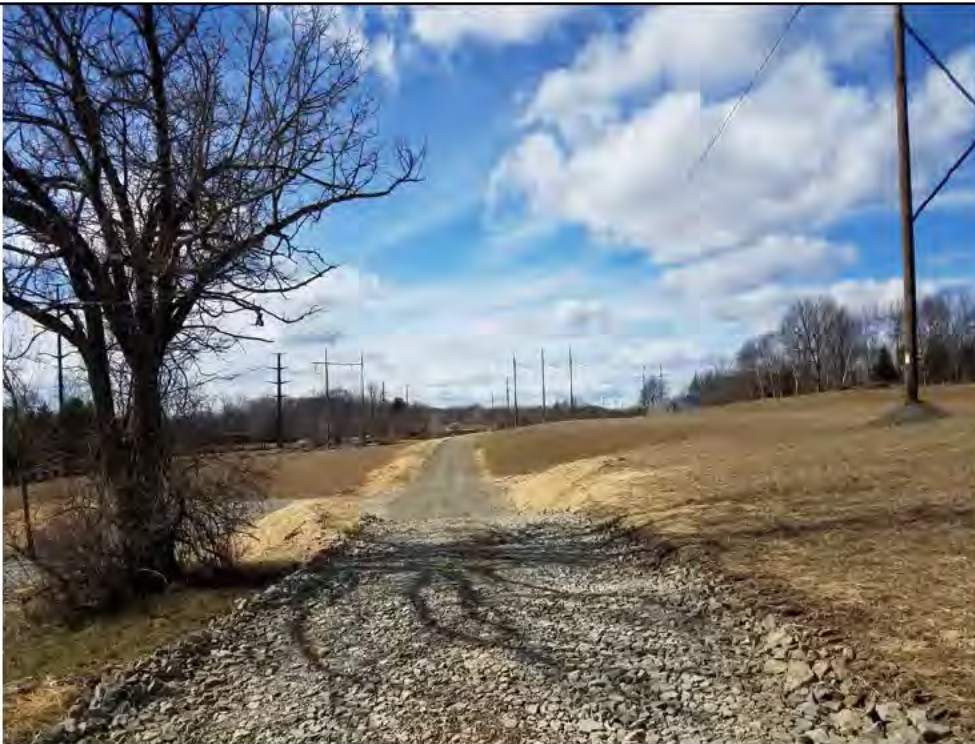
Photo 11: 3/3/2017, Watertown: Map 06, Str14, Farmland Protection Measures.

Photo 12: 3/3/2017, Watertown: Map 06, Str14, Farmland Protection Measures.

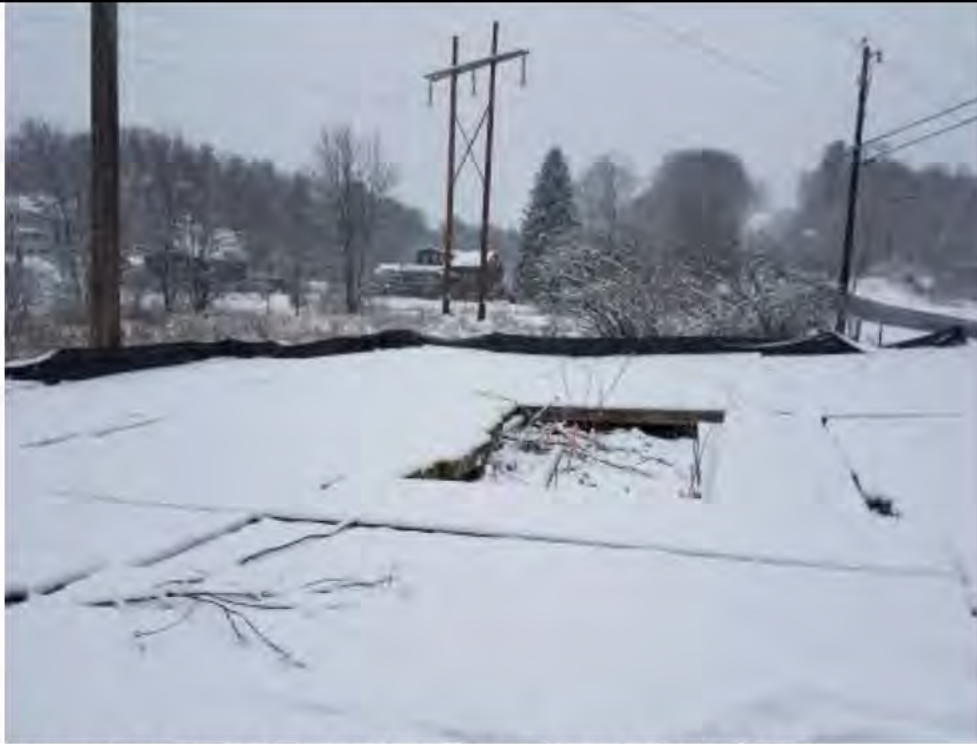
Photo 1: 3/10/2017, Harwinton: Map35, Str95, Silt fence placed around timber mat pad.

Rare, Threatened, and Endangered Species	Interim Week	<p>None observed or reported.</p> <p>Noted in above sections- In the area of Str95 and W-F15, exclusion fencing needs to be placed around the timber mat work pad to prevent turtle access according to the D&M plan notes (Map 35).</p>	<p>Continue to follow BMPs and Rare Species Avoidance and Minimization Measures.</p>	N/A
	Bi-Week	<p>None reported/None observed</p>	<p>Continue to follow BMPs and Rare Species Avoidance and Minimization Measures.</p>	N/A

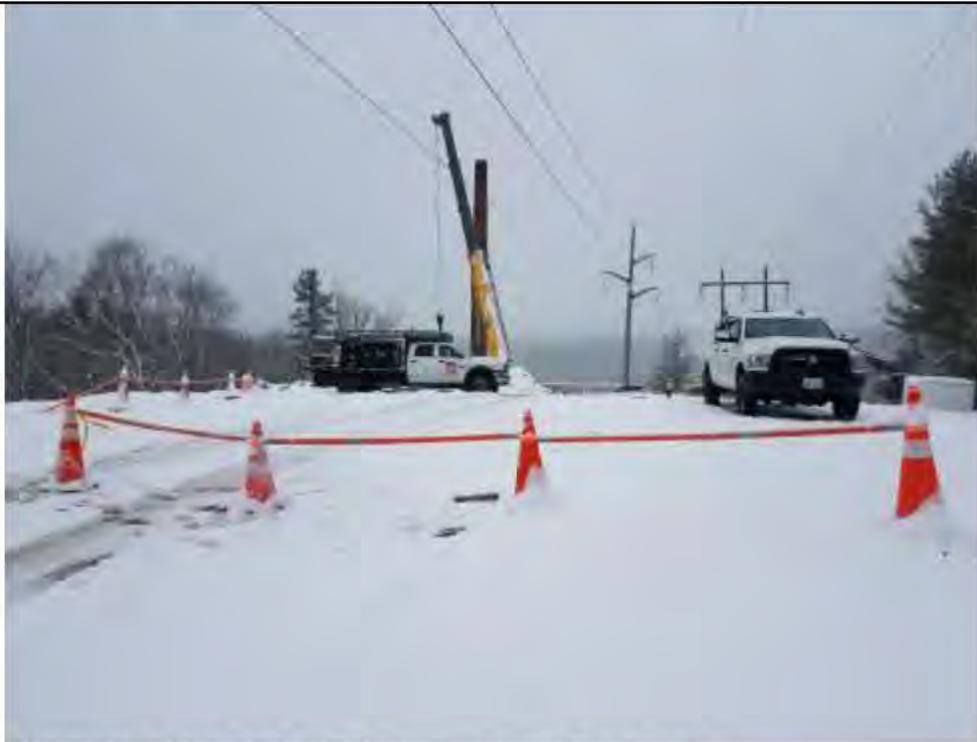
Photo 2: 3/10/2017, Harwinton: Map 32-34, Str88, construction of steel structure.

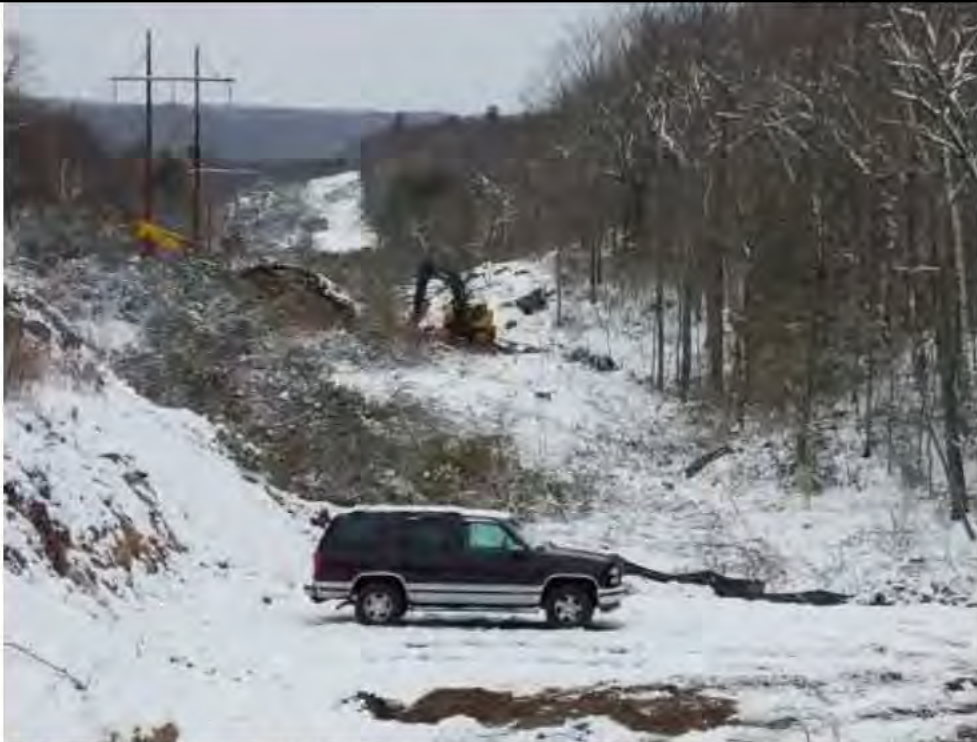
Photo 3: 3/10/2017, Thomaston: Map 25, Str70, mechanical clearing and pad construction.

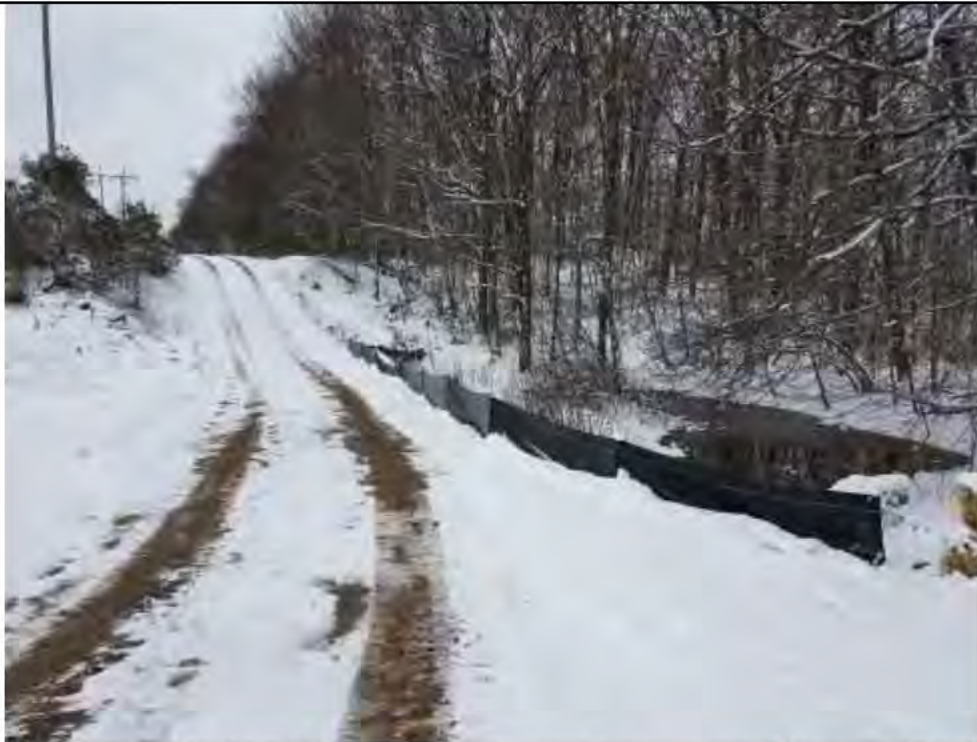
Photo 4: 3/10/2017, Thomaston: Map11, VP-C10-1, silt fence separating access road from vernal pool.
