**Subject: Docket No. 466, Frost Bridge to Campville 115-kV Project
Decision and Order Condition #4 – Independent Environmental Inspector Report**

Please find the enclosed Biweekly Independent Environmental Inspector Report, Report #7, for the **March 17th** and **March 24th 2017**, inspection events for the construction of the Eversource Frost Bridge to Campville 115-kV Project.

Frost Bridge to Campville 115kV Project

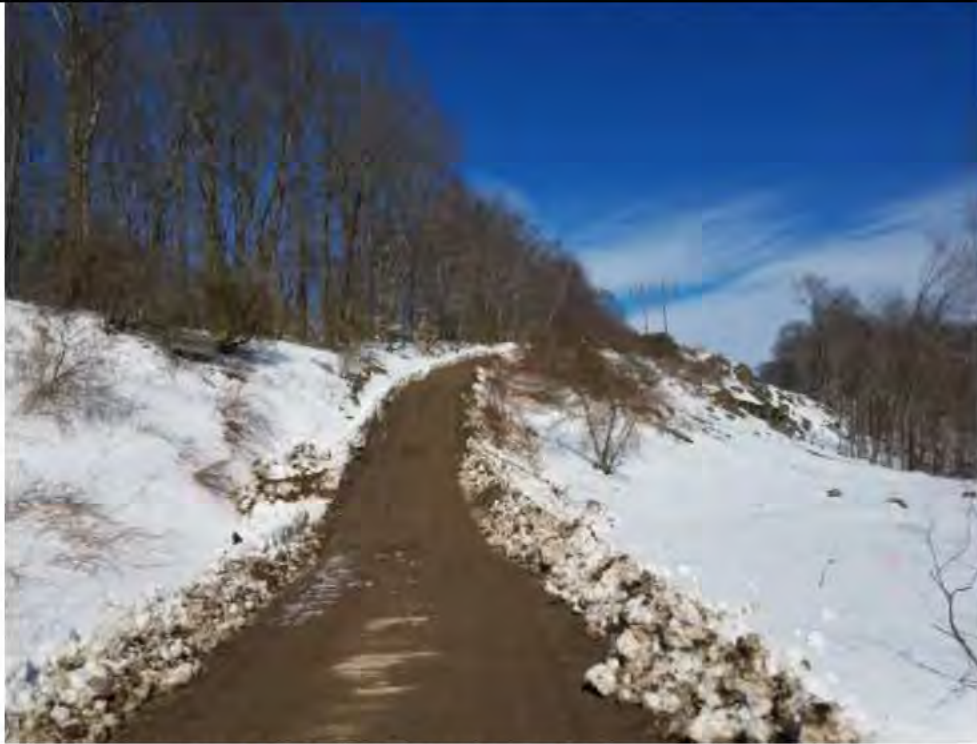
Photo 1: 3/17/2017, Watertown: Maps 09-12, access road snow clearing.

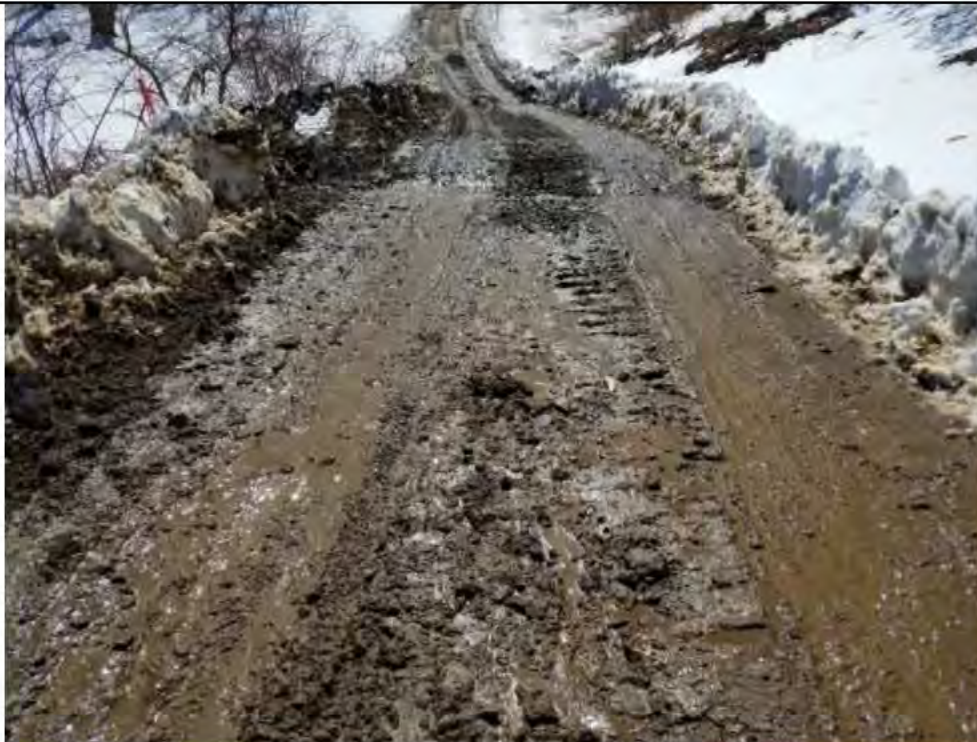
Photo 2: 3/17/2017, Watertown: Maps 09-12, snow melt, access road conditions.

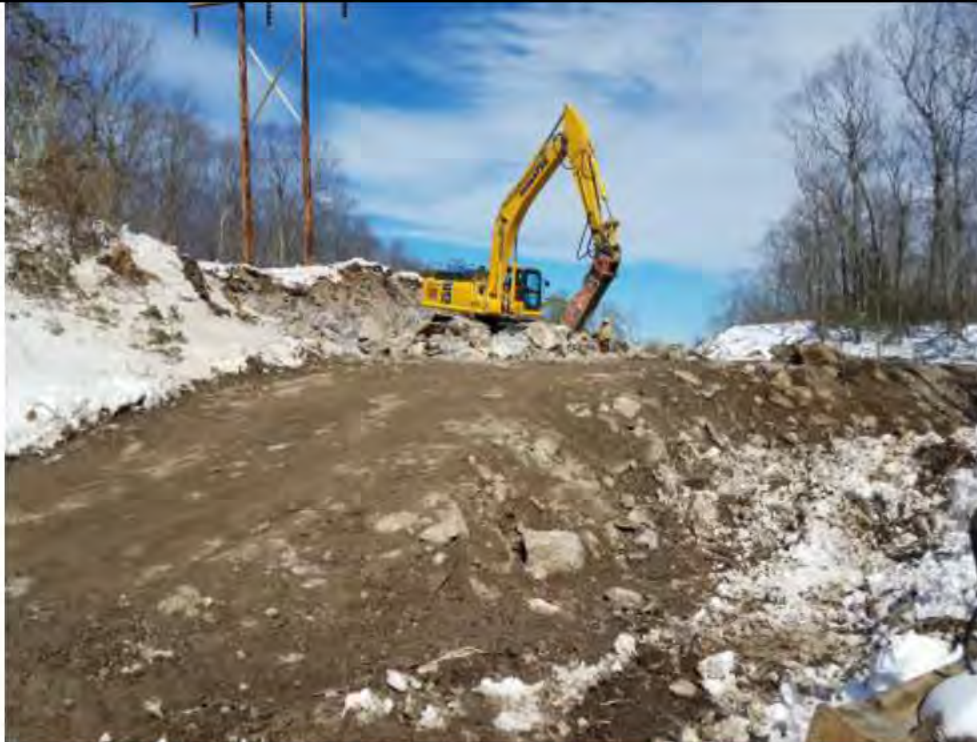
Photo 3: 3/17/2017, Watertown: Map 12, rock hammering at Str33.

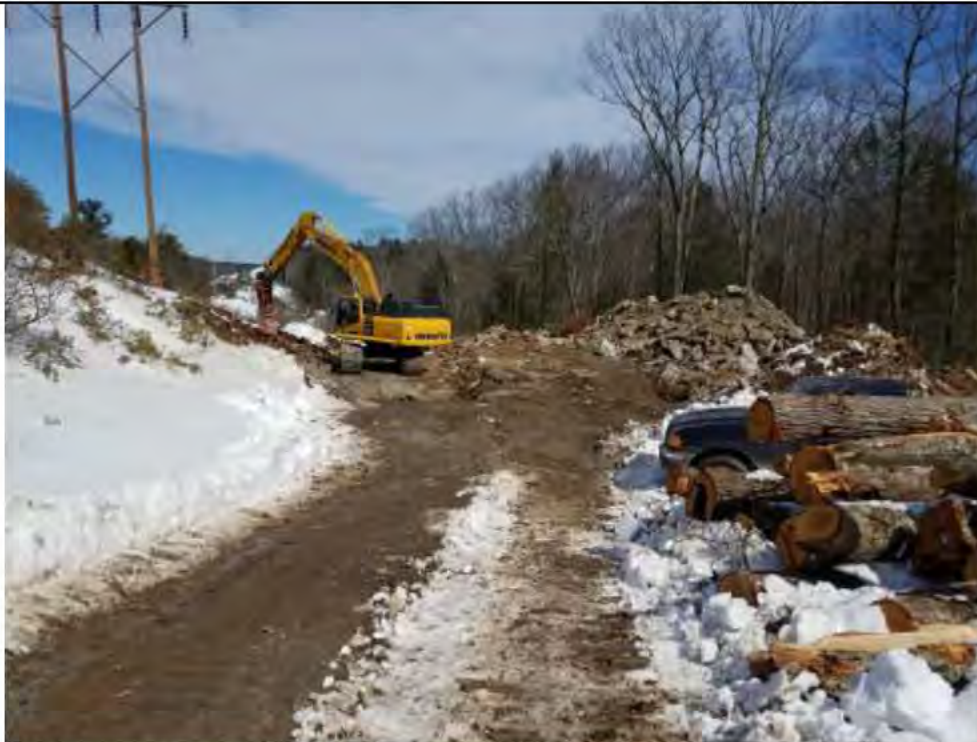
Photo 4: 3/17/2017, Watertown: Map 12, rock hammering at Str34.

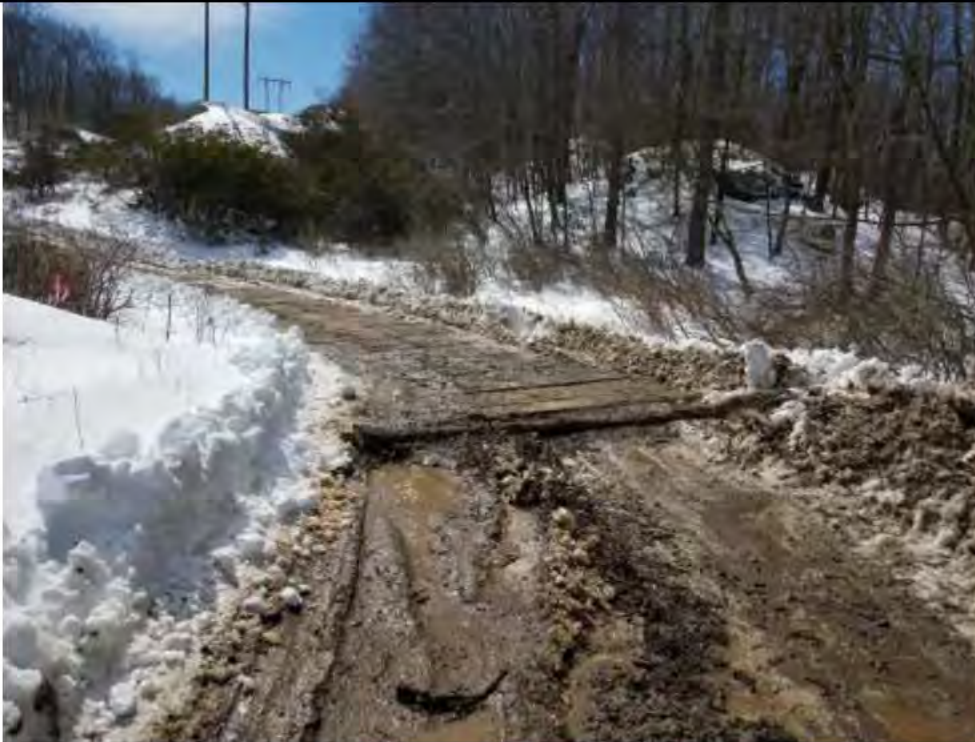
Photo 5: 3/17/2017, Watertown: Maps 09-13, timber mat at S-C4 crossing.

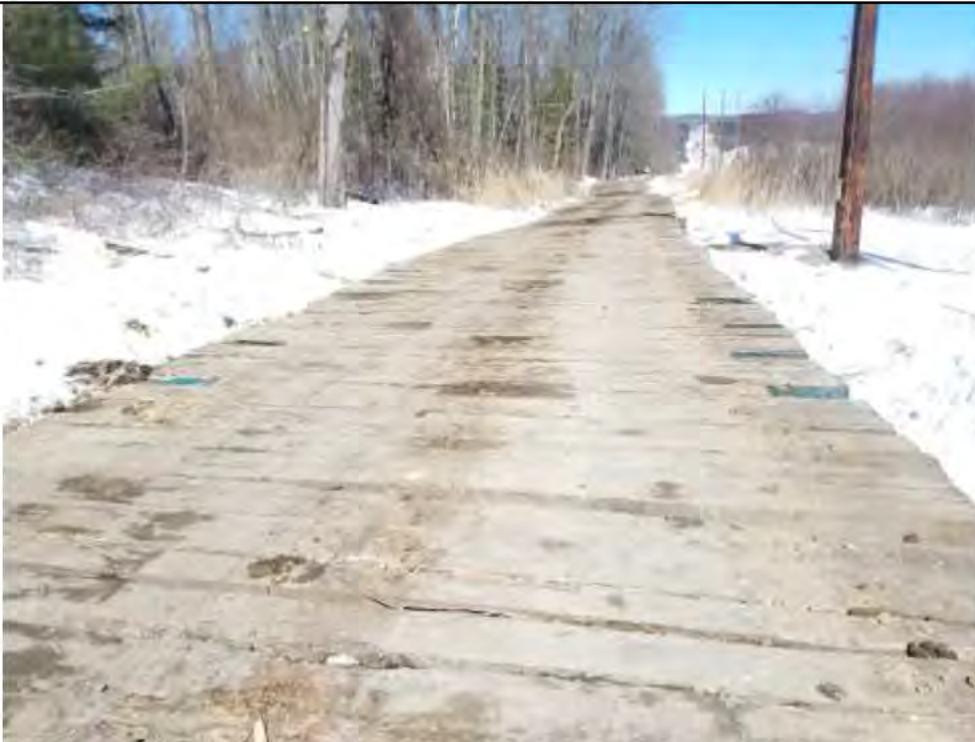
Photo 6: 3/17/2017, Litchfield: Maps 29 & 30, timber mat road through W-F7 to Str84.

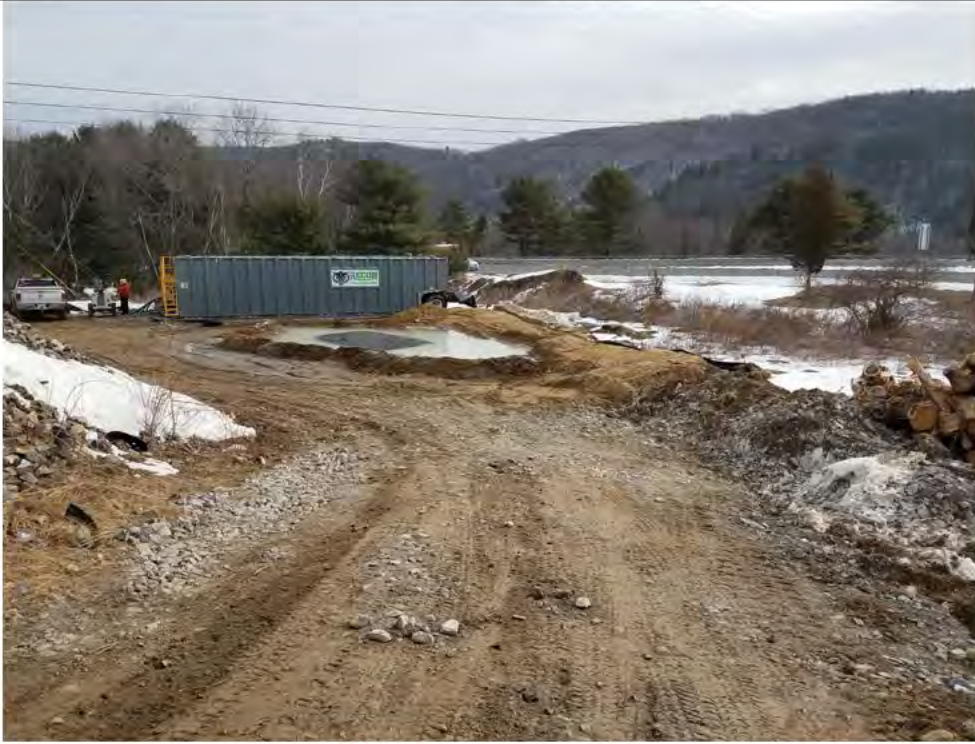
Photo 7: 3/24/2017, Watertown: Map 01, Str3080 and Str2, current dewatering set up (changes pending).

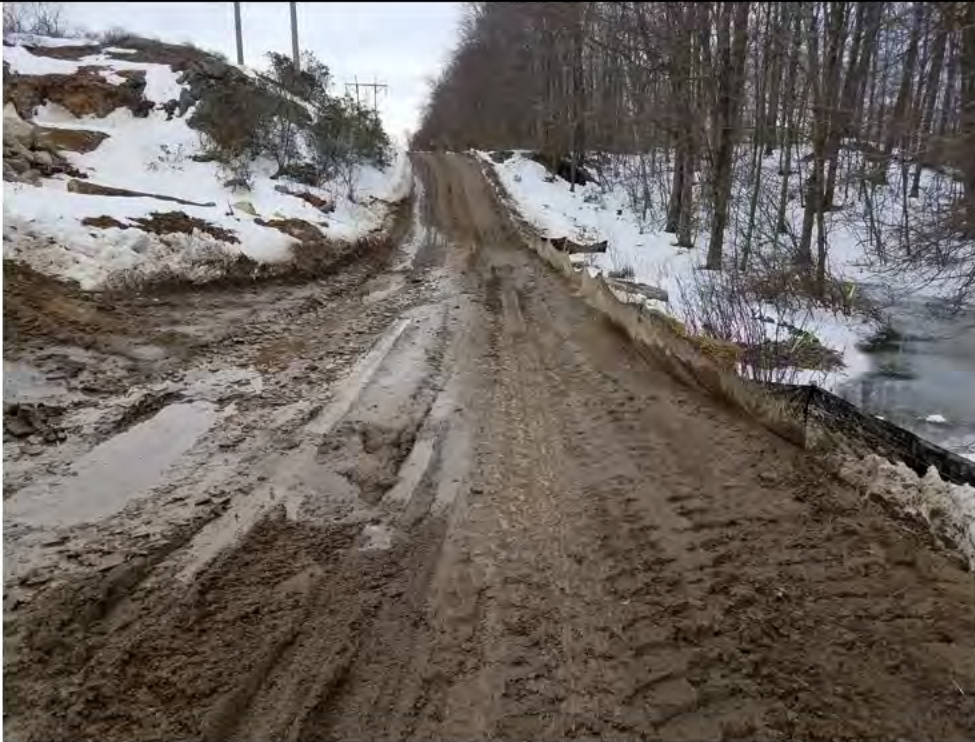
Photo 8: 3/24/2017, Watertown: Maps 09A-13, access road and E&S conditions at W-C16.

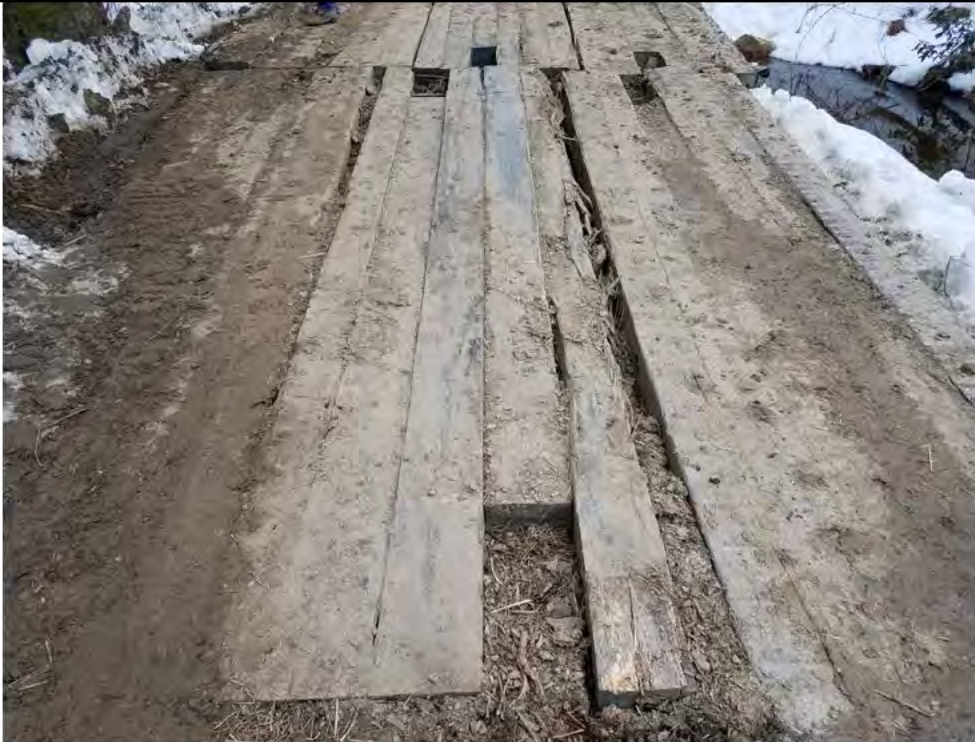
Water Crossings	Interim Week	<p>All crossings appear to be functioning in accordance with BMPs. No sediment appears to be entering the streams or wetlands. Timber mat crossings and hard bottom crossings are clear of excessive buildup of sediments. Water crossings (Timber mats) appeared maintained and cleared of sediment buildup.</p>	N/A	N/A
	Bi-Week	<p>All crossings appear to be functioning in accordance with BMPs. No sediment appears to be entering the streams or wetlands. Timber mat crossings and hard bottom crossings are clear of excessive buildup of sediments. Water crossings (Timber mats) appeared maintained and cleared of sediment buildup. Some minor maintenance is required at S-C4 (Map12) water crossing (timber mats). Timber mats are separating (gaps, see Photo # 9) and need to be reset to prevent sediments from entering watercourse and for safety (vehicle and pedestrian foot traffic).</p>	<p>Current conditions were discussed with Matt Davison and Northern. The timber mats crossing at S-C4 will be cleaned, pulled, and reset.</p>	Update Pending

Photo 9: 3/24/2017, Watertown: Maps 09A-13, timber mat crossing, mat separation occurring at S-C4.

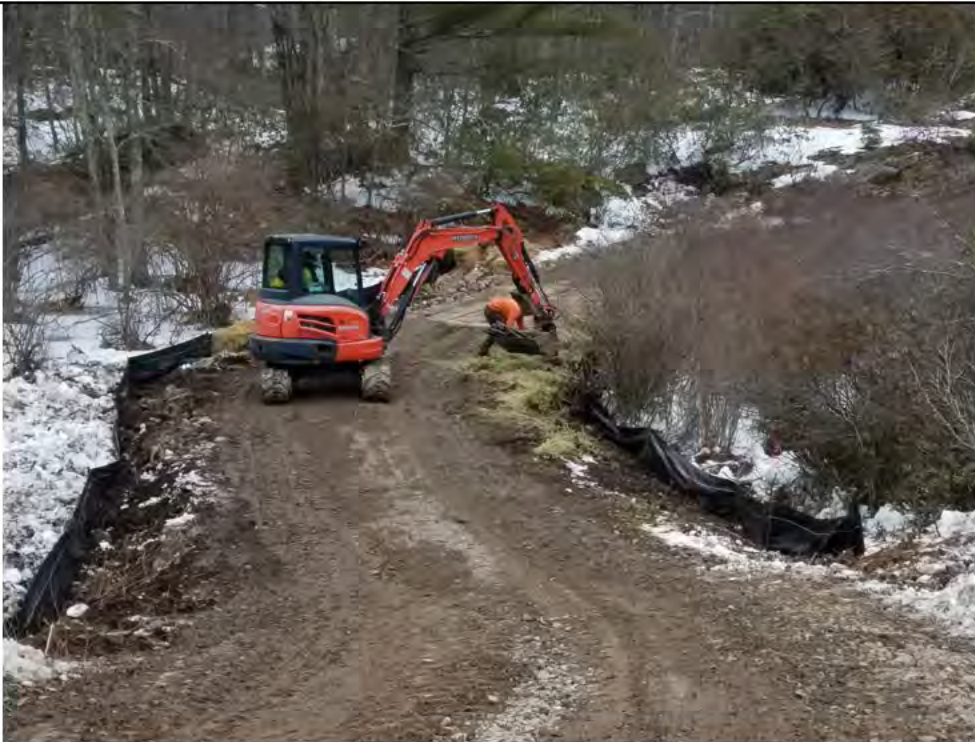
Photo 10: 3/24/2017, Watertown: Maps 09A-13, installing E&S at VP-C15-1.

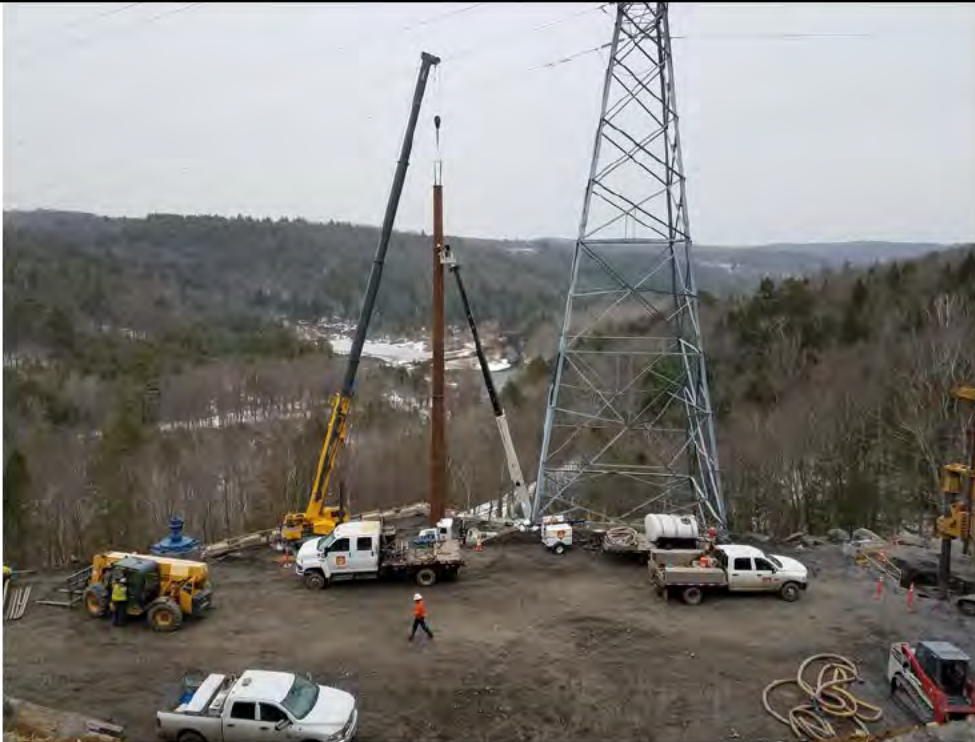
Photo 11: 3/24/2017, Litchfield: Maps 31 & 32, erecting Str86.

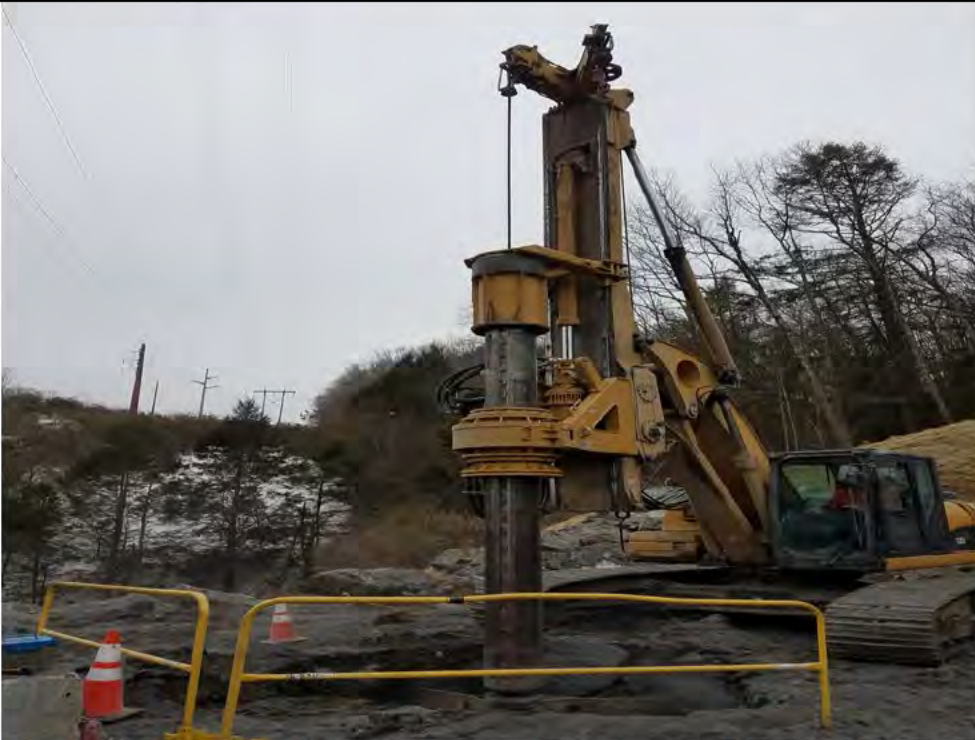
Photo 12: 3/24/2017, Litchfield: Maps 31 & 32, coring base for Vertical Deadend Structure, Str3171.

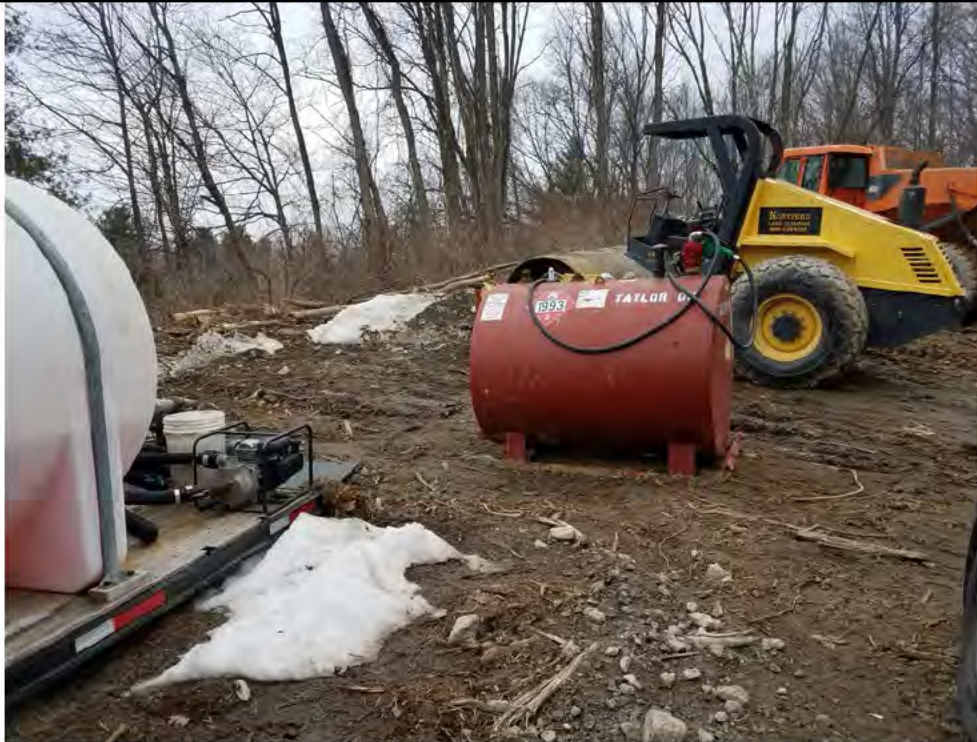
<p style="text-align: center;">Inland Wetland and Watercourse encroachment and mitigation (Continued from previous page)</p>	<p style="text-align: center;">Bi-Week</p>	<p>Timber mat installations (temporary access roads and temporary structure pads) in wetland areas are in accordance with the BMPs as outlined in the D&M.</p>	<p>Continue to follow BMPs as outlined in the D&M.</p>	<p style="text-align: center;">N/A</p>
<p style="text-align: center;">Spills and Material Storage</p>	<p style="text-align: center;">Interim-Week</p>	<p>None reported or observed. Emergency spill kits were observed in all active work areas and secondary containment procedures are implemented when refueling of equipment.</p>	<p style="text-align: center;">N/A</p>	<p style="text-align: center;">N/A</p>
	<p style="text-align: center;">Bi-Week</p>	<p>Diesel fuel storage tank observed without secondary containment and spill kit (See Photo # 13).</p>	<p>Discussed potential for release to the ground and surrounding area with Matt Davison. PAR Electric will remove the contents and demobilize the storage tank from the project area by the end of the day.</p>	<p>PAR Electric removed the the contents of the tank (diesel fuel) on Friday (3/24/17). The the Storage tank was later removed from the site on 3/29/17.</p>

Photo 13: 3/24/2017, Litchfield: Maps 31 & 32, PAR Electric's diesel fuel storage tank (no secondary containment).

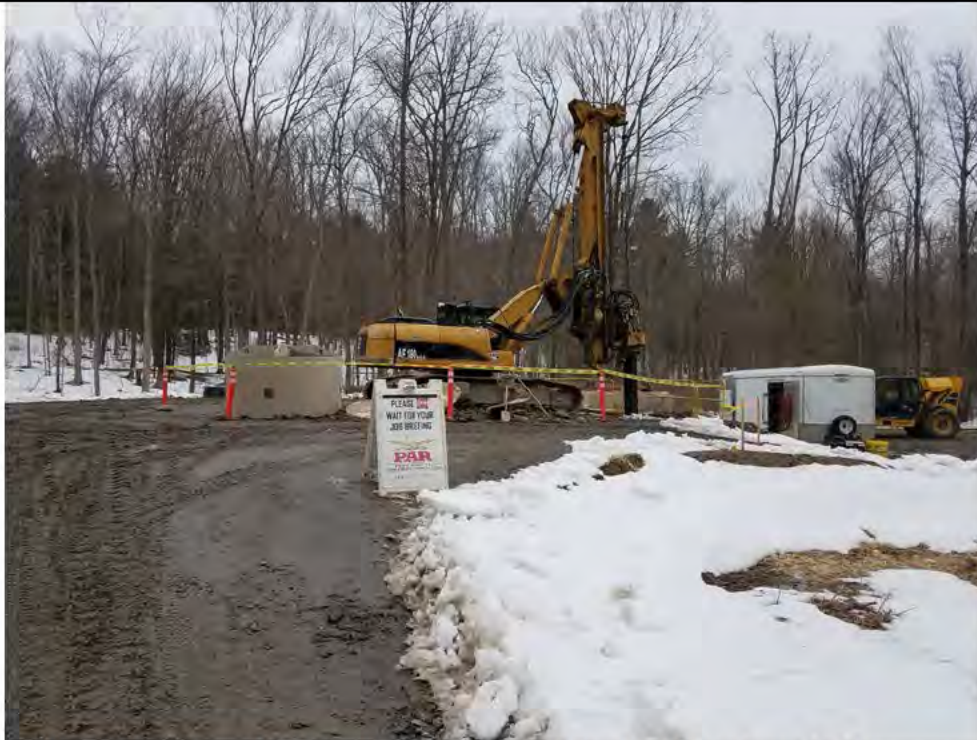
Photo 14: 3/24/2017, Harwinton: Map 35, coring base for Vertical Deadend Structure, Str96.
