**Subject: Docket No. 466, Frost Bridge to Campville 115-kV Project
Decision and Order Condition #4 – Independent Environmental Inspector Report**

Please find the enclosed Biweekly Independent Environmental Inspector Report, Report #10, for the **April 14th** and **April 21st 2017**, inspection events for the construction of the Eversource Frost Bridge to Campville 115-kV Project.

Docket No. 466- Development and Management Plan Inspection

Photograph Log Frost Bridge to Campville 115kV Project

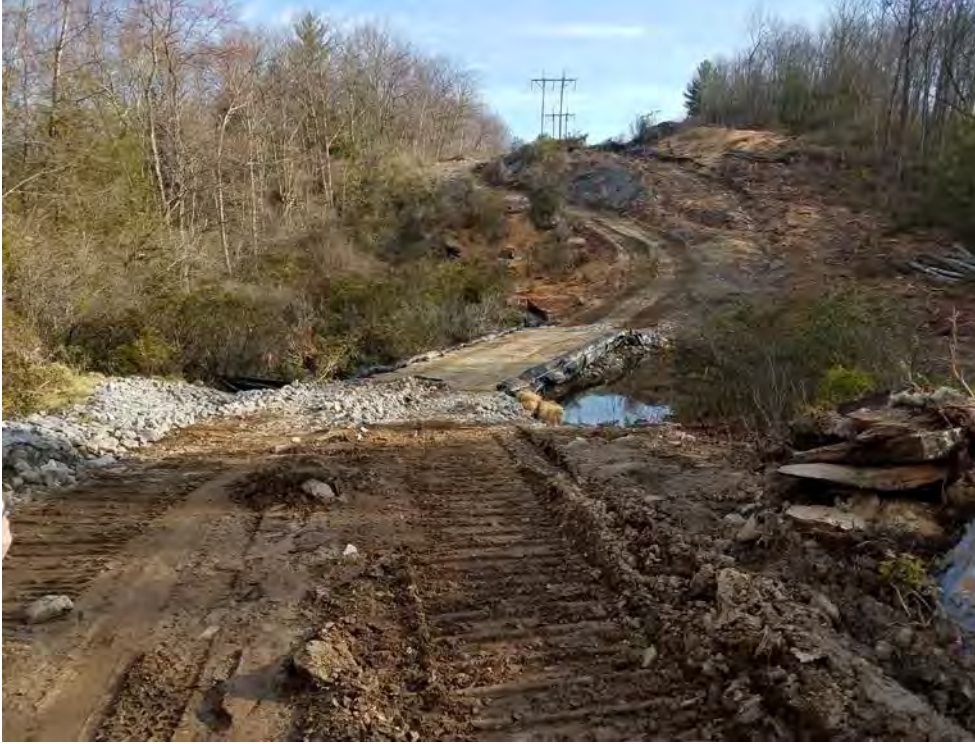
Photo 1: 4/14/2017, Watertown: Map 14, water crossing at W-C20 & VP-C20-1, Stone access tracking pads and E&S Improvements.

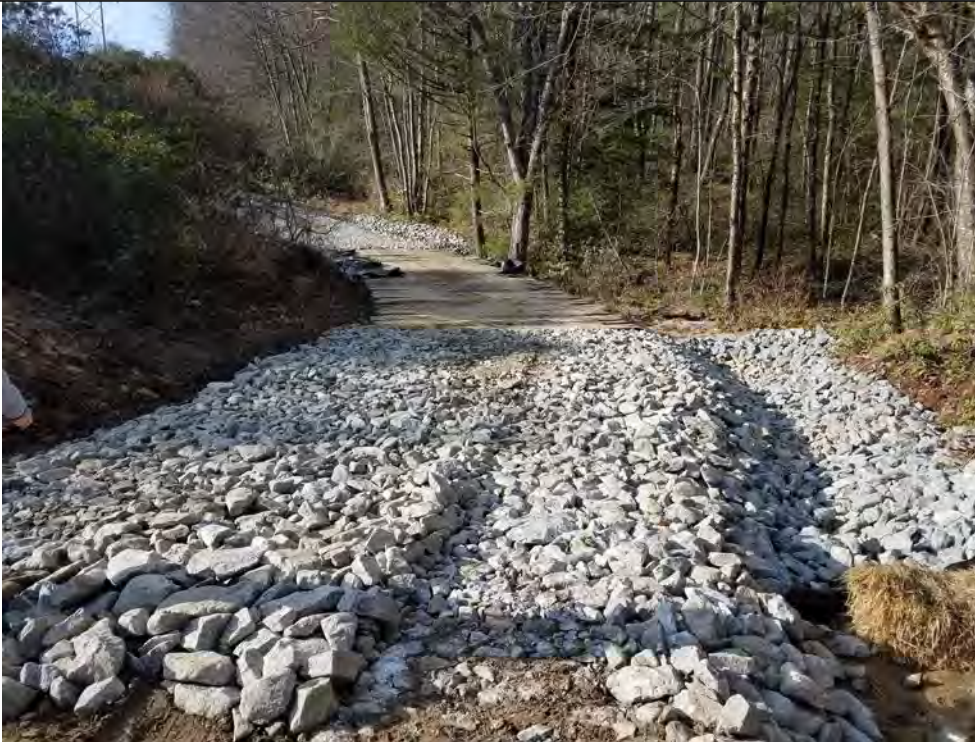
Photo 2: 4/14/2017, Watertown: Map 12, water crossing at W-C15 & S-C4, Stone access tracking pads and E&S Improvements.

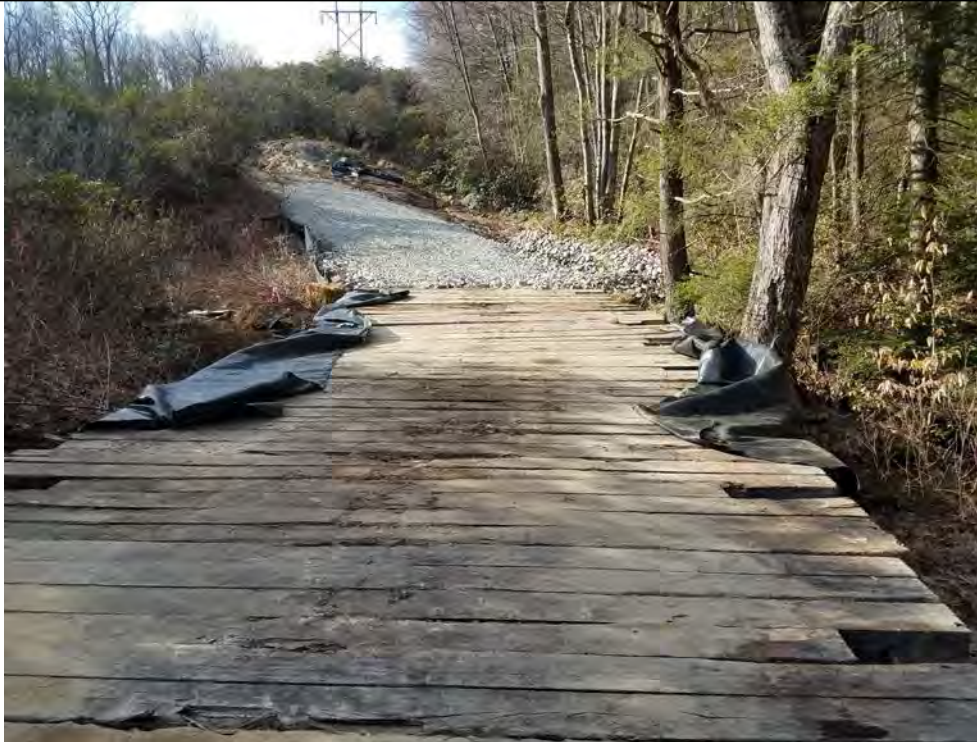
Photo 3: 4/14/2017, Watertown: Map 12, water crossing at W-C14, stone access tracking pads and E&S Improvements.

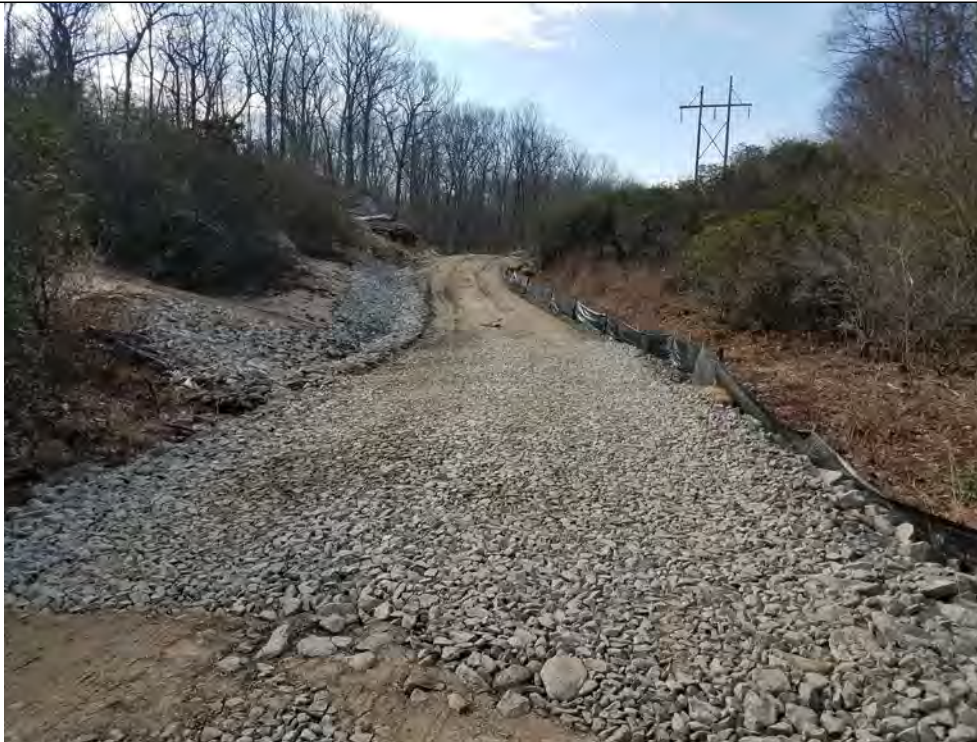
Photo 4: 4/14/2017, Watertown: Map 12, access road improvements, stone swale, and addition of perimeter silt fence.

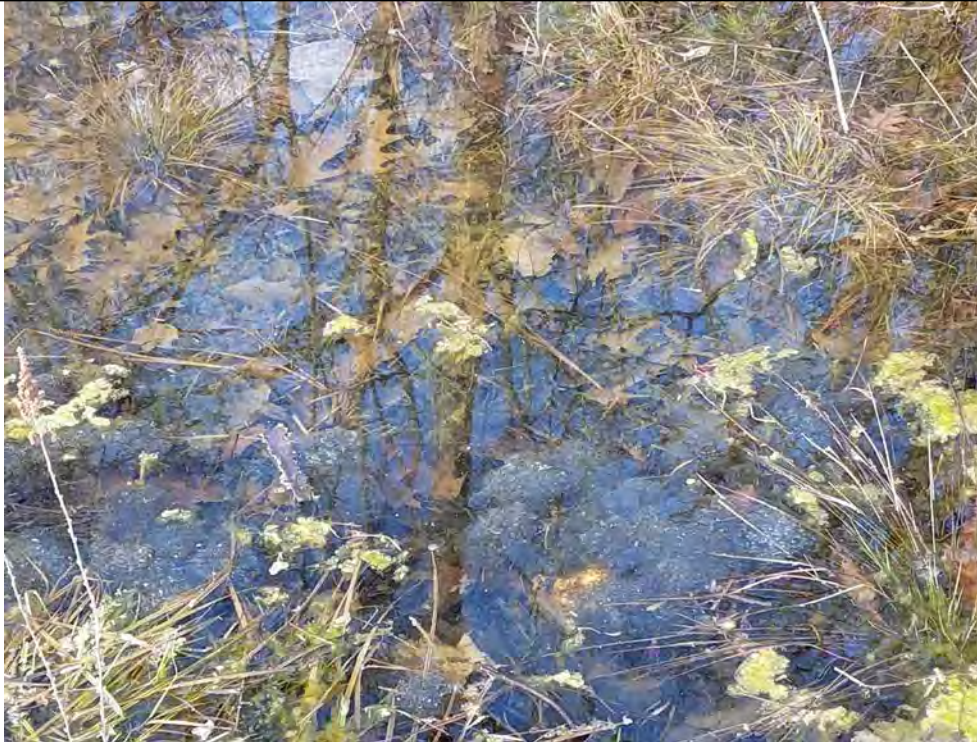
Photo 5: 4/14/2017, Watertown: Map 11, VP-C12-1, wood frog eggs present.

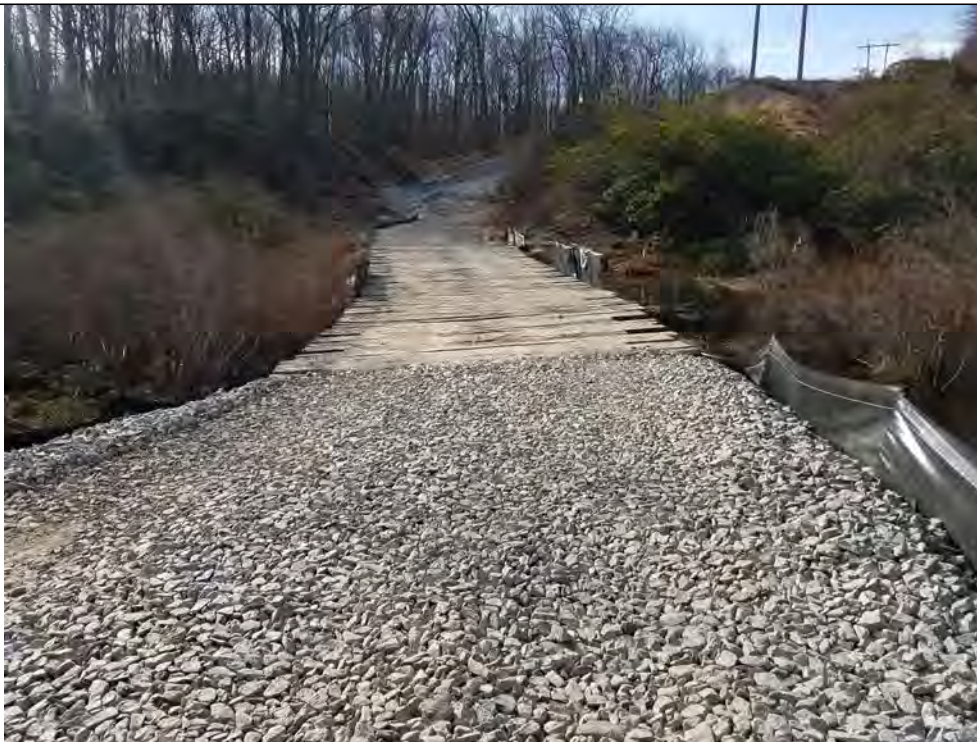
Photo 6: 4/14/2017, Watertown: Map 11, timber mat water crossing at W-C12 & VP-C12-1, access road E&S control improvements.

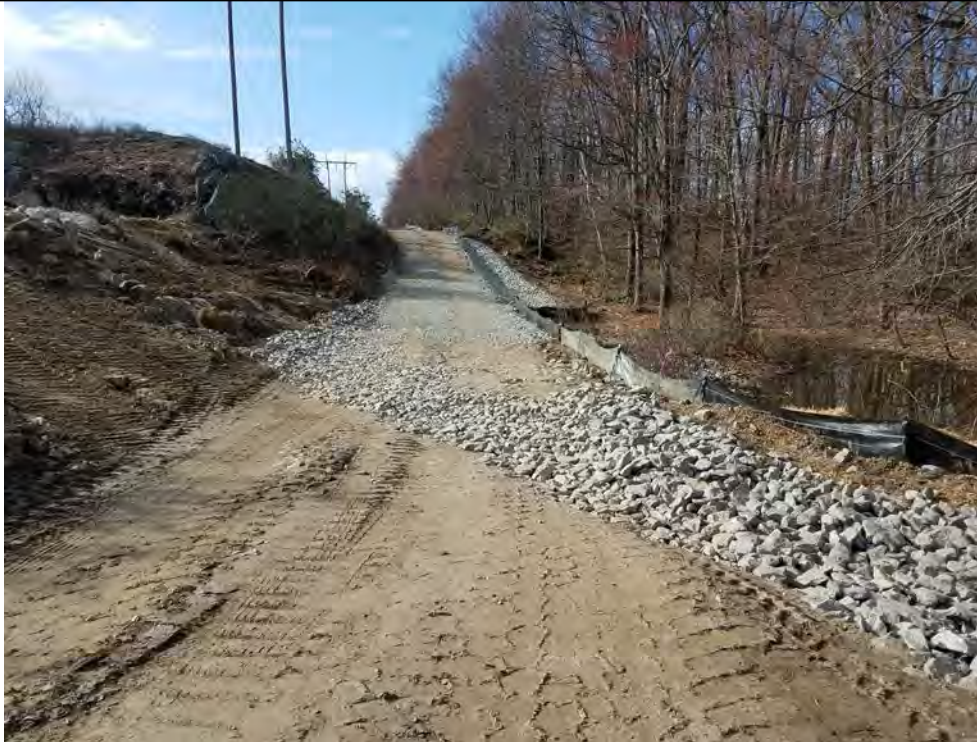
Photo 7: 4/14/2017, Watertown: Map 11, access road, water bar, stone swale and E&S improvements in the area of Str31.

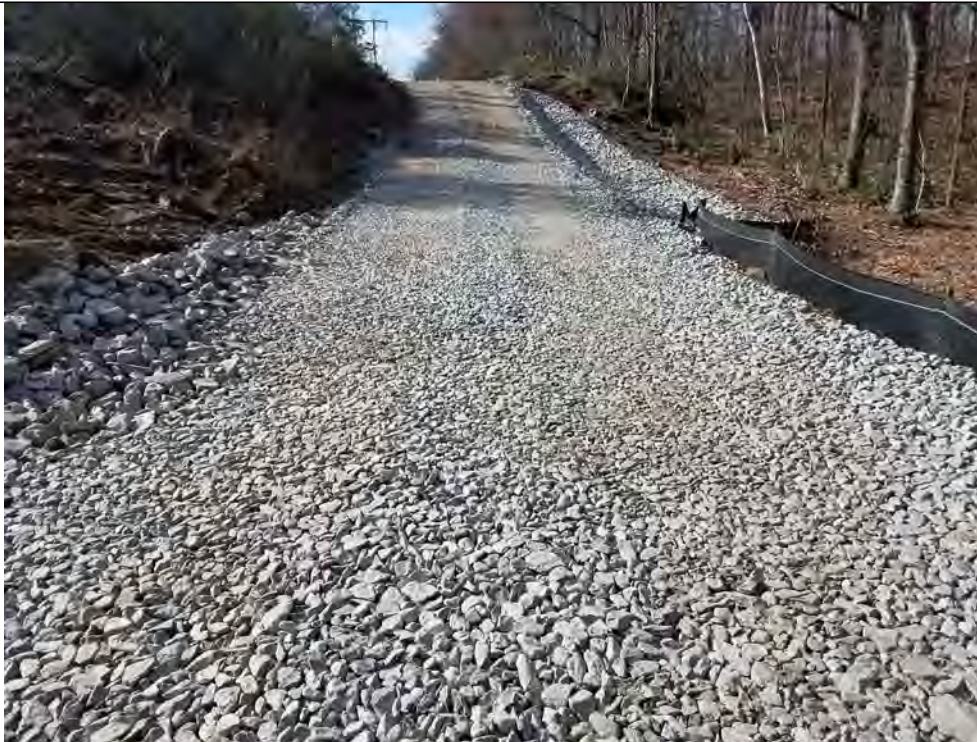
Photo 8: 4/14/2017, Watertown: Map 11, access road, water bar, stone swale and E&S improvements in the area of Str31.

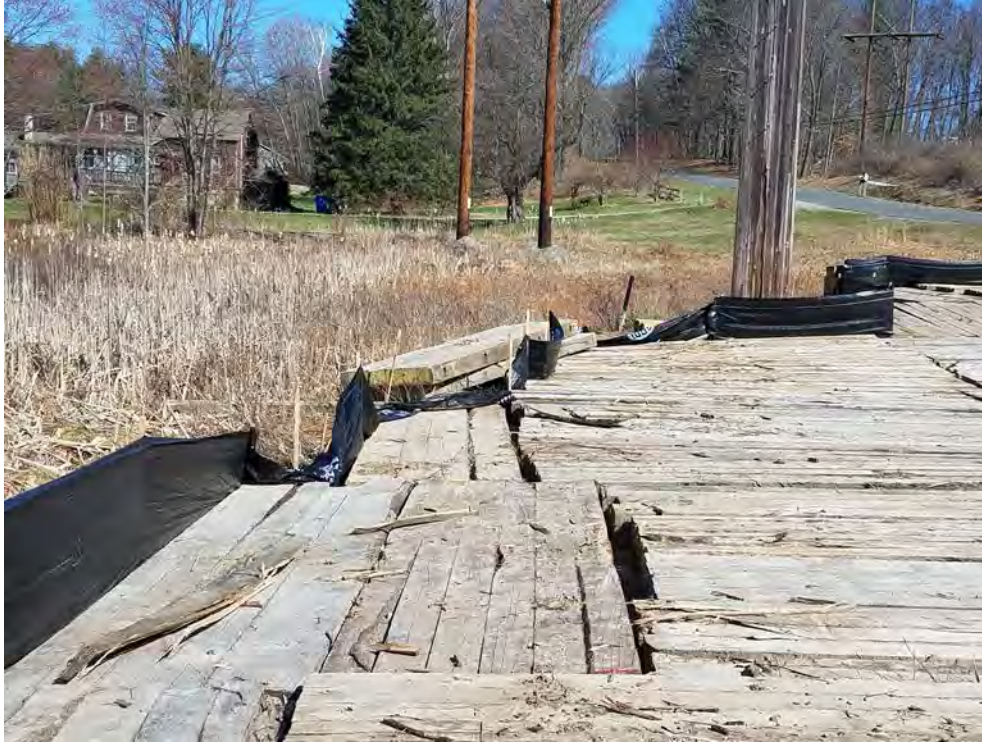
Rare, Threatened, and Endangered Species	Interim Week	<p>The area of pad Str95 was inspected and no turtles were observed in the surrounding area or on the pad itself. The pad is edged with silt fencing to prevent turtle access. However, a few sections of silt fence are in need of repair or replacement. See attached photos.</p>	<p>Continue to follow BMPs and Rare Species Avoidance and Minimization Measures.</p> <p>Repair or replace silt fence in the area of Str95 to prevent turtle access.</p> <p>Matt Davison will be conducting a Contractor Awareness program prior to work in this area.</p>	N/A
	Bi-Week	<p>The pad is edged with silt fencing to prevent turtle access. However, a few sections of silt fence are in need of repair or replacement. No action taken as of this inspection. Spoke with Matt Davison/Davison Environmental and Northern will be repairing perimeter silt fencing in the coming days.</p>	<p>Continue to follow BMPs and Rare Species Avoidance and Minimization Measures.</p>	<p>Silt fencing barrier repaired as of 4/25/2017. Updated photos supplied by Matt Davison/Davison Environmental and placed in the project file.</p>

Photo 9: 4/14/2017, Harwinton: Map 35, Str95, Rare Species Avoidance and Minimization Measures, perimeter silt fence needs repair/replacement.

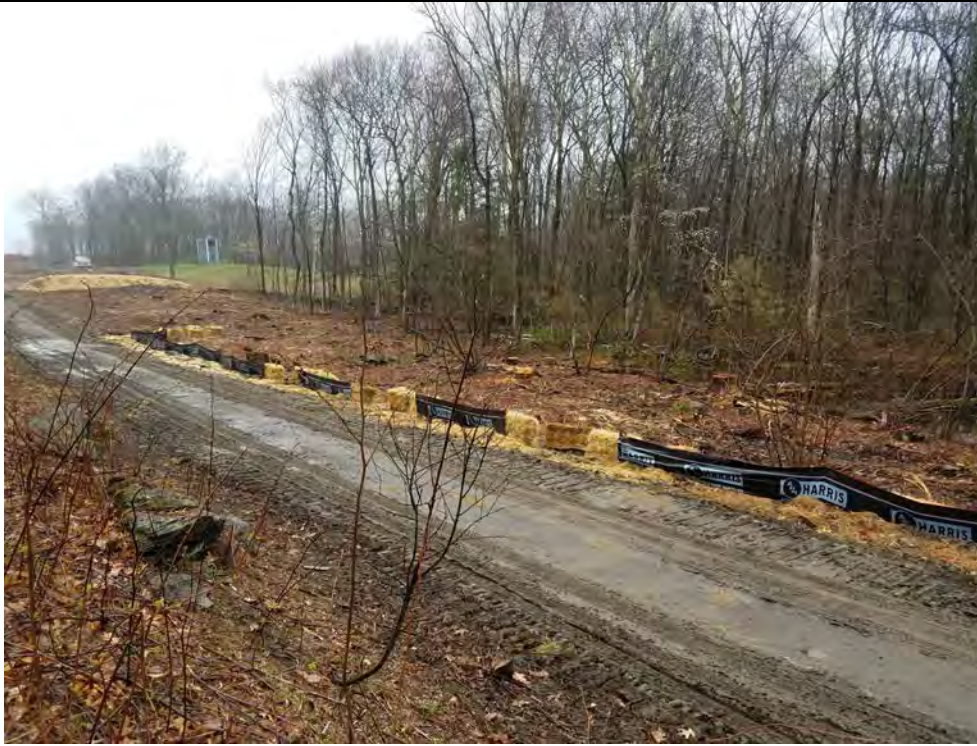
Photo 10: 4/21/2017, Thomaston: Map 19, E&S at W-D4/VP-D4-1.

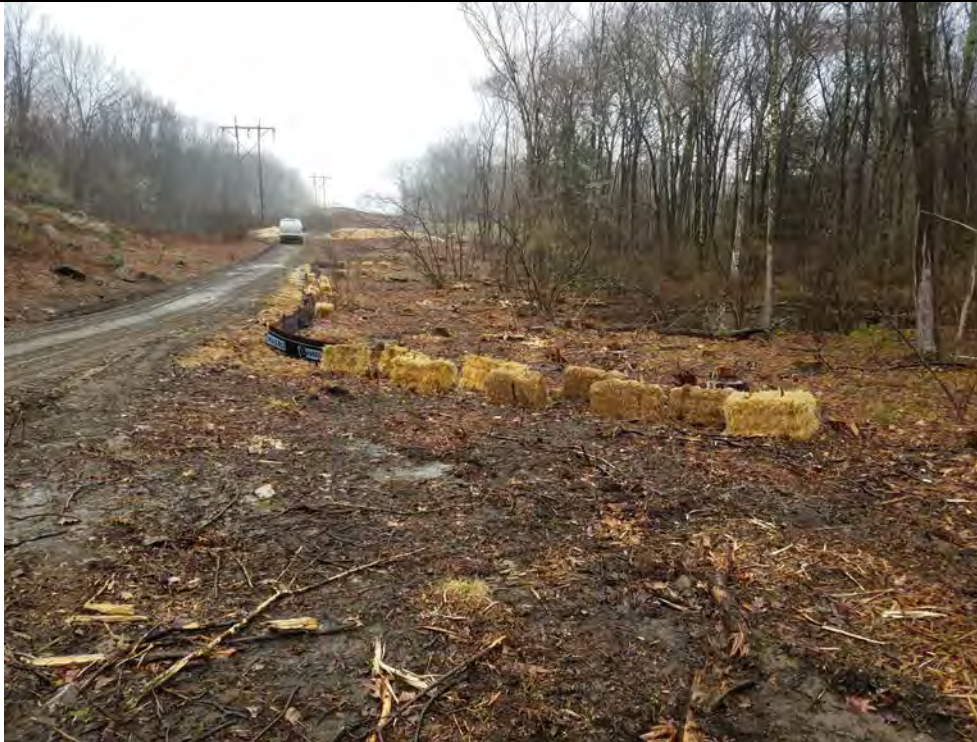
Photo 11: 4/21/2017, Thomaston: Map 19, E&S at W-D4/VP-D4-1.

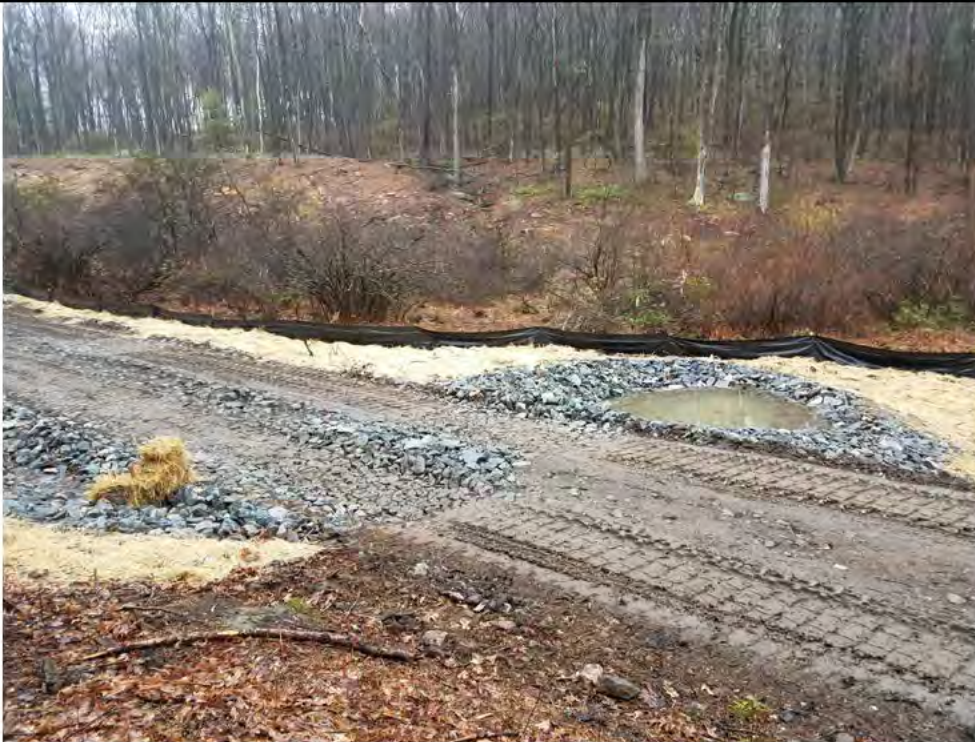
Photo 12: 4/21/2017, Thomaston: Map 18, E&S controls at W-D3.

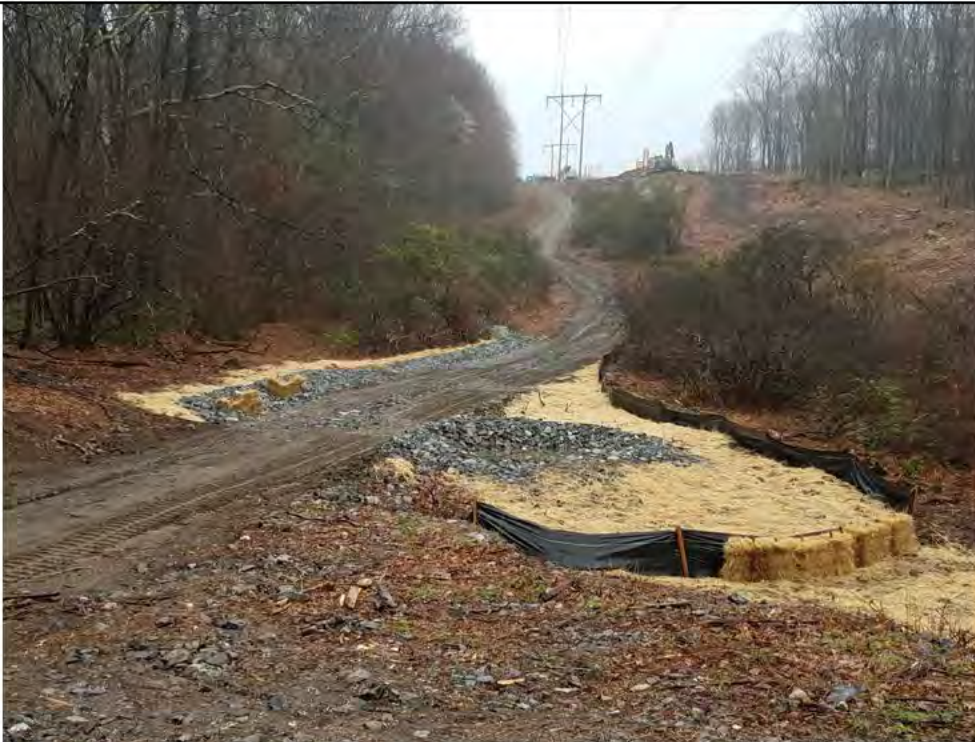
Photo 13: 4/21/2017, Thomaston: Map 18, E&S at W-D3.

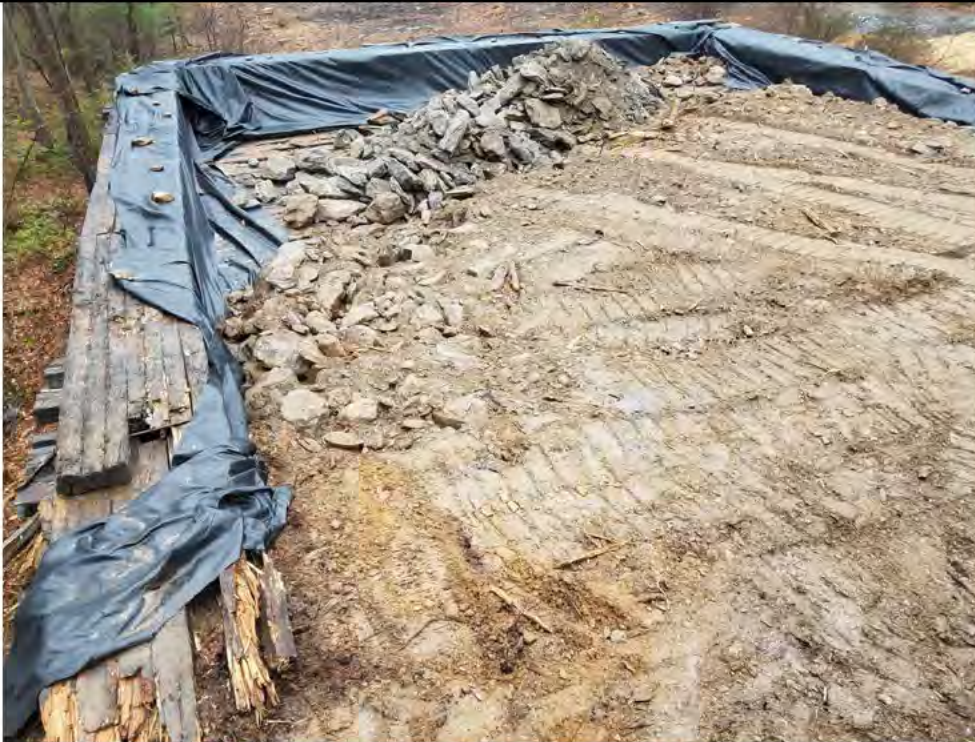
Photo 14: 4/21/2017, Thomaston: Map 18, construction of Str51 abutting W-D3 and S-D3.
