**Subject: Docket No. 466, Frost Bridge to Campville 115-kV Project
Decision and Order Condition #4 – Independent Environmental Inspector Report**

Please find enclosed the Biweekly Independent Environmental Inspector Report, Report #12, for the **May 12th** and **May 19th 2017**, inspection events for the construction of the Eversource Frost Bridge to Campville 115-kV Project.

Docket No. 466- Development and Management Plan Inspection

Frost Bridge to Campville 115kV Project

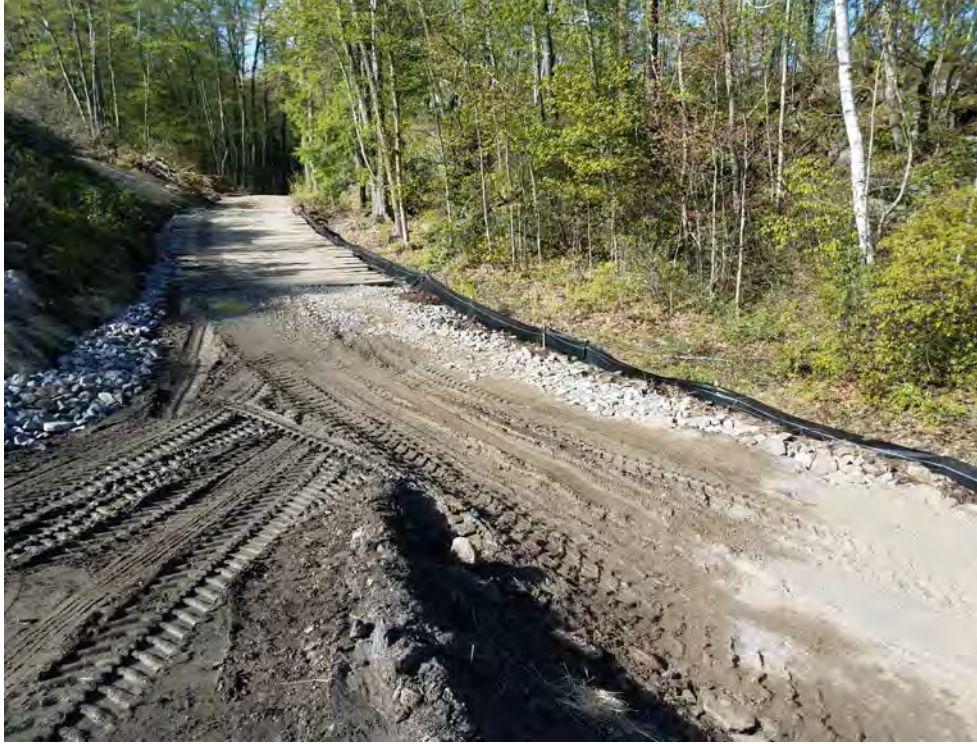
Photo 1: 05/12/2017, Watertown: Map 13, E&S (Silt Fence) controls repaired.

Repairs to E&S controls (Silt fence) were performed (corrective action) by Northern at W-C18 (Map 13) as of the non-conformance reported in the Biweekly Report #11, dated 5/05/17.

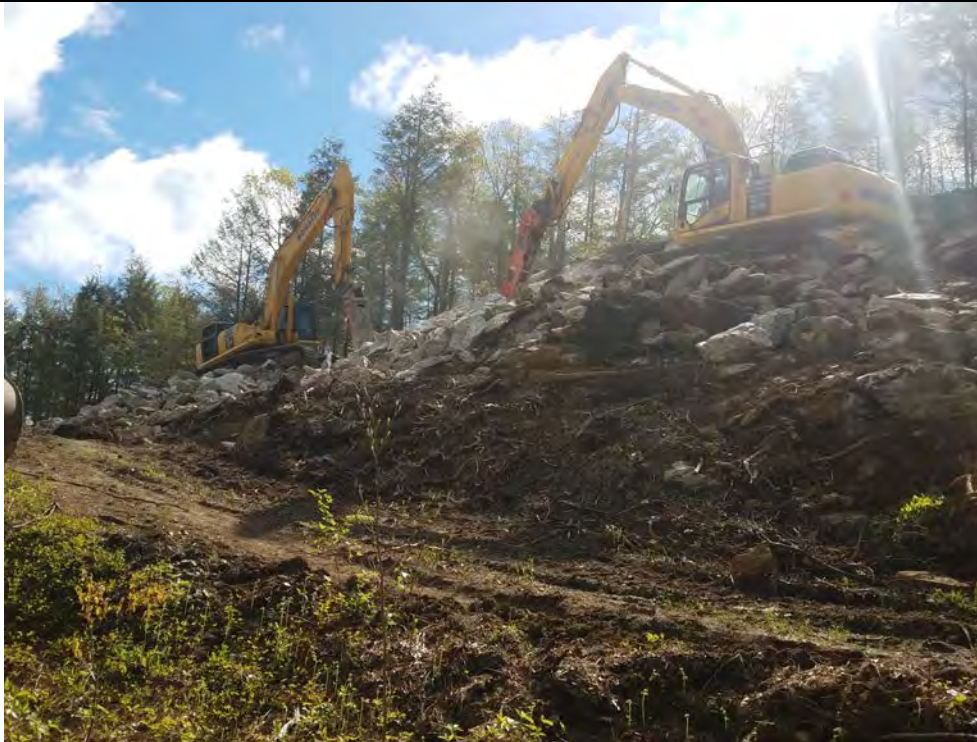
Photo 2: 05/12/2017, Watertown: Map 15, Rock Hammering pad at Str44.

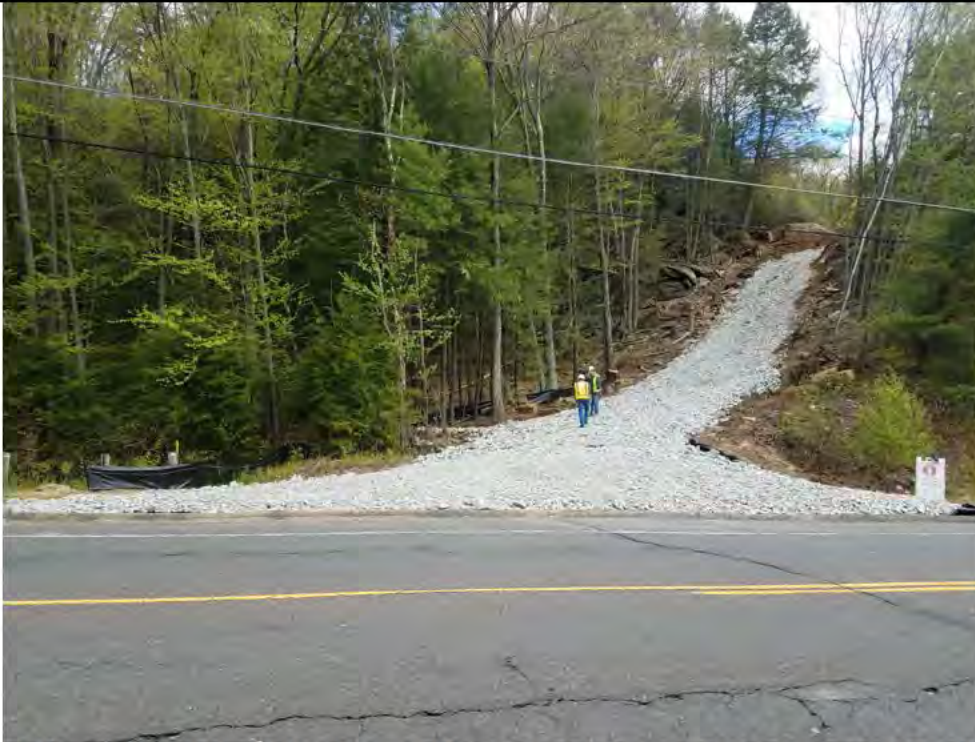
Photo 3: 05/12/2017, Thomaston: Map 17, tracking pad/apron and access road construction at Str48.

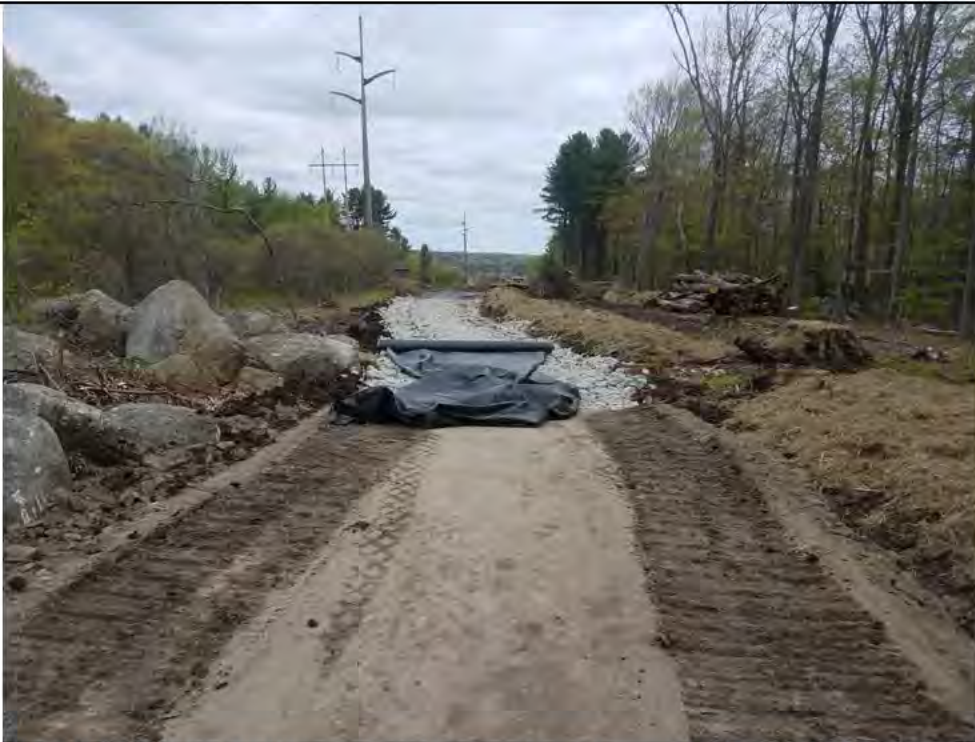
Photo 4: 05/12/2017, Litchfield: Map 28, Access road construction between Str79 and Str80.

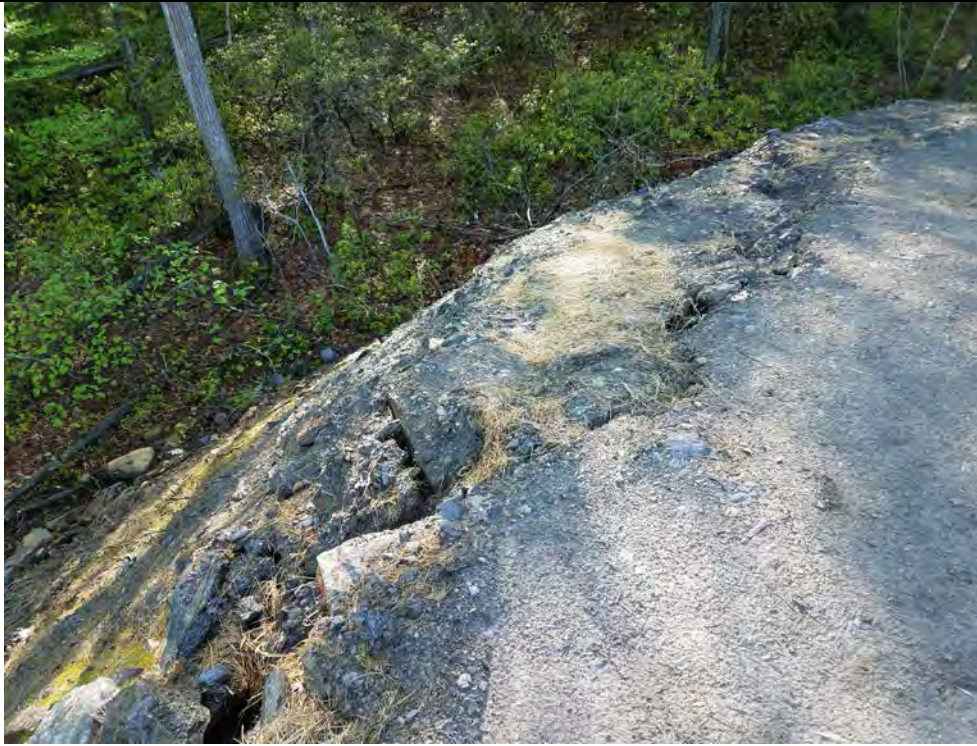
5/12/17: Slope failure is occurring at pad Str38, northeast corner of pad. Destabilization at northeast corner of slope. Rills and tunneling were observed. Slope failure will likely occur but there are no impacts to sensitive areas such as wetlands or watercourses. If failure were to occur, materials would still fall within the proposed area of disturbance because the pad was constructed smaller than originally designed. As of 05/19/17, this has not been addressed.

Photo 5: 05/19/2017, Watertown: Map 13, Structural failure-slope failure occurring at pad Str38.

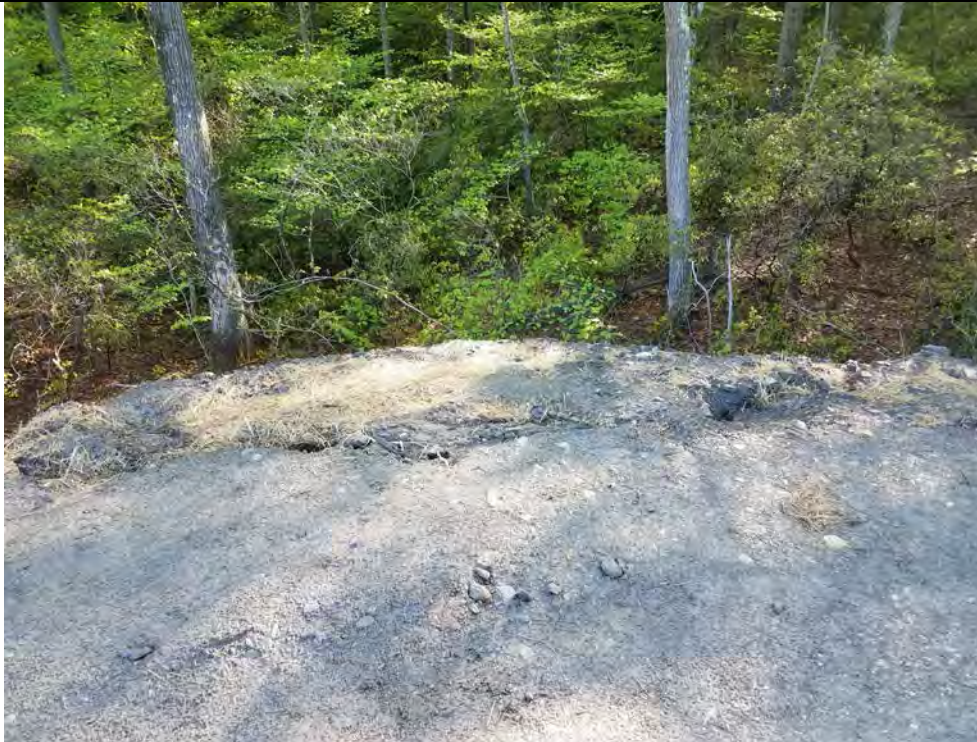
Photo 6: 05/19/2017, Watertown: Map 13, Structural failure-slope failure occurring at pad Str38.

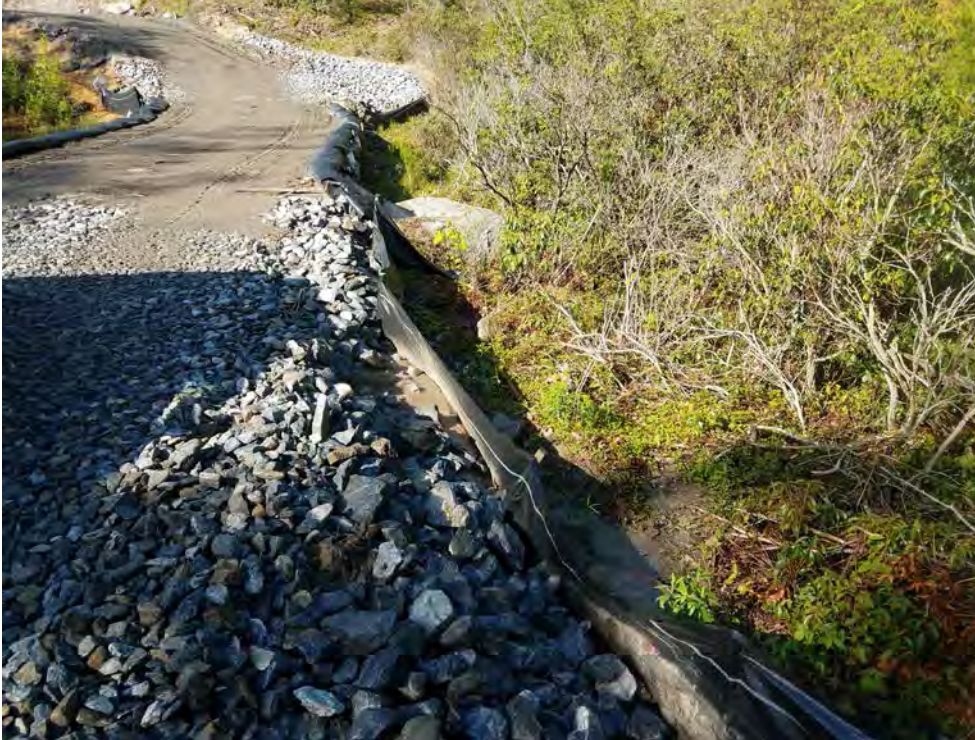
Water Crossings	Interim Week	All crossings appear to be functioning in accordance with BMPs.	N/A	N/A
	Bi-Week	The timber mat crossing at VP-C20-1 had an excessive buildup of sediments (See photo #7) at the time of this site inspection on 05/19/2017. Northern was notified of the conditions and by the end of the day cleared the excessive sediments from the crossing (See photo #8).	Continue to monitor and maintain water crossings for excessive sediment buildup.	N/A

Photo 7: 05/19/2017, Watertown: Map 14, timber mat crossing at VP-C20-1 in need of cleaning and maintenance of perimeter silt fence.

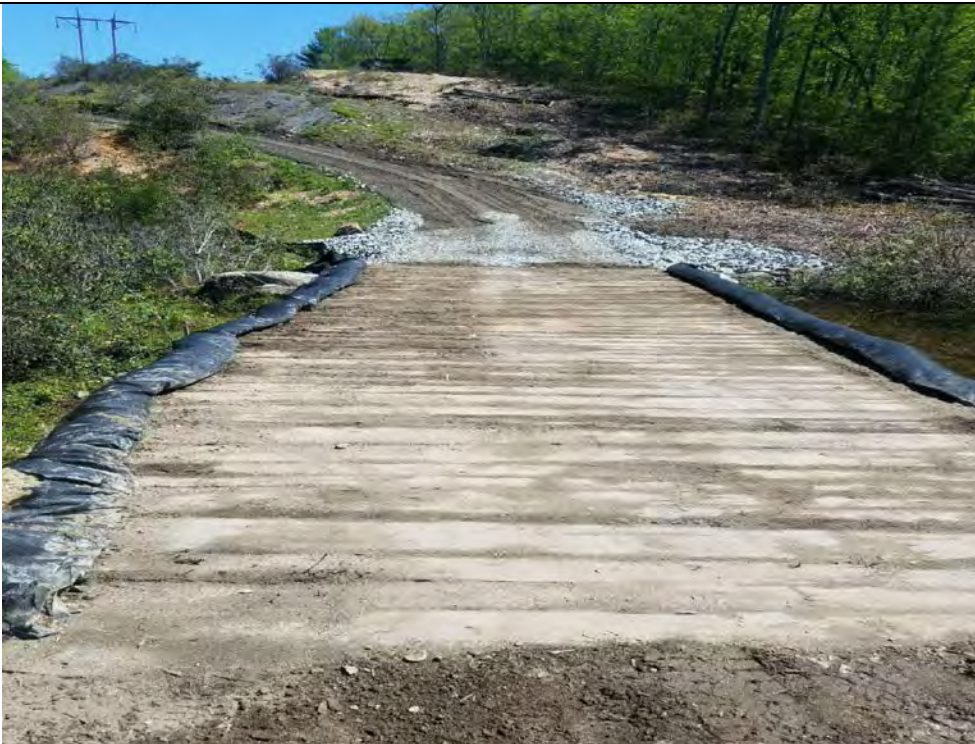
Photo 8: 05/19/2017, Watertown: Map 14, at VP-C20-1 crossing, timber mats and silt fence cleared of excess sediments, completed on 05/19/2017 by Northern.
