**Subject: Docket No. 466, Frost Bridge to Campville 115-kV Project  
Decision and Order Condition #4 – Independent Environmental Inspector Report**

**Docket No. 466- Development and Management Plan Inspection**

### Frost Bridge to Campville 115kV Project

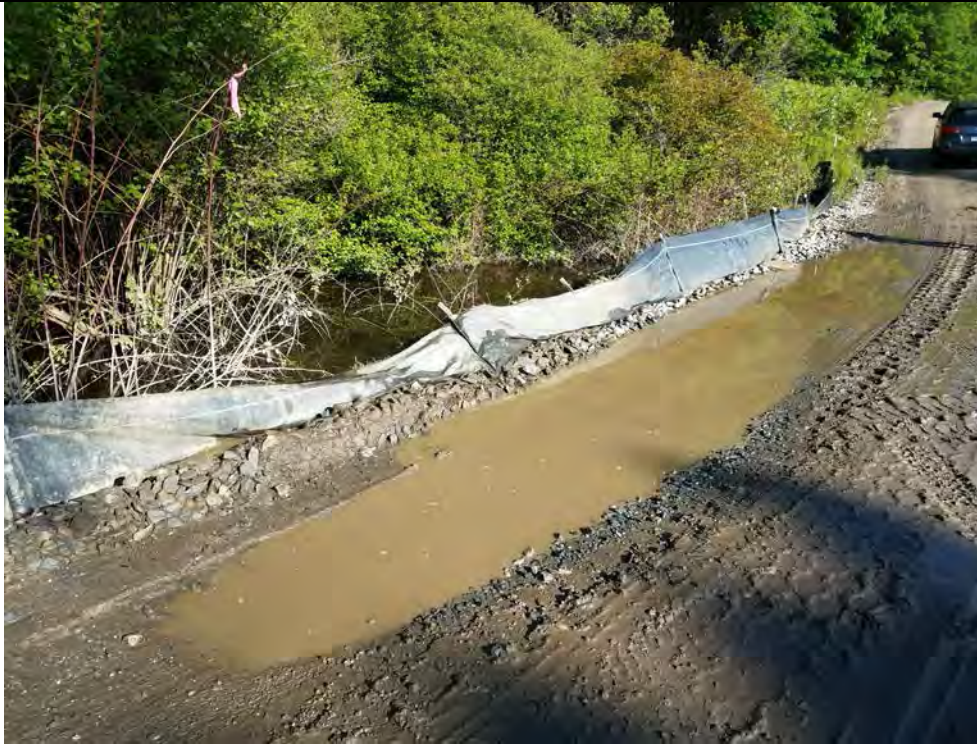
Photo 1: 06/02/2017, Watertown: Map 10, E&S control maintenance and access road improvements required at wetland W-C3.

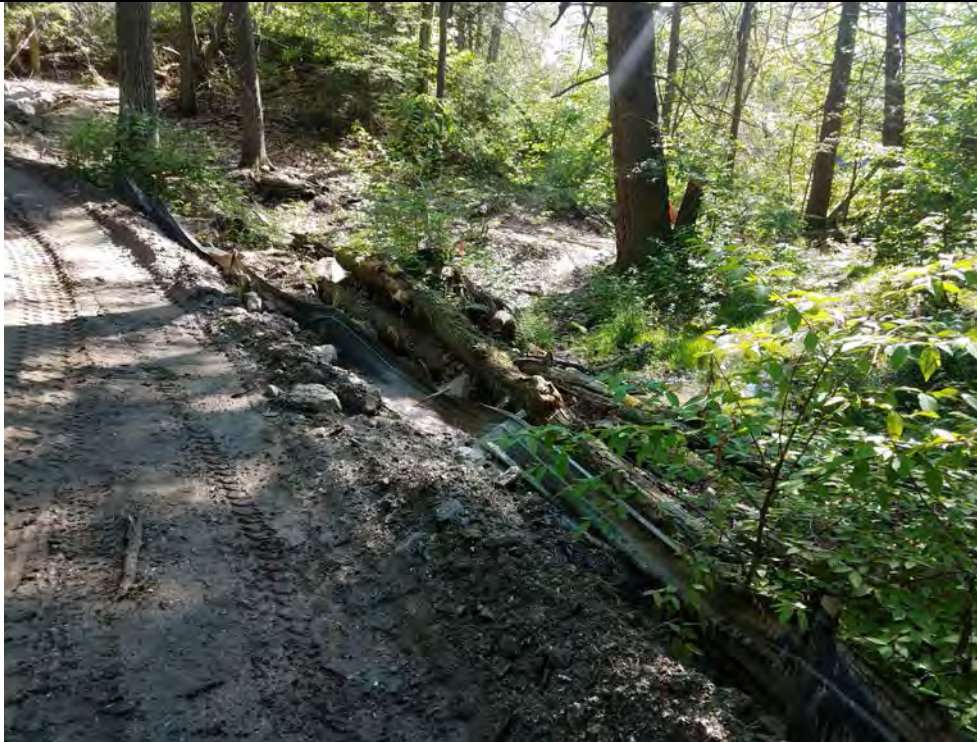
Photo 2: 06/02/2017, Watertown: Map 16, E&S control maintenance and access road improvements required at wetland W-C22.
