**Subject: Docket No. 466, Frost Bridge to Campville 115-kV Project
Decision and Order Condition #4 – Independent Environmental Inspector Report**

Please find enclosed the Biweekly Independent Environmental Inspector Report, Report #15, for the **June 23rd** and **June 30th 2017**, inspection events for the construction of the Eversource Frost Bridge to Campville 115-kV Project.

Docket No. 466- Development and Management Plan Inspection

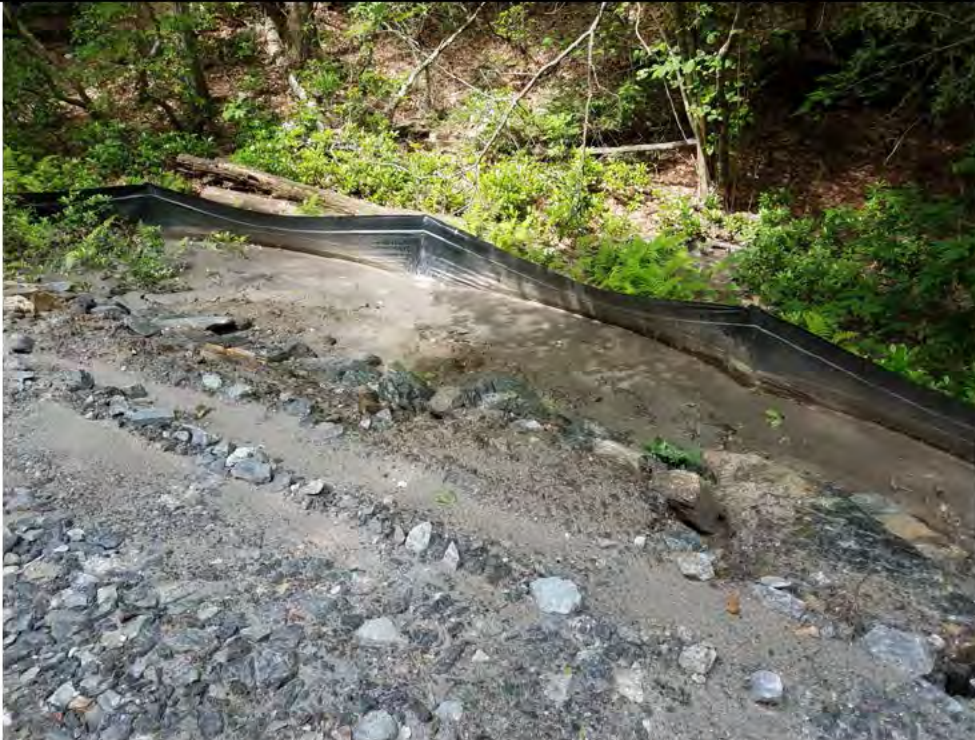
Photo 2: 06/23/2017, Watertown: Map 15, access road between Str41 and Str42, Silt fence maintenance required (Along the same silt fence line as Photo 1 above). UPDATE-As of 6/27/2017, Matt Davison reported this area is being worked on.

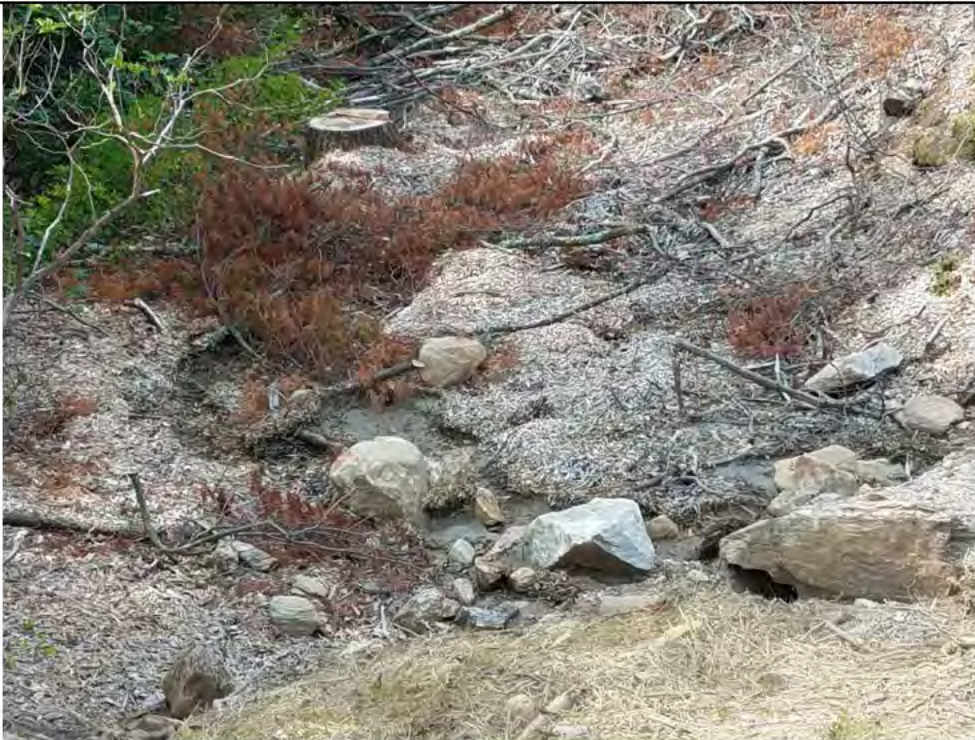
Photo 4: 06/23/2017, Watertown: Map 15, Str42 pad, At south end of the pad, storm water runoff is channeled to the slope via cut swale and fine sediments from the pad materials are travelling down the slope to the south. UPDATE-As of 6/27/2017, Matt Davison reported that this area is being worked on.

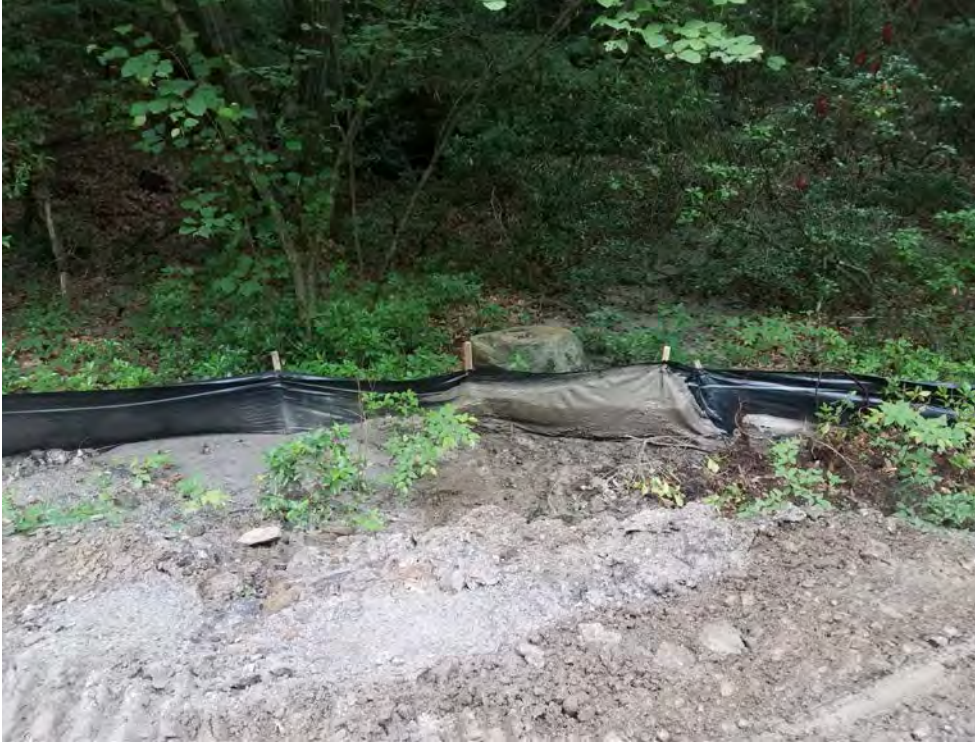
Photo 5: 06/30/2017, Watertown: Map 15, access road between Str41 and Str42, Silt fence maintenance performed. Sedimentation buildup occurred after 7/27/17 is in the process of being removed by Northern.

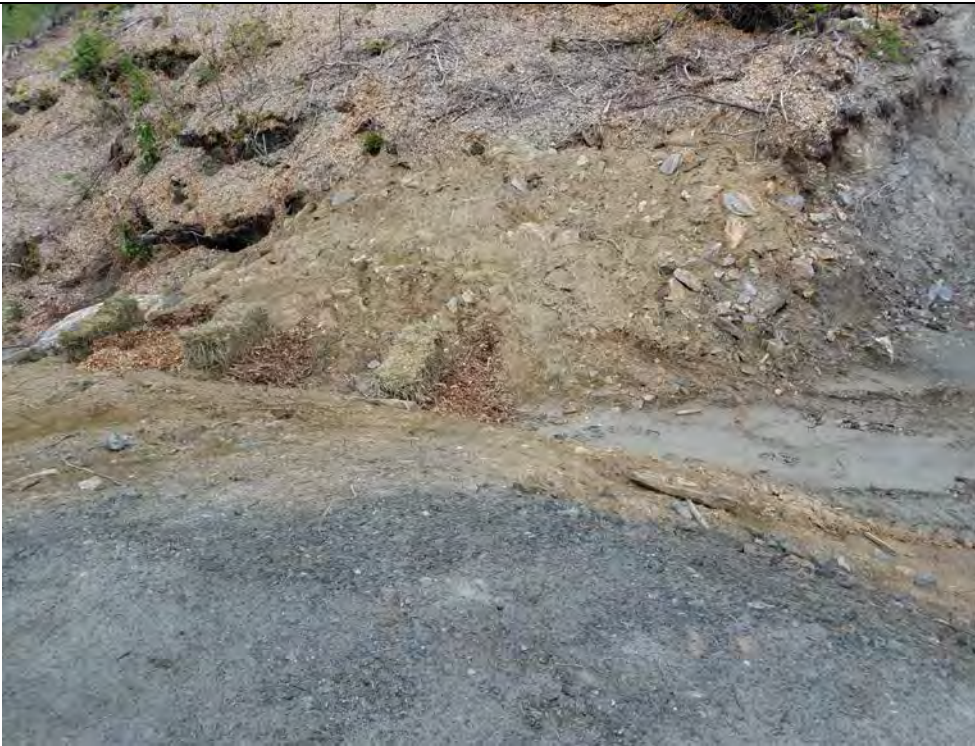
Photo 6: 06/30/2017, Watertown: Map 15, Str42 pad, at south end of the pad, storm water runoff is channeled to the slope via cut swale. Northern placed hay bales and wood chips (check dams) to capture sediments prior to slope. Sedimentation on slope will be addressed as part of the project restoration phase. No sensitive areas affected.
