**Subject: Docket No. 466, Frost Bridge to Campville 115-kV Project
Decision and Order Condition #4 – Independent Environmental Inspector Report**

Please find enclosed revision of the Biweekly Independent Environmental Inspector Report, Report #15 **REVISION**, for the **June 23rd** and **June 30th 2017**, inspection events for the construction of the Eversource Frost Bridge to Campville 115-kV Project.

Docket No. 466- Development and Management Plan Inspection

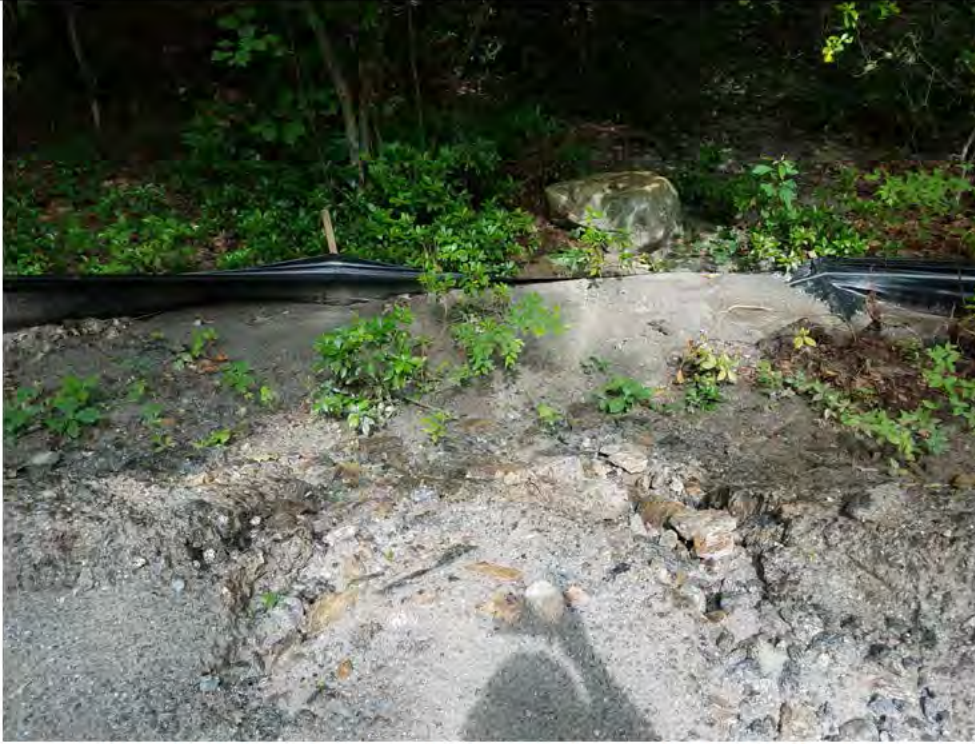
Photo 1: 06/23/2017, Watertown: Map 15, access road between Str41 and Str42, Silt fence maintenance required. No sensitive areas affected. UPDATE-As of 6/27/2017, Matt Davison reported that this area is being worked on.

Silt fence repair (downed silt fence repaired as shown in photos #1 and #5).

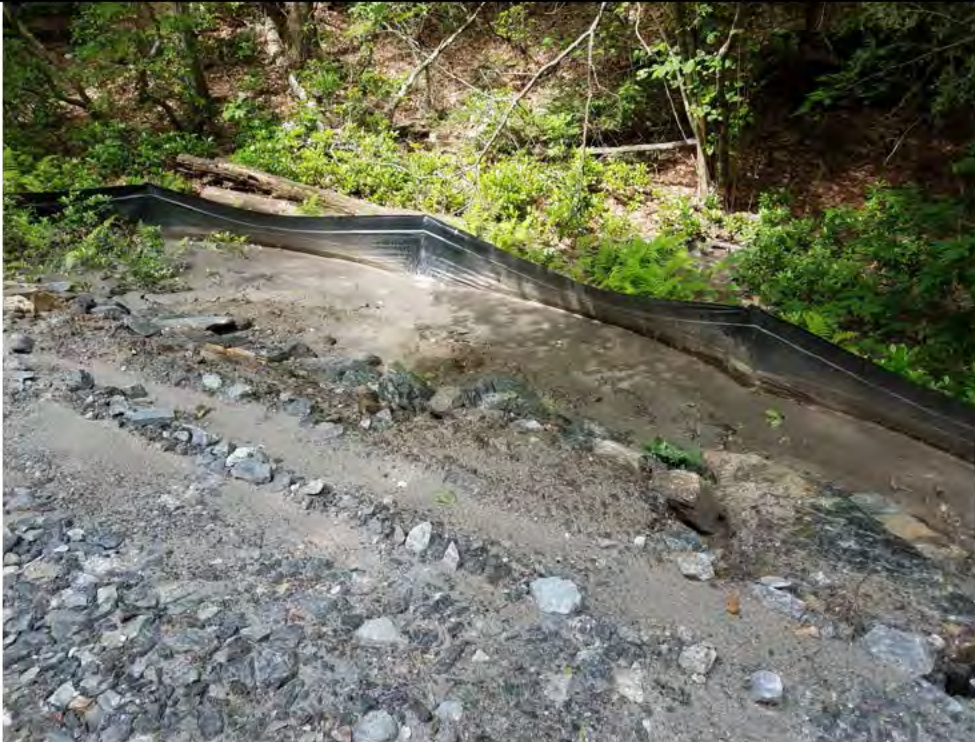
No visible difference was observed in the volume of sediment build up on the silt fence in the area of Str41-Str42 access road. The area was reportedly cleared by hand by Northern however after doing so a rain event occurred

Continued from above- and reportedly the sediment again accumulated against the silt fence. No inspection was performed during or immediately following the removal action nor was a photo provided by Northern of the area showing that the sediment had been cleared as requested. No change can be seen in the photos. Note the leaf by the 3rd stake in from the left on both photos, Photo #2 taken on the 6/23 and Photo #6 taken on 6/30.

Photo 2: 06/23/2017, Watertown: Map 15, access road between Str41 and Str42, Silt fence maintenance required (Along the same silt fence line as Photo 1 above). UPDATE-As of 6/27/2017, Matt Davison reported this area is being worked on.

Same as above, excess sediments must be removed to prevent a break through and to properly maintain perimeter E&S controls.

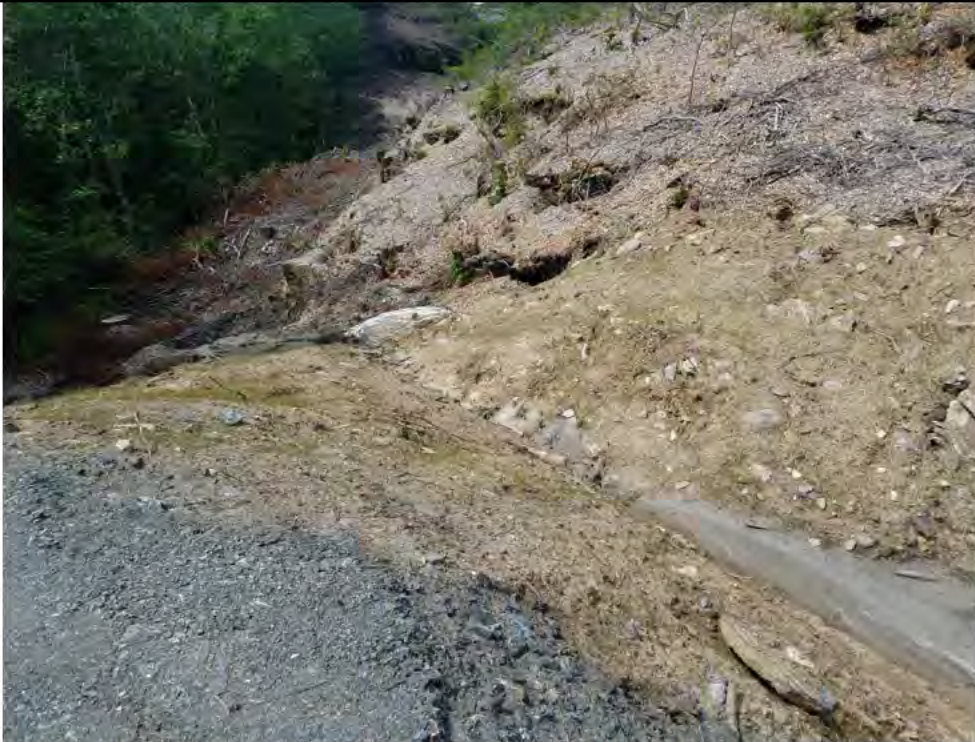
Photo 3: 06/23/2017, Watertown: Map 15, Str42 pad, at south end of the pad, storm water runoff is channeled to the slope via cut swale. Fine sediments from the pad materials are travelling down the slope to the south (See below, Photo 4) however no sensitive areas are affected. E&S controls should be implemented here to capture sediments and prevent further erosion of slope. UPDATE-As of 6/27/2017, Matt Davison reported that this area is being worked on.

Erosion and Sedimentation Controls	Interim Week	<p>Excessive sediments were deposited along the silt fence located just before the bend of the access road (Northwestern most part of the rd) between Str41 & Str42 (Watertown, Maps 14 & 15). Sedimentation and erosion was observed at the south end of the pad and slope at Str42 (See Photos 3 & 4). No sensitive areas directly affected.</p>	<p>Remove buildup of sediments, and repair or replace downed or damaged silt fence (See Photos 1 & 2). Consider installation of water bars and/or temporary sediment pools upland of perimeter E&S and prevent stormwater runoff from eroding slope areas.</p>	<p>As of 6/27/2017, these areas were being attended to and resolved. Updated photos will be taken at the next scheduled inspection on 6/30/2017 and included in the Biweekly Report.</p>
	Bi-Week	<p>Excess sediment buildup on the silt fence that was reported in the interim week report (6/23/17) was still present as of this report (see photo 6). The downed silt fence was repaired (see photo 5). Hay bales and wood chips (check dam) were placed at the south end of Str42 (see photo 7). Sedimentation still exists on slope (see photo 8).</p>	<p>Remove excess sediment buildup on silt fence and continue to maintain or replace E&S controls to prevent buildup and/or break through conditions. Install E&S controls upland of perimeter controls to prevent erosion/sedimentation.</p>	<p>Pending</p>

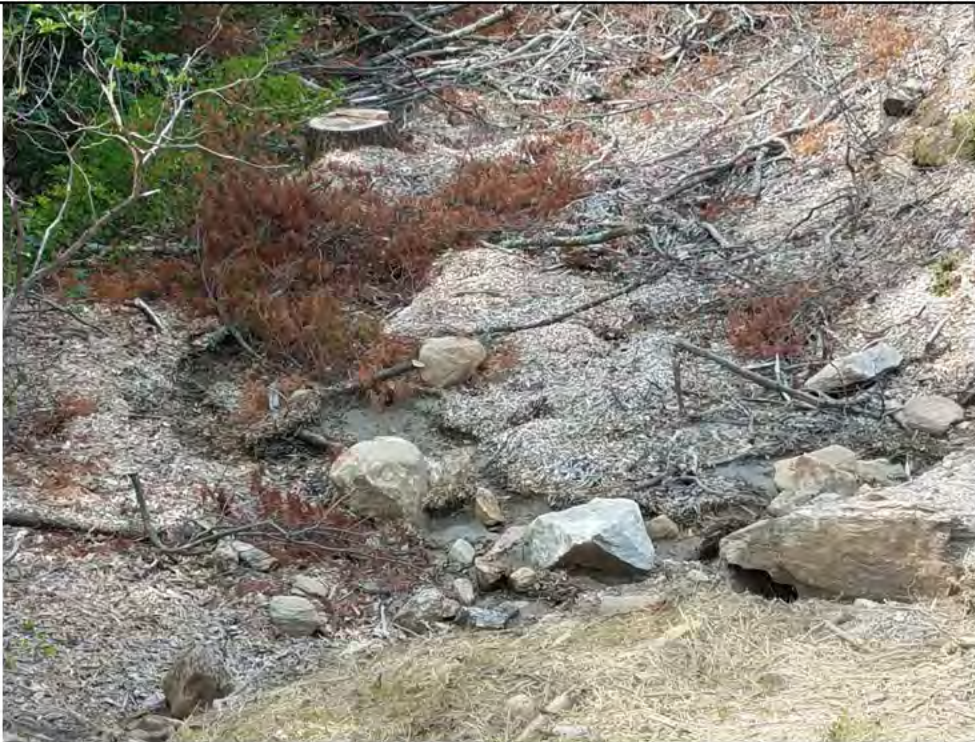
Photo 4: 06/23/2017, Watertown: Map 15, Str42 pad, At south end of the pad, storm water runoff is channeled to the slope via cut swale and fine sediments from the pad materials are travelling down the slope to the south. UPDATE-As of 6/27/2017, Matt Davison reported that this area is being worked on.

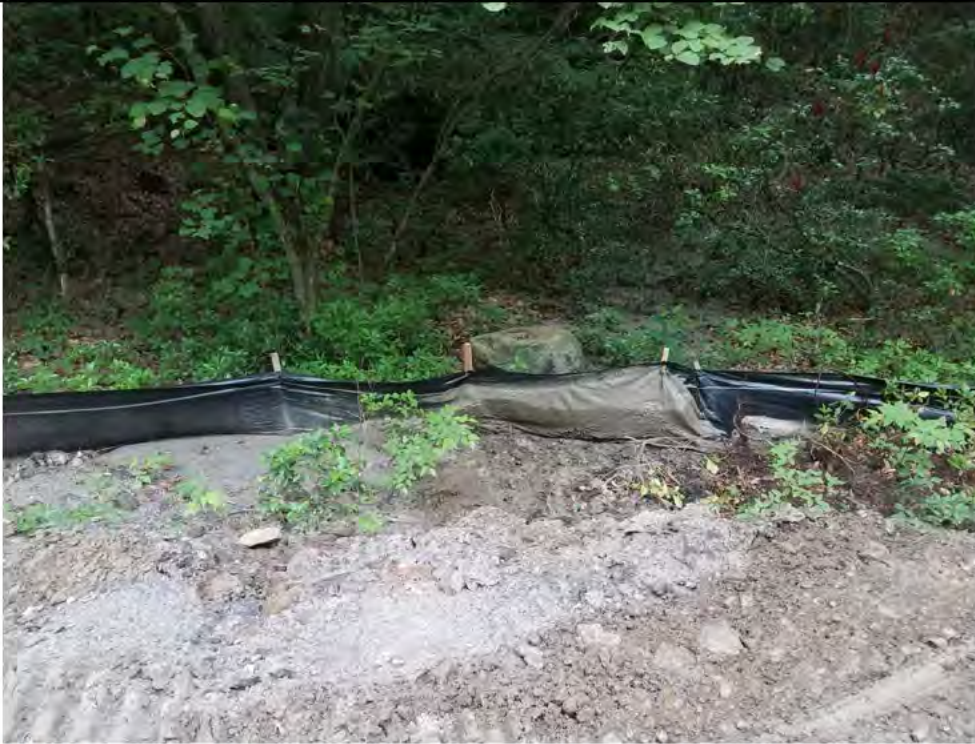
Photo 5: 06/30/2017, Watertown: Map 15, access road between Str41 and Str42, Silt fence maintenance performed.

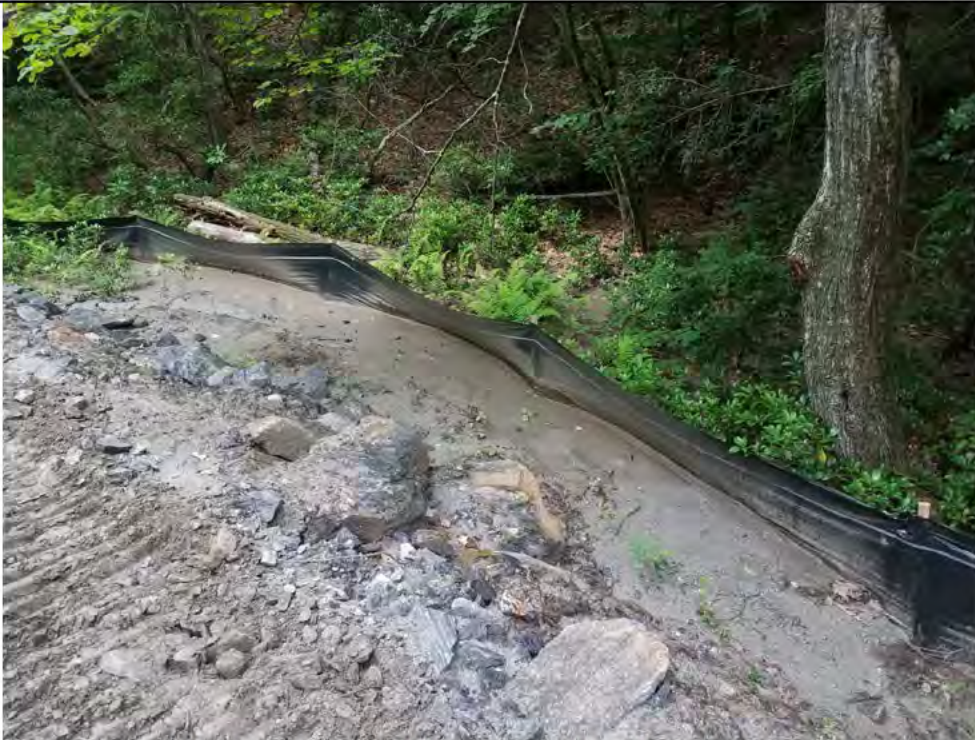
Photo 6: 6/30/2017, Watertown: Map 15, access road between Str41 and Str42, Silt fence maintenance was reportedly performed and since then a rainfall event caused more sediment buildup and the area needs to be cleared again. No noticeable change between this event and the previous Interim event Photo #2. Note the leaf by the 3rd stake in from the left on both photos, Photo #2 taken on the 6/23 and Photo #6 taken on 6/30.

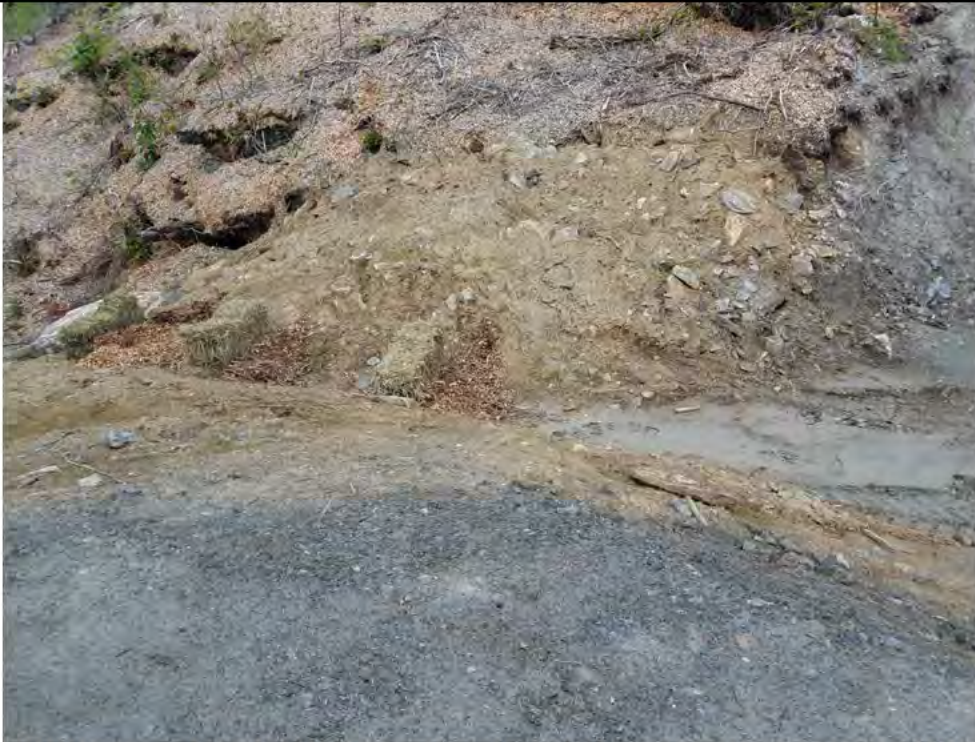
Photo 7: 06/30/2017, Watertown: Map 15, Str42 pad, at south end of the pad, storm water runoff is channeled to the slope via cut swale. Northern placed hay bales and wood chips (check dams) to capture sediments prior to slope.

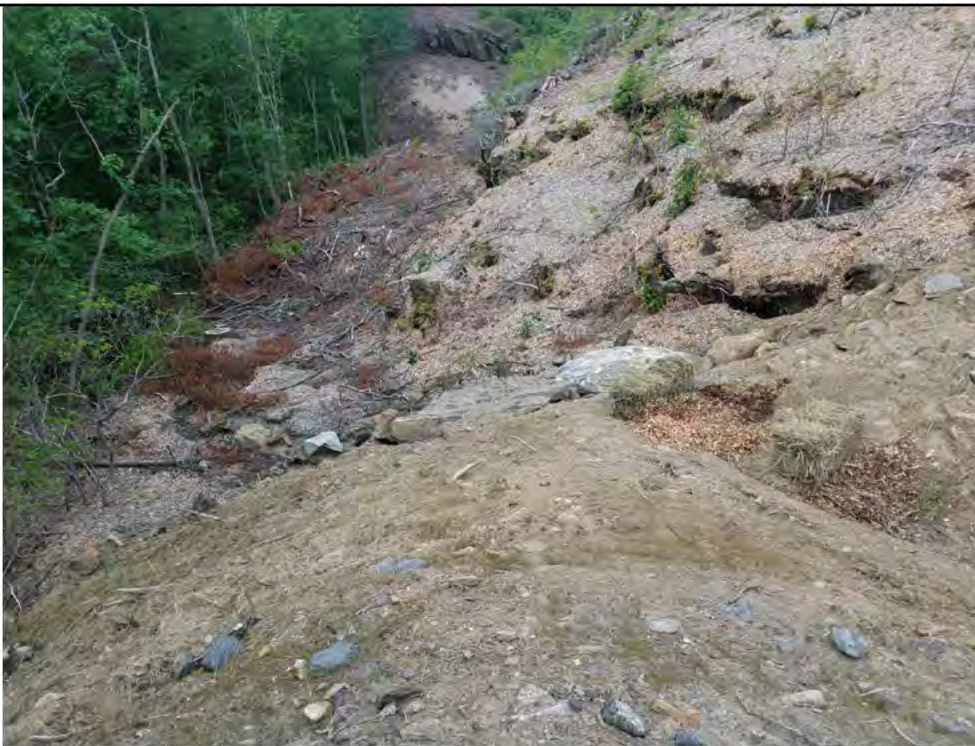
Photo 8: 06/30/2017, Watertown: Map 15, Str42 pad, at south end of the pad, Sedimentation on slope will reportedly be addressed as part of the project restoration phase.
