**Subject: Docket No. 466, Frost Bridge to Campville 115-kV Project
Decision and Order Condition #4 – Independent Environmental Inspector Report**

Please find enclosed the Biweekly Independent Environmental Inspector Report, Report #20, for the **September 1st** and **September 8th, 2017**, inspection events for the construction of the Eversource Frost Bridge to Campville 115-kV Project.

Docket No. 466- Development and Management Plan Inspection

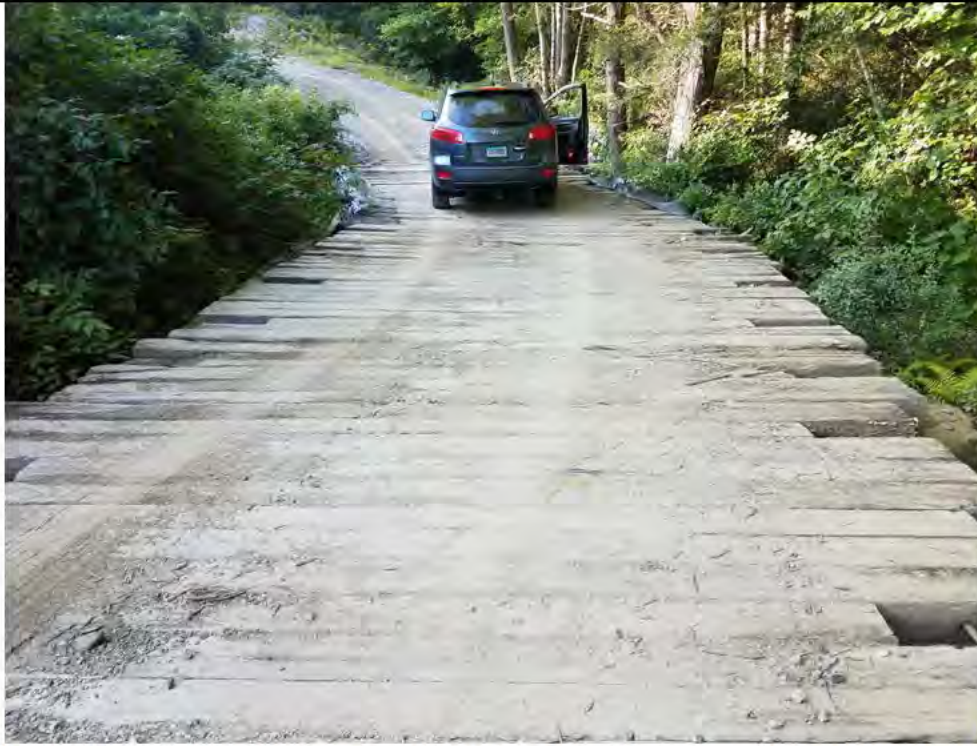
Water Crossings	Interim Week	<p>Observed crossings are clear of tracked sediments and maintained as required.</p> <p>The timber mats set at W-C15/S-C5 need to be reset, they are shifting due to heavy equipment traffic around the bend of the access road, see photos #1 (09/01/17), #3 and #4.</p>	N/A	N/A
	Bi-Week	<p>Timber crossings at W-C15/S-C5, and at W-C20 need to be cleaned of excess sediments (See photos). No impacts to the underlying wetlands or watercourses due to sediments falling through gaps were observed. However, storm water flow across the timbers may cause buildup of sediments to wash into the underlying wetlands or watercourses if not cleared and maintained. The timber mats set at W-C15/S-C5 should be reset. Several mats have shifted due to equipment traffic in the ROW. See photos #1 (09/01/17) and photo #3 and #4 (09/08/17).</p>	<p>Resetting the timber mats at W-C15/S-C5 is purely a health and safety concern with respect to heavy equipment traffic and/or pedestrian foot traffic. No direct impacts to the wetland/watercourse was observed due to the shift in the mats.</p>	PENDING

Photo 1: 09/01/2017, Watertown: Map 12, timber mat crossing at W-C15/S-C5, timbers pushed to the outside of the bend (seen at below the parked vehicle).

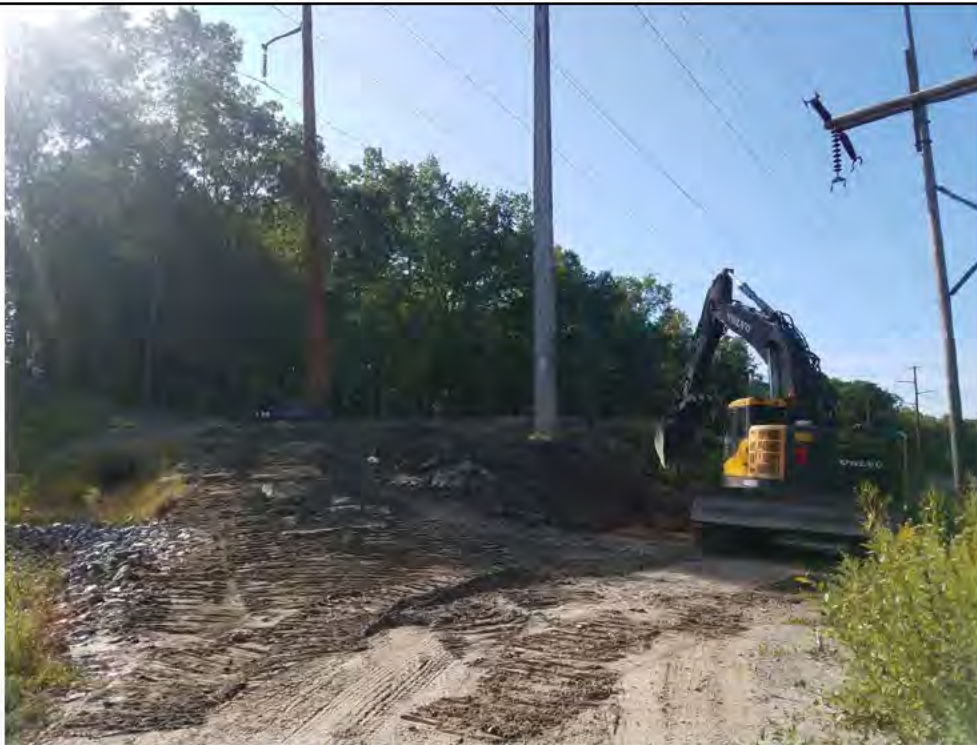
Photo 2: 09/01/2017, Thomaston/Litchfield: Maps 25-26, Eversource Maintenance crew at Str73 grading pad with excavator bucket.

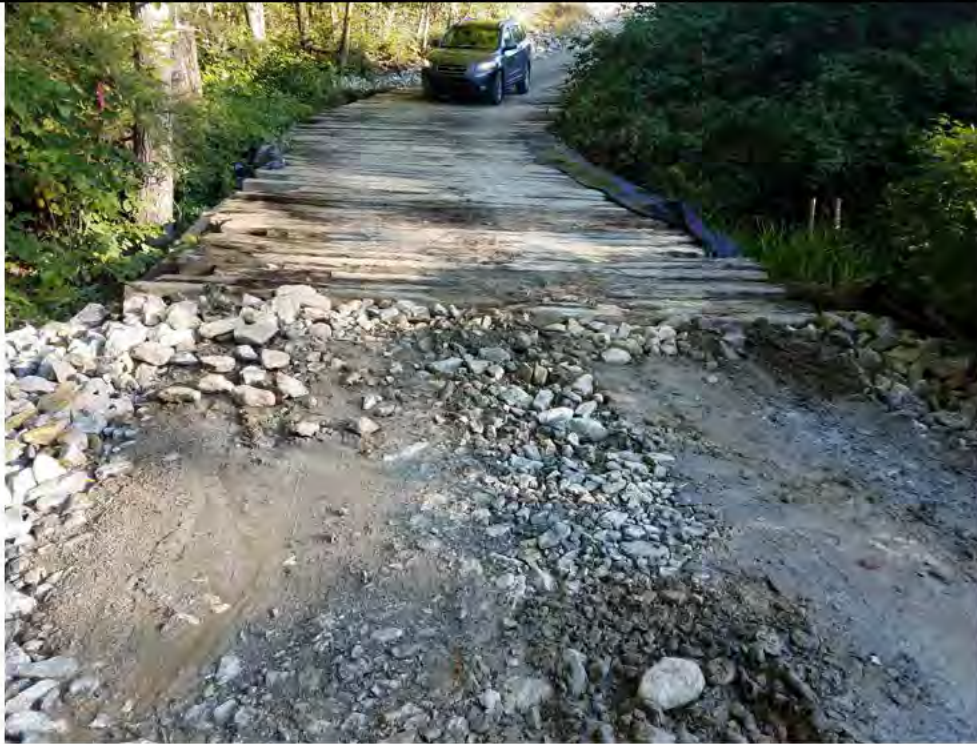
Photo 3: 09/08/2017, Watertown: Map 12, timber mat crossing at W-C15/S-C5, timbers pushed to the outside of the bend in the access road.

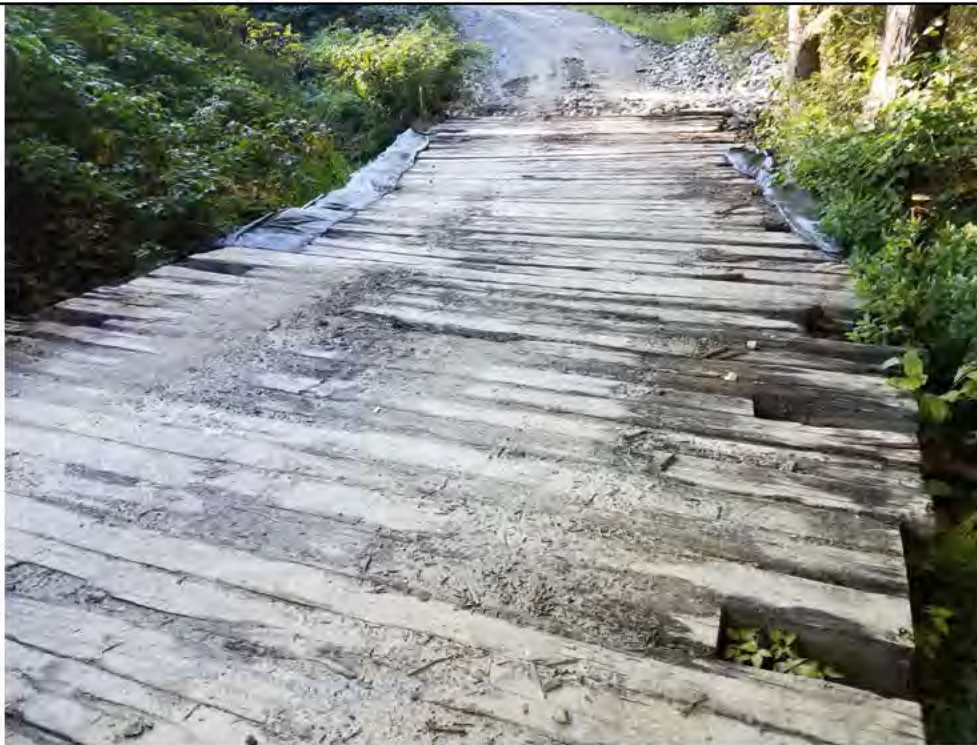
Photo 4: 09/08/2017, Watertown: Map 12, timber mat crossing at W-C15/S-C5, timbers pushed to the outside of the bend in the access road.

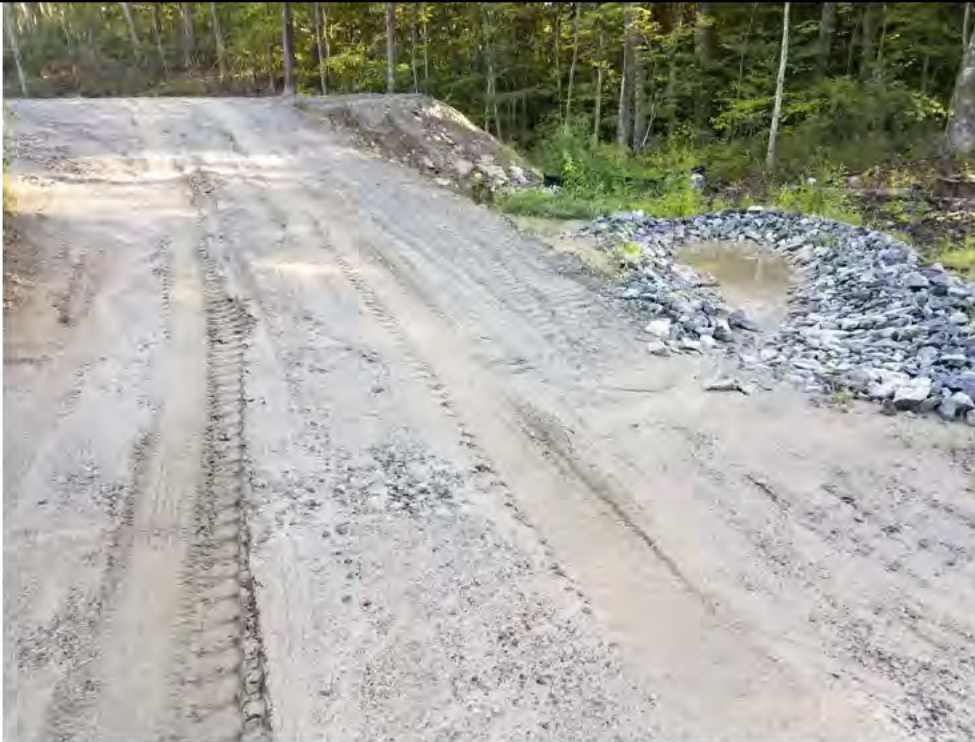
Photo 5: 09/08/2017, Watertown: Map 13, South of Str36, temporary sediment basin, movement of sediments along access road caused by storm water flow.

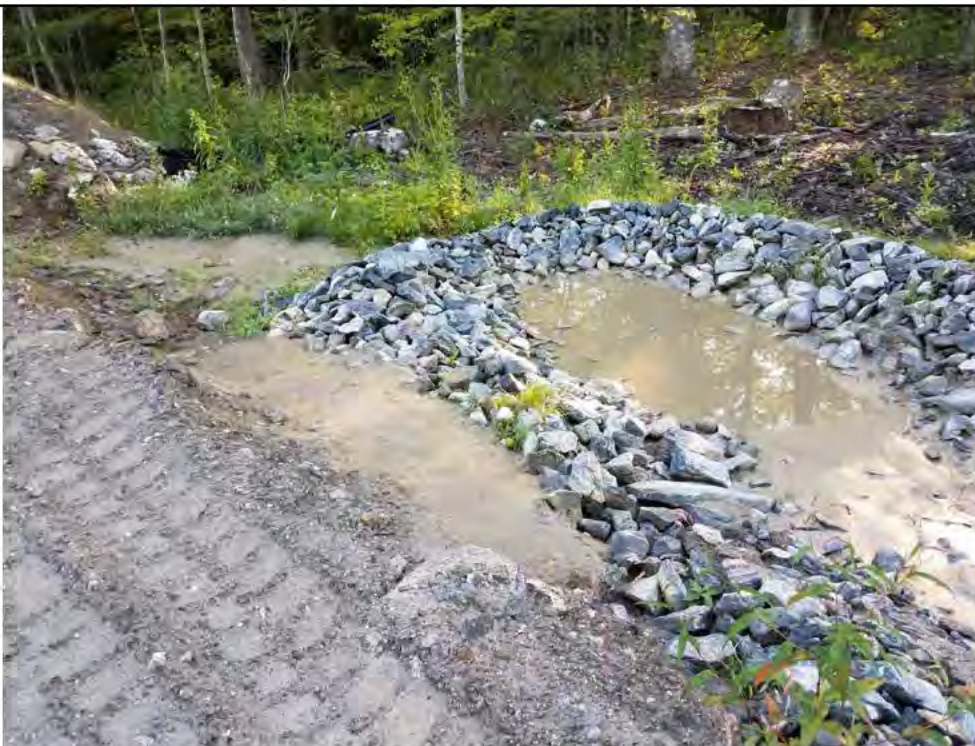
Photo 6: 09/08/2017, Watertown: Map 13, south of Str36, excess sediments in temporary basin, sediment runoff from uncontrolled storm water flow off the access road.

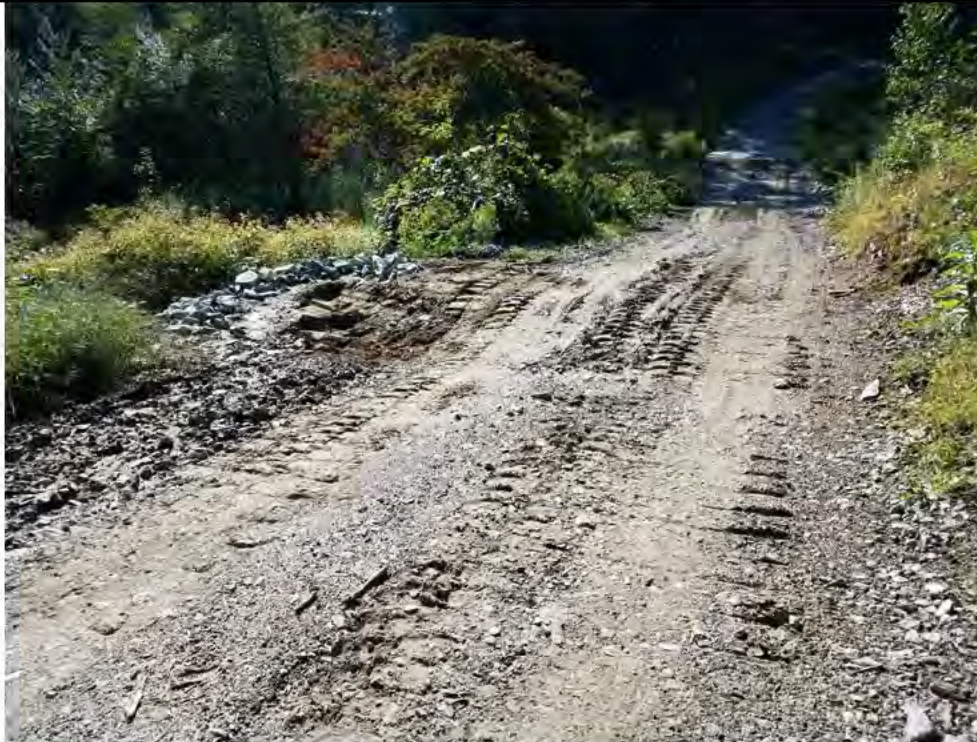
Photo 7: 09/08/2017, Watertown: Map 10, between Str26 and Str27, water bar flattened out, sediment buildup in temporary sediment pond.

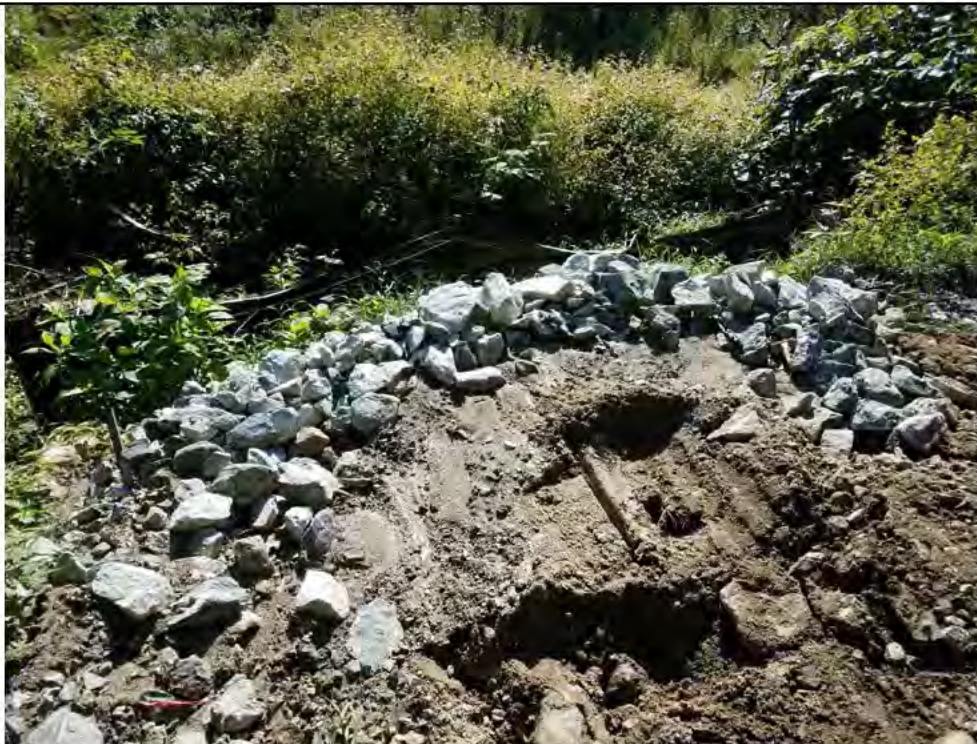
Photo 8: 09/08/2017, Watertown: Map 10, between Str26 and Str27, excess buildup of sediment in temporary sediment pond.

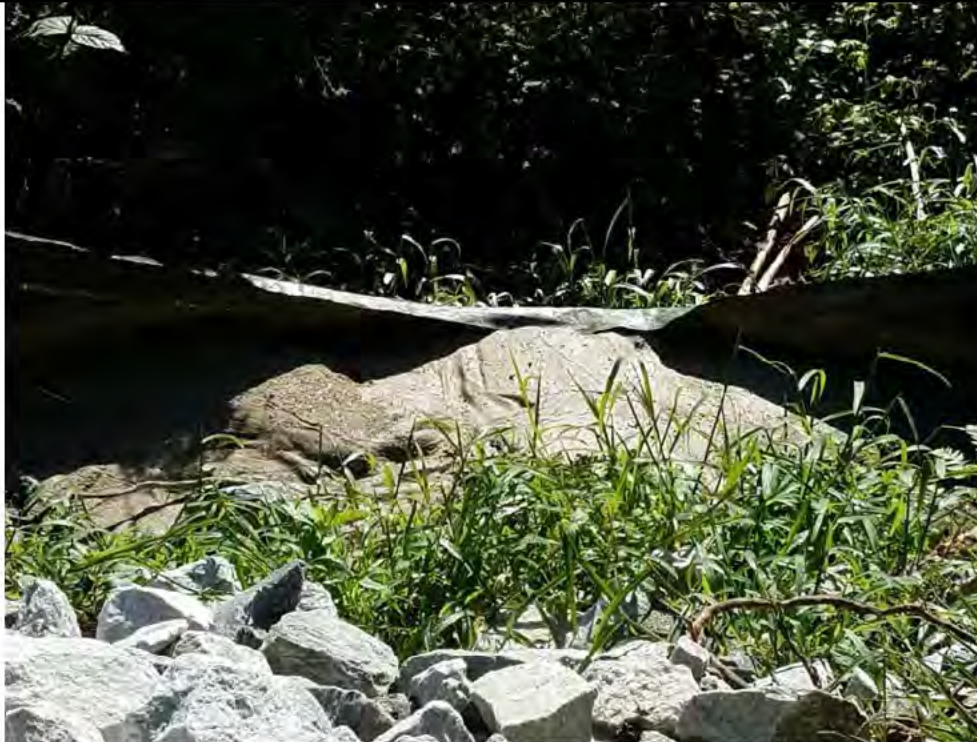
Photo 9: 09/08/2017, Watertown: Map 10, between Str26 and Str27, excess buildup of sediment in temporary sediment pond, excess buildup on silt fence.

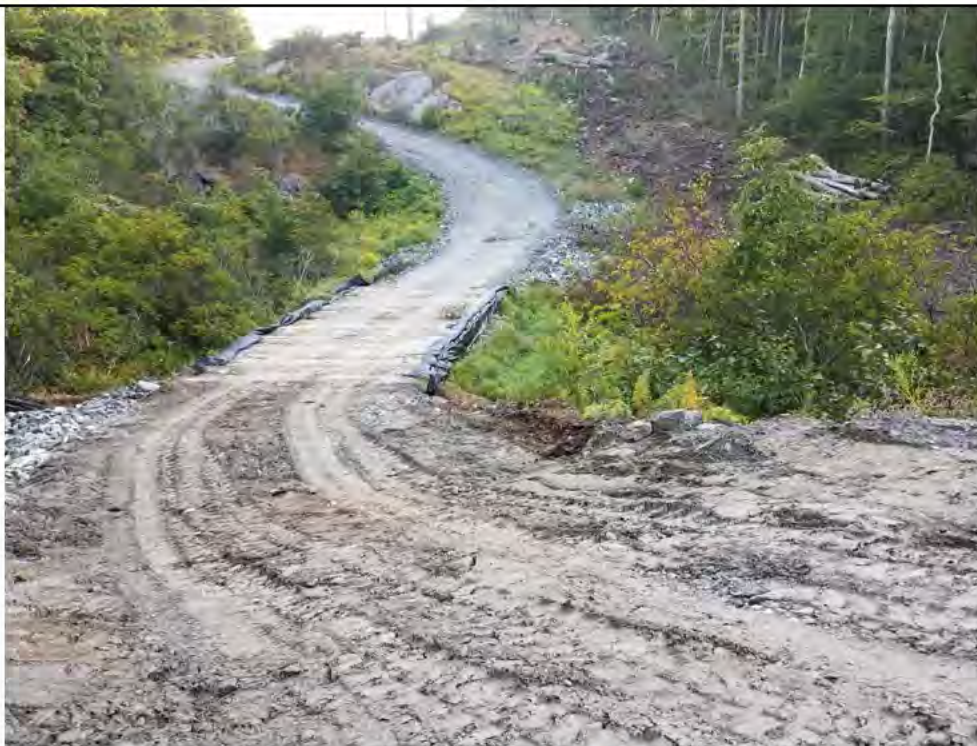
Areas of Inspection		Observation:	Recommended Action/s:	Corrected Action/s:
Access Roads and Adjacent Roadways	Interim Week	ROW access roads appear in good condition with no tire rutting or erosion issues observed.	N/A	N/A
	Bi-Week	ROW access roads appear in good condition overall in areas inspected today with the exception of multiple areas between Str27 and Str45 where erosion and sediment buildup was observed. CONTINUED SEE BELOW-	Repair and maintain ROW access roads, pads, and slopes to prevent movement of soil during future rain events until restoration can be completed and turf has been established.	PENDING
Vegetative Clearing Limits (Including trees to save or danger trees noted.	Interim Week	09/01/17: None occurring at this time. 09/08/17: Access road north of Str39 to W-C20 is in poor condition and storm water flow through this area is continuing to cause sediment buildup on perimeter E&S to the point where repeated break through has occurred over the duration of the project thus far impacting W-C20. See photos 10 through 13.	N/A	N/A

Photo 10: 09/08/2017, Watertown: Map 14, access road north of Str39 to wetland W-C20, water bar flattened out.

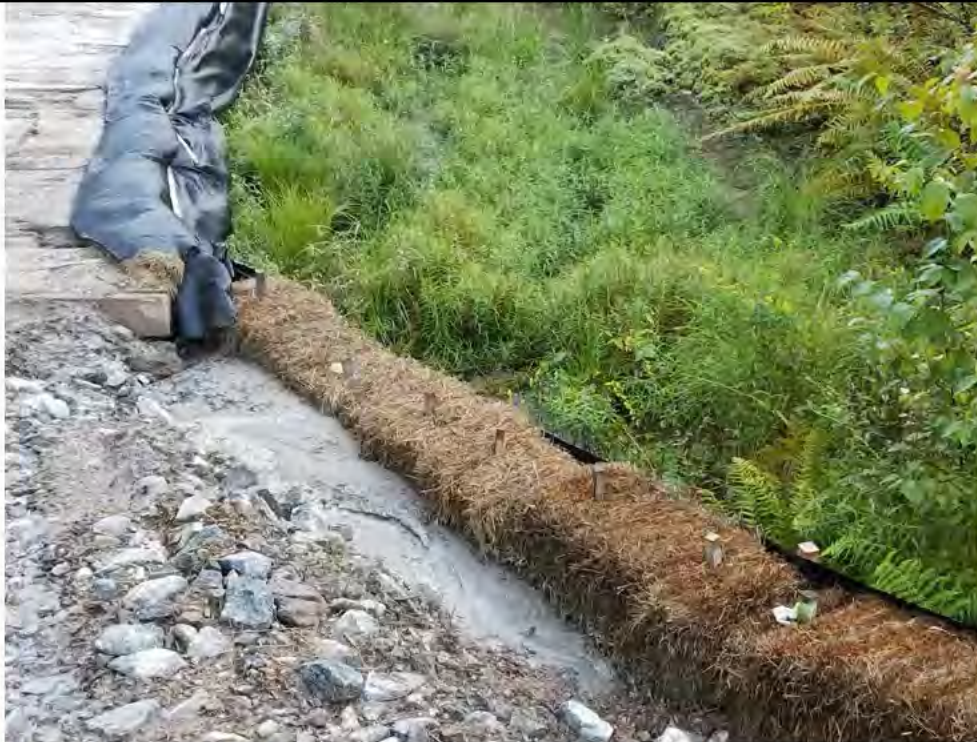
<p style="text-align: center;">Inland Wetland and Watercourse encroachment and mitigation (Continued from previous page)</p>	<p style="text-align: center;">Bi-Week</p>	<p>Sedimentation impacts were observed at W-C20. Excess sediment buildup on perimeter silt fence and hay bales broke through impacting the wetlands. This is a reoccurring problem at this location due to poor road conditions upland (south towards Str39) of the impacted area.</p>	<p>Improve upland road conditions, remove excess sediments from perimeter E&S controls and restore wetlands under the direction of Davidson Environmental.</p>	<p style="text-align: center;">PENDING</p>
<p style="text-align: center;">Spills and Material Storage</p>	<p style="text-align: center;">Interim-Week</p>	<p>None observed or reported.</p>	<p style="text-align: center;">N/A</p>	<p style="text-align: center;">N/A</p>
	<p style="text-align: center;">Bi-Week</p>	<p>None observed or reported.</p>	<p style="text-align: center;">N/A</p>	<p style="text-align: center;">N/A</p>

Photo 11: 09/08/2017, Watertown: Map 14, at southeast corner of timber mat crossing over wetland W-C20, excess buildup of sediments.

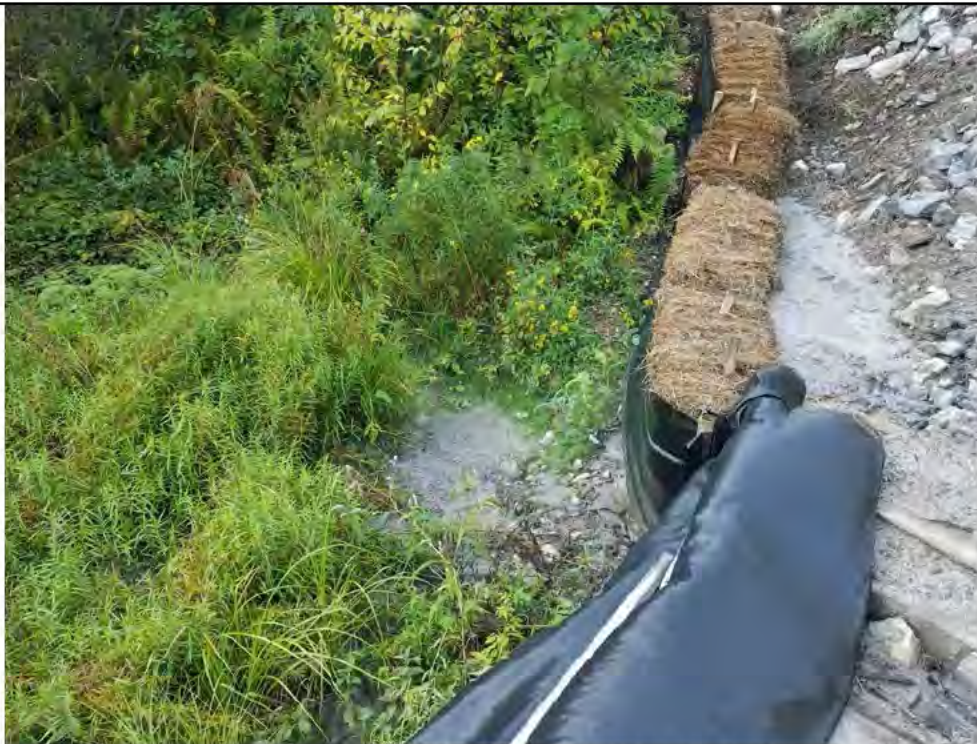
Photo 12: 09/08/2017, Watertown: Map 14, at southeast corner of timber mat crossing over wetland W-C20, excess buildup of sediments and breakthrough into W-C20.

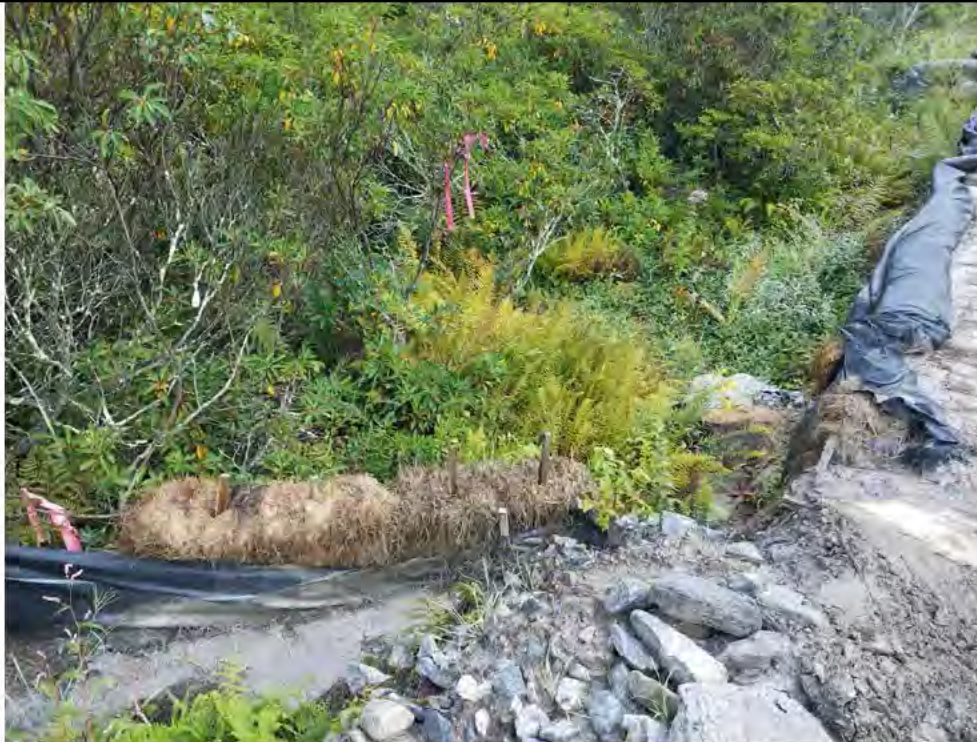
Photo 13: 09/08/2017, Watertown: Map 14, at southwest corner of timber mat crossing over wetland W-C20, excess buildup of sediments and sedimentation into W-C20.

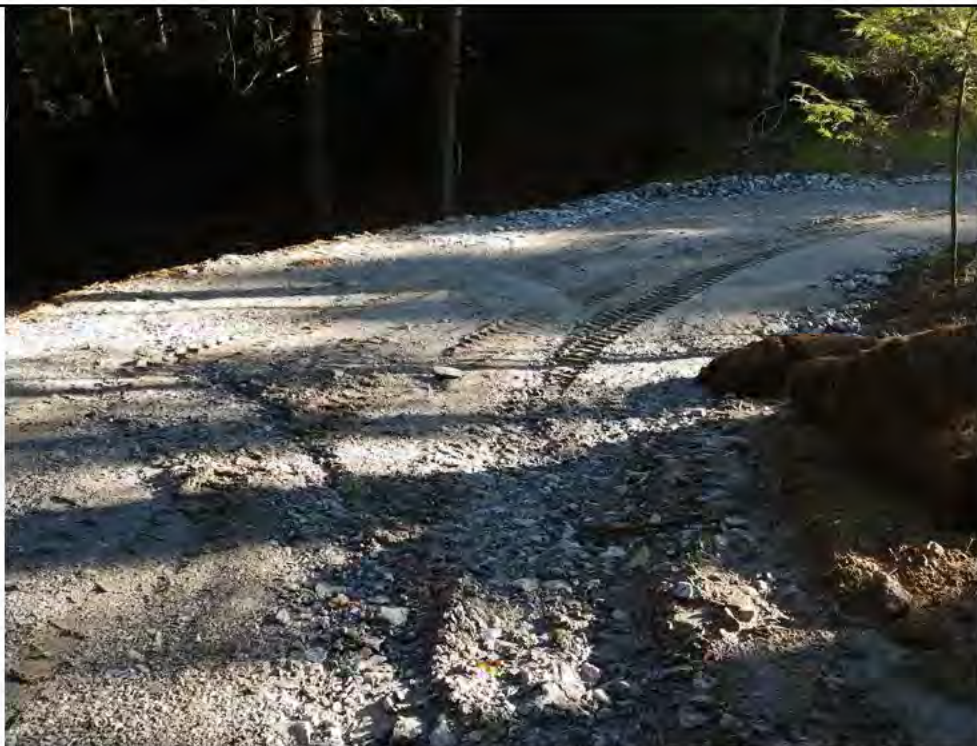
Photo 14: 09/08/2017, Watertown: Map 15, access road between Str42 and Str43, rills and visible sediment flow off outer edge of road from uncontrolled surface water flow.

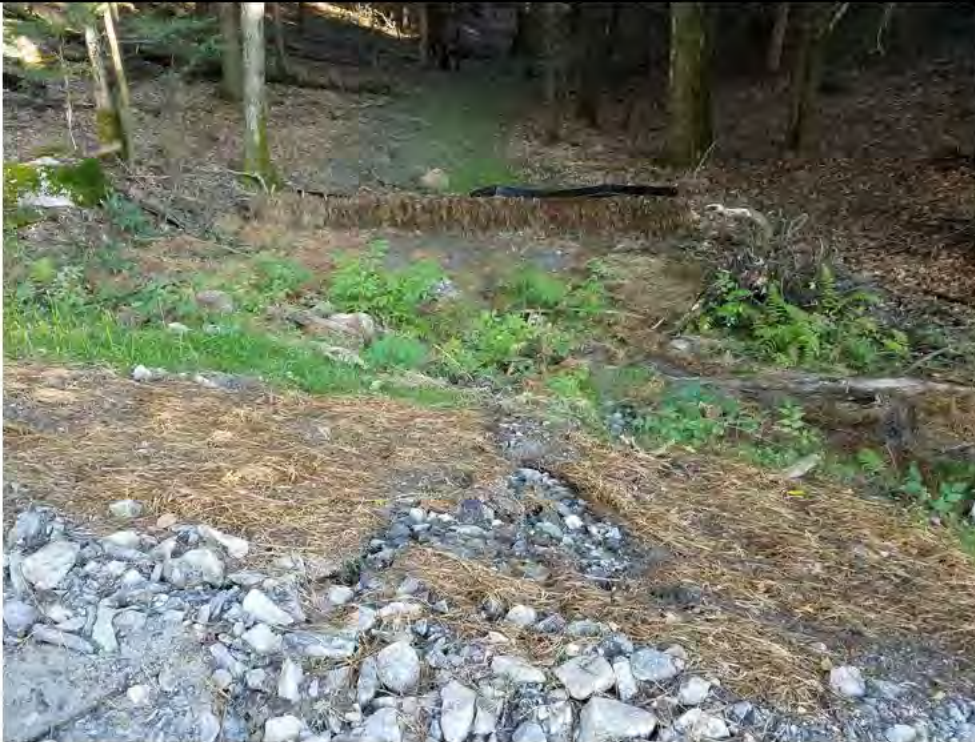
Photo 15: 09/08/2017, Watertown: Map 15, access road between Str42 and Str43, rills and sediment flow off access road, sedimentation visible down to hay bales (previously restored area).

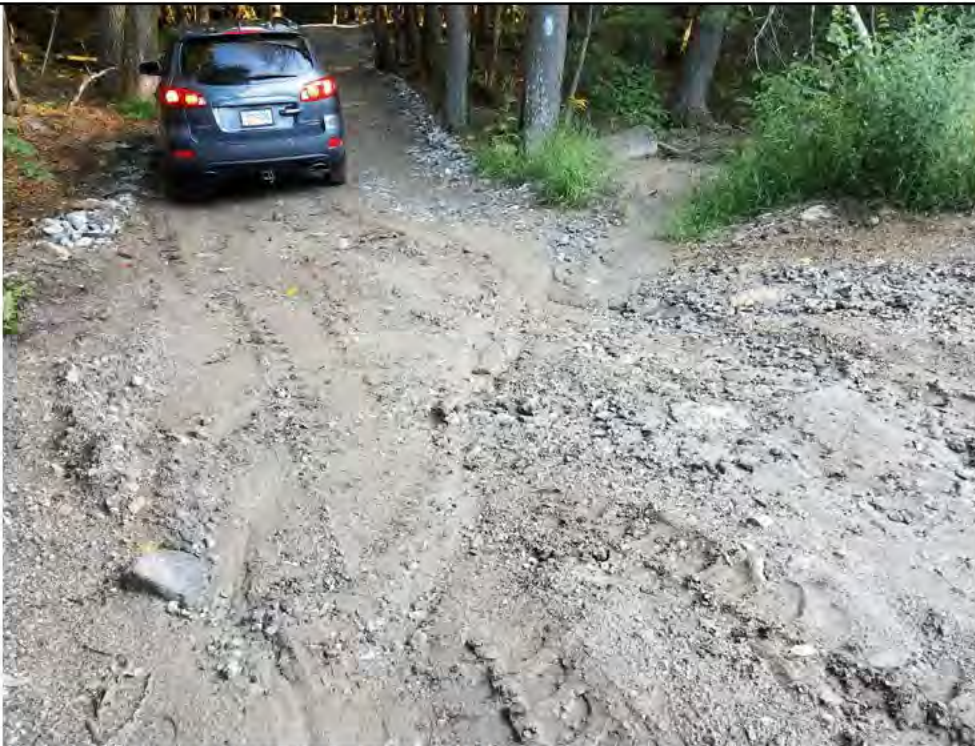
Photo 16: 09/08/2017, Watertown: Map 15, access road at Str44, rills and sediment flow off access road into wooded area.

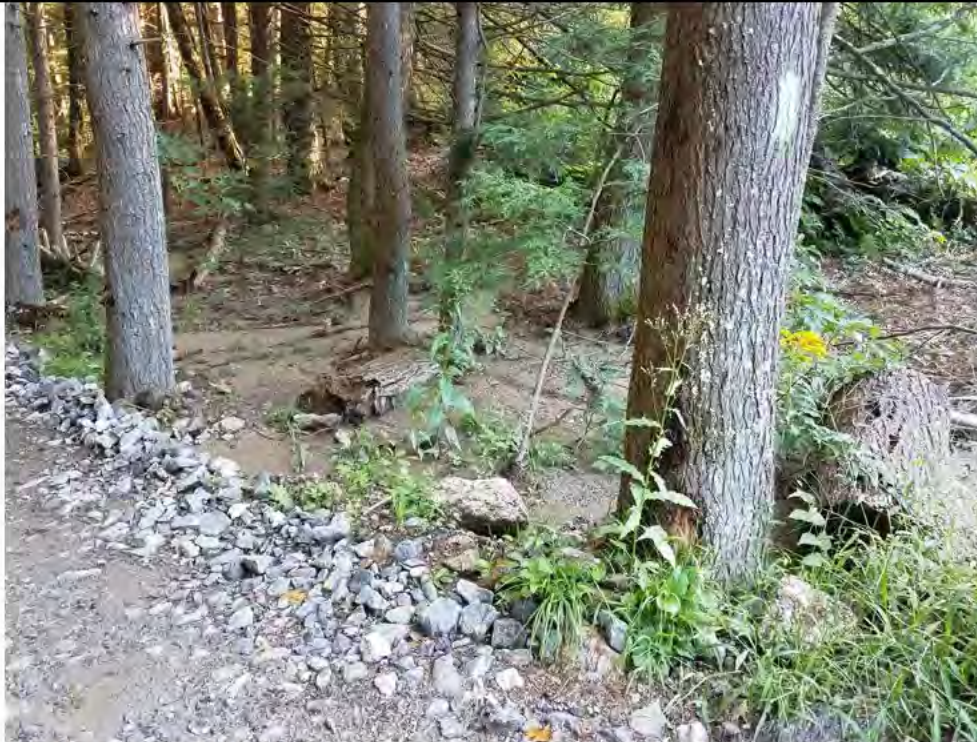
Photo 17: 09/08/2017, Watertown: Map 15, access road at Str44, rills and sediment flow off access road into wooded area.

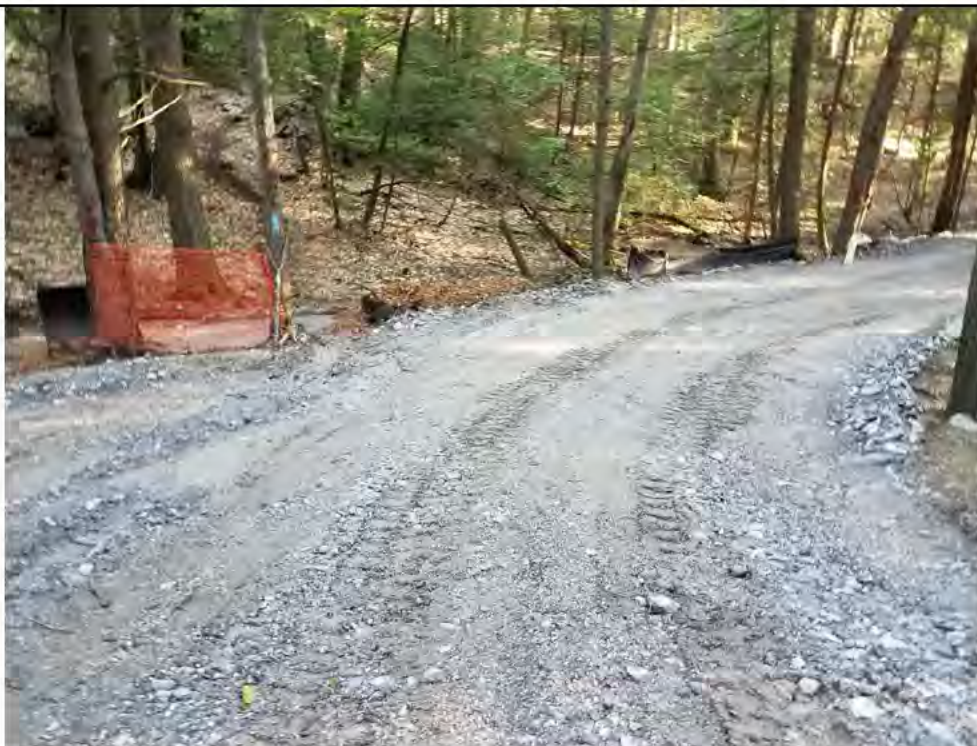
Photo 18: 09/08/2017, Watertown: Map 15, access road between Str44 and Str45 at the CT State marked Hiking trail, rills and sediment flow off access road into the access point of hiking trail.

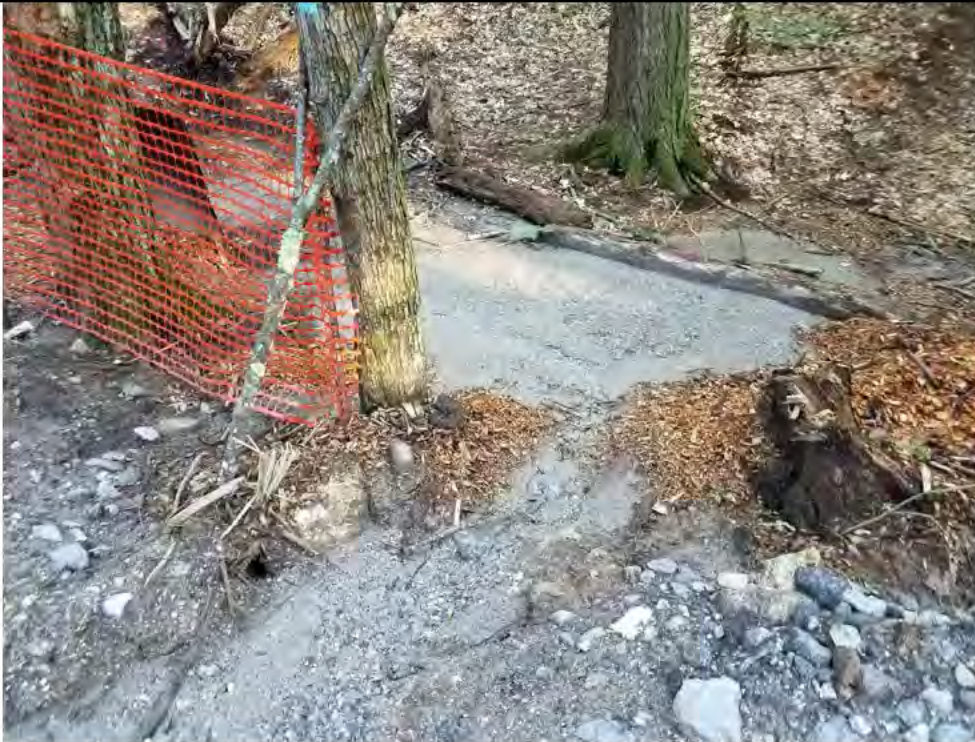
Photo 19: 09/08/2017, Watertown: Map 15, access road between Str44 and Str45 at the CT State marked Hiking trail, rills and sediment flow off access road into the access point of hiking trail.

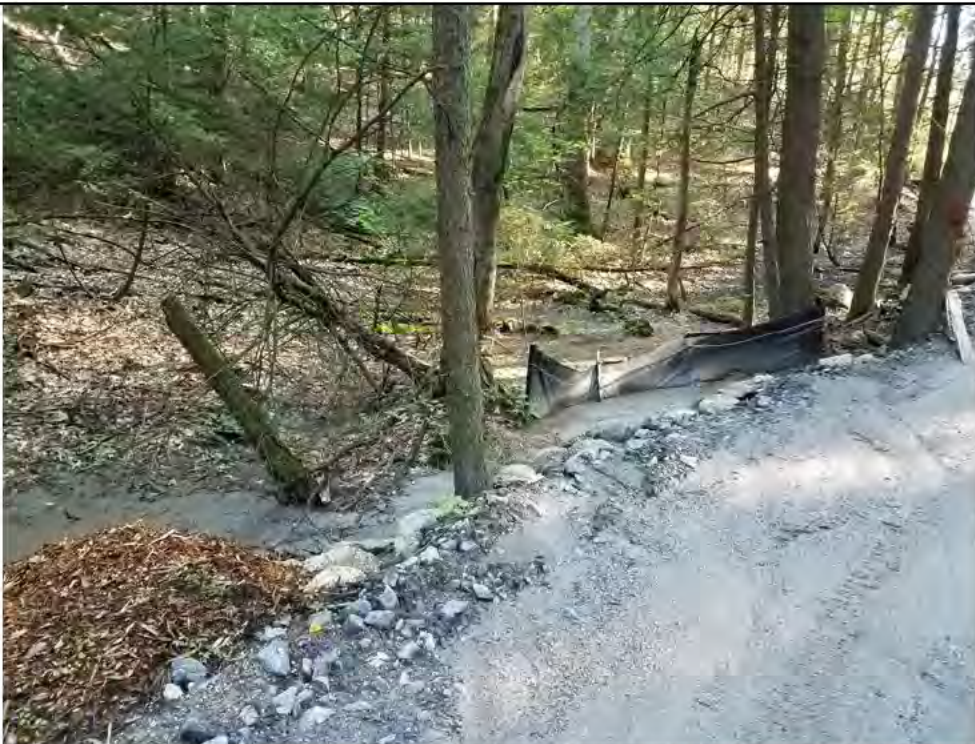
Photo 20: 09/08/2017, Watertown: Map 15, access road between Str44 and Str45 approximately 100 feet north of the CT State marked Hiking trail, rills and sediment flow off access road.

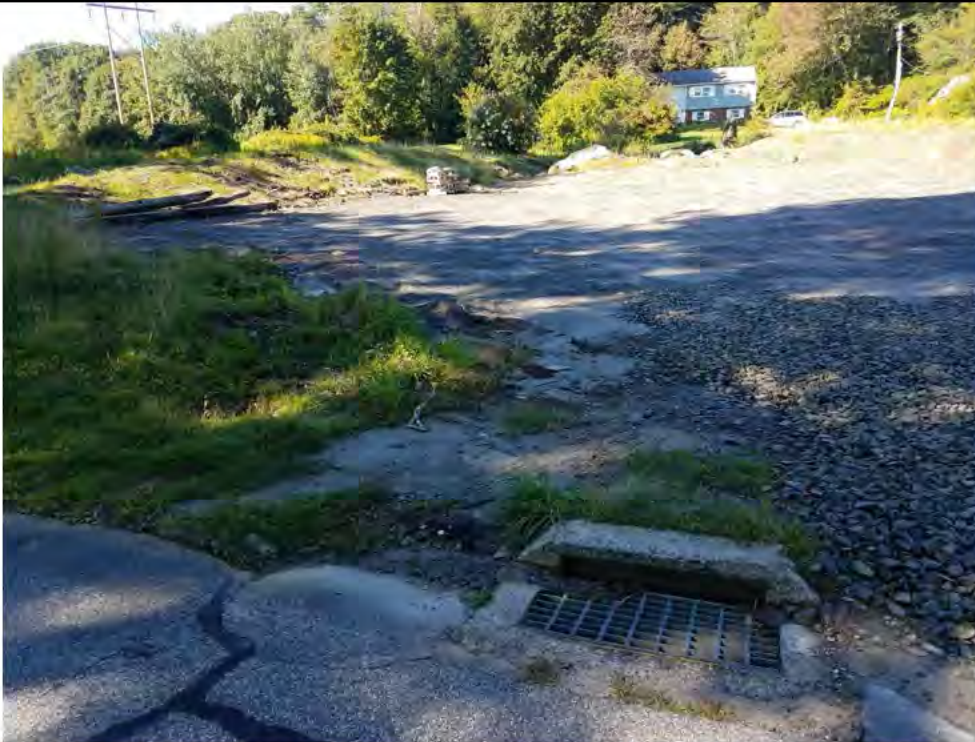
09/08/2017: Sediments are traveling into the catch basin on Campville Road at the edge of Str81 (Litchfield, Map 29). Sediments have built up in the sump to a point where sediments were observed inside the outlet pipe, see photos 21 and 22.

Photo 21: 09/08/2017, Litchfield, Map 29: At Str81, sediment flow into the catch basin located on Campville Road, no silt sack or catch basin protection

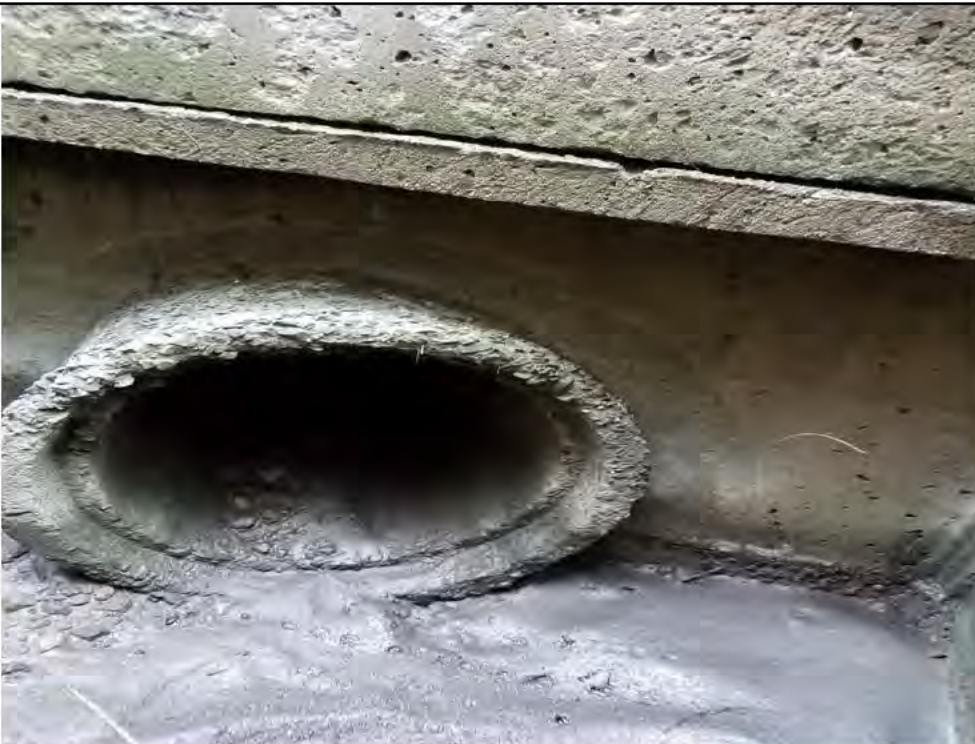
Photo 22: 09/08/2017, Litchfield, Map 29: At Str81, sediment flow into the catch basin located on Campville Road, no silt sack or catch basin protection
