**Subject: Docket No. 466, Frost Bridge to Campville 115-kV Project
Decision and Order Condition #4 – Independent Environmental Inspector Report**

Please find enclosed the Biweekly Independent Environmental Inspector Report, Report #21, for the **September 15th** and **September 22nd, 2017**, inspection events for the construction of the Eversource Frost Bridge to Campville 115-kV Project.

Docket No. 466- Development and Management Plan Inspection

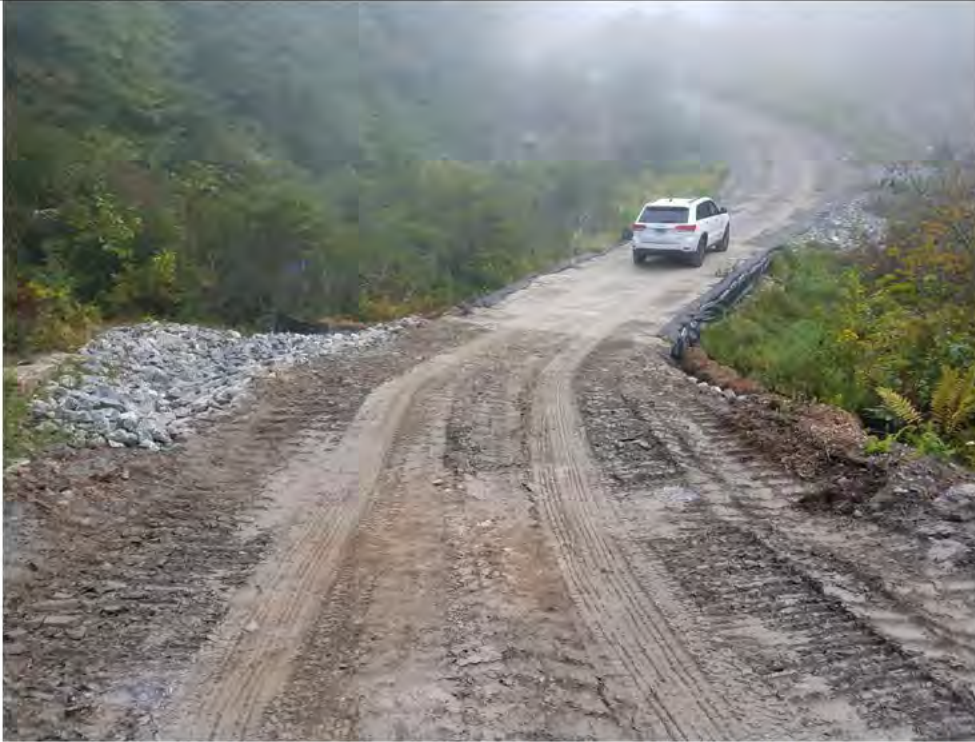
Photo 1: 09/15/17, Watertown: Map 14, access road north of Str39 to wetland W-C20, water bar flattened out. No changes in road conditions from previous inspection on 09/08/15.

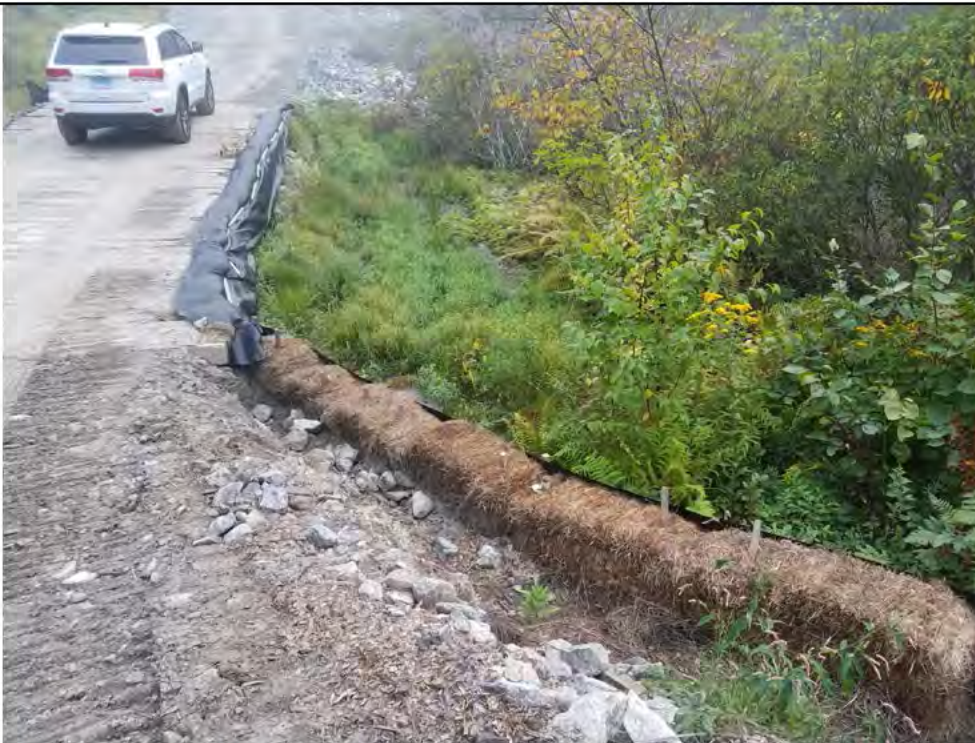
Photo 2: 09/15/17, Watertown: Map 14, at southeast corner of timber mat crossing over wetland W-C20. Corrective actions- CLEARED excess accumulation of sediments.

Water Crossings	Interim Week	A layer of fine sediments are accumulating on the timber mats over W-C20 and on timber mats at W-C15.	Clear excess sediments from timber mats to prevent impacts to surrounding wetlands/watercourses during rainfall events and from continuous vehicle use.	IN PROGRESS
	Bi-Week	A layer of fine sediments are accumulating on the timber mats over W-C20 and on timber mats at W-C15. Not an excessive quantity but due to the high content of fine mica (very fine grain size) in the materials used to build up the access roads and structure pads, the material has been observed under dry dusty conditions (vehicle traffic causing dusty conditions) and during rain conditions (storm water flow), migrating off the timber mats onto surrounding areas.	Continue monitoring and maintenance of water crossings until restoration phase completed.	N/A

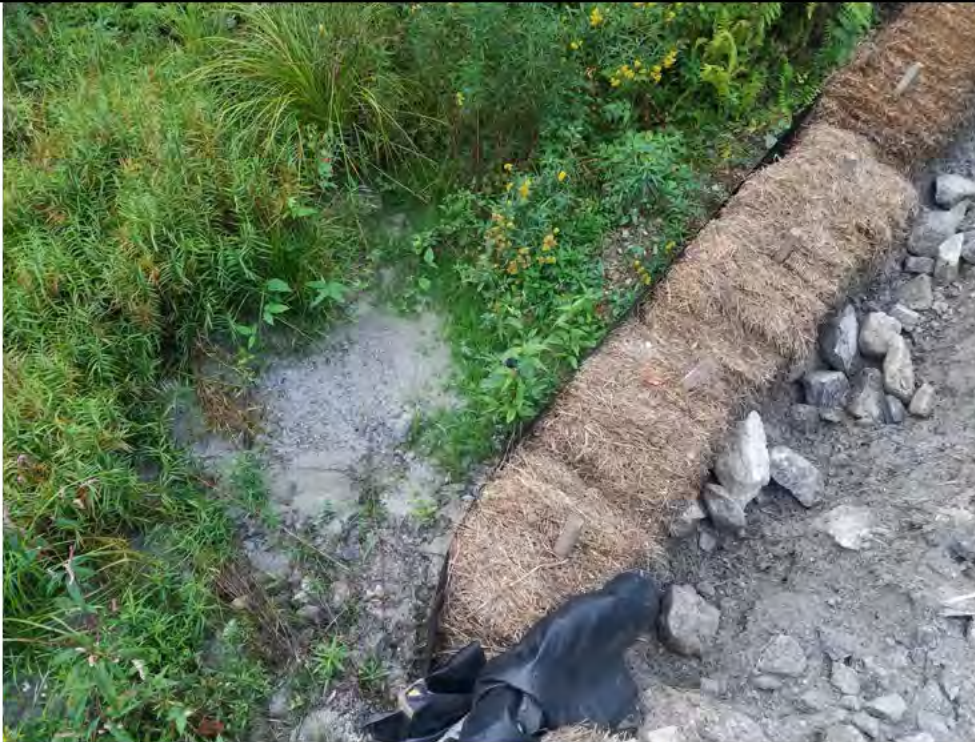
Photo 3: 09/15/17, Watertown: Map 14, at southeast corner of timber mat crossing over wetland W-C20, breakthrough into W-C20, photo taken at the time of this inspection. SEE PHOTO 4 FOR CORRECTIVE ACTION following inspection.

Inland Wetland & Watercourse encroachment & mitigation	Interim Week	<p>Sedimentation impacts reported last week in Biweekly Report #20 at W-C20 has been addressed. Excess sediment buildup on perimeter silt fences and hay bales where break through had occurred has been cleared by hand and seed placed for restoration and stabilization (see photo # 4).</p> <p>Other areas called out in Biweekly Report #20 are in the process of being addressed or plan to be during restoration.</p>	N/A	IN PROGRESS

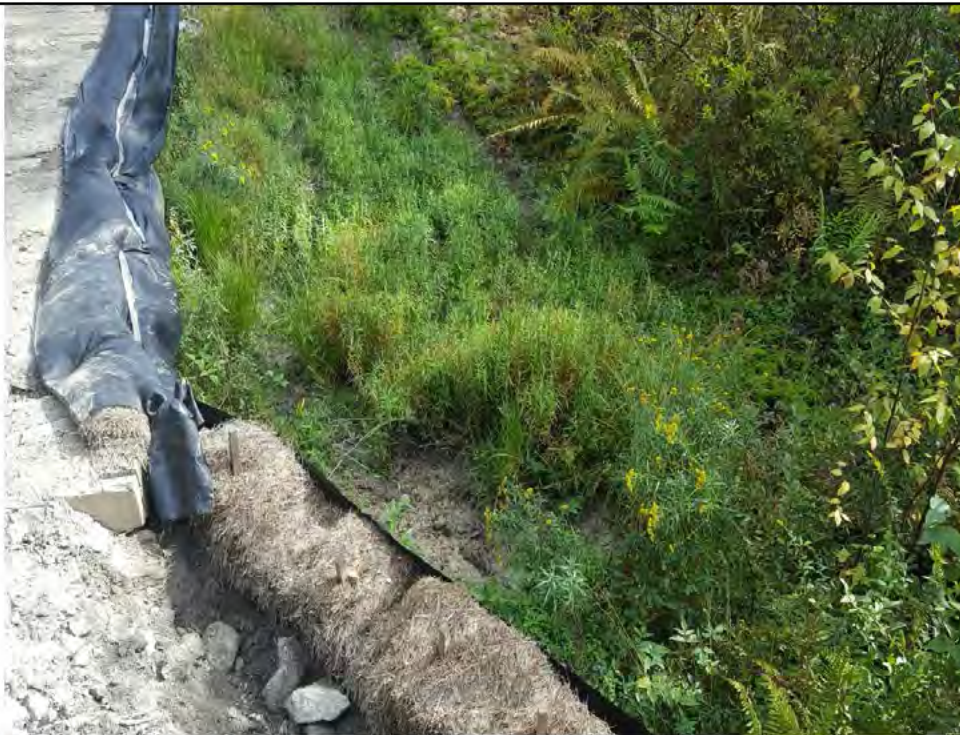
Photo 4: 09/15/17, Watertown: Map 14, at southeast corner of timber mat crossing over wetland W-C20. CORRECTIVE ACTIONS- Accumulation of sediments into wetlands cleared by hand. Photo provided by Northern of the corrective action taken, after initial inspection on 09/15/17.

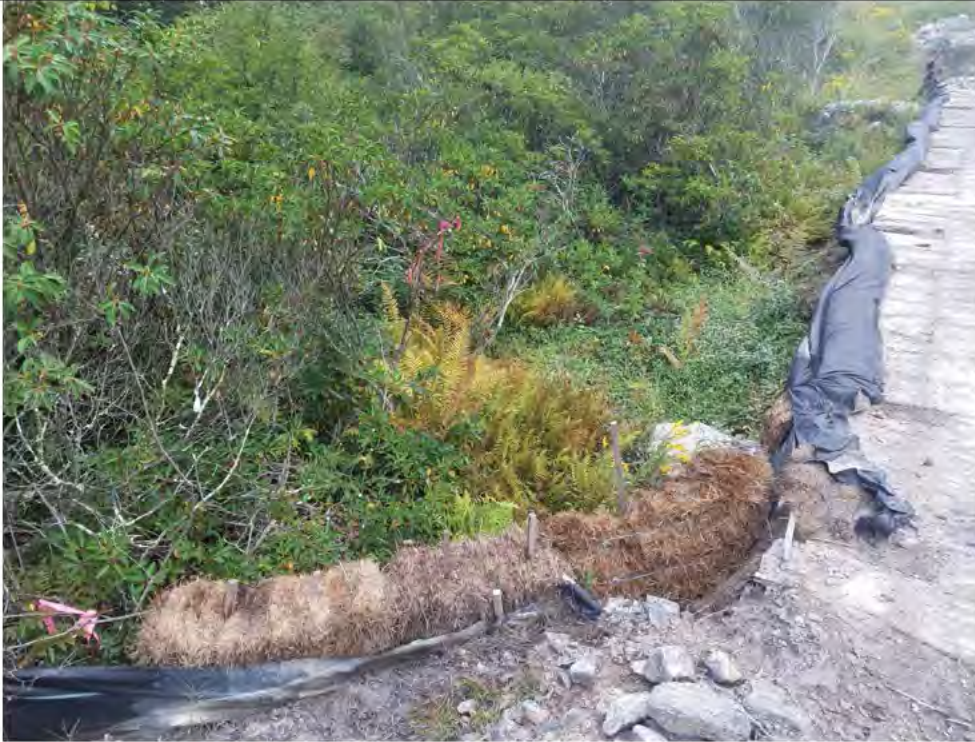
Photo 5: 09/15/2017, Watertown: Map 14, at southwest corner of timber mat crossing over wetland W-C20, excess buildup of sediments and sedimentation into W-C20, silt fence repair required. CORRECTIVE ACTION- Cleared excess sediments by hand, silt fence repair still required.

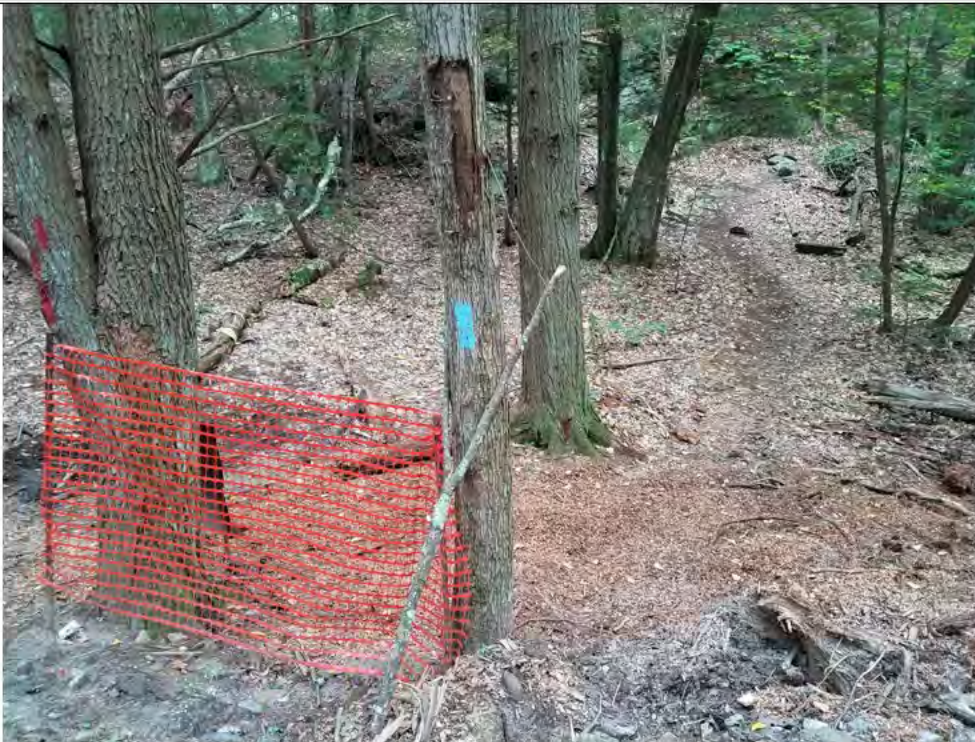
Photo 6: 09/15/17, Watertown: Map 15, access road between Str44 and Str45 at the CT State marked Hiking trail, rills and sediment flow off access road into the access point of hiking trail. CORRECTIVE ACTIONS- Cleared sediments by hand and stabilized with wood chips.

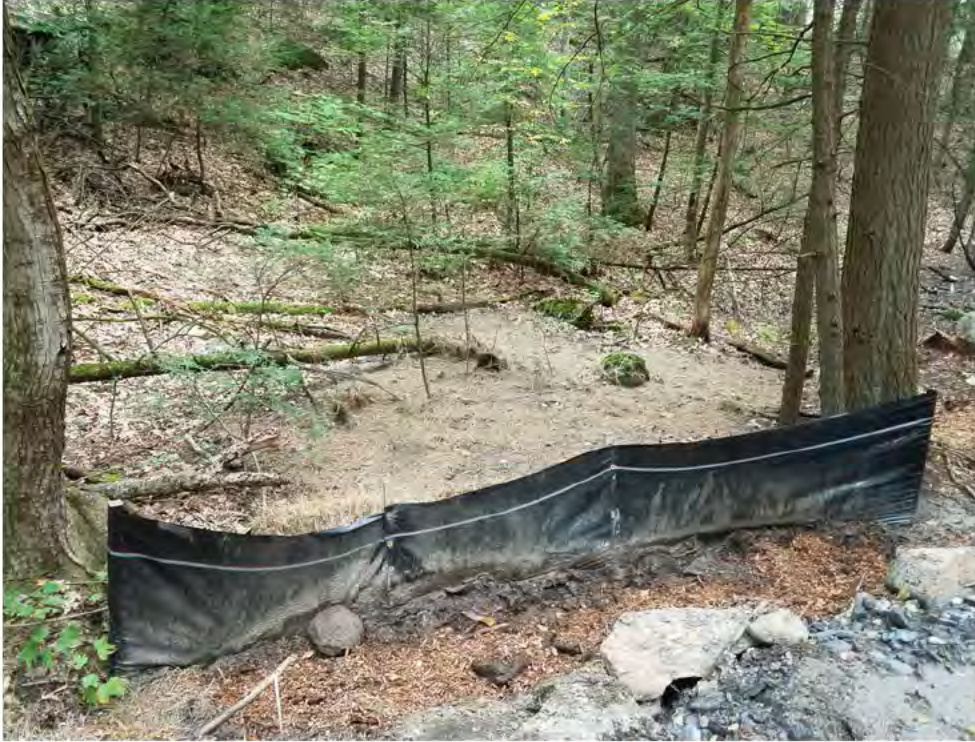
Photo 7: 09/15/17, Watertown: Map 15, access road between Str44 and Str45 approximately 100 feet north of the CT State marked Hiking trail, rills and sediment flow off access road. CORRECTIVE ACTIONS- Cleared sediments by hand and stabilized with wood chips.

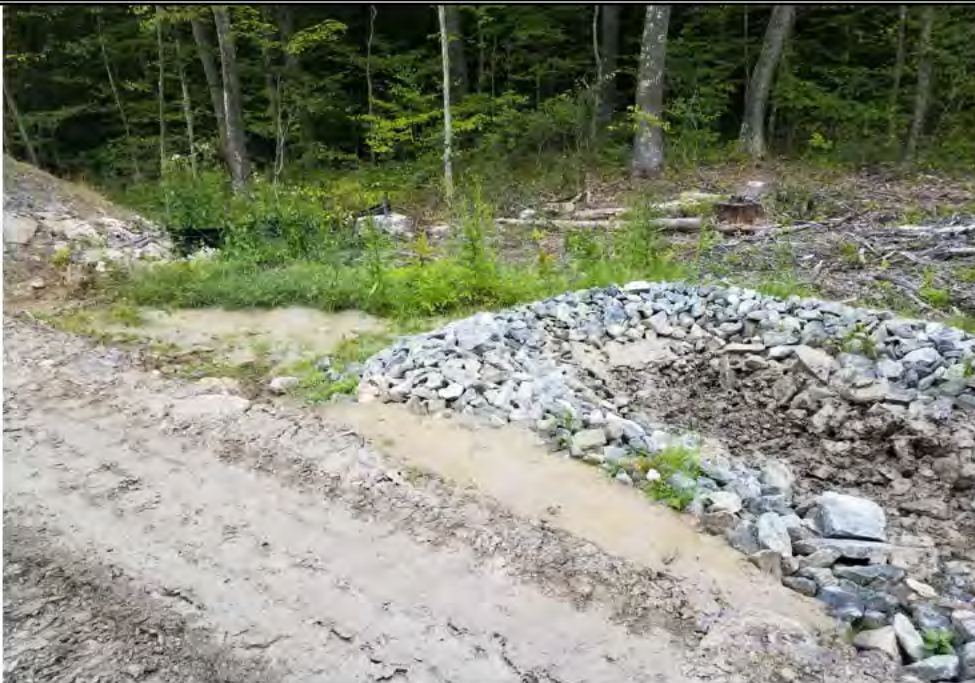
Photo 8: 09/15/17, Watertown: Map 13, south of Str36, excess sediments in temporary basin. CORRECTIVE ACTIONS- Cleared excess sediments from basin. Sediment runoff from uncontrolled storm water flow off the access road still in place.

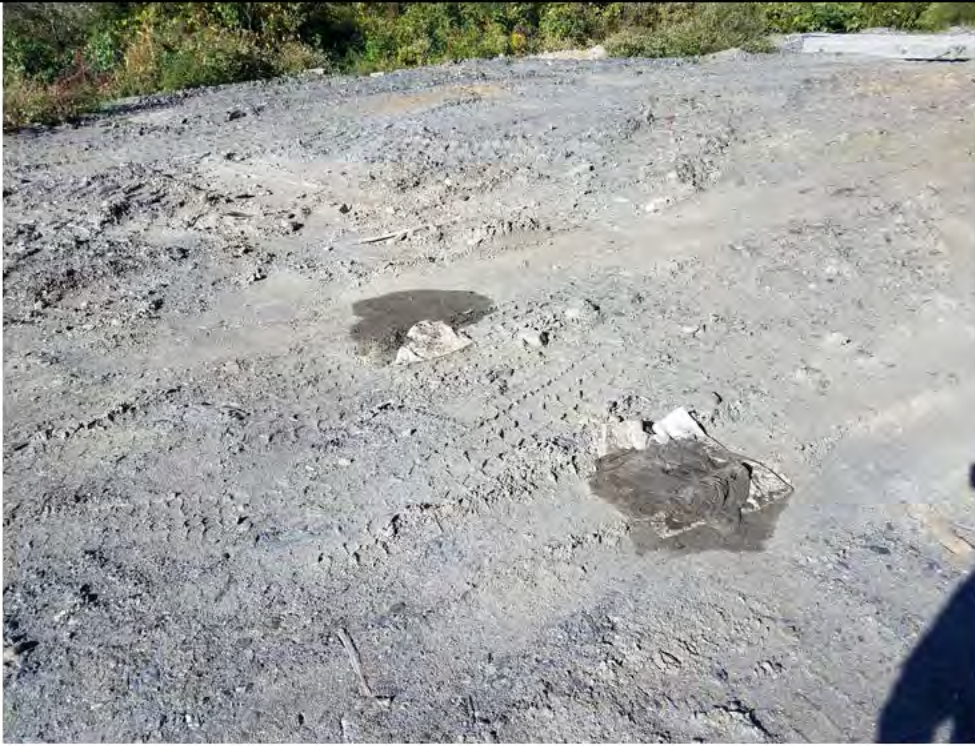
Photo 9: 09/22/17, Watertown: Map 06, Pad at Str15, petroleum release, partial cleanup activities.

Spill report information- PAR called in the report to CTDEEP on 09/22/2017 and Spill No. 201704861 was generated.

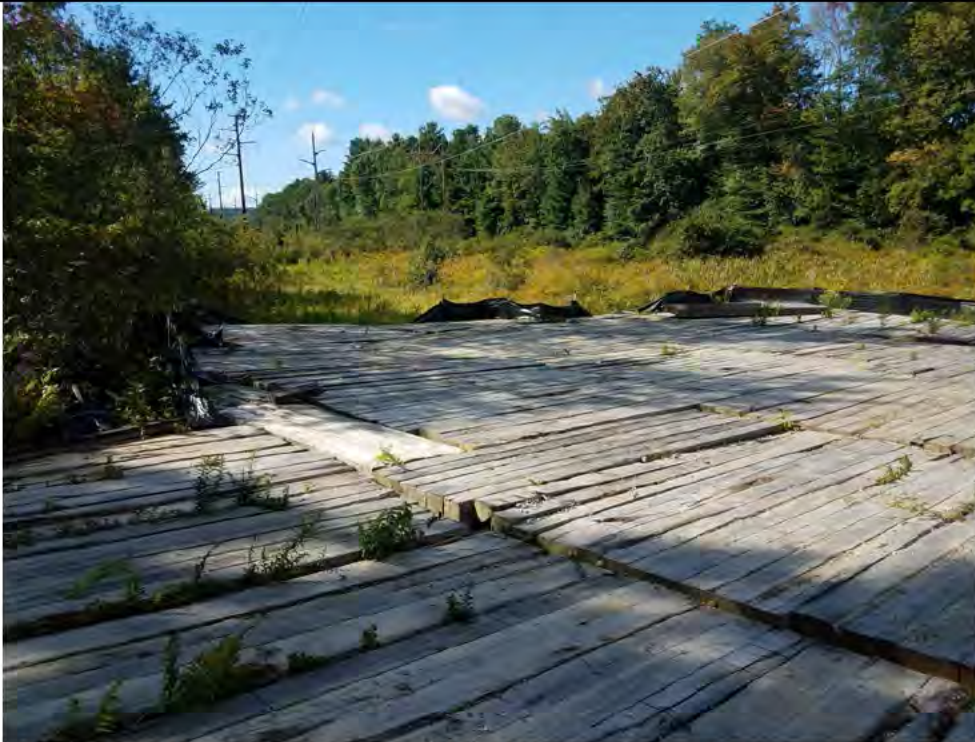
Photo 10: 09/22/17, Harwinton: Map 35, timber mat pad at Str95, perimeter silt fencing utilized to prohibit turtle access is in need of repair or removal.

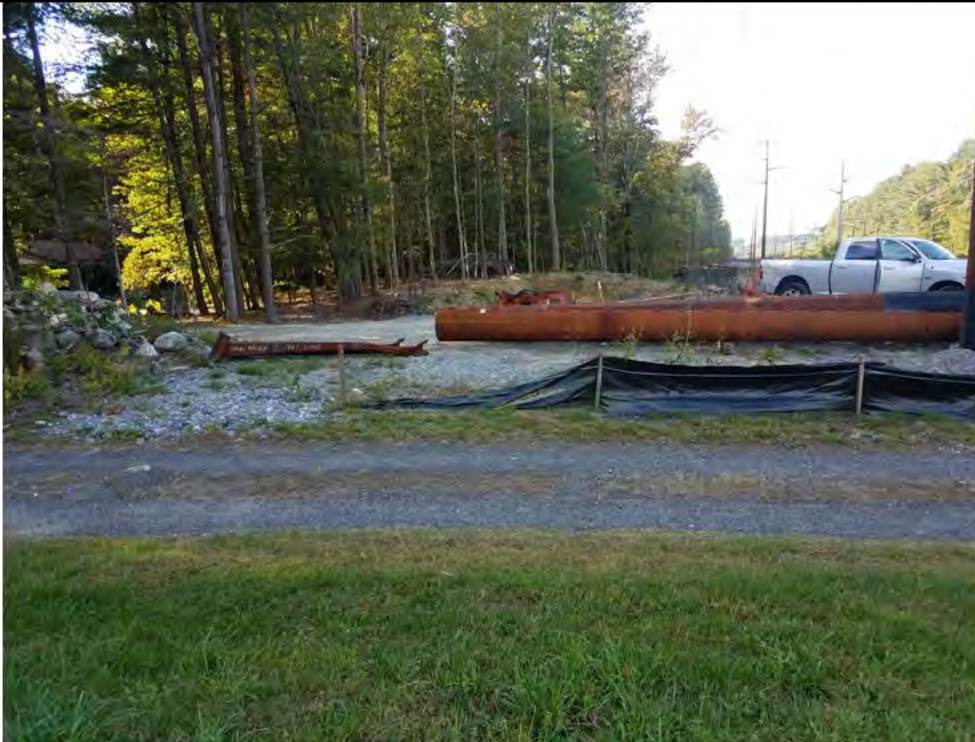
Exclusion fencing along the north edge of the Str94 pad (Map 34, Harwinton) is down and/or missing. Repair and/or replace is required. See Photo #11.

Photo 11: 09/22/17, Harwinton: Map 34, exclusion fencing along the north edge of the pad at Str94 is in need of repair/replacement.

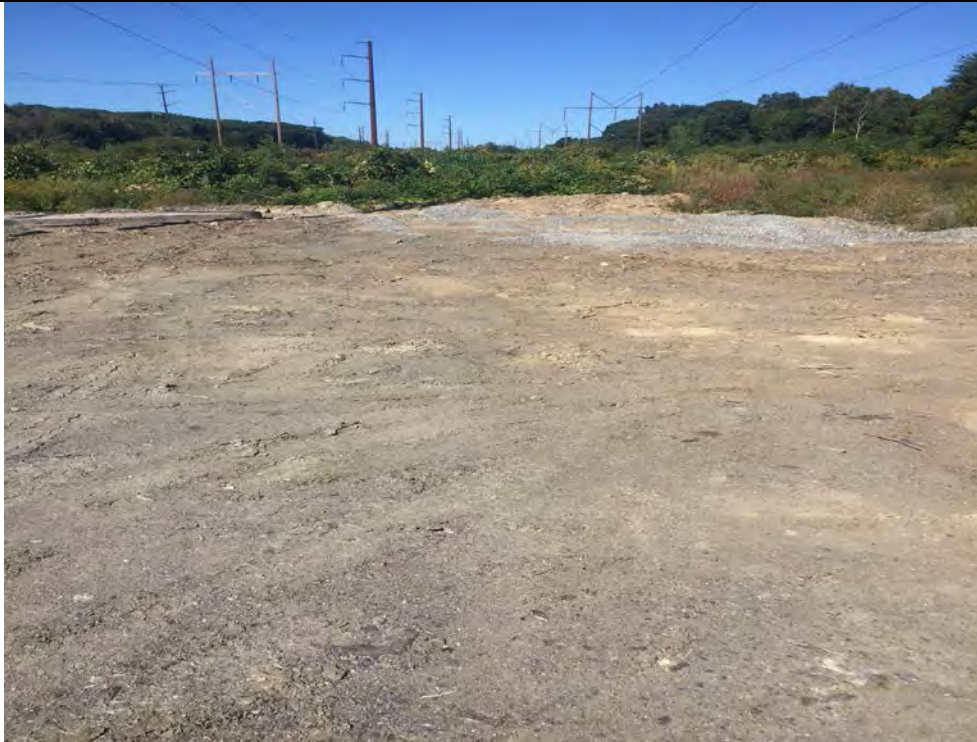
Photo 12: UPDATE provided on 09/27/17, Information and photo received from Matt Davison of Davison Environmental. The petroleum release area observed at Str15 and Str14 (Map 6) was reported on 09/22/2017 to the CTDEEP (spill #201704861, badge #205) and removal of the impacted pad material was completed.

<p style="text-align: center;">Inland Wetland and Watercourse encroachment and mitigation (Continued from previous page)</p>	<p>Bi-Week</p>	<p>Areas called out in the previous 2 reports have been closed out.</p> <p>Timber mat pad removed from Str78 and placed to the south at Str3244 (Eversource maintenance line work).</p>	<p>Wetland and watercourses impacted by sedimentation would further benefit from restoration/stabilization with an approved wetland seed mix.</p>	<p>N/A</p>
	<p>Spills and Material Storage</p>	<p>Interim-Week</p>	<p>None observed or reported.</p>	<p>N/A</p>
<p>Bi-Week</p>		<p>Ground surface staining was observed at Str14 and Str15 from apparent equipment mechanical leaks. See photo #9.</p> <p>UPDATED-09/27/17, see Photo #12. Spill reported to CTDEEP on 09/22/17 and the impacted materials removed.</p>	<p>N/A</p>	<p>N/A</p>
