**Subject: Docket No. 466, Frost Bridge to Campville 115-kV Project
Decision and Order Condition #4 – Independent Environmental Inspector Report**

Please find enclosed the Biweekly Independent Environmental Inspector Report, Report #24, for the **October 27th** and **November 3rd, 2017**, inspection events for the construction of the Eversource Frost Bridge to Campville 115-kV Project.

Docket No. 466- Development and Management Plan Inspection

Frost Bridge to Campville 115kV Project

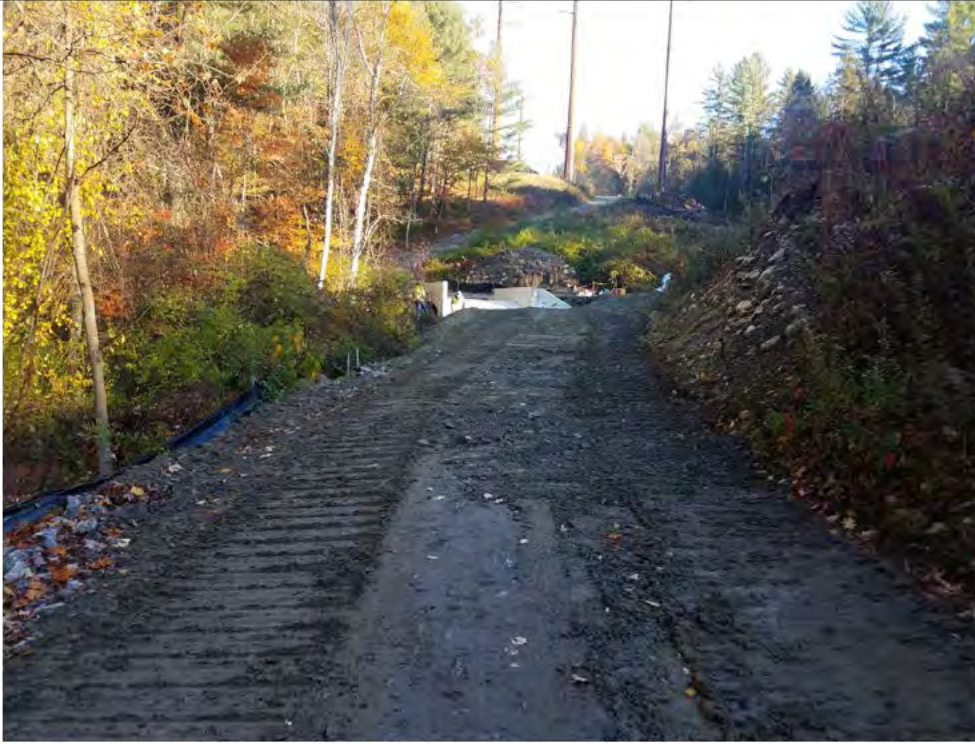
BluRoc working on the culvert replacement at W-F11/S-F10 (Harwinton, Map 32, see photos1-4)

Photo 1: 10/27/17, Harwinton: Map 32, access road to culvert across W-F11/S-F10.

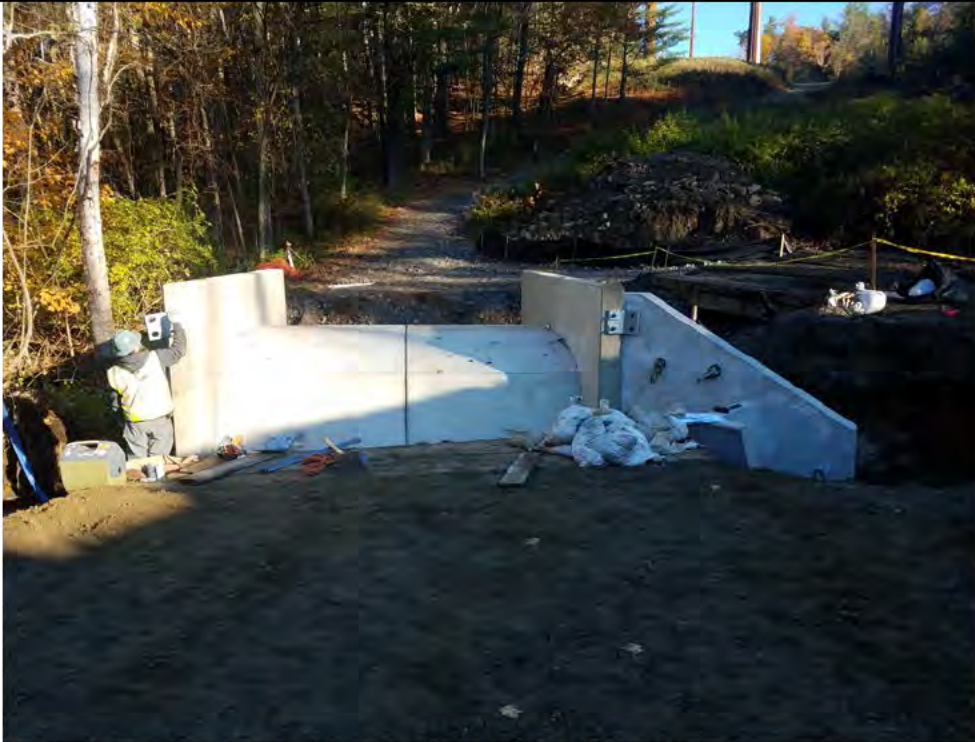
Photo 2: 10/27/17, Harwinton: Map 32, culvert replacement at W-F11/S-F10.

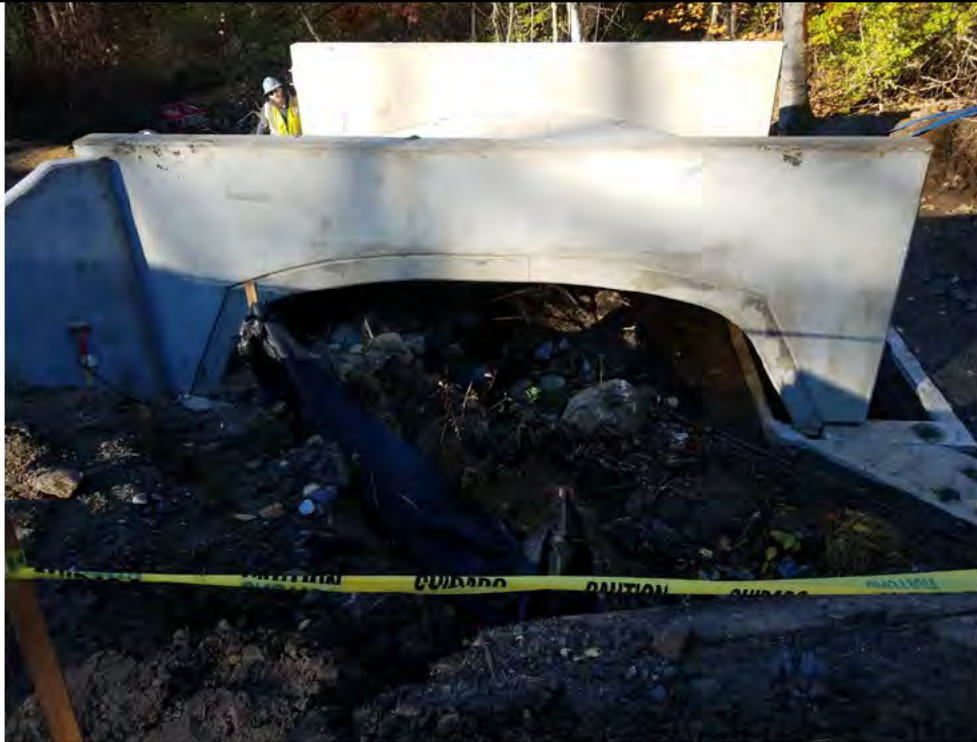
Photo 3: 10/27/17, Harwinton: Map 32, culvert replacement at W-F11/S-F10.

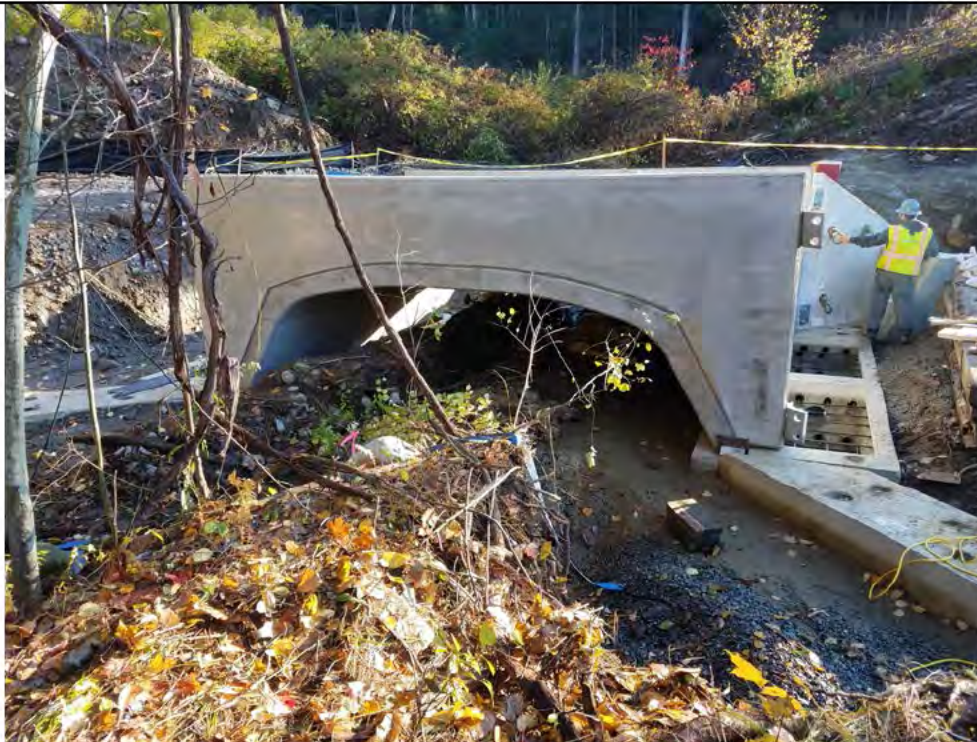
Photo 4: 10/27/17, Harwinton: Map 32, culvert replacement at W-F11/S-F10.

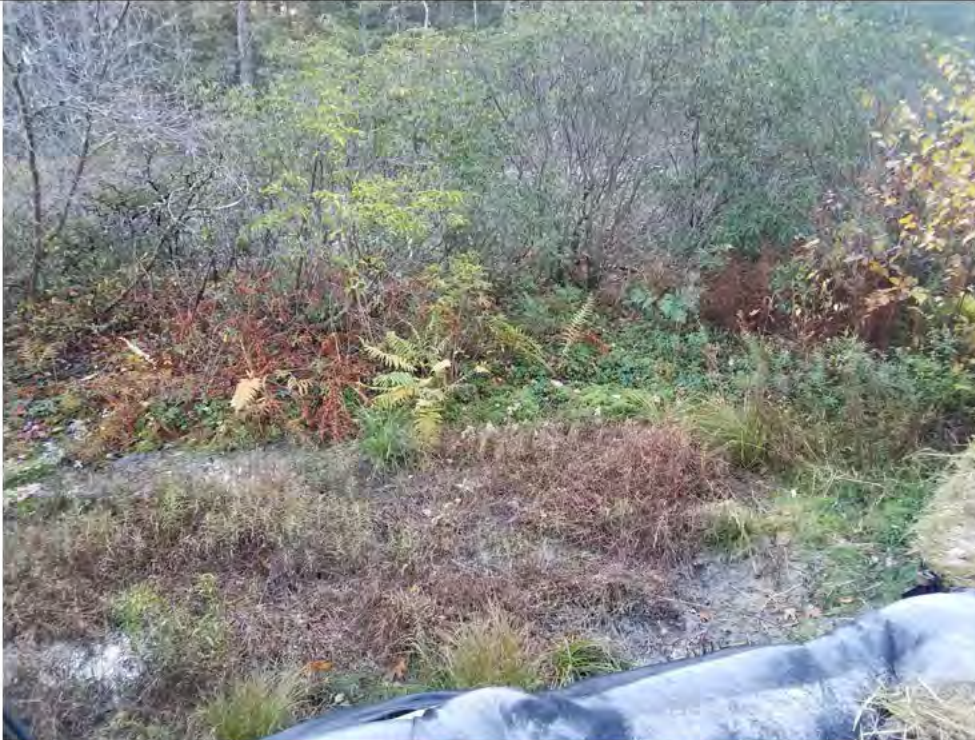
Water Crossings	Interim Week	<p>Additional impacts observed at W-C20 (See Photo #5) from a recent rainfall event, 2.0" of rainfall on 10/25.</p>	<p>Will be addressed during restoration activities.</p>	<p>Pending</p>
	Bi-Week	<p>Additional impacts observed at W-C20 (See Photo #11) from a recent rainfall event, 5.0" of rainfall on 10/30 (see photo 11).</p> <p>Potential sedimentation impacts to W-C15 due to E&S control failure and heavy stormwater flow from recent rainfall events (see photo 14).</p> <p>Timber mats at crossing have buildup of sediments at W-C20 and W-C18 (see photo 12).</p> <p>BluRoc finished work on the culvert replacement at W-F11/S-F10 (Harwinton, Map 32, see photos 7-10).</p>	<p>Impacts to W-20 and breakthrough at W-C15 to be addressed as part of restoration work.</p> <p>Timber mat crossings should be cleared of excess sediment to prevent runoff into wetland and watercourses.</p> <p>Access roads and water bars immediately upland of wetlands and watercourses should be graded and maintained to prevent excessive tracking of road sediments over water crossings.</p>	<p>In Progress</p>

Photo 5: 10/27/17, Watertown: Map 14, W-C20 sedimentation breakthrough due to recent rainfall event.

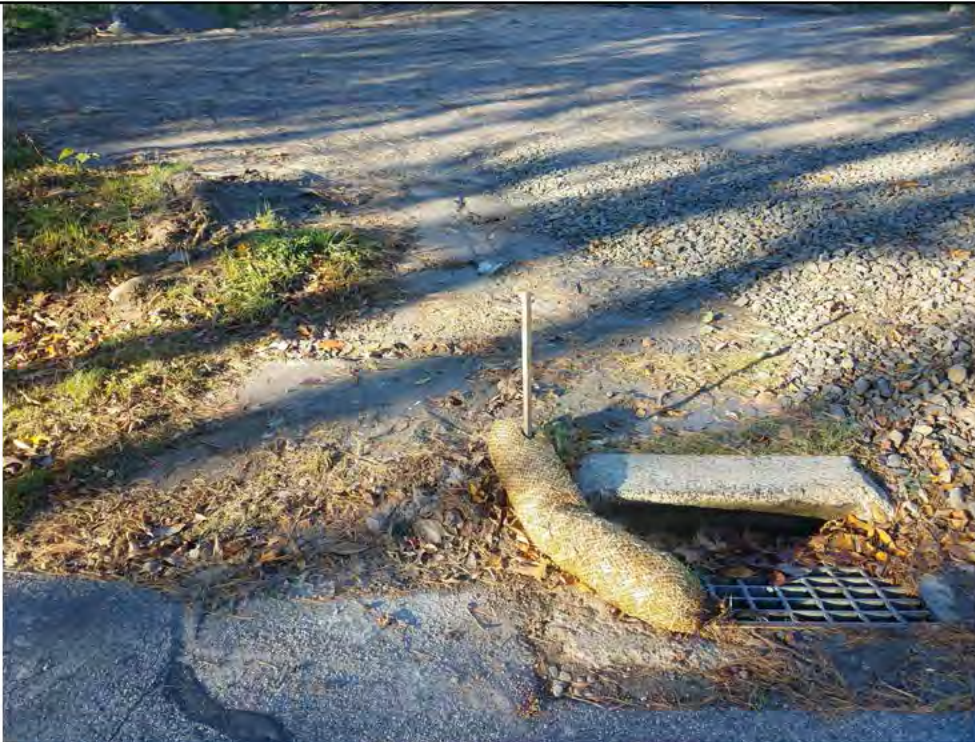
The catch basin located immediately south of Str81 on Campville Road is protected at this time(see photo 6). A Straw wattle/tube has been installed to help prevent sediment runoff into the catch basin from the pad. The wattle provides minimal protection at this time. A full length or two full lengths of straw wattle should be installed according to BMPs such that they are installed upland and somewhat parallel with the road side and catch basin. Continued -

Photo 6: 10/27/17, Litchfield: Map 29, catch basin at Str81 west side of Campville Road, straw wattle installed.

The wattle/s should be anchored at multiple points to prevent movement as well as be trenched in below grade to provide structure. As of 11/3/17, no changes made to existing E&S controls or current pad conditions.

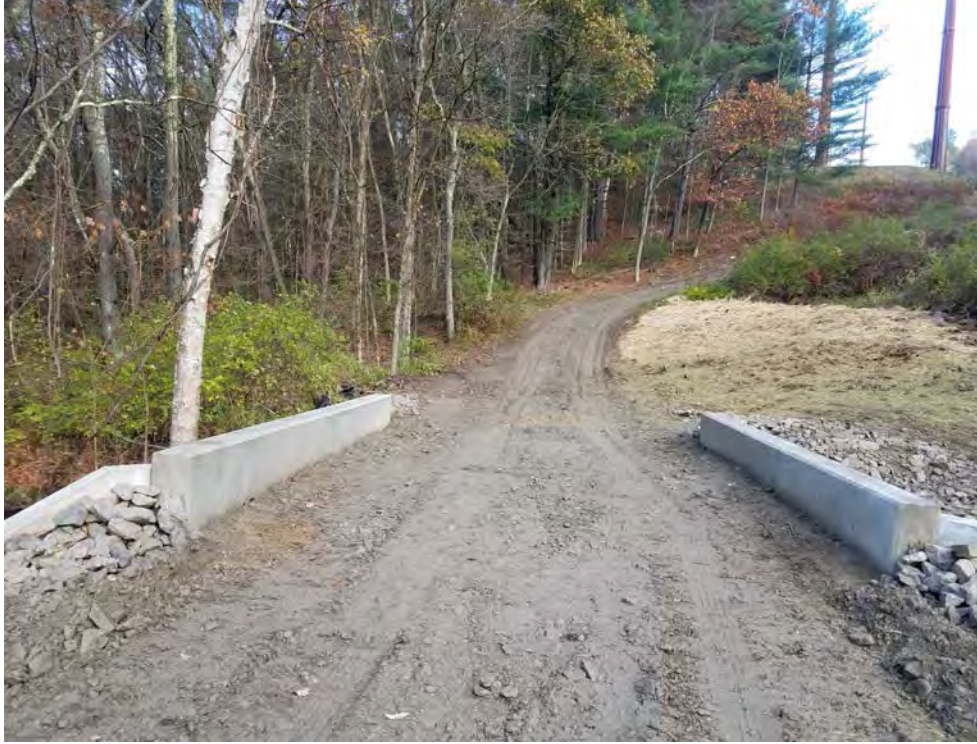
Photo 7: 11/03/17, Harwinton: Map 32, access road to culvert spanning W-F11/S-F10, photo taken facing north toward Str87, Str3174, Str3235.

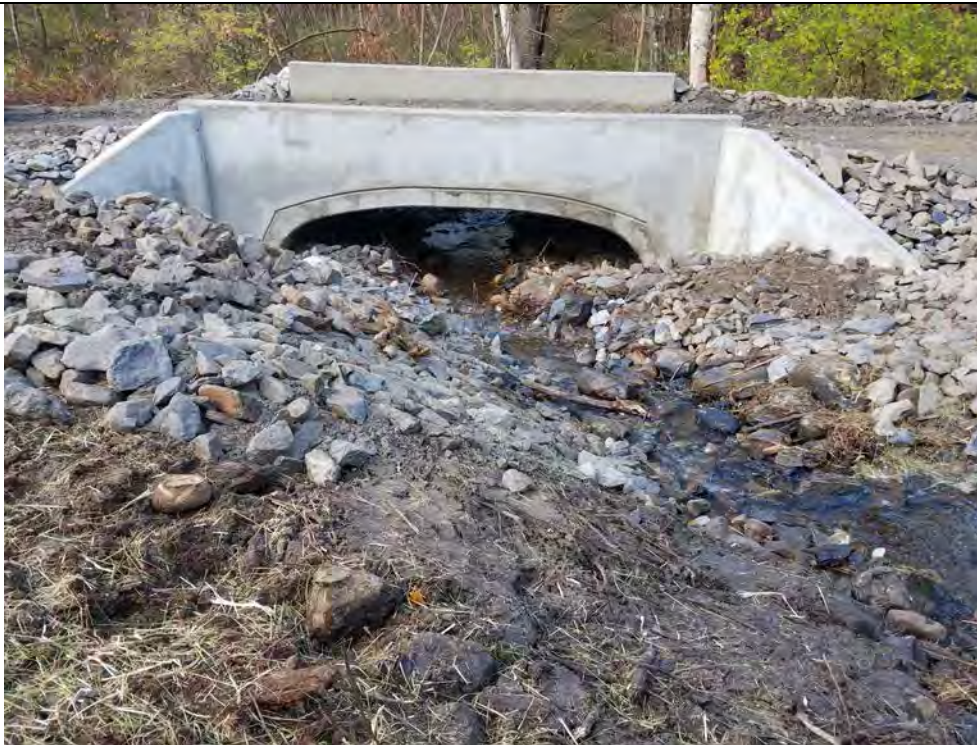
Photo 8: 11/03/17, Harwinton: Map 32, access road to culvert spanning W-F11/S-F10, up gradient side, photo taken facing west toward Valley Road.

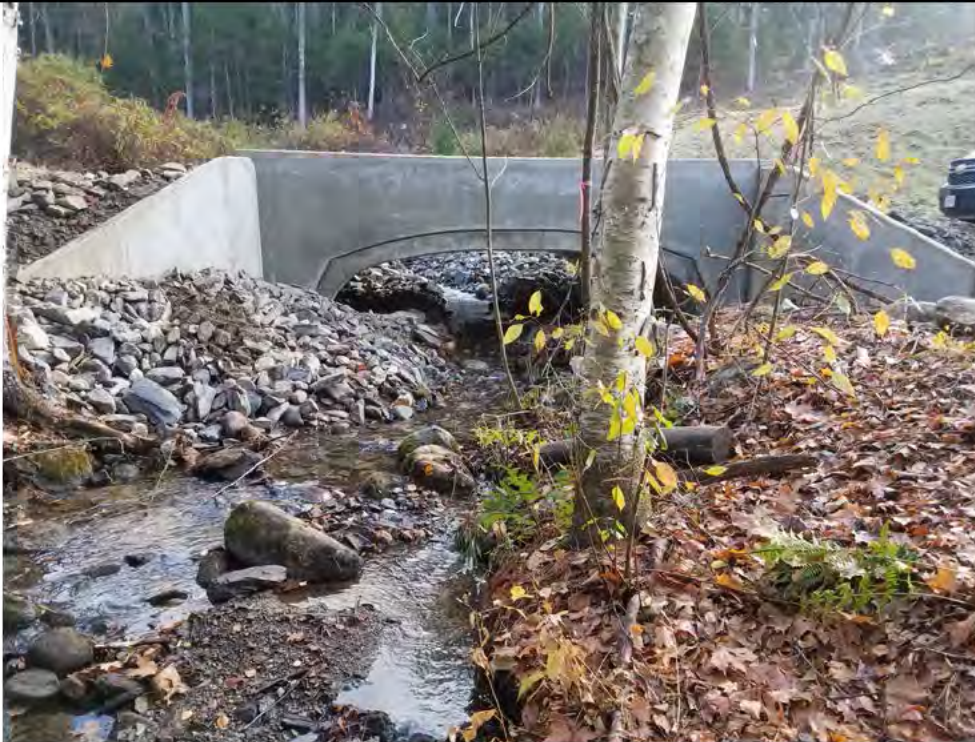
Photo 9: 11/03/17, Harwinton: Map 32, access road to culvert spanning W-F11/S-F10, down gradient side, photo taken facing east toward W-F11.

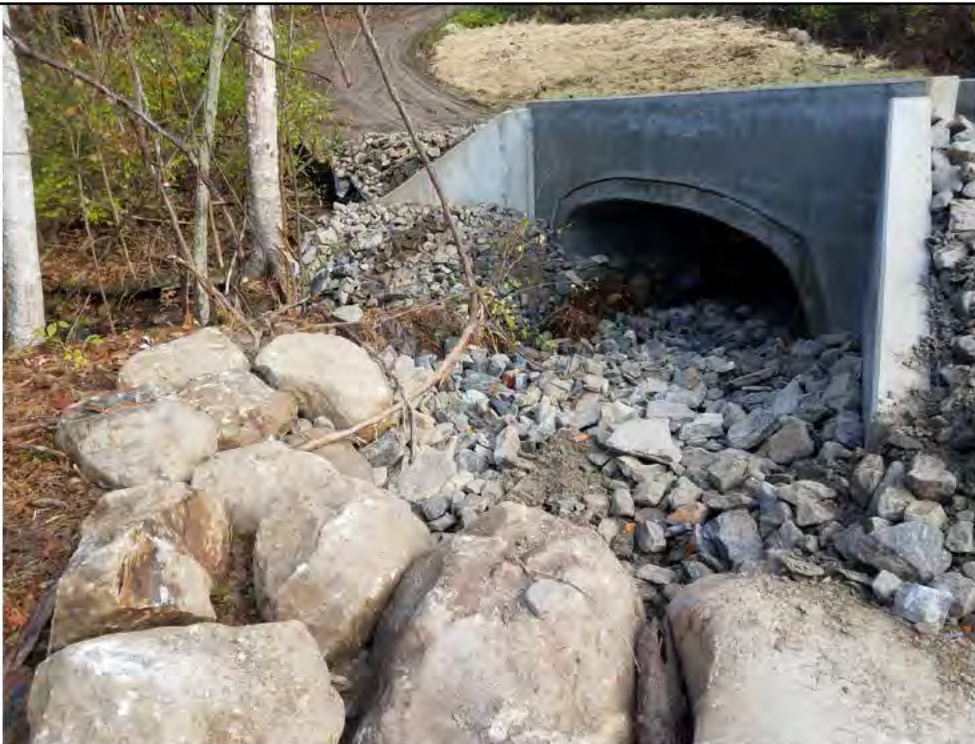
Photo 10: 11/03/17, Harwinton: Map 32, access road to culvert spanning W-F11/S-F10, down gradient side, photo taken facing south toward Str87, Str3174, Str3235.

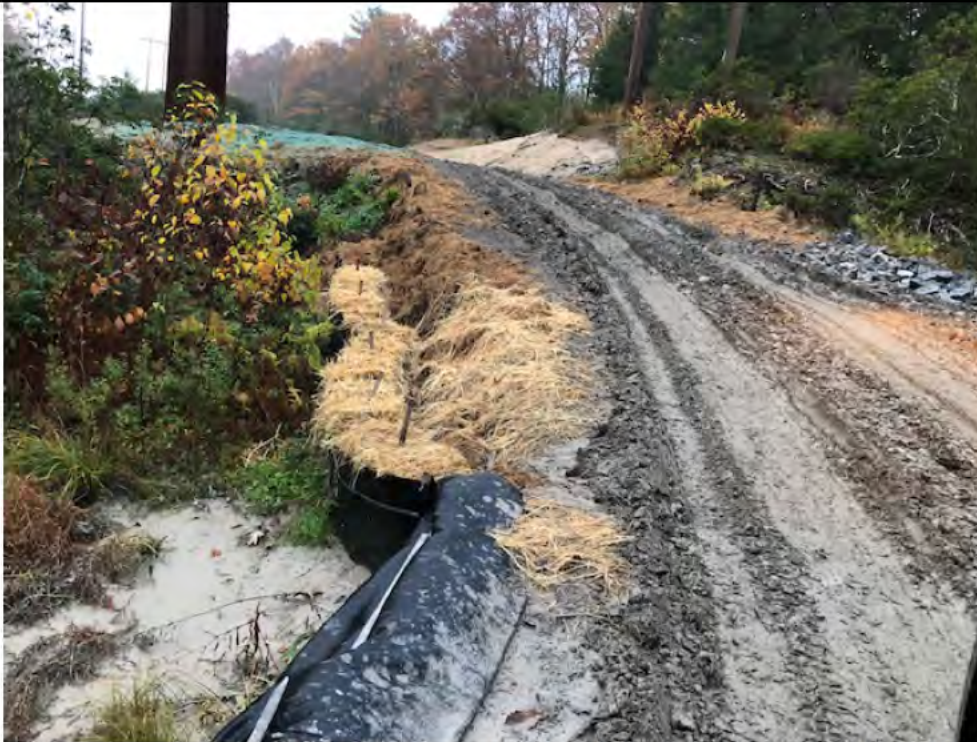
Photo 11: 11/03/17, Watertown: Map 14, W-C20 sedimentation breakthrough due to recent rainfall events (2).

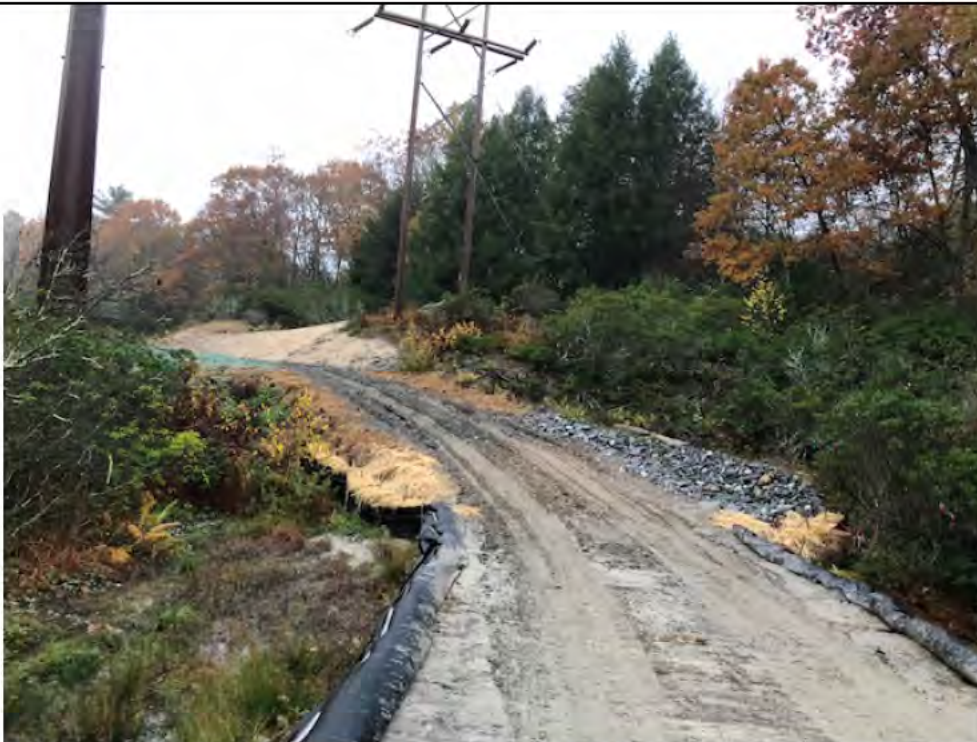
Photo 12: 11/03/17, Watertown: Map 14, timber mat crossing at W-C20 excessive sediment buildup and poor road drainage conditions.

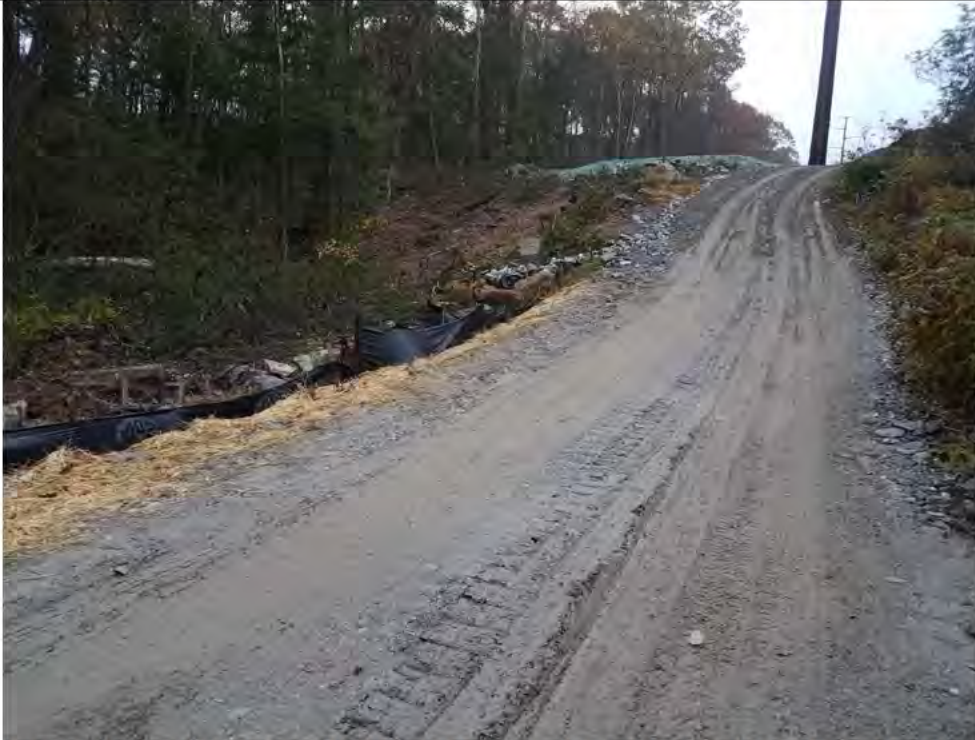
Photo 13: 11/03/17, Watertown: Map 12, south of Str34 flattened water bar, soft road conditions due to poor surface water drainage.

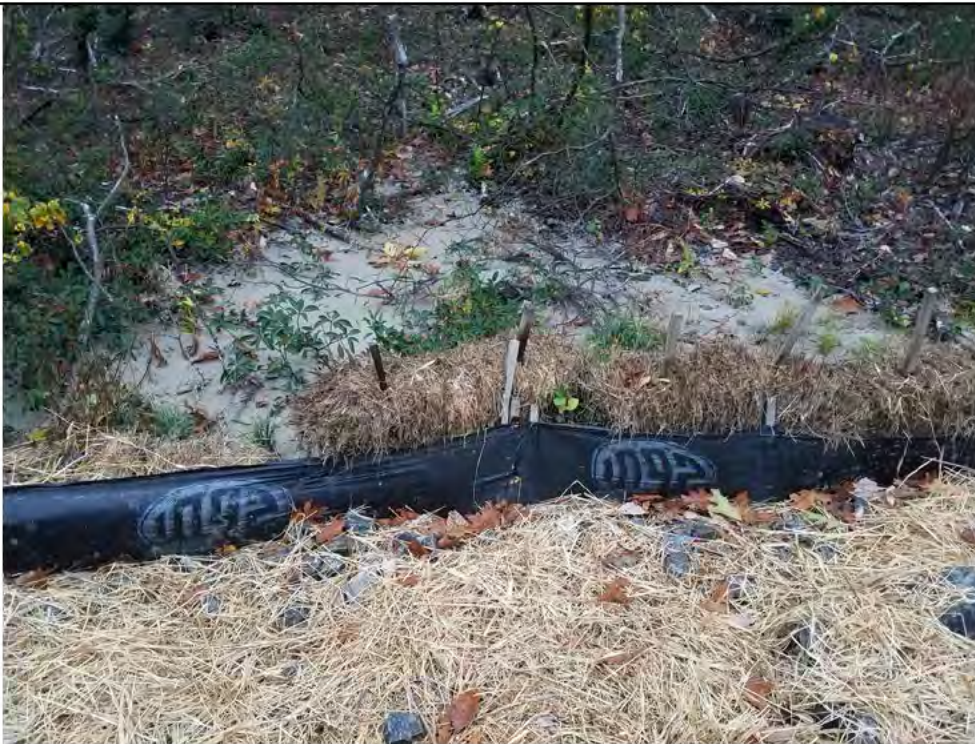
Photo 14: 11/03/17, Watertown: Map 12, south of Str34 sedimentation through E&S controls slightly upland of W-C15.

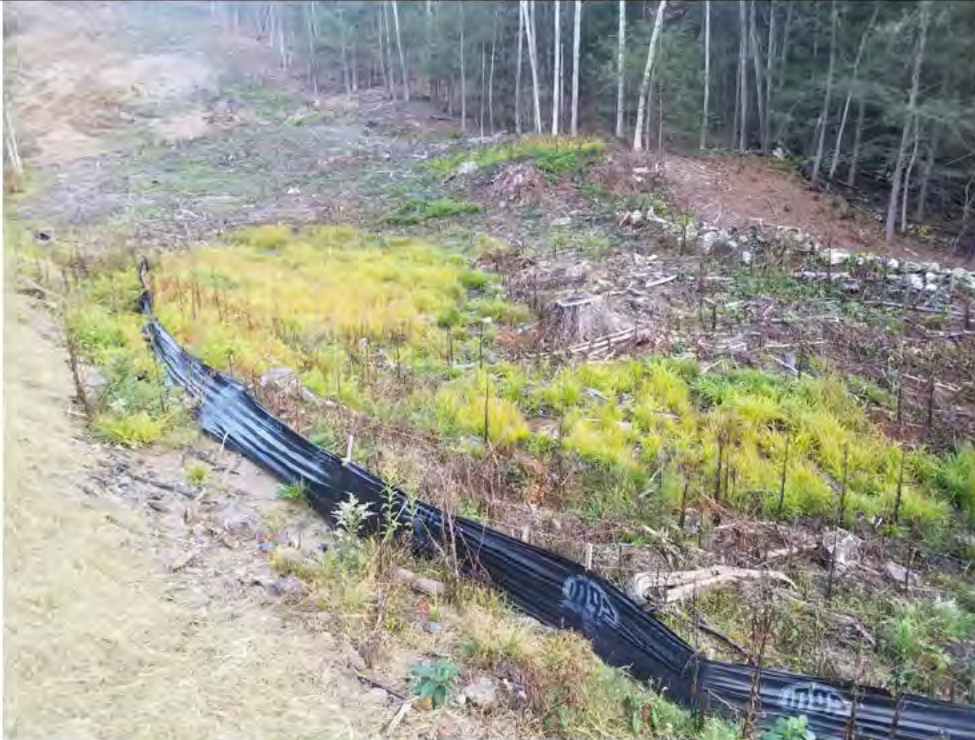
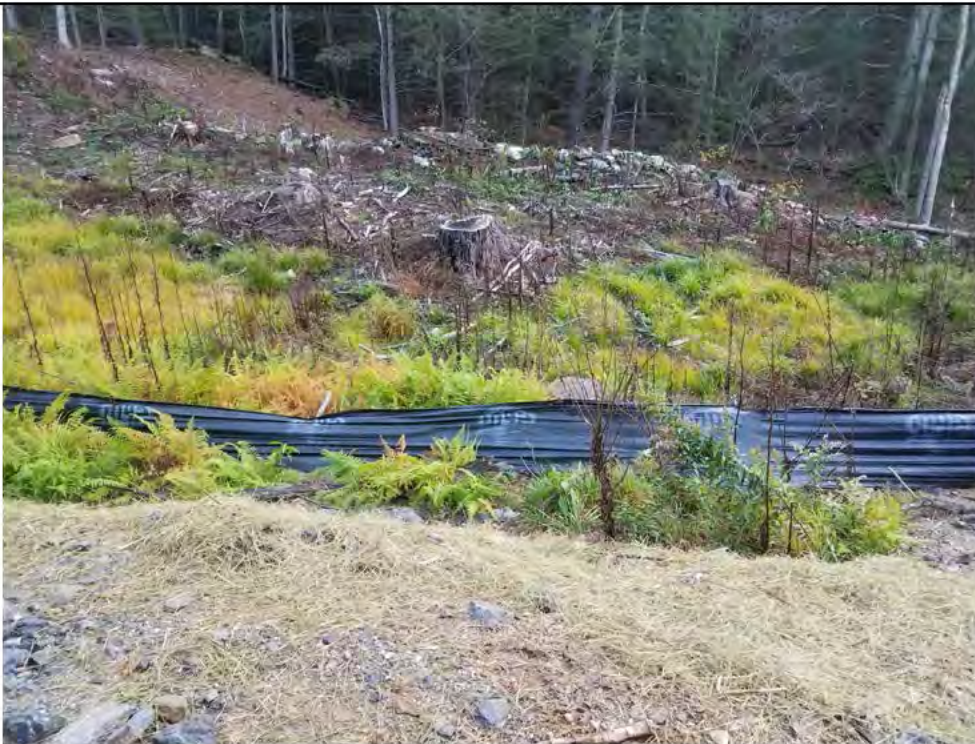
Photo 15: 11/03/17, Harwinton: Map 32, damaged silt fence south of Str3235 at W-F12.

Photo 16: 11/03/17, Harwinton: Map 32, damaged silt fence south of Str3235 at W-F12.

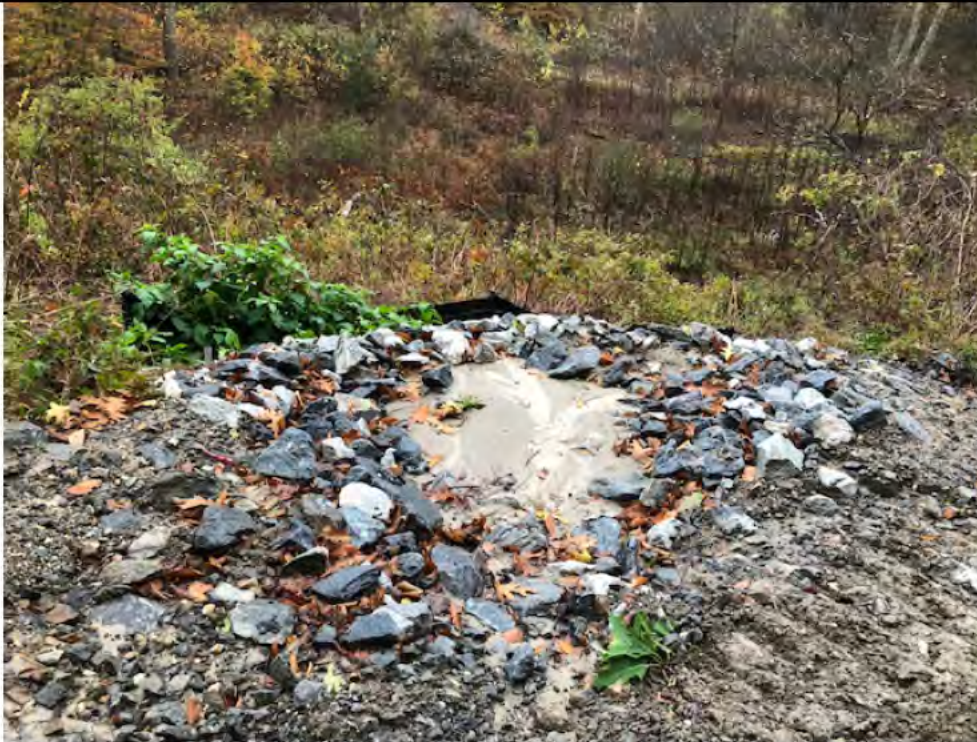
Photo 17: 11/03/17, Watertown: Maps 09-16, photo of typical sediment trap filled to capacity observed throughout this section of ROW due to recent rainfall events.
