**Subject: Docket No. 466, Frost Bridge to Campville 115-kV Project
Decision and Order Condition #4 – Independent Environmental Inspector Report**

Docket No. 466- Development and Management Plan Inspection

Frost Bridge to Campville 115kV Project

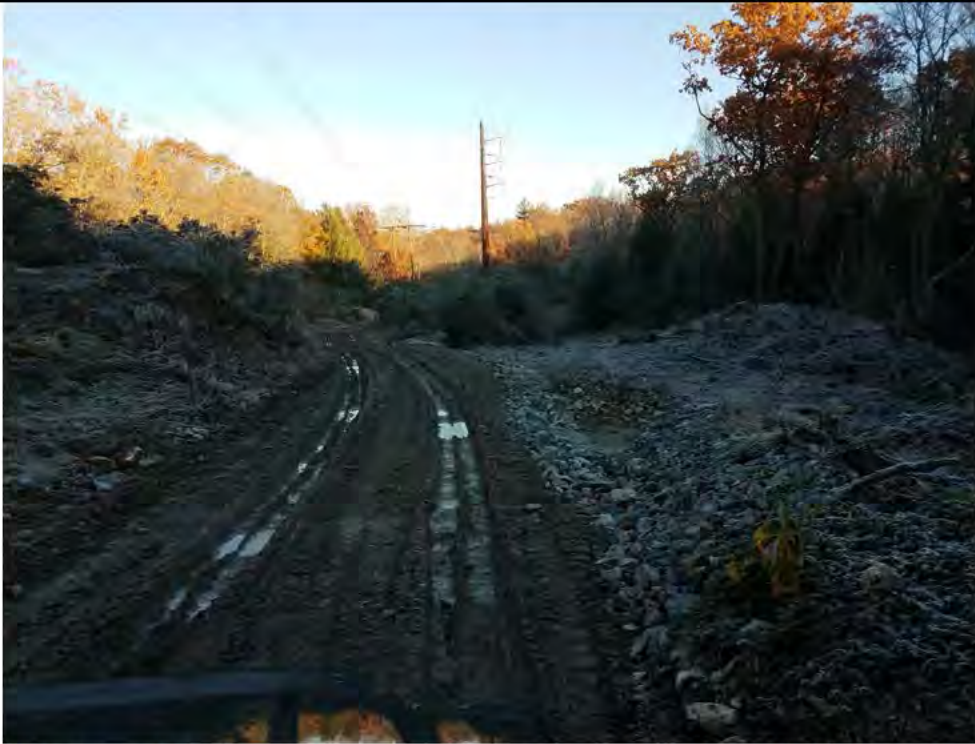
Areas of Inspection		Observation:	Recommended Action/s:	Corrected Action/s:
Access Roads and Adjacent Roadways	Interim Week	Saturated road surfaces, tire rutting, muddy conditions, and off access road impacts observed in the areas between Str24 through Str46 (See Photos 1 and 2).	Limit vehicle and heavy equipment access until conditions improve, regrade affected areas of access road to improve drainage and remove rutting.	In Progress
	Bi-Week	No change between Str24 and Str39. Restoration (pads, slopes, disturbed areas, access road, etc.) between Str39 and Str46 is completed.		In Progress, as restoration is progressing from Str39 to Str24 the access road is being repaired and vehicle traffic prohibited.
Vegetative Clearing Limits (Including trees to save or danger trees noted.	Interim Week	Task Completed	N/A	N/A
	Bi-Week	Tasked Completed	N/A	N/A

Photo 1: 11/09/17, Watertown: Map 14, access road conditions between Str38 and Str39, tire rutting, poor drainage and ponding visible, flattened water bar and poor access road grading at the sediment trap.

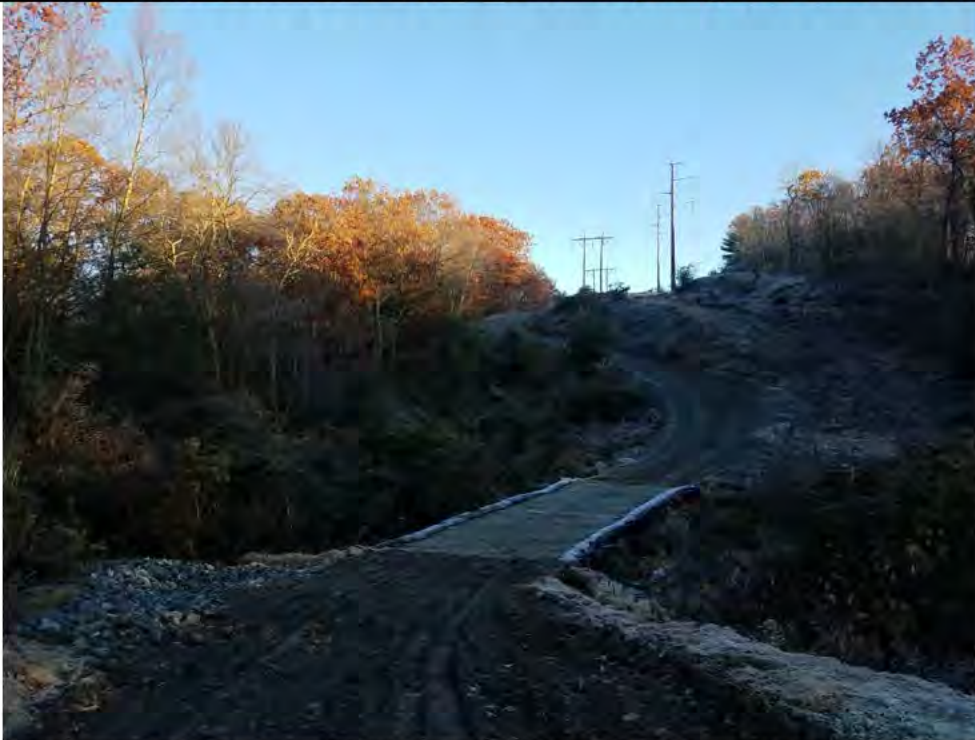
Photo 2: 11/09/17, Watertown: Map 14, access road conditions at W-C20, flattened water bar, visible tire rutting, poor access road grading at the sediment trap.

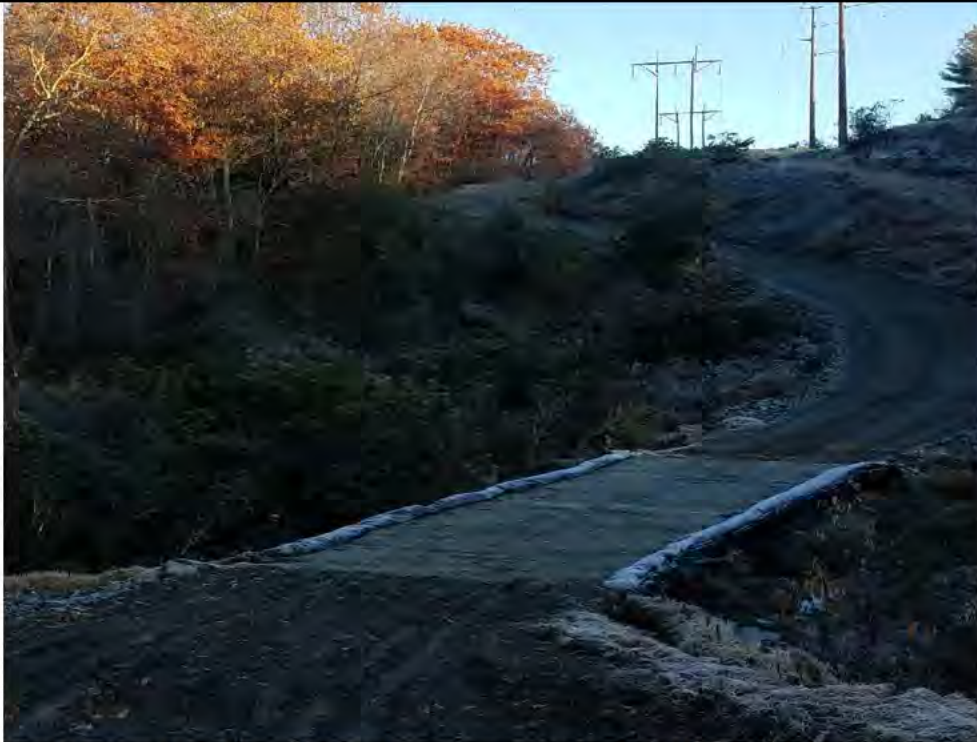
Water Crossings	Interim Week	<p>Conditions observed in the previous 2 inspections (Interim and Biweekly Reports #24) have not improved or been repaired.</p> <p>Timber mat crossings have heavy sediment buildup and muddy conditions upland of crossings, and additional sedimentation into W-C20 was observed (see photo 3).</p>	<p>Clean timber mat crossings and improve access road drainage upland of sensitive areas (especially W-C20). Areas upland of crossings should be regraded and water bars constructed so that surface water flow during storm events is diverted away from sensitive areas (wetlands and watercourses).</p>	<p>Pending restoration activities.</p>
	Bi-Week	<p>Timber mats at W-C20 have been cleared of excess sediment build up and water bars have been installed upland of the crossing diverting surface water runoff to sediment traps upland of the wetland. Impacts to W-C20 remain at this time.</p>		<p>In Progress</p>

Photo 3:11/09/17, Watertown: Map 14, timber mat crossing conditions at W-C20, buildup of sediments on timber mats due to upland access road area conditions.

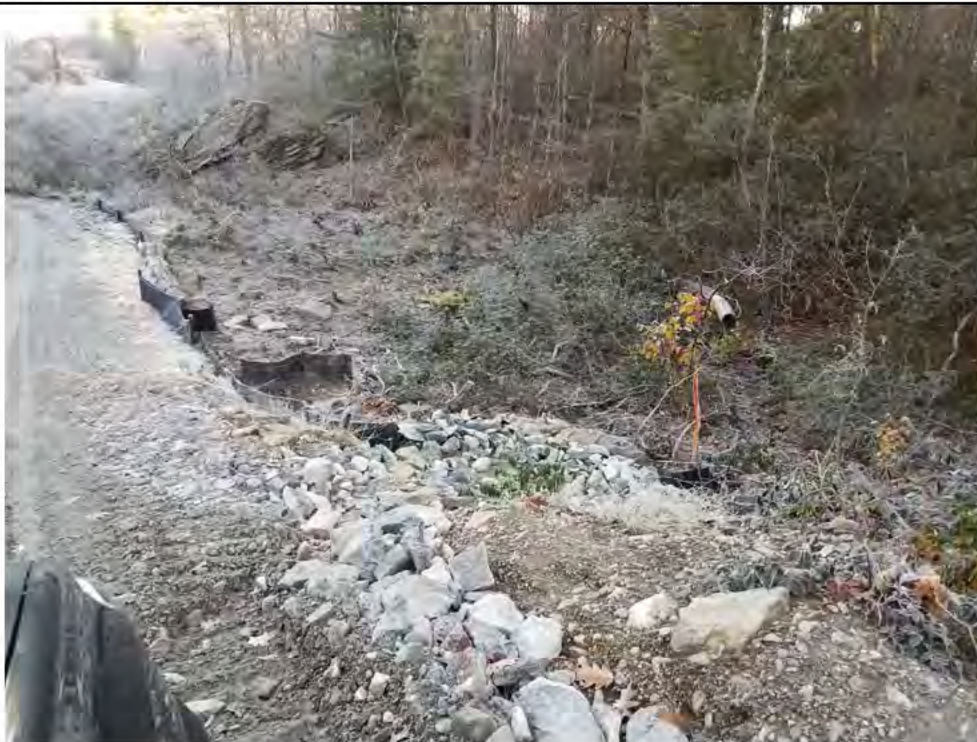
Erosion and Sedimentation Controls	Interim Week	<p>Various sections of silt fence and straw bales need full replacement in the areas between Str24 and Str46. Many are at their limits functionally and structurally and/or repairs are not possible (see Photos 4 and 5).</p>	<p>Continue to maintain/repair/replace existing E&S controls until veg establishment and stabilization is achieved following restoration activities.</p>	In Progress
	Bi-Week	<p>Repairs in progress in the areas between Str24 and Str39. Silt fence repair needed at Str23 (see photo 8). Straw blown on seeded slopes in the area of Str4 and Str5 has been blown into windrows due to weather conditions (see photo 9). Missing E&S controls at Str1A,</p>	<p>CONT. surface water runoff has caused rills on the pad slopes to the east and sedimentation to the low lying areas near the Connecticut Wetland Only designated area (see Map 01) abutting wetland W-F-B1 (see photos 10-12).</p>	<p>E&S installed at Str1A, other areas repairs in progress.</p>

Photo 4:11/09/17, Watertown: Map 12, south of Str34, non-compliant silt fence conditions, sedimentation through E&S controls, road base materials exceeding height limits (structural) of silt fence, punctures through silt fence material due to road base gravel.

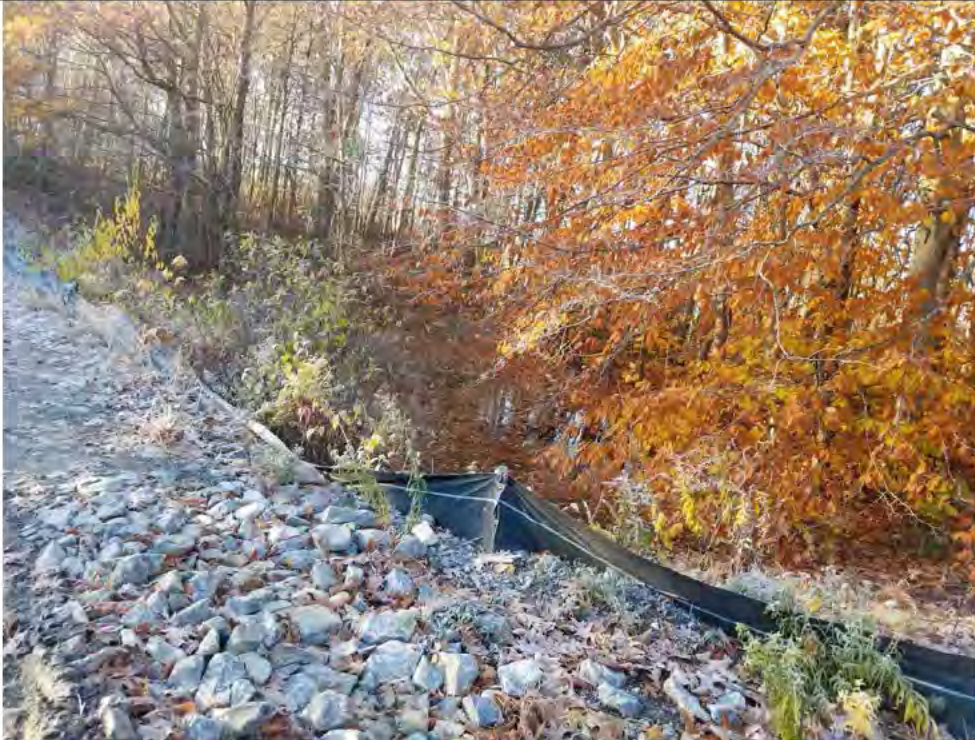
Photo 5: 11/09/17, Watertown: Map 11, west of Str31, non-compliant silt fence conditions, road base material height and pressing against silt fence, broken stakes, pictures through silt fence material due to road base gravel.

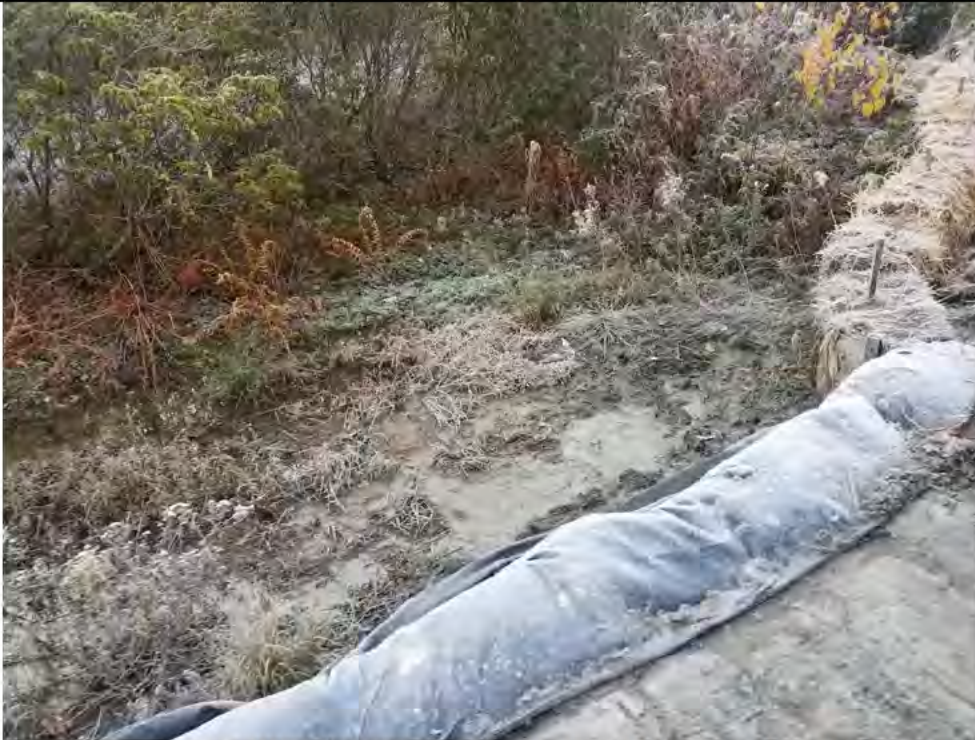
Inland Wetland & Watercourse encroachment & mitigation	Interim Week	<p>Wetland W-C20 continues to be impacted by uncontrolled surface water flow off of the access road upland of the wetlands during and following rain events.</p> <p>Corrective actions at or restoration of W-C20 has occurred several times however the root cause of the impacts has not been sufficiently addressed and impacts continue to occur after rain fall events (see Photo 6).</p>	N/A	In Progress

Photo 6: 11/09/17, Watertown: Map 14, W-C20 sedimentation through E&S controls and excess sediment buildup on timber mat crossing due to poor upland access road conditions.

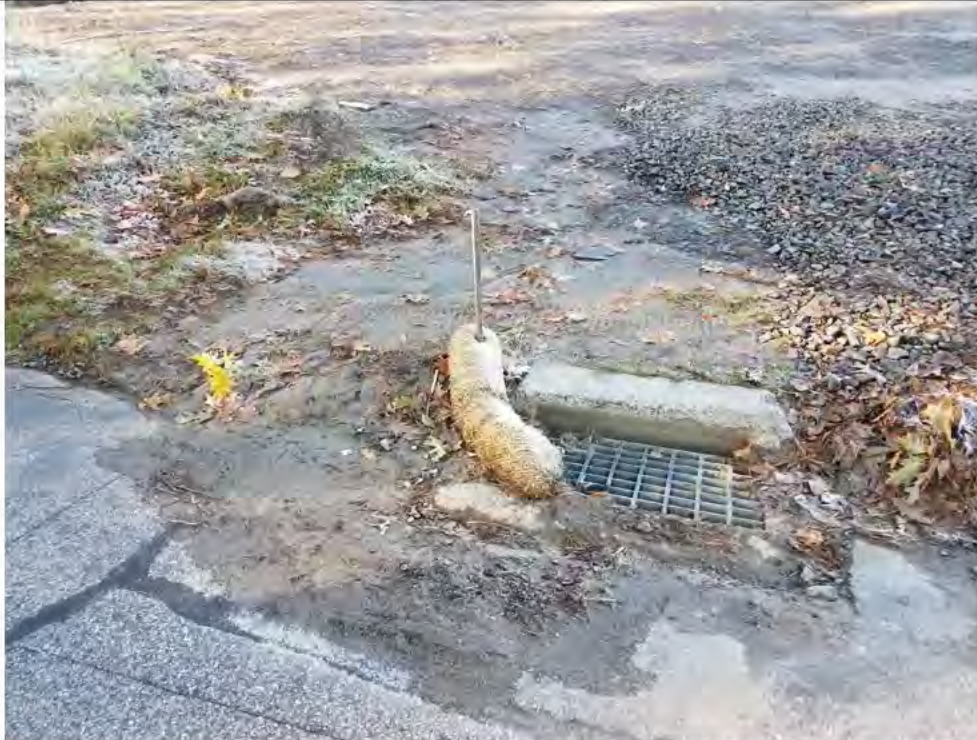
Photo 7: 11/09/17, Litchfield: Map 29, catch basin at Str81 west side of Campville Road, sediment movement from surface water runoff impacting catch basin and public access roadway.

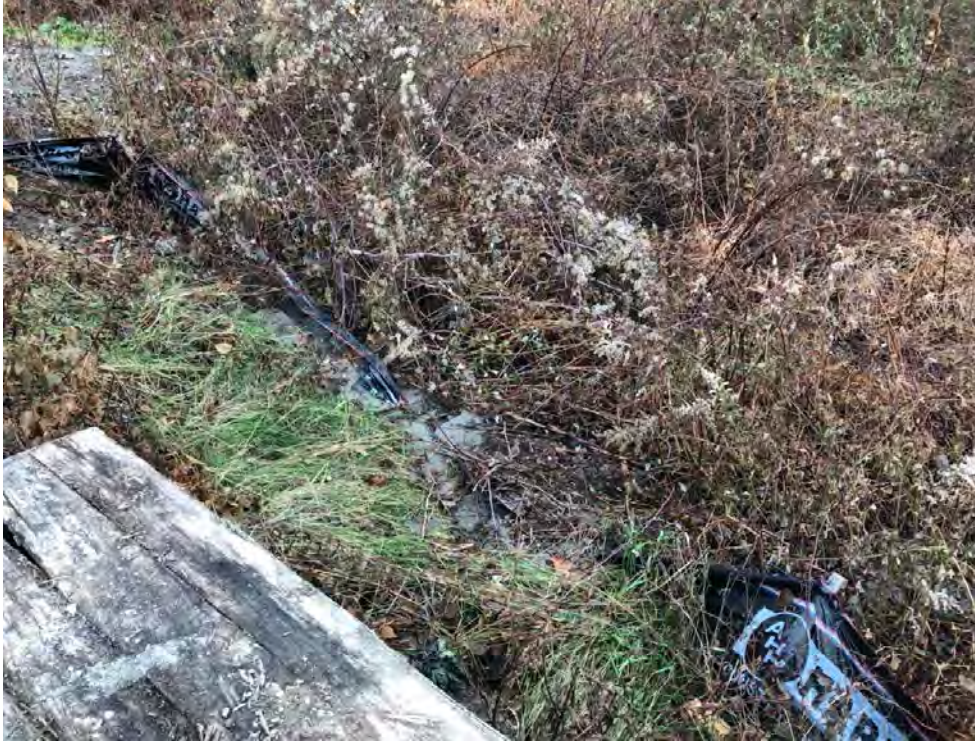
Photo 8: 11/17/2017, Watertown: Map 09, Str23, damaged silt fence.

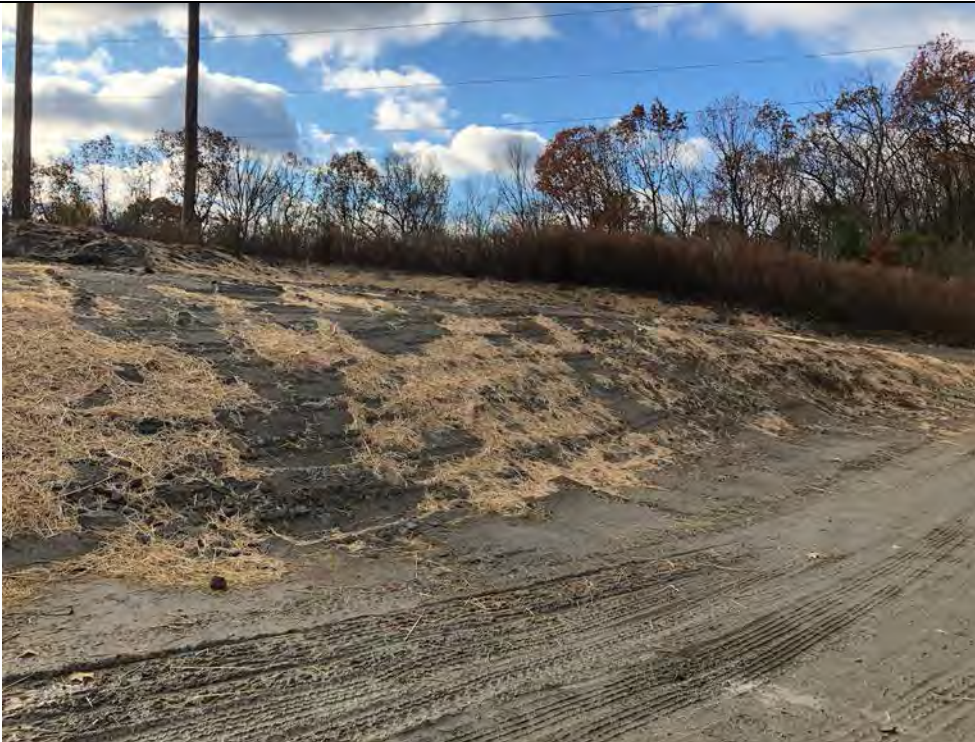
Photo 9: 11/17/2017, Watertown: Map 02, Str4, windblown straw covering seed on slope and top of pad.

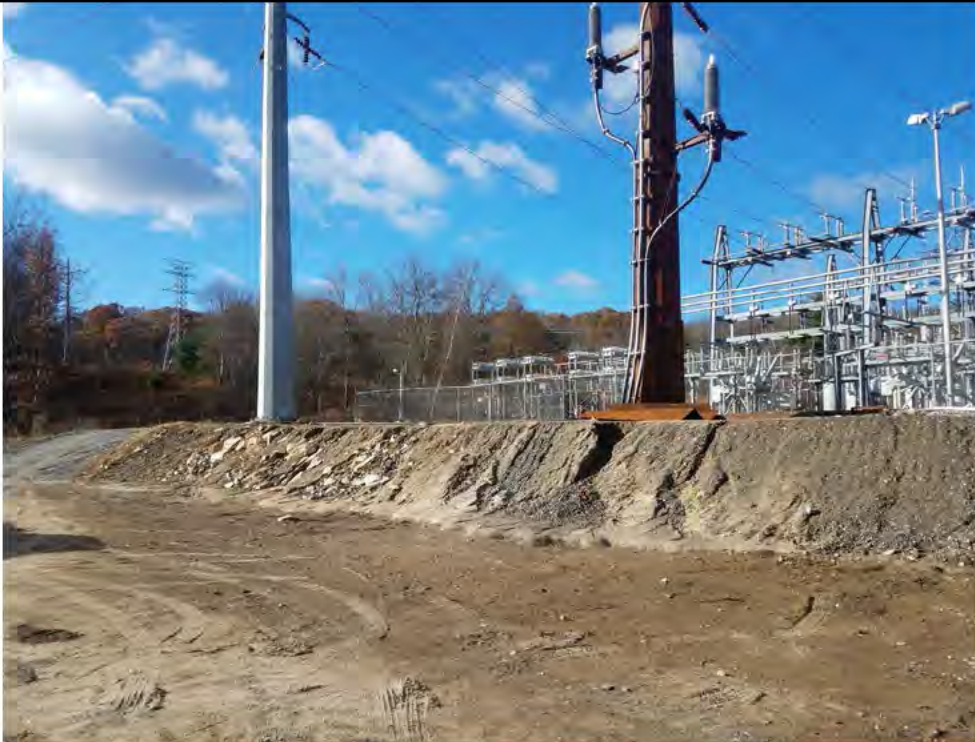
Photo 10: 11/17/2017, Watertown: Map 01, Str1A, rill erosion and sedimentation down gradient of work pad.

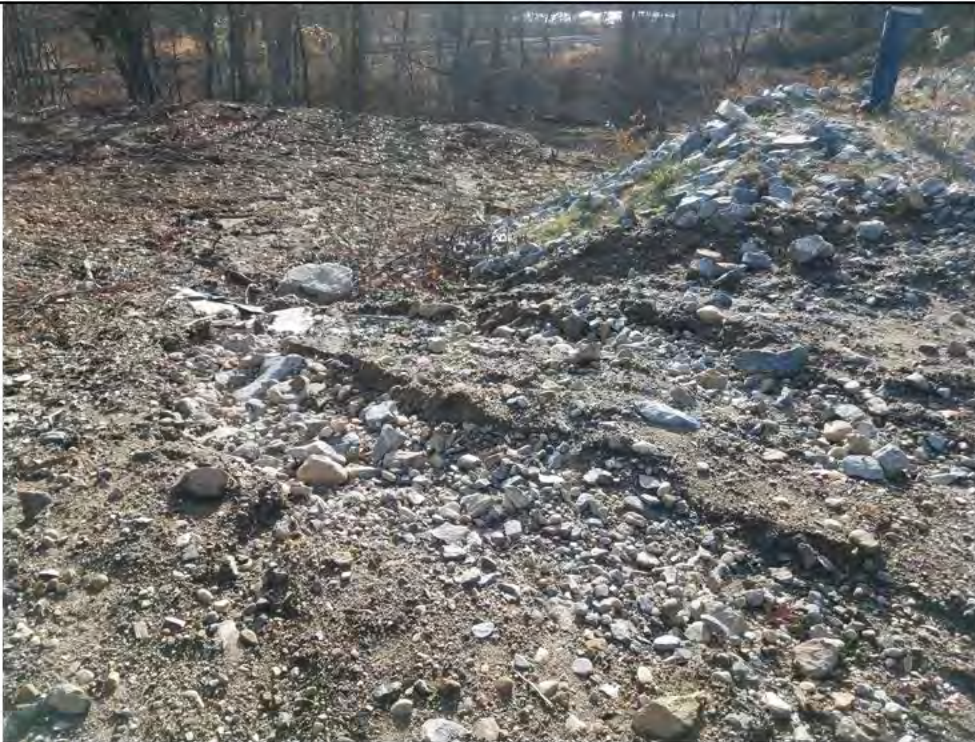
Photo 11: 11/17/2017, Watertown: Map 01, down gradient of Str1A, rill erosion and sedimentation down gradient to the east toward the Connecticut Wetland Only designated area.

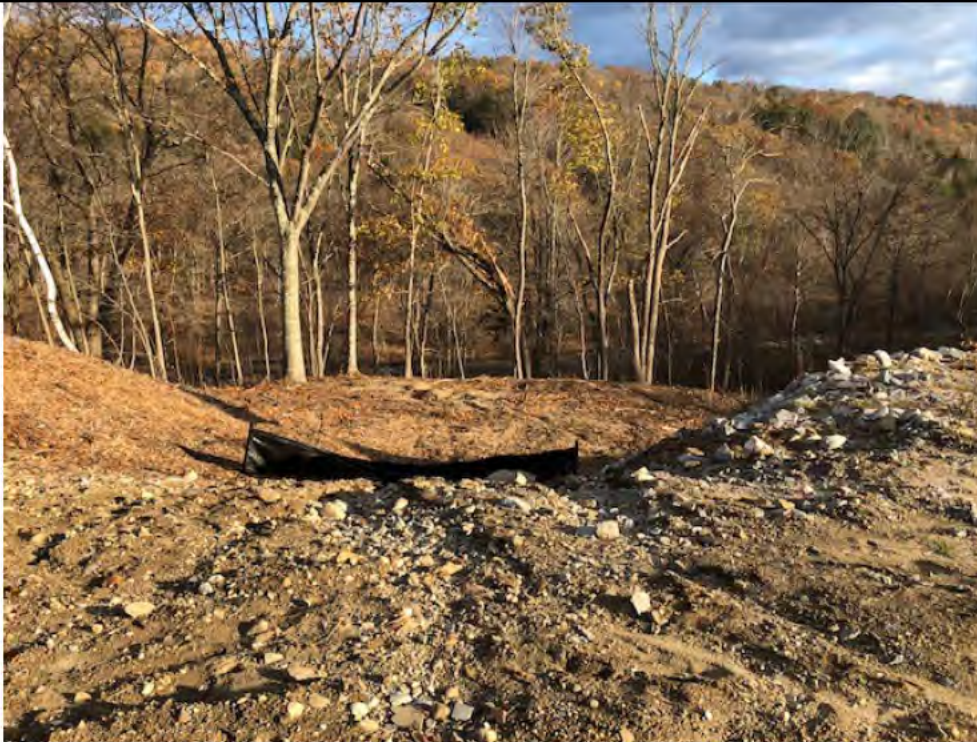
Photo 12: 11/17/2017, Watertown: Map 01, down gradient of Str1A, rill erosion and sedimentation down gradient to the east toward the Connecticut Wetland Only designated area, CORRECTIVE ACTION-E&S (silt fence) installed.

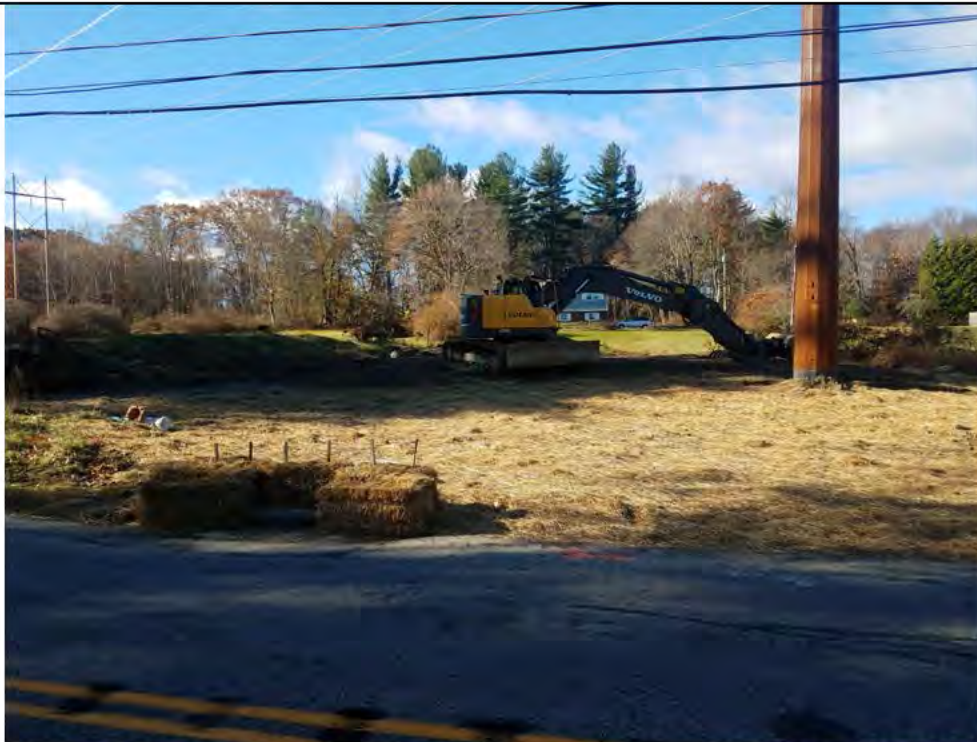
Rare, Threatened, and Endangered Species	Interim Week	<p>BMPs and Rare Species Avoidance and Minimization Measures are being followed.</p> <p>No rare, threatened, or endangered species have been observed and/or reported to date.</p>	<p>Continue to follow BMPs and Rare Species Avoidance and Minimization Measures.</p>	N/A
	Bi-Week	<p>No rare, threatened, or endangered species have been observed and/or reported to date.</p>	N/A	N/A
<p>Additional Documentation Comments:</p> <p>Notes:</p> <p>Open Items from previous inspections:</p> <p>Closed Items from previous inspections:</p> <p>The catch basin located immediately south of Str81 on Campville Road is now protected and pad restoration has begun (see photo 13).</p>

Photo 13: 11/17/2017, Litchfield: Map 29, Str81 and catch basin on Campville Road, CORRECTIVE ACTION- Installed E&S controls to protect catch basin, sediments were removed from the catch basin, straw placed over work pad to aid in controlling surface water runoff, restoration of the work pad has begun.
