**Subject: Docket No. 466, Frost Bridge to Campville 115-kV Project
Decision and Order Condition #4 – Independent Environmental Inspector Report**

Please find enclosed the Biweekly Independent Environmental Inspector Report, Report #27, for the **December 7th** and **December 15st, 2017**, inspection events for the construction of the Eversource Frost Bridge to Campville 115-kV Project.

Docket No. 466– Development and Management Plan Inspection

Frost Bridge to Campville 115kV Project

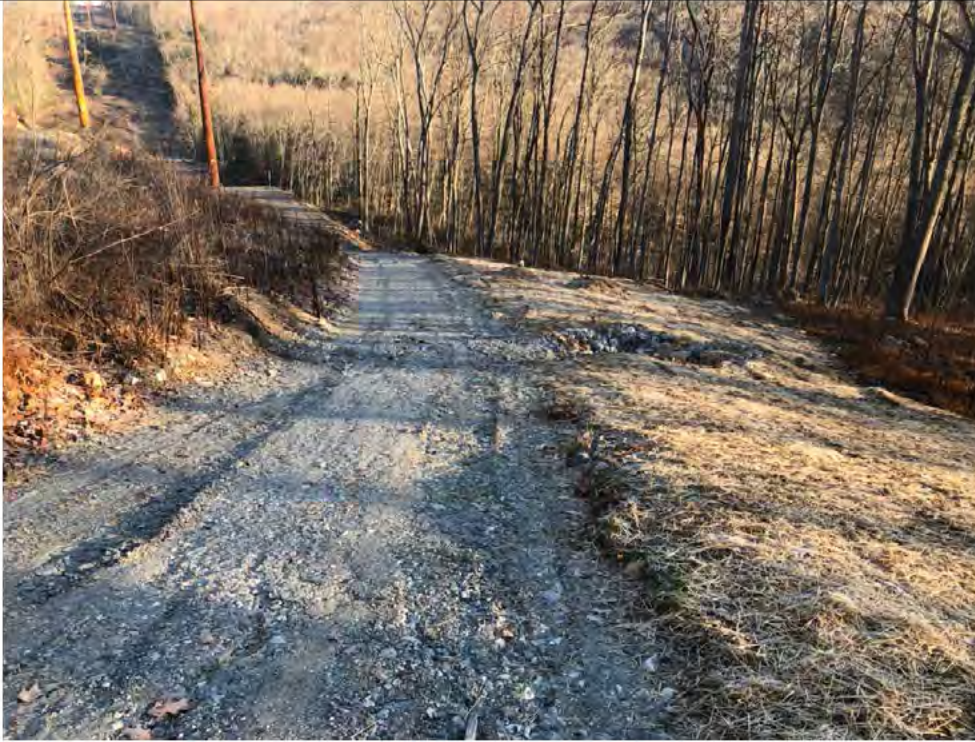
Areas of Inspection		Observation:	Recommended Action/s:	Corrected Action/s:
Access Roads and Adjacent Roadways	Interim Week	-Access Road at Str69 has visible rills (see Photo 1). -Access Road to Str87 has visible rills.		
	Bi-Week	In areas inspected, roads were covered with approximately 2" of snow. Some roads between Str 31 and Str39 were rutted and frost was observed.	N/A	
Vegetative Clearing Limits (Including trees to save or danger trees noted.	Interim Week	Task Completed	N/A	N/A
	Bi-Week	Task Completed	N/A	N/A

Photo 1: 12/07/2017, Thomaston: Map 24, Str69, rills on access road.

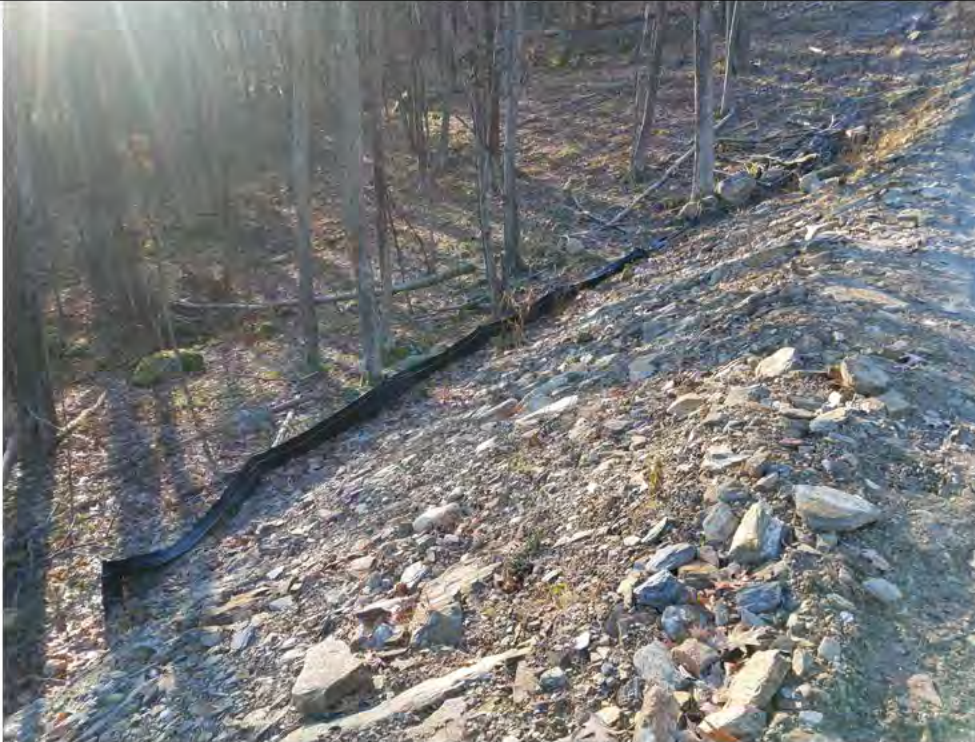
Erosion and Sedimentation Controls	Interim Week	<p>-No improvement in conditions of E&S in the areas between Str24 and Str39 as reported in the 2 previous reports.</p> <p>-Silt fence at Str69 needs repairs (see Photo 2)</p> <p>-Silt fence at the new culvert (below Str87) installed improperly, sedimentation flowing underneath (see Photo 3).</p> <p>-The entire Silt fence line at Str87 requires repair (see Photos 4 and 5).</p>	<p>-Sediment trap off of the access road to Str87 is completely full and non-functional(see Photo 6).</p> <p>-Silt fence at Str23 is still in need of repair as reported previously on 11/17/17.</p> <p>- E&S repairs(water bars and removal of sediment build up on silt fences) were completed in Str65-Str69.</p>	
	Bi-Week	<p>No corrective actions were observed in the areas between Str24 and Str39 at the time of this inspection. The BluRoc crew was in the process of starting at the time of this inspection.</p> <p>-Silt fence down on access road near Str31.</p> <p>-Silt fence down at Str96, and fence should be extended further upland.</p>	<p>-At Str87, no silt fence repairs observed and a seep at the base of the Str3235 pad was actively flowing and sedimentation and rills were observed.</p> <p>-Sediment trap at Str87 has been cleaned and is functioning as designed.</p>

Photo 2: 12/07/2017, Thomaston: Map 24, Str69, silt fence at toe of slope in need of repair.

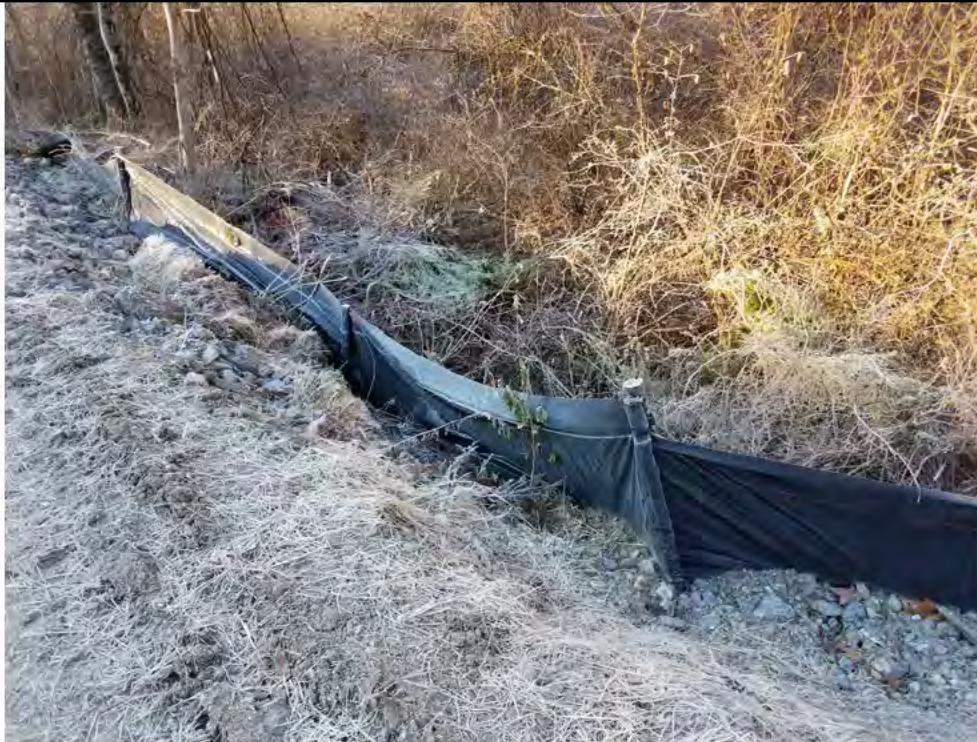
Inland Wetland & Watercourse encroachment & mitigation	Interim Week	<p>Impacts to W-C20 remain, restoration still pending.</p> <p>Sedimentation was observed at the culvert replacement area, W-F11/S-F10 (southwest of Str87), due to improperly installed silt fence. However, it was observed within the designated Permanent Impact Area as shown on Map 32 (Harwinton).</p>

Photo 3: 12/07/2017, Harwinton: Map 32, Wetland W-F11, silt fence not toed into ground surface.

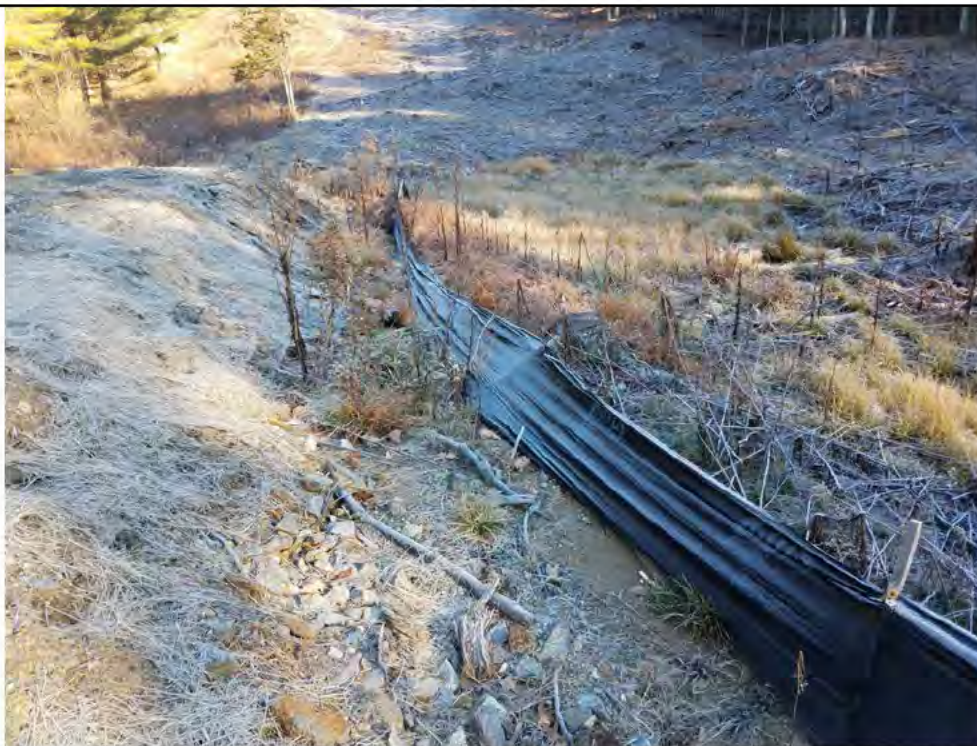
Photo 4: 12/07/2017, Harwinton: Map 32, Str87, full line of silt fence at toe of slope in need of repair.

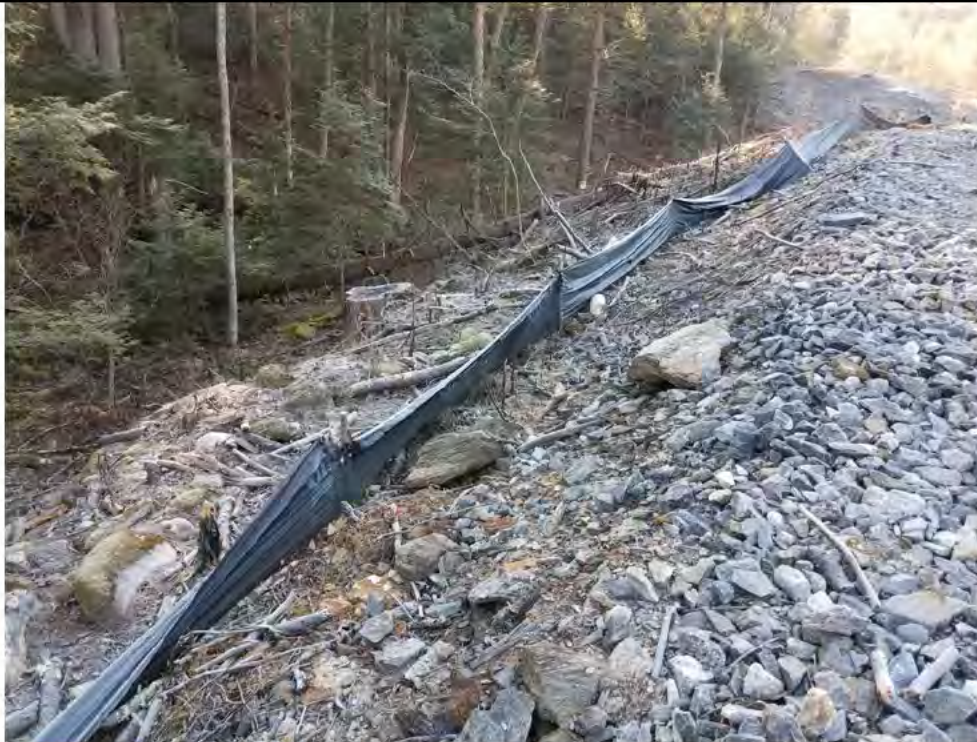
Photo 5: 12/07/2017, Harwinton: Map 32, Str87, full line of silt fence at toe of slope in need of repair.

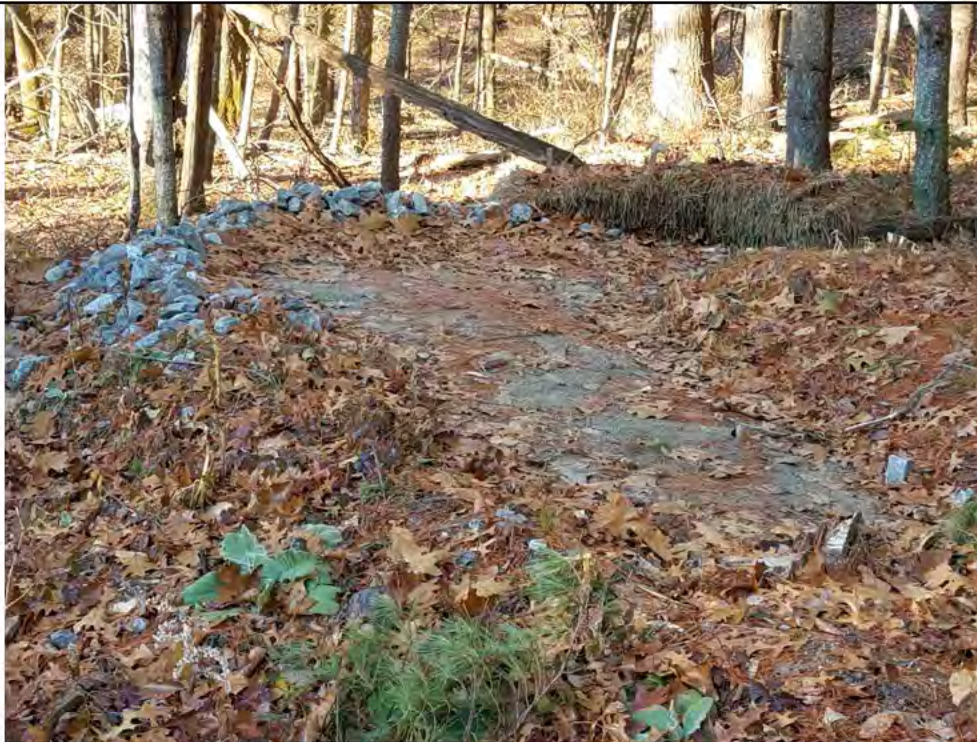
Photo 6: 12/07/2017, Harwinton: Map 32, access road sediment trap in the area of Str87/Str3174/Str3235, excessive sediment buildup.
