**Subject: Docket No. 466, Frost Bridge to Campville 115-kV Project
Decision and Order Condition #4 – Independent Environmental Inspector Report**

Please find enclosed the Biweekly Independent Environmental Inspector Report, Report #31, for the **February 1st** and **February 9th, 2018**, inspection events for the construction of the Eversource Frost Bridge to Campville 115-kV Project.

Docket No. 466- Development and Management Plan Inspection

Frost Bridge to Campville 115kV Project

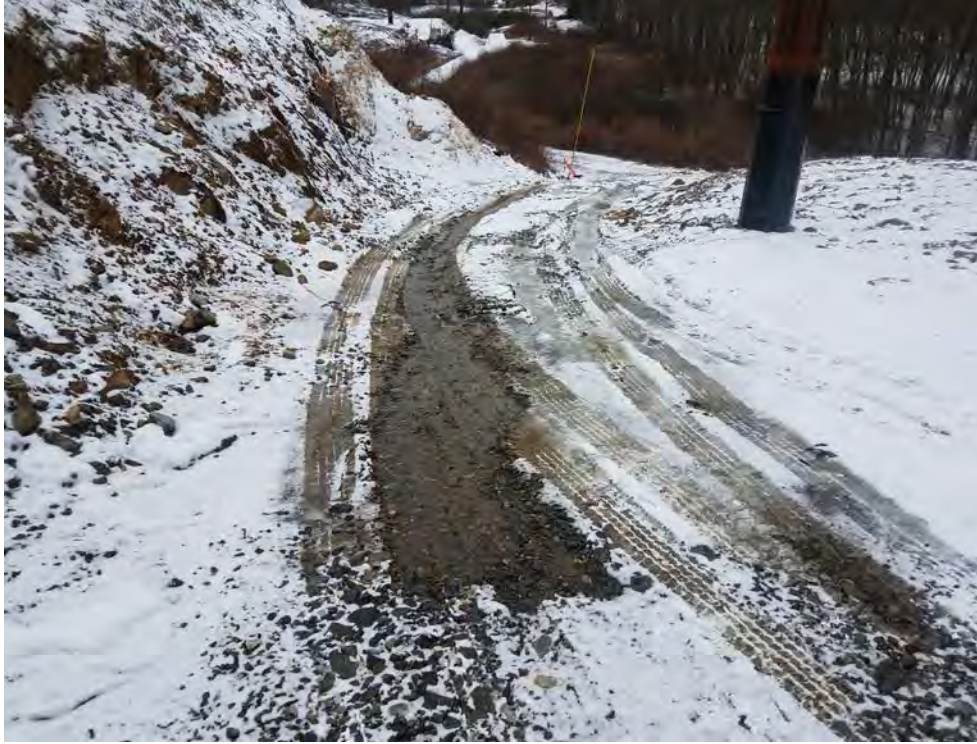
Areas of Inspection		Observation:	Recommended Action/s:	Corrected Action/s:
Access Roads and Adjacent Roadways	Interim Week	Seasonal impacts (snow/ice covered, minor rills, surface water runoff, and sediment erosion due to thaws) were observed throughout the ROW. See photo #1, Str73 (Litchfield, Map 26).	Observed conditions are minor at this time, and not impacting wetlands or watercourses. Corrective actions can be performed during restoration when warmer conditions allow.	Areas identified during the inspection will be placed in a project Excel Table with other project items that are to be addressed based on priority and when seasonal conditions allow.
	Bi-Week	Observed no significant changes in overall site conditions. See above Interim Week observations.	See above	See above
Vegetative Clearing Limits (Including trees to save or danger trees noted.	Interim Week	N/A	N/A	
	Bi-Week	N/A	N/A

Photo 1: 02/01/2018, Litchfield: Map 26, ice sheet and visible rills on the access road below Str73 down to wetland W-E2, runoff from upland drainage and from the pad for structure Str73.

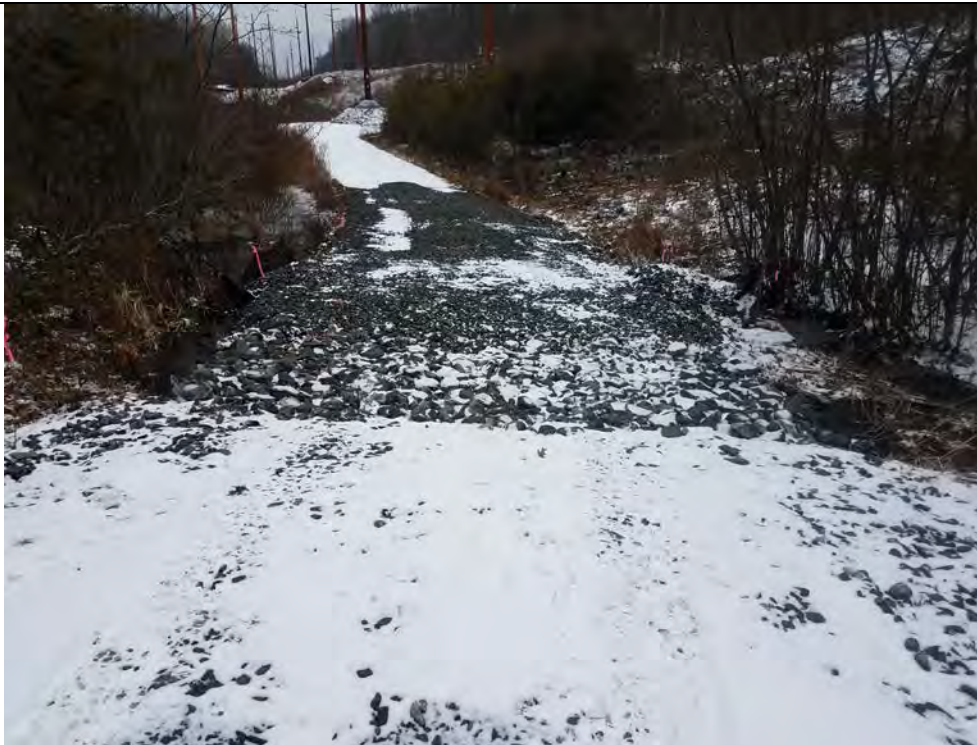
Water Crossings	Interim Week	Hard bottom crossing restoration completed at S-E3 (Thomaston, Map 25), see Photo #2.	N/A	N/A
	Bi-Week	No significant changes observed in overall site conditions. Timber mat and hard bottom crossings were functional and maintained.	N/A

Photo 2: 02/01/2018, Thomaston: Map 25, Hard bottom crossing restoration at S-E3 completed.

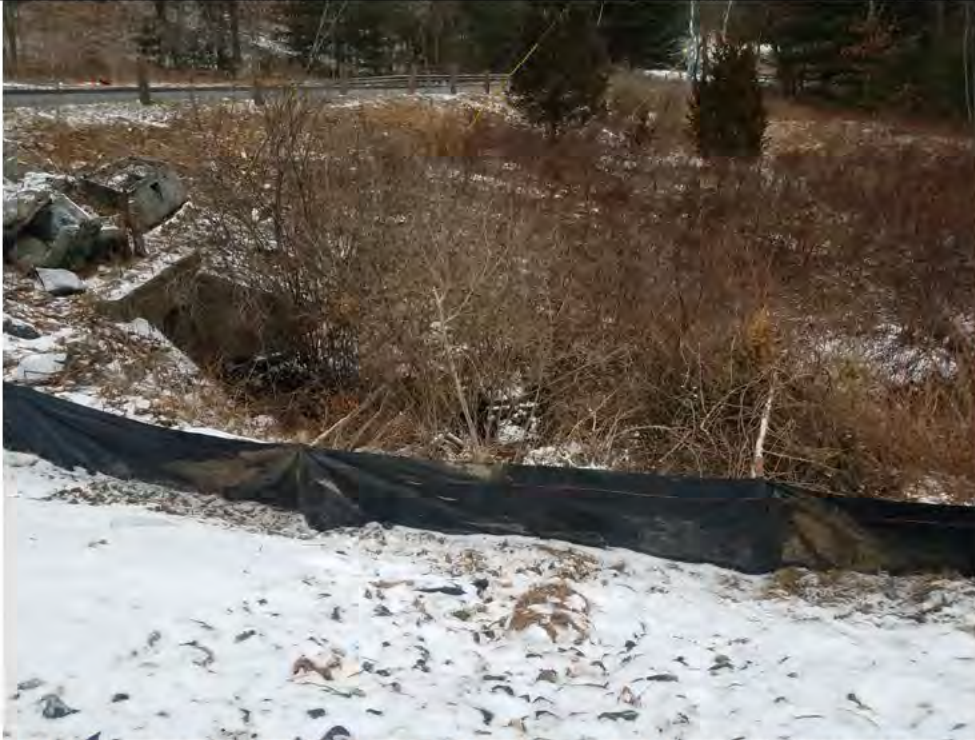
Photo 3: 02/01/2018, Watertown: **CORRECTIVE ACTION:** Map 01, Str2 pad, failed silt fence at toe of slope abutting S-A1 repaired. Failure reported in Biweekly Report #30 dated 1/26/2017.

Erosion and Sedimentation Controls	Interim Week	<p>Corrective actions: Silt fence at Str02 and S-A1 has been repaired (see Photo #3). Silt fence at Str01 upland of the CT Designated Wetland has been repaired (see Photo #4).</p> <p>Silt Fence repairs needed at: -Str69 upland of W-D14 (Photo #5) -Str71 upland of W-E2 (Photo #6) -Str97 below pad, upland of W-G1 (Photos # 7 & 8).</p>	<p>Due to current site conditions, access issues, and the low level potential at this time for impacts to wetlands and/or watercourses, the silt fence repairs needed at Str69, 71, and 97, can be postponed until conditions are more suitable to perform corrective actions. Until such actions can be</p>	<p>performed, these areas will be monitored and if conditions degrade, impacts or eminent impacts are observed, corrective actions will be required immediately.</p>
	Bi-Week	<p>Areas inspected appeared to be stabilized. Minimal snow cover at this time. Ice cover, minimal snow melt, and light surface water flow/drainage, is present in many areas or the ROW. Frost layer is site wide with temperatures remaining at/or around freezing during daylight and in the 20's to low 30's overnight.</p>	N/A

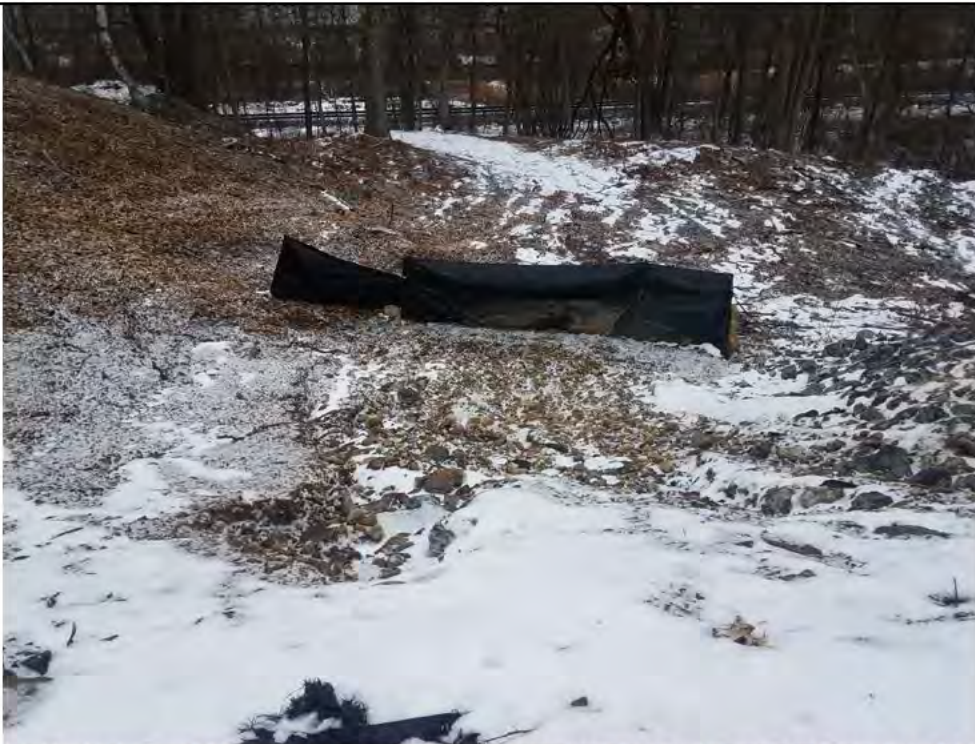
Photo 4: 02/01/2018, Watertown: **CORRECTIVE ACTION:** Map 01, Str1A pad, failed silt fence off of the pad upland of the Connecticut Designated Wetland. Failure reported in Biweekly Report #30 dated 1/26/2017.

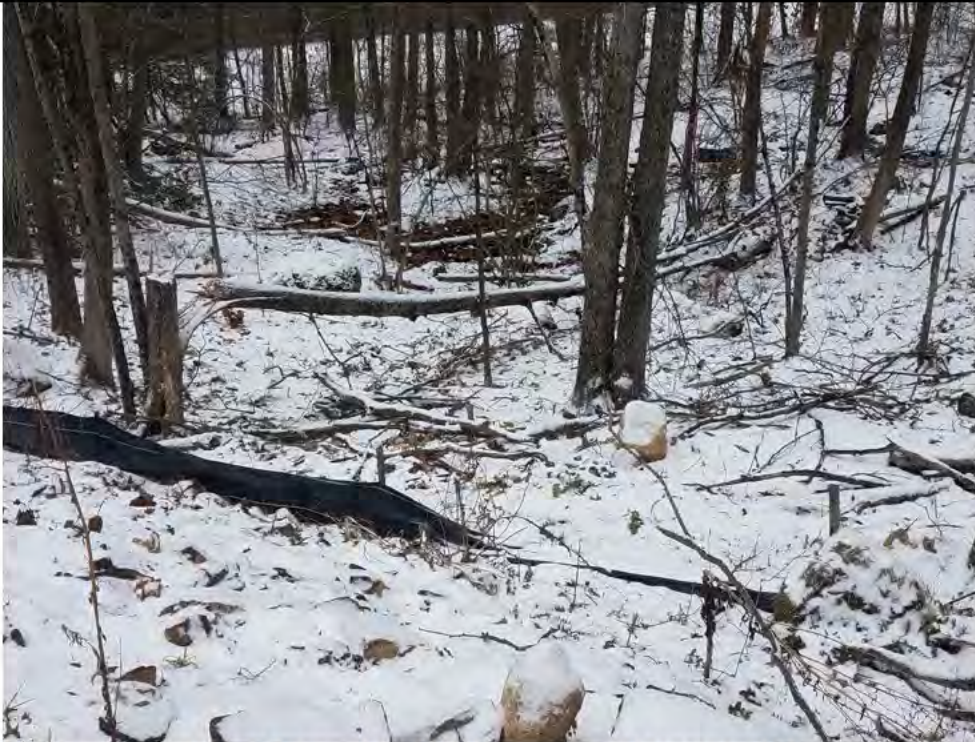
Photo 5: 02/01/2018, Thomaston: Map 24, toe of pad at Str69 upland of W-D14, silt fence repairs needed. No visible indications of ground movement observed at this time.

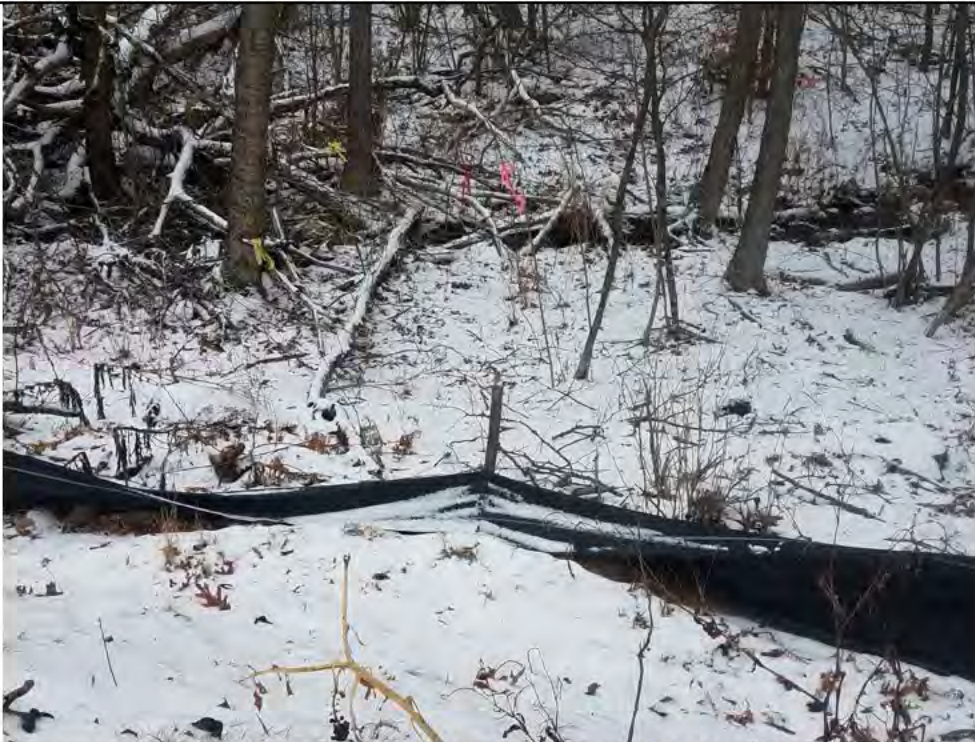
Photo 6: 02/01/2018, Thomaston: Map 25, toe of pad at Str71 abutting W-E2/S-E3, Minor silt fence repairs needed. No visible indications of ground movement observed at this time.

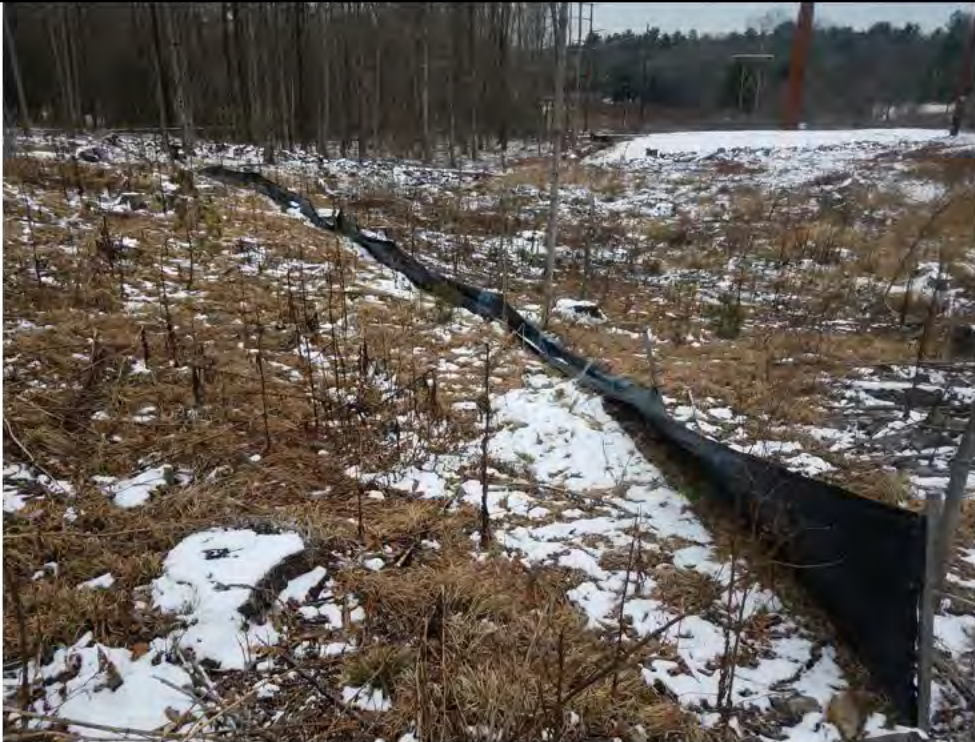
Photo 7: 02/01/2018, Harwinton: Map 35, below Str97 and upland of W-G1/S-G3, silt fence repairs needed. No visible indications of ground movement observed at this time and full veg growth present. Area appears stabilized and silt fence may be removed if work in the upland area has been completed.

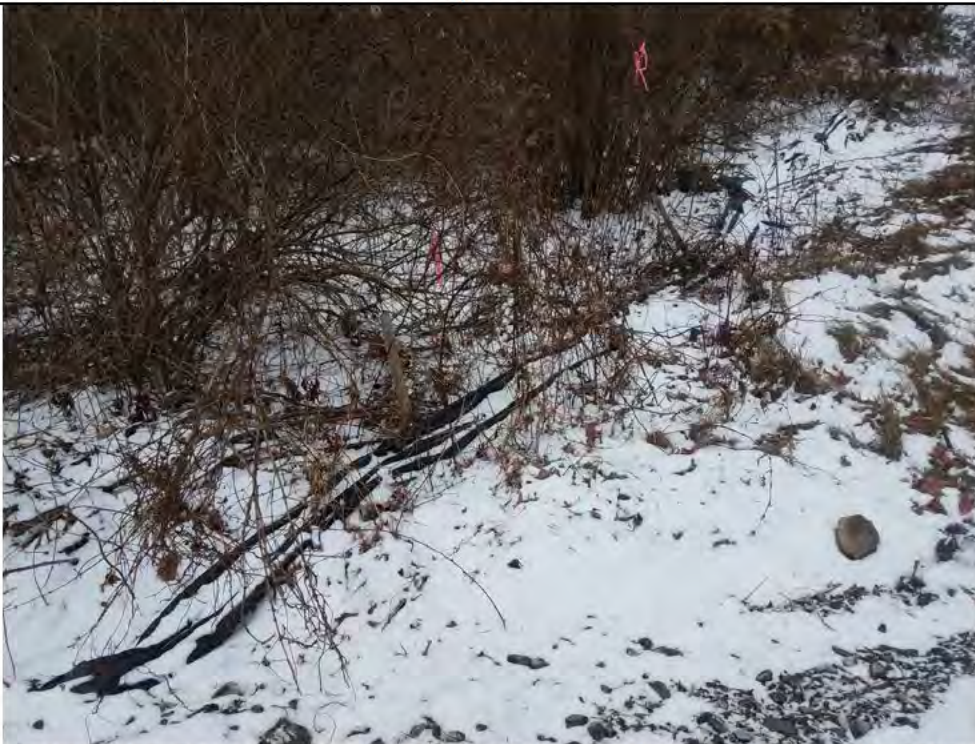
Photo 8: 02/01/2018, Harwinton: Map 35, between Str97 and Str96, silt fence line butting W-G1/S-G3 and the access road, silt fence repairs needed. No visible indications of ground movement observed at this time and veg growth present.
