ENVIRONMENTAL MONITORING
DAILY SITE OBSERVATION FORM

Report No. 3

Project: Verizon Wireless Hamden 8 Facility
 Address: 208 Kirk Road, Hamden, Connecticut

APT Project #: CT1414200

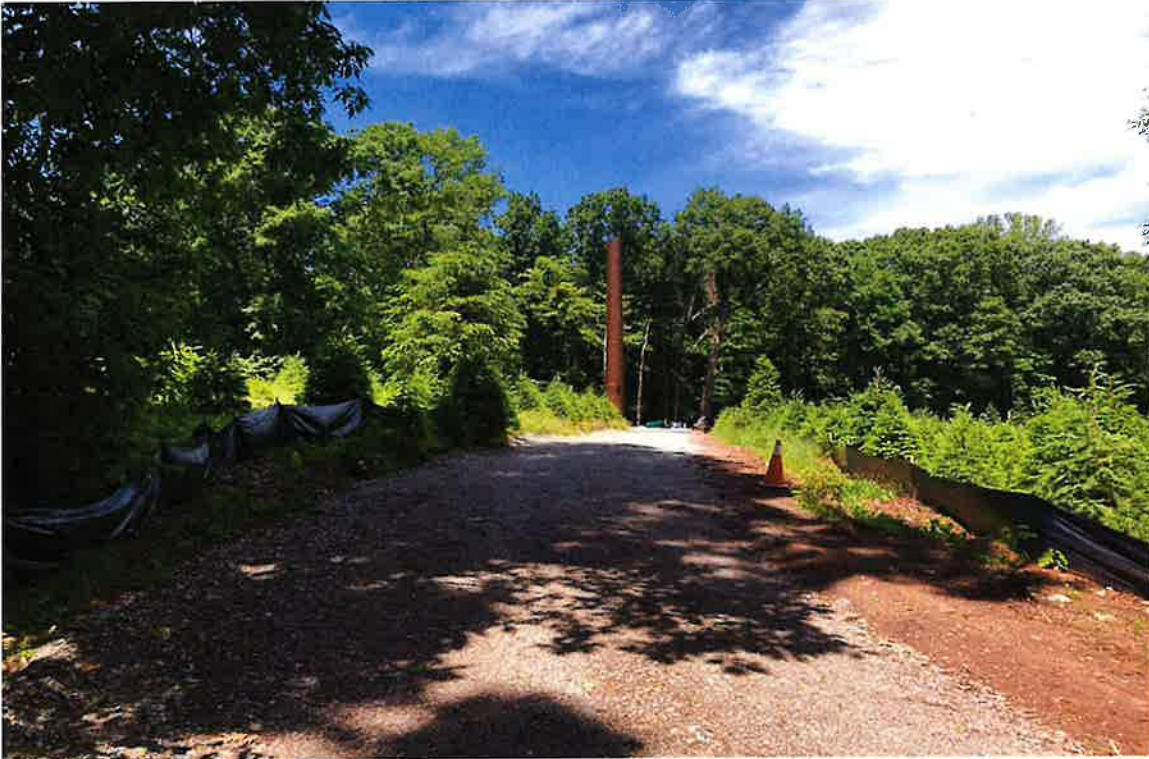
Photo 1: View of access road leading to tower.

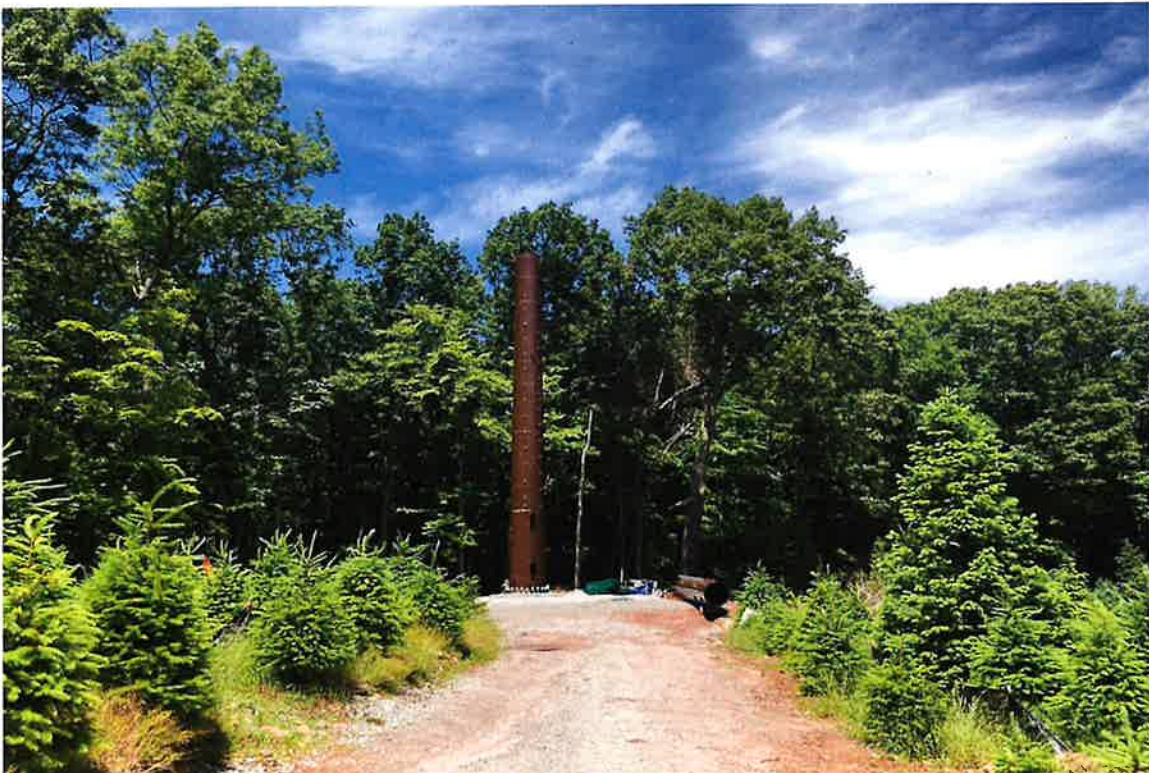
Photo 2: View of first section of tower erected.

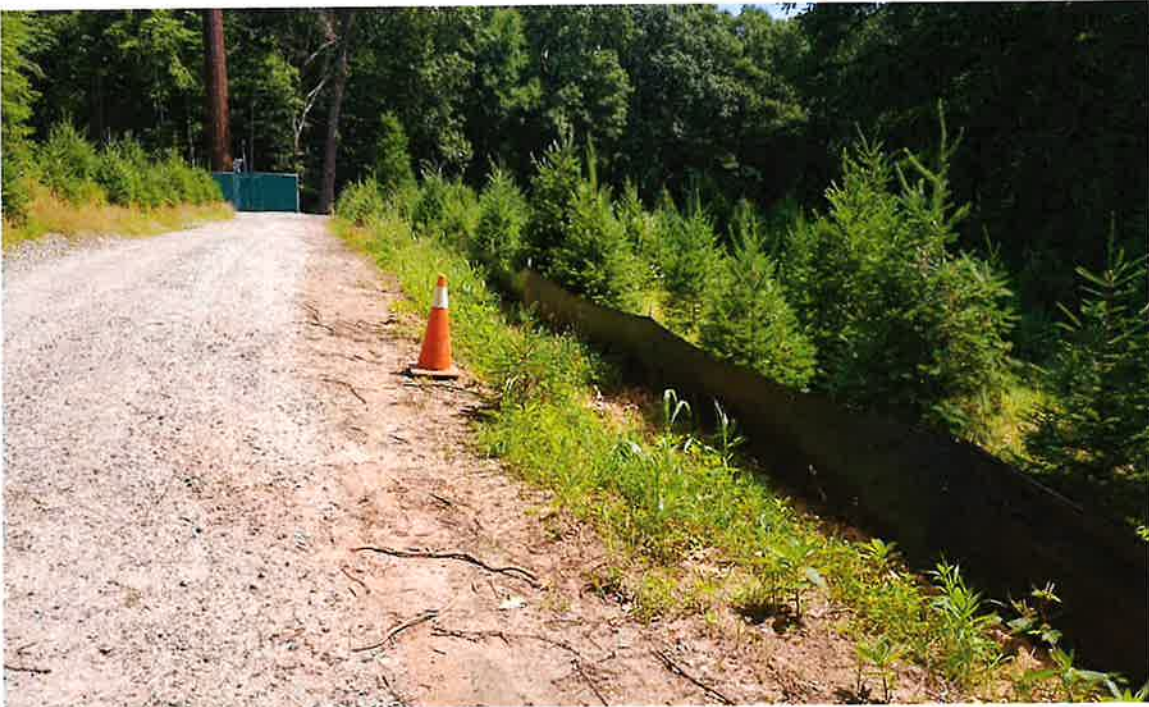
Photo 3: View of properly installed/maintained exclusionary silt fence.

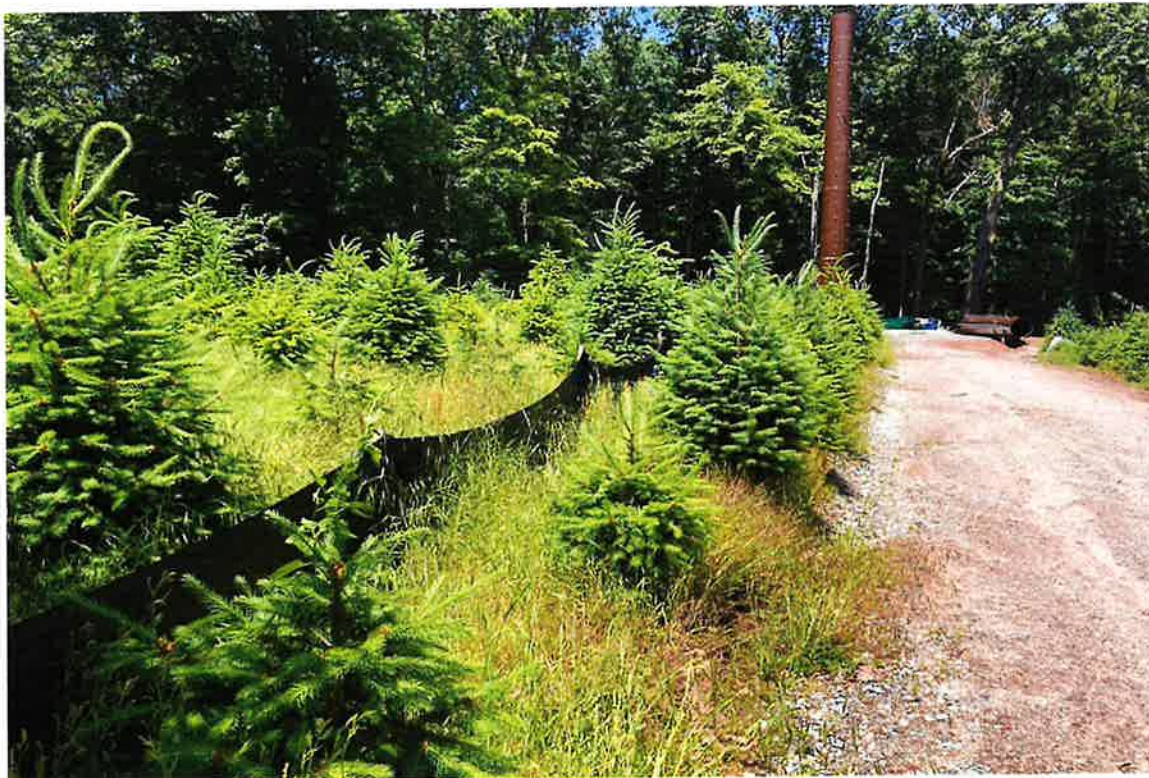
Photo 4: View of silt fence maintained.

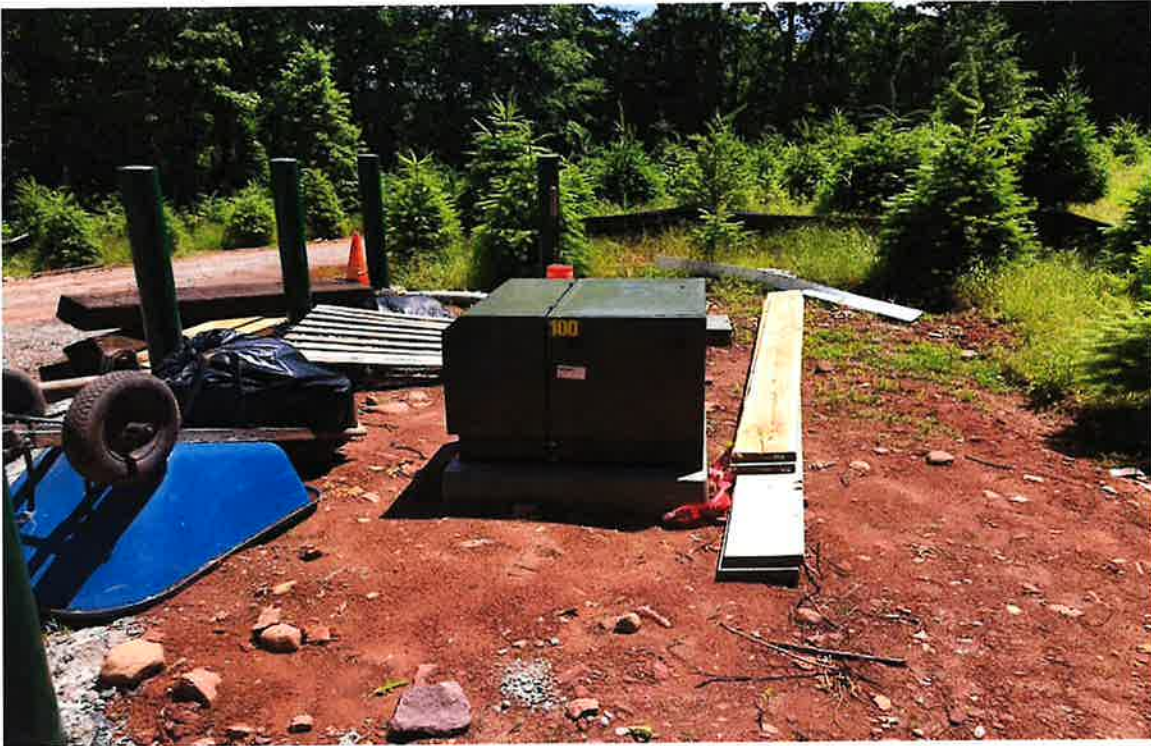
Photo 5: View of completed utility work.
