Re: Docket No. 475 – Cellco Partnership d/b/a Verizon Wireless Application for a Certificate of Environmental Compatibility and Public Need for the Construction, Maintenance and Operation of a Wireless Telecommunications Facility Located South of Folly Lane, Coventry, Connecticut

Construction MONITORING
DAILY SITE OBSERVATION FORM

Report No. 3

Project: Verizon Wireless Coventry NW Facility
Address: Folly Lane, Coventry, Connecticut

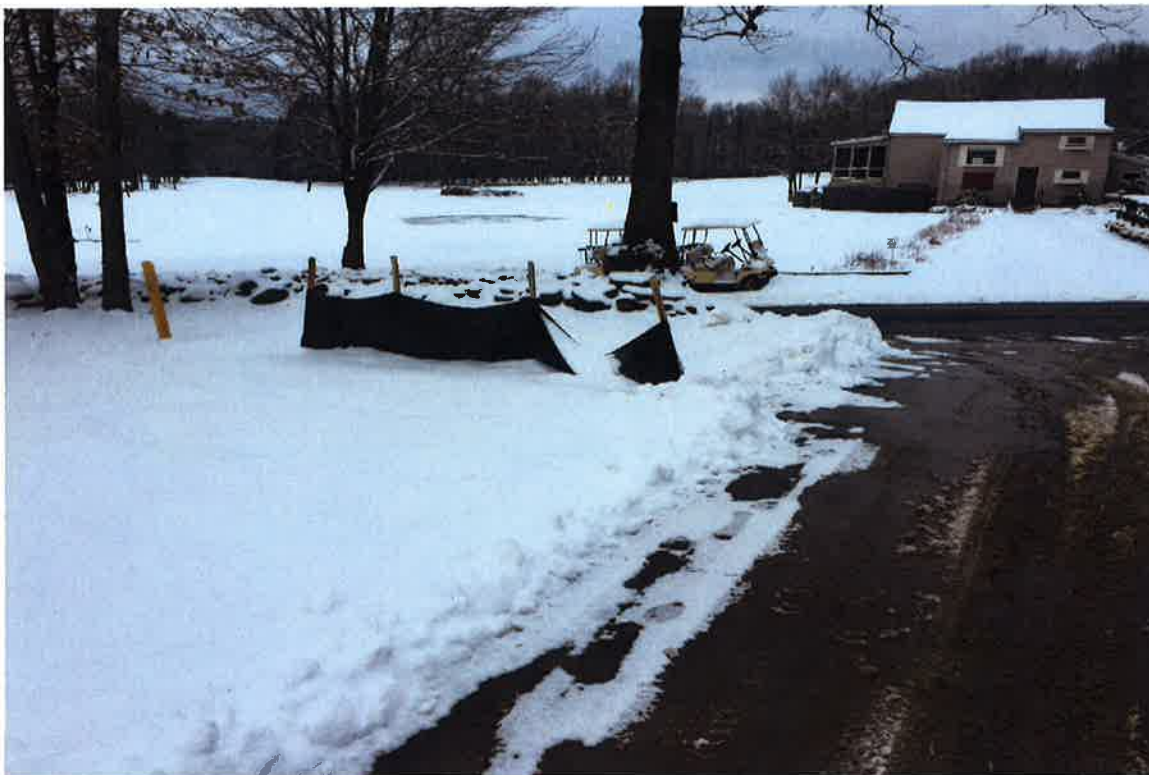
Photo 1: View of erosion controls at construction entrance off Folly Lane.

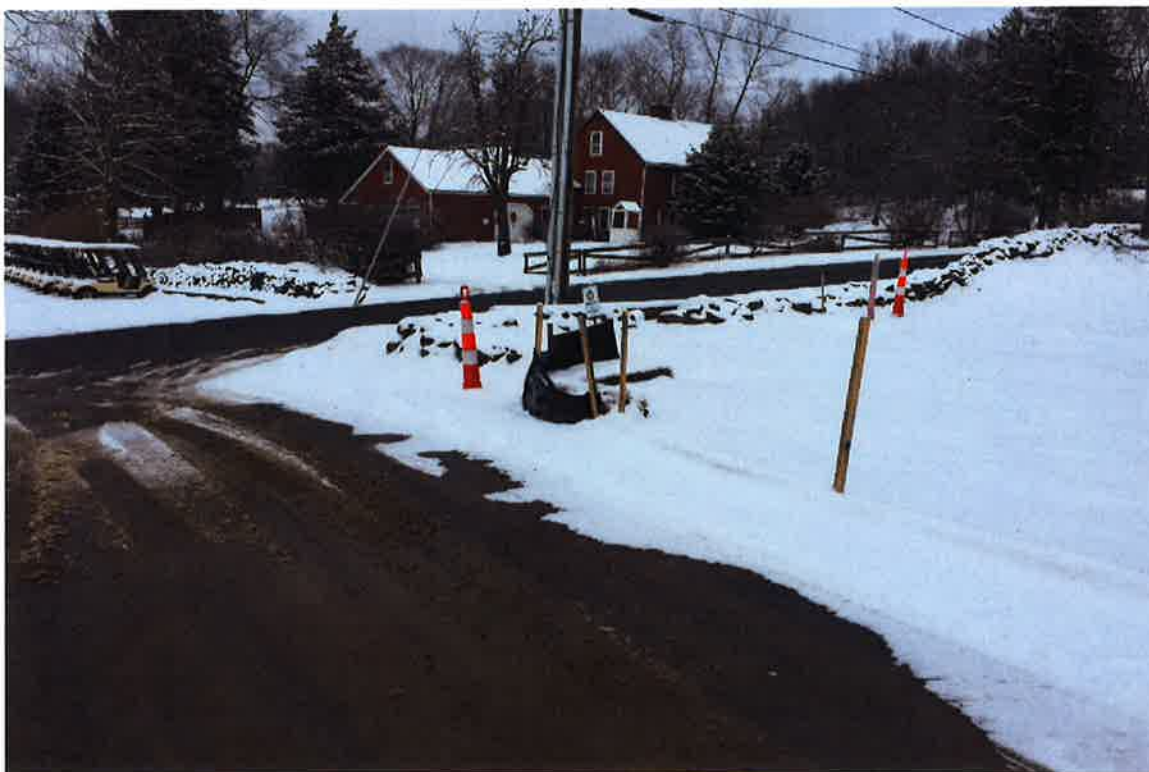
Photo 2: View of erosion controls at construction entrance off Folly Lane.

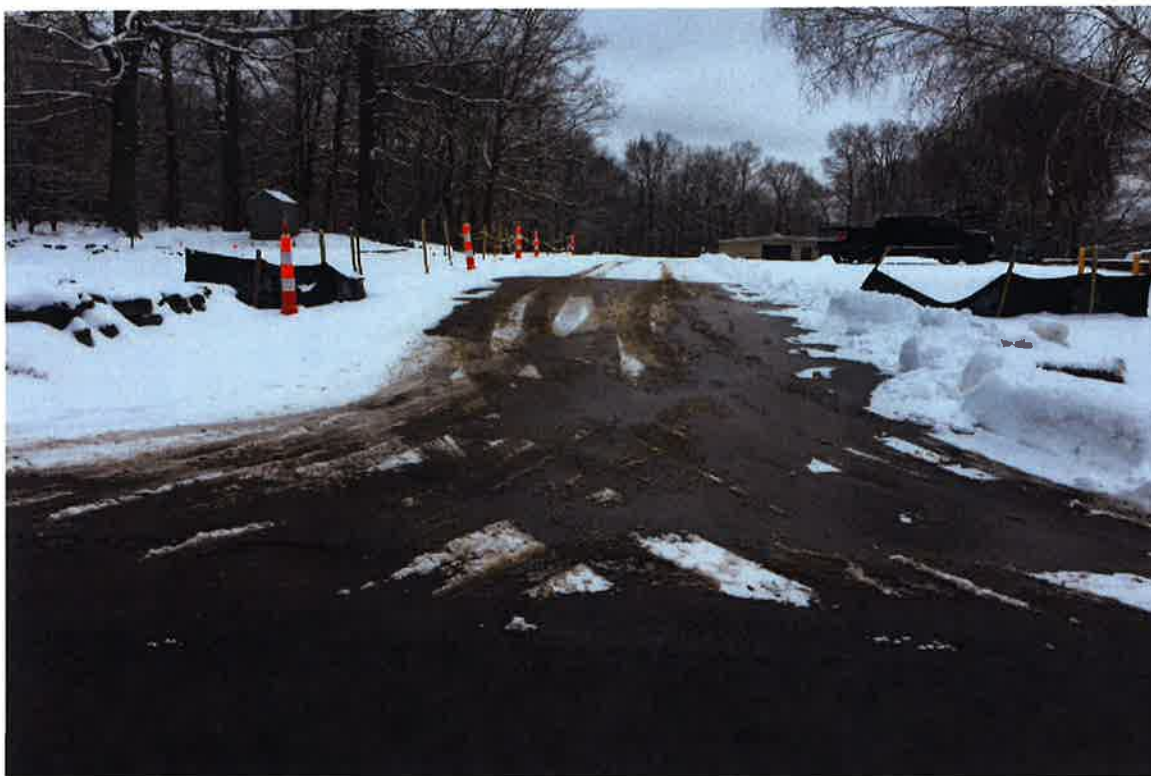
Photo 3: View of construction entrance looking from Folly Lane.

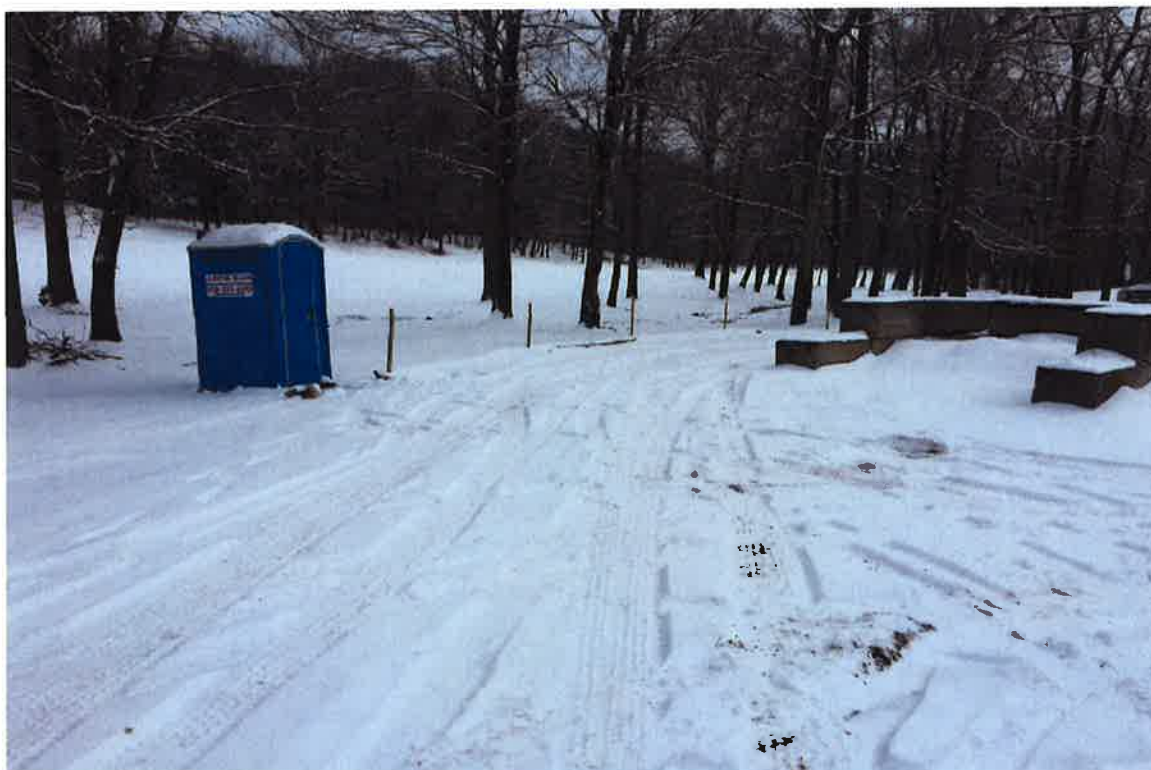
Photo 4: View of preexisting washout location by bulk storage bins.

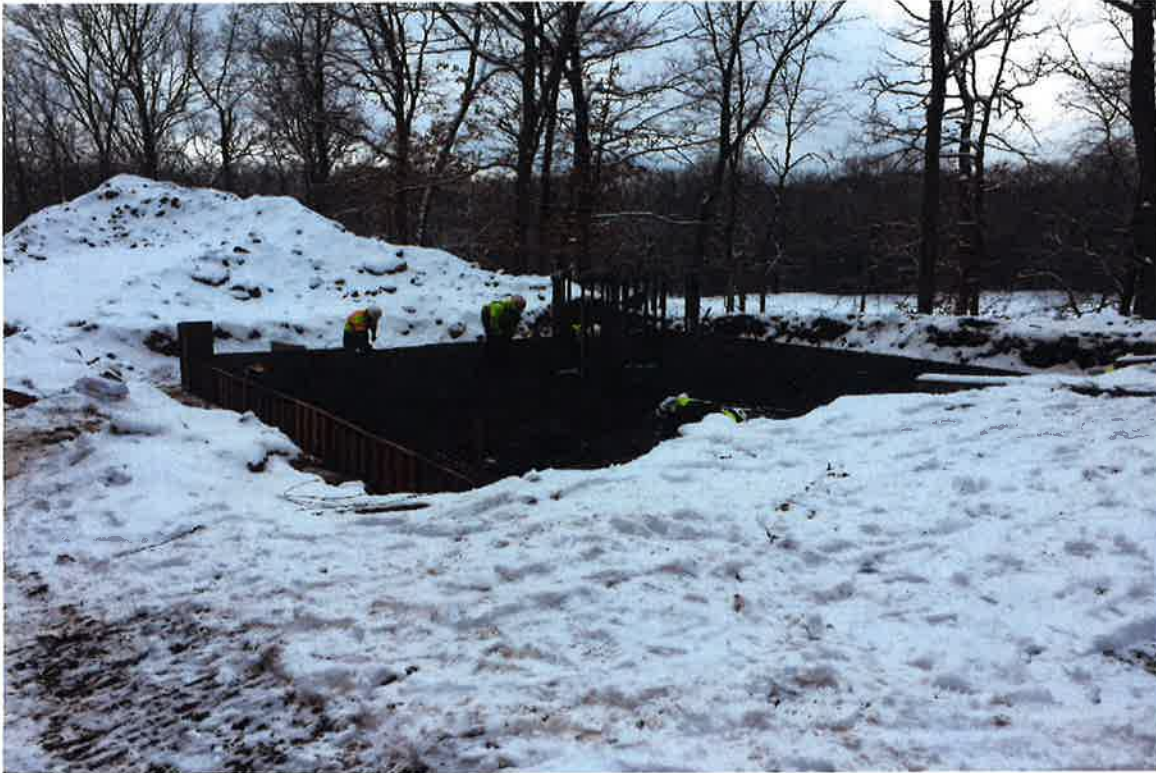
Photo 5: View of foundation work underway.

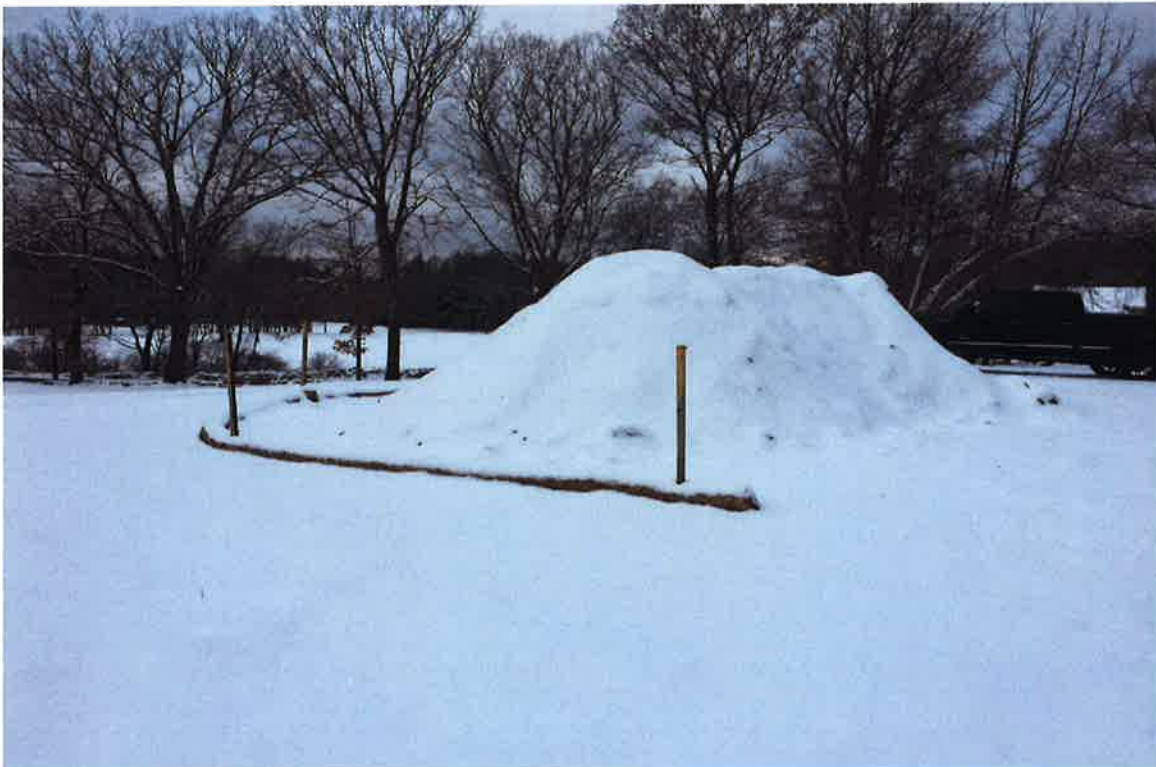
Photo 6: View of material storage pile.

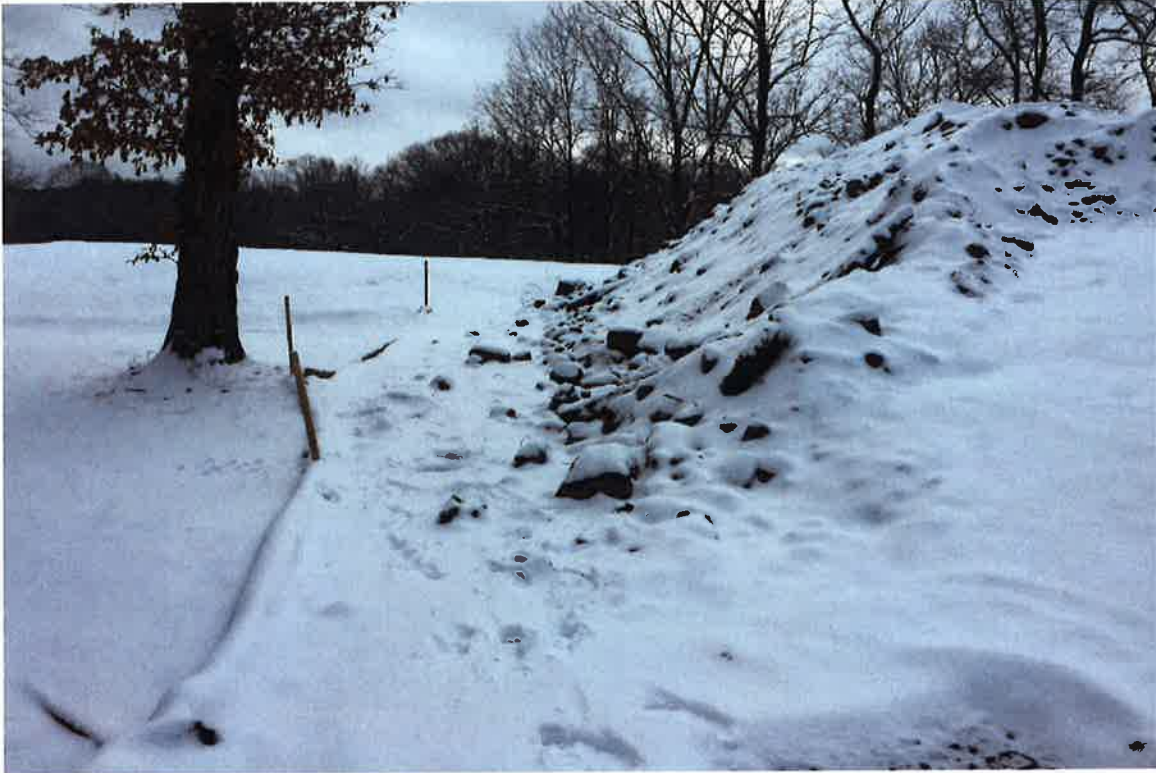
Photo 7: View of excavation material stockpile.

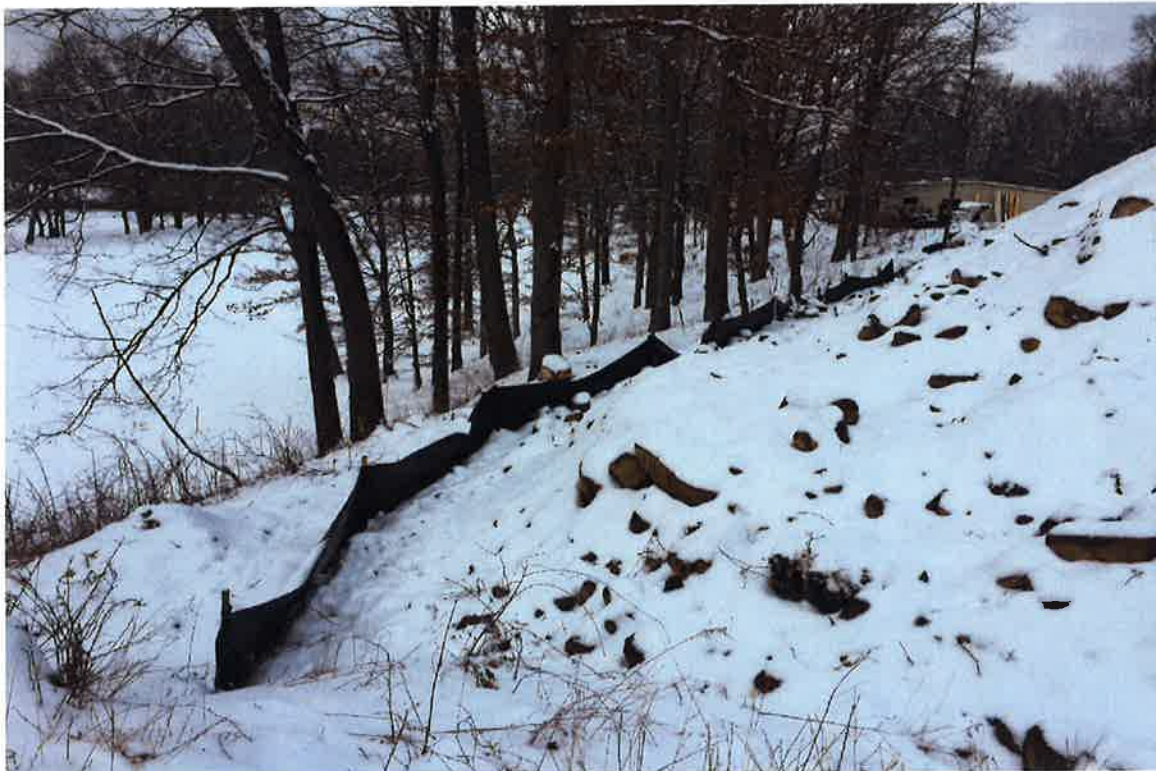
Photo 8: View of excavation material stockpile.

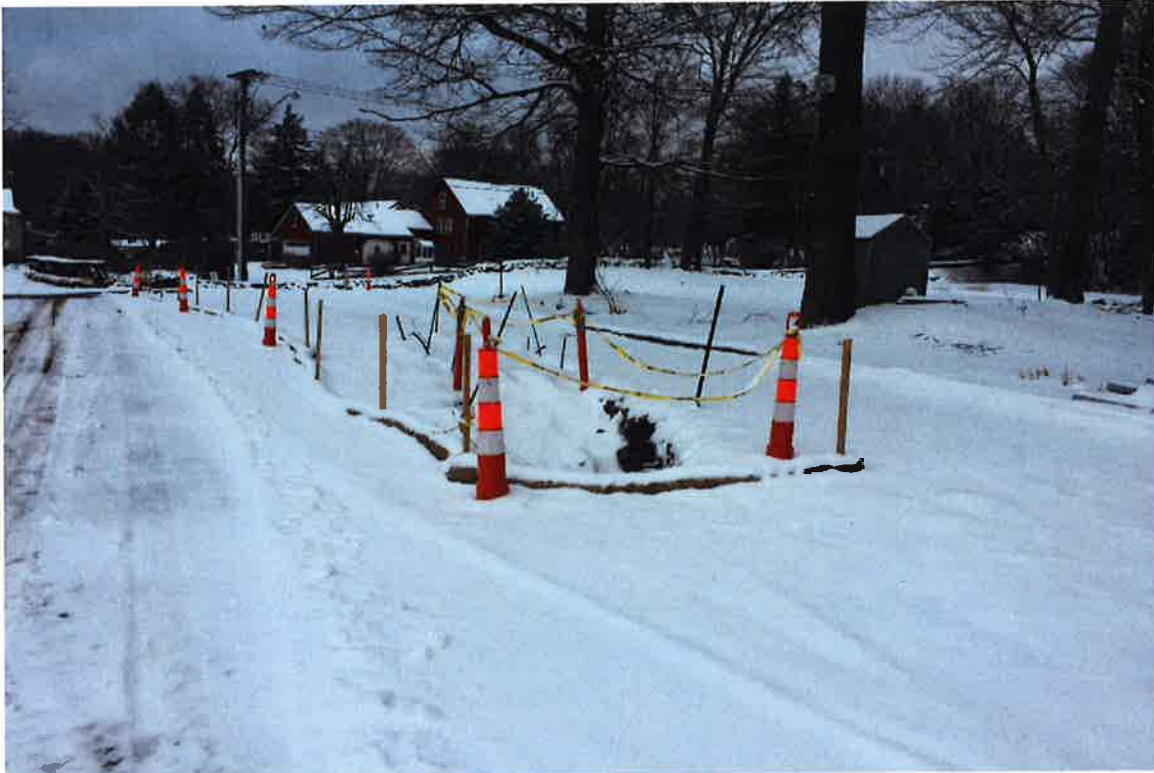
Photo 9: View of inactive utility trench.
