**Construction MONITORING**  
**DAILY SITE OBSERVATION FORM**

**Report No. 4**

Project: Verizon Wireless Coventry NW Facility  
Address: Folly Lane, Coventry, Connecticut

APT Project #: CT1417820

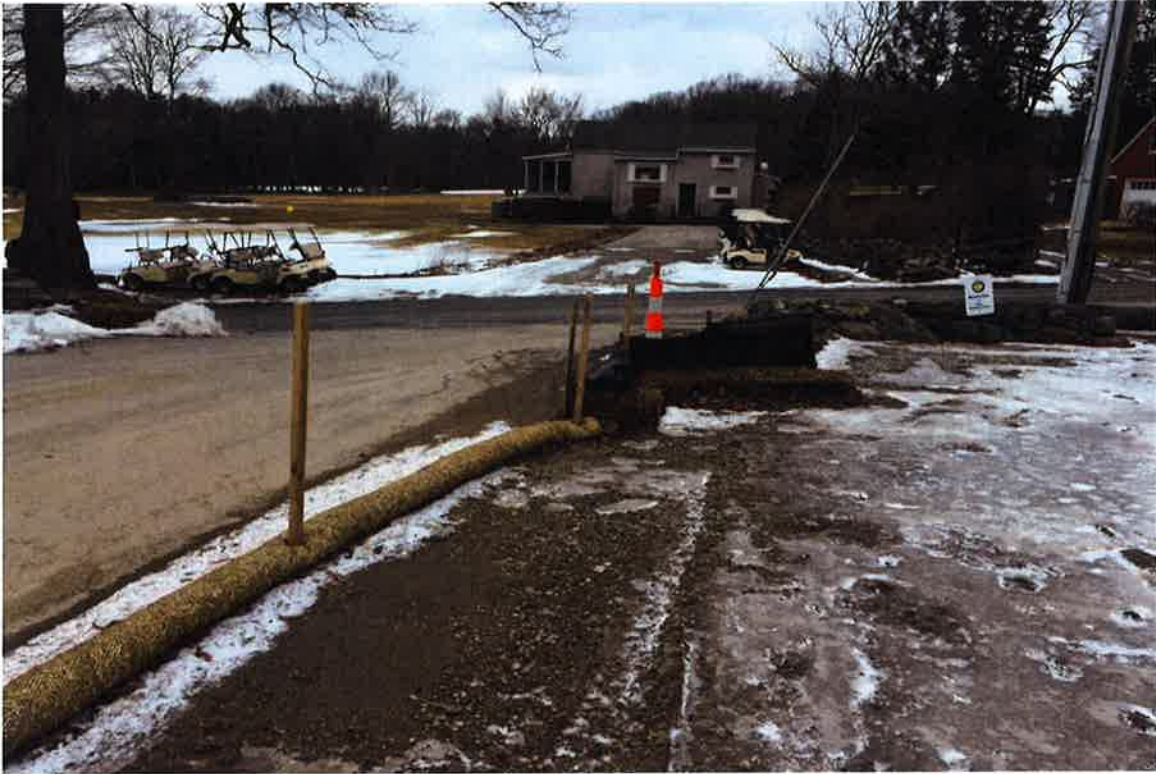
Photo 1: View of erosion controls at construction entrance off Folly Lane.

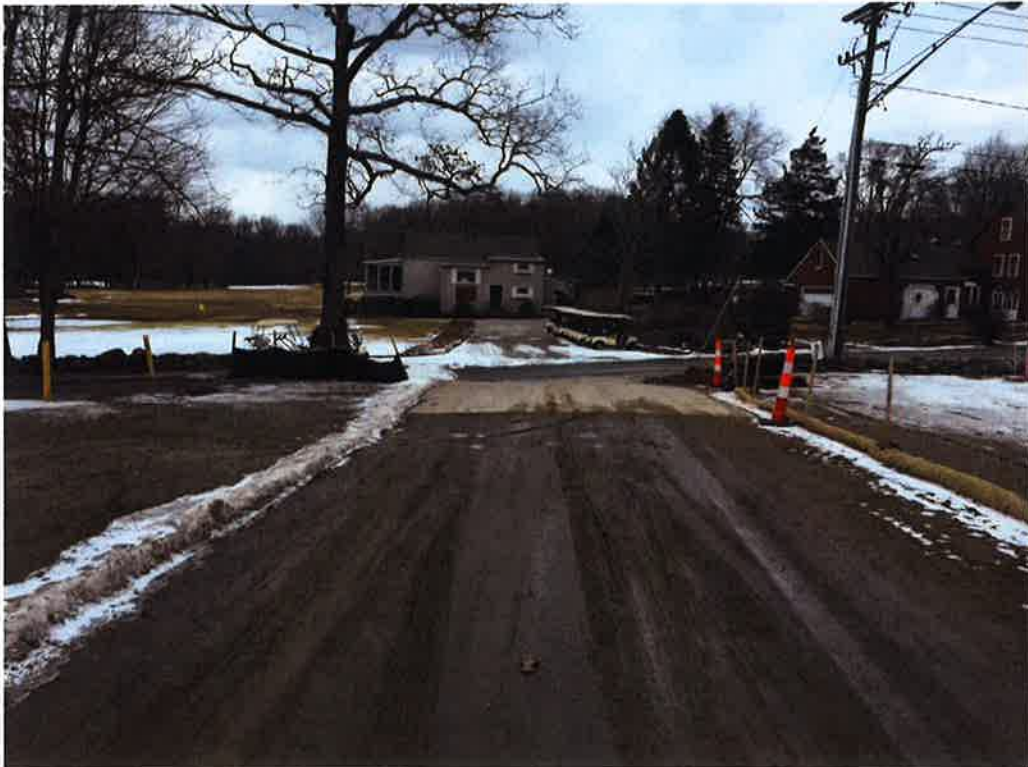
Photo 2: View of erosion controls at construction entrance off Folly Lane.

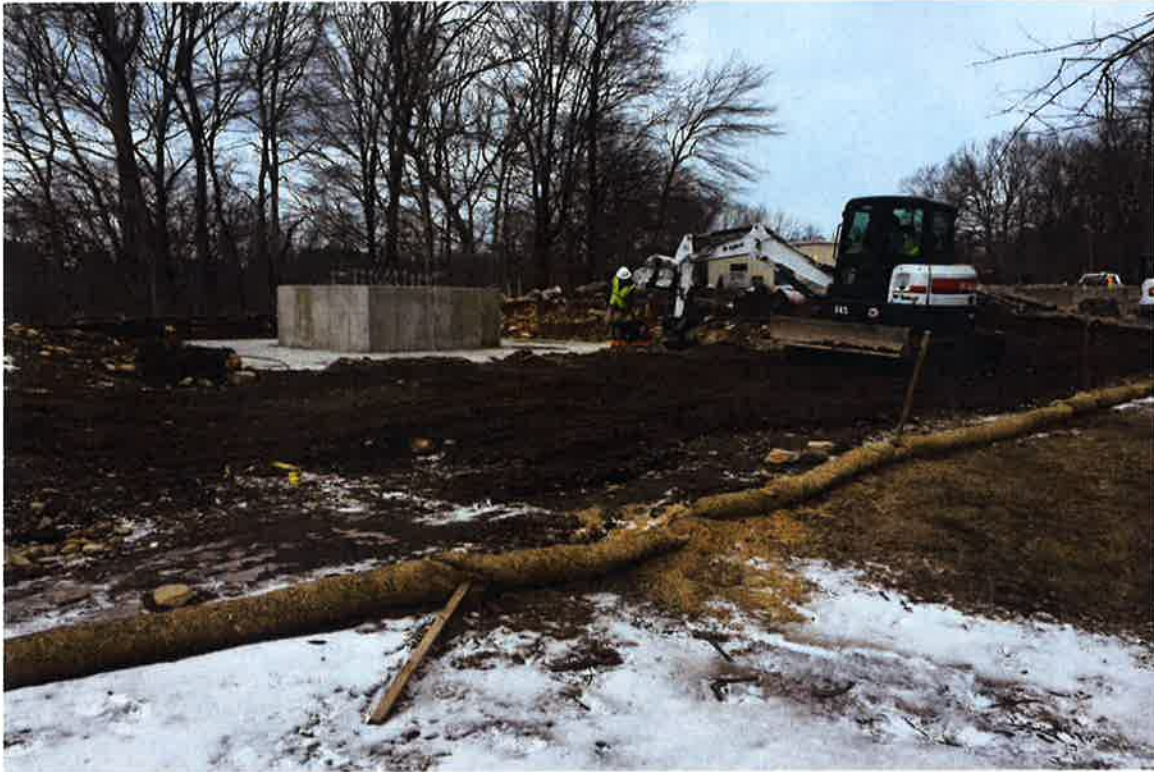
Photo 3: View of foundation work underway.

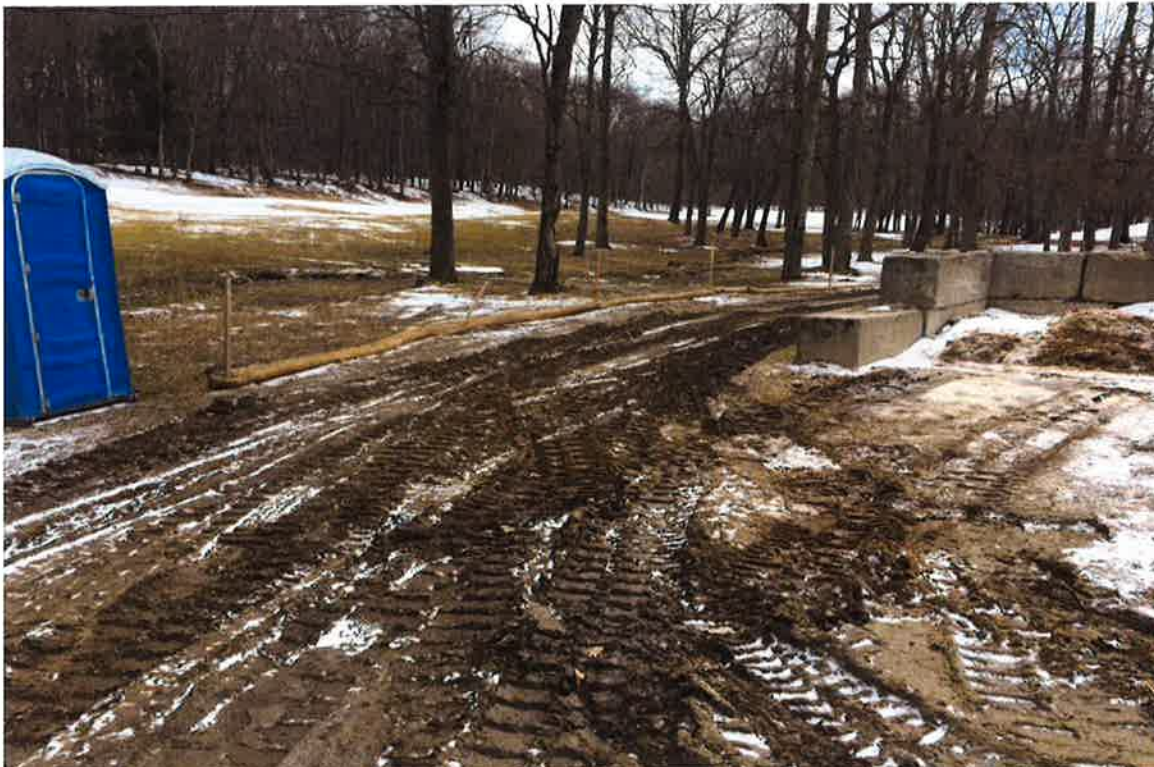
**2/25/19** – Foundation work is ongoing at the compound location. Foundation poured and backfill ongoing. Installation of additional E&S controls remains on-hold due to deep ground frost. Pre-existing washout by bulk storage bins needs to be closely monitored due to heavy tracking within that area. Folly Lane remains free of sediment.

Photo 4: View of pre-existing washout location by bulk storage bins.

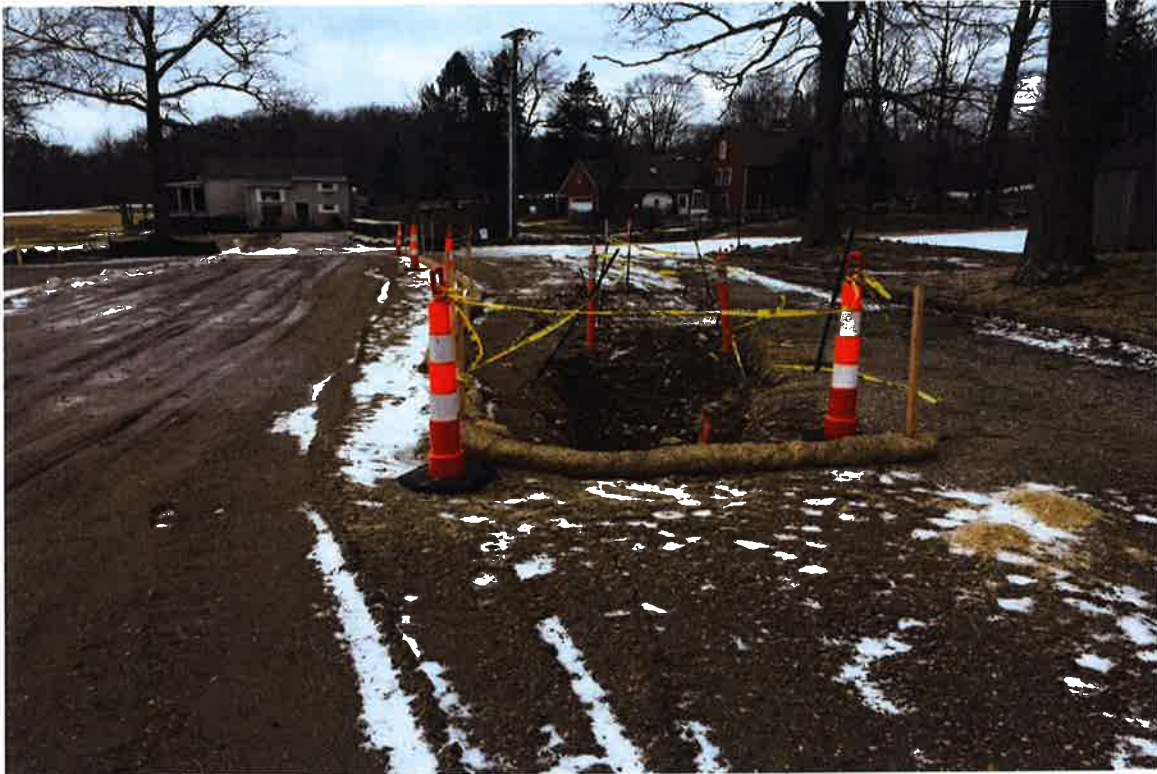
Photo 5: View of inactive utility trench work.

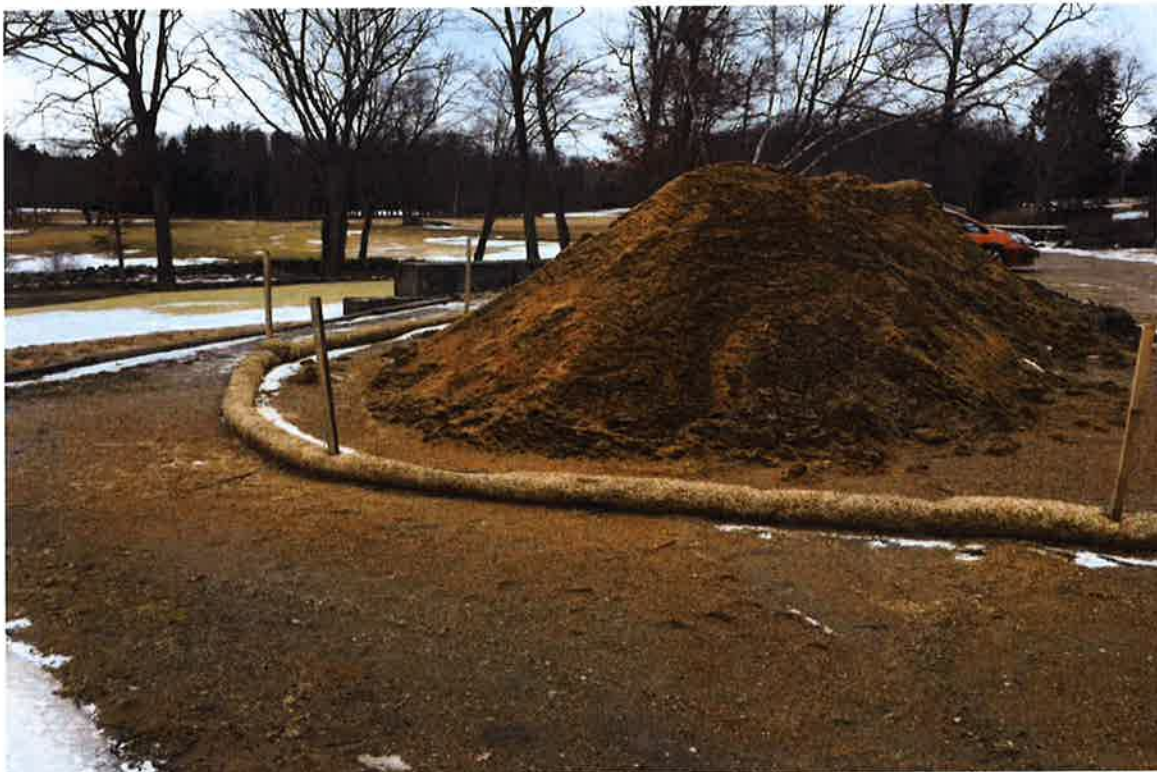
Photo 6: View of material storage pile.

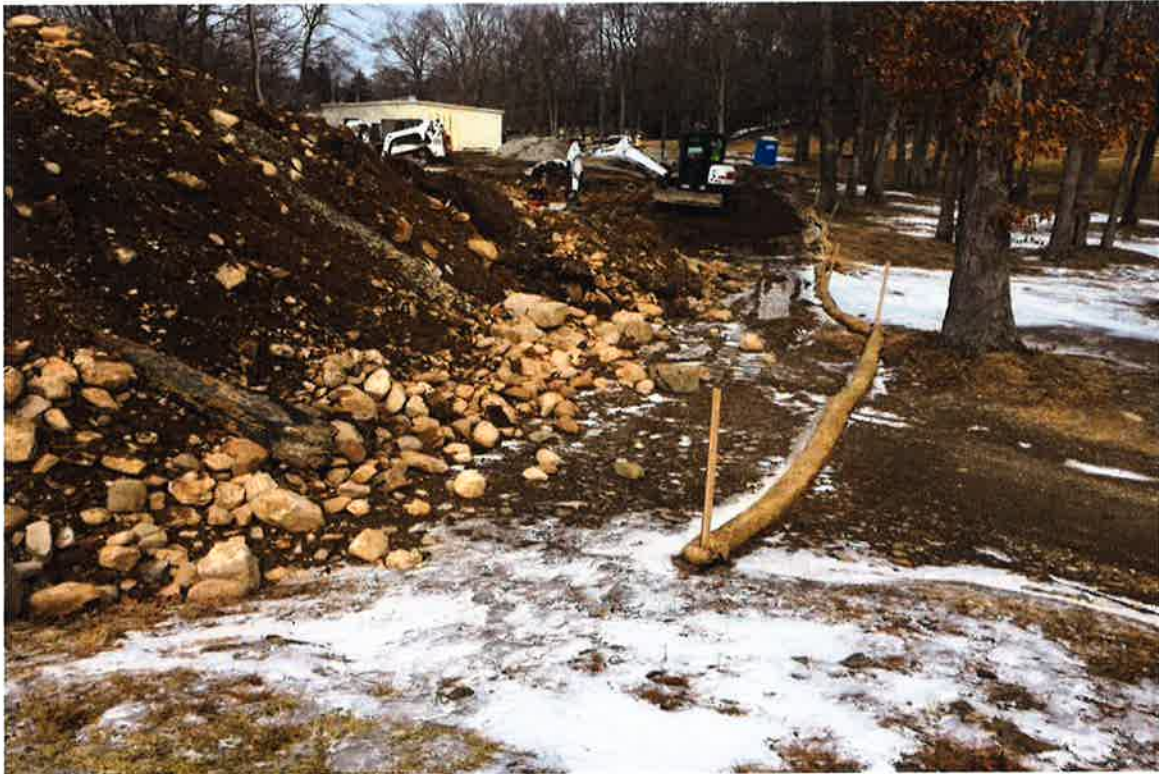
Photo 7: View of excavation material stockpile.

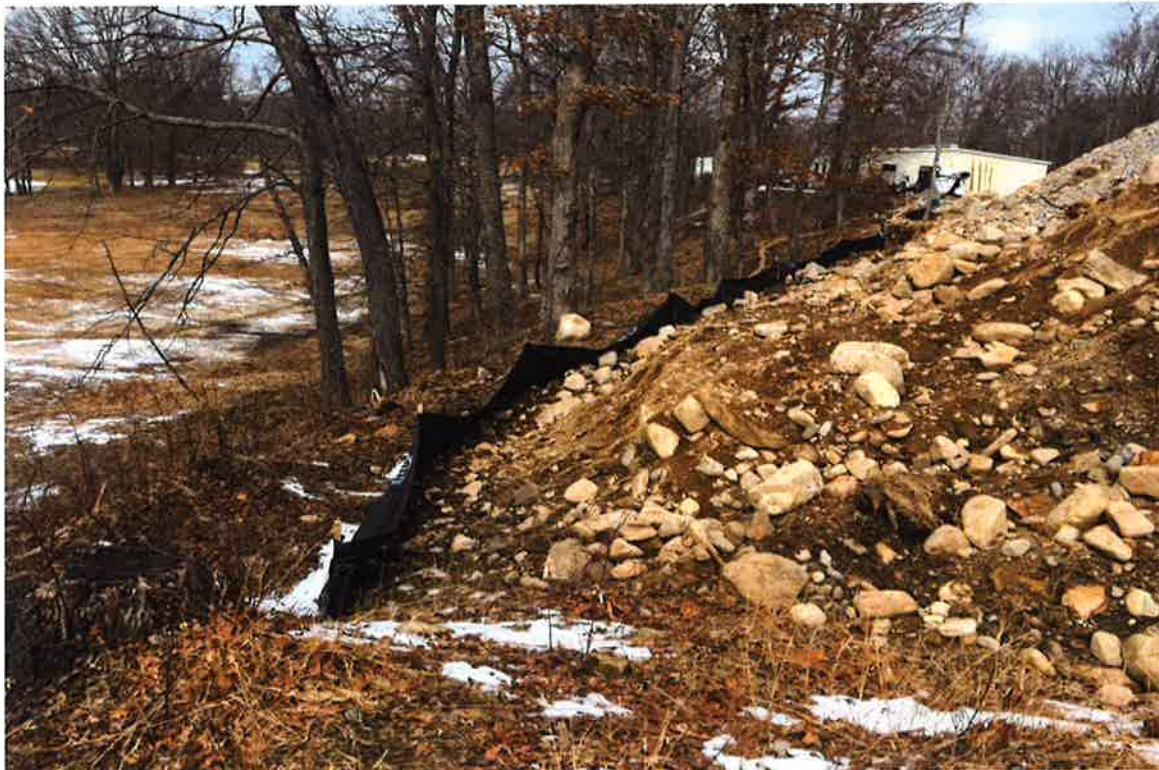
Photo 8: View of excavation material stockpile.
