George Nobos - Library

BUILDING ENVELOPE STUDY
25 Sigourney Street
Hartford, Connecticut

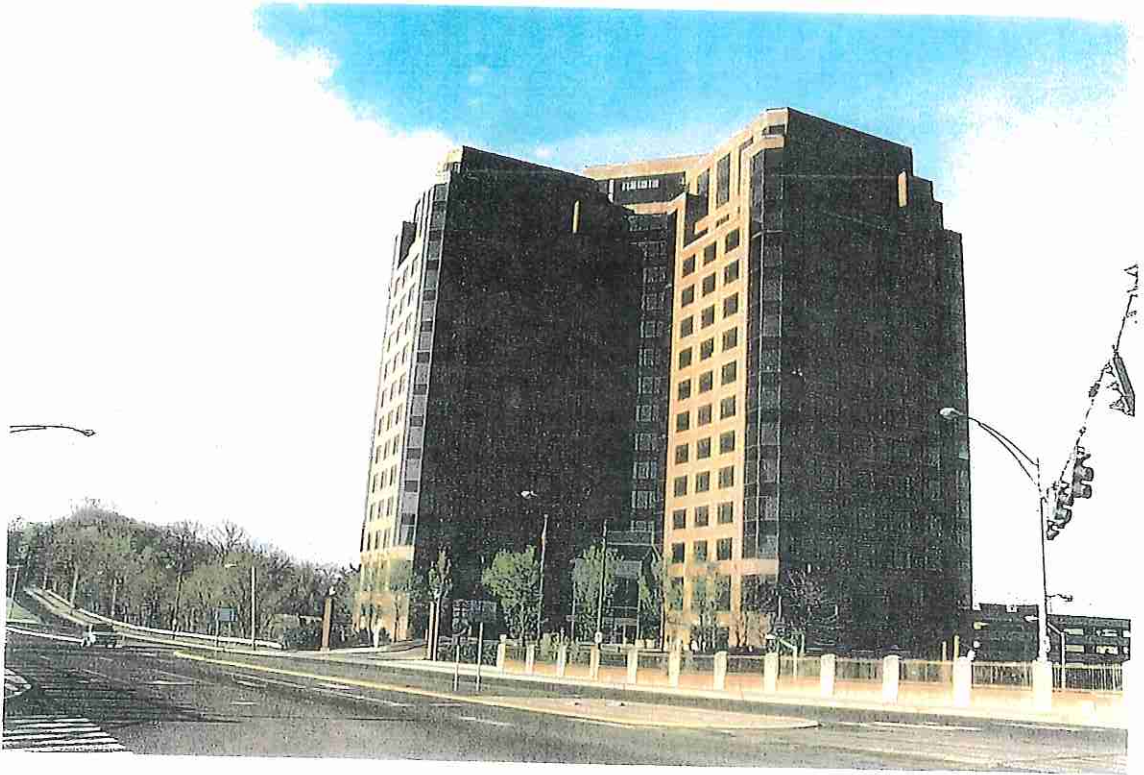
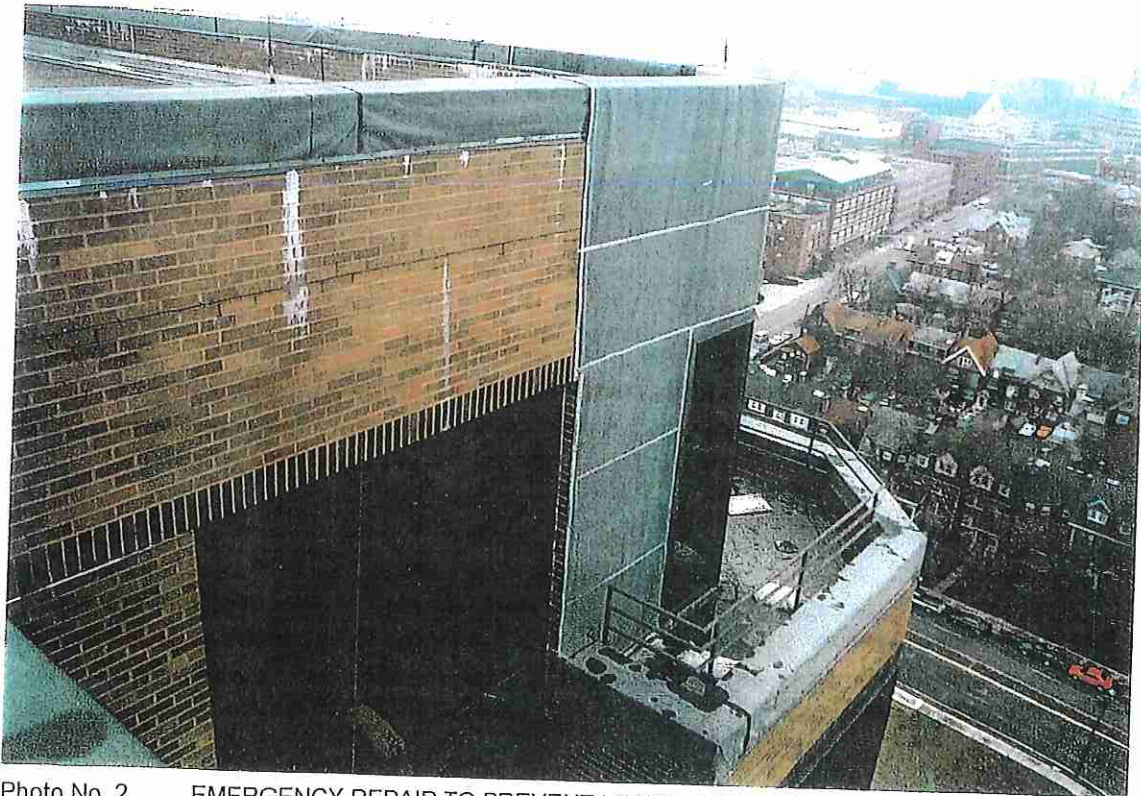
Photo No. 2 EMERGENCY REPAIR TO PREVENT LEAKS - FULLY ADHERED EPDM OVER COPINGS AND FACE OF WALL SECURED WITH TERMINATION BARS.

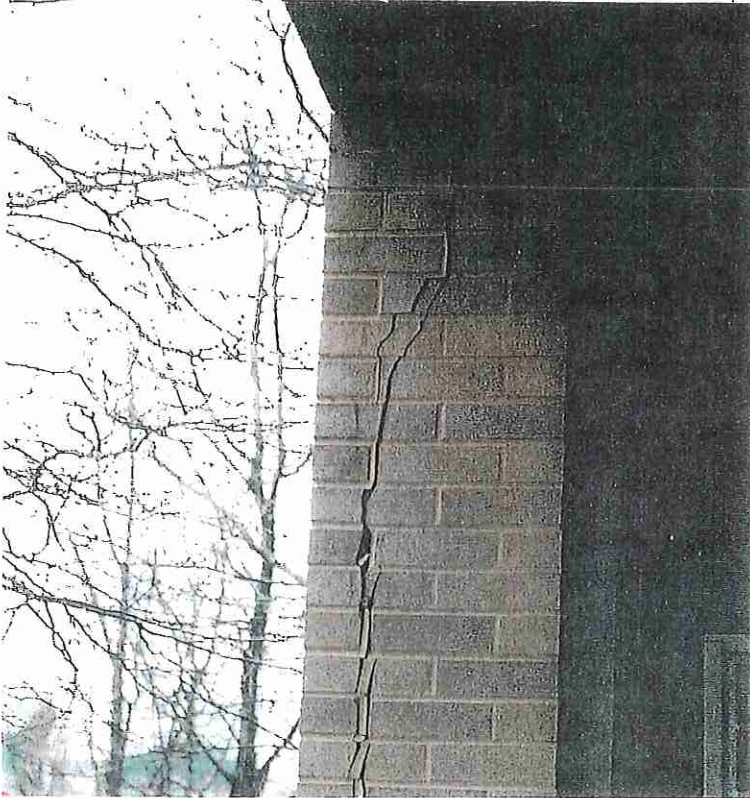
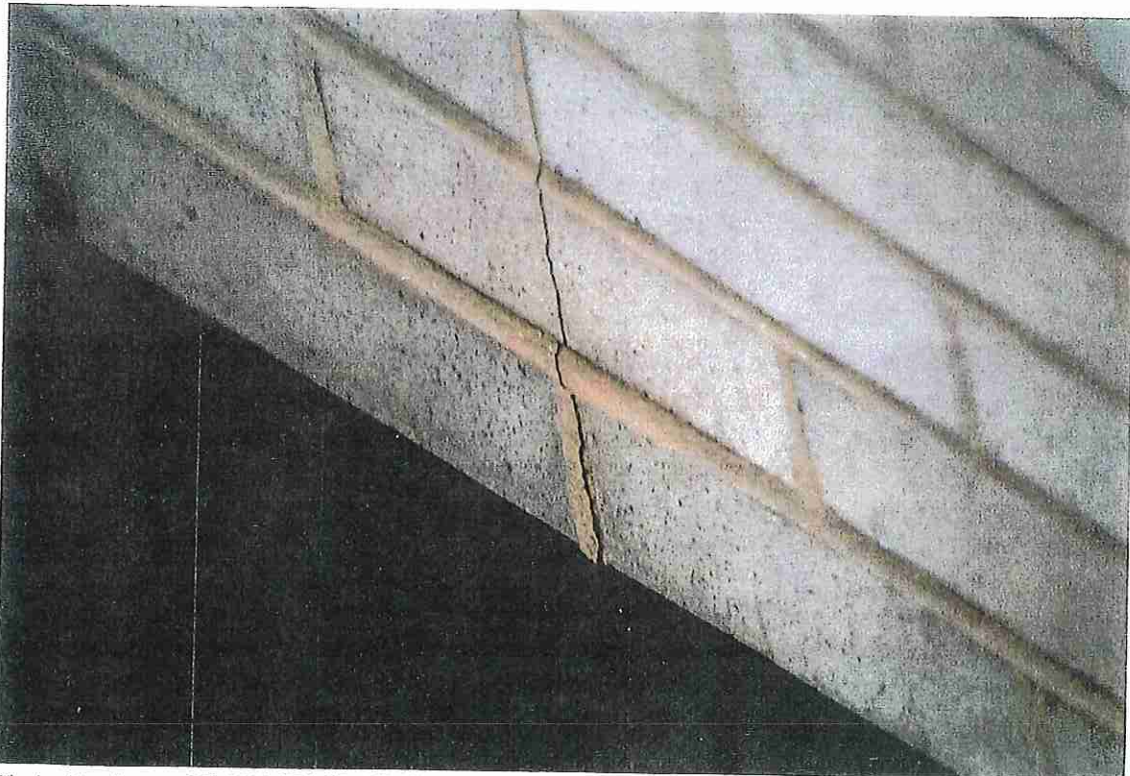
Photo No. 4
15-4/2/98

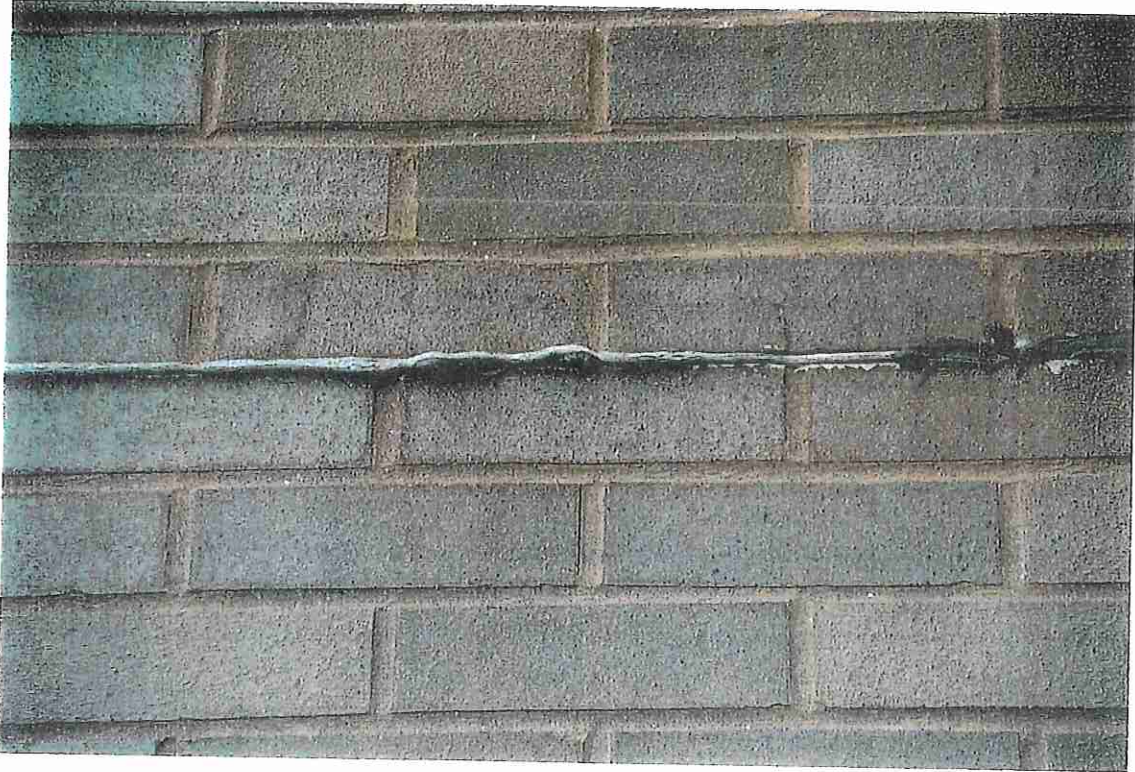
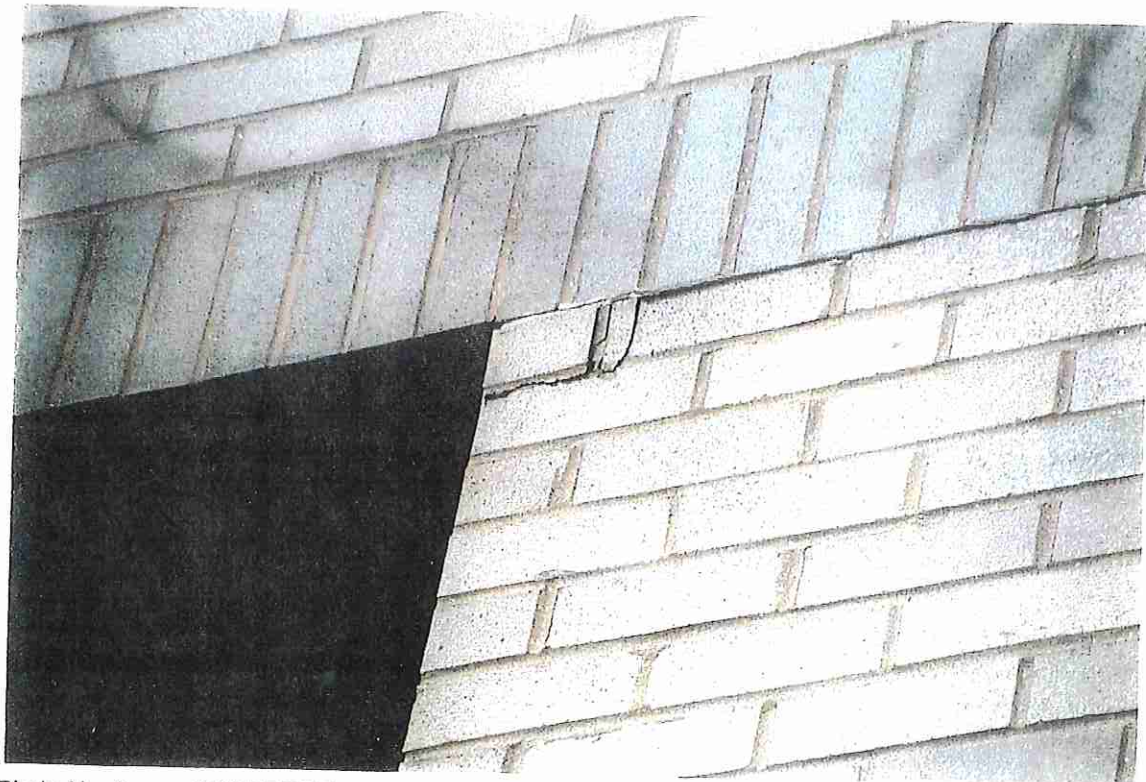
Photo No. 6 COMPRESSION CRACK AT LINTEL BEARING DUE TO LACK OF PROPER SOFT
20A-4/18/98 JOINT AND POSSIBLE DETACHMENT OF LINTEL TO CONCRETE BEAM.

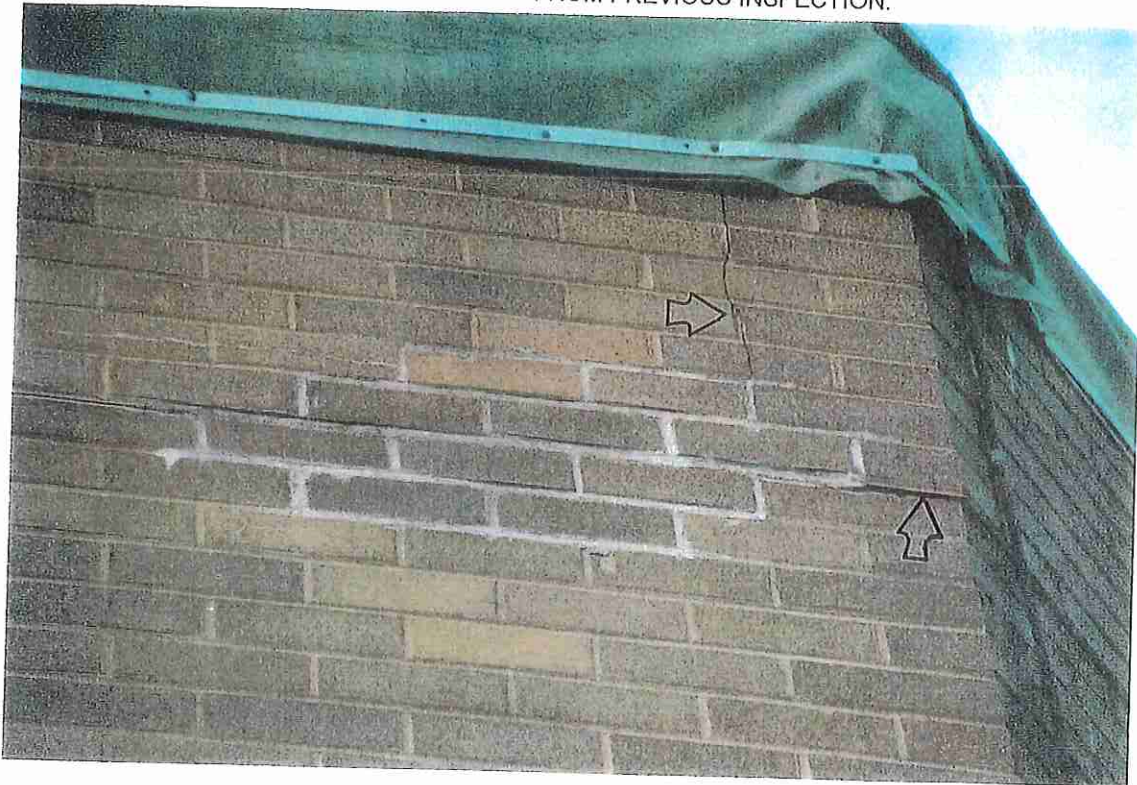
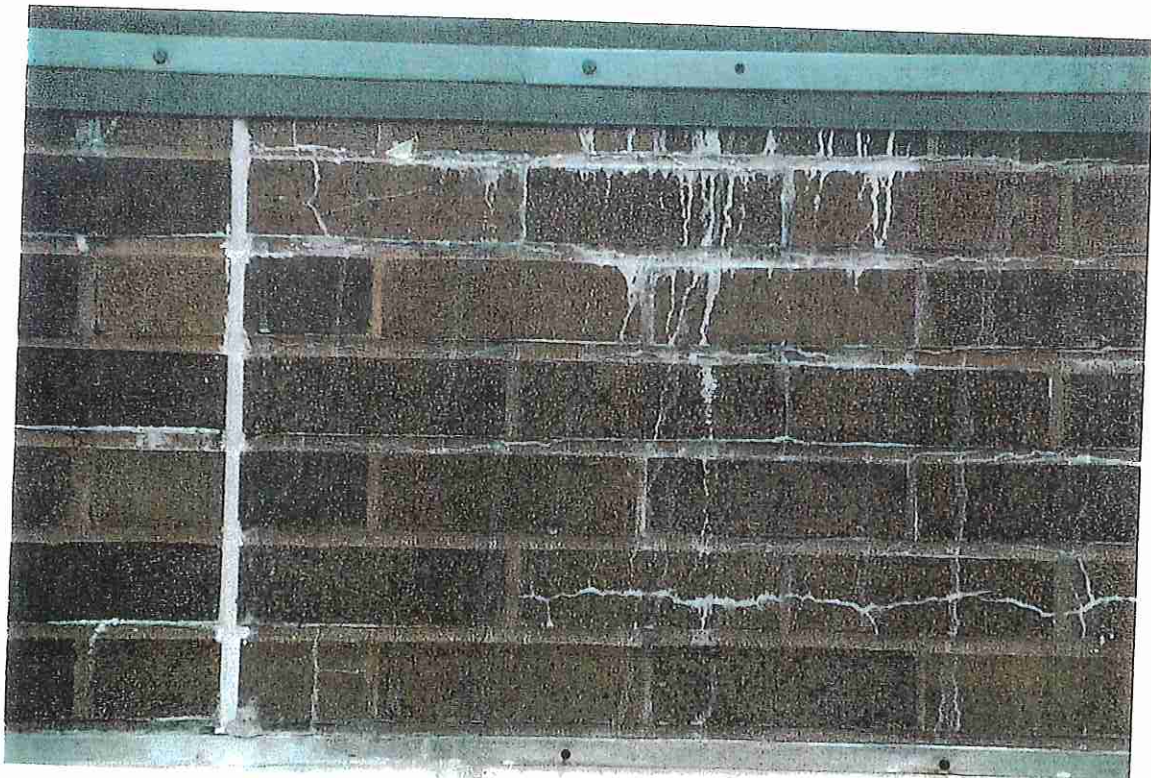
Photo No. 8
6A-4/18/98

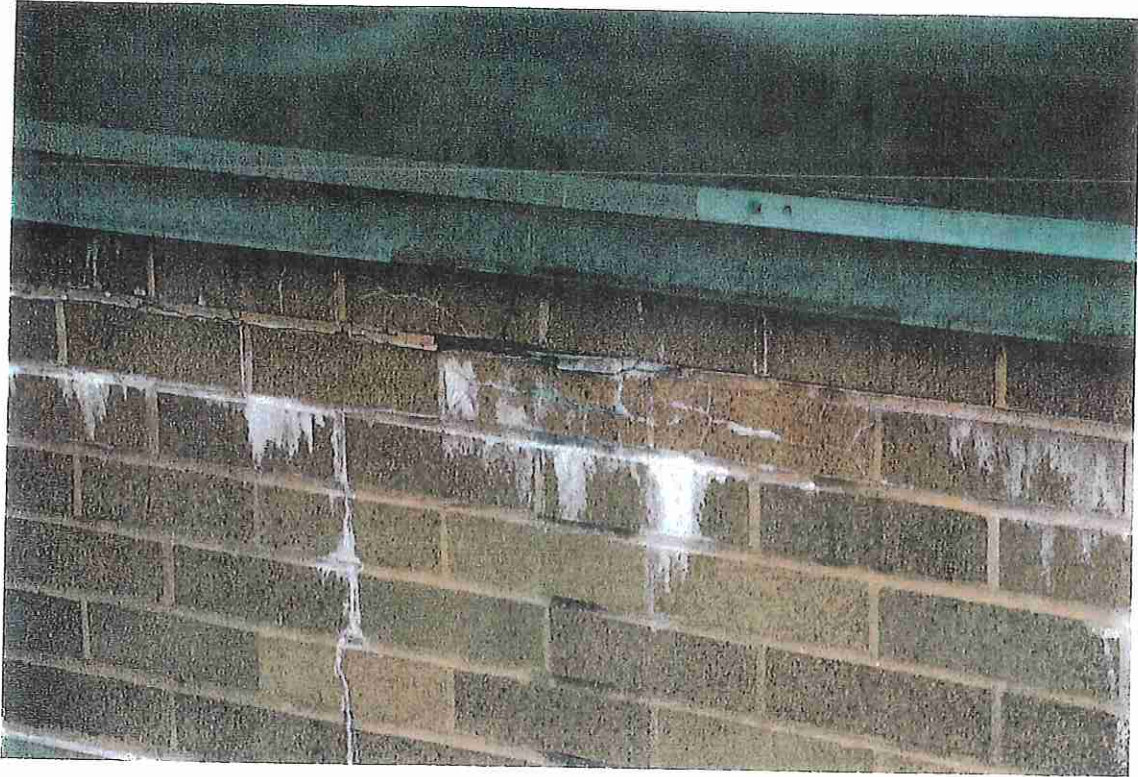
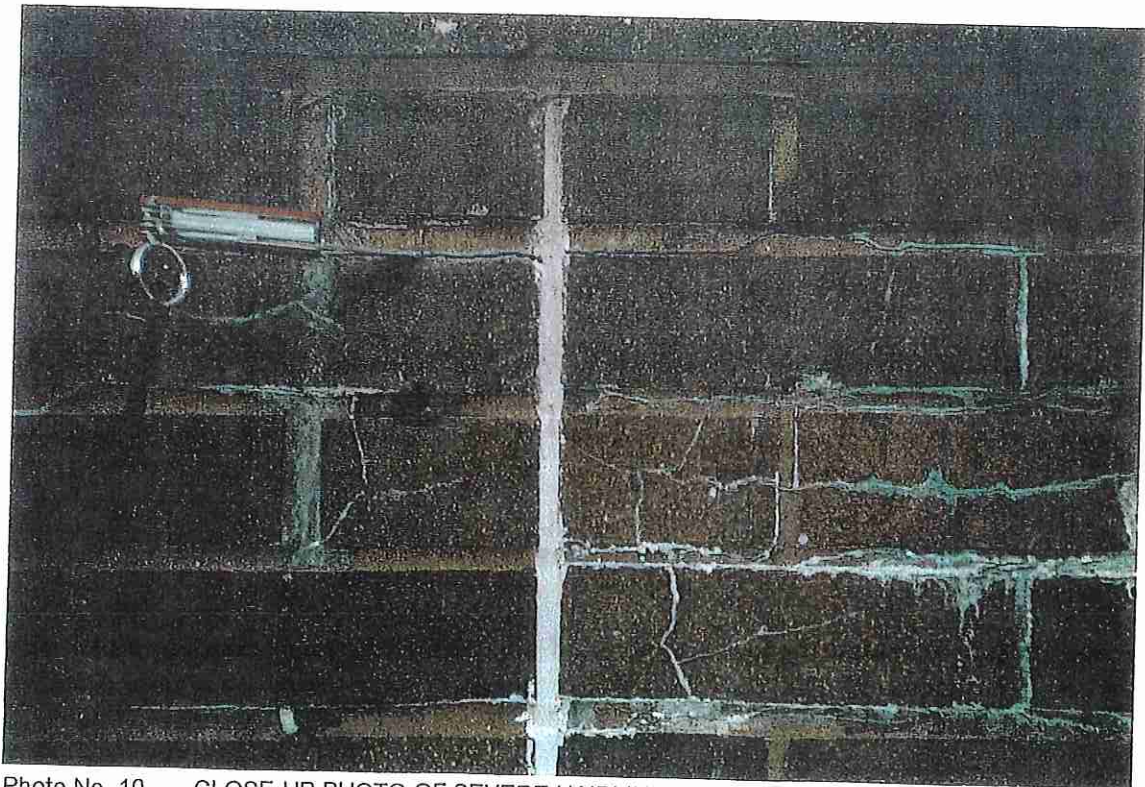
Photo No. 10 CLOSE-UP PHOTO OF SEVERE HAIRLINE CRACKING IN BRICK VENEER. NOTE DEFECTIVE MORTAR JOINTS.

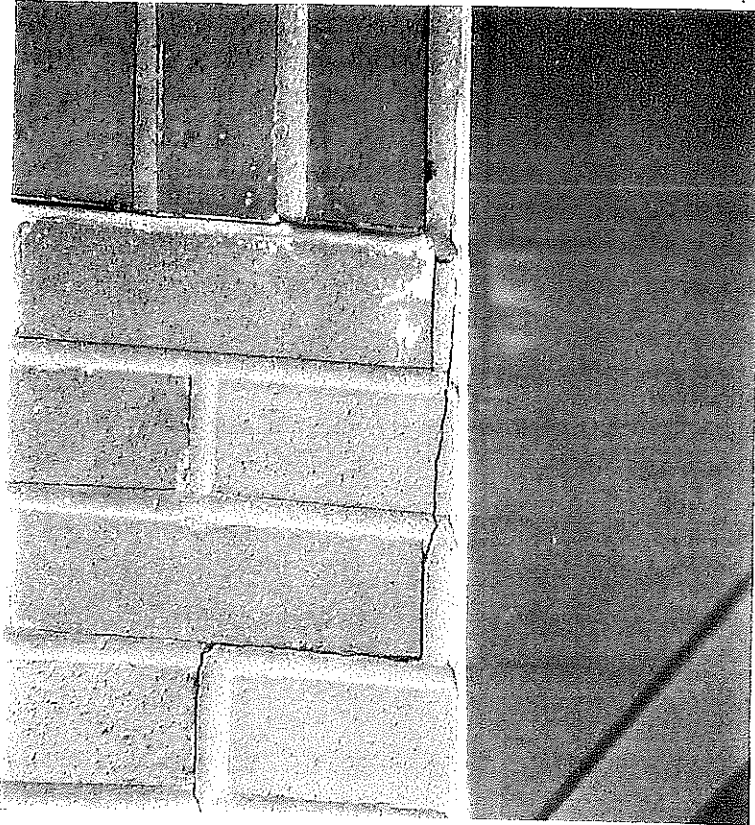
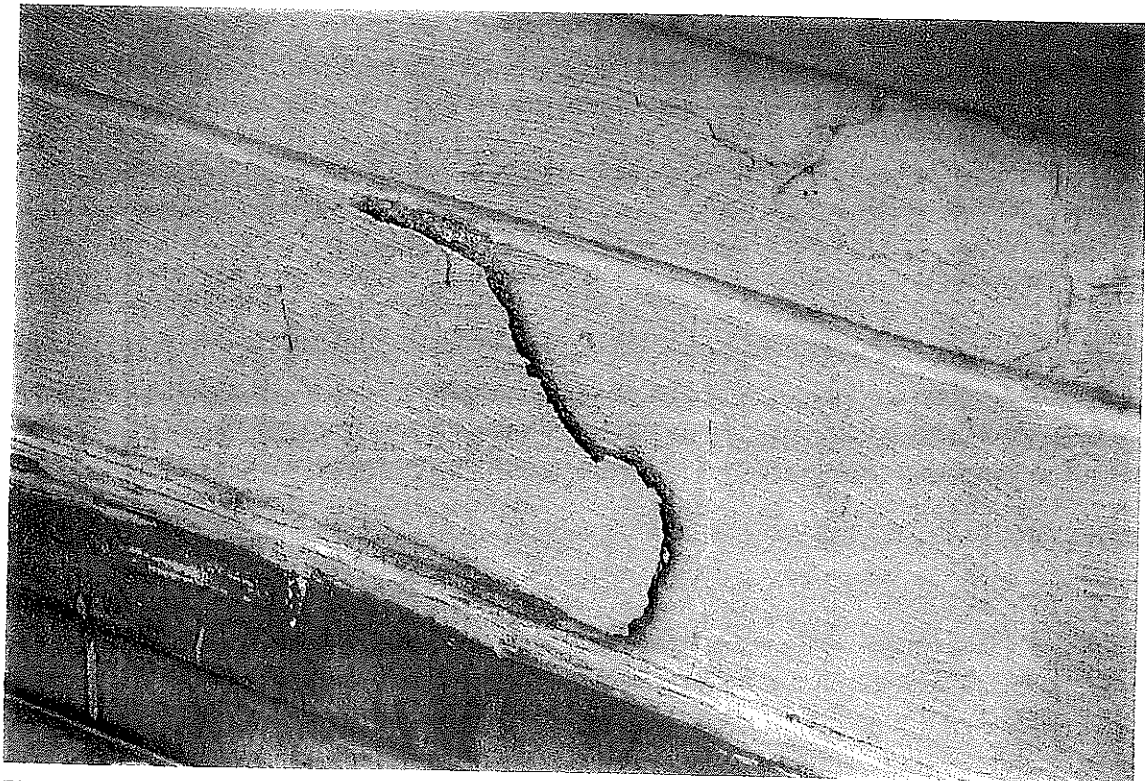
Photo No. 12 COATED INTERIOR FACE OF PENTHOUSE PARAPET WALL. NOTE SPALLED
10-4/2/98 MASONRY.

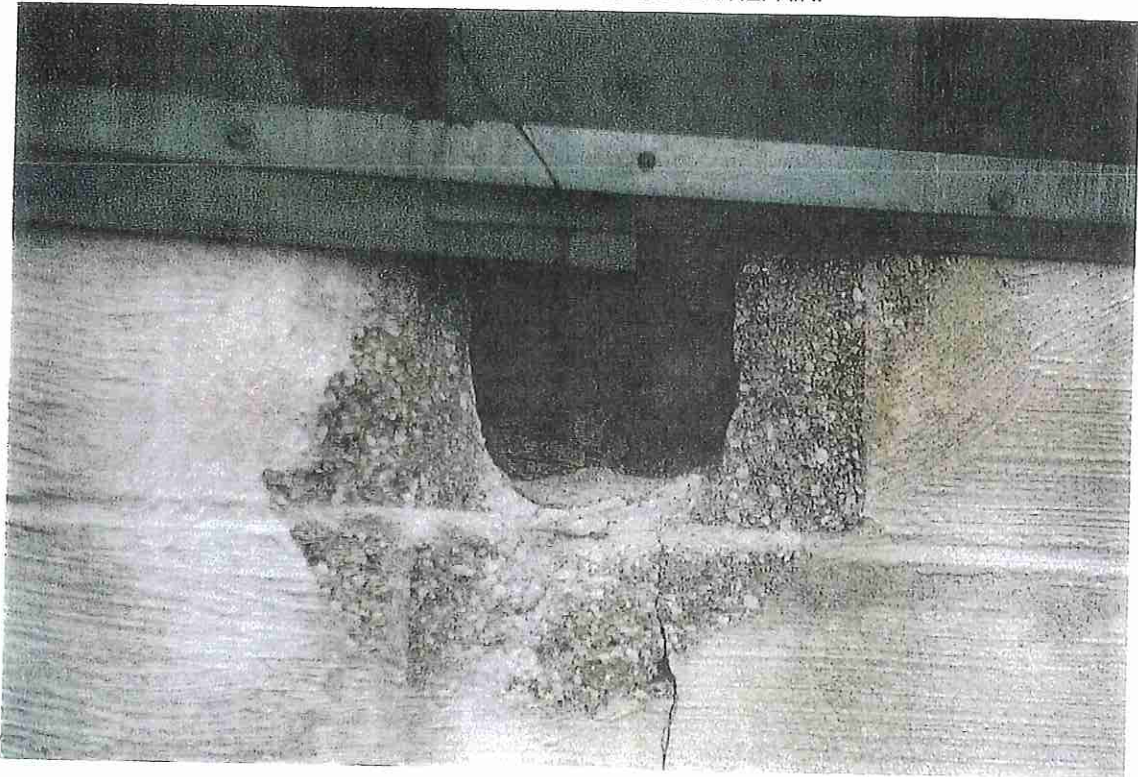
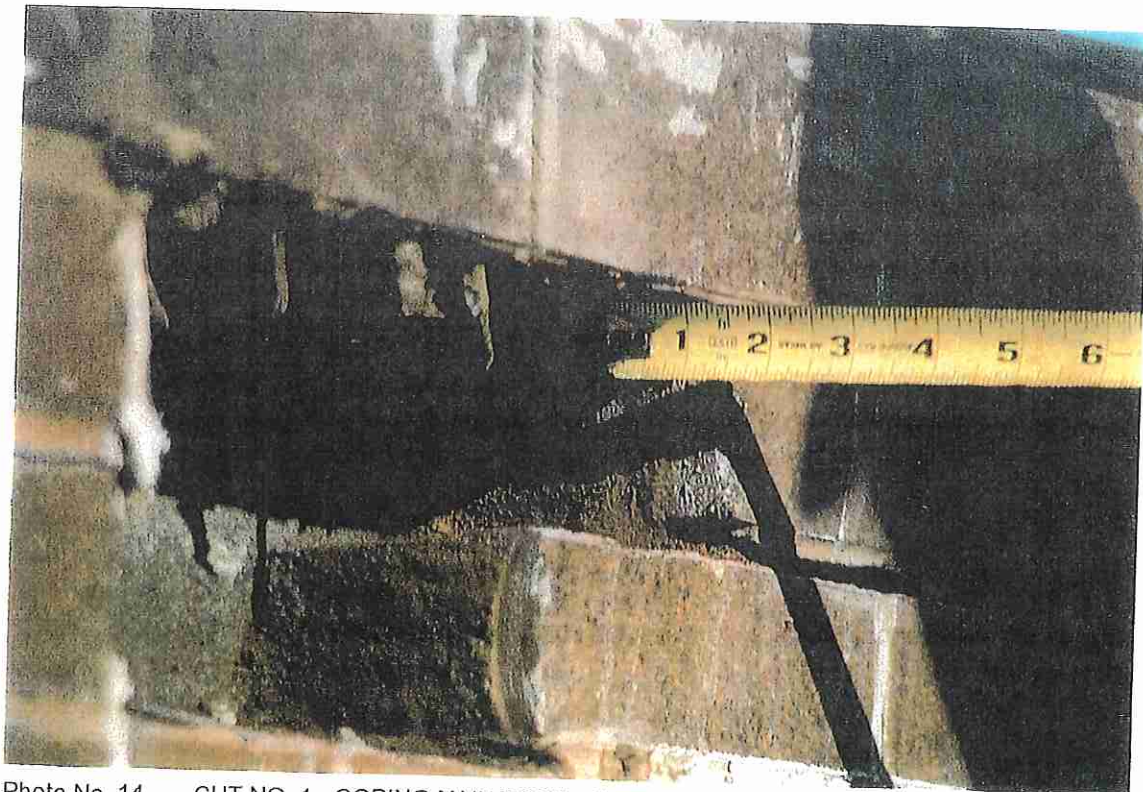
Photo No. 14 CUT NO. 1 - COPING MAIN ROOF. NOTE FLASHING UNDER COPINGS IS HELD BACK 1" FROM FACE OF BRICK.

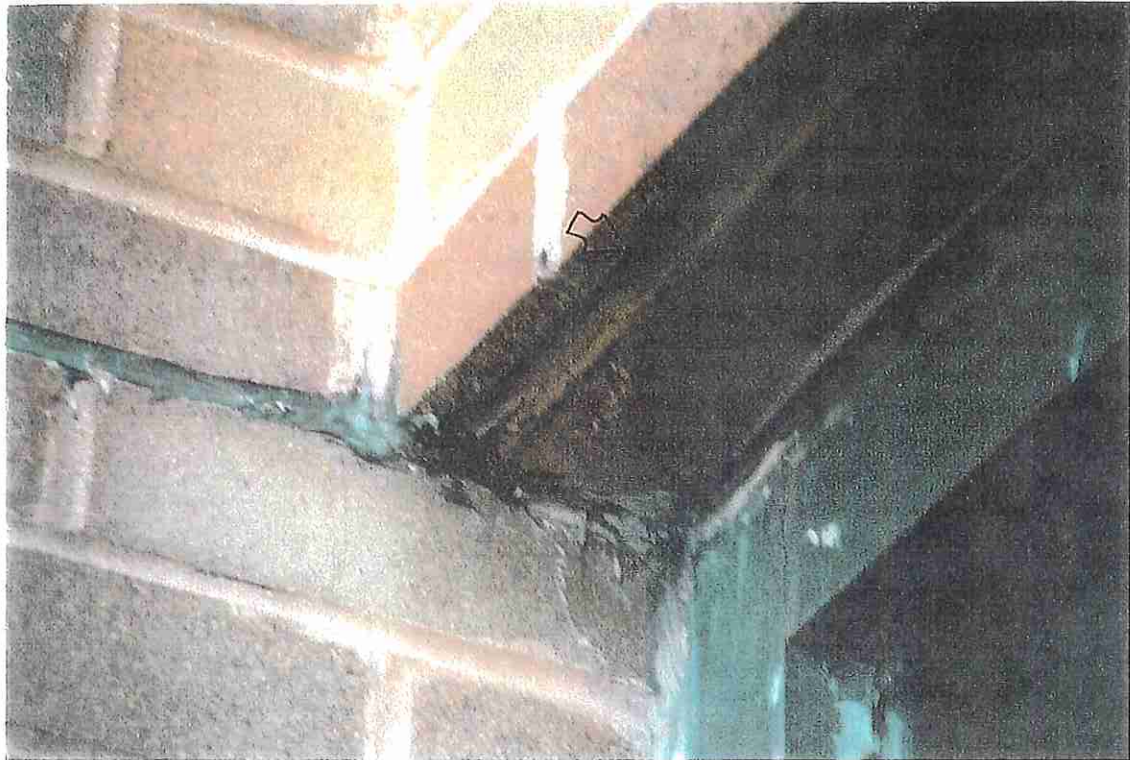
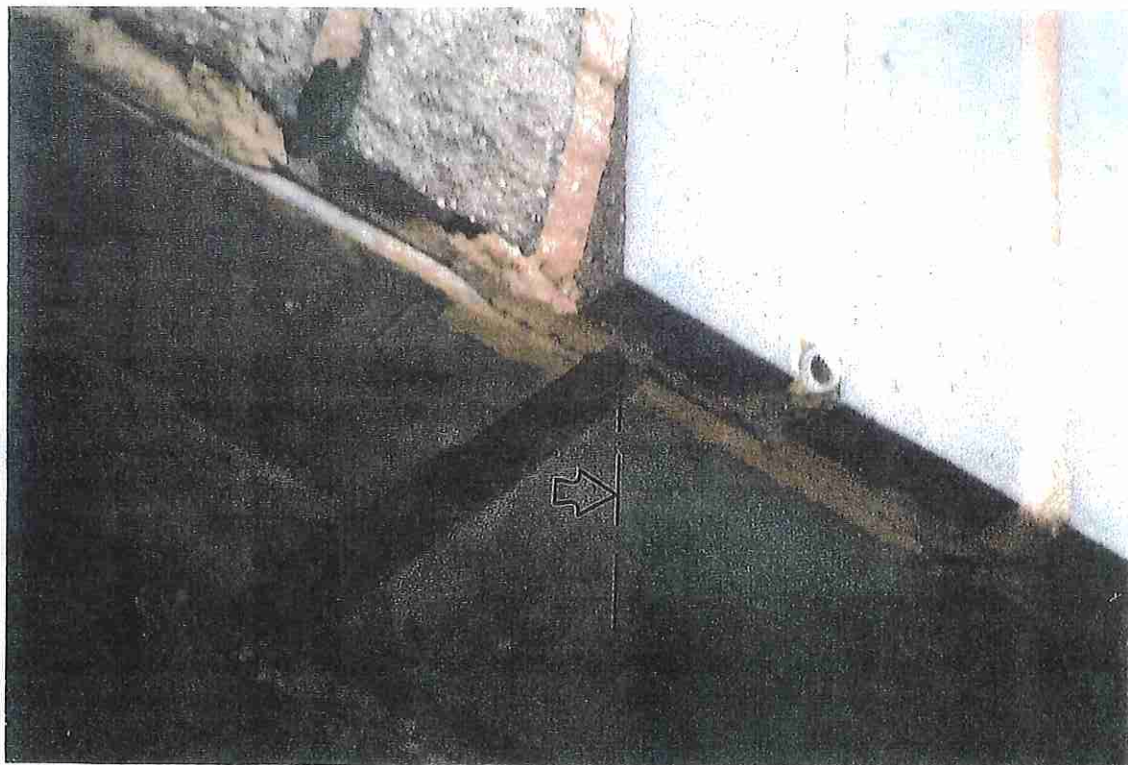
Photo No. 22 CLOSE-UP PHOTO OF LINTEL FLASHING CONDITION. NOTE FLASHING STOPS SHORT OF EDGE OF STEEL AND JOINT IS FILLED SOLID WITH MORTAR.

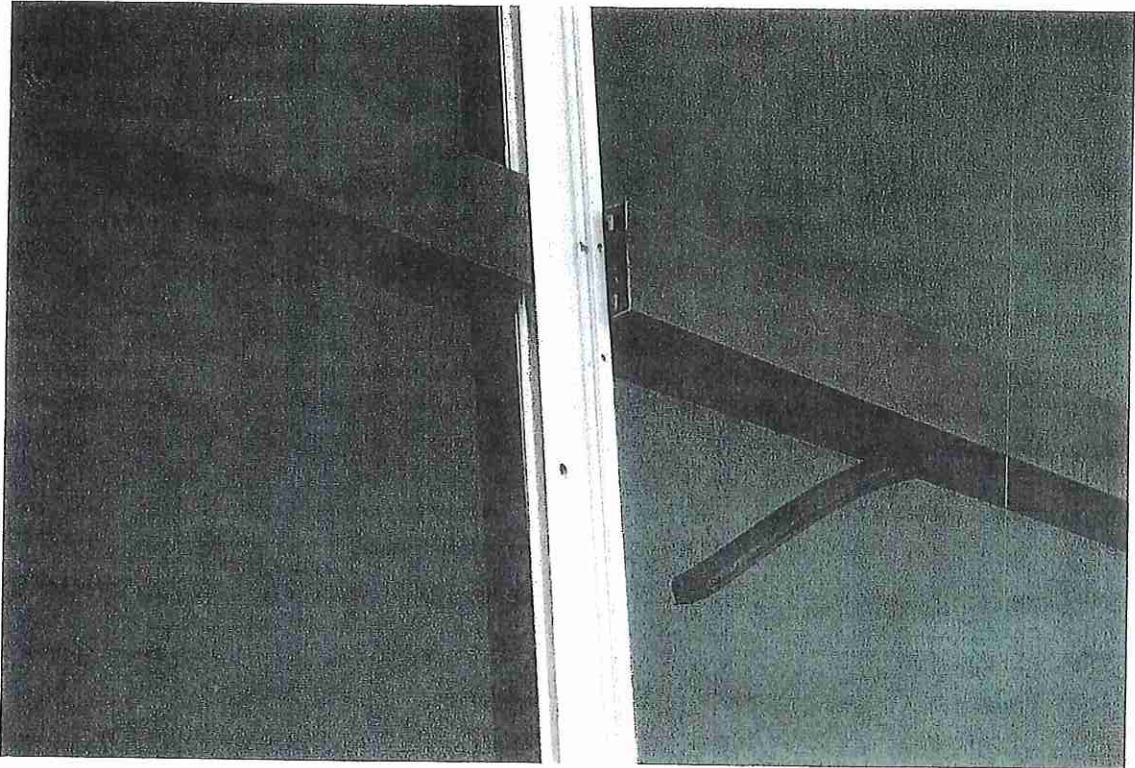
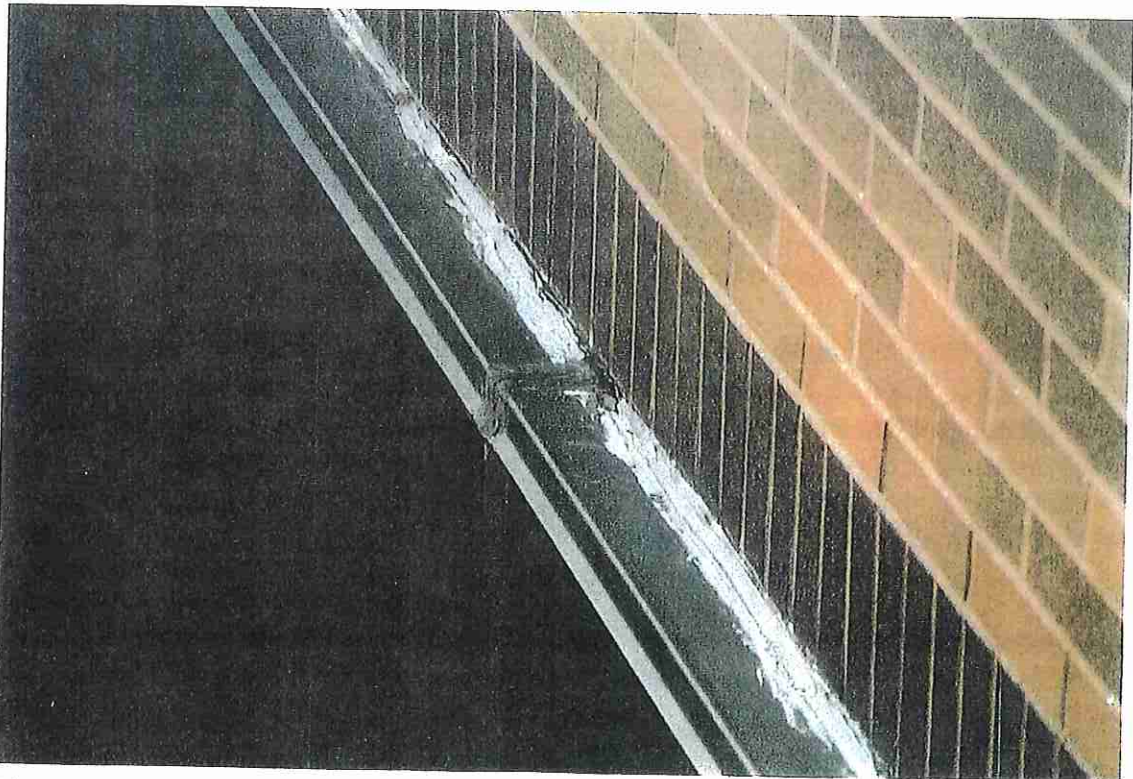
Photo No. 26 METAL CAP ON CURTAIN WALL TILTS BACK TOWARDS MASONRY AND PONDS WATER. NOTE POOR APPLICATION OF SEALANT AND OPEN SEAM.

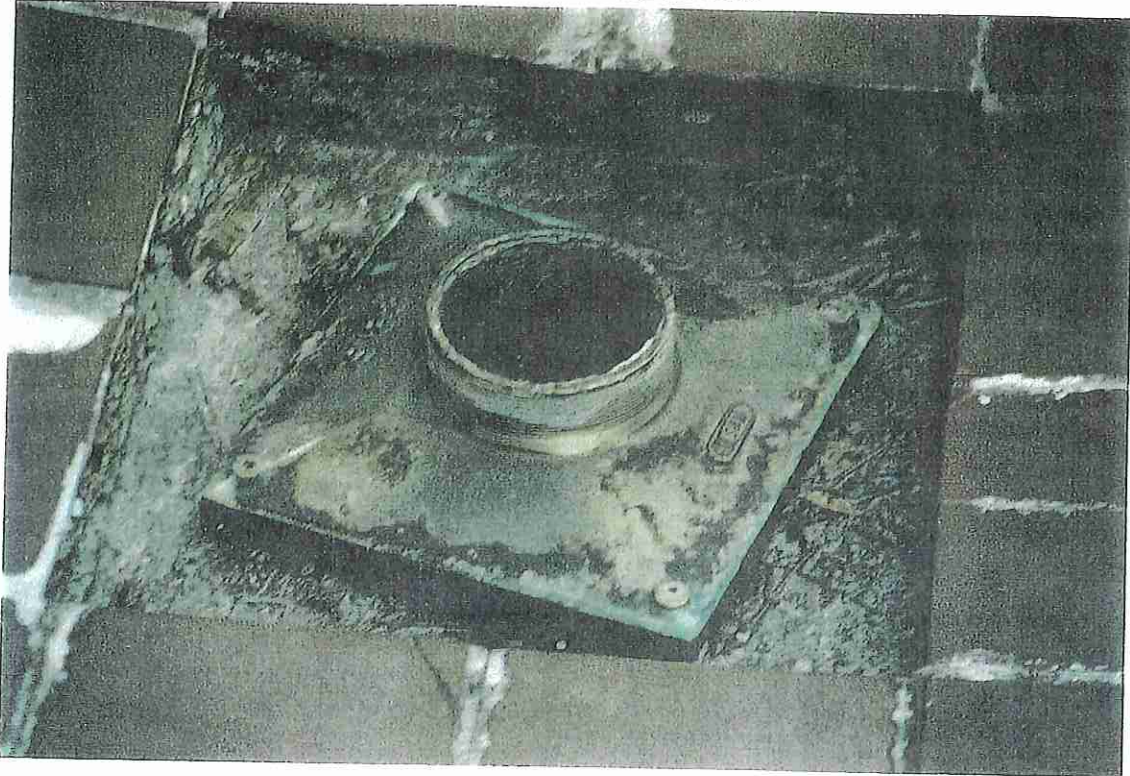
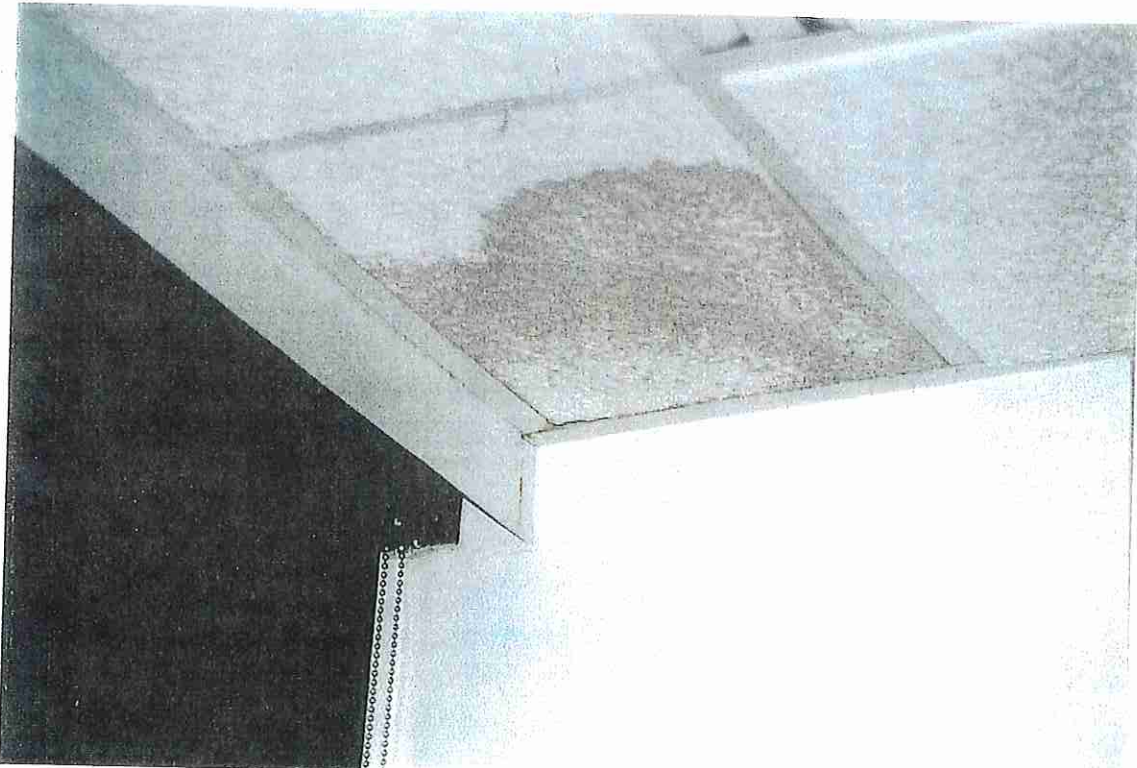
Photo No. 28 INTERIOR WATER DAMAGE AT WINDOW HEAD - 17TH FLOOR.
18A-4/18/98

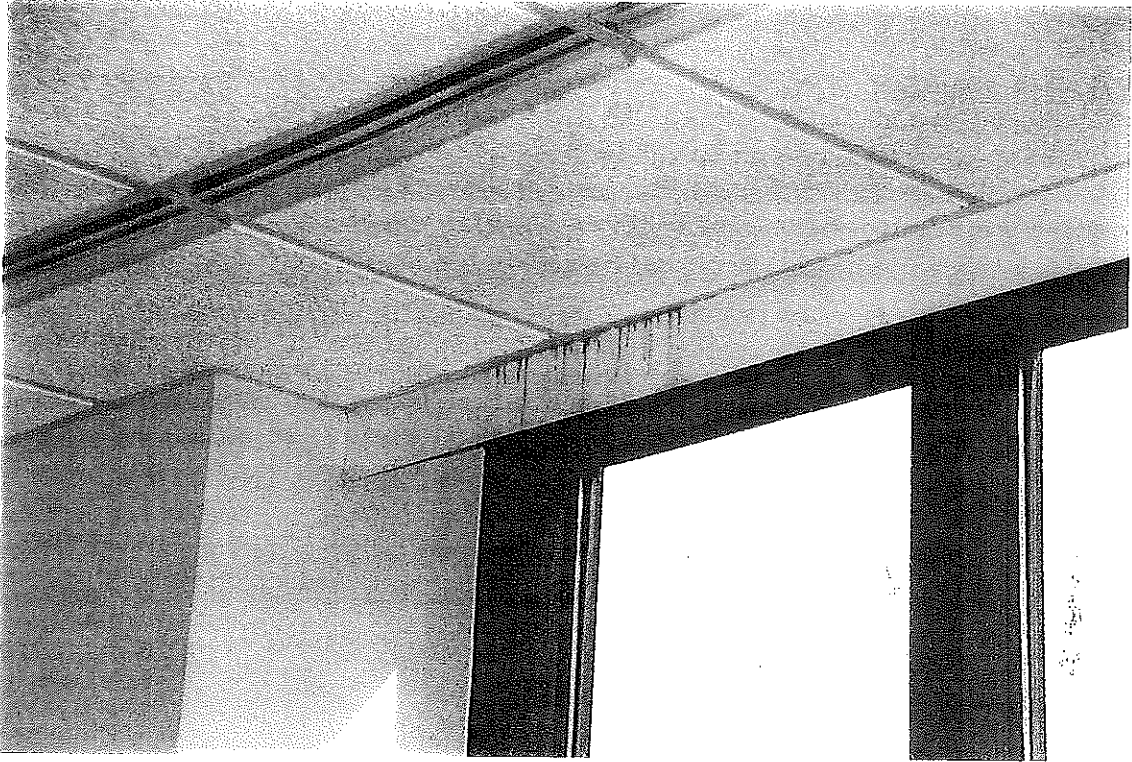
Photo No. 29 INTERIOR WATER DAMAGE AT WINDOW HEAD - 17TH FLOOR.
17A-4/18/98
