**STUDY FOR DRAINAGE PLANE**

25 Sigourney Street  
Hartford, Connecticut

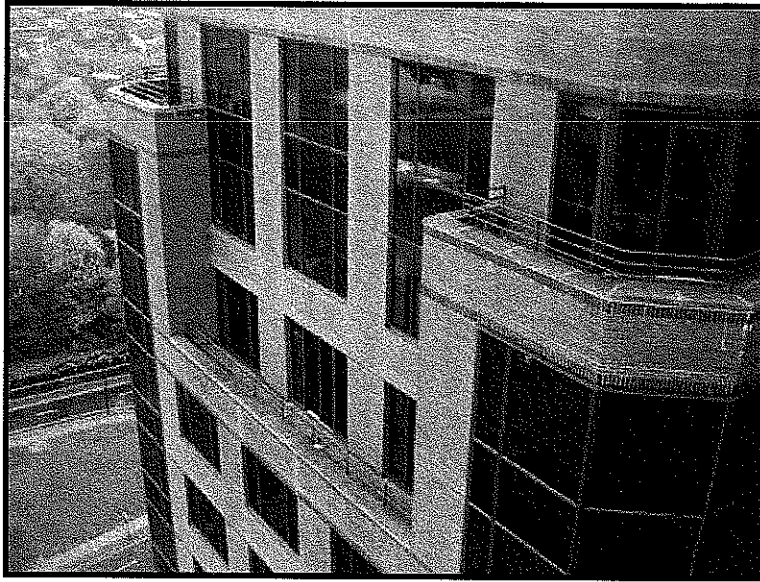
#1 North elevation. Note efflorescence and cracked brick at corner of both terraces.

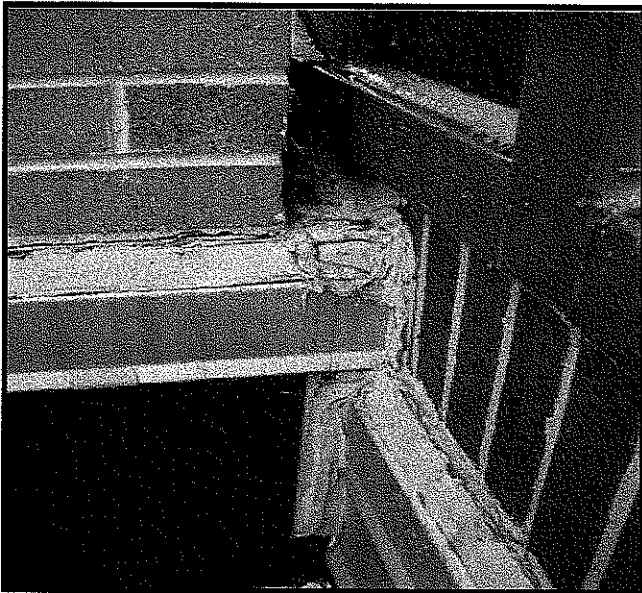
#2 Bad detailing of junction of parapet end to window. Note excessive quantity of sealant used in an attempt to make watertight.

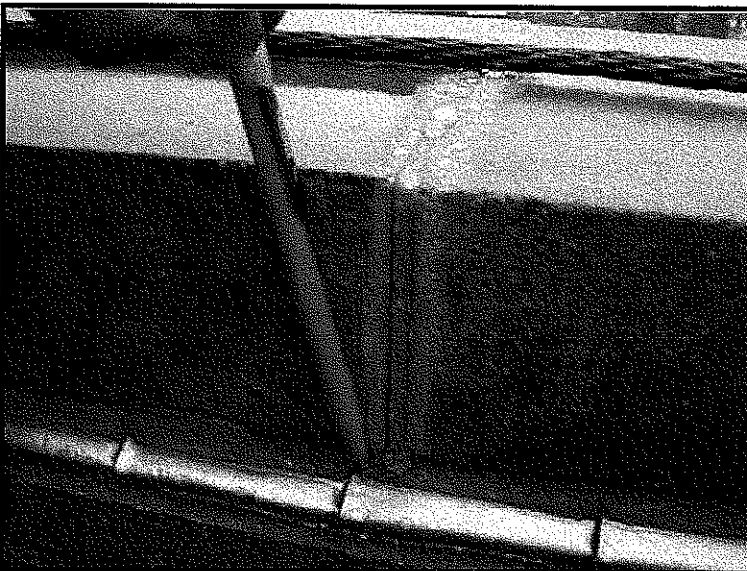
#3 Adhesive failure between sealant and coping stone.

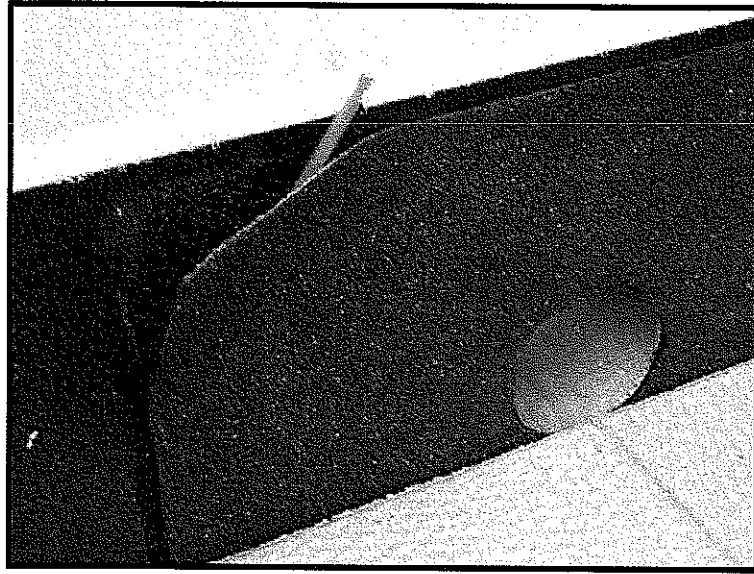
#4 Through wall scupper in main roof parapet. Poor adhesion of target patch.

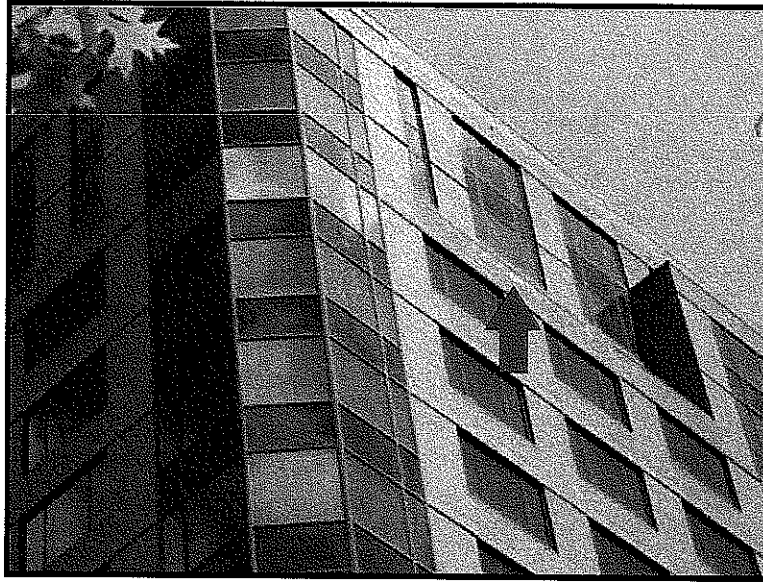
#7 Typical terrace curtain wall condition. Note efflorescence along face of terrace.

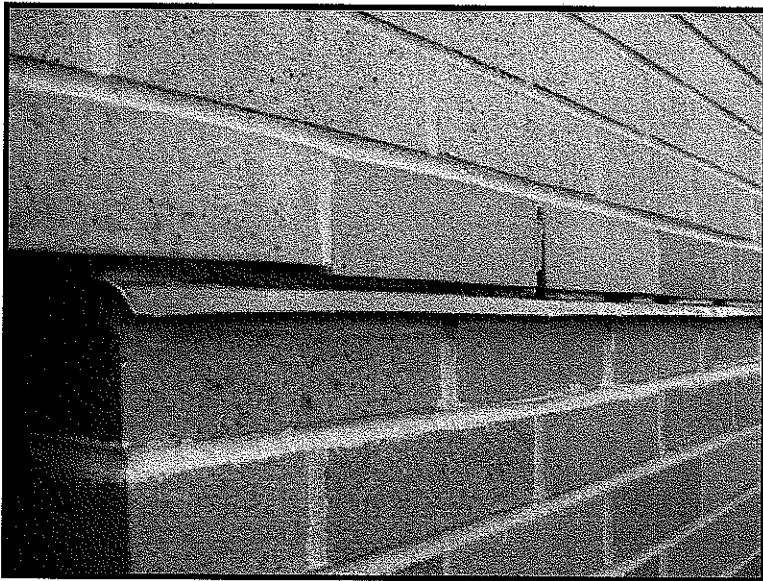
#8 New metal drip edge installed during recent masonry repair.

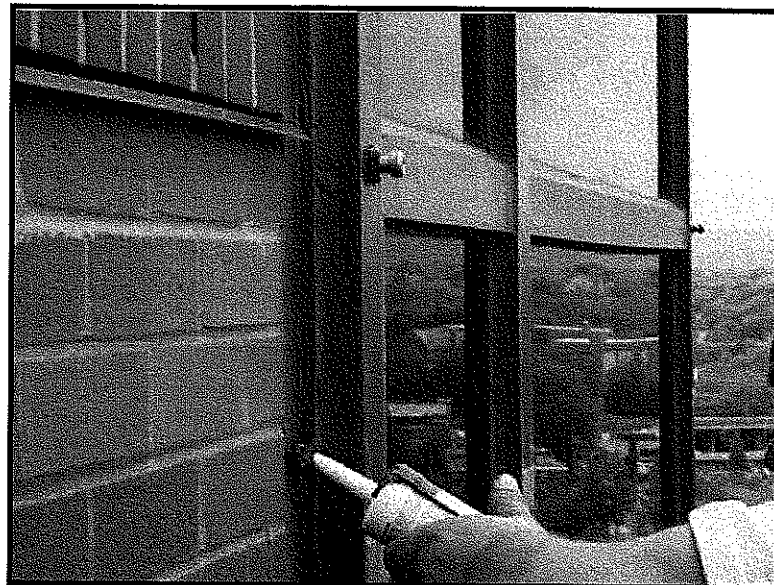
#9 Sealant repairs being performed at junction of curtain wall to masonry.

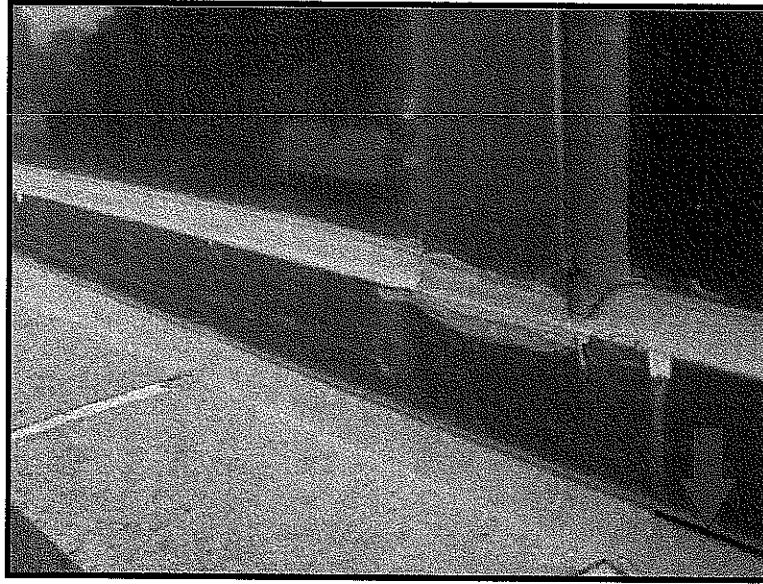
#10 View of curtain wall sill.  
Note gap in sealant along  
base.

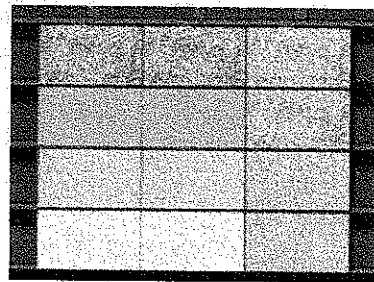
Various stone samples

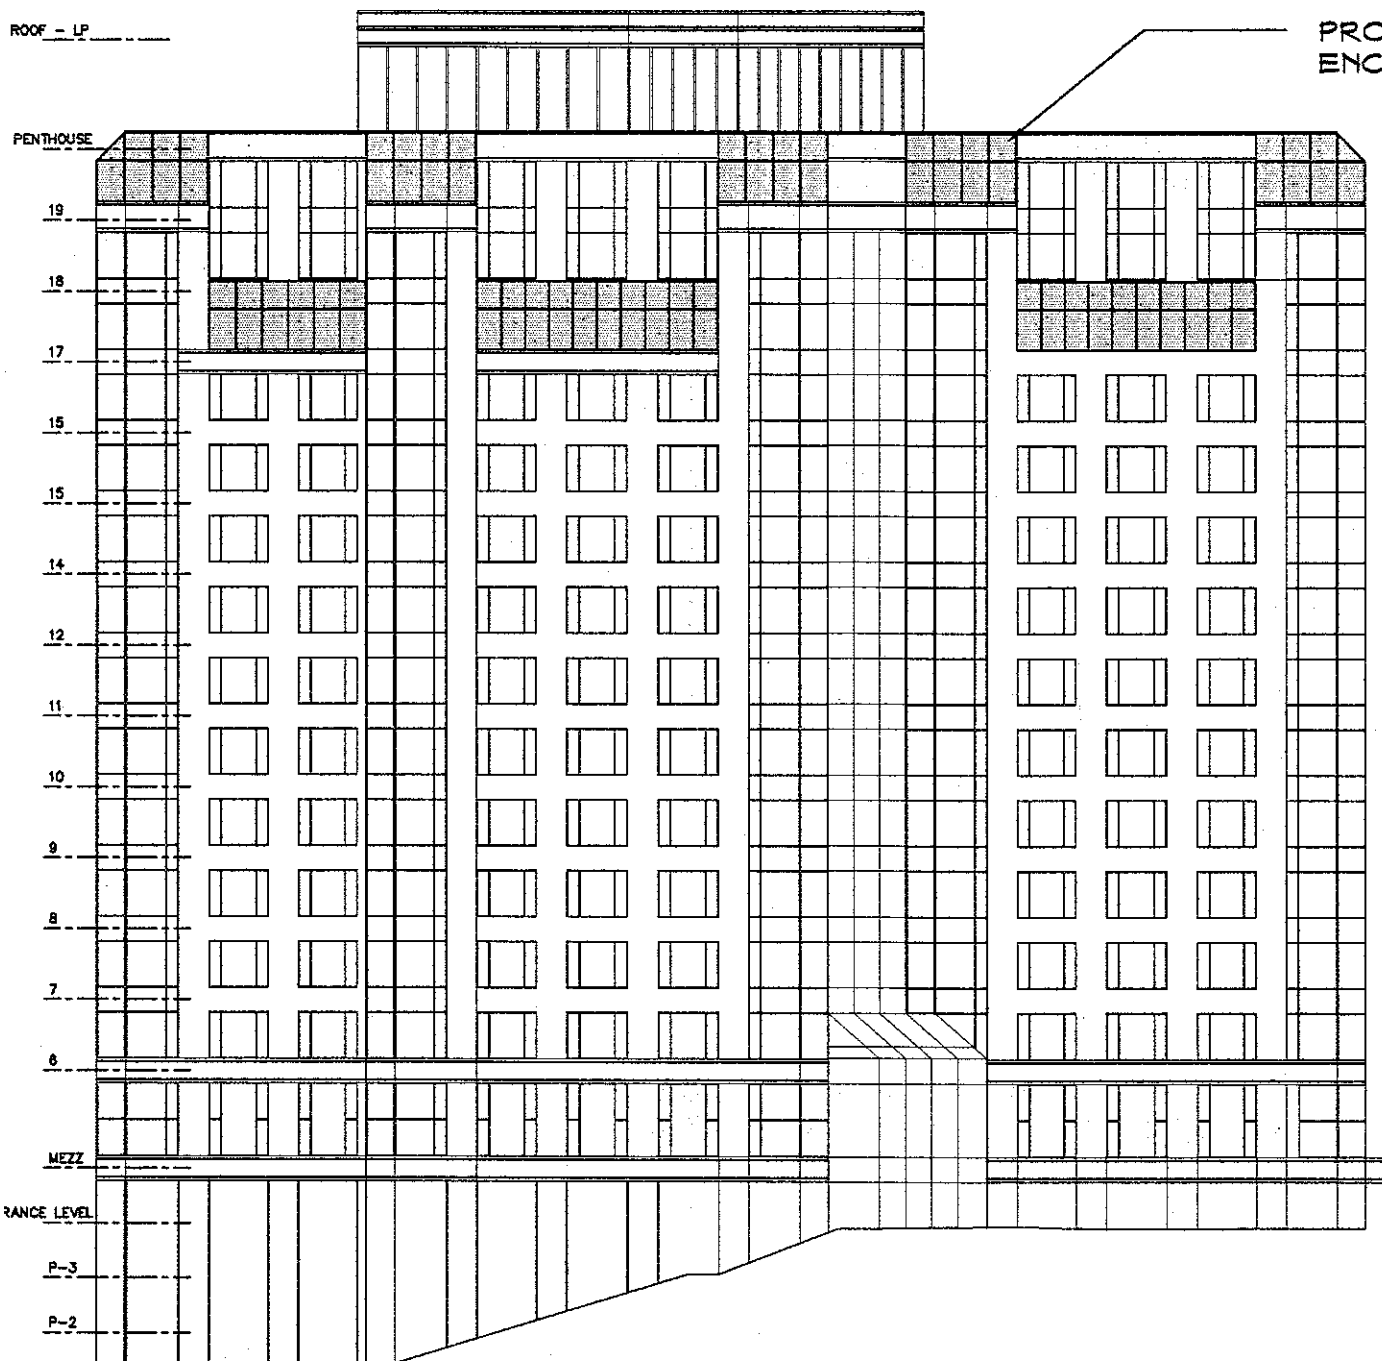
**	Based on total value of a smaller project size.					
<p>Some of the dollar figures used were calculated based on information obtained from the 2006 Building Construction Cost Data, published by Robert Snow Means Company, Inc. Kingston, Massachusetts. Additional figures were obtained from similar active projects with inflation and geographical percentages included and manufacturer's pricing. The final dollar amount shown is for guidance only and is a "ball park" figure. An assumption is made that all repair work will be performed under one contract and not spaced out over a period of time. The amount does not include any Architectural / Engineering fees or contingencies. Total dollar amount to be adjusted if work is to be performed during off hours or on weekends.</p>

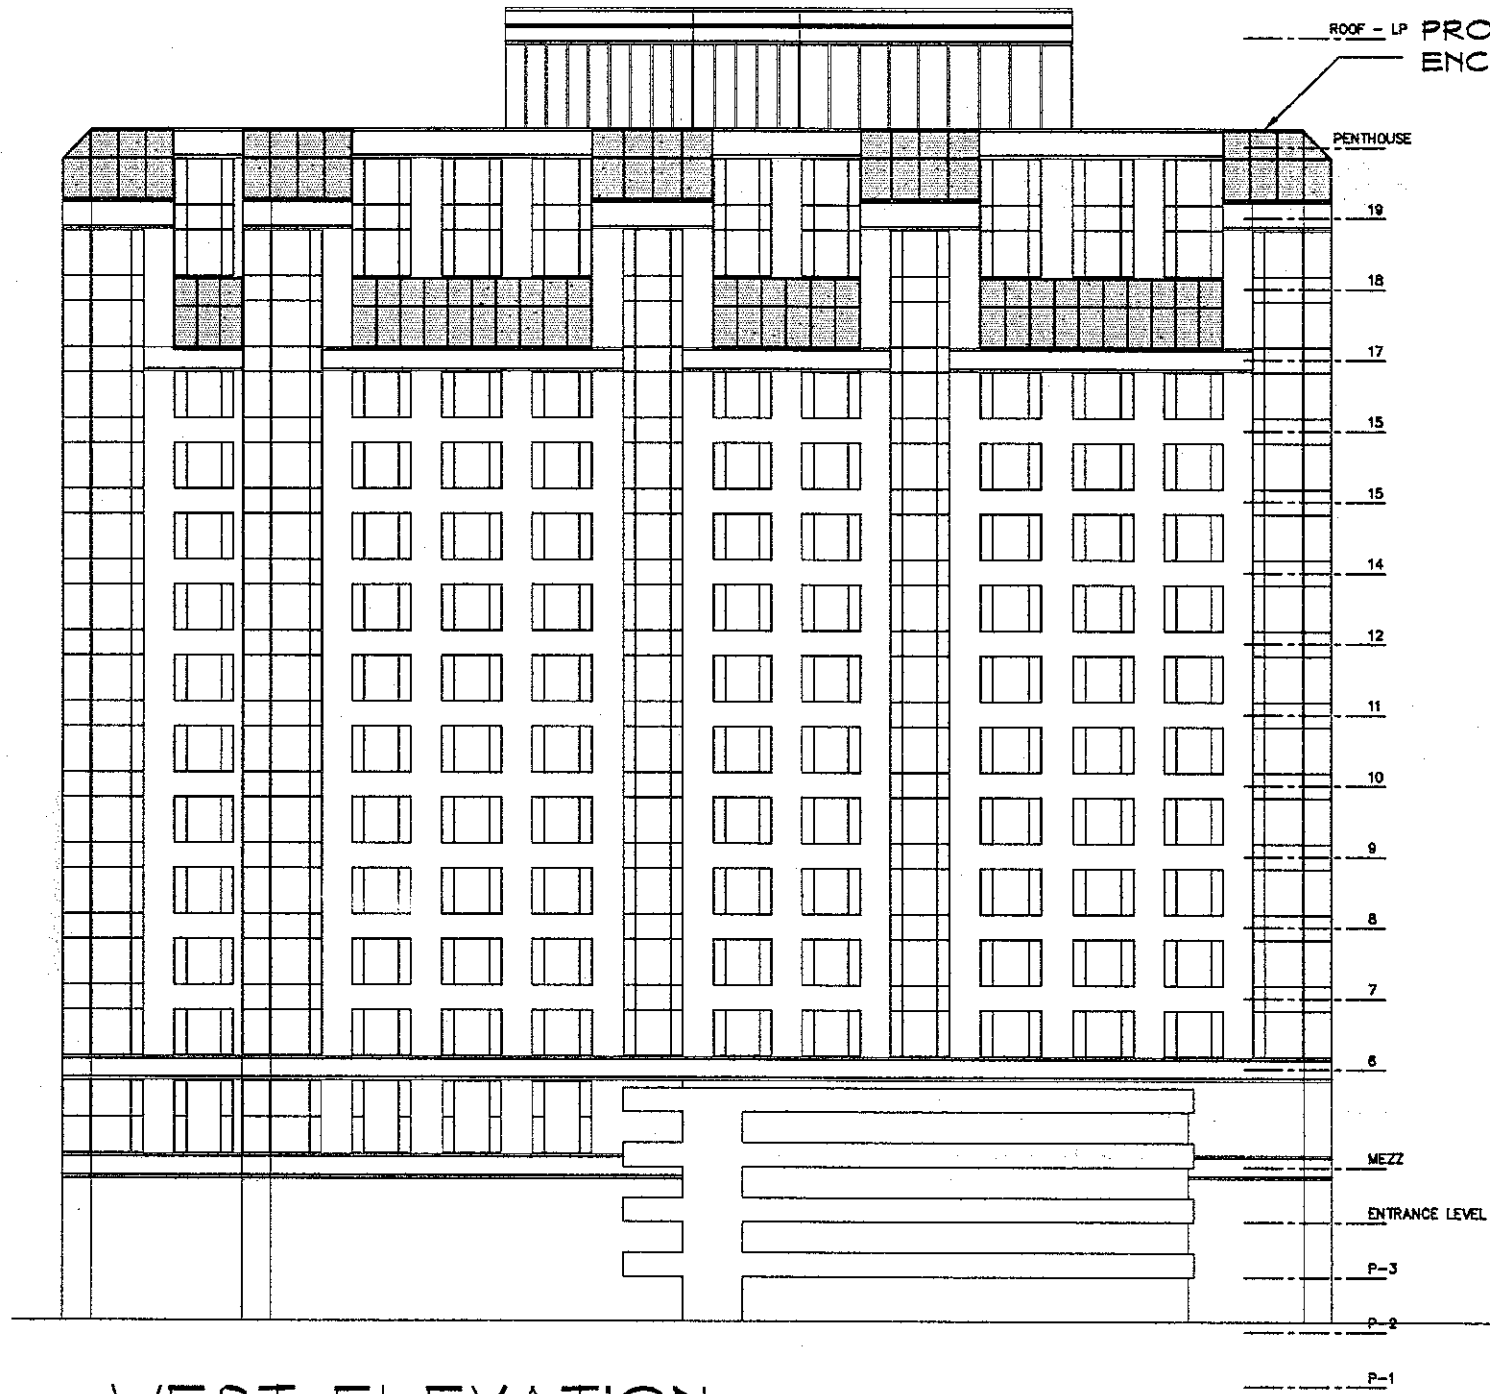
Drawing Title <b>APPENDIX D ELEVATIONS</b>		STATE OF CONNECTICUT DEPARTMENT OF PUBLIC WORKS	
REVISIONS Mark   Date   Description		Drawing Prepared By MARTIN A. BENASSI, A.I.A., ARCHITECT TWO BROADWAY HAMDEN, CONNECTICUT 06518	
		Date 7/21/08	
		Scale AS NOTED	
		Drawn By MEP	
		Approved By MAB	
		Drawing No. <b>SK-1</b>	
		Project No. 91-28-033.1
