**Study for Outside Air Quantity
25 Sigourney Street
Hartford, Connecticut**

Final Report

August 21, 2006

**State of Connecticut
Department of Public Works
Project Number BI-2B-033 J**

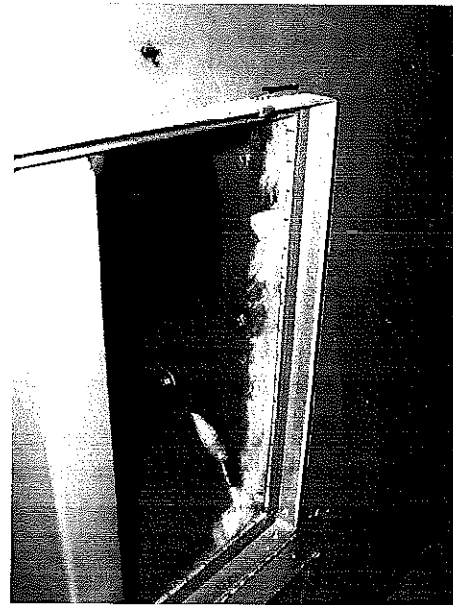
This may have been a problem in the past before the recent controls upgrade. Condensation could occur regularly during the summer on the outside of the casing due to warm mixed air in the mechanical room in areas where the casing

Figure 1 - Air handling unit with failing insulation

insulation within the air handling unit had worn away or fallen off. The existing internal insulation on all units is being replaced and should be complete at the time of the issue of this report.

A likely cause of moisture penetration on the former internal casing of the air handling unit and on fiberglass liner in the ductwork just downstream of the fan is moisture carryover due to a high velocity at the cooling coil. As the moisture condenses on the cooling coil, it drips down the coil and collects in the drain pan. As the velocity increases at the coil, the likelihood that the drops of condensation will be pulled into the airstream increases. Standard design typically limits the face velocity at the coil to 500-550 feet per minute. According to the most recent test report (July 14, 2005 – Wing’s Testing and Balancing), the velocity at design conditions was 760 feet per minute on the typical floors. This velocity is not unusual with limited mechanical space, which is the case with this building.

Moisture carryover can be reduced with larger air handling units (or larger cooling coil face area), by installing moisture eliminators downstream of the cooling coil, or dehumidifying the outside air. The first two options require new air handling equipment in limited mechanical space. The dehumidification unit would have to be sized for economizer operation at 100,000 cfm (to match the original design and maximize the energy-saving capabilities of the system, which is limited by the existing outside air shaft sizes). A dehumidification unit would also reduce the possibility of moisture migration through the walls of the outside air shafts.

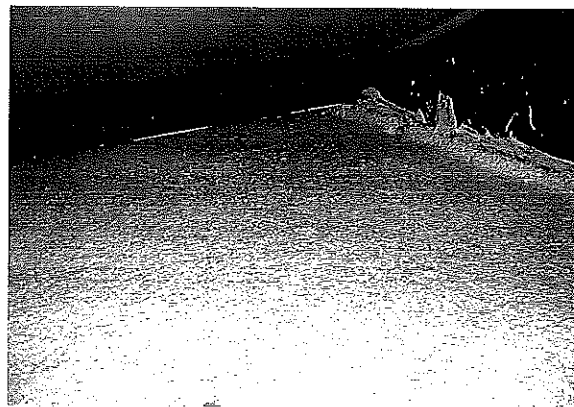
Figure 4 - Refurbished air handling unit floor

The new coating appears to have improved the condition of the floor, but proper pitch inside the unit cannot be verified or corrected because of the drainage arrangement. Since the unit is equipped with two drain connections and only one is connected on most units, it is possible that the floor is not draining properly in all cases. As part of preventative maintenance, pitch of discharge piping should be examined periodically and corrected, if necessary. Additionally, the fan section bases should be examined periodically during high humidity days to assure proper drainage. The units are nearing the end of their expected useful life and should be considered for replacement with units equipped with stainless steel IAQ drain pans.
