CONNECTICUT
DEPARTMENT
OF
TRANSPORTATION

CONDITION INSPECTION
FOR THE
DANBURY STATION

CONN. DEPT OF TRANSPORTATION
STATION INSPECTION REPORT
SHEET 3 OF 42

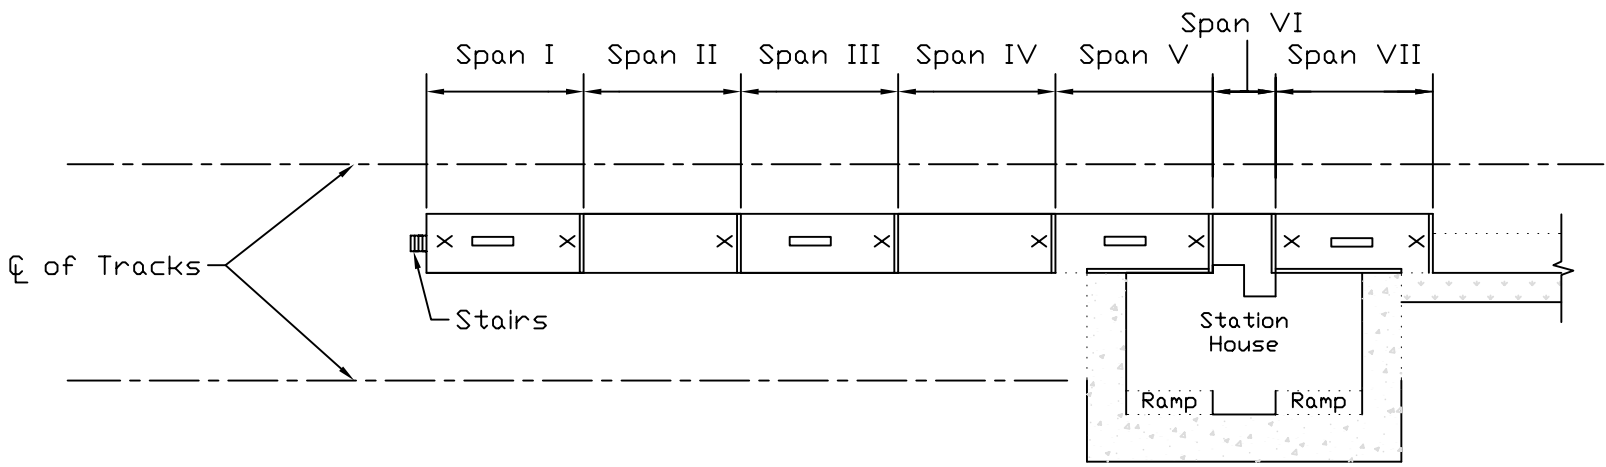
Urbitran Associates, Inc.
Connecticut Dept. of Transportation
Danbury Station Platform Plan
Date: 12-04-01

1. Top of the platform exhibits 25% map cracking in Span VI

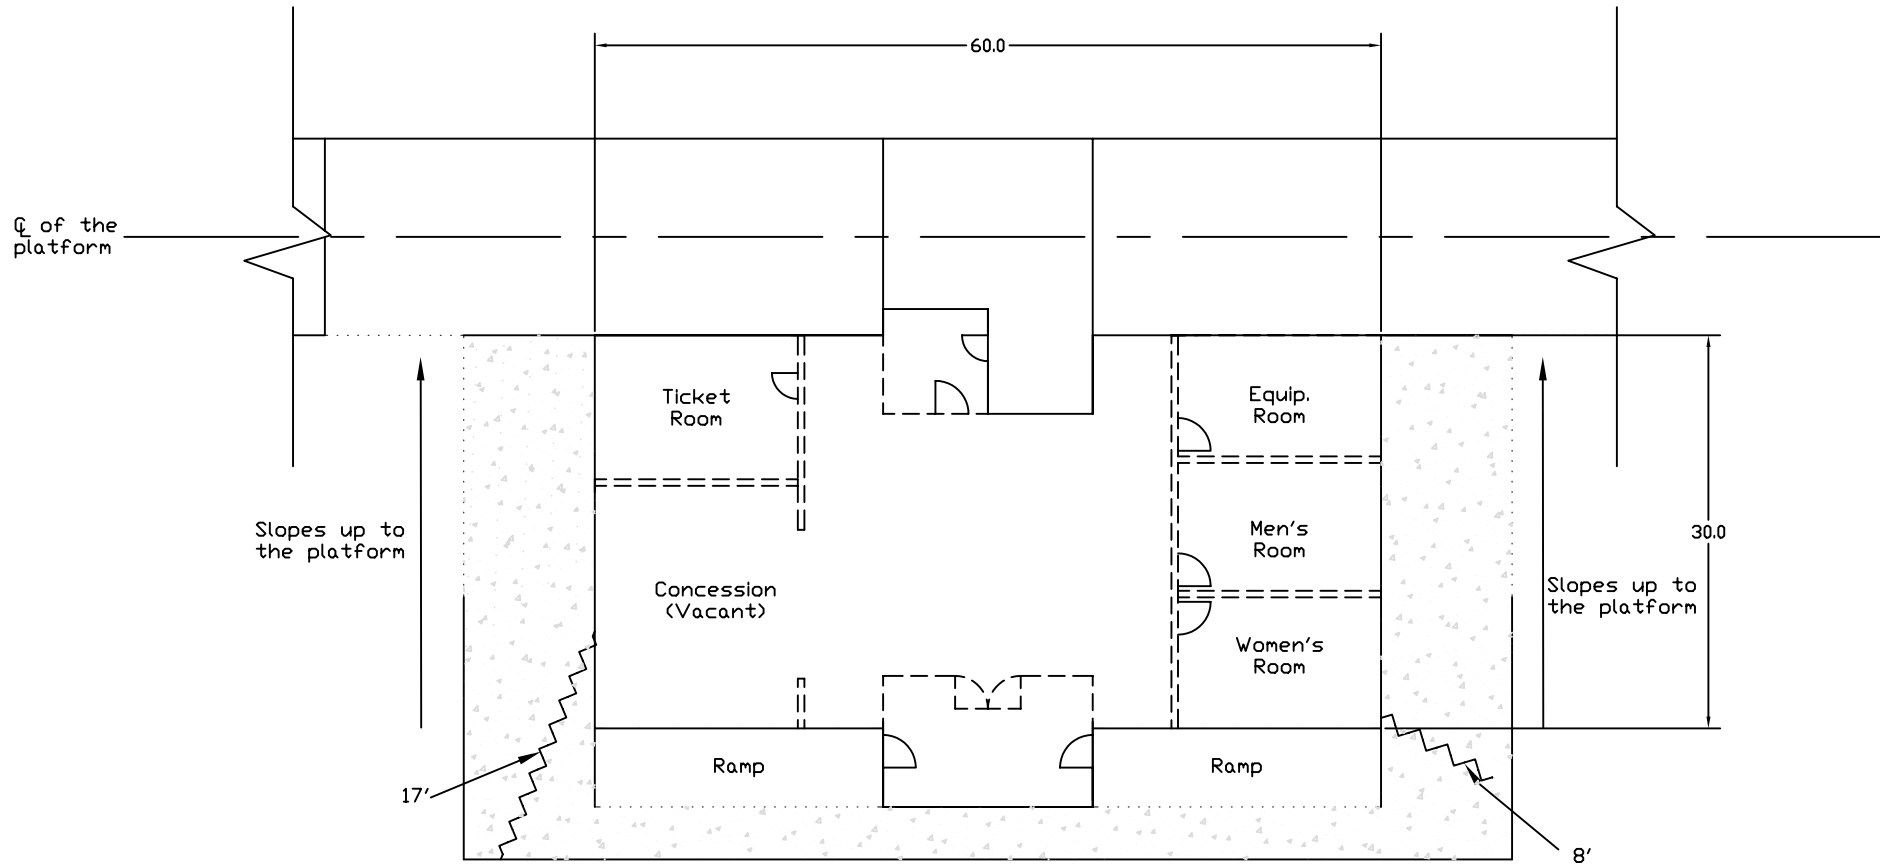
Urbitran Associates, Inc.
Connecticut Dept. of Transportation
Danbury Station Building Plan
Date: 12-05-01

- NOTES:
1. A lock to a bathroom stall is missing in both the men's and women's room.

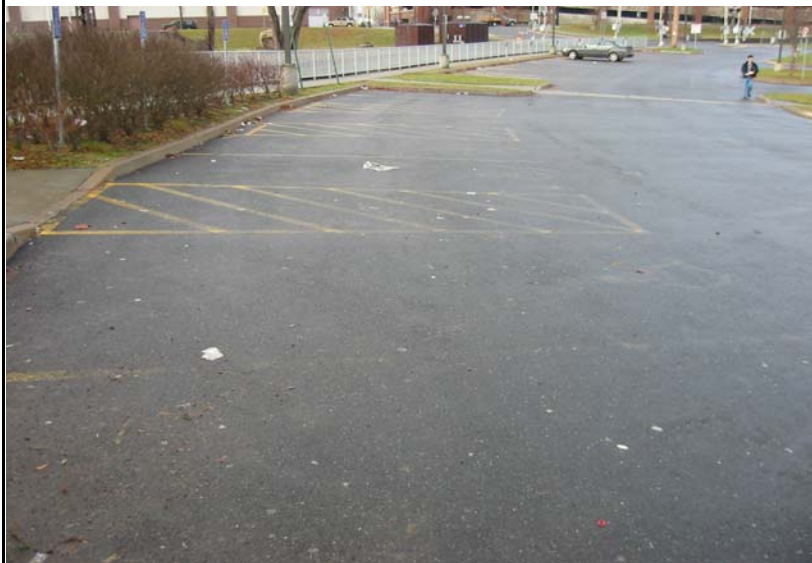
PHOTO NO. 14

Location: Westside of Quad II

Description: Typical view of the stripping in Quad II that is slightly faded

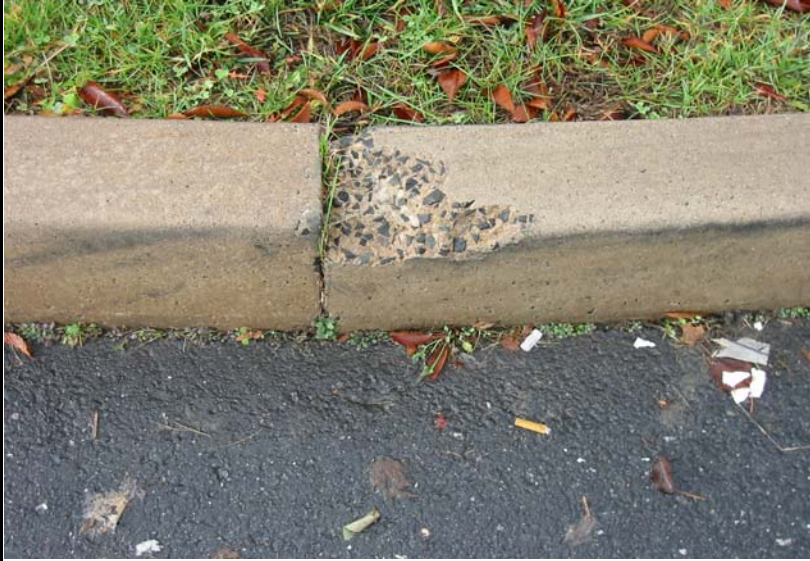
Description: _____
Typical spalled concrete
area (6" x 4" x 1") along
the curb

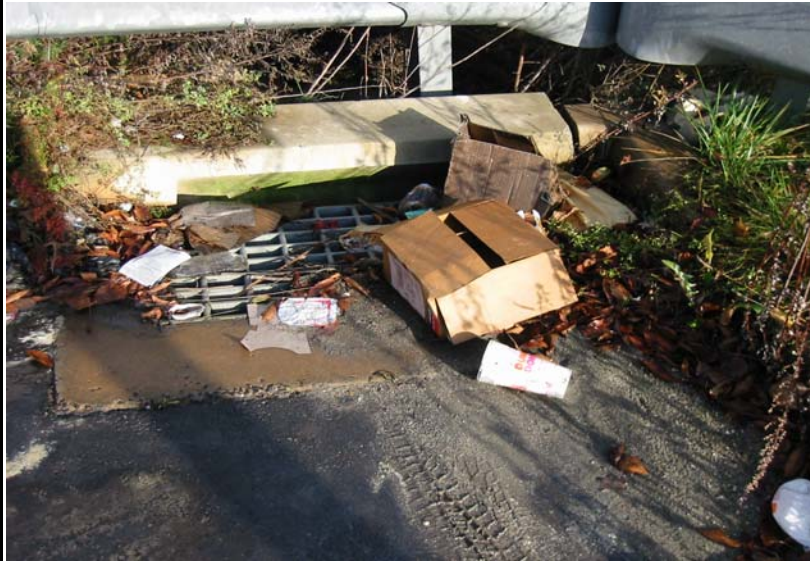
PHOTO NO. 18

Location: _____
Eastside of Quad I,
close to the Northside
Quad I

Description: _____
Garbage and vegetation
covering the drain

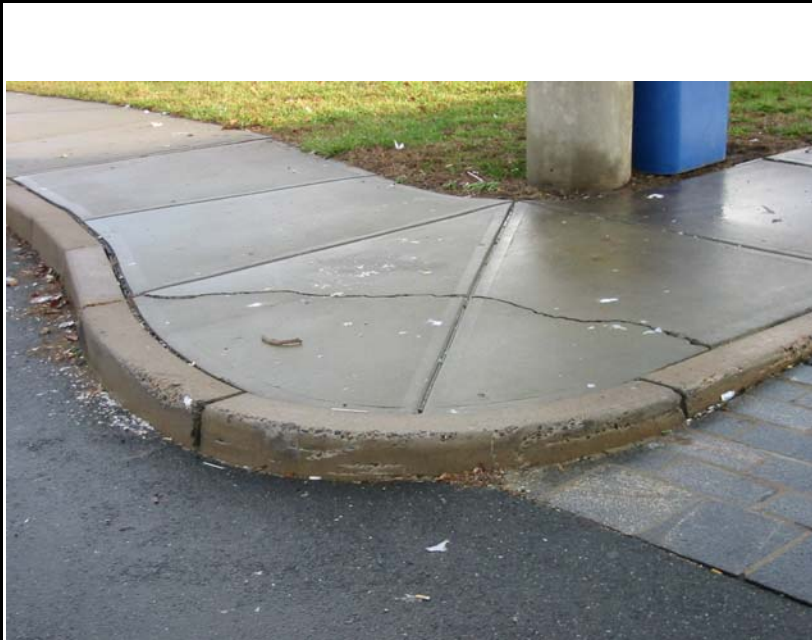
Description: 6' crack and spalled concrete curb (5'x1"x1/4") on the Northwest corner of the island in front of the station house

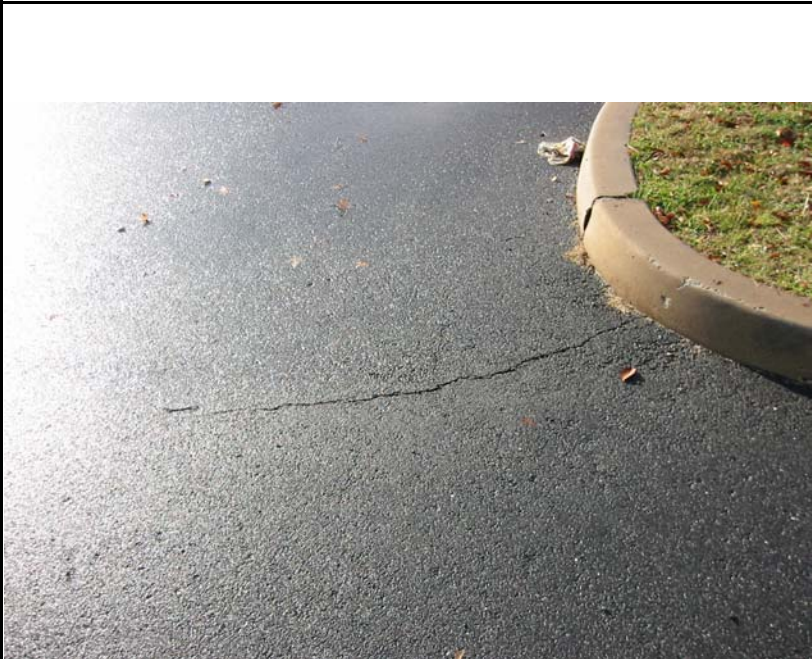
PHOTO NO. 20

Location: Southside of Quad II

Description: 4' crack extending from the Northeast corner of the South island in Quad II

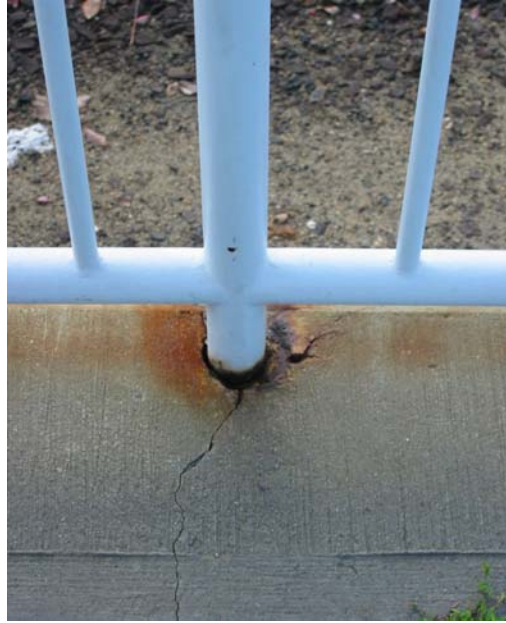
Description: _____
Rust and an 8 inch
crack extending from
bottom of the railing
post, typical throughout
the railing

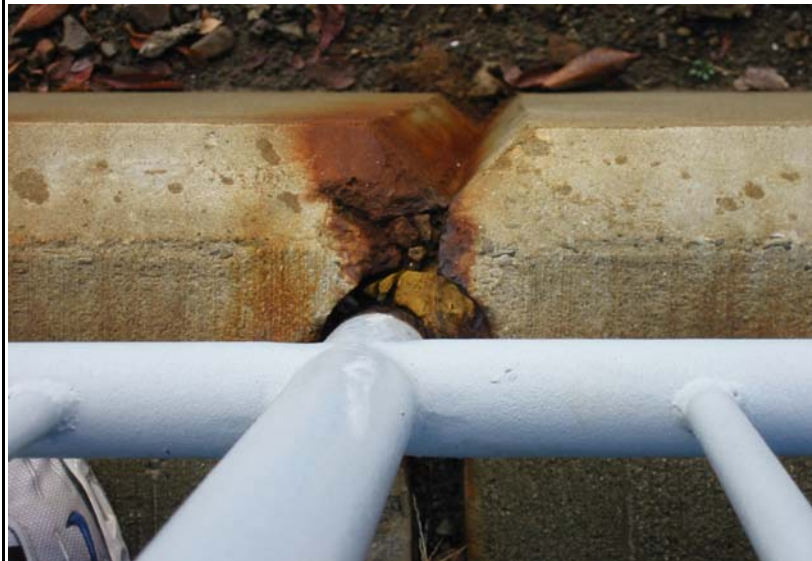
PHOTO NO. 22

Location: _____
Westside railing in
Quad II

Description: _____
Rust, spalled concrete,
and cracking exhibited
at the base of the railing
post

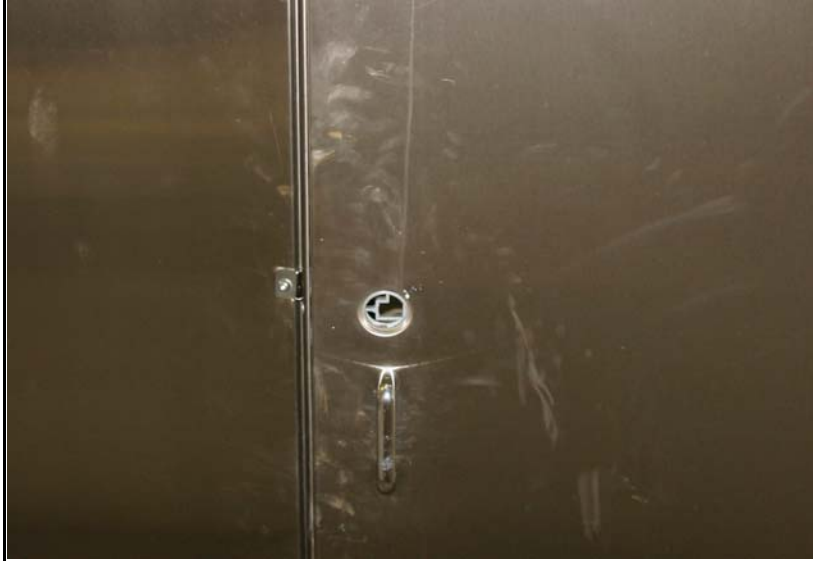
Description: _____
Missing lock on
the handicap stall

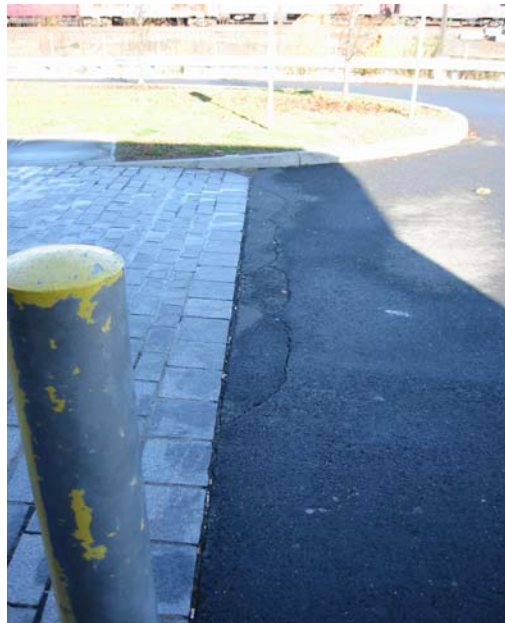
PHOTO NO. 24

Location: _____
Northwest corner of
Quad I

Description: _____
20' crack along the
Southside of the brick
in front of the station
house

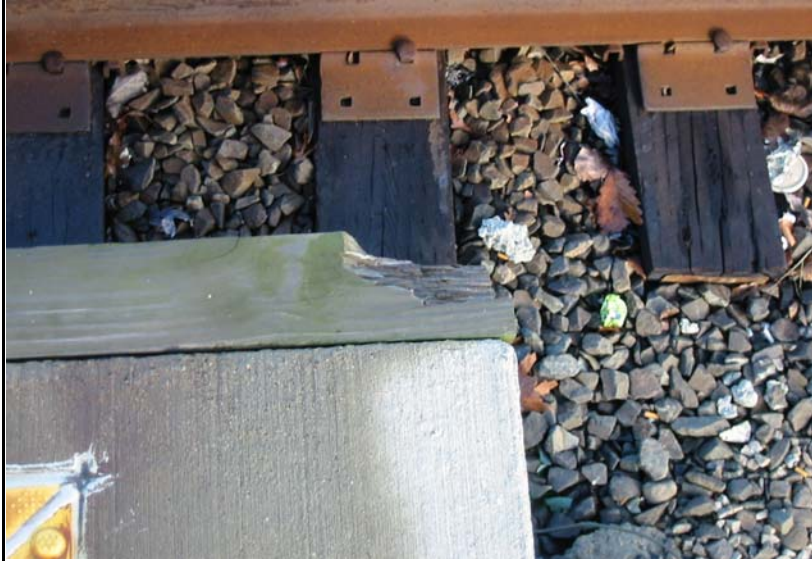
Description: _____
Broken timber rubbing
board (3" x 3" x 2")

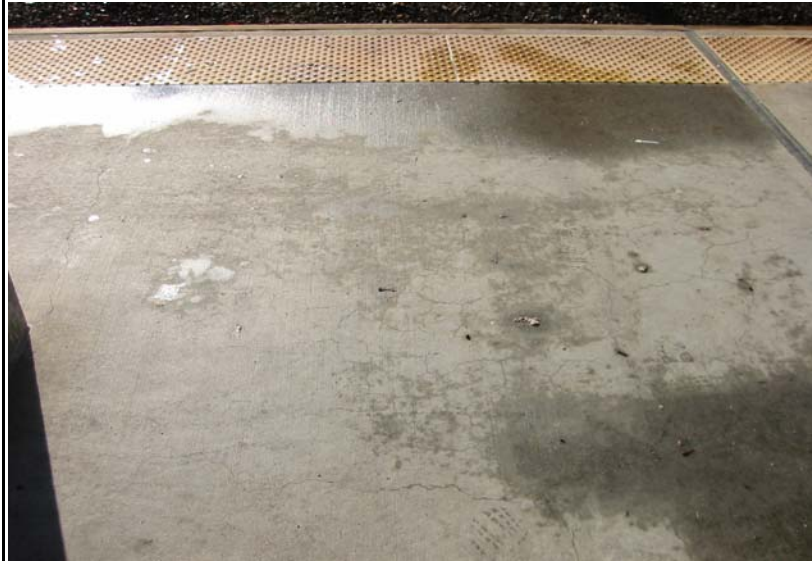
PHOTO NO. 26

Location: _____
Eastside of Span VI

Description: _____
25% map cracking in
Span VI

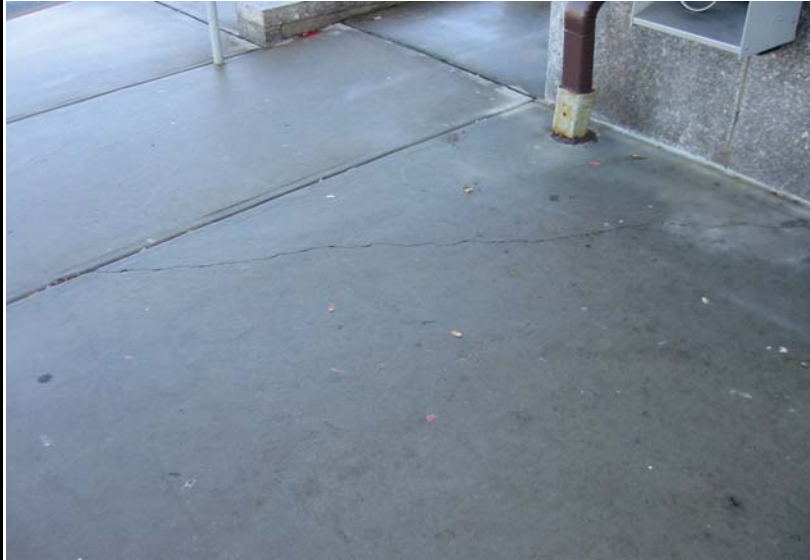
Description: _____
8' crack extending from
the Northeast corner of
the sidewalk

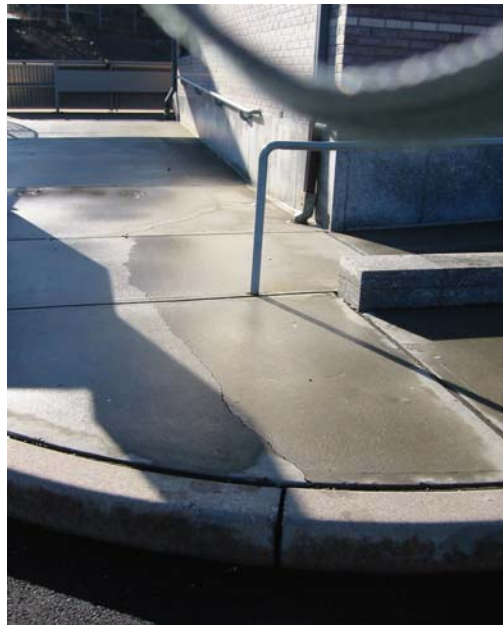
PHOTO NO. 28

Location: _____
Northwest corner of
Quad I

Description: _____
17' crack extending to
from the curb to the
South face of the
station house

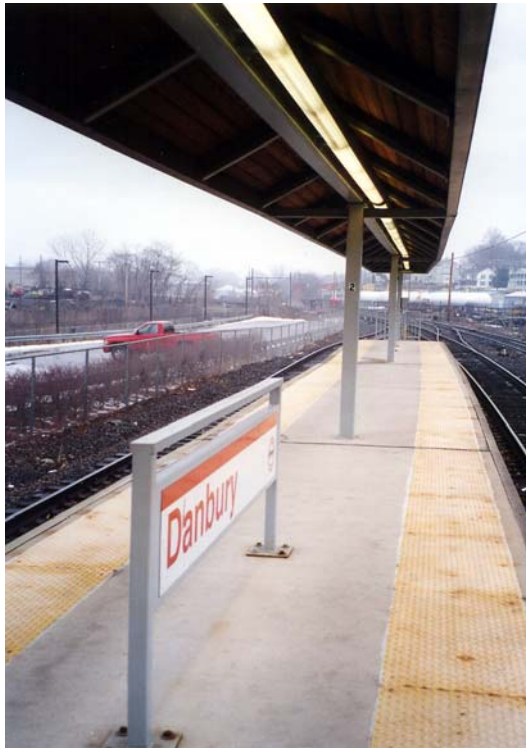
PHOTO NO. 32

A continuous row of lights is installed under the canopy that maintain an average of 17.5 foot-candles, which exceeds the minimum light levels as recommended by the IESNA. However, the gaskets at the lenses are not continuous and may allow moisture to penetrate the fixture and compromise the fixtures light output. There is no recommendation at this time to replace them, but it is likely that these fixtures will need to be replaced within ten years, if the above item is not addressed.

Location:
platform

Description:
lighting

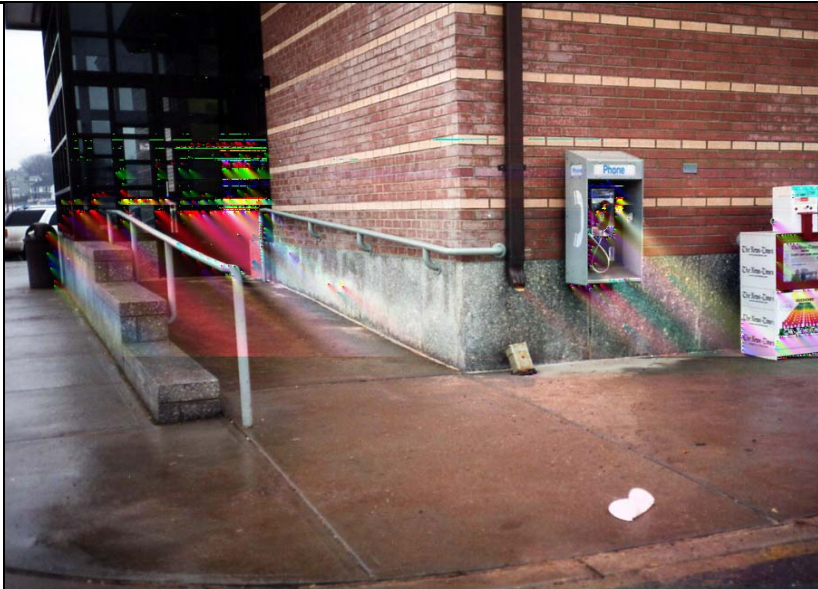
Building gutters and downspouts in Good Repair.
Downspouts are galvanized sheet metal, one is deteriorated at the bottom.

Description:
Side of building
with deteriorated
downspouts

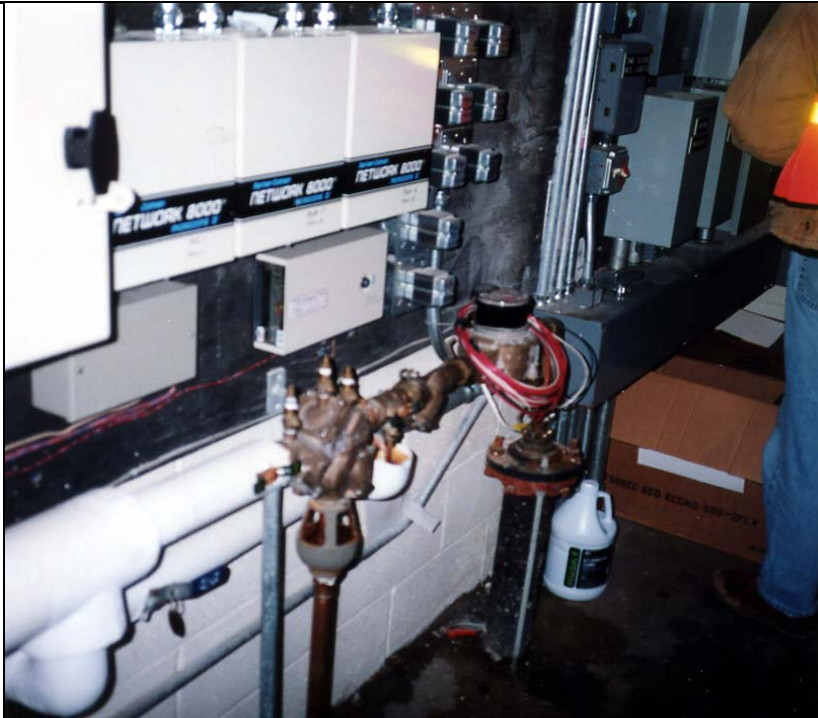
There is a ¾" back flow preventer for the make-up water for the boiler exchanger, which is defective and is planned to be replaced by the town-engineering department.

Description:
Backflow
preventer for
heating makeup
water
