CONNECTICUT
DEPARTMENT
OF
TRANSPORTATION

CONDITION INSPECTION
FOR THE
OLD GREENWICH STATION

**CONN. DEPT OF TRANSPORTATION
STATION INSPECTION**

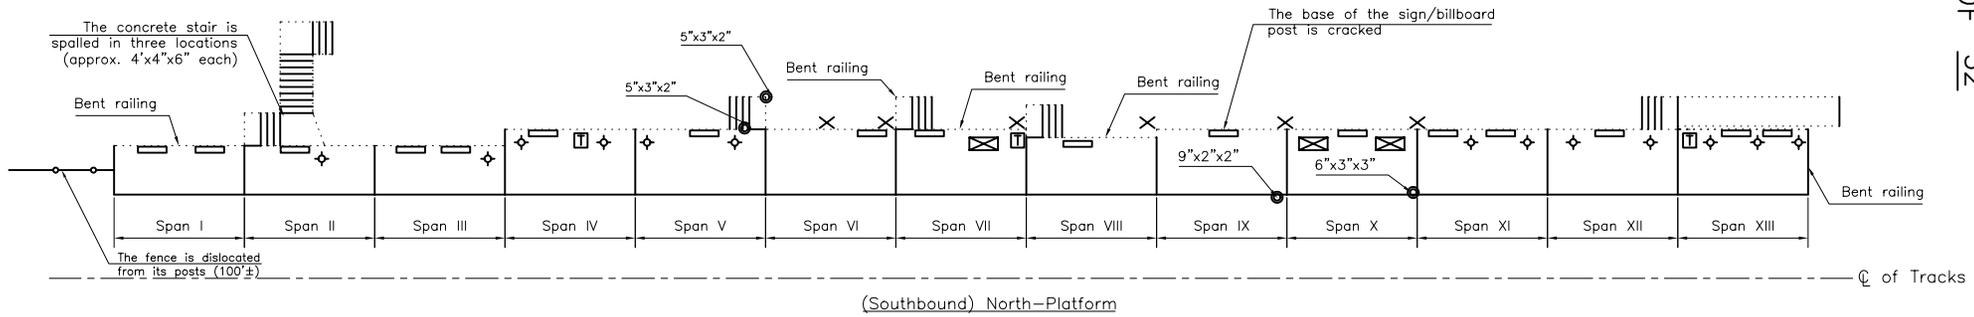
1. The base plates for the double tee are rusted and deteriorated throughout the platform.
1. The railing base plates are rusted and deteriorated throughout the platform.

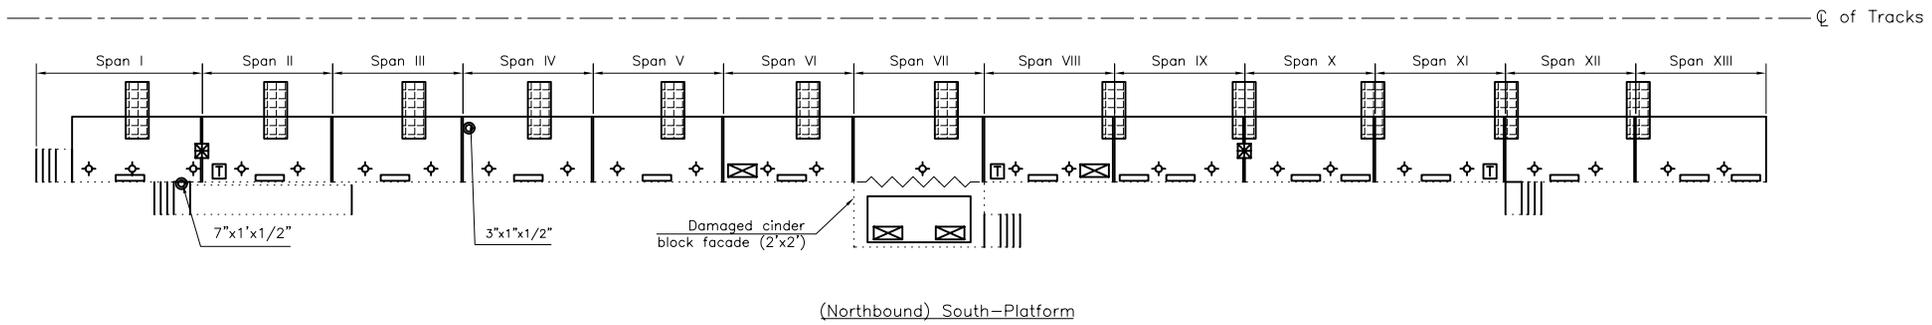
1. The base plates for the double tee are rusted and deteriorated throughout the platform.
2. The railing base plates are rusted and deteriorated throughout the platform.

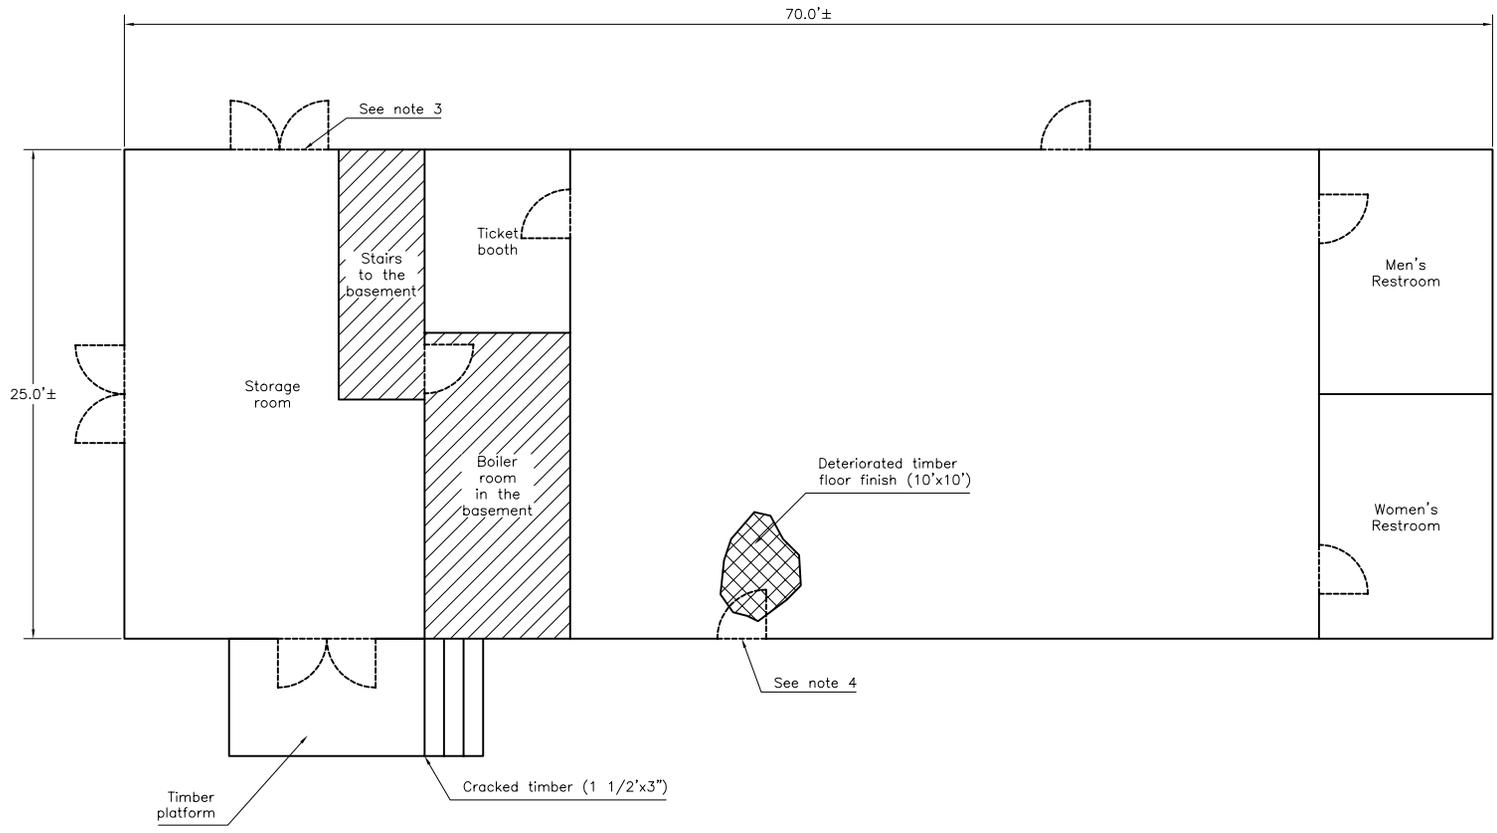
Urbitran Associates, Inc.
Connecticut Dept. of Transportation
Old Greenwich Station Station House Plan
Date: 11/30/01

1. The roofing shingles are buckling in random locations.
2. The exterior paint has started to chip and peel; also there are isolated areas where there are cracks in the timber facade.
3. There is a gap between the southeast corner door and the door frame.
4. The hinge is not aligned correctly and could not be moved.

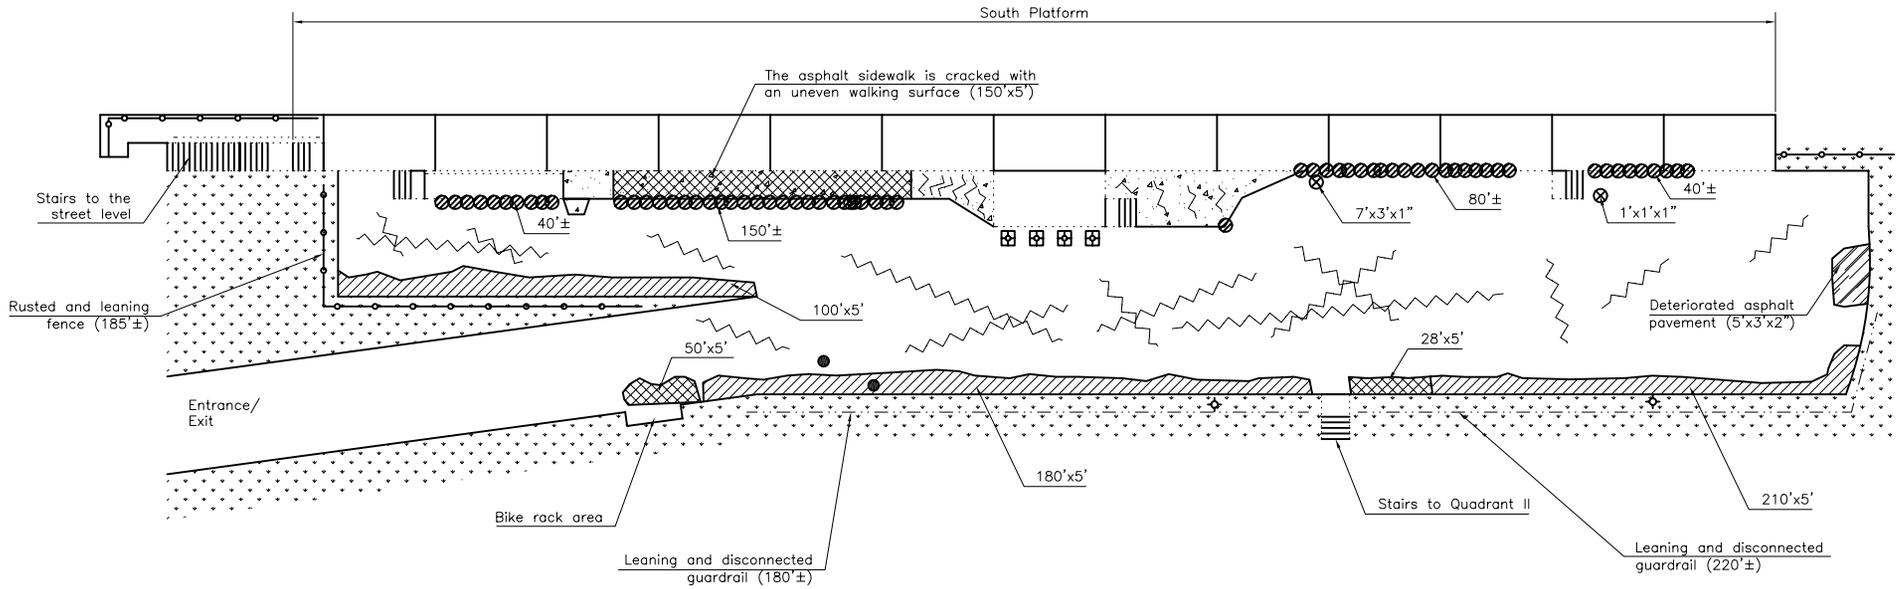
Urbitran Associates, Inc.
Connecticut Dept. of Transportation
Old Greenwich Station Quadrant I Plan
Date: 1/26/02

1. In the parking area there are 2000'± of asphalt cracks.
2. There are 80'± of asphalt cracks in the sidewalk.

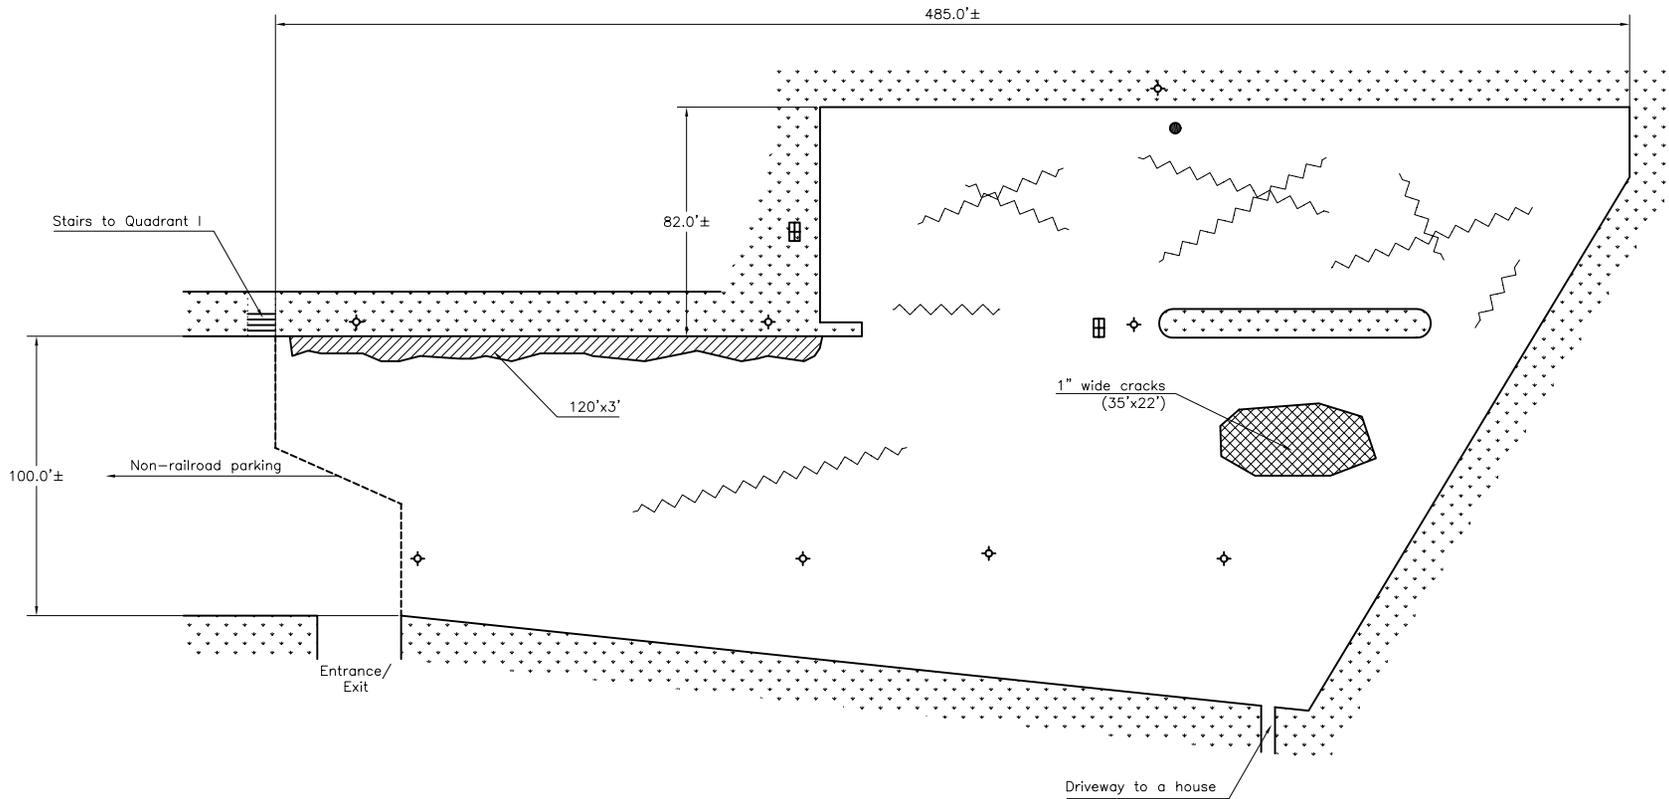
Urbitran Associates, Inc.
Connecticut Dept. of Transportation
Old Greenwich Station Quadrant II Plan
Date: 1/26/02

1. Most of the curb is missing throughout this Quadrant.
2. In the parking area there are 500'± of asphalt cracks.

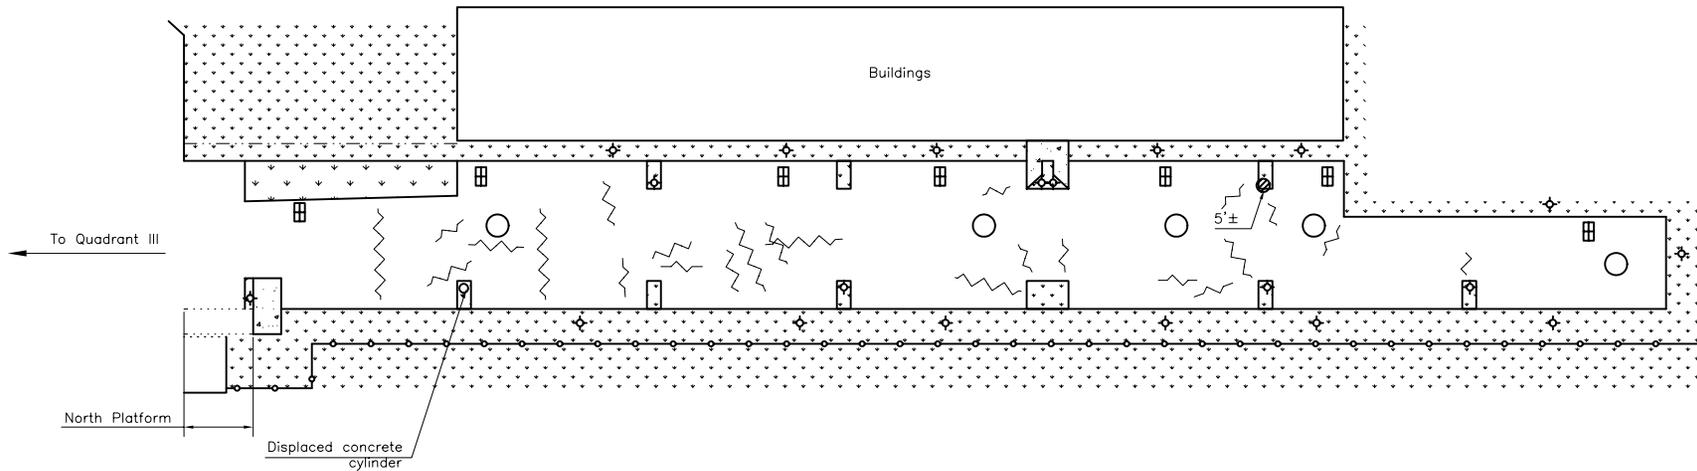
1. In the parking area there are 300'± of asphalt cracks.

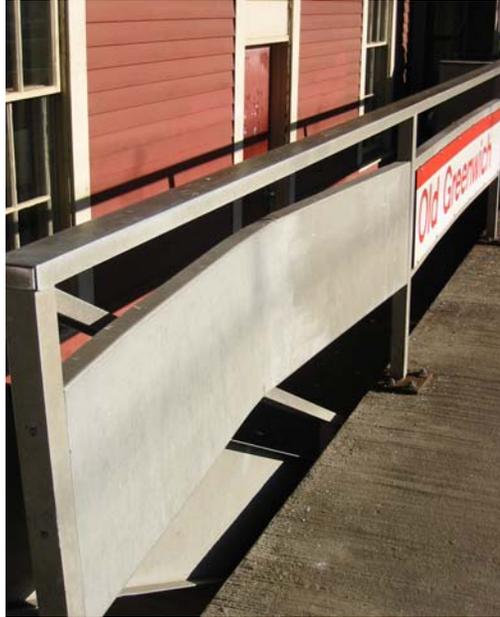
Description: Typical bent railing

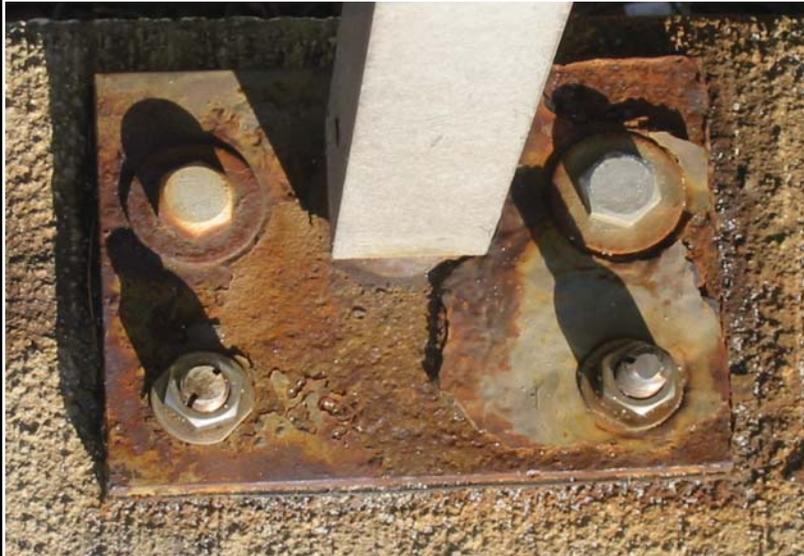
PHOTO NO. 14

Description: Typical rusted and deteriorated railing base plate

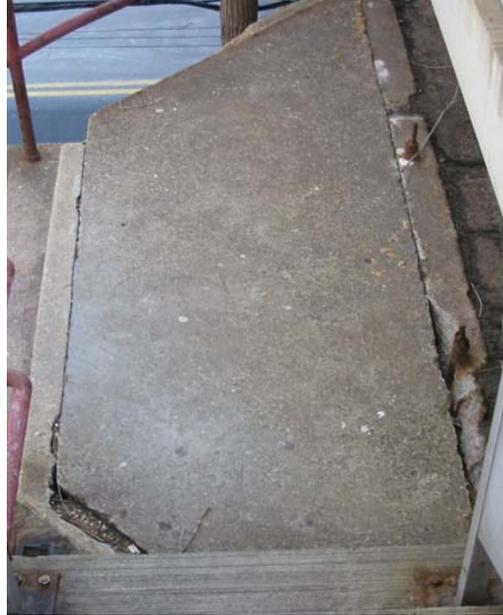
Description: _____
Spalled concrete stairs

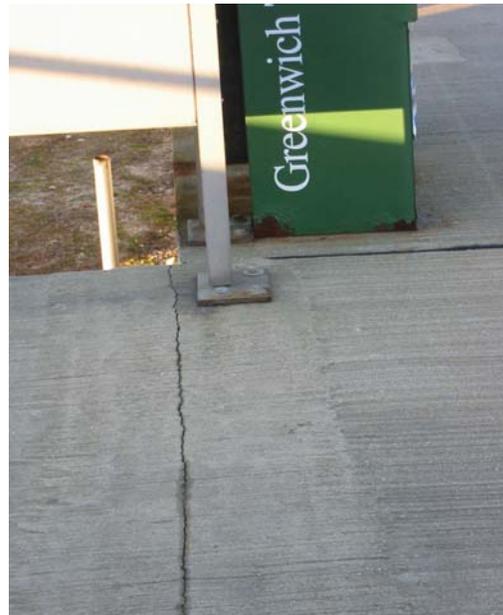
PHOTO NO. 16

Description: _____
Crack concrete

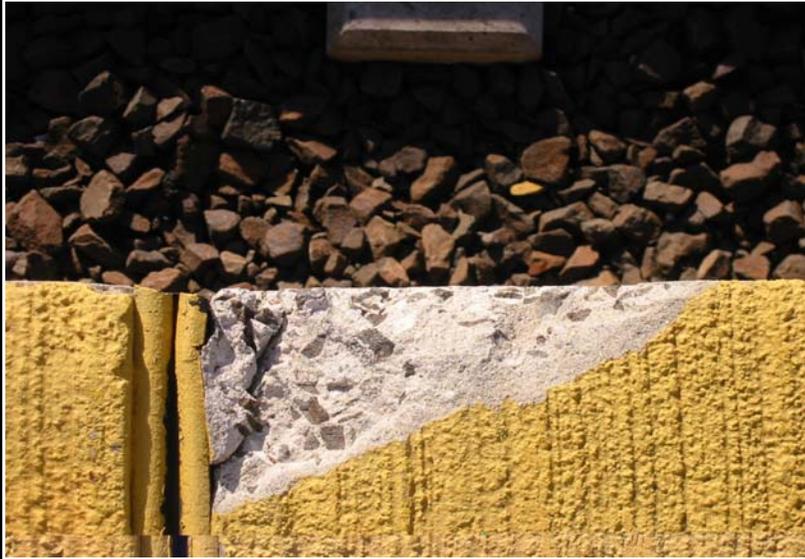
Description: _____
Spalled concrete

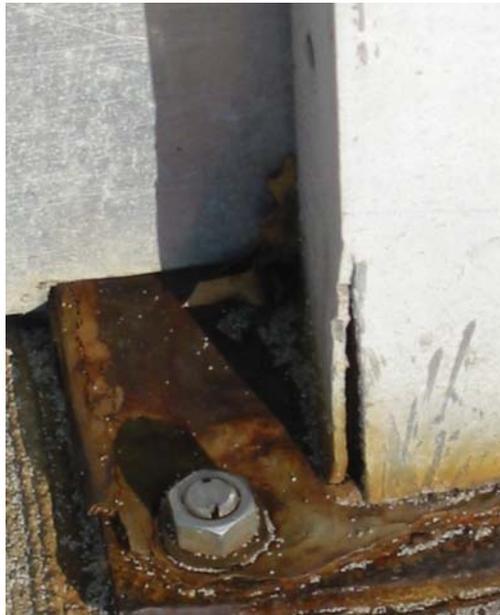
PHOTO NO. 18

Description: _____
The sign post is
cracked at the base

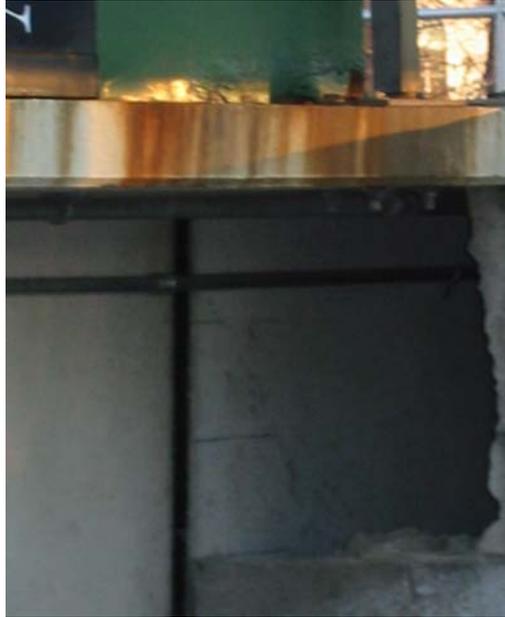
Description: _____
Damaged cinder block
façade

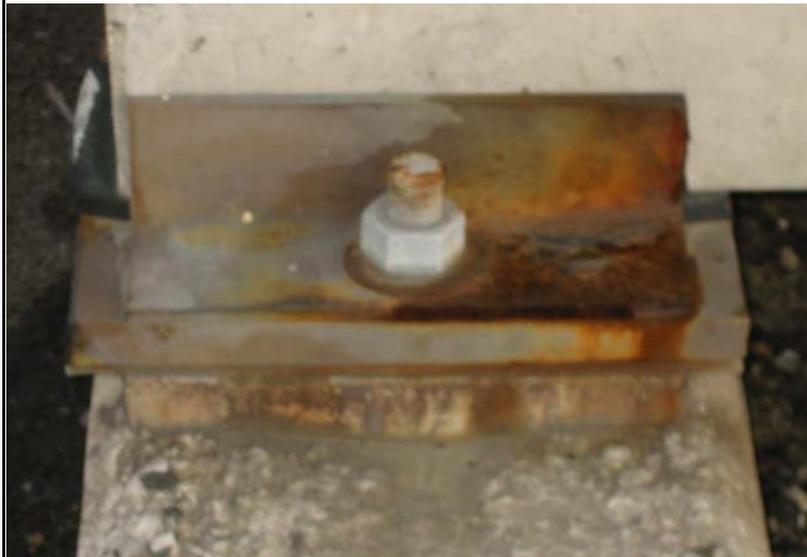
PHOTO NO. 20

Description: _____
Typical rusted base
plate for the double tee

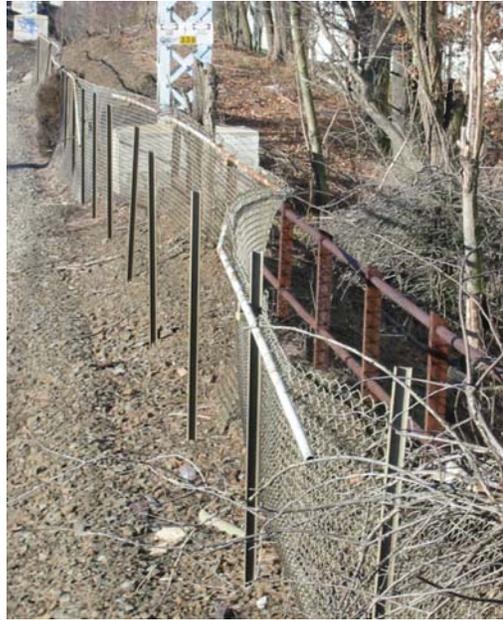
Description: _____
The fence is dislocated
from its posts

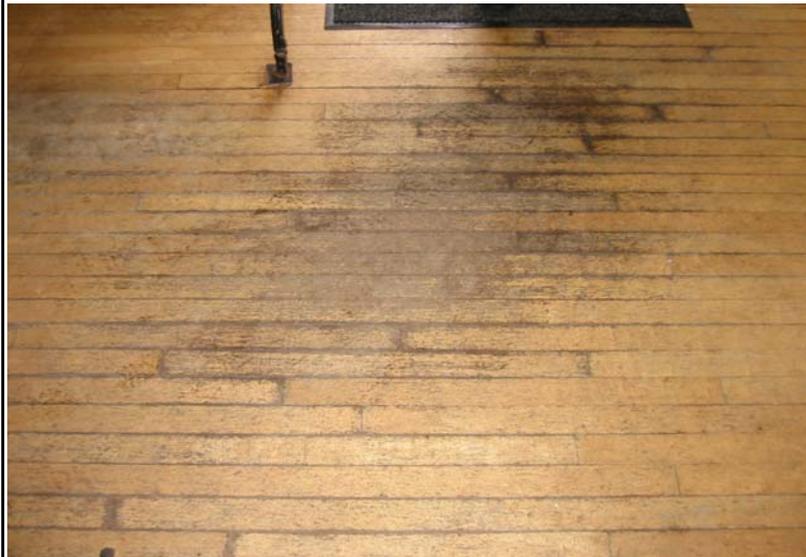
PHOTO NO. 22

Description: _____
The timber floor finish is
deteriorated

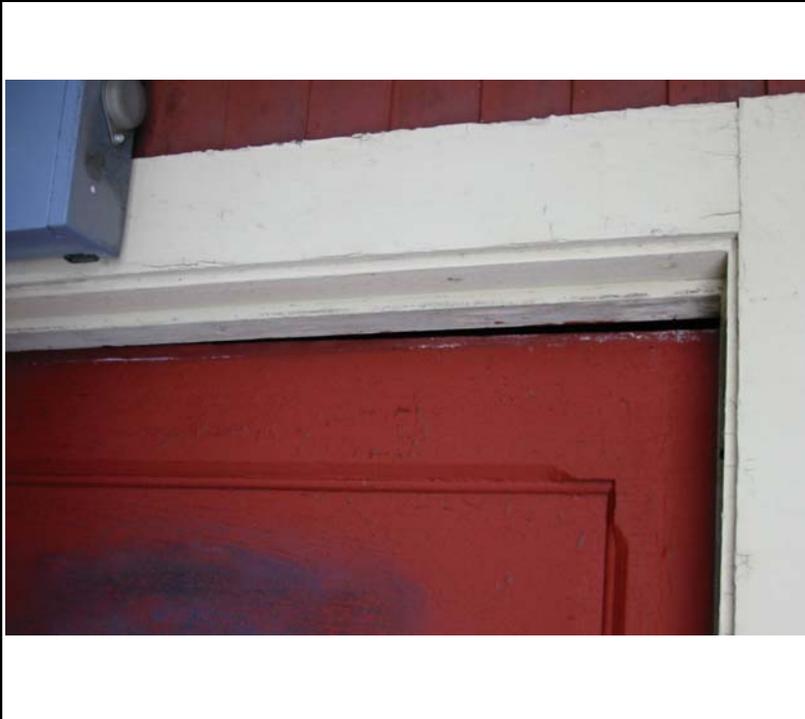
Description: The door does not align with the door frame

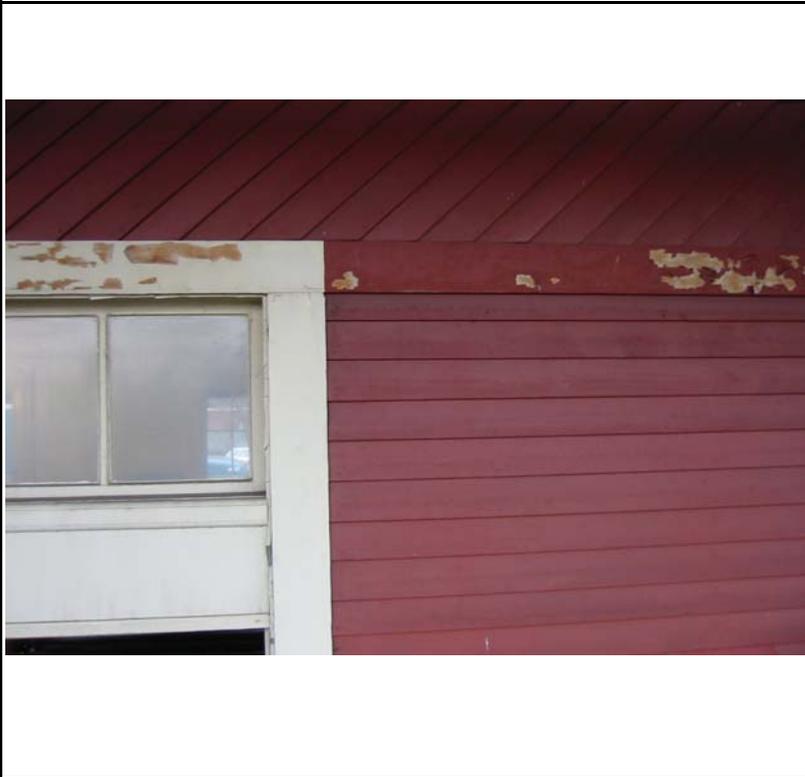
PHOTO NO. 24

3		24	Station House 27 - There are isolated areas where the paint is starting to chip and peel.
3		25	Station House 27 - There are isolated areas where there are cracks in the timber façade.

Description: Typical paint chip on the window frame and timber panels

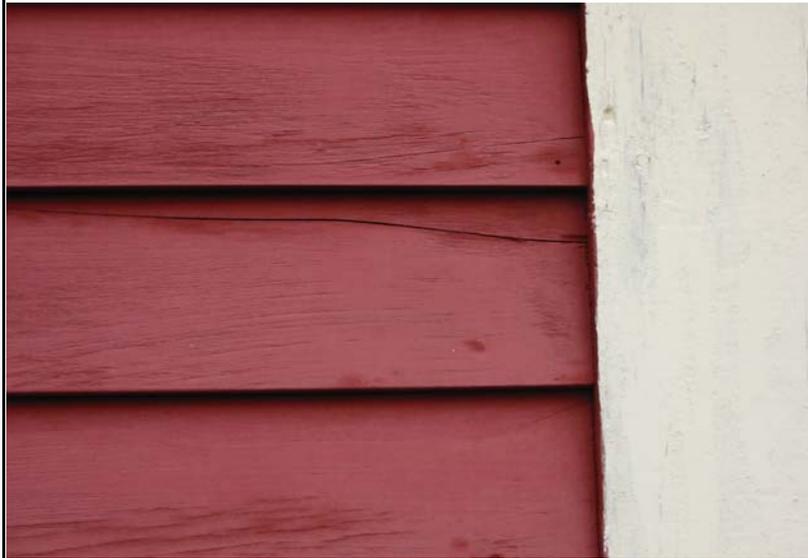
Description: _____
Cracked timber façade

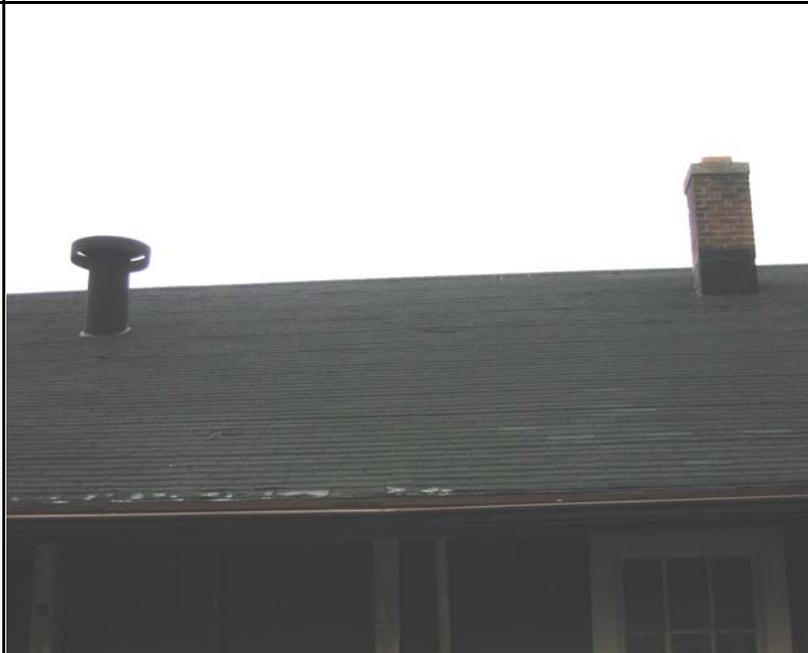
PHOTO NO. 26

RATINGS		PHOTO NO.	REMARKS:	
NEW	PREV			
3		26	Station House	30 - The roof shingles are showing signs of deterioration. They are starting to buckle.
3		27	Station House	33 - There is an isolated location where the door hinge is not aligned and could not be moved.
3		28	Station House	NA - The timber platform adjacent to the building is cracked in an isolated location.
2		29	Quad I	Surface - There is an isolated area where the asphalt surface is deteriorated.
2		30, 31	Quad I, II	Surface - There are areas where the asphalt surface is cracked; Also there are areas where there is an uneven driving surface with cracks.
2		32	Quad I	Guardrail - The guardrail is leaning and disconnected in multiple locations.
2		33	Quad I	Fence - The fence is leaning and rusted
2		34	Quad I	Curb - There are multiple locations where the concrete curb is spalled.
2		35	Quad I,II,III	Curb - There are multiple locations where the asphalt curb is displaced, missing, or damaged.

Description: _____
The roof shingles are
buckling in random
locations

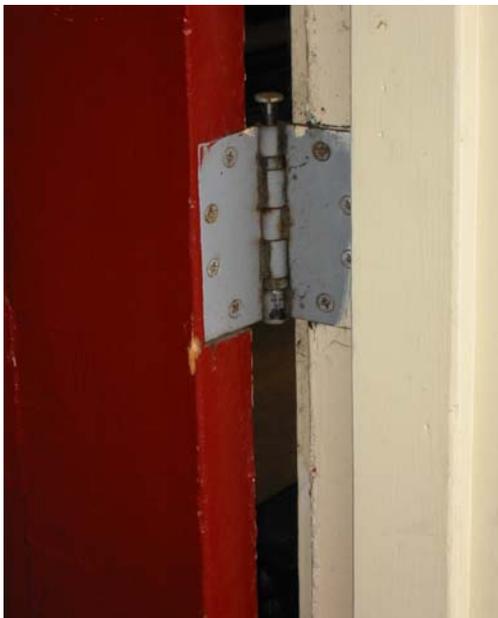
Description: _____
The door hinge pin is
not aligned correctly
and the pin could
not be moved

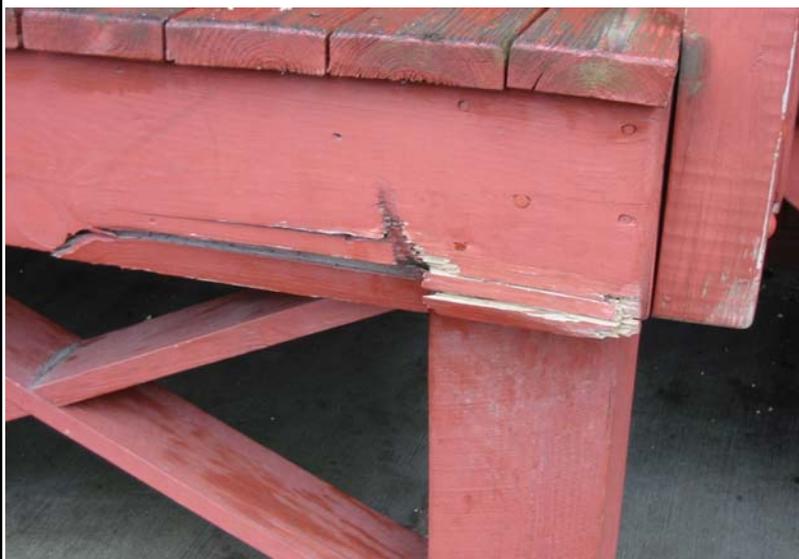
PHOTO NO. 28

Description: _____
Cracked timber platform

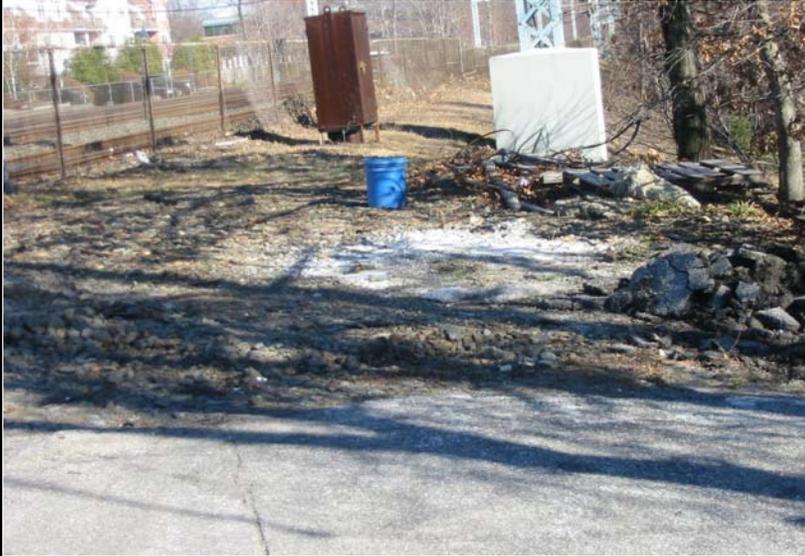
Description: The asphalt surface is deteriorated

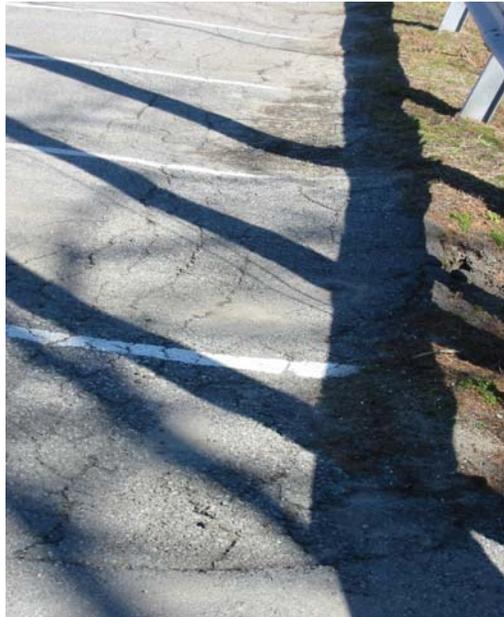
PHOTO NO. 30

Description: Typical uneven driving surface with cracks

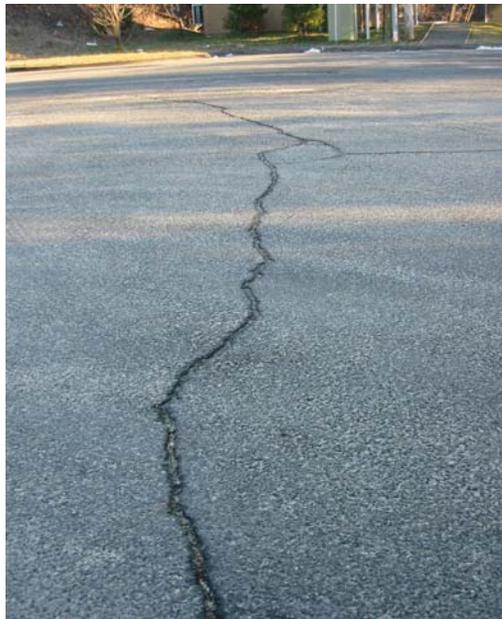
Description: Typical crack

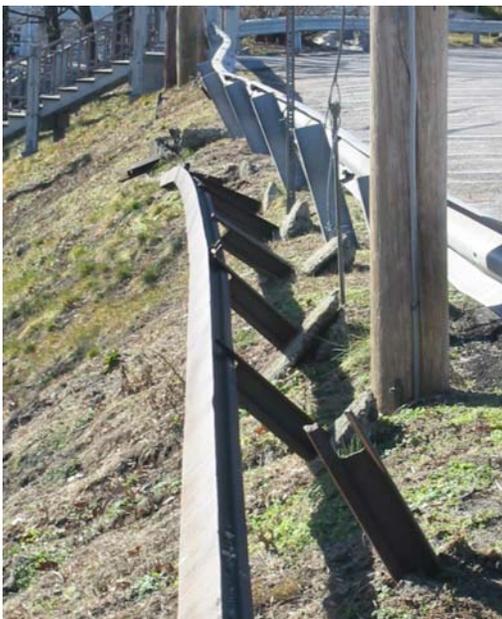
PHOTO NO. 32

Description: Typical leaning and disconnected guardrail

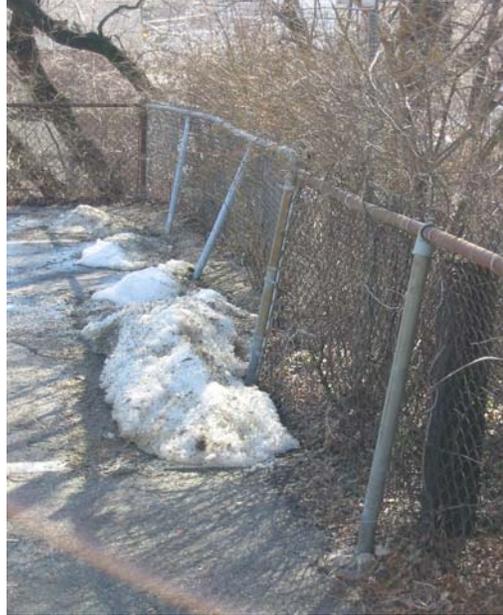
Description: Typical leaning and rusted fence

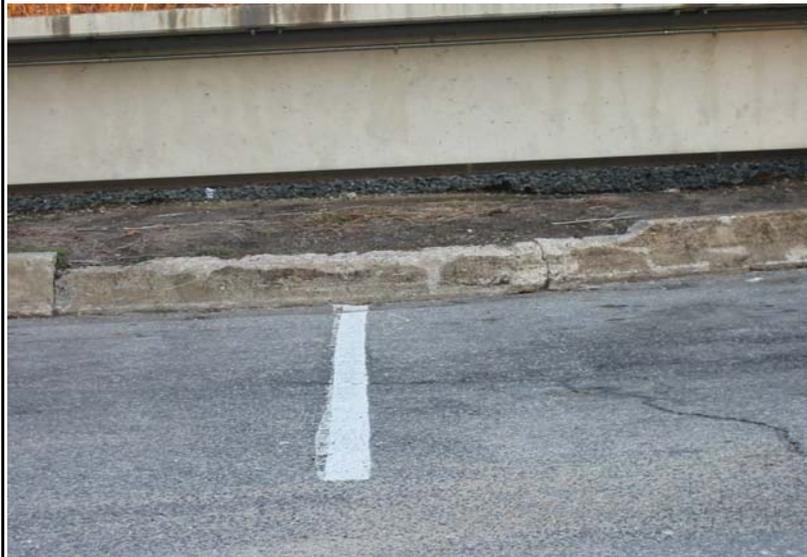
PHOTO NO. 34

2		34	Quad I	Sidewalk - The sidewalk is deteriorated in an isolated area.
3		36	Quad IV	Curb - There is an isolated area where the curb is missing.

Description: Spalled concrete curb and deteriorated asphalt sidewalk

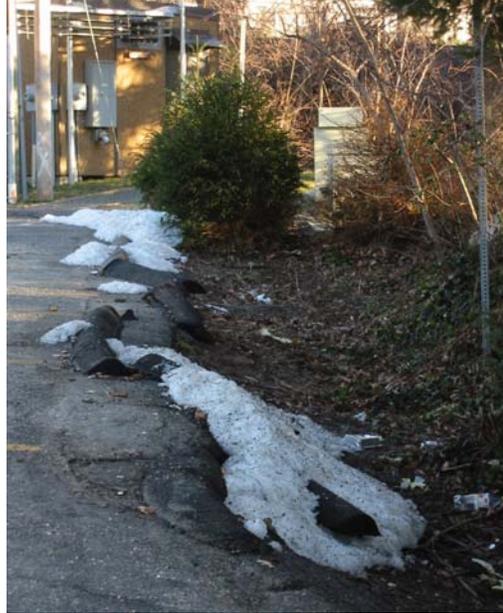
Description: _____
Displaced and missing
asphalt curb

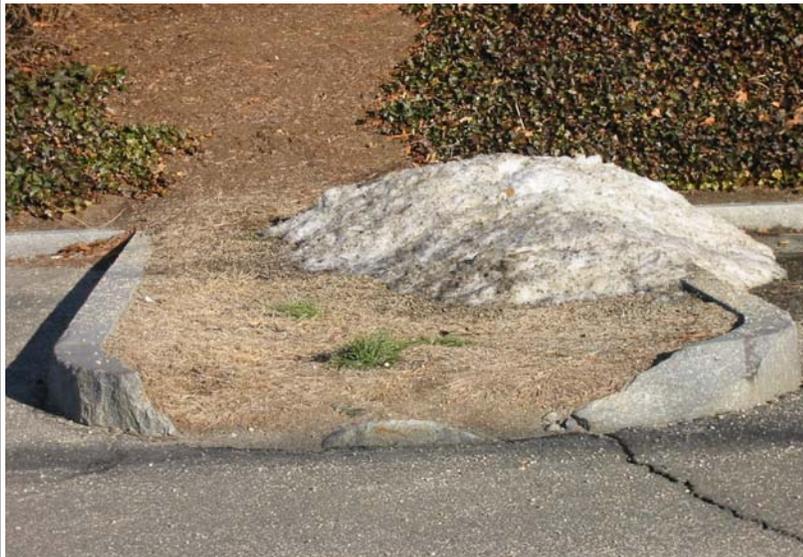
PHOTO NO. 36

Description: _____
Missing curb

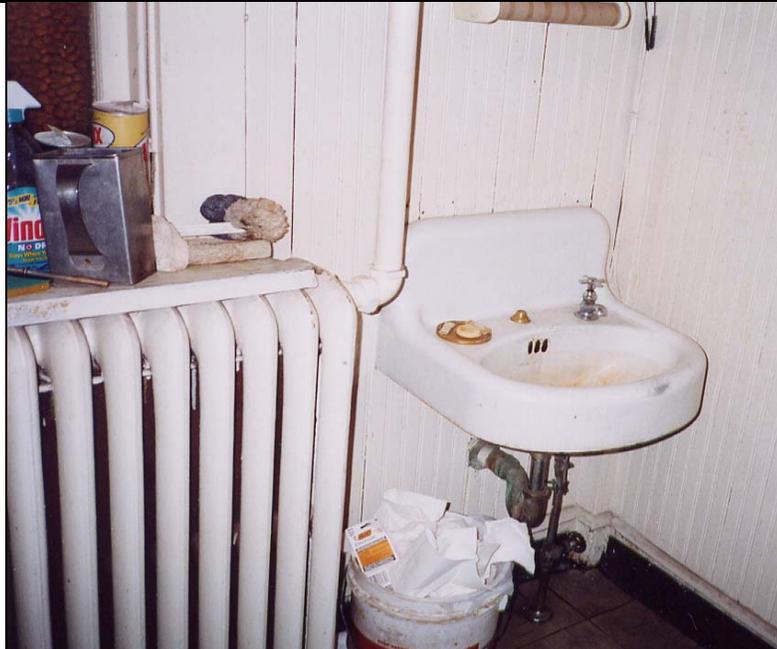
Plumbing fixtures are old and deteriorated. There are no water conservation or handicapped type fixtures. There is no hot water at the lavatories. There is no water heater installed. The entire system should be fitted with new fixtures in conformance with ADA, water conservation and hot water. The new boiler installed should contain a coil for producing domestic hot water or a water heater should be installed.

Description:
Men's room
small old
lavatory
no hot water

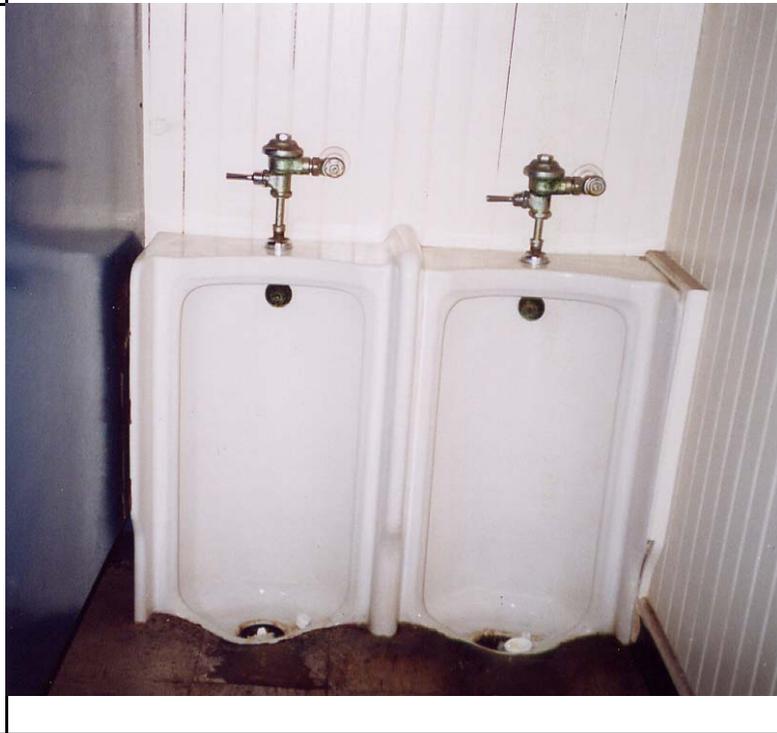
PHOTO NO. 46

Description:
Two old
urinals still
in working
conditions
