CONNECTICUT
DEPARTMENT
OF
TRANSPORTATION

CONDITION INSPECTION
FOR THE
SOUTHPORT STATION

**CONN. DEPT OF TRANSPORTATION
STATION INSPECTION**

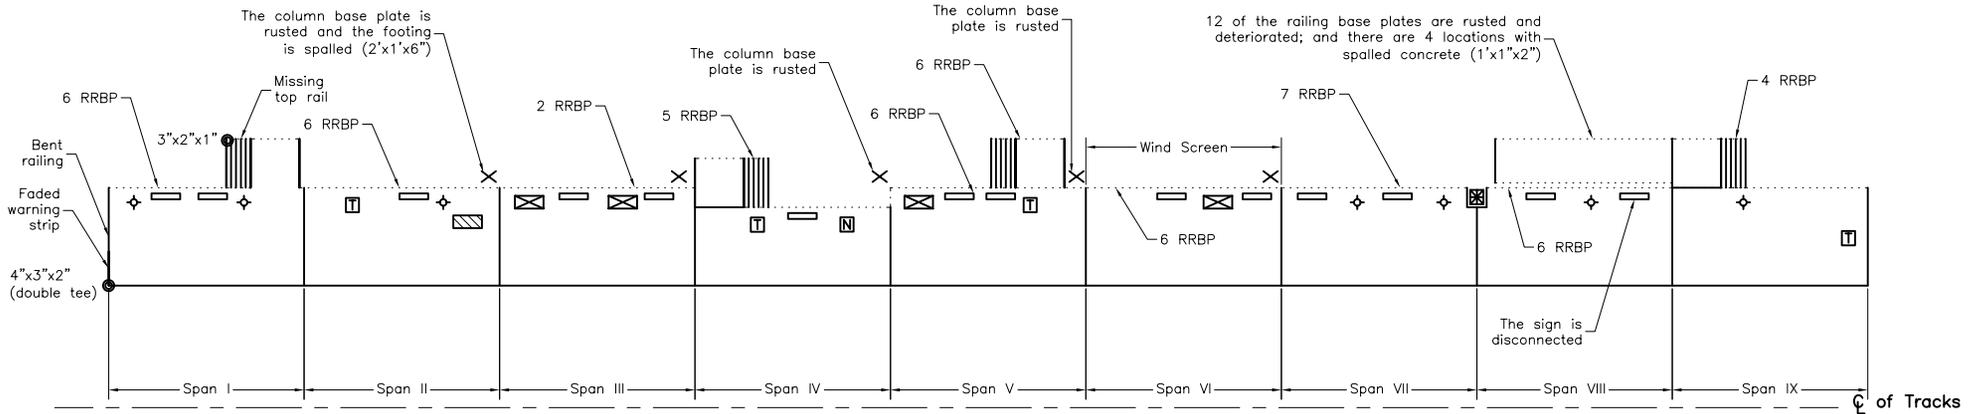
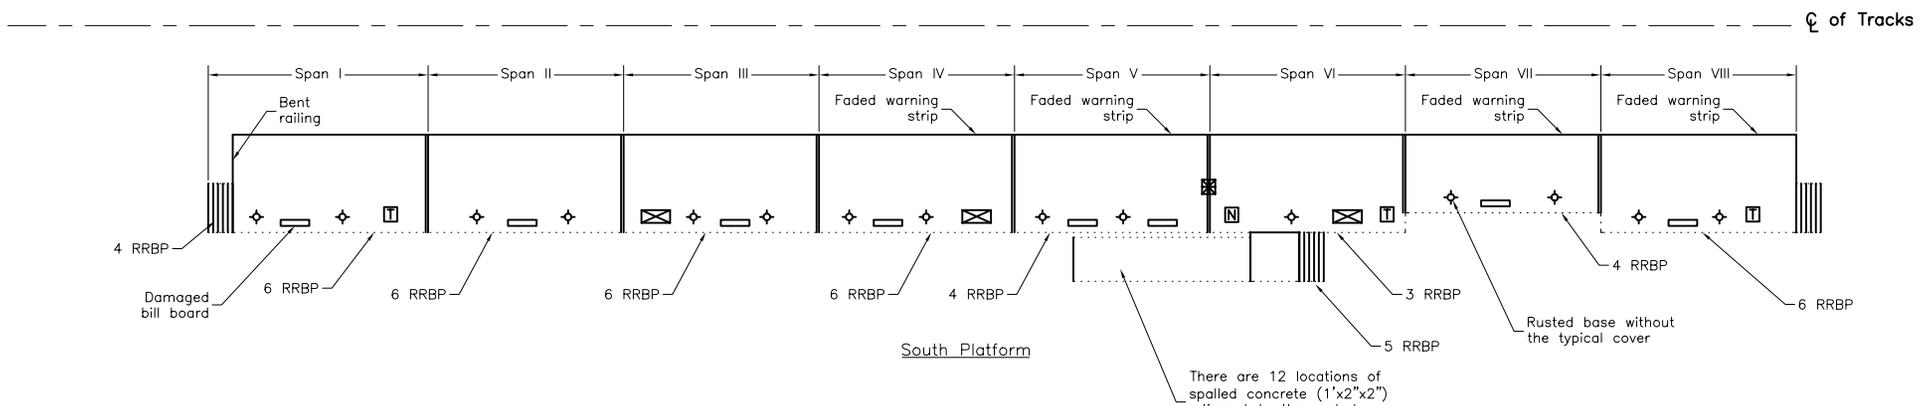
Urbitran Associates, Inc.
Connecticut Dept. of Transportation
Southport Station North and South Platform Plans
Date: 8/3/02

NOTES:
 1. All of the base plates adjacent to the footings and double tees are rusted and deteriorated.

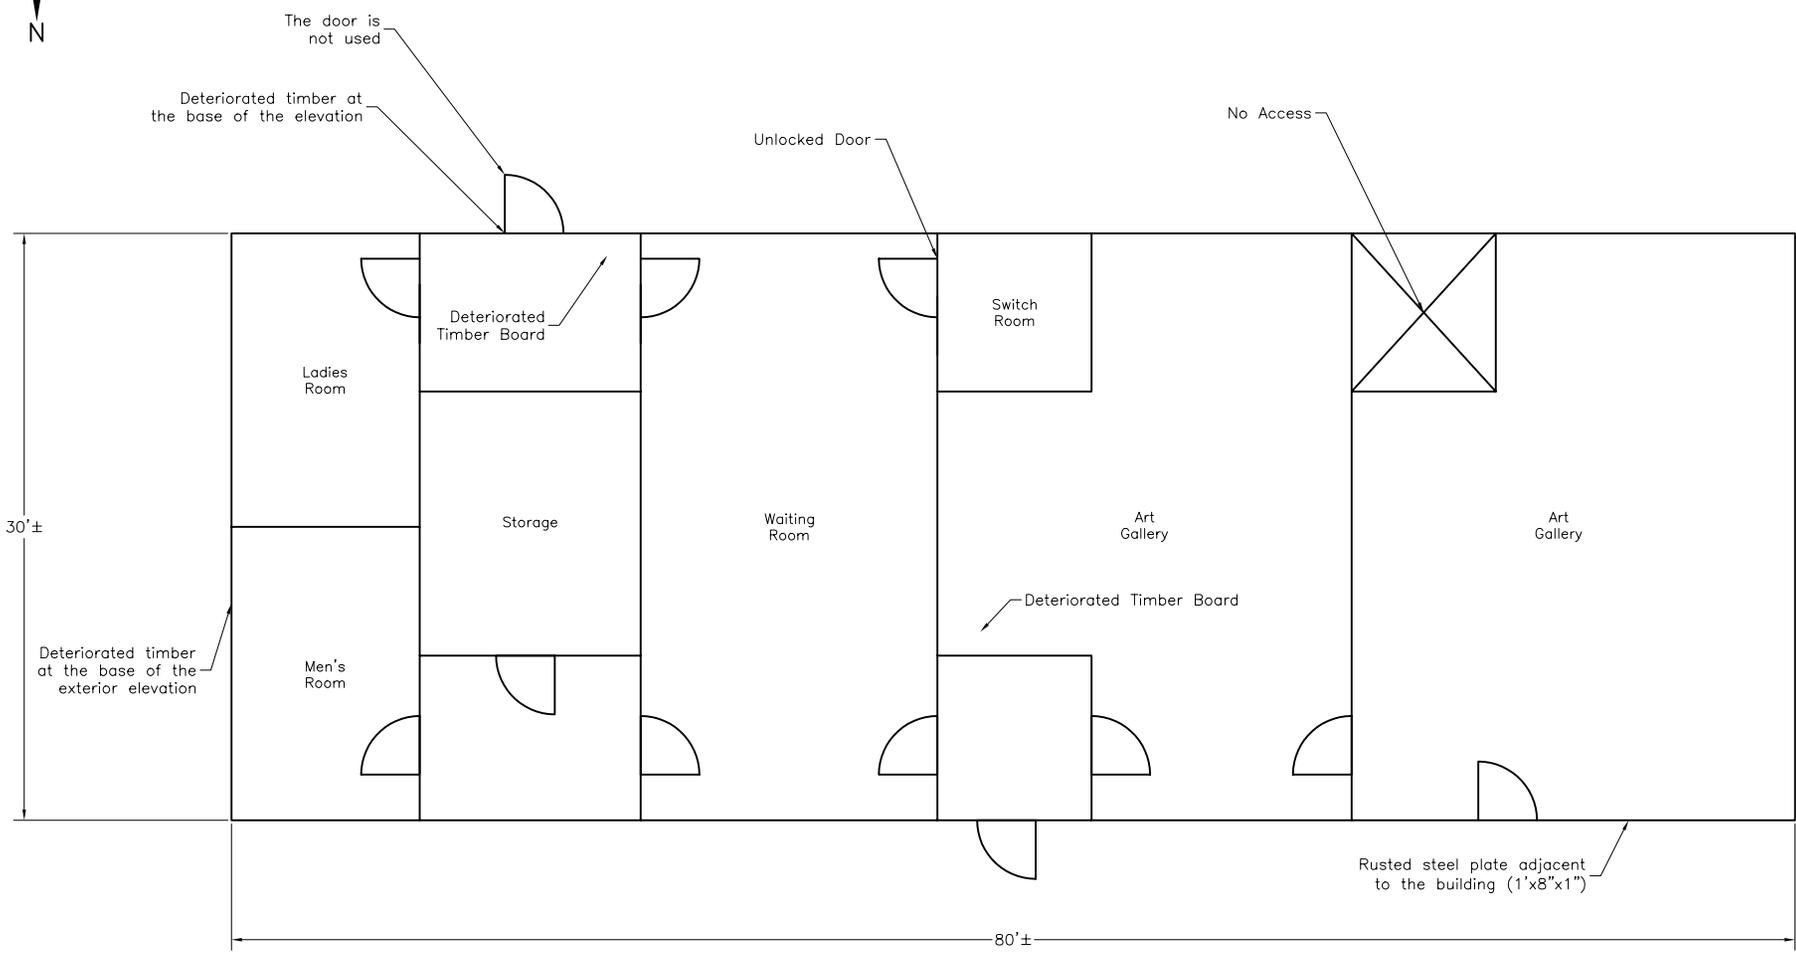
Urbitran Associates, Inc.
Connecticut Dept. of Transportation
Southport Station North Station House
Date: 12-06-01

- 1. The ceiling paint above the waiting room contains minor map cracking
- 2. The protective coating floor finish is worn down through out the station house.

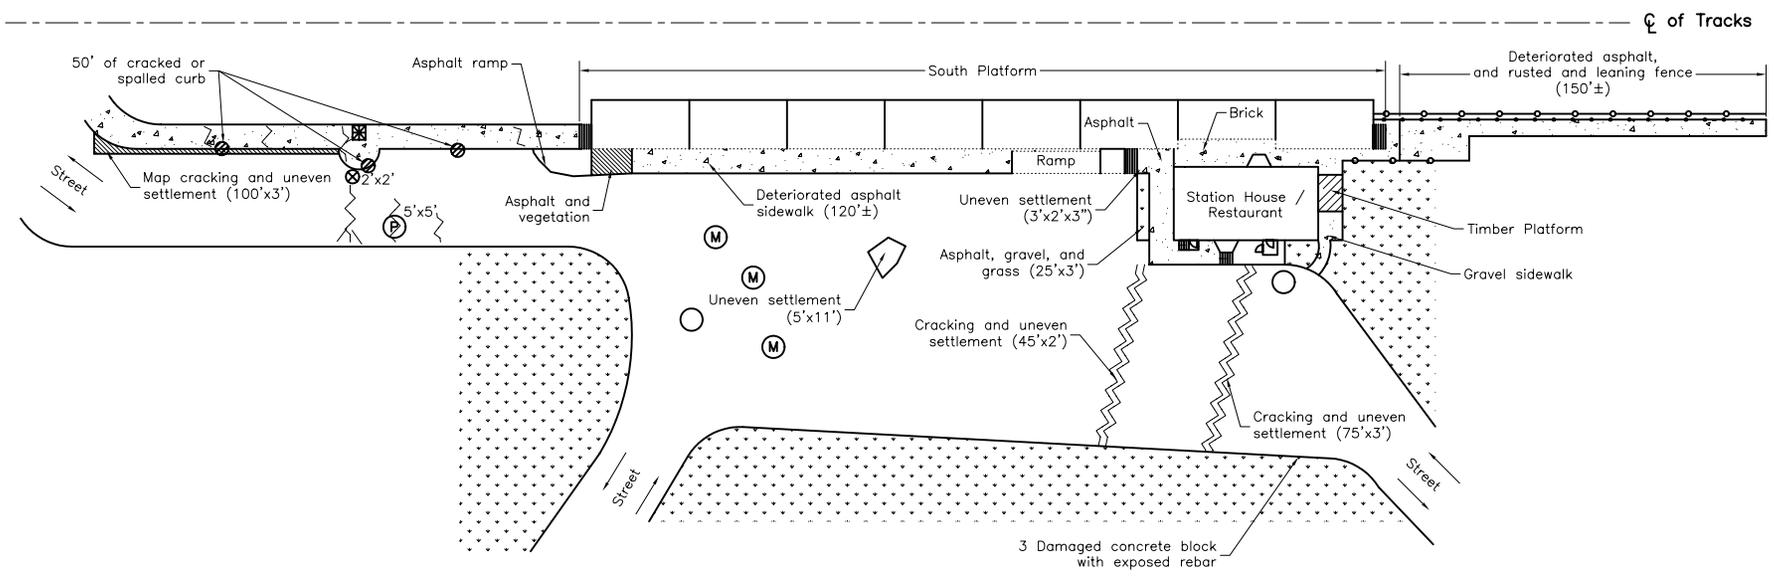
NOTES:
 1. 10% of the asphalt pavement contains additional cracks that are not shown on the drawing for clarity.

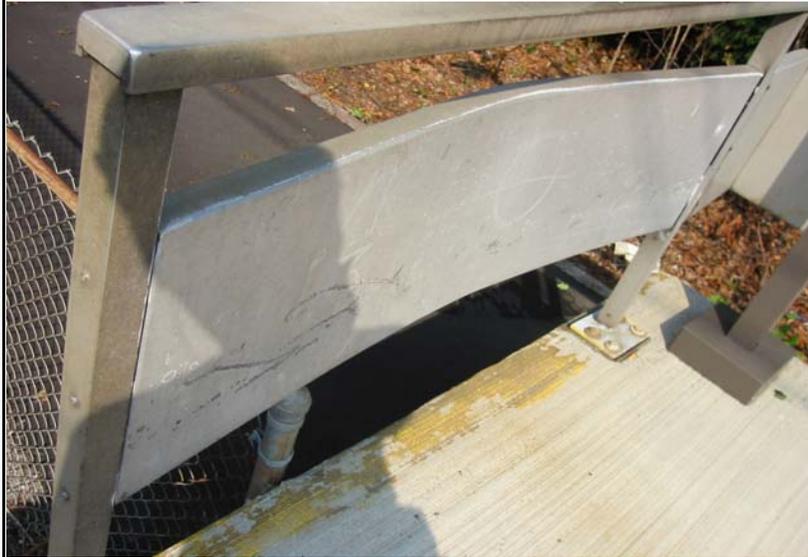
Description: Bent railing and faded warning strip

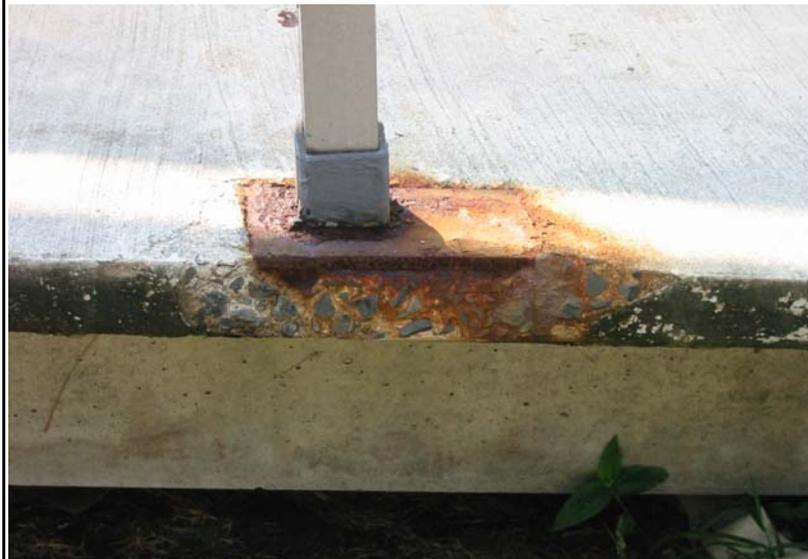
PHOTO NO. 10

Description: Typical spalled concrete (1'x1"x2") adjacent to the rusted railing base plate

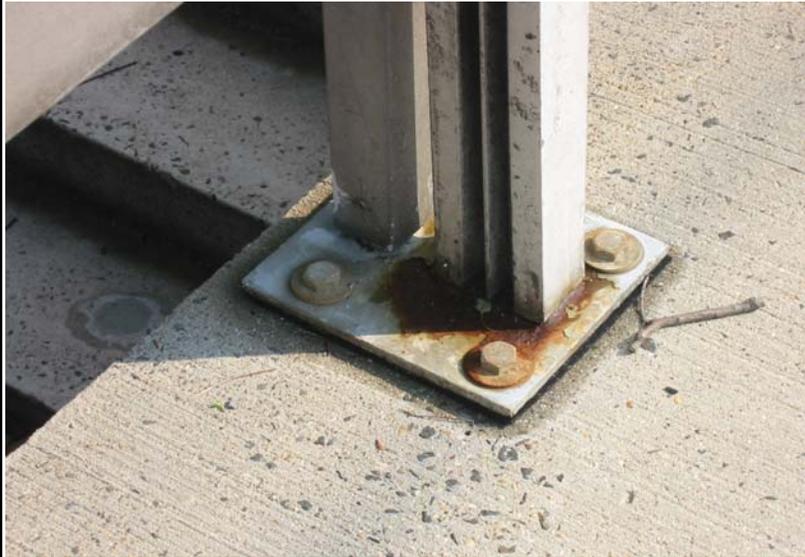
Description: _____
Typical rusted railing
base plate

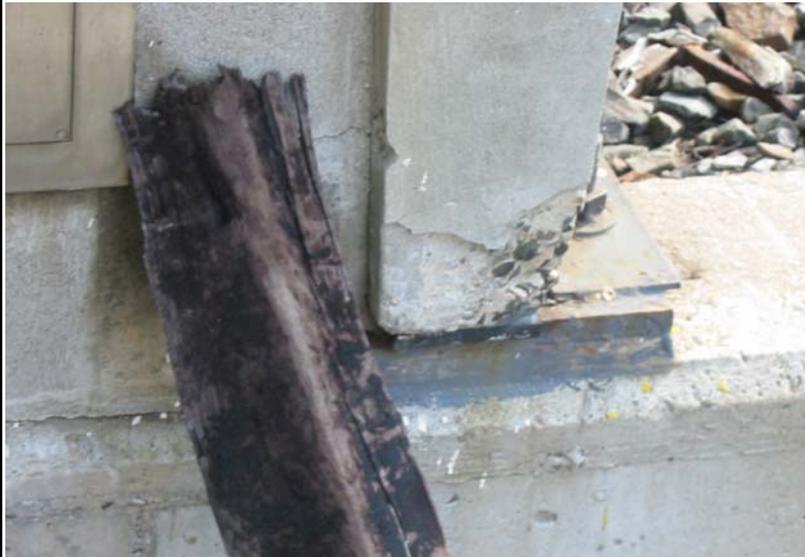
PHOTO NO. 12

Description: _____
Spalled concrete
(3"x2"x1") at the base
of the double tee web

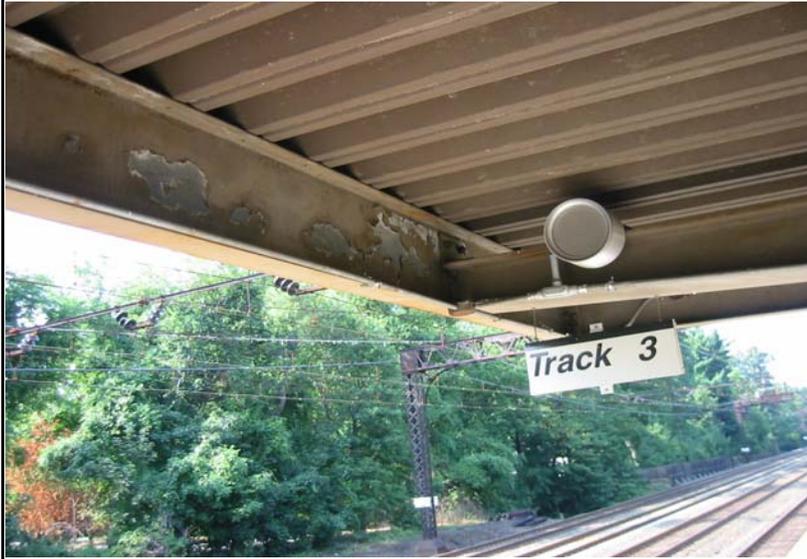
Description: Typical peeling and rusted paint

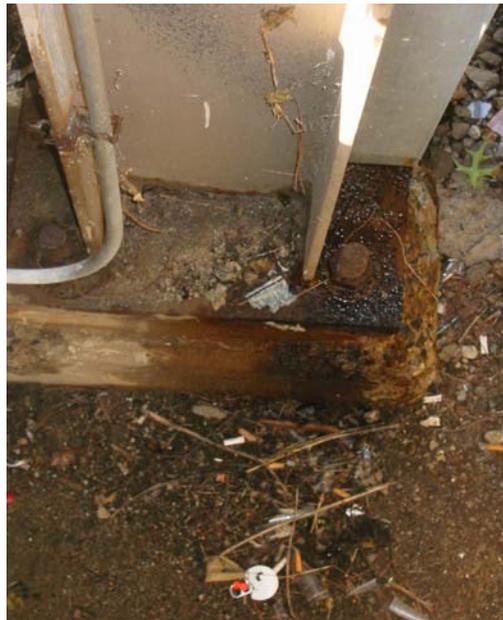
PHOTO NO. 14

Description: Rusted column base plate and spalled concrete footing (2'x1'x6")

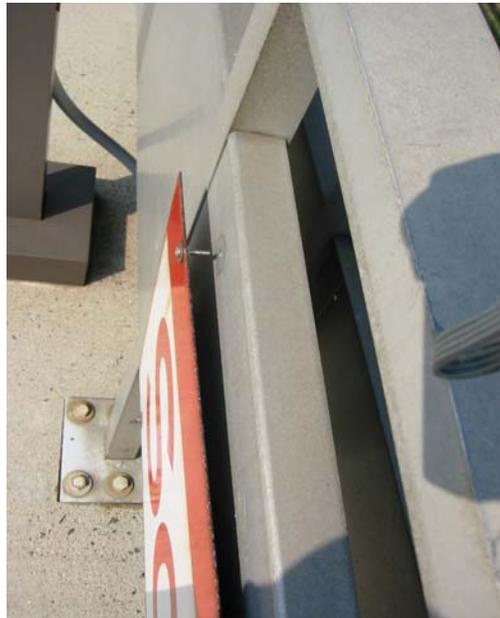
Description: Disconnected sign

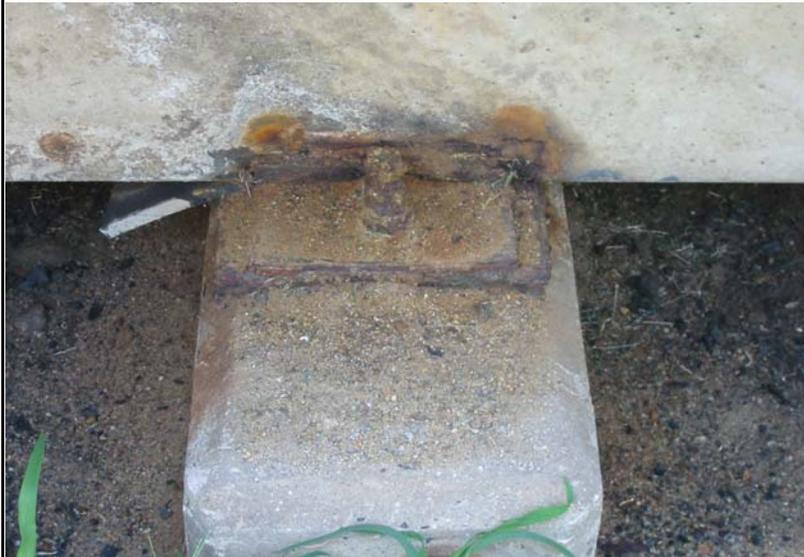
PHOTO NO. 16

Description: Typical rusted base plate adjacent to the footing and double tee

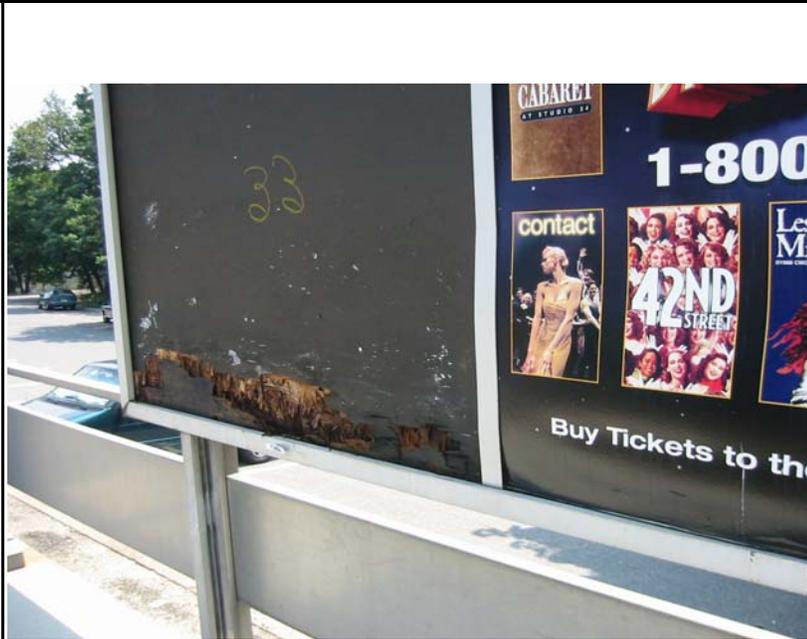
Description: _____
Damaged sign billboard

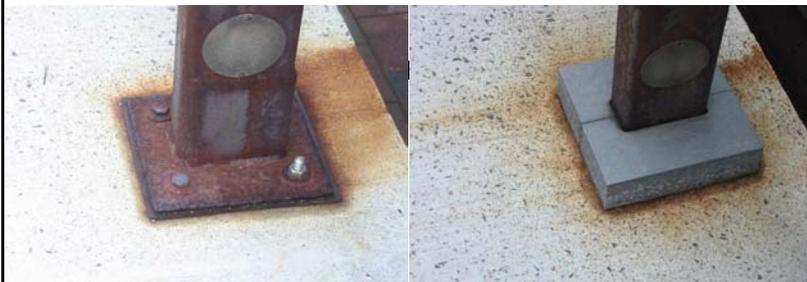
PHOTO NO. 18

Description: _____
Rusted light pole base
plate without the typical
cover (on the left);
Typical base of the light
poles (on the right)

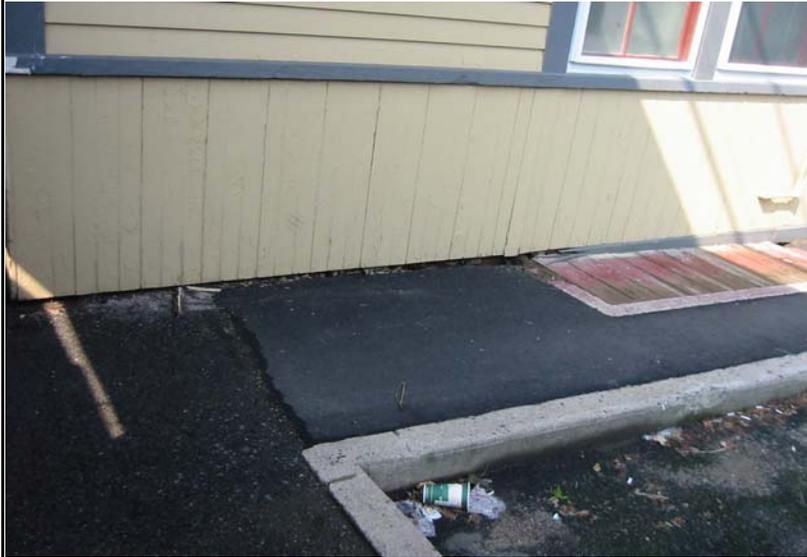
Description: _____
Missing trim at the base
of the east elevation

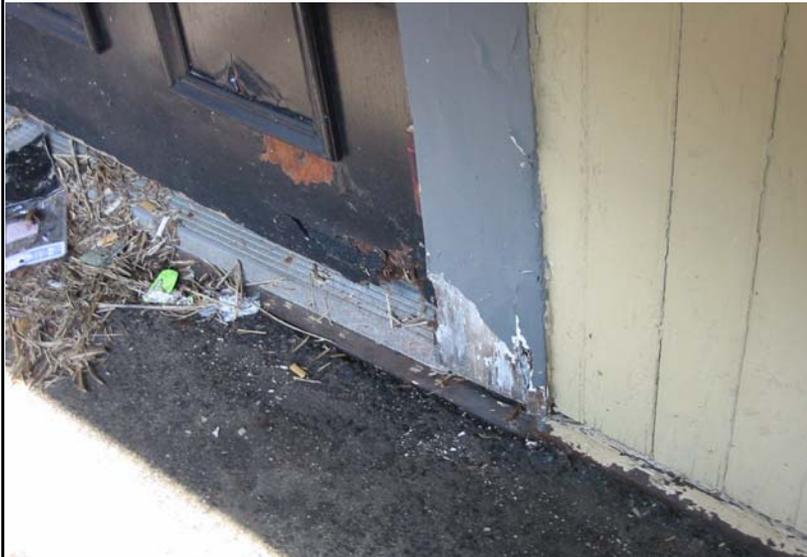
PHOTO NO. 20

Description: _____
Deteriorated timber and
missing trim at the base

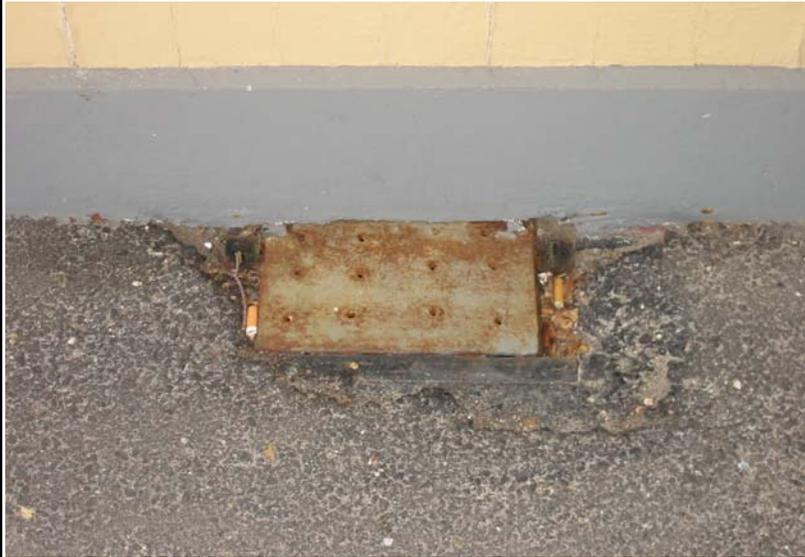
Description: _____
The asphalt adjacent to
the building is starting
to settle and there is
exposed rusted steel

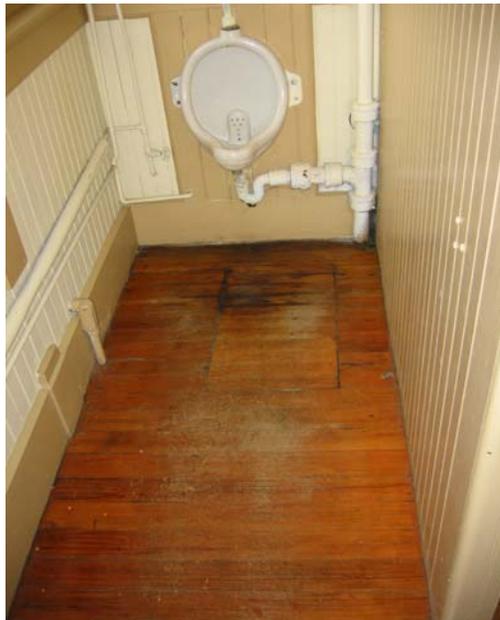
PHOTO NO. 22

Description: _____
Typical protective
coating floor finish
is worn down

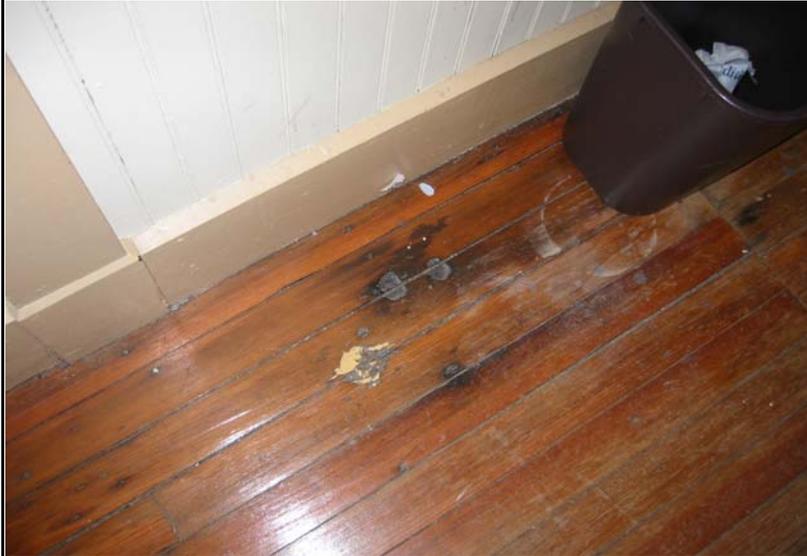
Description: Isolated area where the timber floor board is deteriorated

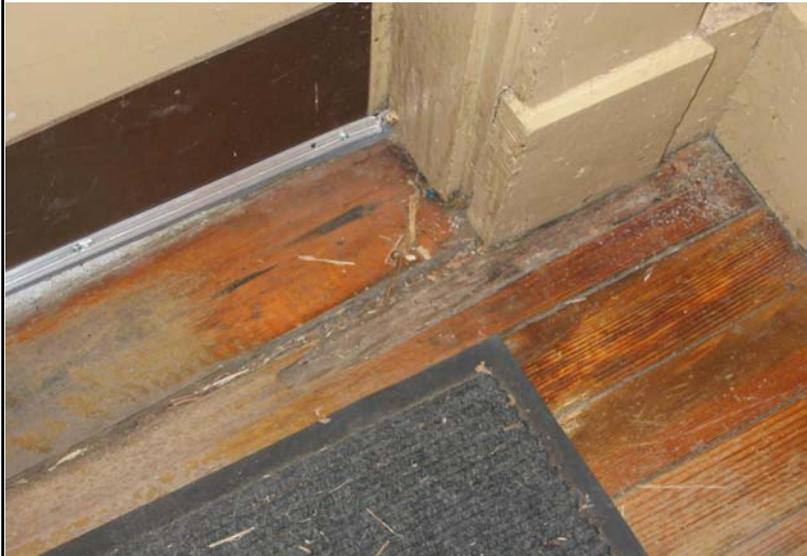
PHOTO NO. 24

Description: Deteriorated timber floor board adjacent to the south exit

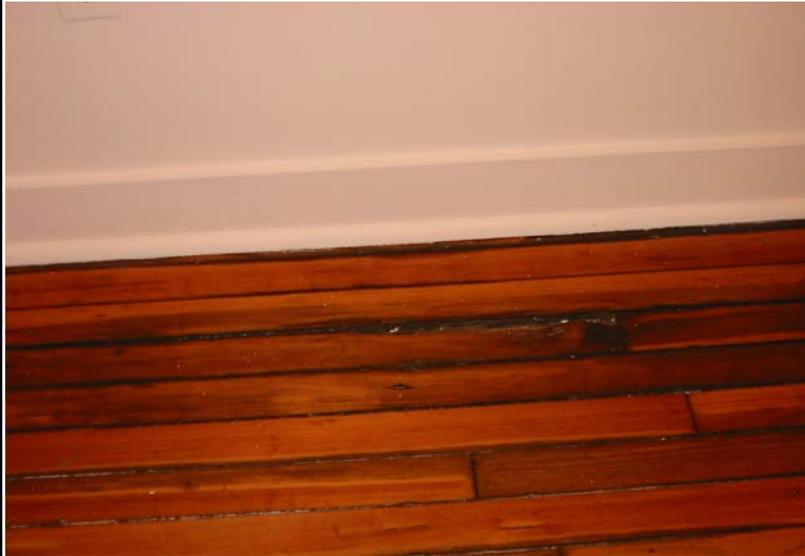
Description: _____
Isolated area of
deteriorated timber floor
board

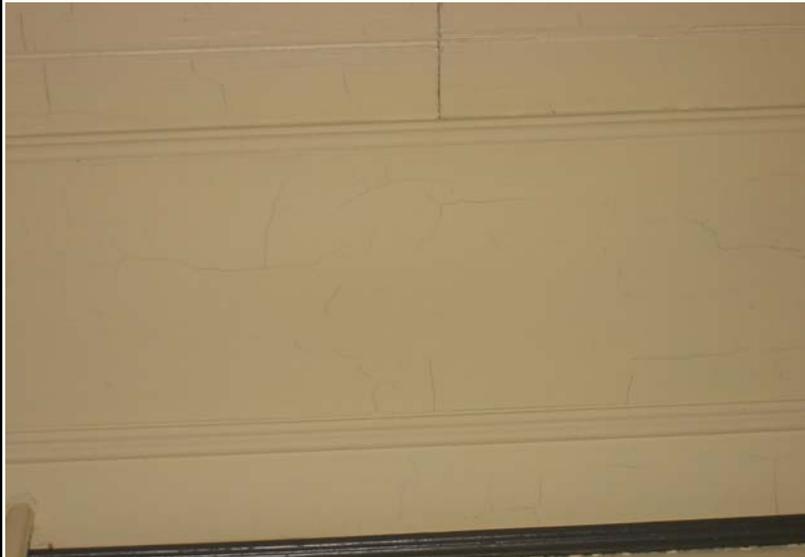
PHOTO NO. 26

Description: _____
Typical map cracking
around the border of the
ceiling in the waiting
area

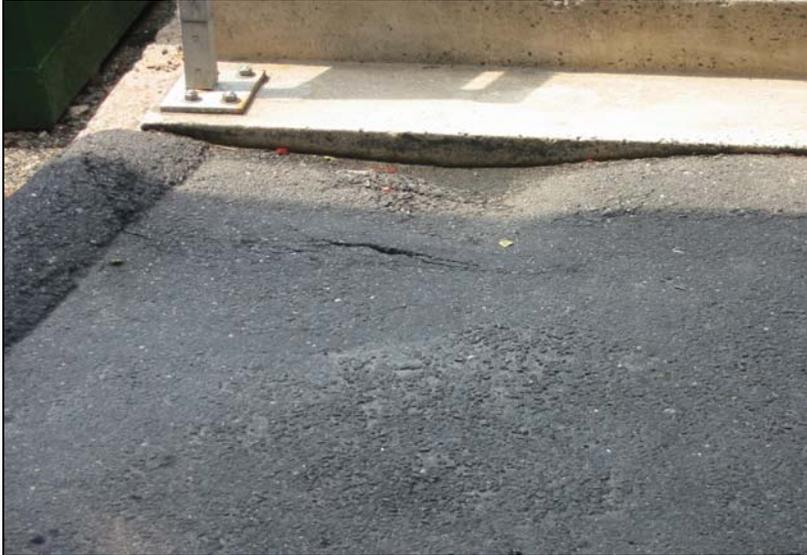
Description: _____
Differential settlement
of the asphalt adjacent
to the stairs (3'x2'x3")

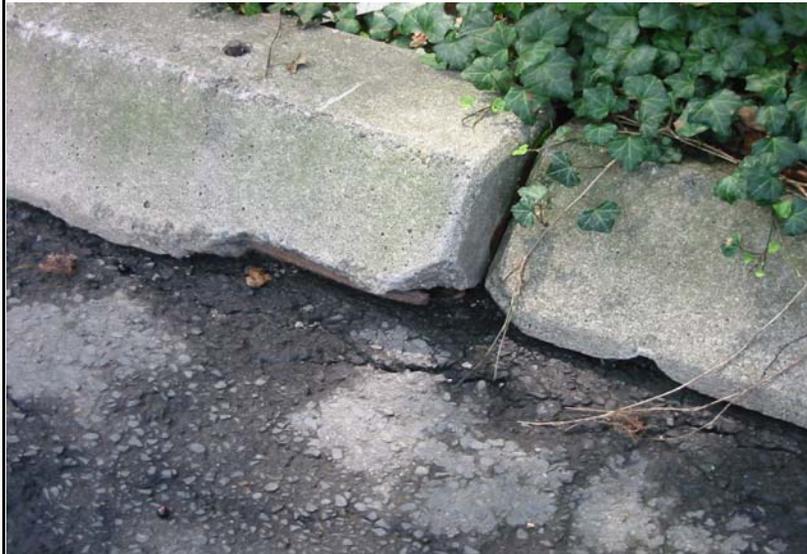
PHOTO NO. 28

Description: _____
Typical concrete
parking block with
exposed rebar

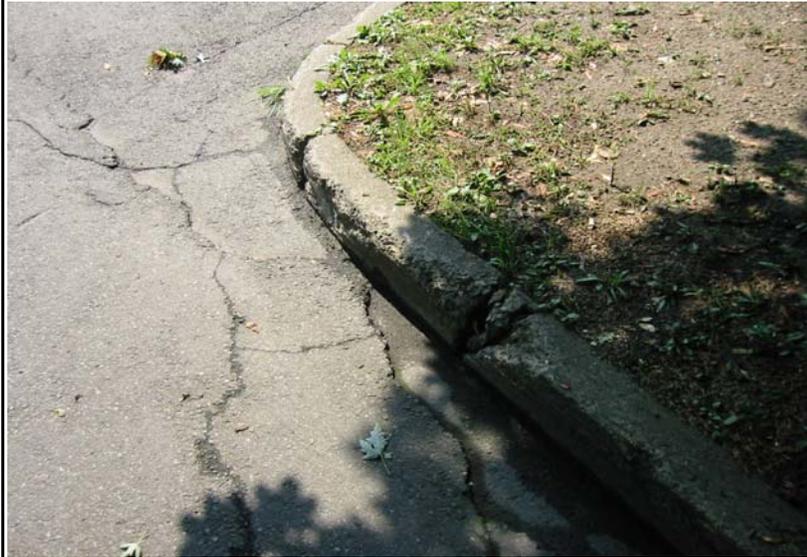
Description: _____
Spalled concrete curb
and cracked asphalt
with uneven alignment
(1")

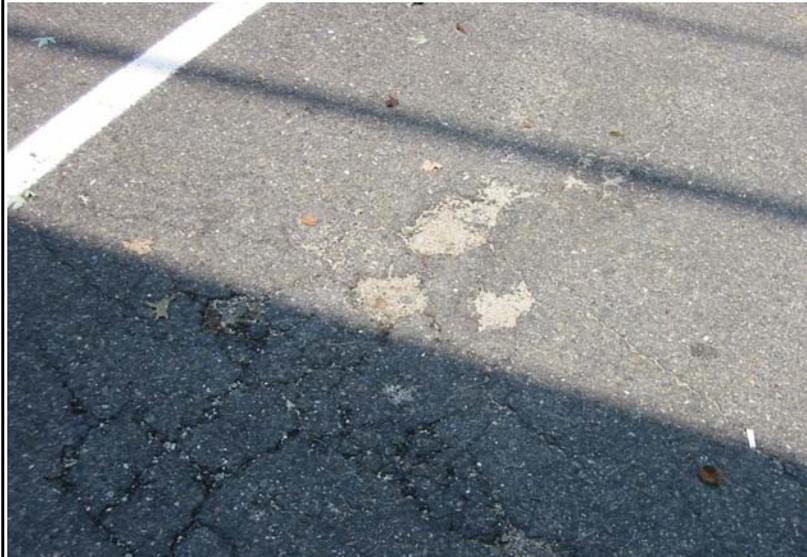
PHOTO NO. 30

Description: _____
Potholes and map
cracking (2'x2')

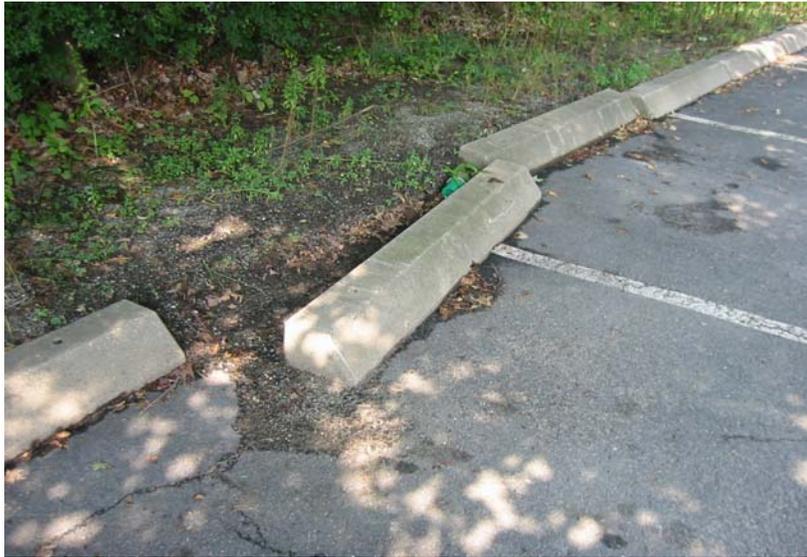
Description: _____
Displaced concrete
parking block

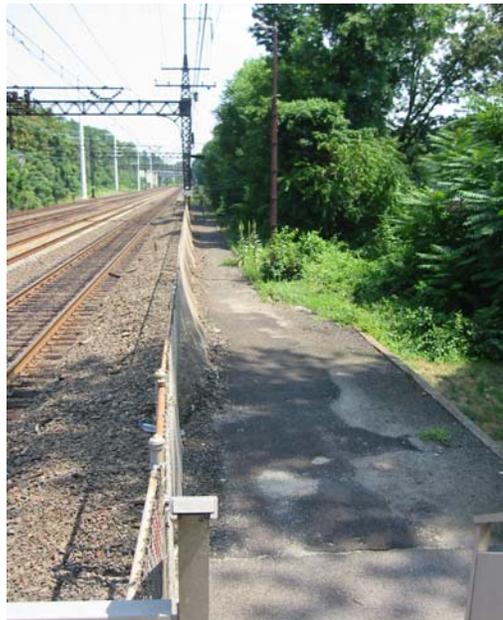
PHOTO NO. 32

Description: _____
Deteriorated asphalt
sidewalk, and rusted
and leaning fence in
Quad II

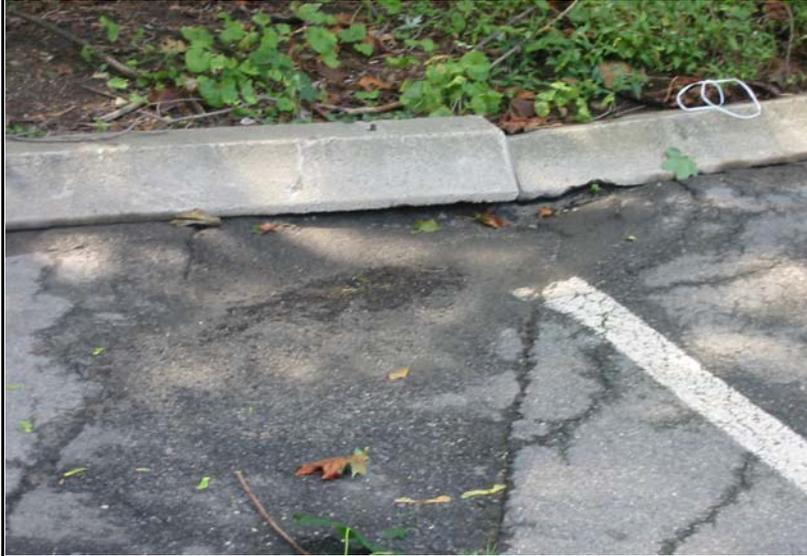
Description: _____
Cracked and uneven
asphalt pavement

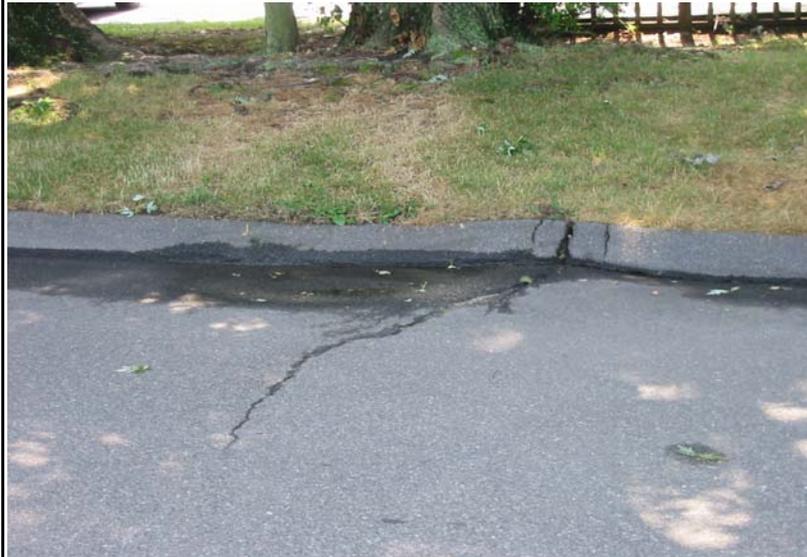
PHOTO NO. 34

Description: _____
Cracked and uneven
asphalt pavement and
curb; Note ponding of
water

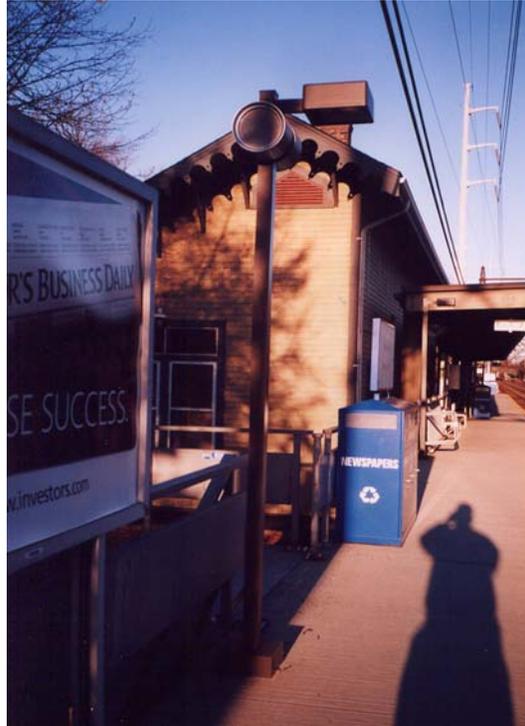
The platform lighting was not fully operational at the time of inspection and measured below recommended levels. We were unable to find the cause of the luminaires not working and recommend that the circuits be investigated beyond the parameters of this scope. However, we estimate that if the platform luminaires were operational, they would at least exceed the minimum recommended practice of IESNA.

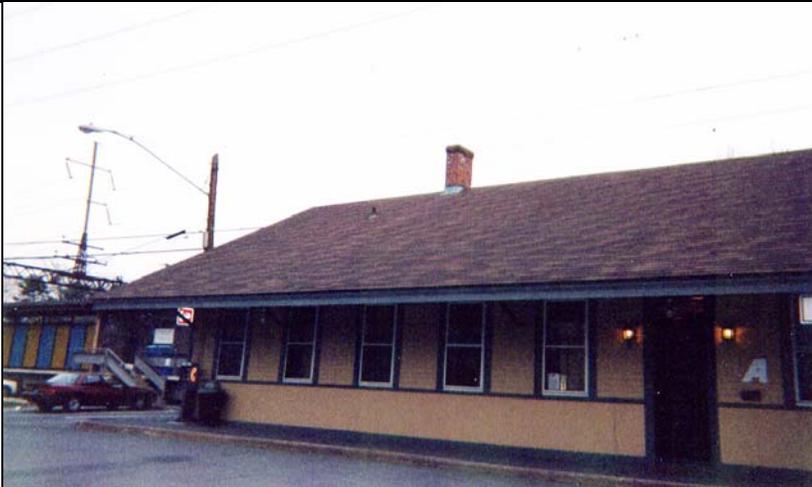
On the platform side of the building the gutters are in good condition, but there are no gutters or downspouts on the front of the building

Description:
View of building
gutters, downspouts
missing on front
of building
