Individual Station Report

Redding

Station Condition Inspection

CONDITION INSPECTION WEST REDDING STATION

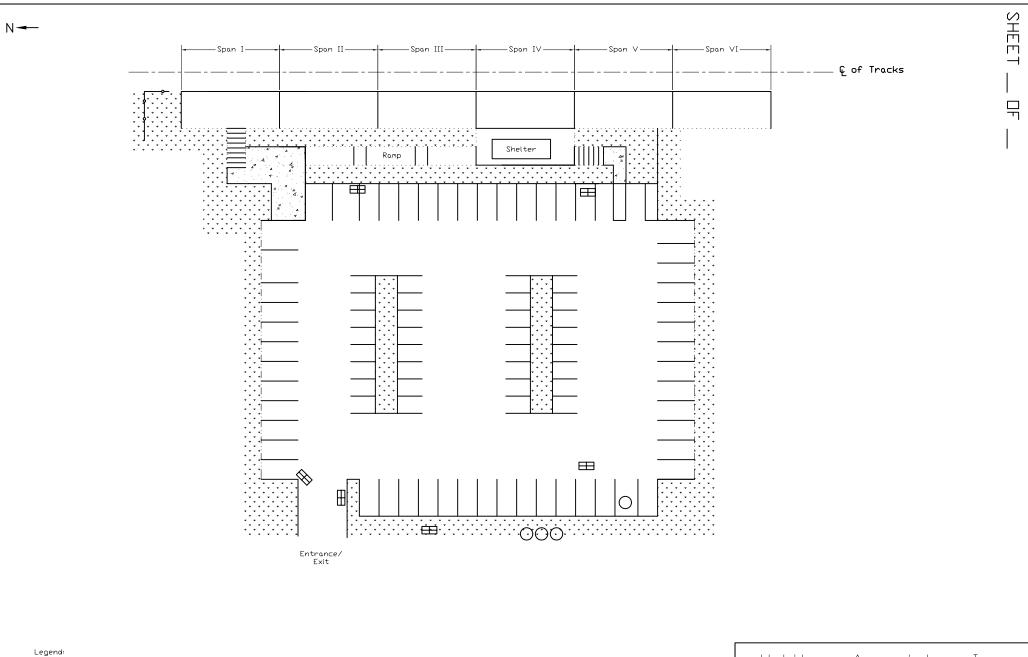
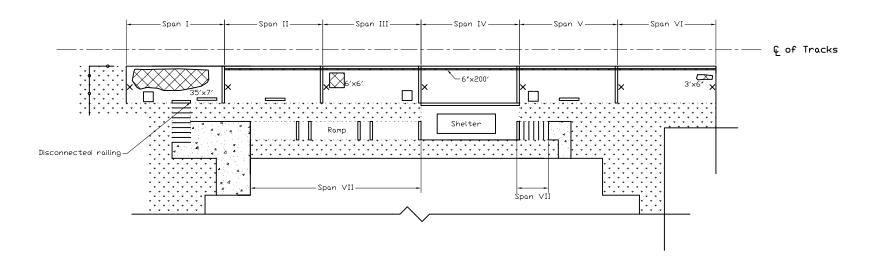
Platform Plan

- 1'x3" area that contains cracked and borken concrete at the bottom of the North end of the double-tee.
- 2. $2' \times 6' \times 6''$ section that contains cracked and broken concrete at the bottom of the South end of the double-tee.

A Hairline crack around the perimeter of the South end footing (The perimeter = 90')

He concrete under the 30'x10' shelter exhibits a rough surface with minor holes.

The type and extent of deterioration will not affect the station operations or commuters. Therefore, we recommend that the defects noted in this report be included in a future station maintenance rehabilitation contract.
