CONNECTICUT
DEPARTMENT
OF
TRANSPORTATION

CONDITION INSPECTION
FOR THE
TALMADGE HILL STATION

**CONN. DEPT OF TRANSPORTATION
STATION INSPECTION**

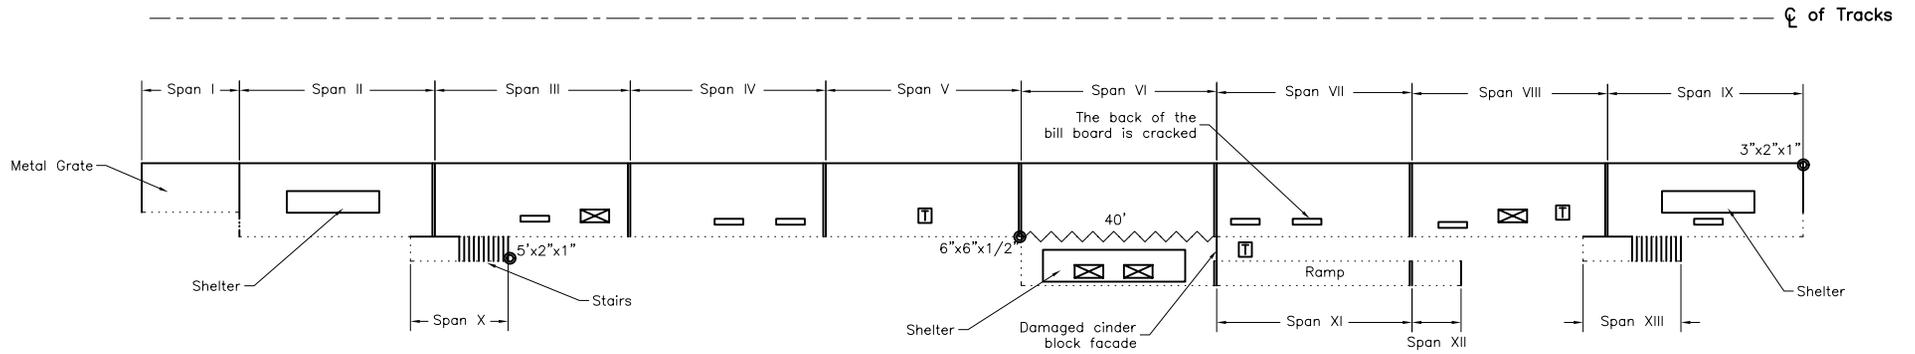
Urbitran Associates, Inc.
Connecticut Dept. of Transportation
Talamadge Hill Station Platform Plan
Date: 12-18-01

1. The bridge viaduct north of the platform exhibits major spalled concrete throughout its entire length.
2. The railing base plate is rusted and deteriorated throughout the platform.
3. The base plates for the double tee is rusted and deteriorated.

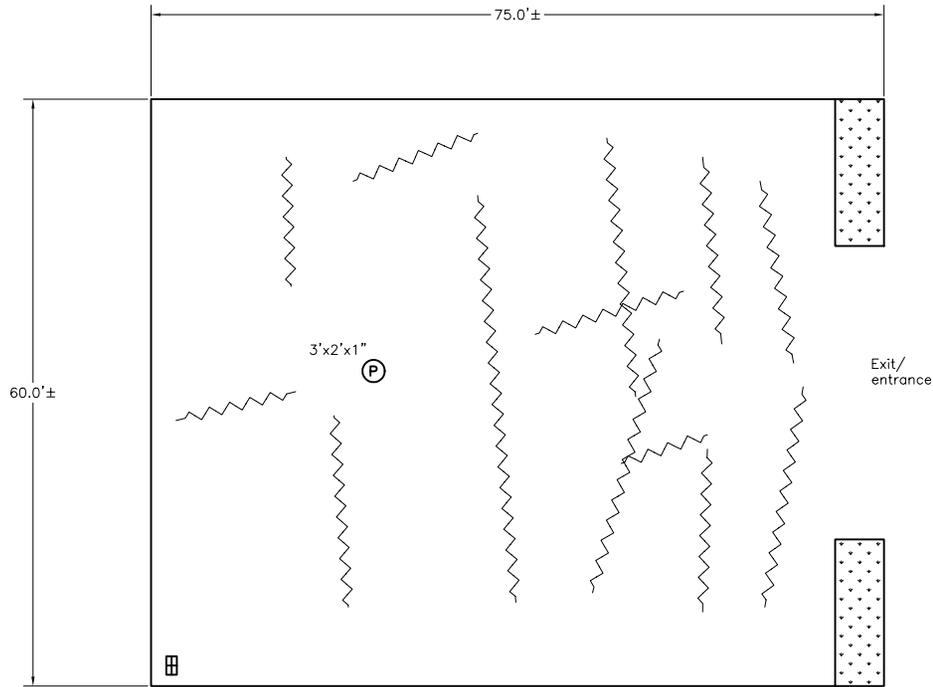
Urbitran Associates, Inc.
Connecticut Dept. of Transportation
Talmadge Hill Station Quadrant I Details
Date: 12-18-01

1. 40% of the asphalt pavement is cracked.
2. 5% of the asphalt pavement is uneven.
3. 60' of the asphalt curb is either missing, spalled, or cracked.

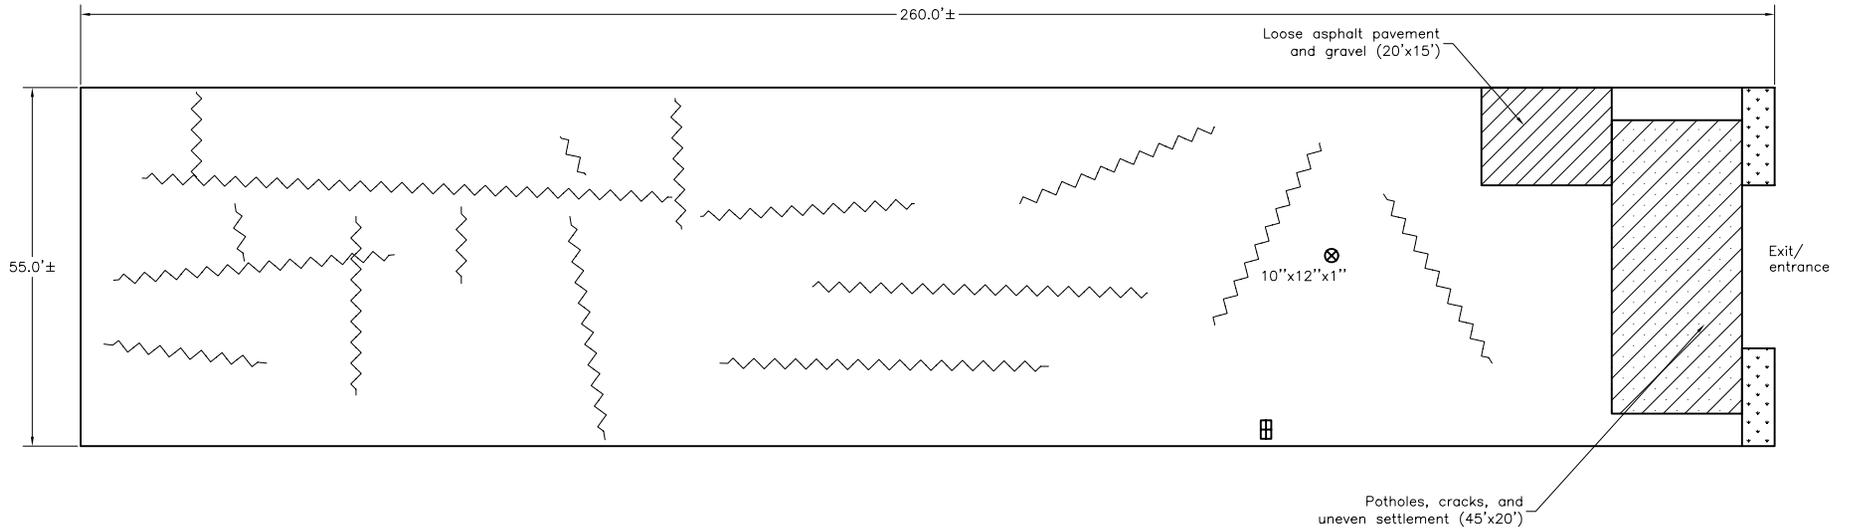
Urbitran Associates, Inc.
Connecticut Dept. of Transportation
Talmadge Hill Station Quadrant II Details
Date: 12-18-01

1. 35% of the asphalt pavement is cracked.
2. 40% of the asphalt pavement is uneven.
3. 120' of the asphalt curb is either missing, spalled, or cracked.

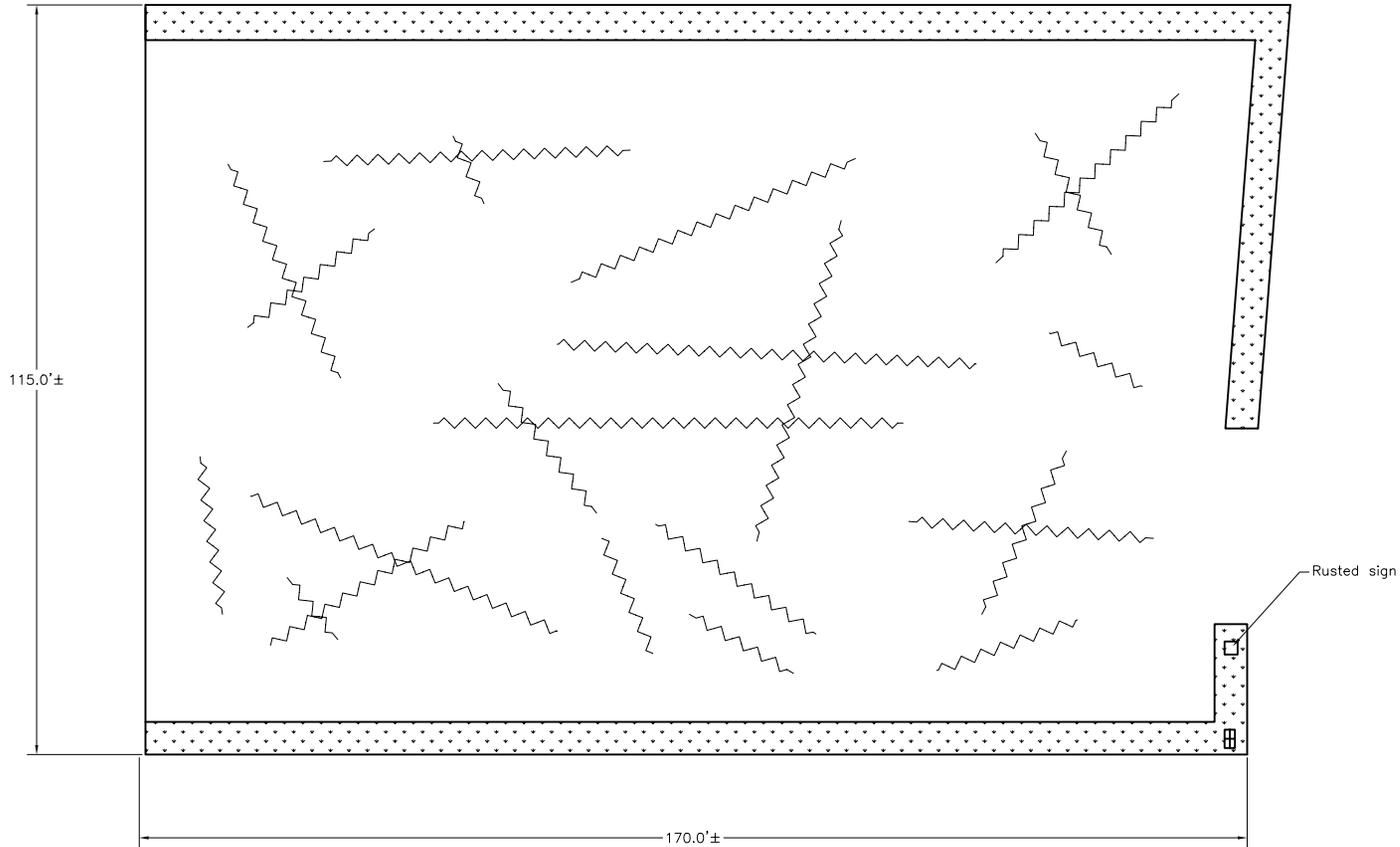
Urbitran Associates, Inc.
Connecticut Dept. of Transportation
Talmadge Hill Station Quadrant III Details
Date: 12-18-01

1. 25% of the asphalt pavement is cracked.
2. There is no curb present.
3. 12 of the concrete parking blocks are either missing, spalled, or displaced

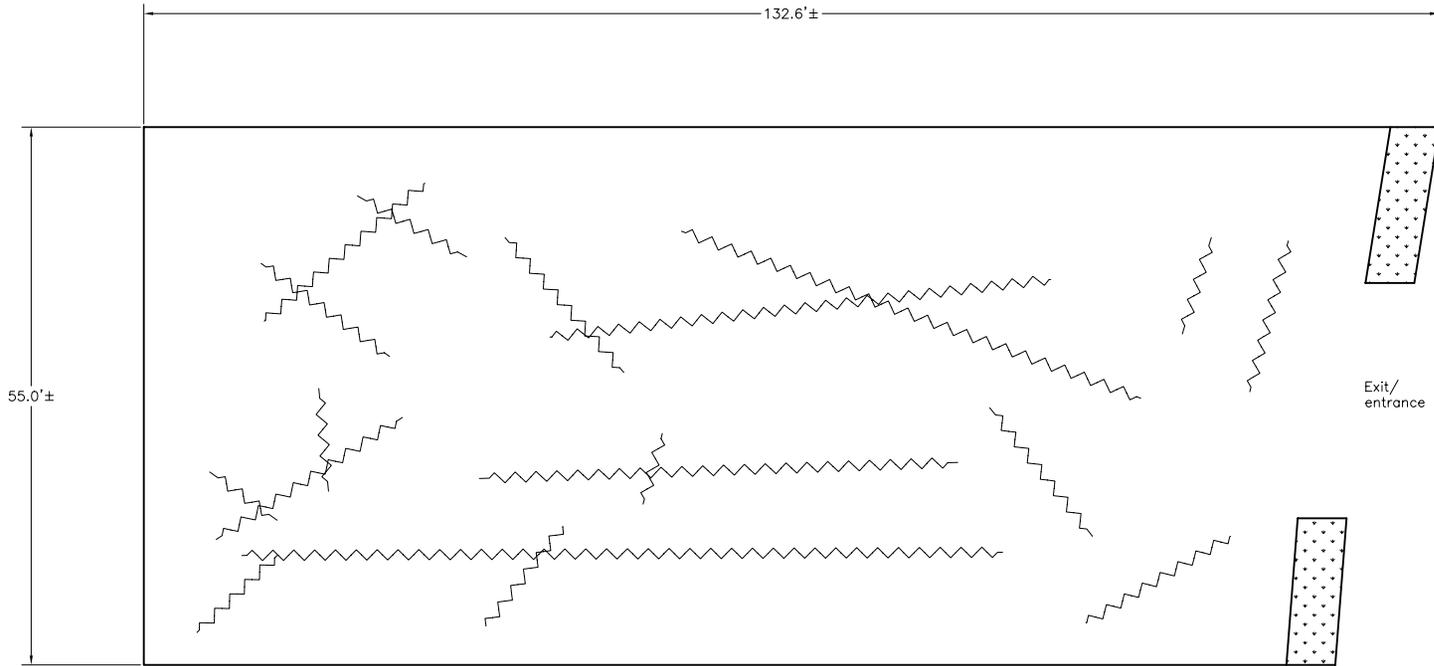
Urbitran Associates, Inc.
Connecticut Dept. of Transportation
Talmadge Hill Station Quadrant IV Details
Date: 12-18-01

1. 30% of the asphalt pavement is cracked.
2. 10% of the asphalt pavement is uneven.
3. 180' of the curbing is missing, spalled, or cracked.
4. 12 of the parking meters are missing, rusted, and bent.

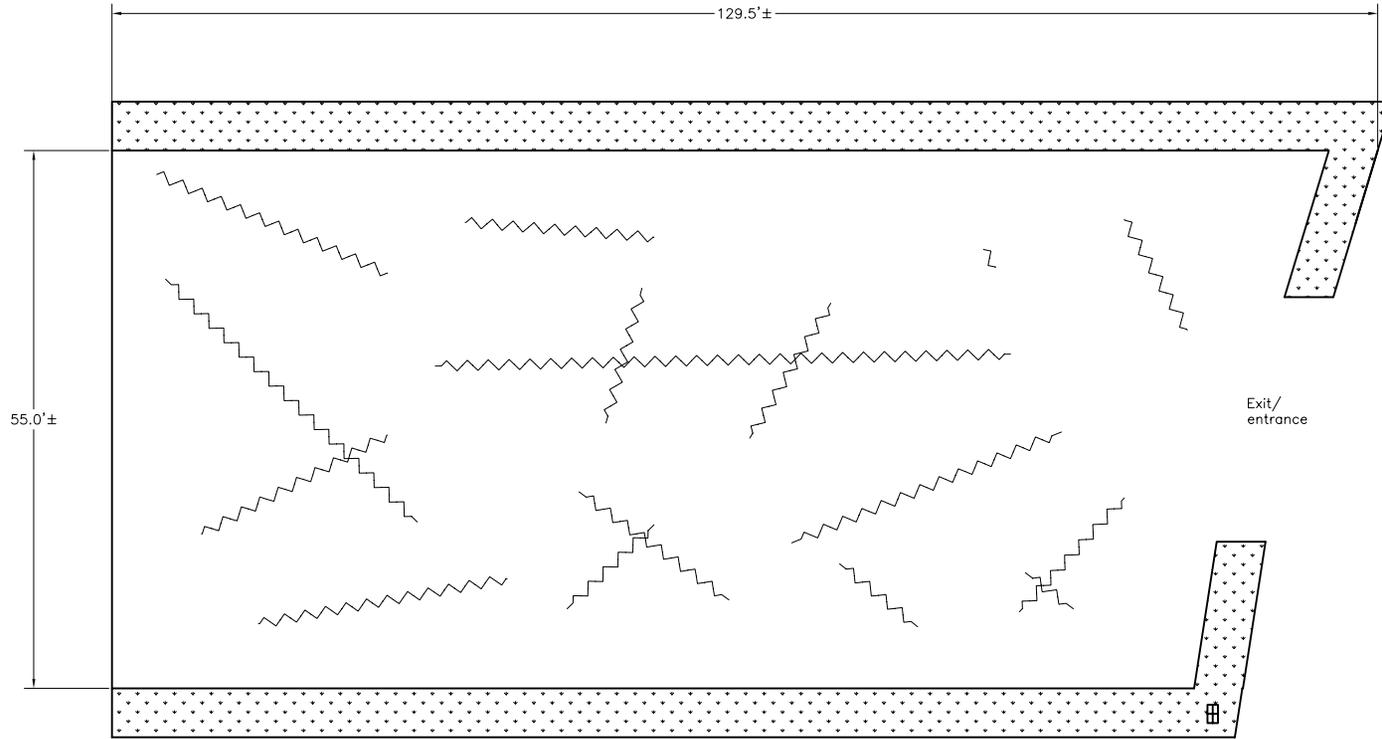
Urbitran Associates, Inc.
Connecticut Dept. of Transportation
Talmadge Hill Station Quadrant V Details
Date: 12-18-01

1. 30% of the asphalt pavement is cracked.
2. 10% of the asphalt pavement is uneven.
3. 70' of the curbing is missing, spalled, or cracked.
4. 15 of the parking meters are missing, rusted, and bent.
5. 2 of the parking meters' concrete footings are exposed.

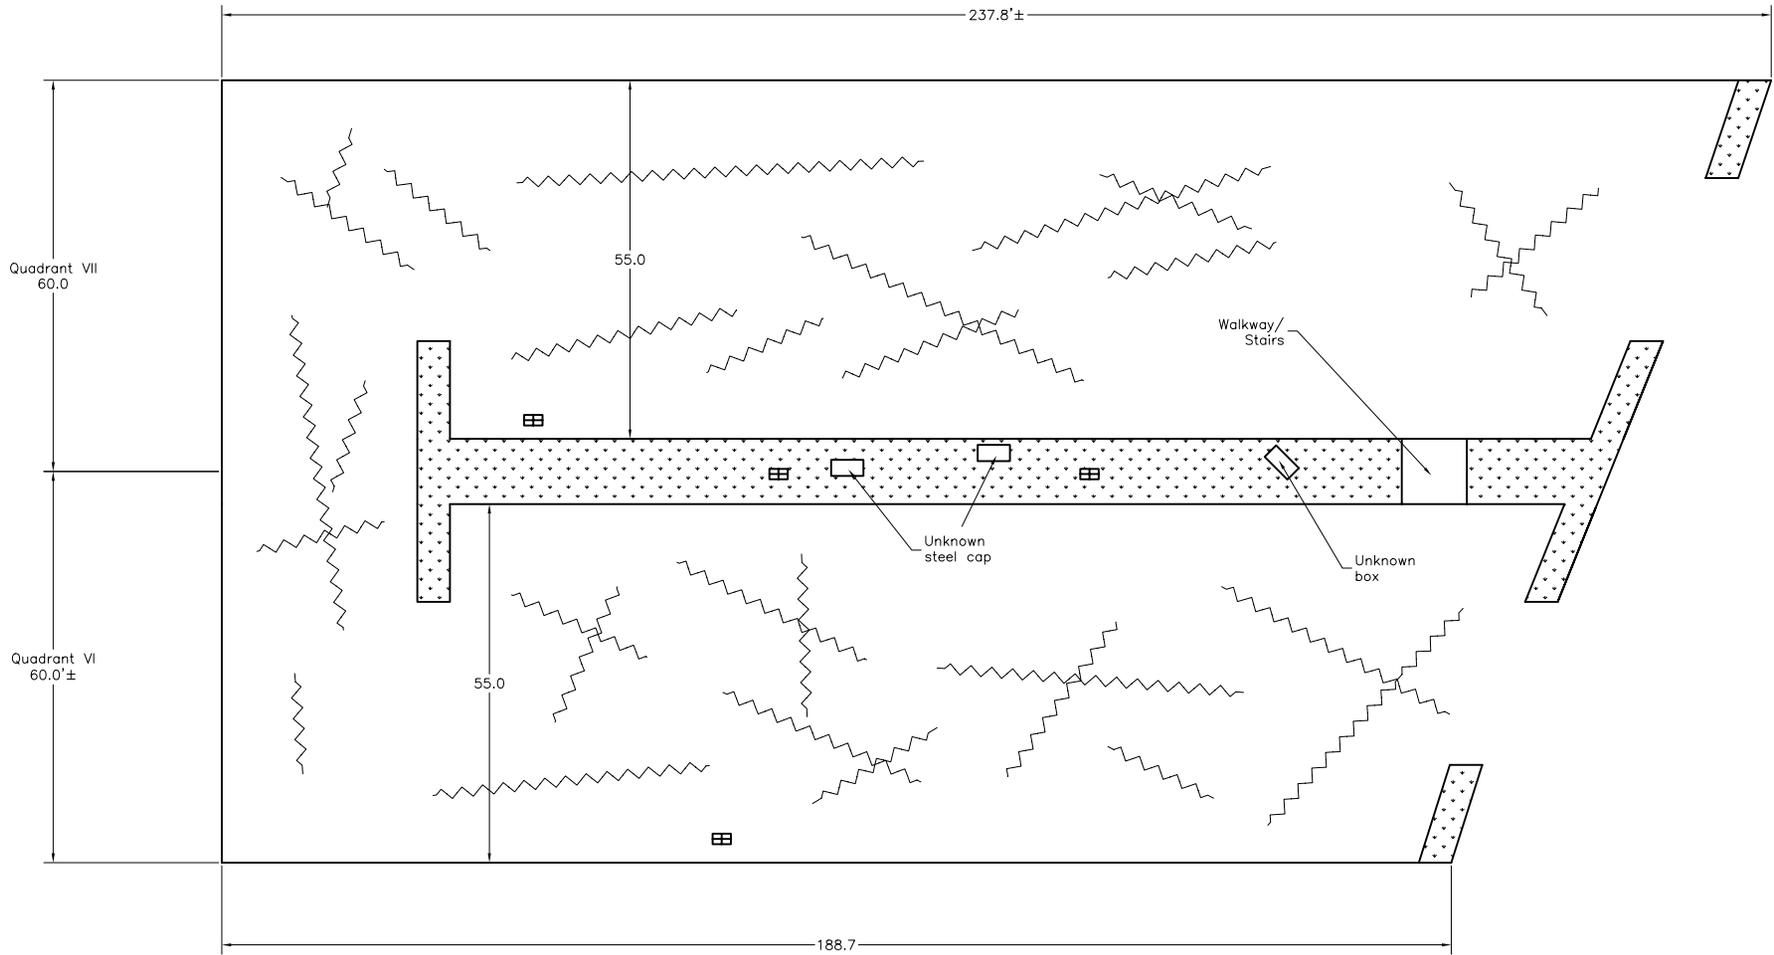
Urbitran Associates, Inc.
Connecticut Dept. of Transportation
Talmadge Hill Station Quadrant VI and VII Details
Date: 12-18-01

- NOTES:
1. 45% of the asphalt pavement in Quadrant VI is cracked.
 2. 10% of the asphalt pavement in Quadrant VI is uneven.
 3. 30% of the asphalt pavement in Quadrant VII is cracked.
 4. 80' of the curbing is missing, spalled, or cracked in Quadrant VII.
 5. 3 of the parking meters are missing, rusted, and bent in Quadrant VI.

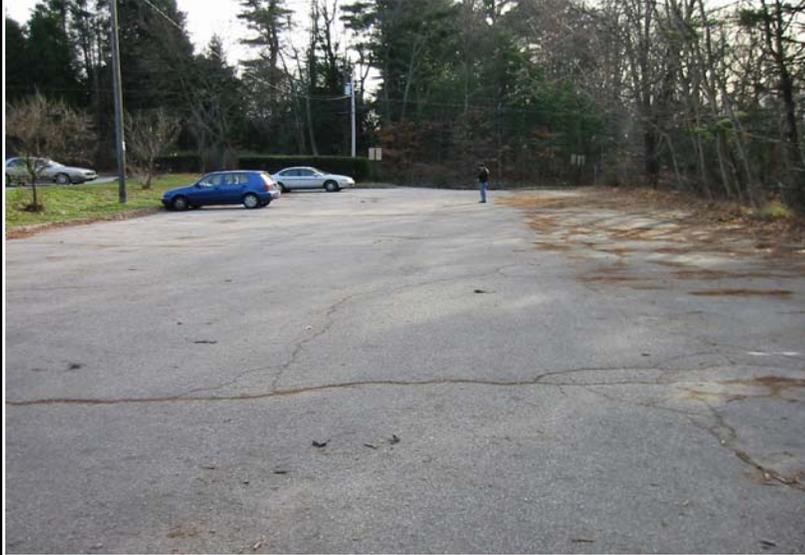
PHOTO NO. 3

Description: _____
General view of Quad I;
Note asphalt cracks
and accumulation of
leaves in the parking
area

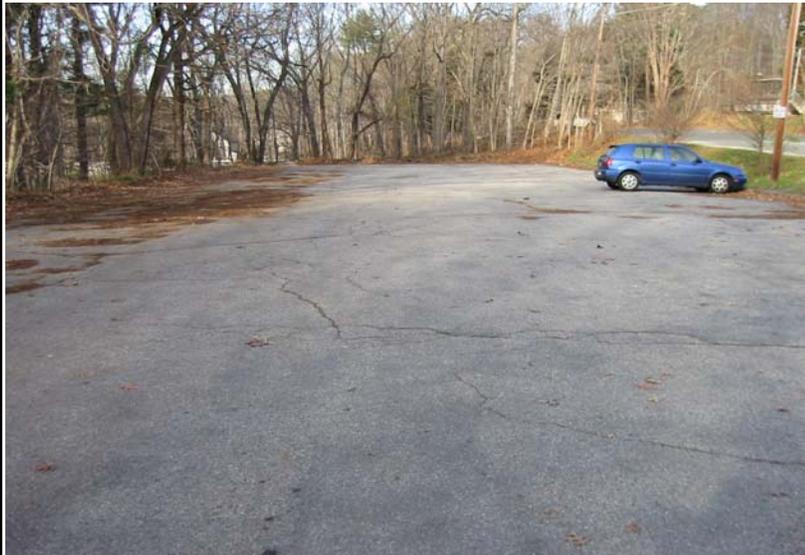
PHOTO NO. 4

Description: _____
General view of Quad I;
Note asphalt cracks
and accumulation of
leaves in the parking
area

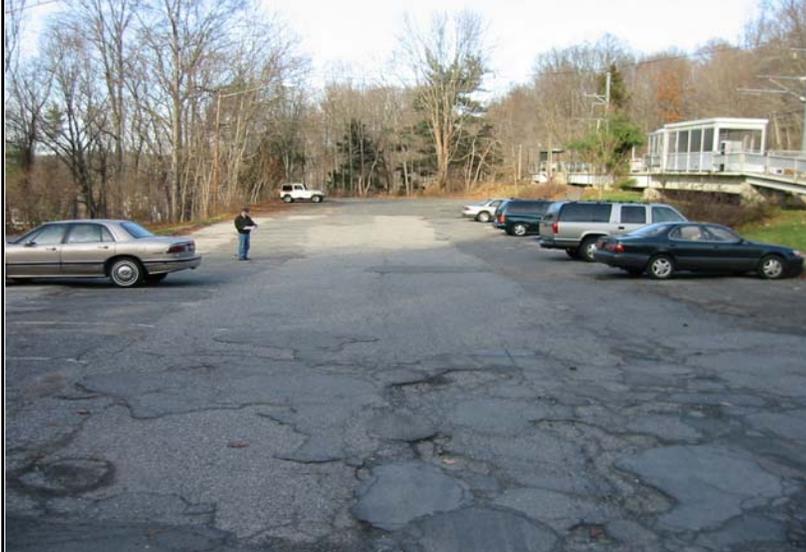
PHOTO NO. 5

Description: _____
General view of Quad II;
Note the uneven driving
surface and cracks

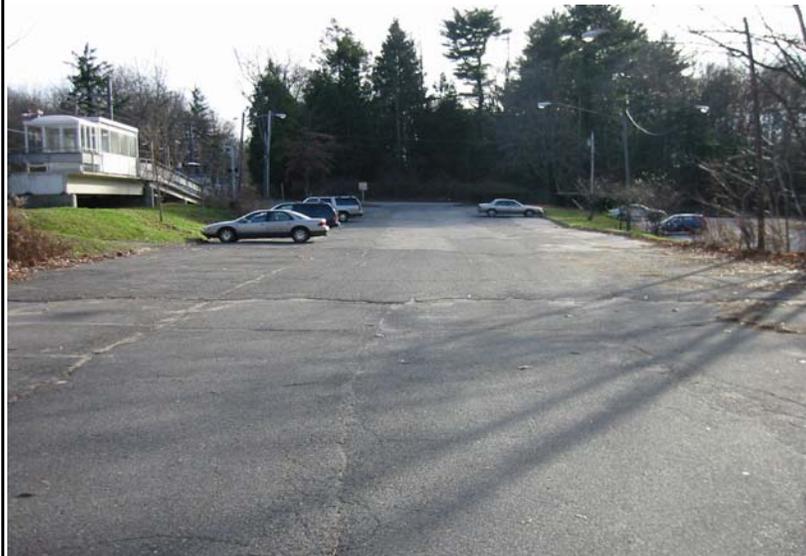
PHOTO NO. 6

Description: _____
General view of Quad II;
Note the uneven driving
surface and cracks

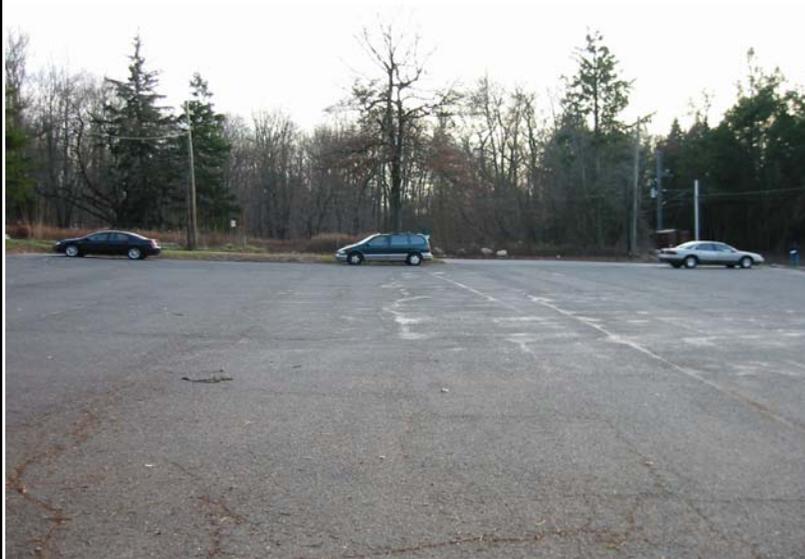
PHOTO NO. 8

Description: _____
General view of Quad III;
Note the uneven driving
surface and cracks

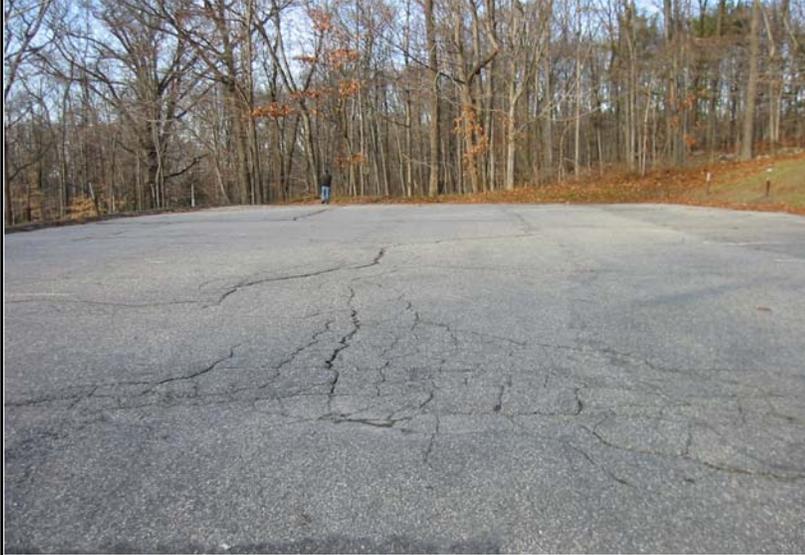
PHOTO NO. 9

Description: _____
General view of Quad IV;
Note the cracks

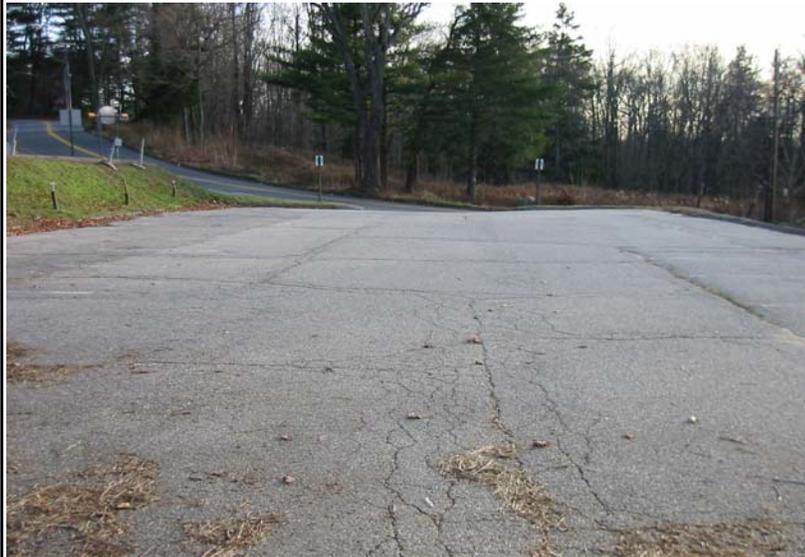
PHOTO NO. 10

Description: _____
General view of Quad IV;
Note the uneven driving
surface, and cracks
with vegetation growth

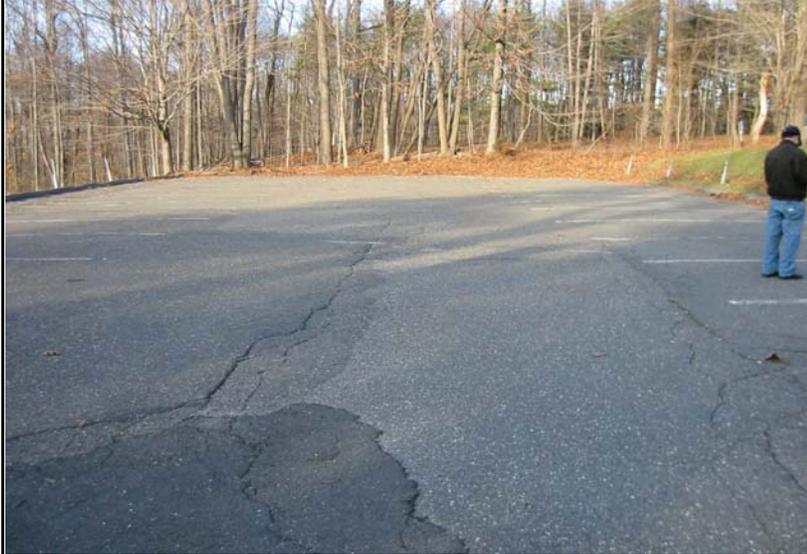
PHOTO NO. 11

Description: _____
General view of Quad V;
Note the cracks

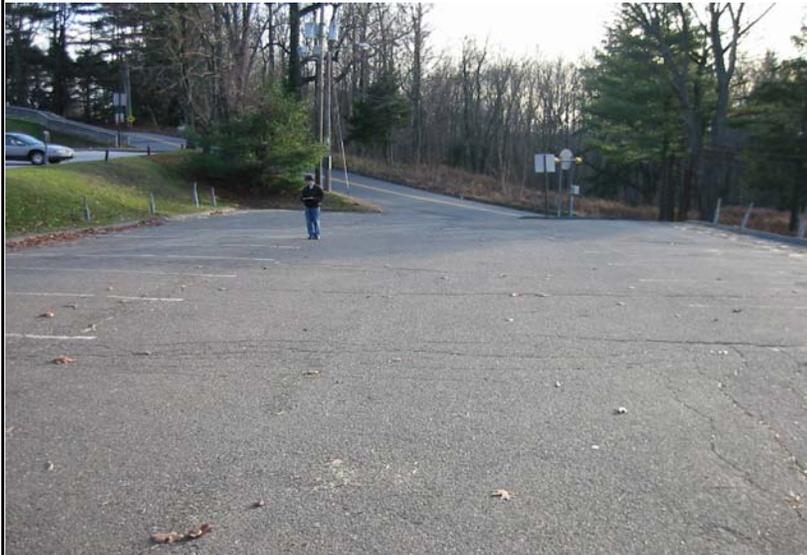
PHOTO NO. 12

Description: _____
General view of Quad V;
Note the cracks

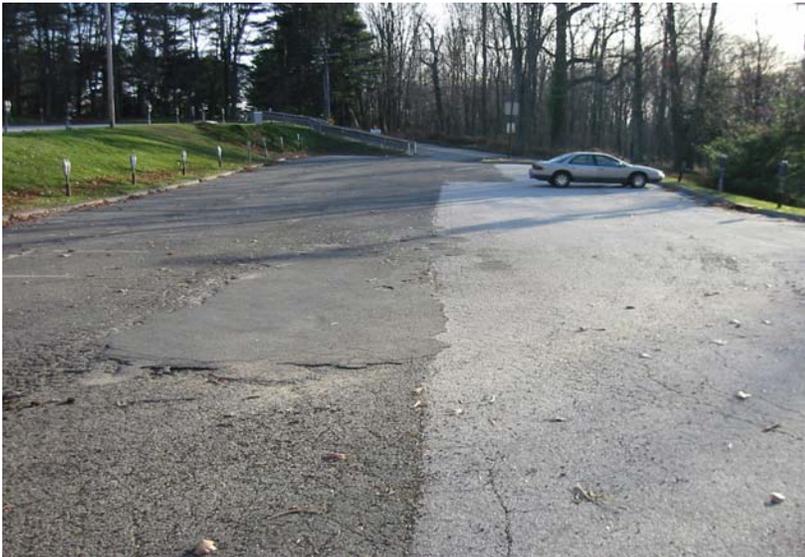
PHOTO NO. 14

Description: _____
General view of Quad VI;
The asphalt pavement
has uneven settlement
and cracking

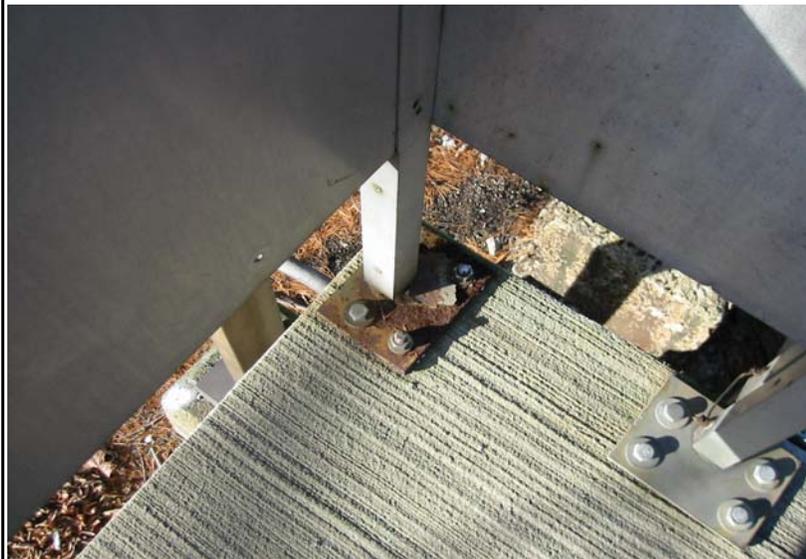
PHOTO NO. 18

RATINGS		PHOTO NO.	REMARKS:
NEW	PREV		
2		18	All Spans 2 - The railing base plates are rusted and deteriorated
3		19	Span X 3 - There is minor areas of scalled/honeycomb concrete along the stairs
3		20	Span V,IX 4 - There are two isolated area of spalled concrete on the exterior flange of the double tee
2		21	Span VII 7 - The back of the sign is cracked
3		23	All Spans 17 The double tee base plates are rusted and deteriorated.
2		22	Span VII NA - The cinder block façade is damaged
2		3-16	All Quads Surface - The top of the asphalt pavement is cracked and uneven
2		3-16	All Quads Striping - The striping is faded
2		24	All Quads Landscape - Typical accumulation of leaves into the parking area
2		25	Quad I,II,IV,V,VII Curb - Typical cracked and missing asphalt curb
3		26	Quad III Signage - There is a rusted sign in the southwest corner
2		27,28	Quad III Misc. - There are concrete parking blocks which are missing, spalled or displaced

Description: _____
Typical rusted and
deteriorated railing base
plate

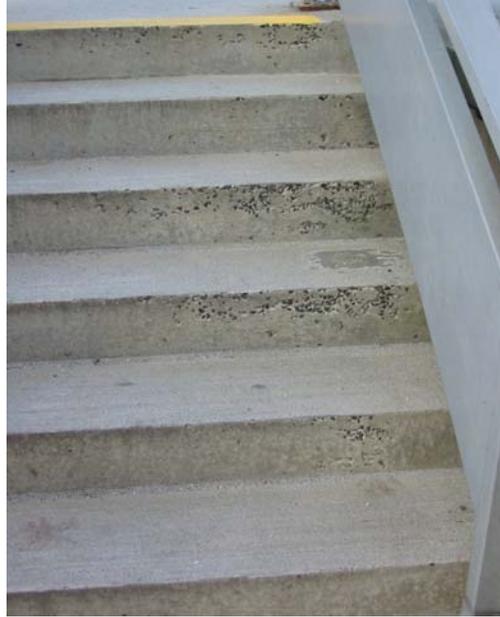
PHOTO NO. 19

Description: _____
Typical scaled /
honeycombed concrete
stairs

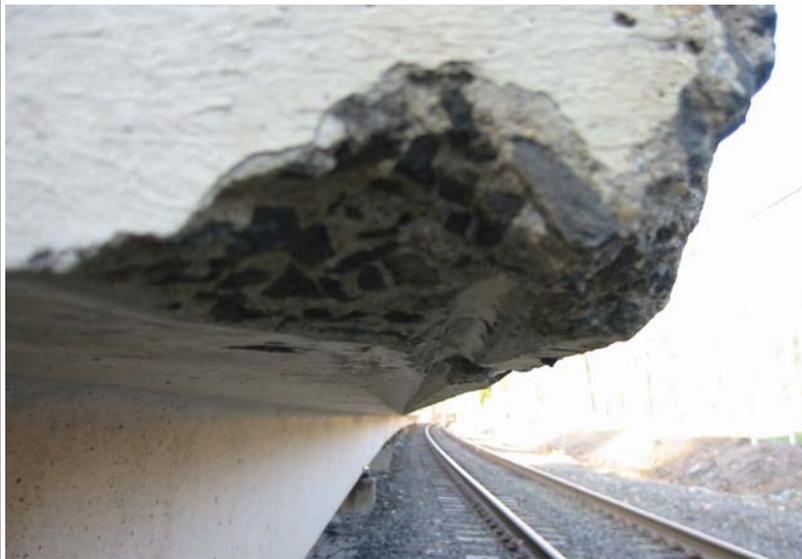
PHOTO NO. 20

Description: _____
Spalled concrete
(1'x1'-6"x1')

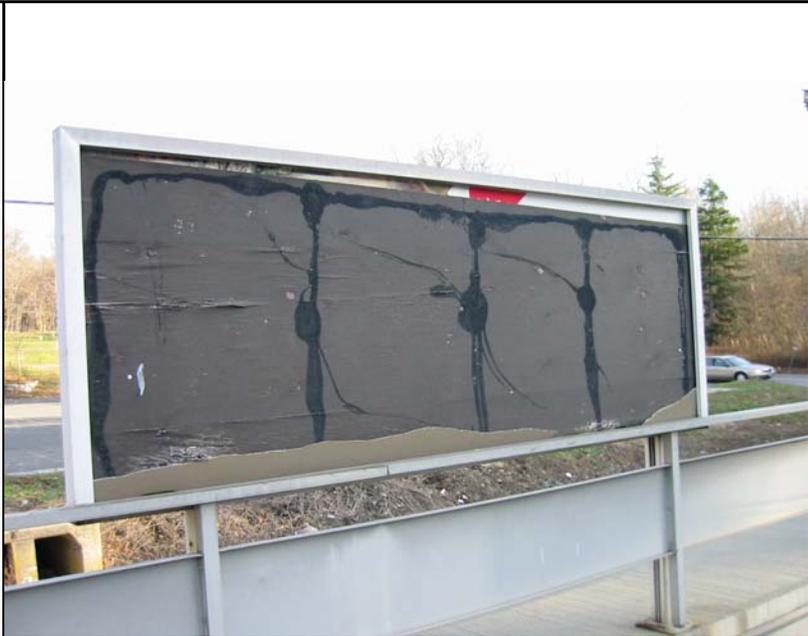
PHOTO NO. 21

Description: _____
The back of the sign is
cracked and missing

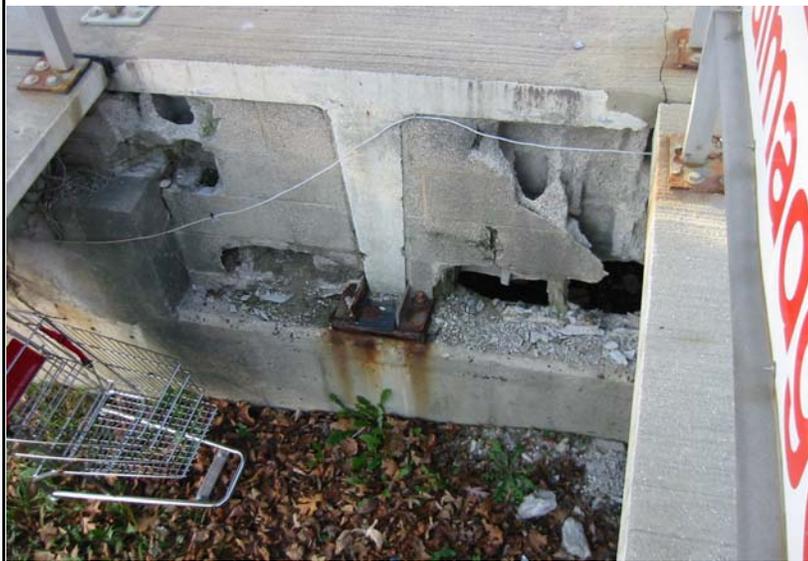
PHOTO NO. 22

Description: _____
The cinder block façade
is damaged

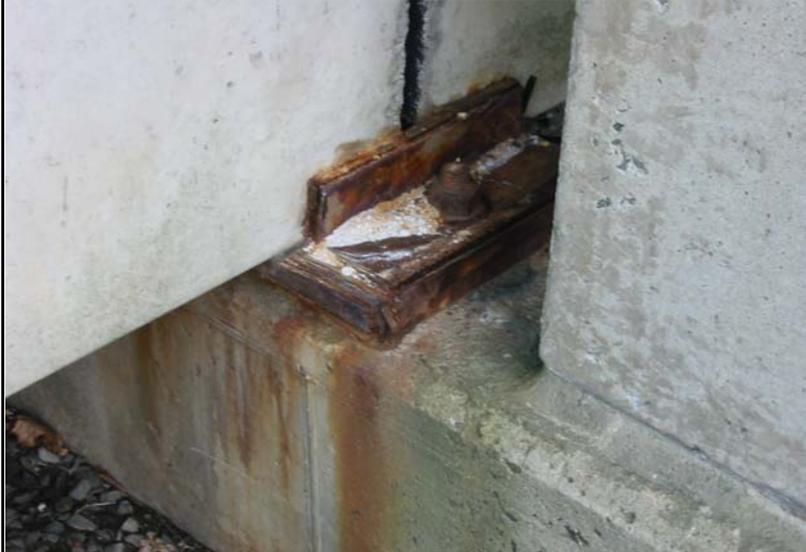
PHOTO NO. 23

Description: _____
Typical rusted and
deteriorated base plate
under the double tee

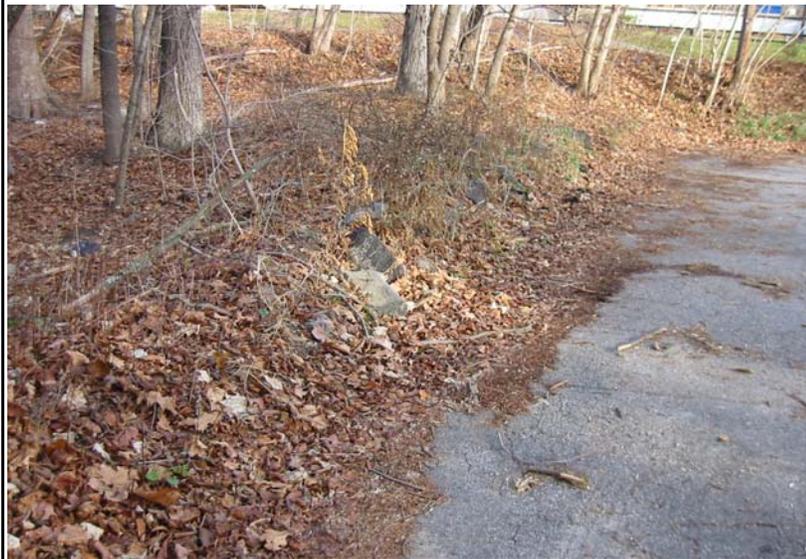
PHOTO NO. 24

Description: _____
Typical broken branches
and accumulation of
leaves into the parking
area

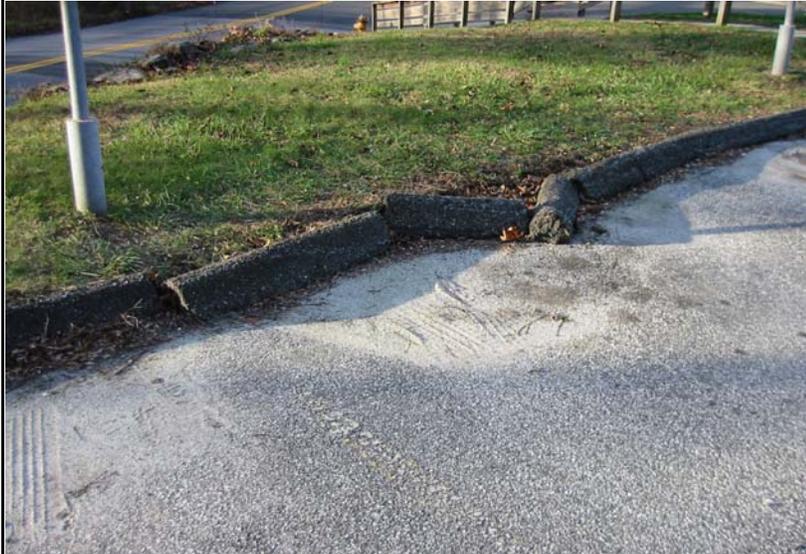
PHOTO NO. 25

Description: _____
Displaced and cracked
asphalt curb

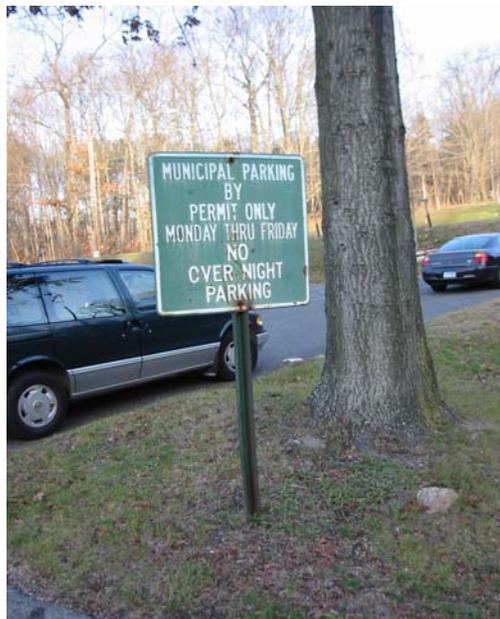
PHOTO NO. 26

Description: _____
The sign is rusting

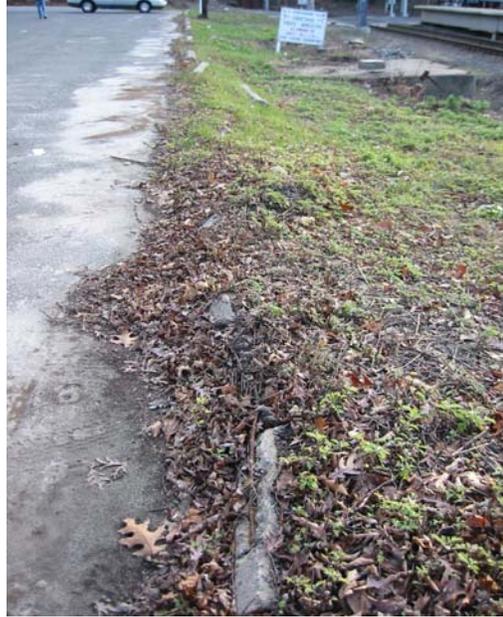
PHOTO NO. 27

Description: _____
General view of the
spalled and
displaced concrete
parking blocks

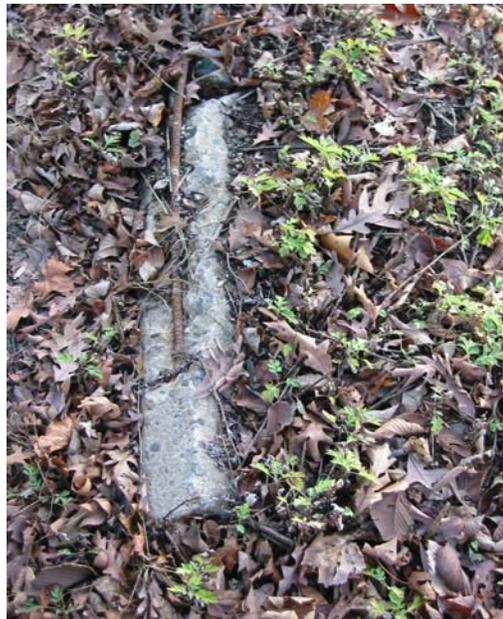
PHOTO NO. 28

Description: _____
Typical spalled concrete
parking block with
exposed rebar

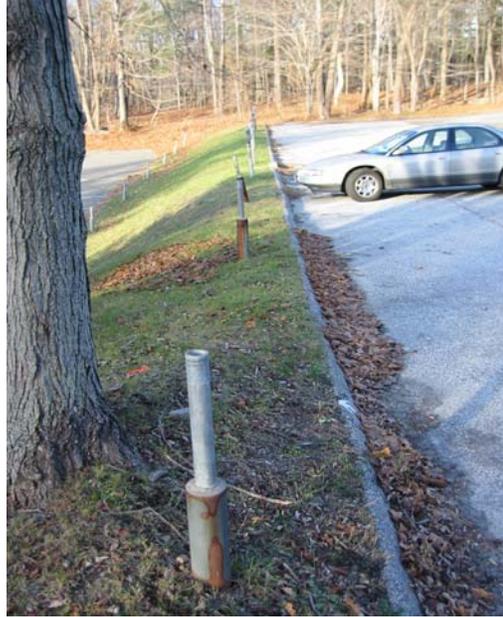
PHOTO NO. 29

2		29,30	Quad IV,V,VI Misc. - The parking meters are either missing rusted, bent or uplifting from the ground

Description: _____
Typical missing, rusted,
or bent parking meters

* It is our observation that the parking meters are no longer in use and should only be removed.

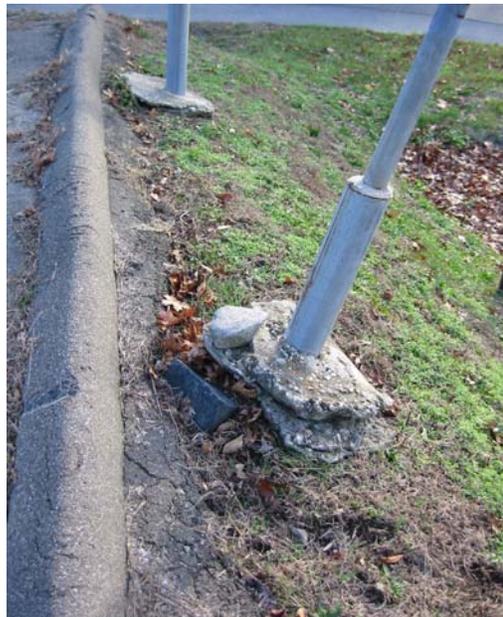
PHOTO NO. 30

Description: _____
Exposed parking
meter's footings

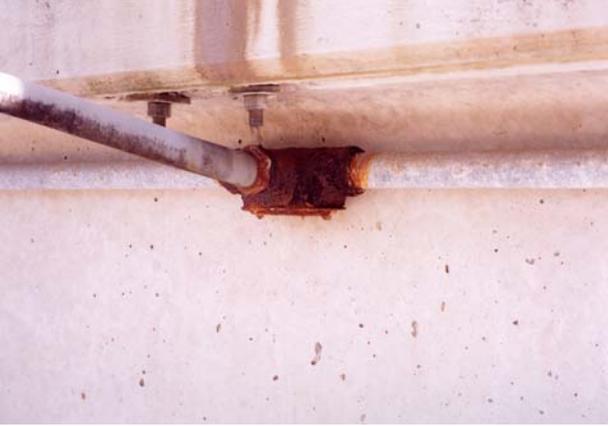
The platform luminaires are pole mounted metal halide and produce an average of 8.53 foot-candles. However, over grown vegetation impairs the output of one of the luminaires and results in light levels averaging 2.9 foot-candles near this pole. After this vegetation is removed, the entire platform will exceed the light levels as recommended by the IESNA. The conduit fittings serving the light poles are corroding and will likely lose electrical integrity in the near future. The cause of this corrosion may be the result of the heavy use of salt on the platform during winter months.

<p>PHOTO NO. <u>34</u></p> <p>Location: <u>beneath platform</u></p> <p>Description: <u>a typical corrosion</u> <u>of platform lighting</u> <u>conduit fittings</u></p> <p>Reference: <u>Platform Lighting</u> <u>Section</u></p>

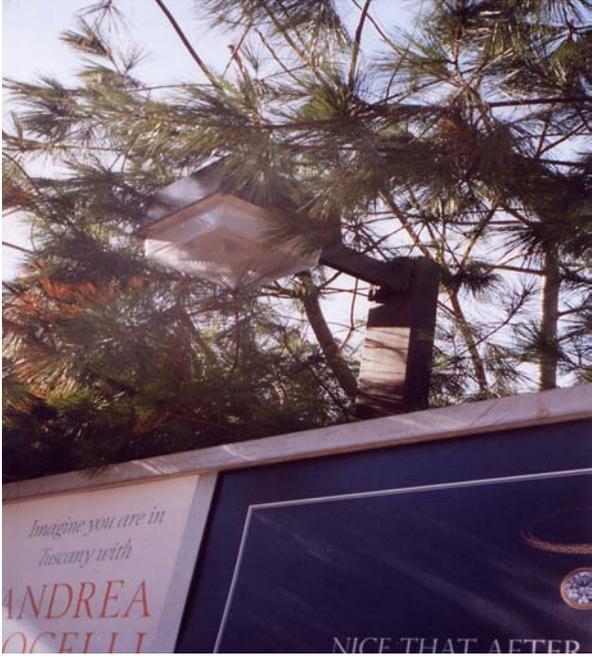
<p>PHOTO NO. <u>35</u></p> <p>Location: <u>platform</u></p> <p>Description: <u>overgrown</u> <u>vegetation at</u> <u>platform light</u> <u>pole</u></p> <p>Reference: <u>Platform Lighting</u> <u>Section</u></p>
