# STRUCTURE NO. 04343

NORTH SHORE ROAD  
over  
BANTAM RIVER  
LITCHFIELD

*Indepth Inspection*  
on  
6/23/2009

**BRIDGE NO. 04343  
NORTH SHORE ROAD  
OVER  
BANTAM RIVER  
LITCHFIELD, CONNECTICUT**

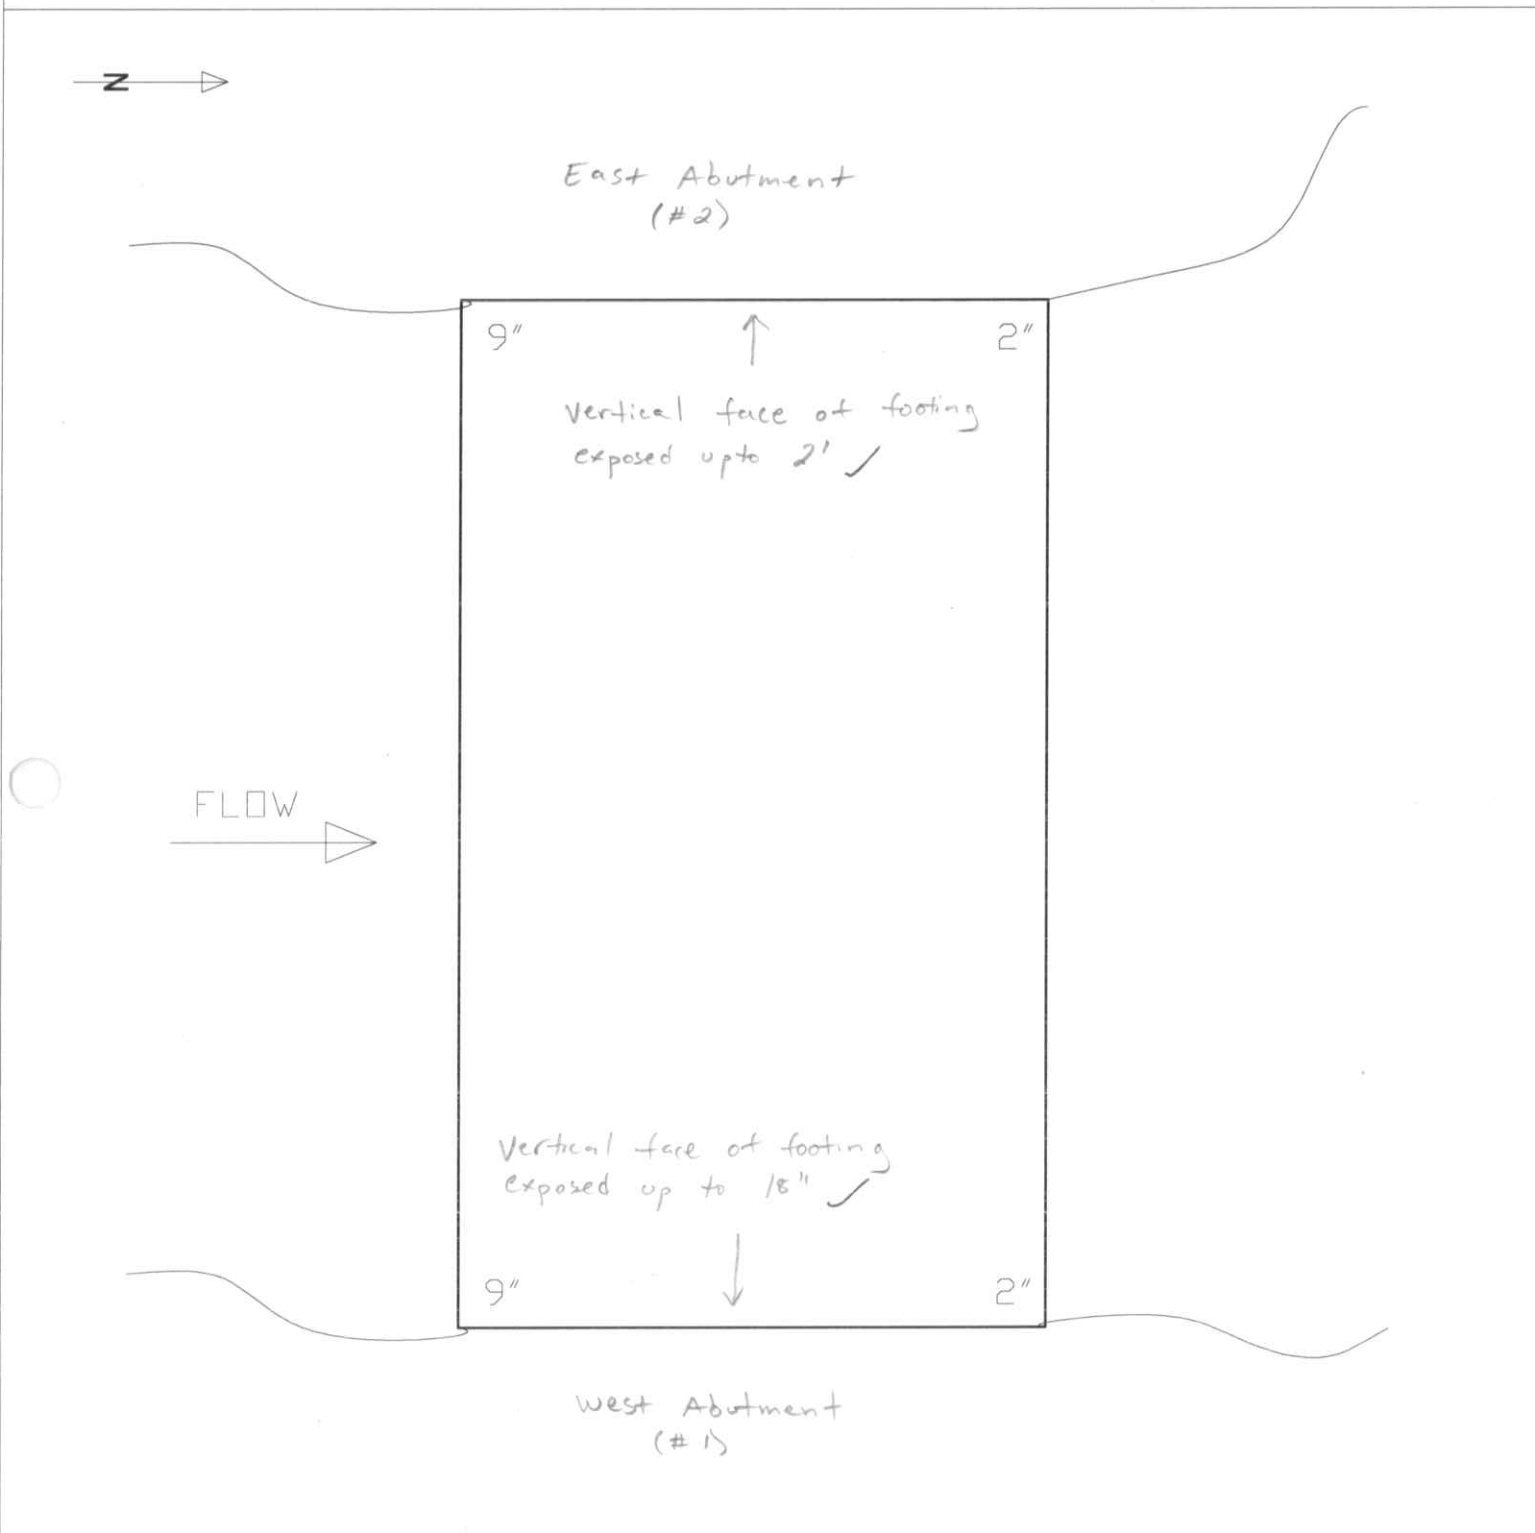
DESCRIPTION: Stream Channel

Measurements taken from top of footing to water surface

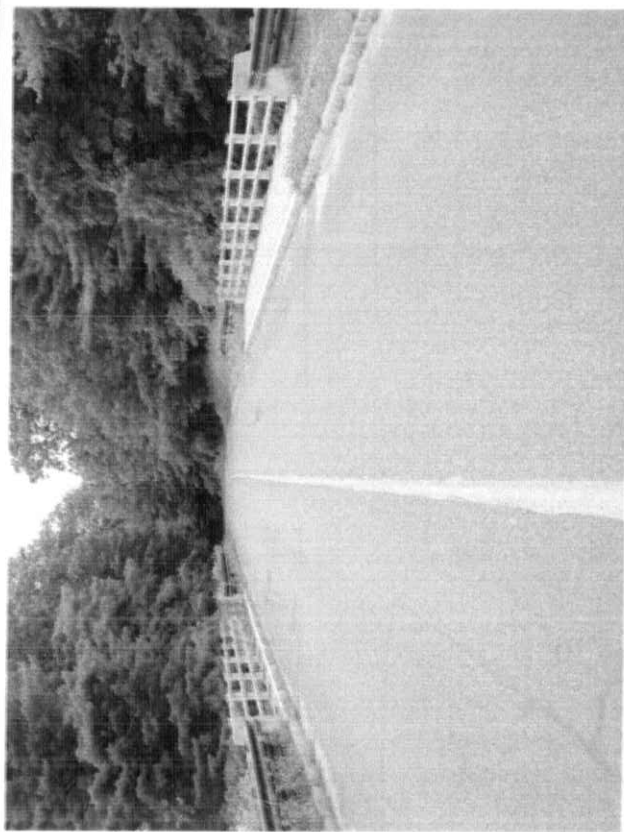
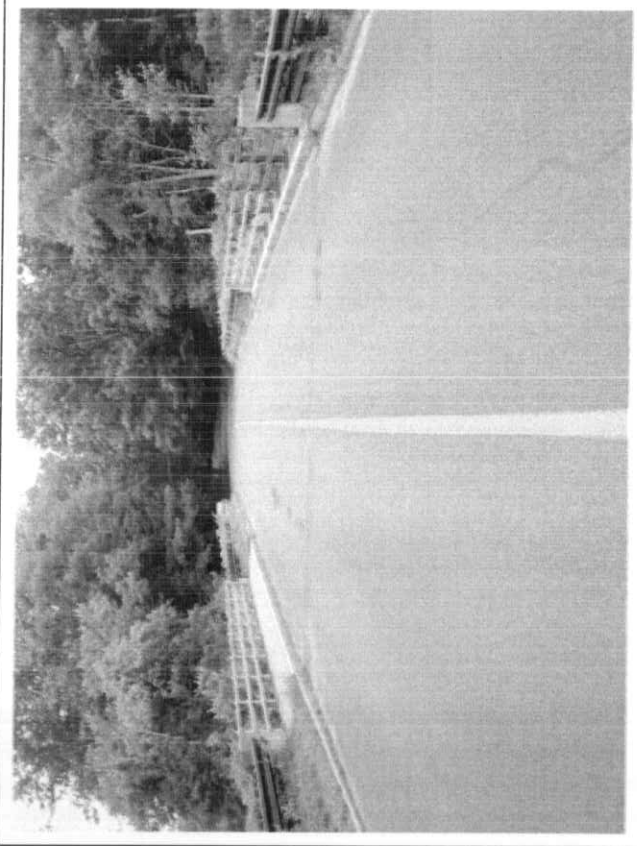
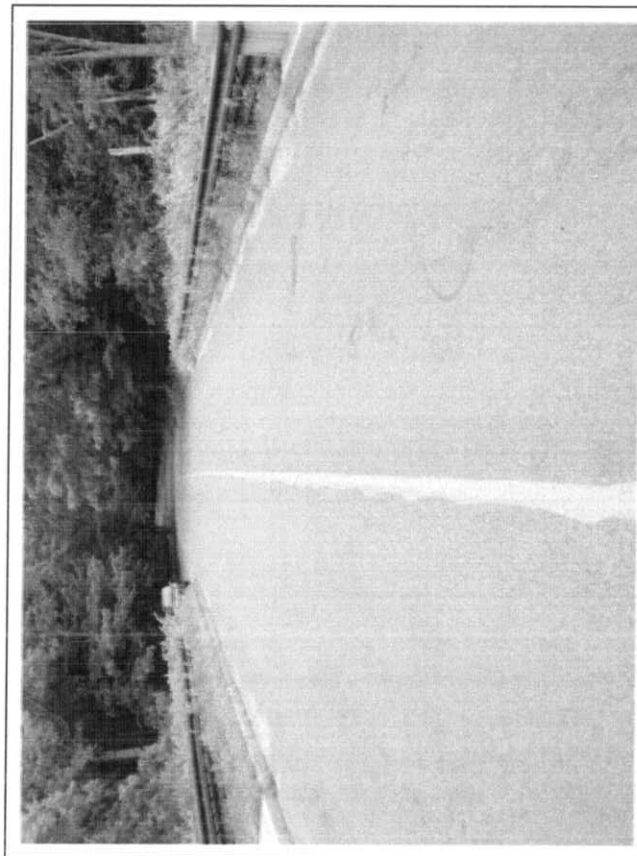
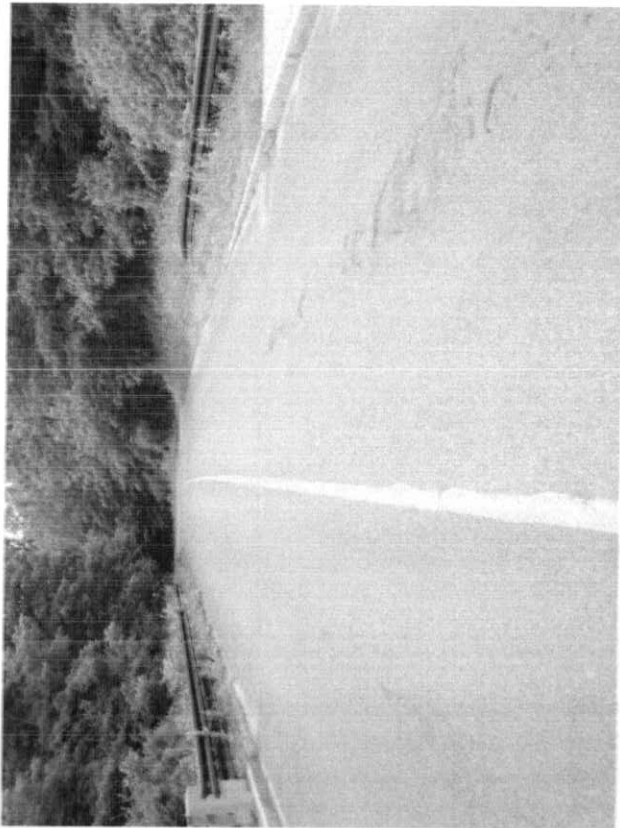
APPROACH PAVEMENT **6** The bituminous concrete pavement shows isolated transverse, longitudinal and diagonal cracks, some of which have been sealed and there is minor settlement at the deck ends. In addition, the east pavement shows potholes up to 2' x 1' x 2" deep. See sheet 11 and photos 4-7.

**Photo # 4:** Bridge from the west approach.

Photo # 5: Bridge from the east approach.

Photo # 6: West approach from the bridge.

**Photo # 7:** East approach from the bridge.

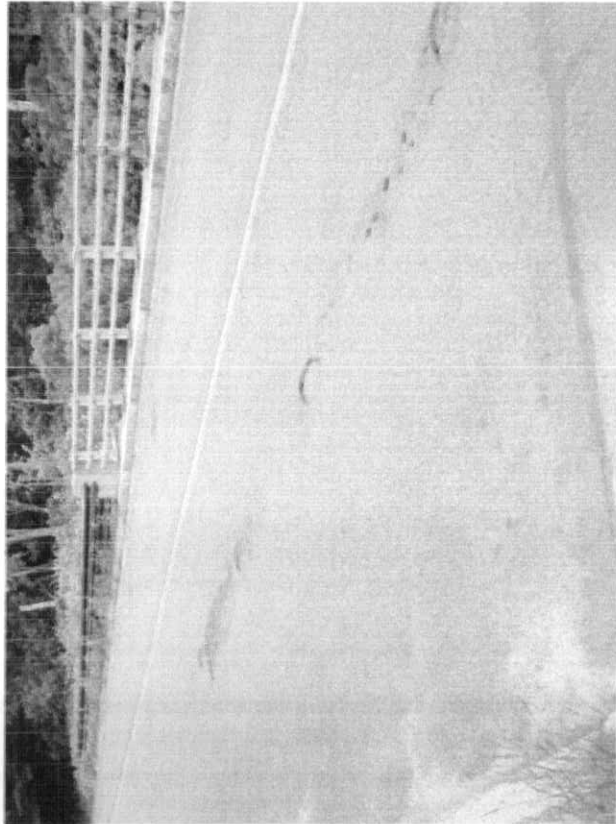
1. The bituminous concrete overlay shows random isolated transverse and longitudinal cracks, wheel path rutting that are up to 4" deep and several potholes up to 7' long x 3' wide x 3" deep. Repair/patch the potholes (1 Ton).

<b>RATING</b>	
OVERLAY	<b>6</b>	Bituminous Concrete Overlay with Sheet Membrane Waterproofing. The overlay shows random isolated transverse and longitudinal cracks. Wheel path on eastbound side is severely rutted and shows potholes up to 7' long x 3' wide x 3" deep. Westbound side has two severe potholes, one 2' x 3' x 4" deep, the other 1' x 2' x 2" deep. See sheet 11 and photo 9.
DECK STR. CONDITION	<b>6</b>	The bridge consists of ten prestressed concrete box beams with a bituminous concrete overlay. Rating based on condition of overlay. See Item 59 Superstructure section entitled "Girders".
CURBS	<b>7</b>	Granite curbs. The curbs show random scrapes and gouges throughout. The average curb reveal is 7-3/4 inches. See sheet 11 and photo 10.
MEDIAN	<b>N</b>	
SIDEWALKS	<b>7</b>	Concrete Sidewalks. The sidewalk shows random isolated transverse hairline cracks throughout. The safety walk also shows minor isolated hairline cracks.

**Photo # 9:** View of the bituminous concrete overlay.

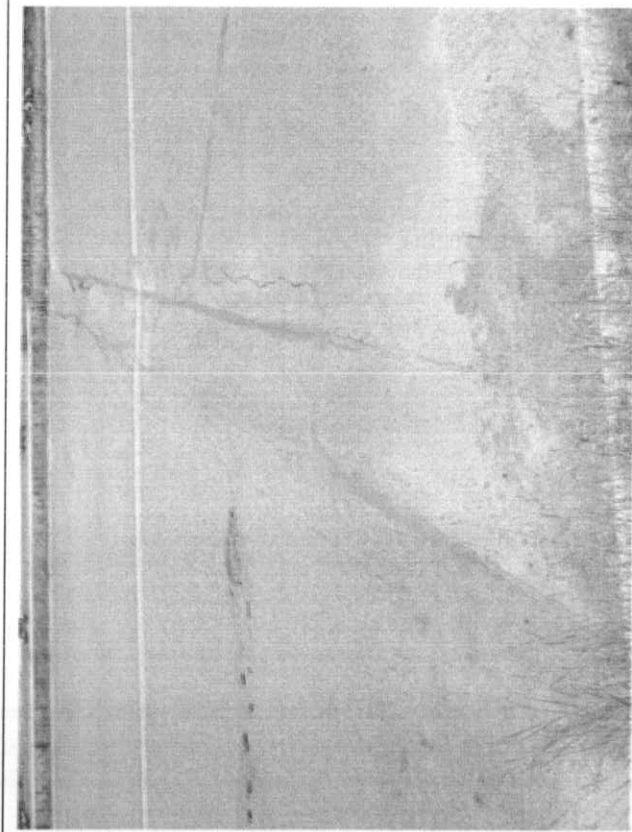
4. Sawed and sealed joints at each abutment. Both the east and west end show two transverse cracks at the joints that have been crack-sealed. Several other transverse cracks and minor potholes have propagated near these cracks. Reseal cracks and patch potholes as part of routine maintenance.

**Photo # 11:** Deck joint at the east abutment.

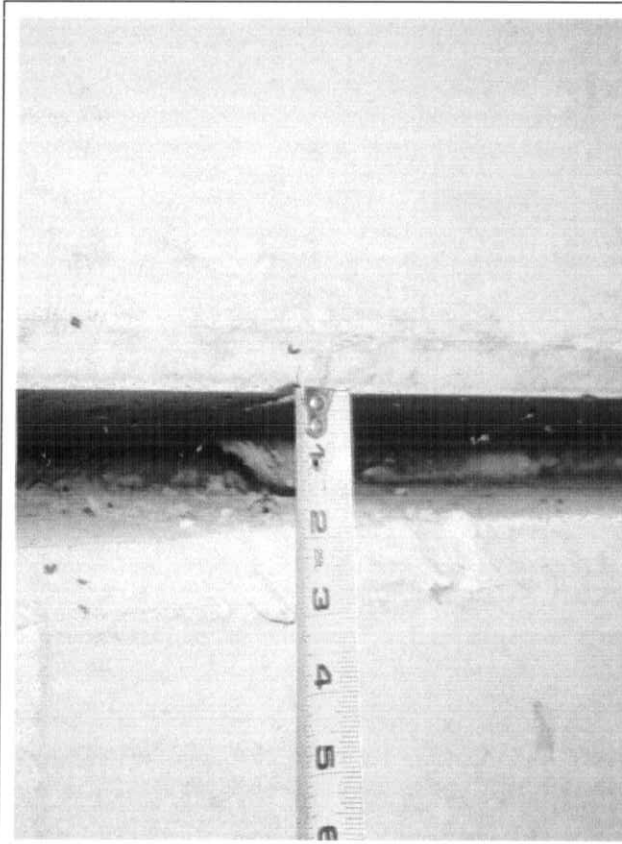
1. The premolded joint material from bridge bearing is bulging out between the top of the abutment and bottom of the box beams at both ends of the bridge. No repair at this time.
2. Prestressed concrete box beams (10 total) show evidence of leakage located between beams 1 & 2 for the full length and between beams 6 & 7, 7 & 8, and 8 & 9 at the east end. Underside of beams show minor scaling, map cracking and random exposed steel reinforcement supports throughout. No repair at this time.
3. There is a 1-7/8" wide gap along the underside of the shear key located between beams 7 & 8 at the west abutment. No repair at this time.

**Photo # 12:** 1-7/8" wide gap along the underside of the shear key between beams 7 and 8 at the west abutment.

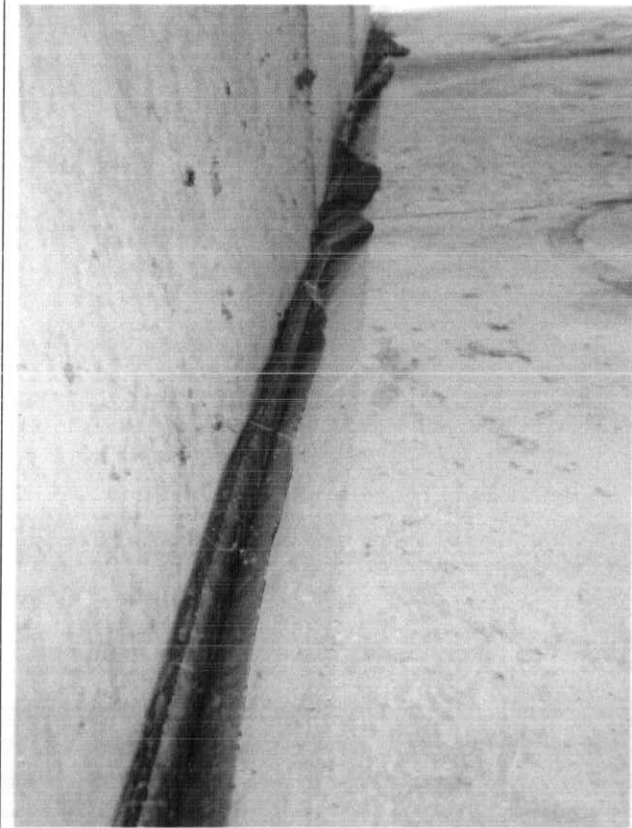
<b>RATING</b>	
BEARING DEVICES	<b>6</b>	The premolded joint material from bridge bearing is bulging out from between the top of the abutment and bottom of the box beams at both ends of the bridge. See photo 13.
STRINGERS	<b>N</b>	Prestressed concrete box beams (10 total) show evidence of leakage from between beams 1 & 2 for the full length and between beams 6 & 7, 7 & 8, and 8 & 9 at the east end. See Item 59 section entitled "Girders".
GIRDERS	<b>7</b>	Underside of beams show minor scaling, hairline map cracking and random exposed steel reinforcement supports. See sheet 12 and photo 9.
FLOOR BEAMS	<b>N</b>

**Photo # 13:** Bulging bearing material for bridges at the west abutment.

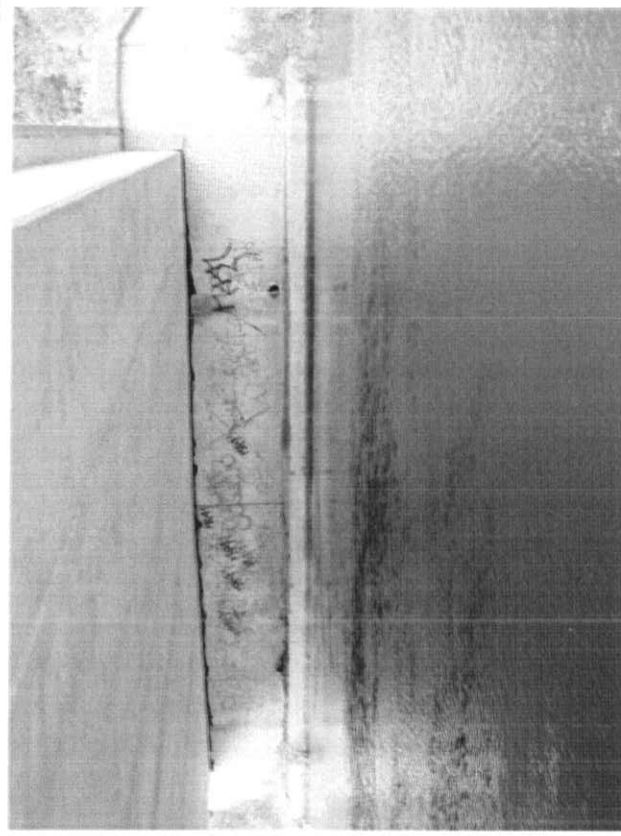
1. The vertical face of the west abutment footing is exposed up to 18" and the east abutment footing is exposed up to 2' from channel scour. No undermining of the footings was observed. Continue to monitor channel protection during the next inspection.

**Photo # 14:** East abutment elevation.
