**STATE PROJECT NO. 170-2729
BRIDGE SAFETY INSPECTION**

**BRIDGE NO. 04433
NORTH SHORE ROAD
OVER
BUTTERNUT BROOK
LITCHFIELD, CONNECTICUT**

**IN-DEPTH INSPECTION
AUGUST 6, 2009**

Prepared By:
**COLLINS
ENGINEERS INC.**
101 HAMMER MILL ROAD
ROCKY HILL, CT 06067

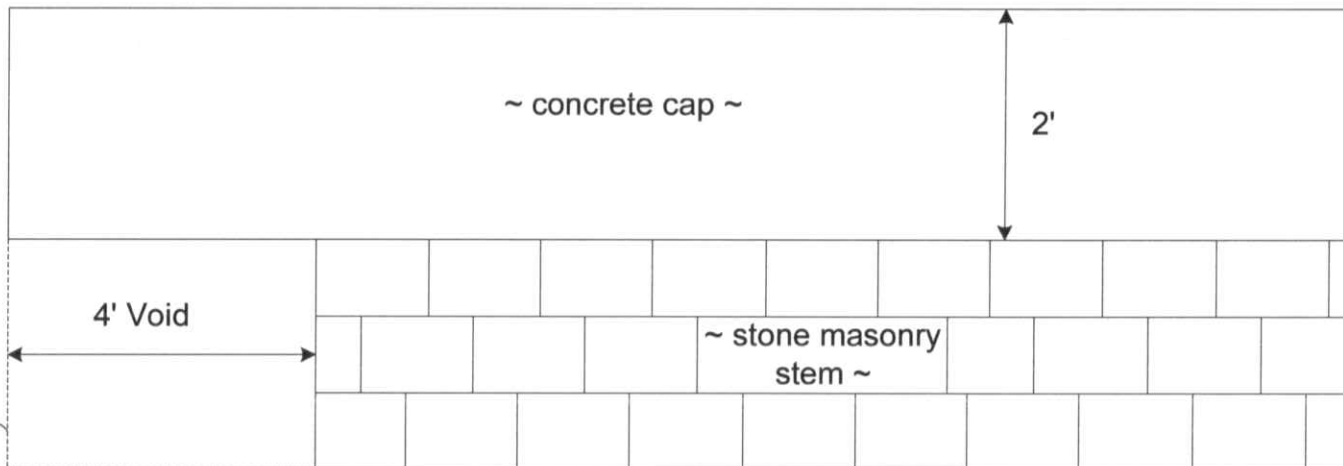
DESCRIPTION: North Abutment

- 1) The concrete cap has areas of light scaling and minor honeycombing.
- 2) The stone masonry abutment stem has 50% of the overall mortar missing, heaviest at the upstream and downstream ends.
 - a) The downstream end (west) has a 4' long x 2' high void due to missing stones and fill material. The penetration under the cap section is up to 13".
 - b) The upstream half (12' long +/-) of the stem has 90% missing mortar and penetrations up to 8" deep between stones.
 - c) From the midpoint of the stem to +/-6' from the downstream end the mortar is in good condition with less than 5% missing (up to 3" penetration between stones).
 - d) The downstream end (6' long +/-) has up to 50% missing mortar with up to 6" penetration between stones.
 - e) The abutment footing is not visible.

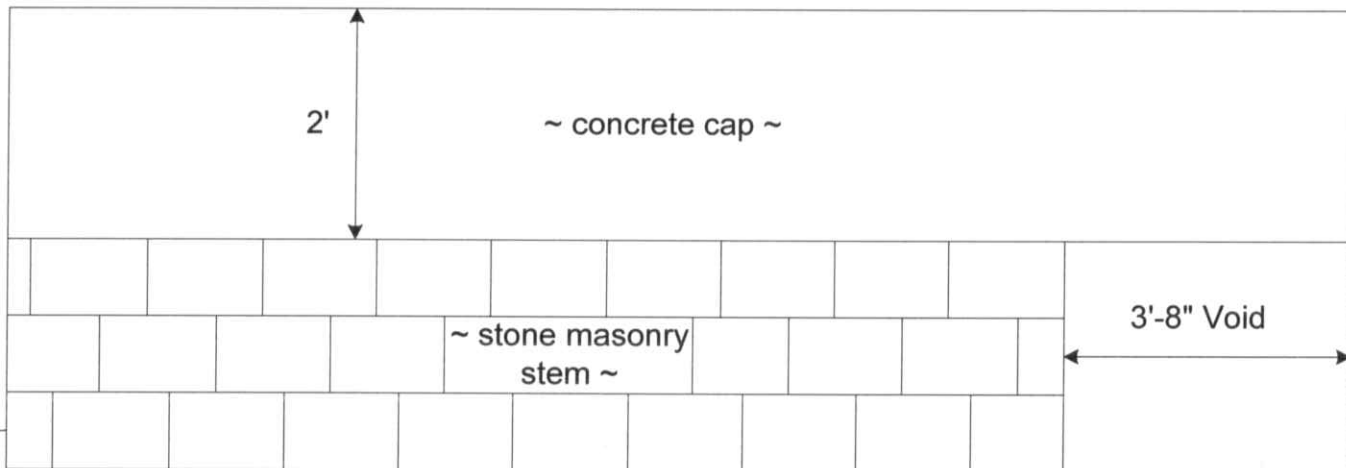
DESCRIPTION: South Abutment

- 1) The concrete cap has areas of light scaling and minor honeycombing.
- 2) The stone masonry abutment stem has areas of mortar missing mostly below the water surface.
 - a) The downstream end (west) has a 3'-8" long x 2' high area void due to missing stone and fill material. The penetration under the cap section is up to 30". The bituminous patch in the approach pavement above this area has sloughed through the void below.
 - b) At the upstream quarter (+/- 6' from end) of the stem has a stone/mortar void measuring 18" long x 10" high x 6" deep.
 - c) Mortar from the waterline up is in good condition with less than 5% missing mortar (up to 3" maximum penetration between stones).
 - d) From the waterline down to the channel bottom, 50% of the mortar is missing with penetrations up to 6" deep between the stones.
 - e) The footing is not visible.

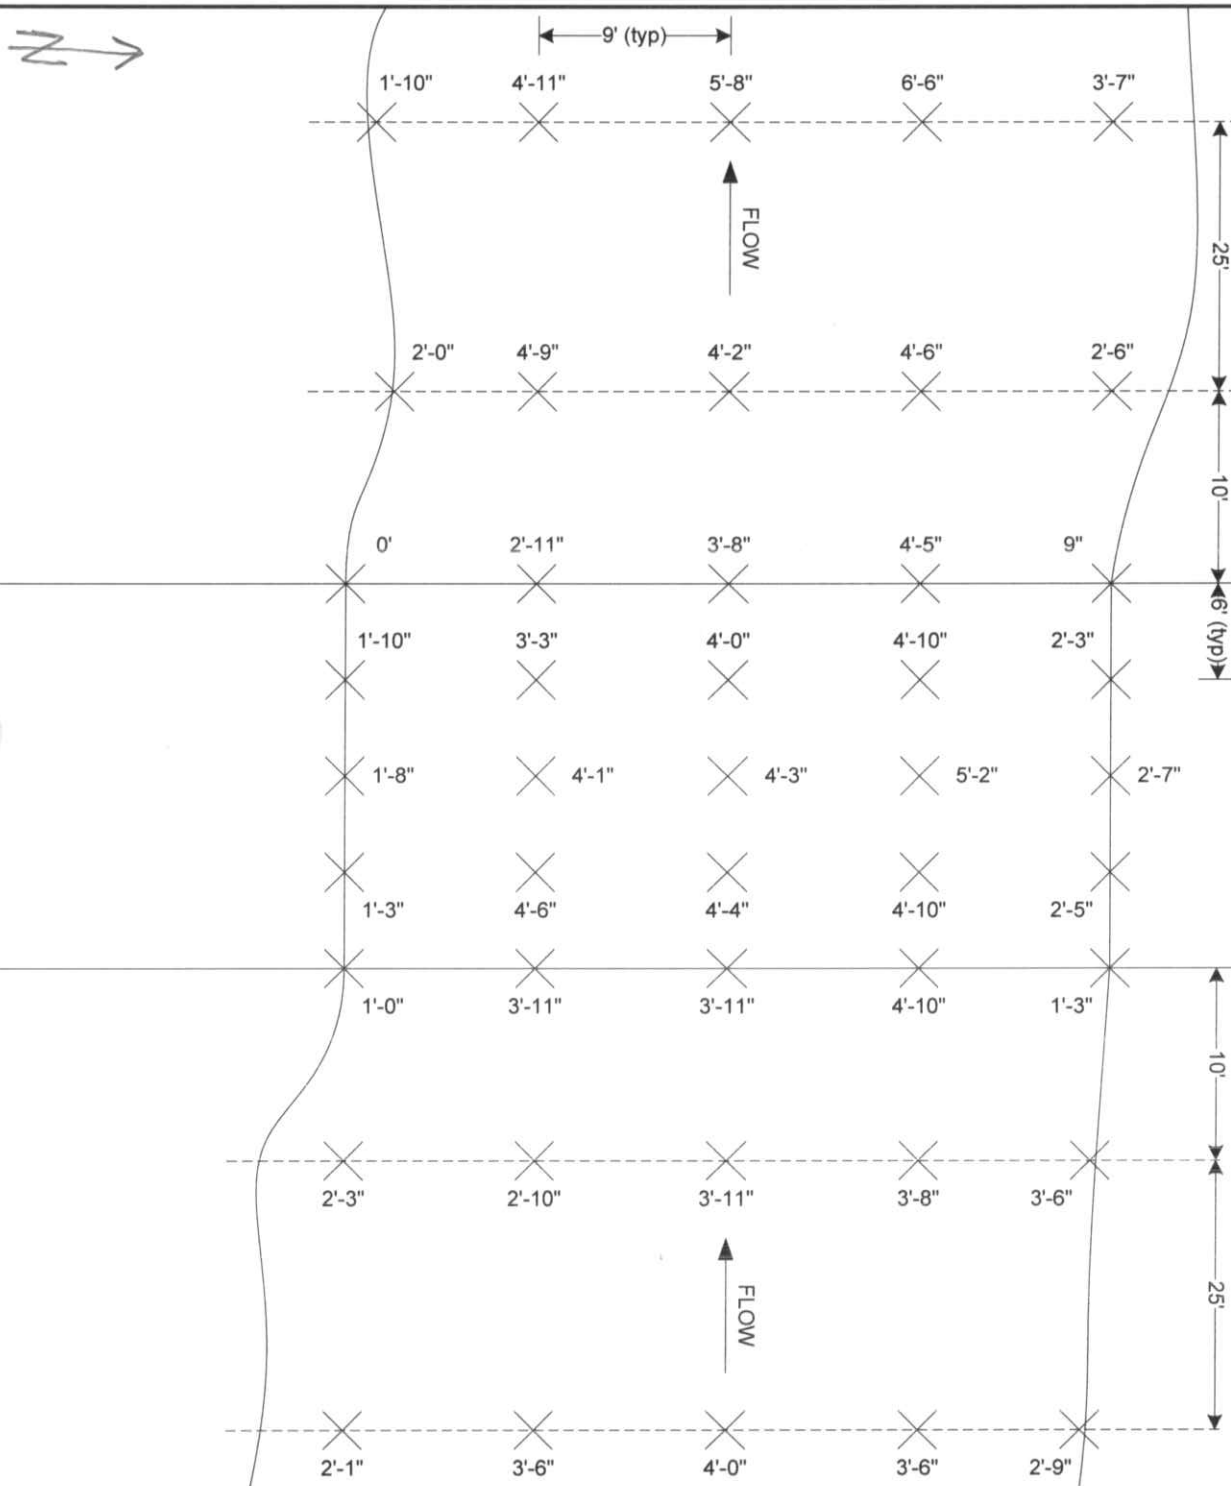
DESCRIPTION: Channel Diagram and Soundings

- 1) Datum elevation 0.0' taken from midspan at upstream fascia.
- 2) Water surface elevation is 3'-8" (freeboard). All channel measurements are from water surface to channel bottom.
- 3) Channel bottom is silty sand with 50% small rocks and cobbles. Penetrations into the channel bottom are up to 6".
- 4) Embankments are heavily vegetated with aquatic grass.

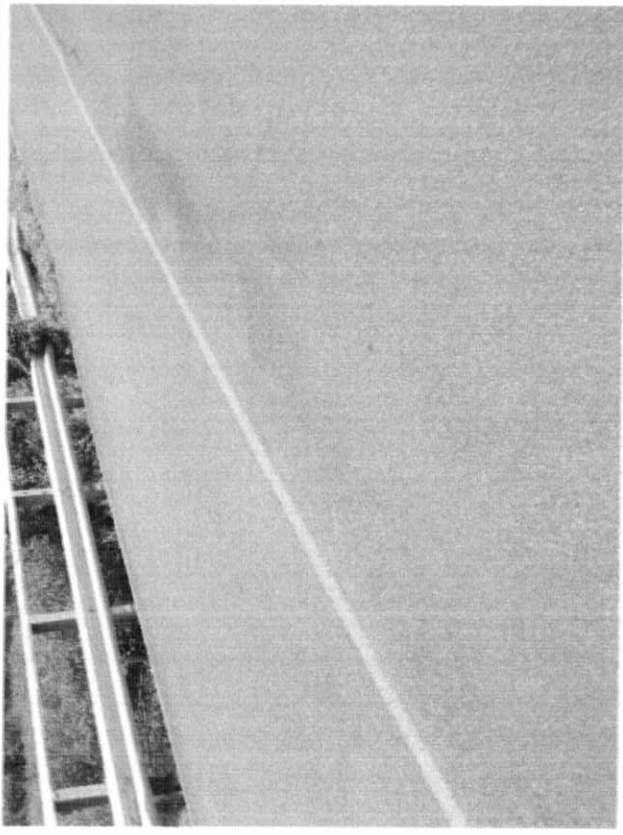
OVERLAY	7	The bituminous overlay has minor raveling throughout. Near the north end of the bridge in the southbound travel lane, there is a 2' x 1' x up to 2" deep depression on the bituminous. At the bridge ends, there are full width sealed cracks up to 1/4" wide. See sheet 10 & photo 6.
DECK STR. CONDITION	7	Deck is integral with the superstructure, rating based on the condition of the "Girders".
CURBS	N	
MEDIAN	N	
SIDEWALKS	N	
PARAPET	N	
RAILING	6	Steel bridge railing with I-beam posts and top rail angle which is bolted into the concrete bridge fascia. The approach guiderails are carried across the bridge and attached to the bridge railings. The bridge railings typically have light to moderate rust on the posts and hardware at the post connection to the bridge fascia. At the west side of the bridge, there are a few bent/damaged bridge rail posts due to collision damage. The guiderail in front of the bridge rail has some minor scrapes. The guiderail has terminal trailing ends which are damaged due to collision. See sheet 10 and photos 7 & 8.

Photo # 6: Bituminous concrete overlay

1. The bituminous overlay has a 2' x 1' x up to 2" deep depression in the bituminous at the north end of the bridge in the southbound travel lane. No repairs at this time.

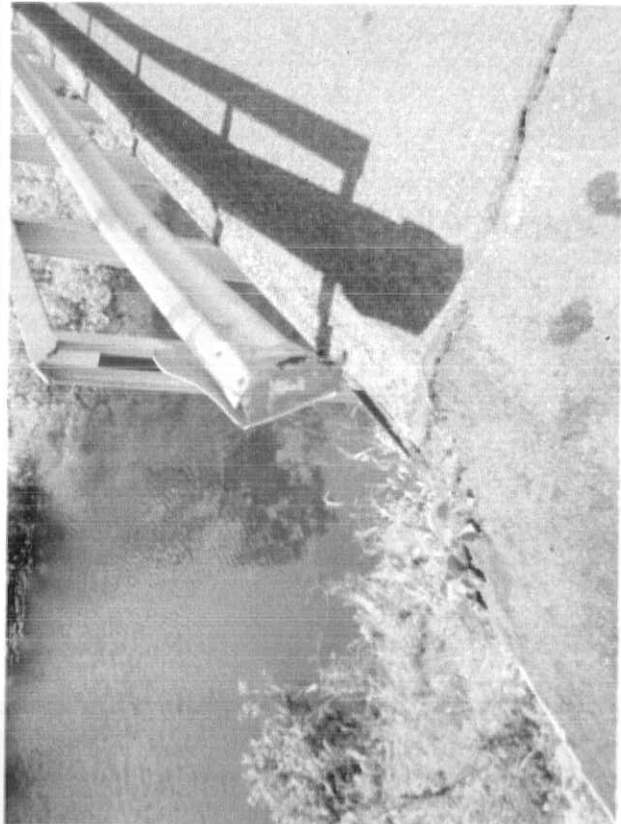
Photo # 7: Trailing edge bridge guide rail with terminal end (southwest corner shown)

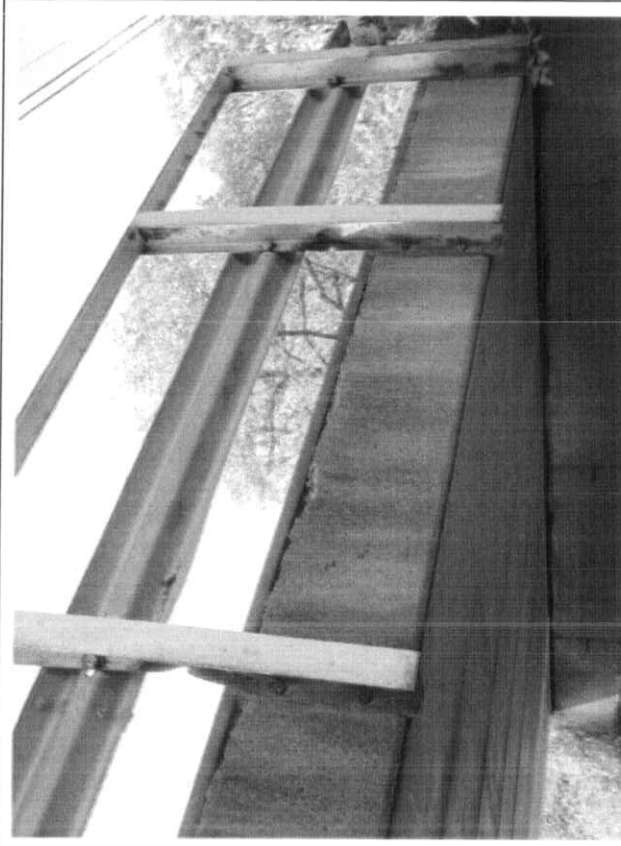
59. SUPERSTRUCTURE	Eight prestressed concrete deck units	OVERALL RATING 7
	angles dams up to 2" wide x 1/2" deep for up to 50% of the length of the bridge. See photo 8. Also, see sheets 11 & 12.	
GIRDERS	N	
FLOOR BEAMS	N	
TRUSSES-GENERAL	N	
TRUSSES-PORTALS	N	
TRUSSES-BRACING	N	
PAINT	N	
RUST	N	
MACHINERY MOV SPAN	N	
RIVETS & BOLTS	N	
WELDS & CRACKS	N	
TIMBER DECAY	N	
CONCRETE CRACKING	7	See "Girders" item above.
COLLISION DAMAGE	8	
MEMBER ALIGNMENT	7	There is up to 1/2" vertical misalignment between adjacent deck units likely due to construction.
DEFLECT. UNDER LOAD	N	Normal.
VIBR. UNDER LOAD	N	Normal.
STAND PIPES	N	
BARREL LADDERS	N	
ARE BARREL LADDERS OSHA COMPLIANT?		NA

8. The interface between the deck units and the reinforced concrete fascia appear to be in good condition.
9. At the reinforced concrete fascias, there is light scaling throughout with edge spalling at the interface with the steel curbing material, up to 2" x 1/2" deep for up to 50% of the span length.

Photo # 8: Condition of west fascia concrete with edge spalling

Note: light to moderate rust on the bridge rail post connections to the fascia

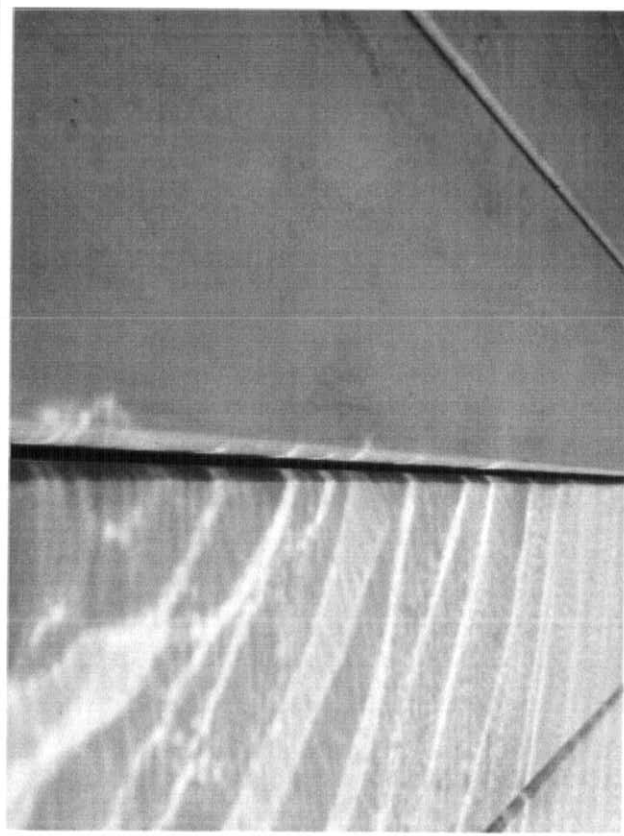
3. Joints between the deck units are open between 1/4" to 5/8". All joint material is missing between the deck units.
4. There is evidence of leakage between the deck units.

Photo # 10: Joints between deck units open up to 5/8" with missing joint material

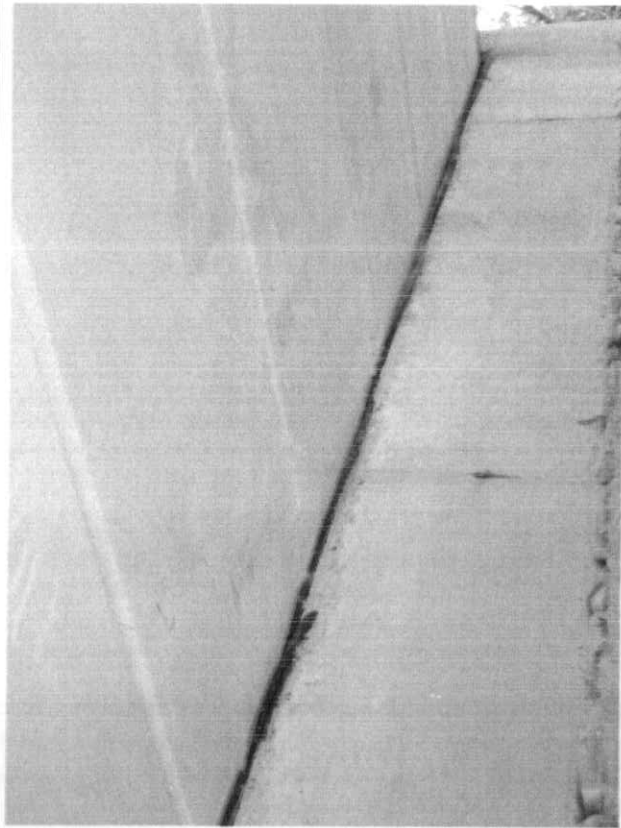
BEARING DEVICES	7	Premolded elastomeric bearing material between the deck units and the cap section of the abutments. The bearing material has squeezed out up to 4" longitudinally. See sheet 12 and photos 11 & 12.
STRINGERS	7	The prestressed concrete deck units are generally in good condition. The joints between deck units are open between 1/4" and 5/8" with missing joint material. There is up to 1/2" vertical misalignment between adjacent deck units likely due to construction. There is evidence of leakage through the joints between the deck units with random areas of light debris in the joints likely due to past high water. See photos 9 & 10. The reinforced concrete fascias have light scaling and edge spalling at the interface of the steel

Photo # 11: Bearing material between deck units and the north abutment cap squeezing out

1. The premolded elastomeric bearing material between the deck units and the cap section of the abutments has squeezed out up to 4" longitudinally. No repairs at this time.
2. The joints between prestressed concrete deck units are open up to 5/8" with missing joint material. There is up to 1/2" vertical misalignment between adjacent deck units likely due to construction. There is evidence of leakage through the joints between the deck units with random areas of light debris in the joints likely due to past high water. No repairs at this time.

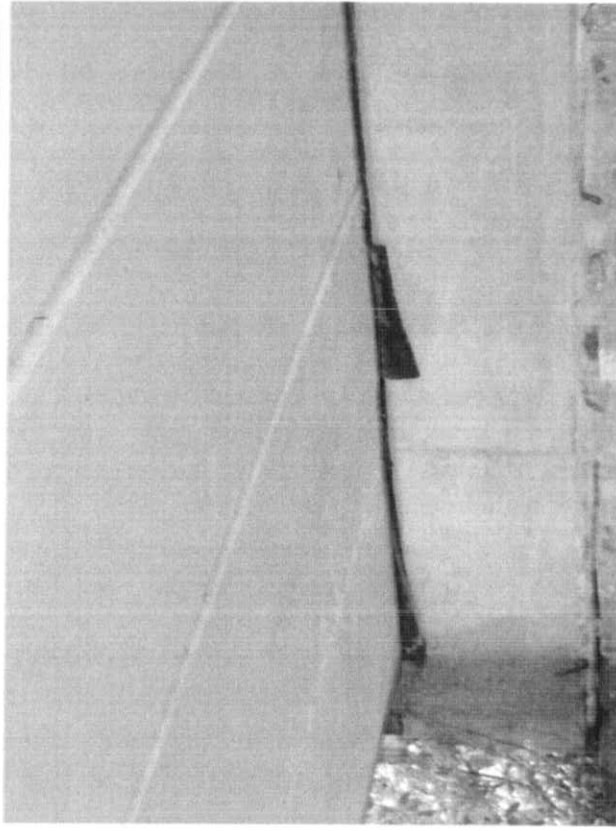
Photo # 12: Bearing material between deck units and the south abutment cap squeezing out

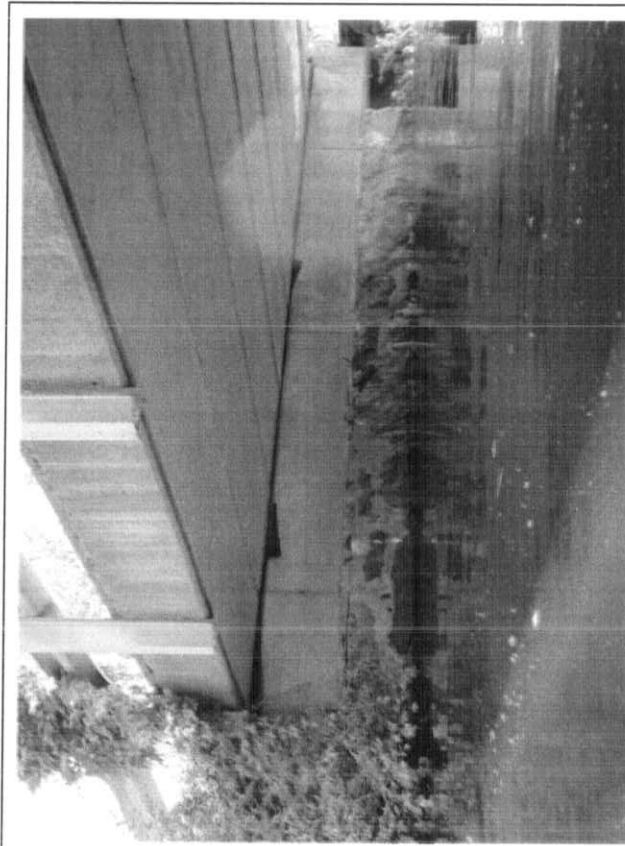
60. SUBSTRUCTURE	Stone masonry abutment stems with reinforced concrete cap sections.	OVERALL RATING 5
	RATING	
ABUTMENTS-STEM	5	<p>The reinforced concrete cap sections of the abutments have areas of light scaling and areas of minor honeycombing.</p> <p>North abutment: The stone masonry stem has approximately 50% missing mortar overall, mostly at the upstream and downstream ends. At the upstream end (12' length), there is 90% missing mortar with up to 8" penetration between stones. At the downstream end (6' length), there is approximately 50% missing mortar with up to 6" penetration between stones. The remainder of the stem has less than 5% missing mortar with up to 3" penetration. At the downstream (west) end, the stem has failed with a 4' long x 2' high void due to missing stones and loss of the unconsolidated fill material behind the stem. The total penetration underneath the cap section is 13". See photos 13, 15 & 16.</p> <p>South abutment: The masonry stem typically has less than 5% missing mortar above the water surface with up to 3" penetration between stones. From the water surface to the channel bottom, there is approximately 50% missing mortar with penetrations up to 6" between stones. At the upstream quarter point (6' from the end of the stem), there is a 18" long x 10" high x 6" deep stone/mortar void. At the downstream (west) end, the stem has failed with a 3'-8" long x 2' high void due to missing stone work and loss of the unconsolidated fill material behind the stem. The void extends up to 30" underneath the cap section. Previous bituminous patch material from the approach pavement above the void has sloughed through the void. See photos 14, 17 & 18. Also, see sheets 13 & 14.</p>

Photo # 14: South abutment elevation

1. The stone masonry abutment stems have areas of missing mortar with a maximum of 8" penetration between stones. ✓ Near the upstream end of the south abutment, there is 18" long x 10" high x 6" deep stone/mortar void. ✓ Repoint the mortar joints at the north and south abutments (\pm 50 SF) and repair void in the south abutment stem (< 1 CF).

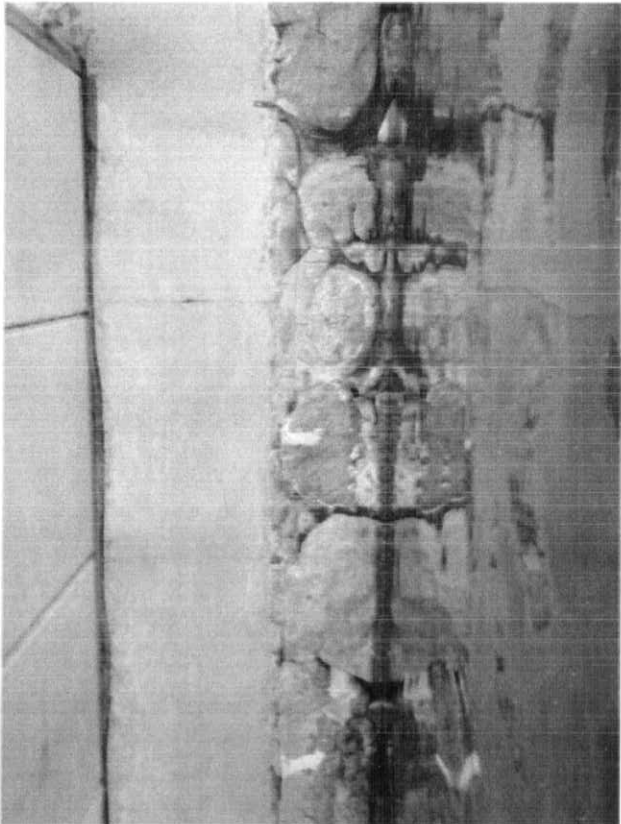
Photo # 15: Upstream (east) end of north abutment stem with stone and mortar voids above the water surface

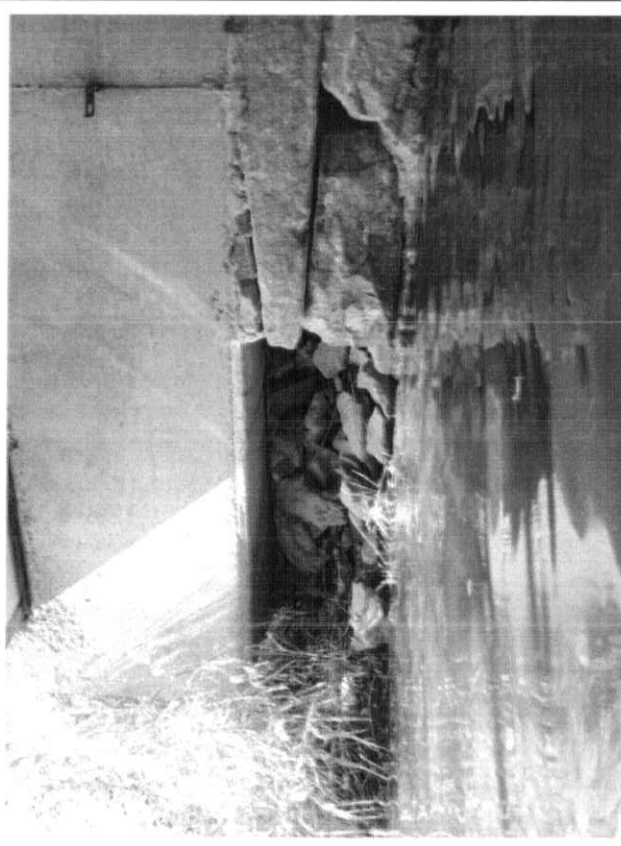
Photo # 16: Downstream (west) end of north abutment stem with showing 3'-8" long x 2' high void with 30" penetration underneath the cap and unconsolidated fill material ✓

2. At the downstream (west) end of the north and south abutment stems, the stems have failed with voids due to missing stones and loss of the unconsolidated fill material behind the stem. ✓ At the north abutment, the void is 4' long x 2' high and extends up to 13" underneath the concrete cap section of the abutment. At the south abutment, the void is 3'-8" long x 2' high and extends up to 30" underneath the abutment cap section. Previous bituminous patch material from the south approach pavement above the void has sloughed through the void. Stabilize the fill behind the abutment stems and repair voids.

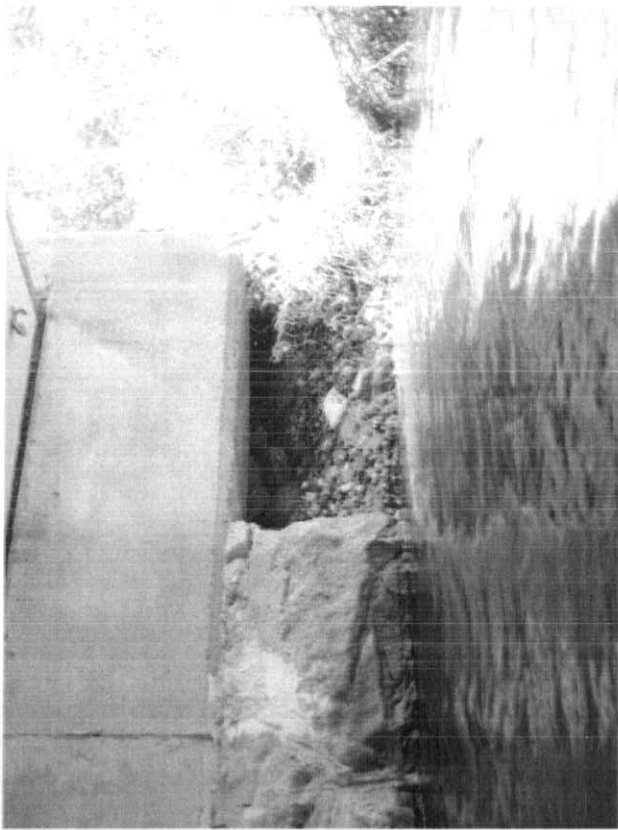
Photo # 17: Downstream (west) end of south abutment stem with 4' long x 2' high void with 13" penetration underneath the cap and unconsolidated fill material ✓

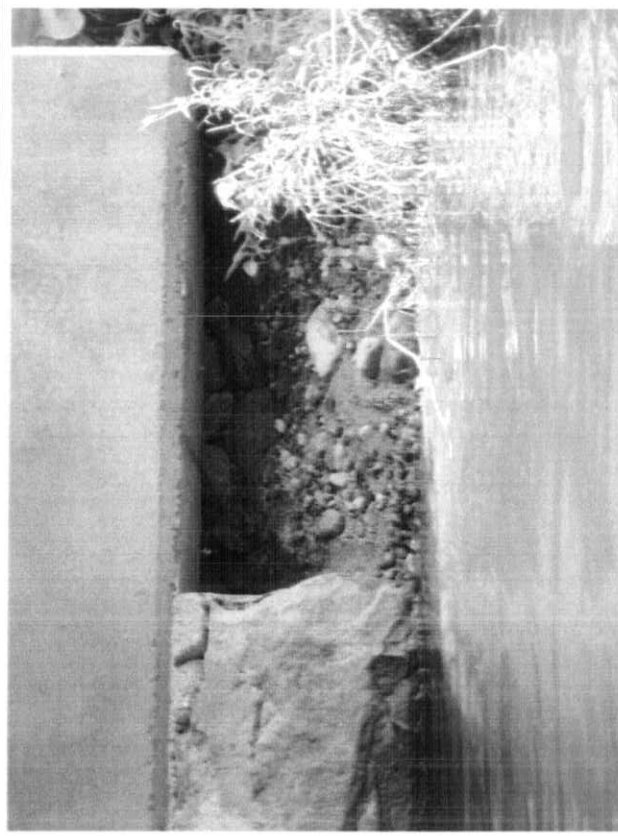
Photo # 18: Close-up of photo 17 showing bituminous patch material that has sloughed through ✓

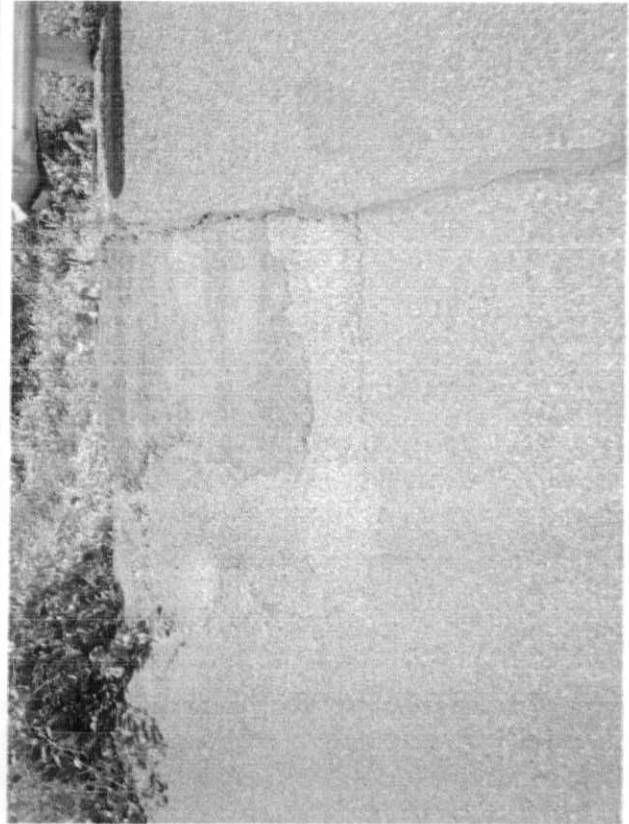
The approach pavements have minor raveling and random sealed cracks. At the south approach at the abutment, there is a slightly settled 5' x 2' bituminous patch to repair the pavement that has sloughed through the void in the abutment stem beneath. See sheet 10 and photo 19.

Photo # 19: Bituminous concrete patch repair in approach pavement over void in south abutment stem
Note: evidence of previous patching in same area due to bituminous material sloughing through void

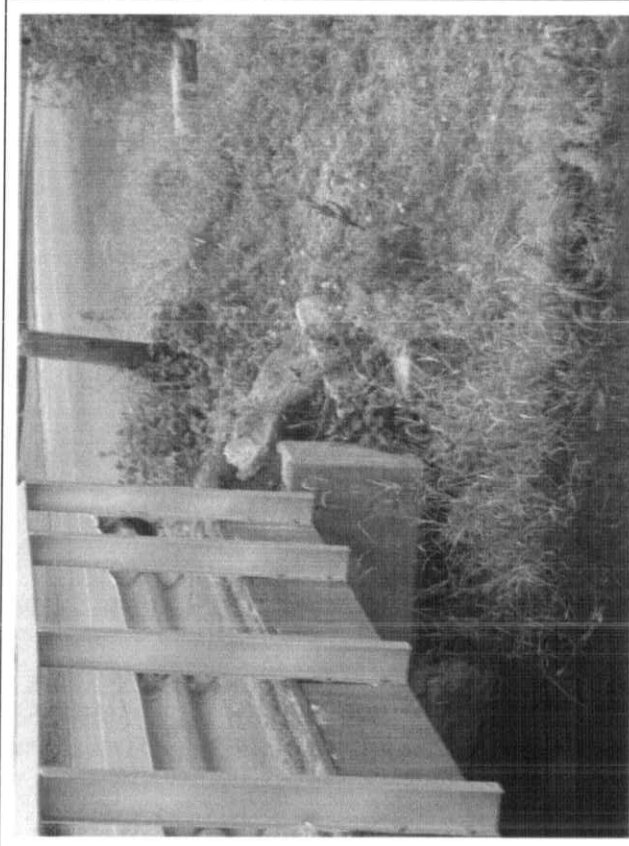
There is minor erosion along the approach embankments. See photo 20.

Photo # 20: Southwest approach embankment
