# STRUCTURE NO. 04601

NORTH BEAR HILL RD  
over  
NATCHAUG RIVER  
CHAPLIN

Indepth Inspection  
on  
7/8/2009

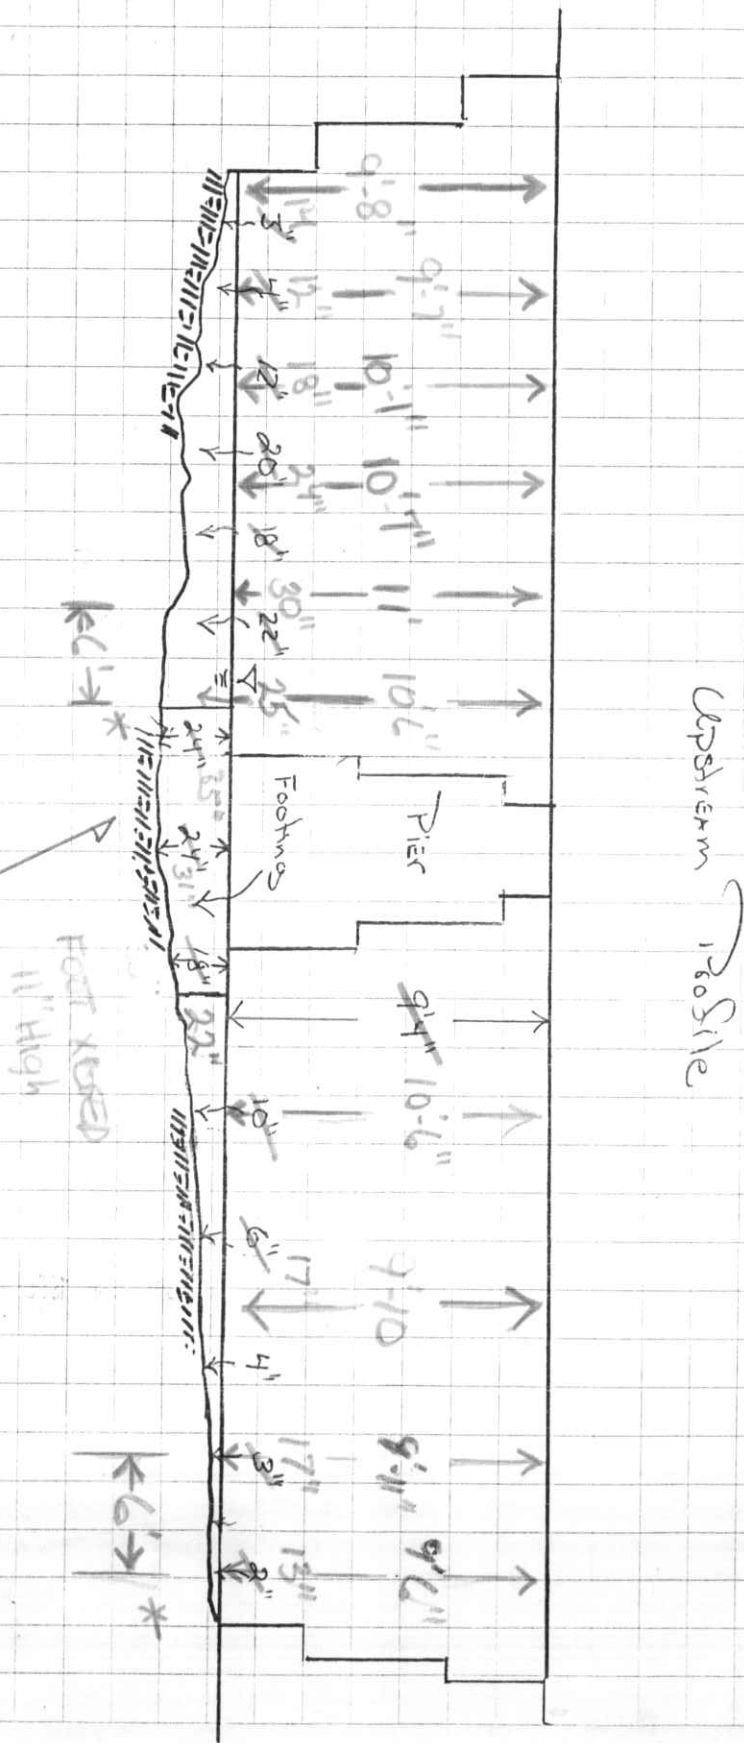
NOTE: LARGE ROCK AT NOSE OF PIER CAUSING SCOUR PROBLEM. SHOULD BE REMOVED.

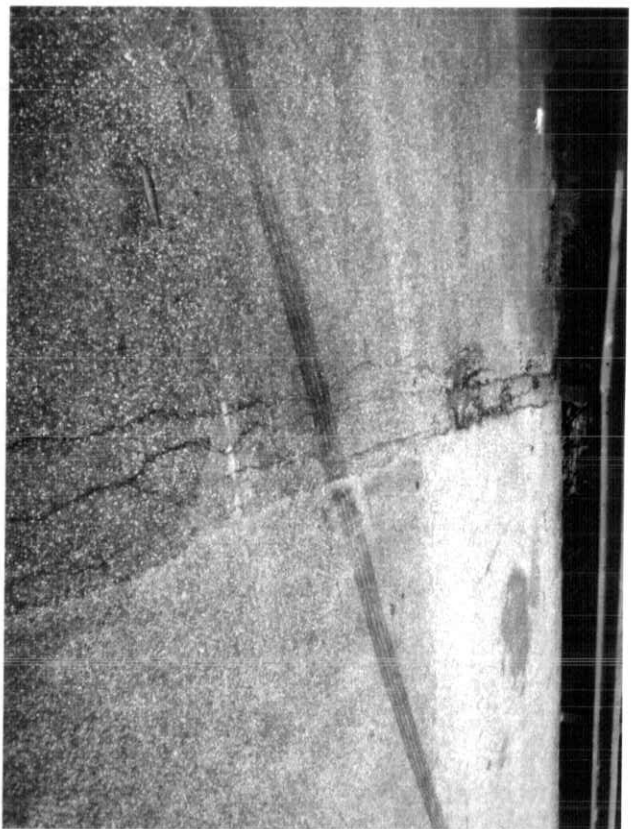
Photo # 9: TRANSVERSE CRACKS AT EAST DECK  
END.

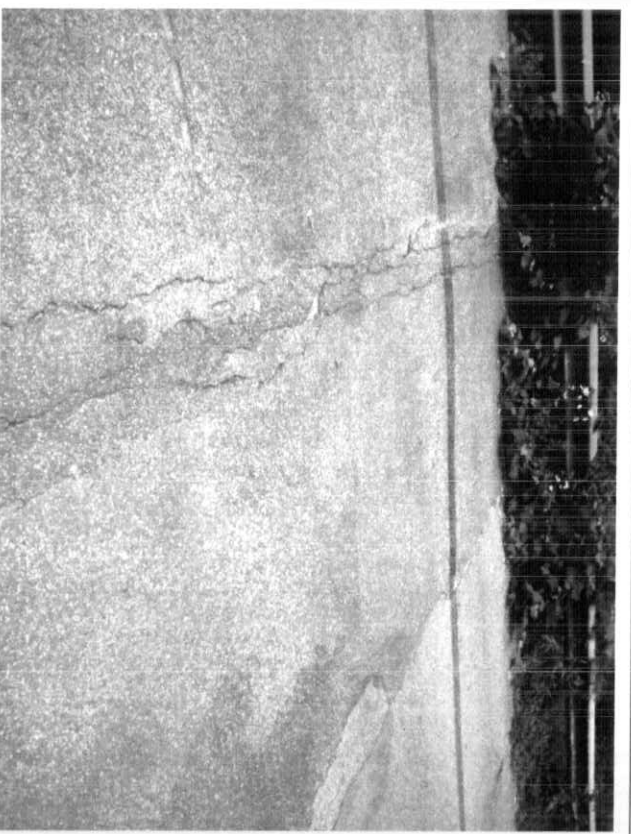
Photo # 10: TRANSVERSE CRACKS AT WEST DECK  
END.

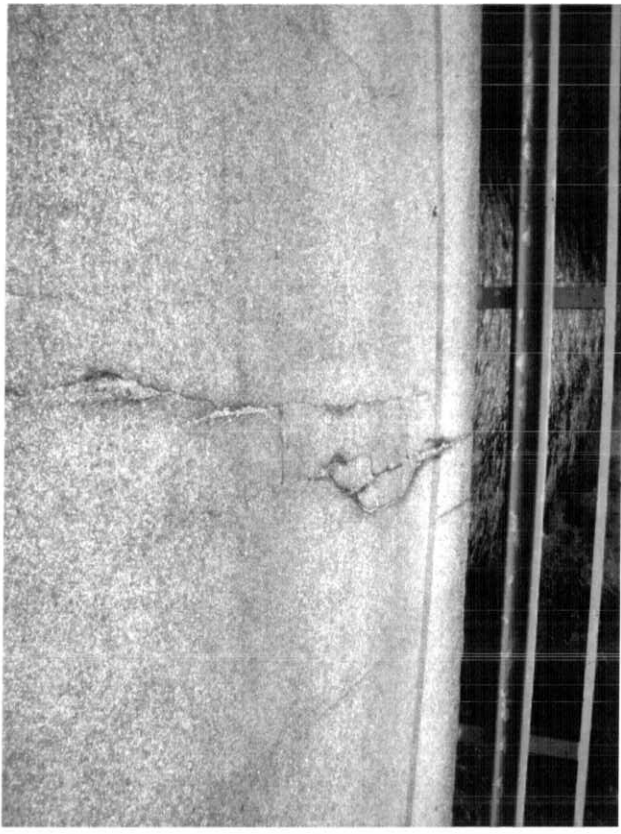
Photo # 11: TRANSVERSE CRACKS OVER PIER.

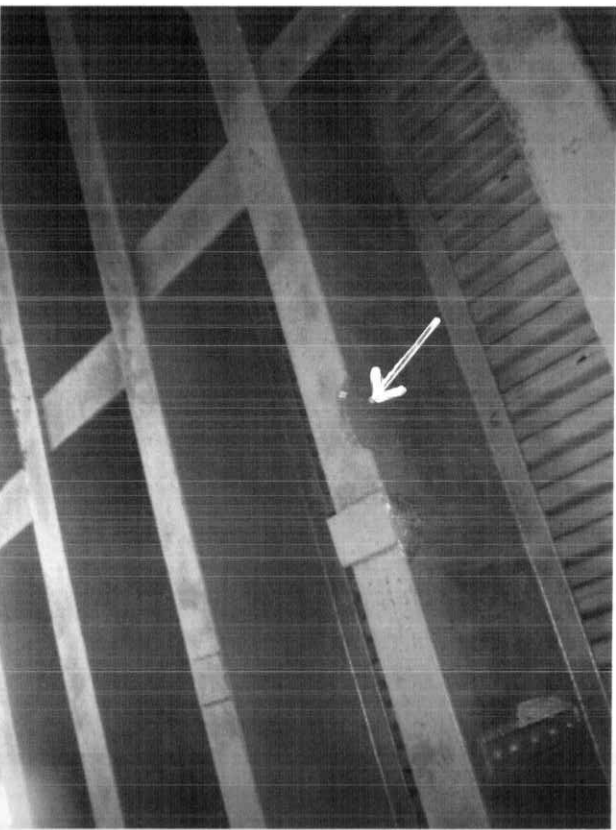
Photo # 16: BEAM # 6 IN SPAN # 1 WITH A TORCH CUT SECTION, 7 IN. X 3 IN., REMOVED FROM THE NORTHSIDE OF THE BOTTOM FLANGE, AT CENTER OF SPAN.

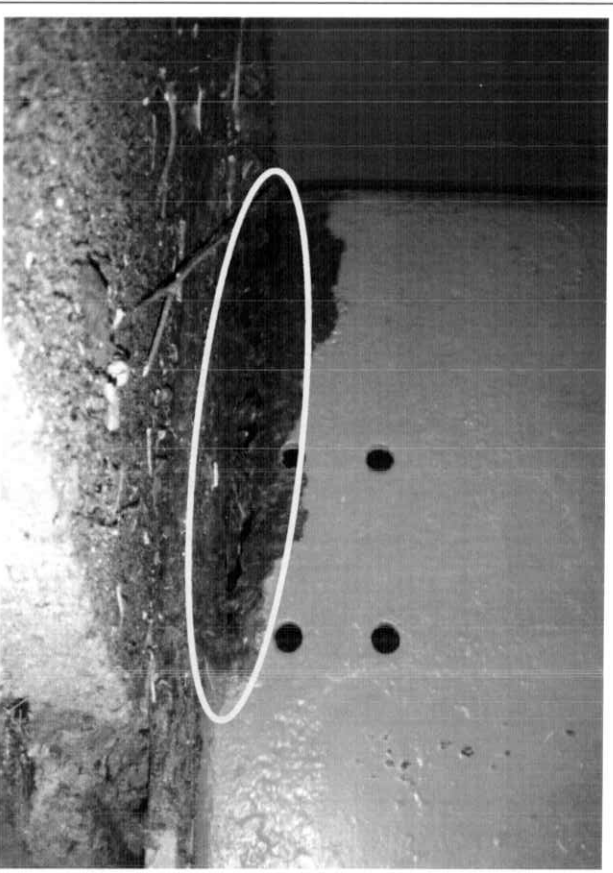
**Photo # 17: BEAM # 5 NORTH FACE, OVER BEARING AREA, AT ABUTMENT # 1 WITH A 15 IN. X 1 IN. HOLE IN BOTTOM OF WEB.**

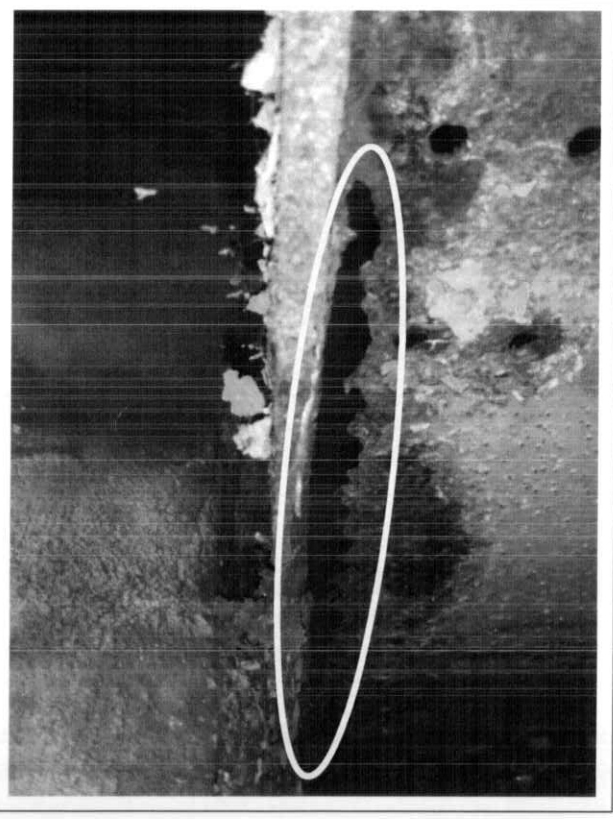
**Photo # 18: BEAM # 5 SOUTH FACE, OVER BEARING AREA, AT PIER IN SPAN # 1 WITH A 33 IN. X 1 3/4 IN. HOLE IN BOTTOM OF WEB.**

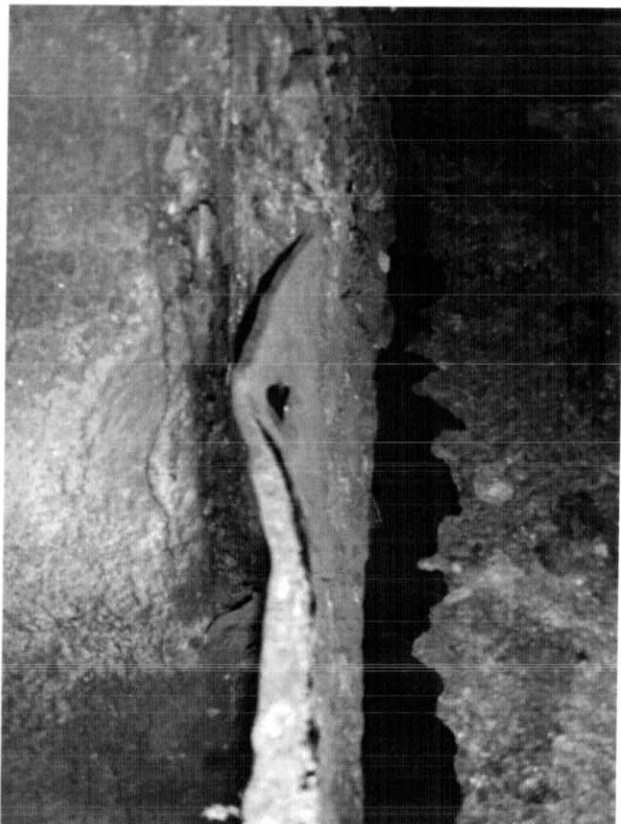
Photo # 19: BOTTOM FLANGE BEAM # 5 NORTH SIDE AT PIER, IN SPAN # 1 IN FRONT OF BEARING AREA.

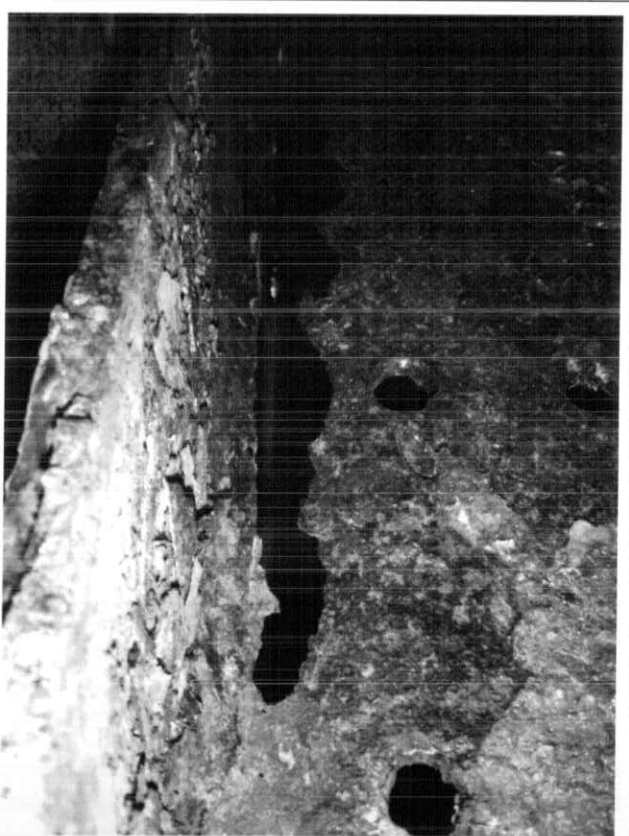
Photo # 20: NORTH FACE OF HOLE IN PHOTO # 18.

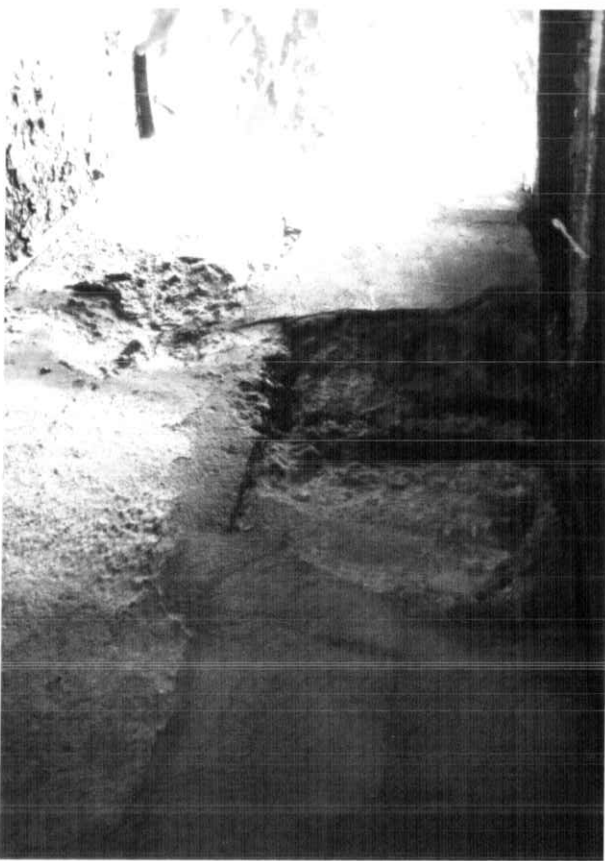
**Photo # 23: EAST FACE OF PIER WITH A 30 IN. X 15 IN. X 4 1/2 D. SPALL WITH EXPOSED REBAR UNDER BEARING # 8.**

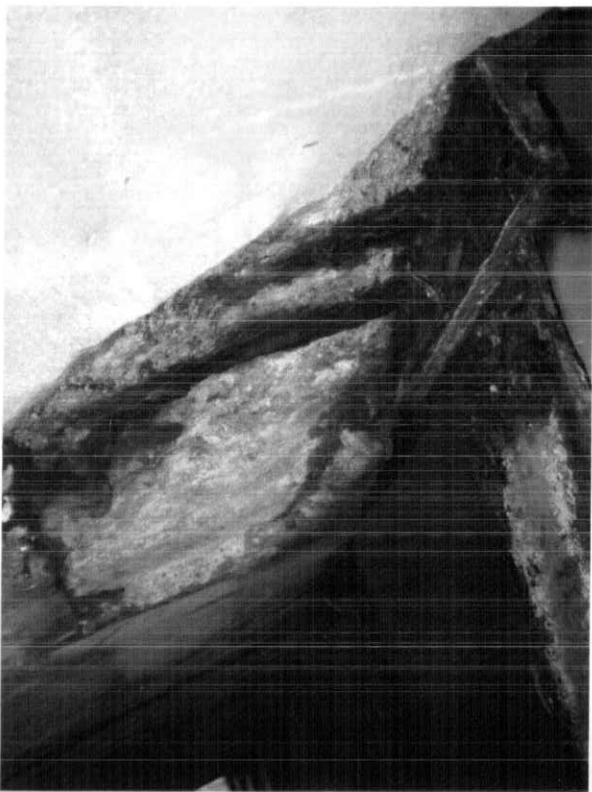
**Photo # 24: SEE PHOTO 23. UNDERMINING, 18 IN. X 4 1/2, OF BEARING PLATE # 8.**

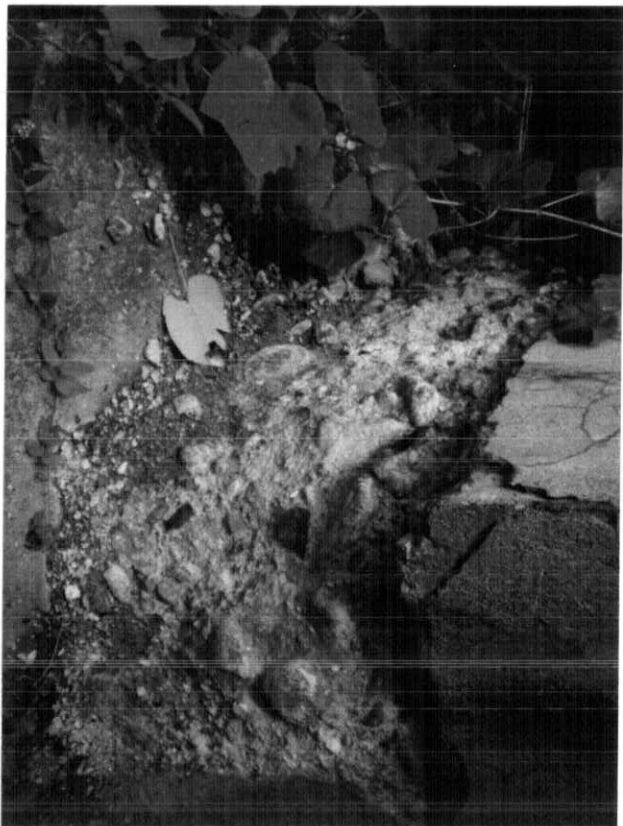
Photo # 25: SOUTH END OF PIER CAP WITH A 3½ FT. X 15 IN. X 2 IN. D. SPALL.

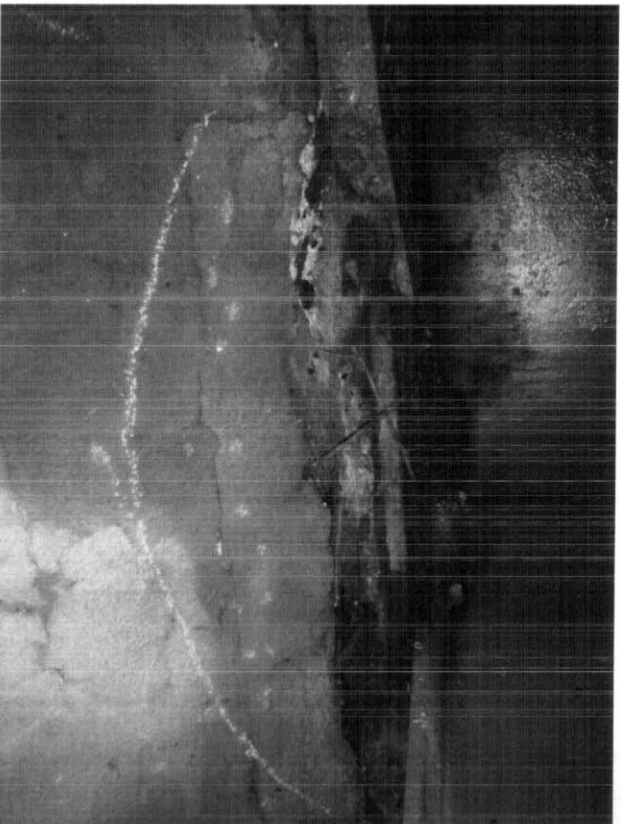
Photo # 28: 20 IN. X 3 IN. X 2 1/2 IN. SPALL IN ABUTMENT CAP # 2.

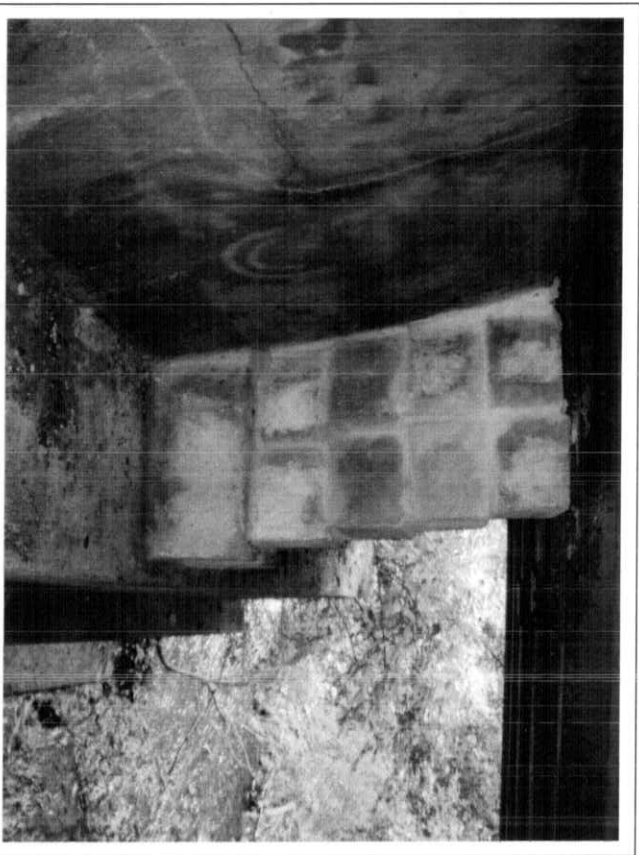
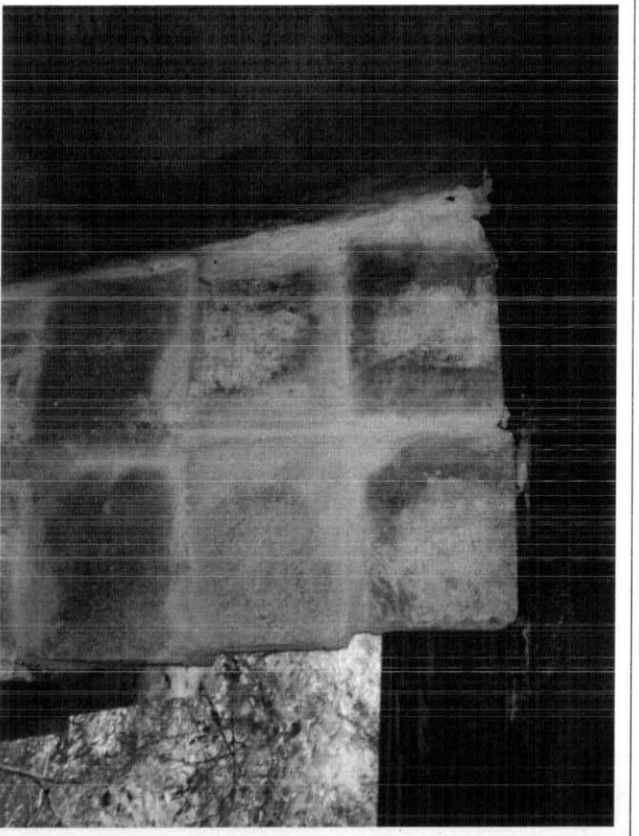
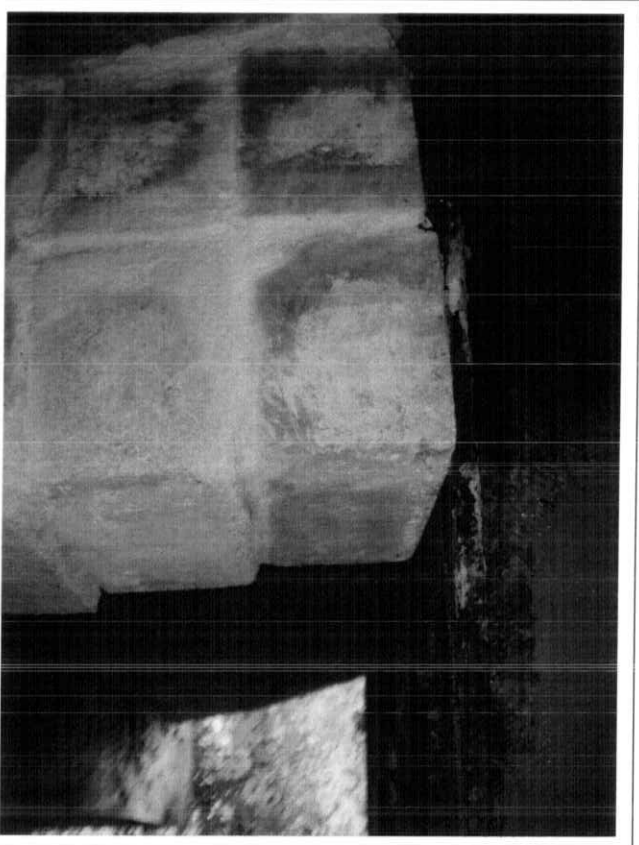
Photo # 1: CRIBBING UNDER BEAM 5 IN SPAN 1 AT PIER.

Photo # 2: CRIBBING UNDER BEAM 5 IN SPAN 1 AT PIER.

**Photo # 3: CRIBBING UNDER BEAM 5 IN SPAN 1 AT PIER.**

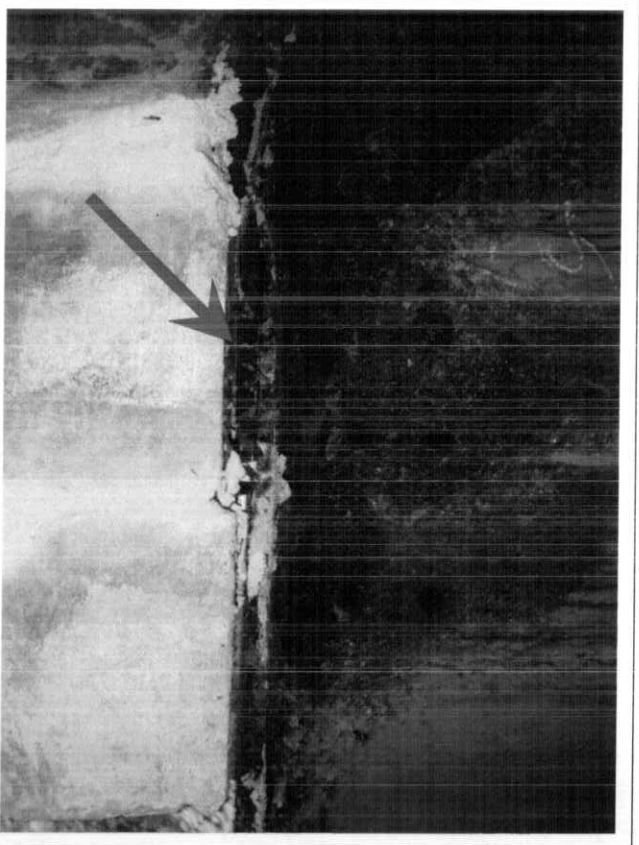
**Photo # 4: STEEL SHIM & BLOCK ON CRIBBING UNDER BEAM 5 IN SPAN 1 AT PIER.**
