# STRUCTURE NO. 04746

SUNNYSIDE STREET

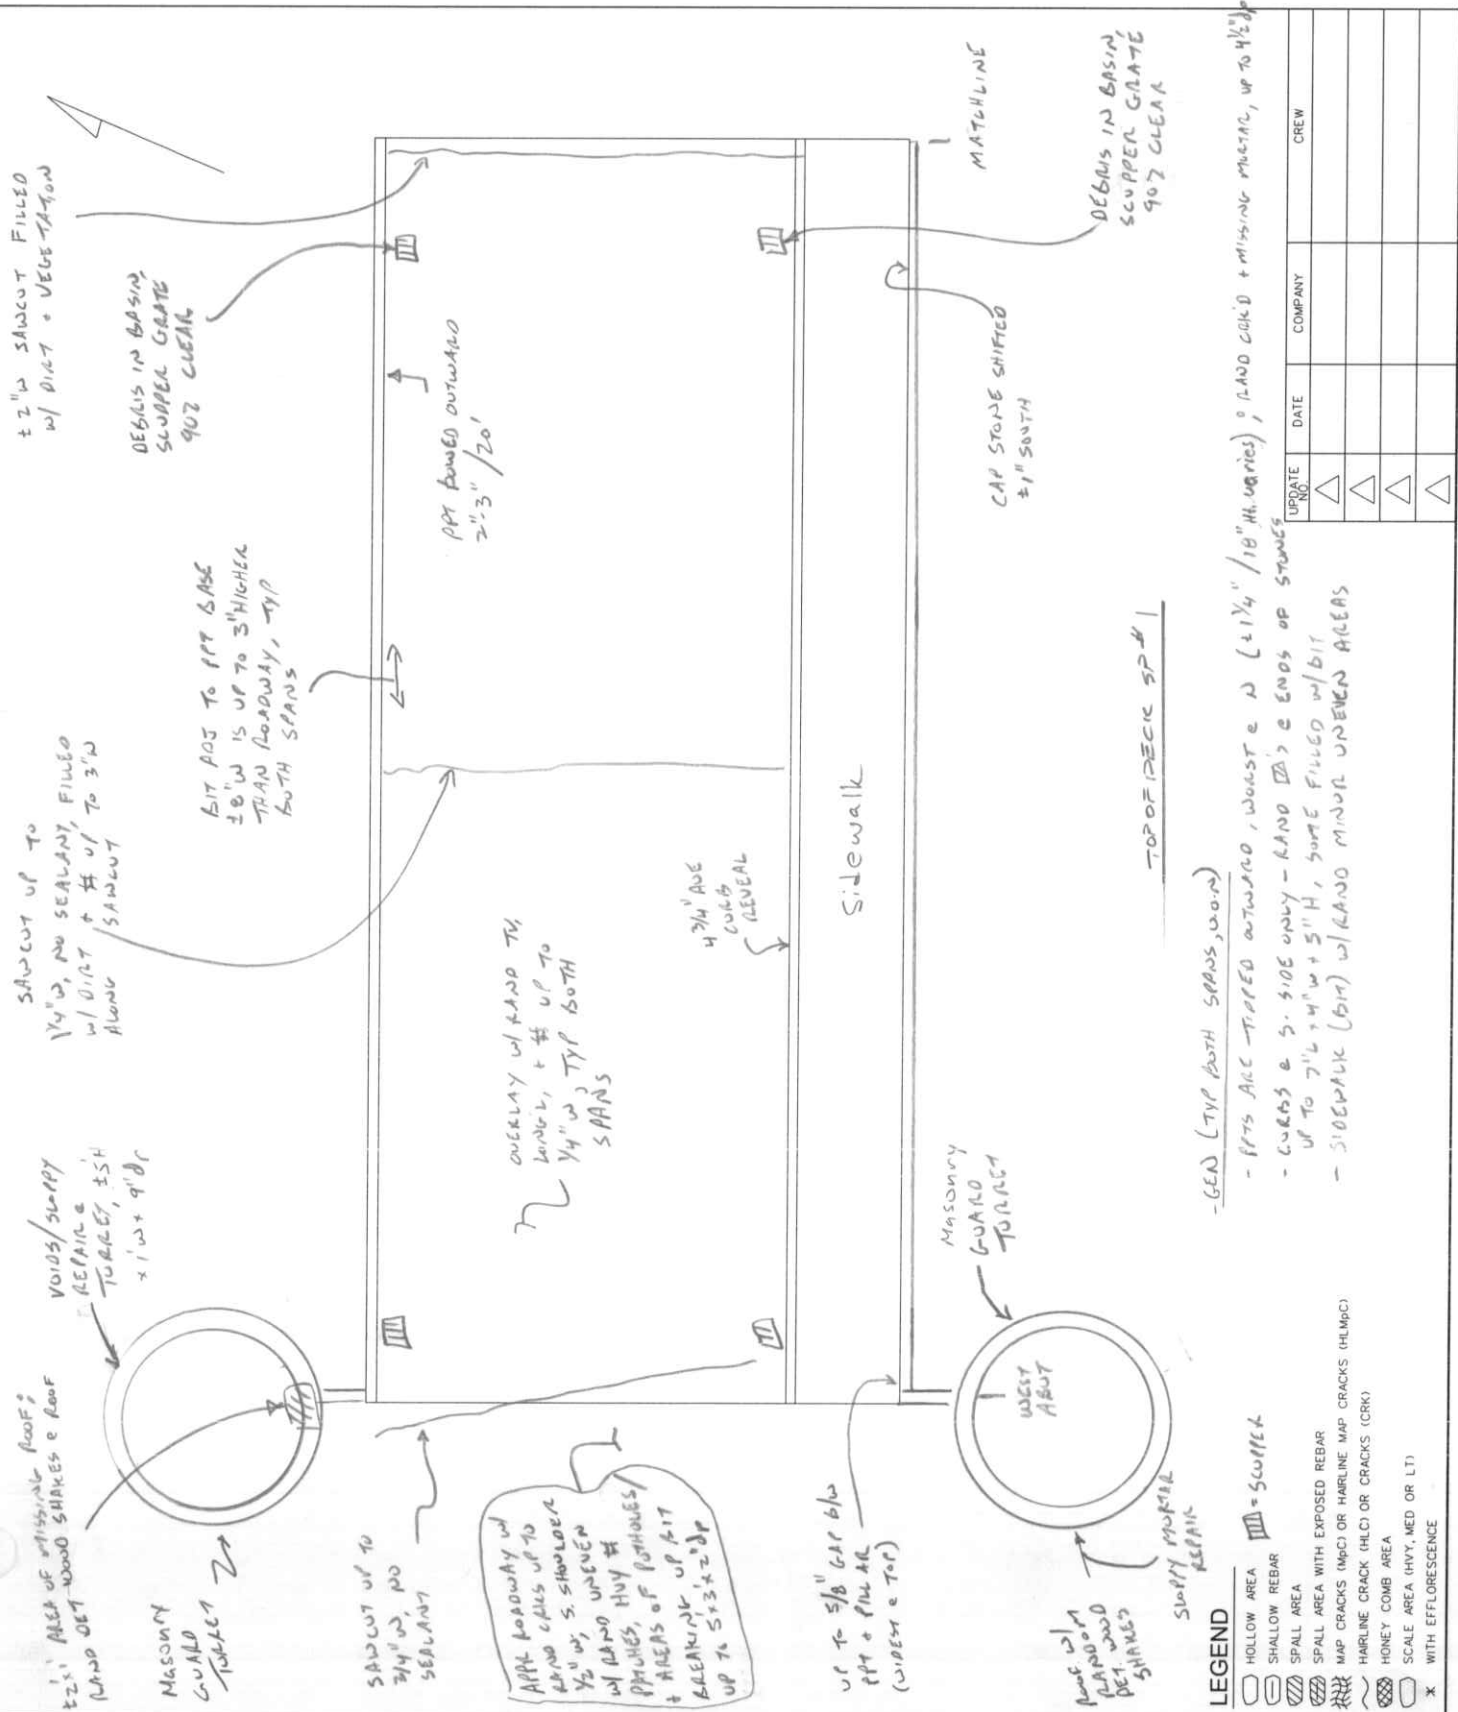
UPDATE NO.	DATE	COMPANY	CREW
△			
△			
△			
△

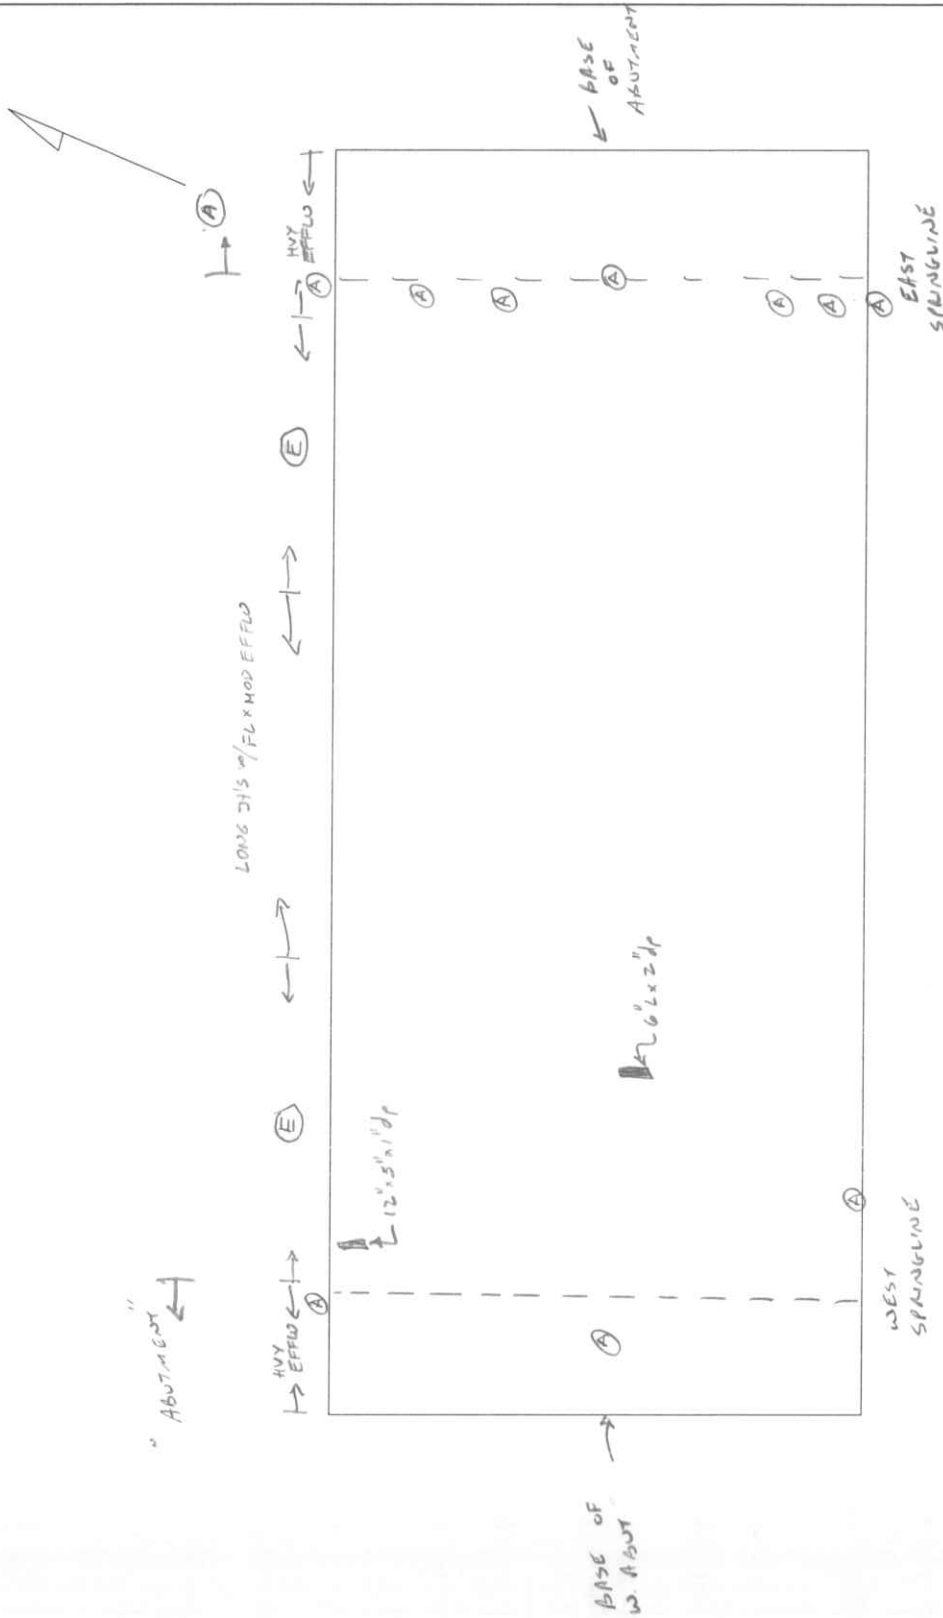
DESCRIPTION: Underside of Deck

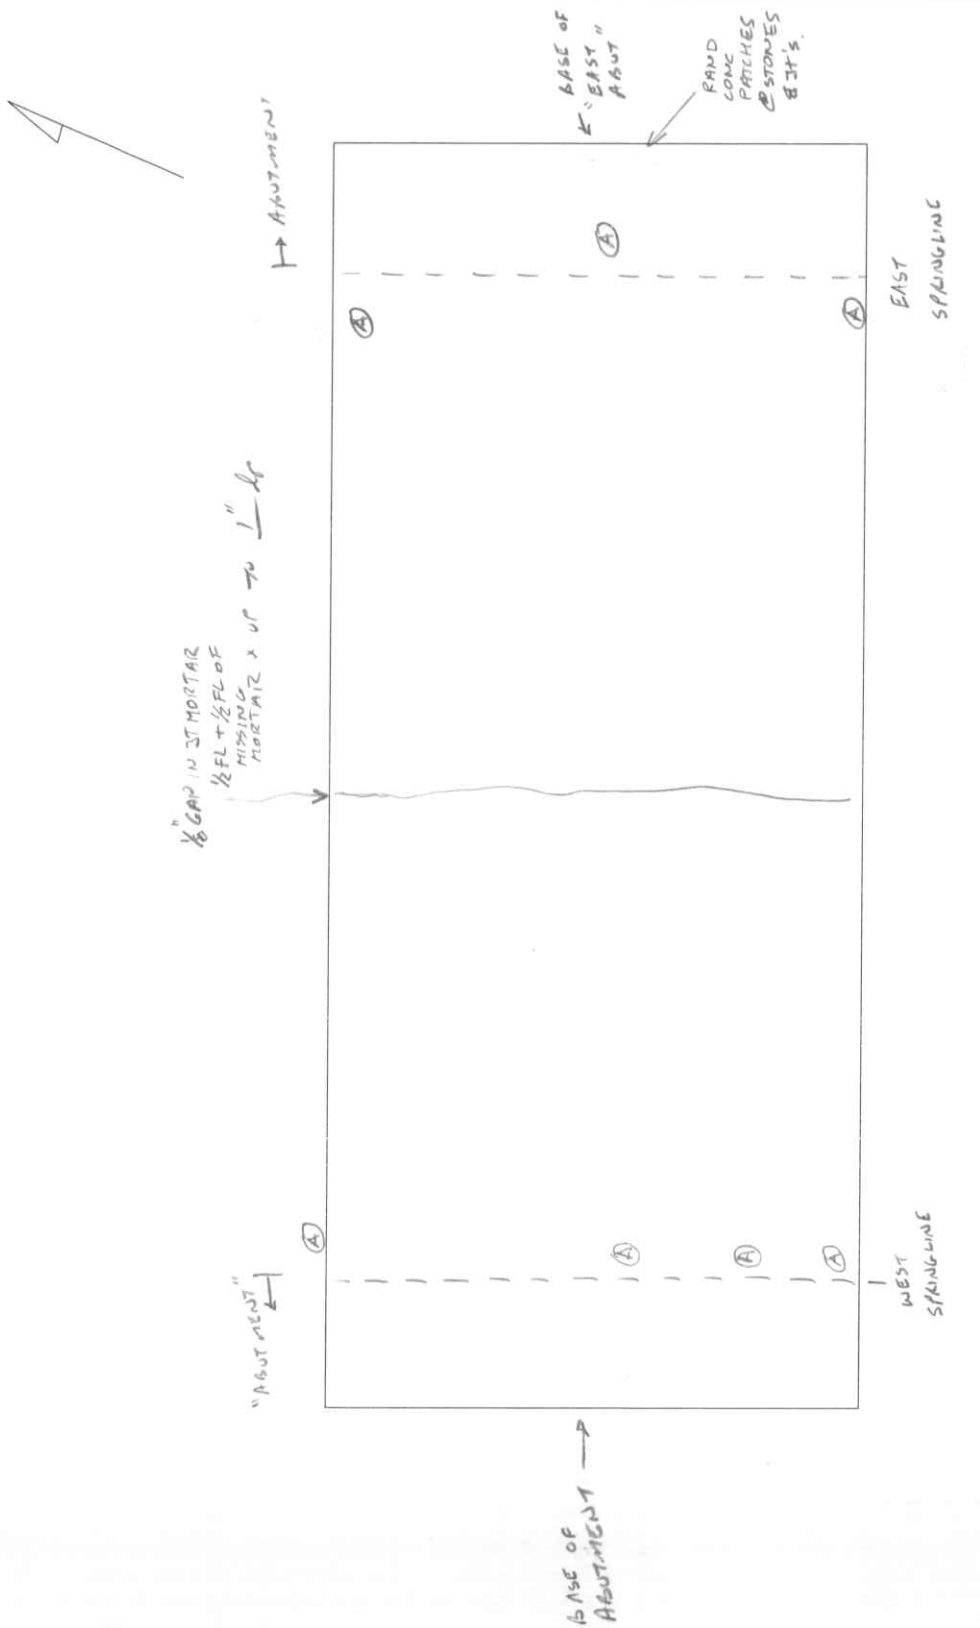
DESCRIPTION: Underside of Deck

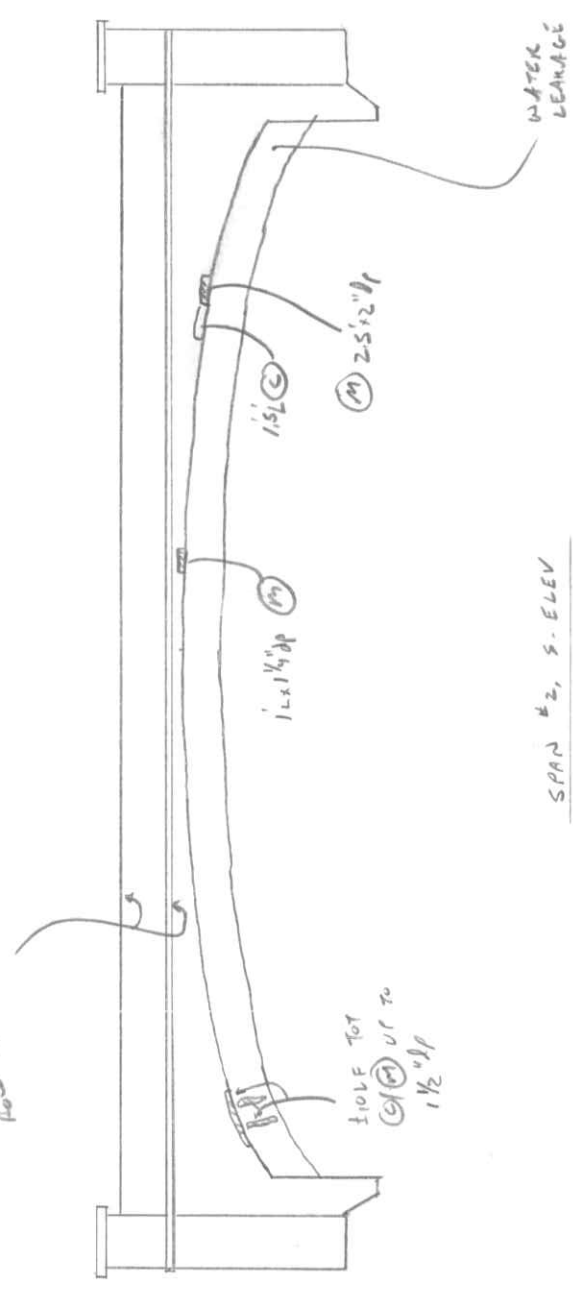
LAND CRACK MORTAR BELOW THIS  
FLOW OF STONES, 7/16" x 1/8" W.

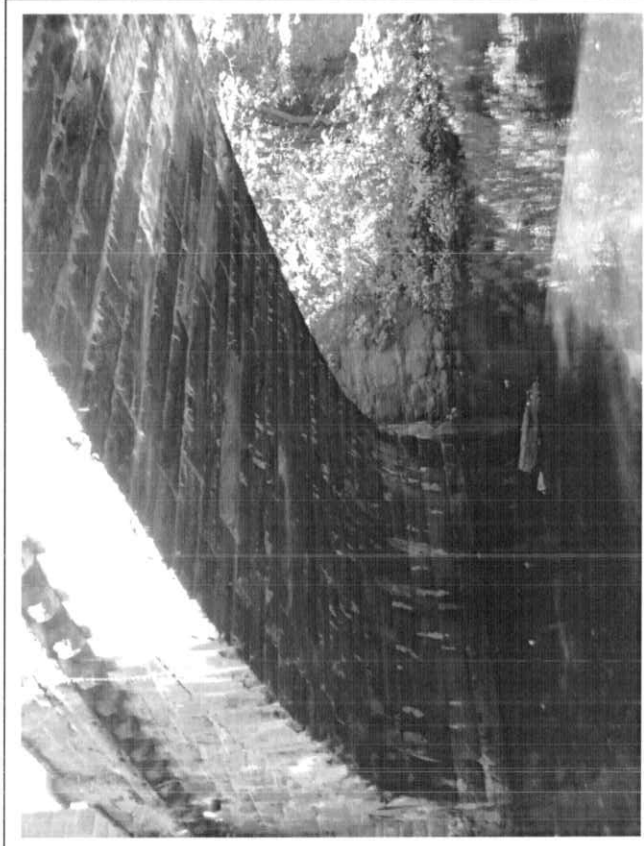
**Photo # 4: Typical underside, span 1 (looking west).**

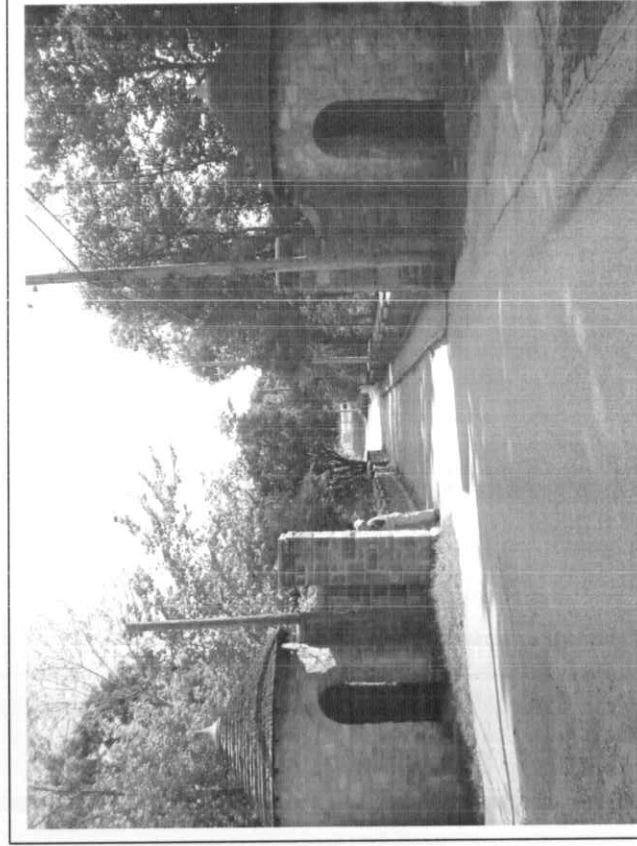
**Photo # 5: Bridge from the west approach.**

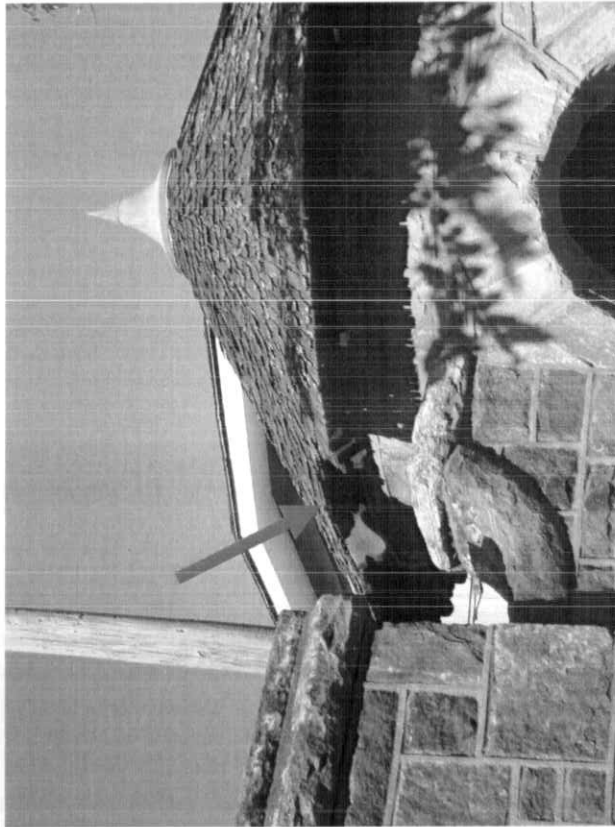
**Photo # 13: North guard turret: Missing section of roof at the south side of the turret.**

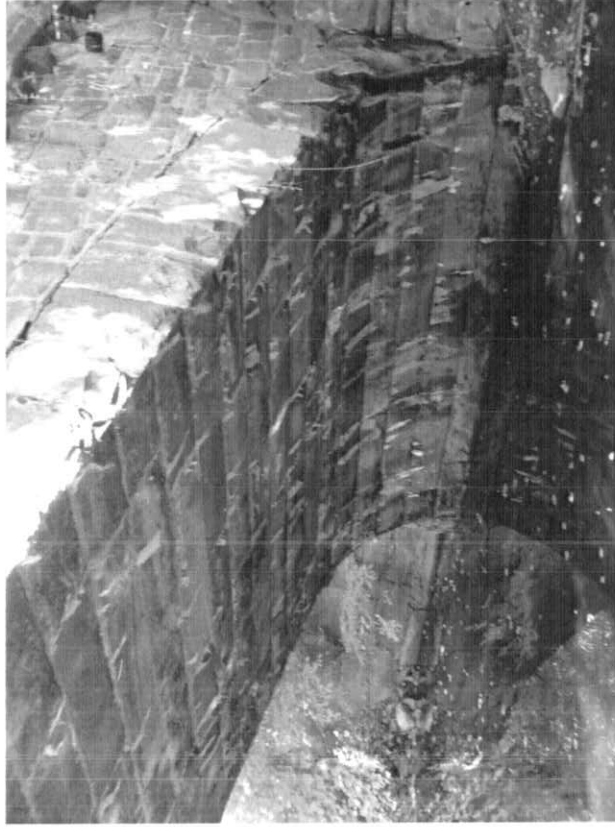
**Photo # 14: East end of span 1: Areas of heavy efflorescence and areas of water leakage through the arch intrados.**

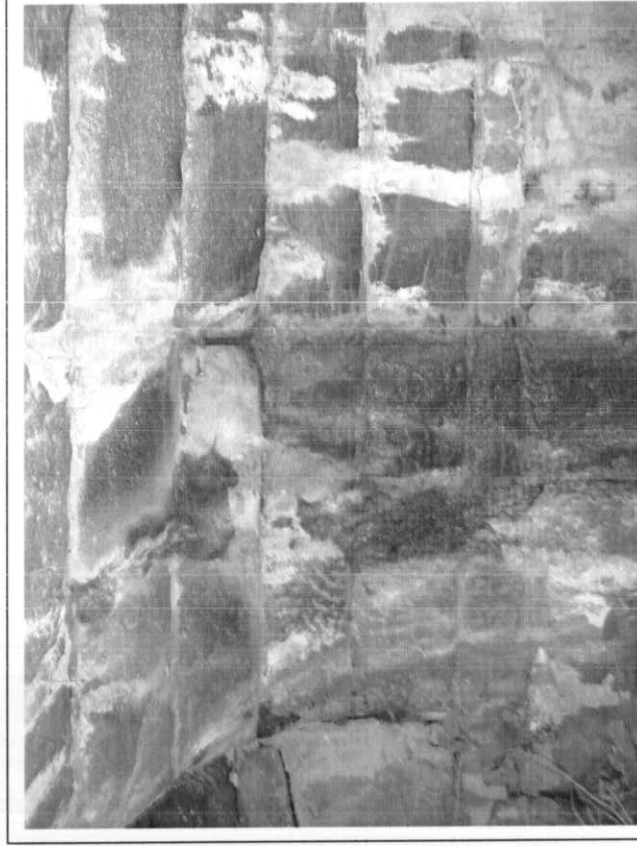
**Photo # 15: East end of span 2: Heavy efflorescence and water leakage through the arch intrados.**

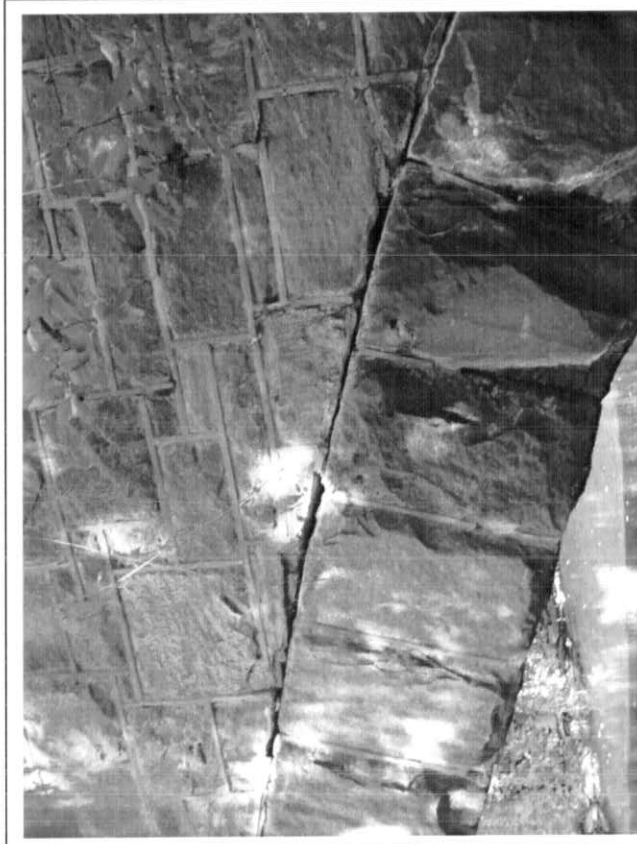
**Photo # 16: Span 1, south elevation, east end: Deteriorated mortar between the arch ring stones and the spandrel wall.**

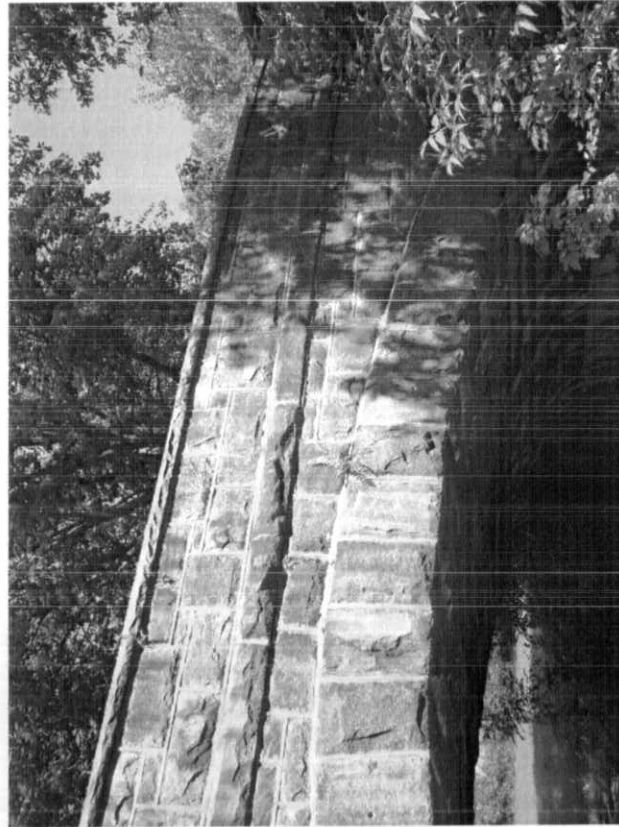
**Photo # 17: Span 2, south spandrel and railing, typical.**

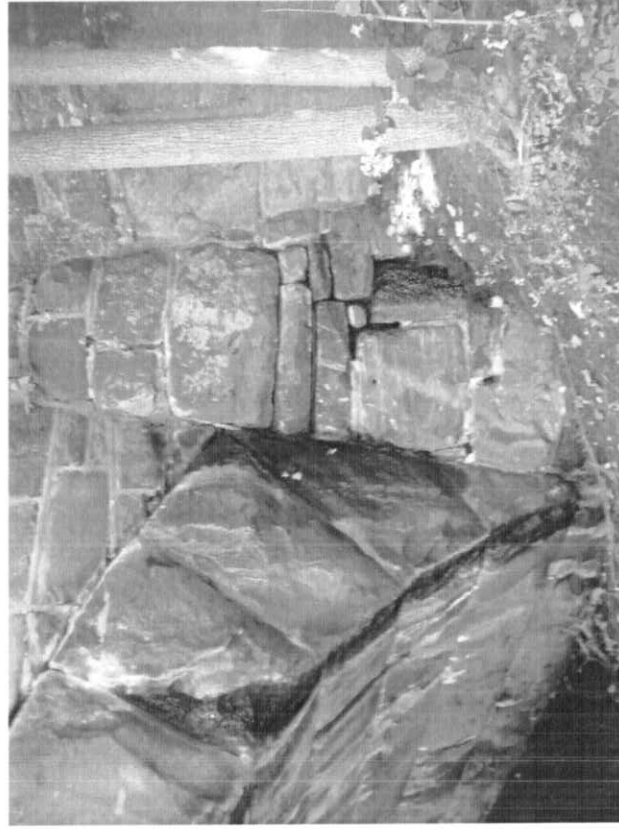
**Photo # 18: Span 1, southeast corner: Architectural stone treatment at the corner of the span has deteriorated mortar/voids between the stones. Also note the leakage through the arch ring.**

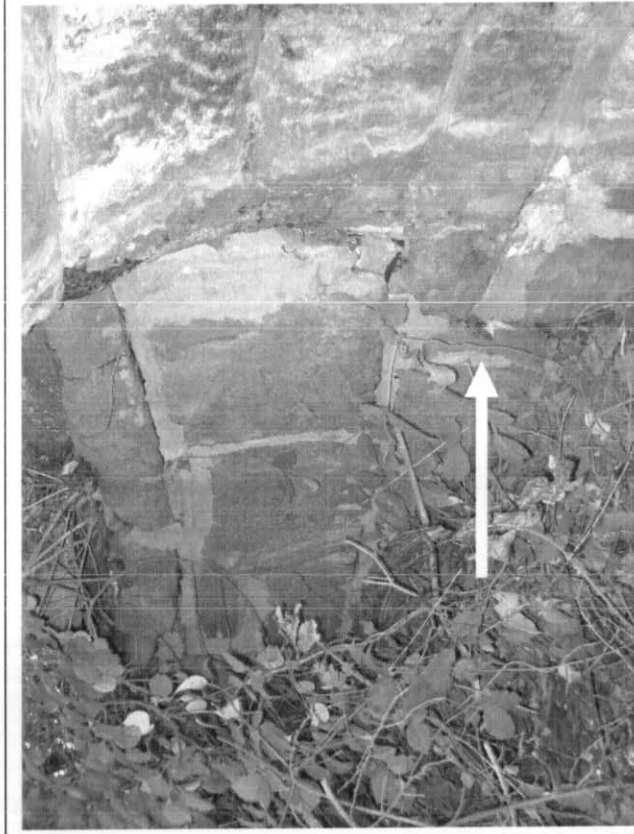
**Photo # 19: Northeast wingwall: Stones shifted out at the base.**

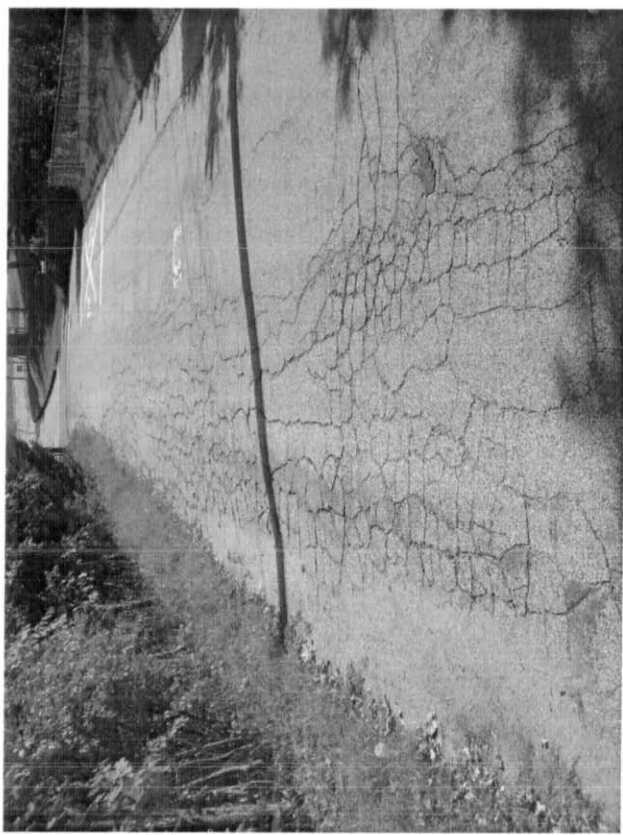
**Photo # 26: East approach pavement with heavy cracking.**

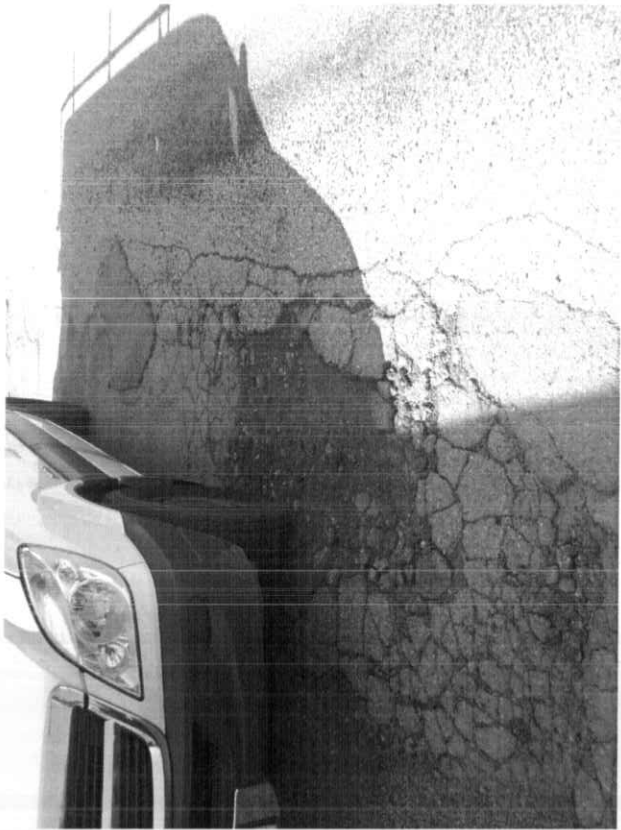
<p style="text-align: center;"><u><i>Intentionally left blank.</i></u></p>
<p><b>Photo # 27: Deteriorated bituminous at the west approach, south shoulder.</b></p>
