CONNECTICUT
DEPARTMENT
OF
TRANSPORTATION

CONDITION INSPECTION
FOR THE
COS COB STATION

**CONN. DEPT OF TRANSPORTATION
STATION INSPECTION**

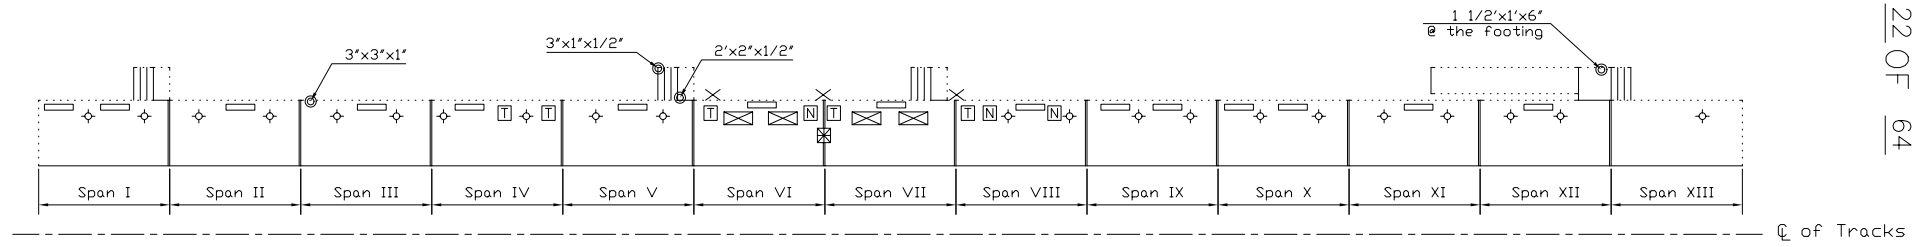
(Southbound) North Platform

1. The base plates for the double tee are rusted and deteriorated throughout the entire length of the platform.
2. The canopy in Spans VI–VIII is rusted.
3. The railing base plates are rusted and deteriorated throughout the entire length of the platform.

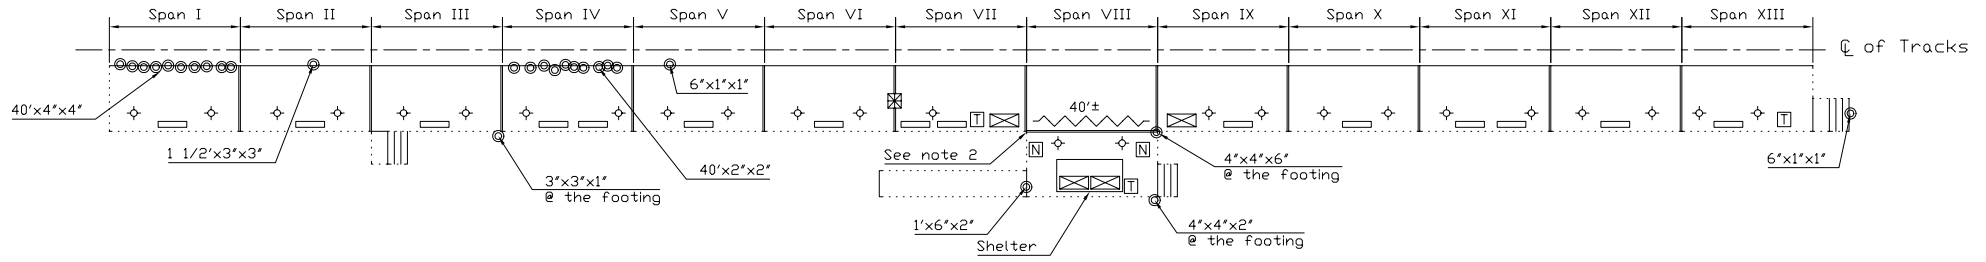
(Northbound) South Platform

1. The base plates for the double tee are rusted and deteriorated throughout the entire length of the platform.
2. There is spalled concrete with exposed steel (2'x2'x2").
3. The railing base plates are rusted and deteriorated throughout the entire length of the platform.

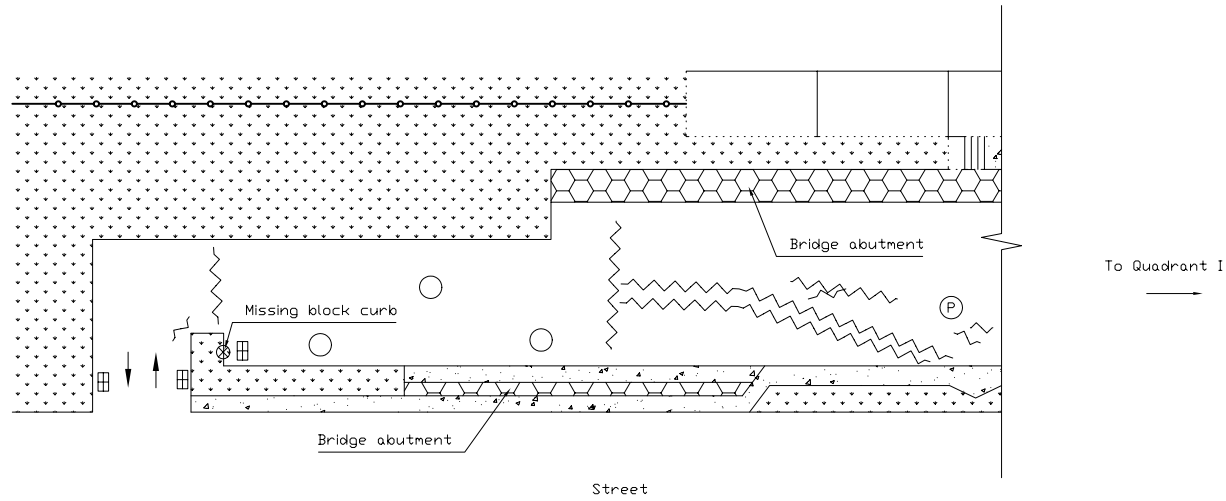
Urbitran Associates, Inc.
Connecticut Dept. of Transportation
Cos Cob Station Quadrant I (Lot 4) Plan
Date: 2/10/02

1. The asphalt surface is cracked (300'±).

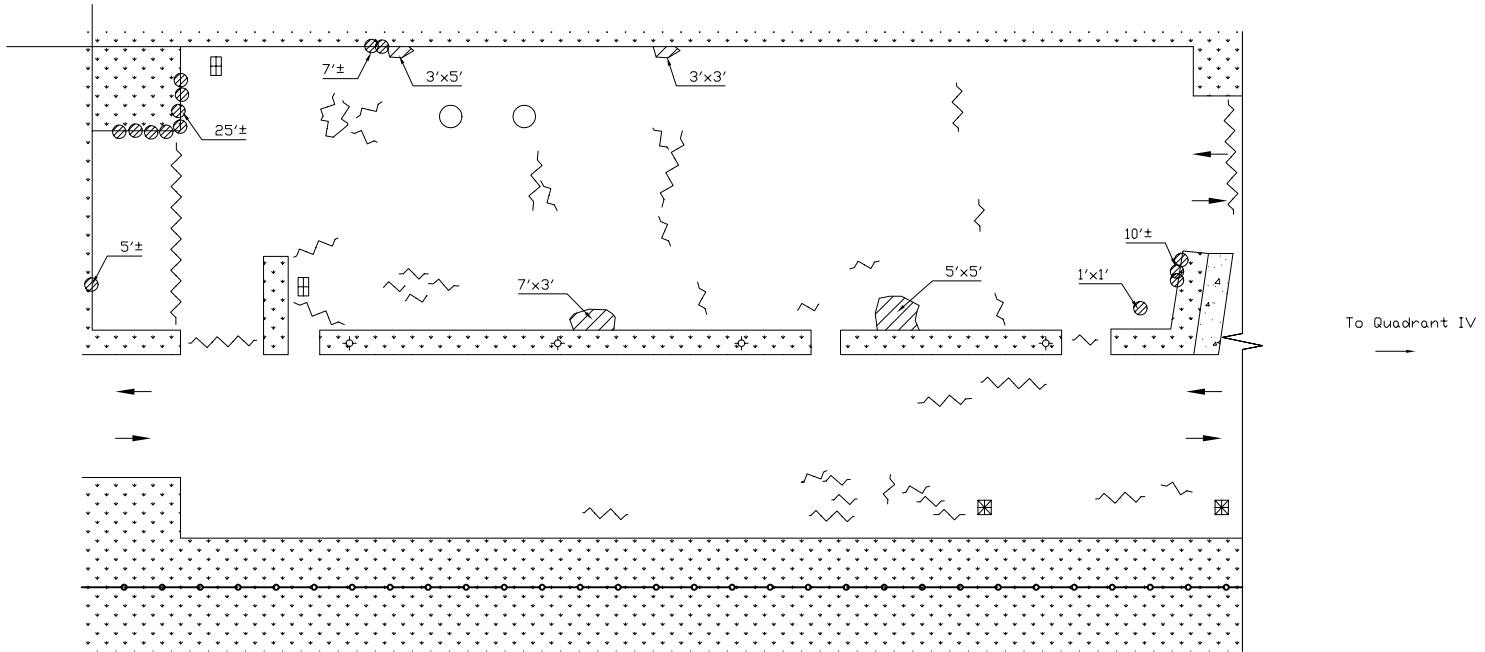
Urbitran Associates, Inc.
Connecticut Dept. of Transportation
Cos Cob Station Quadrant II (Lot 4) Plan
Date: 2/10/02

1. The asphalt surface is cracked (300'±).

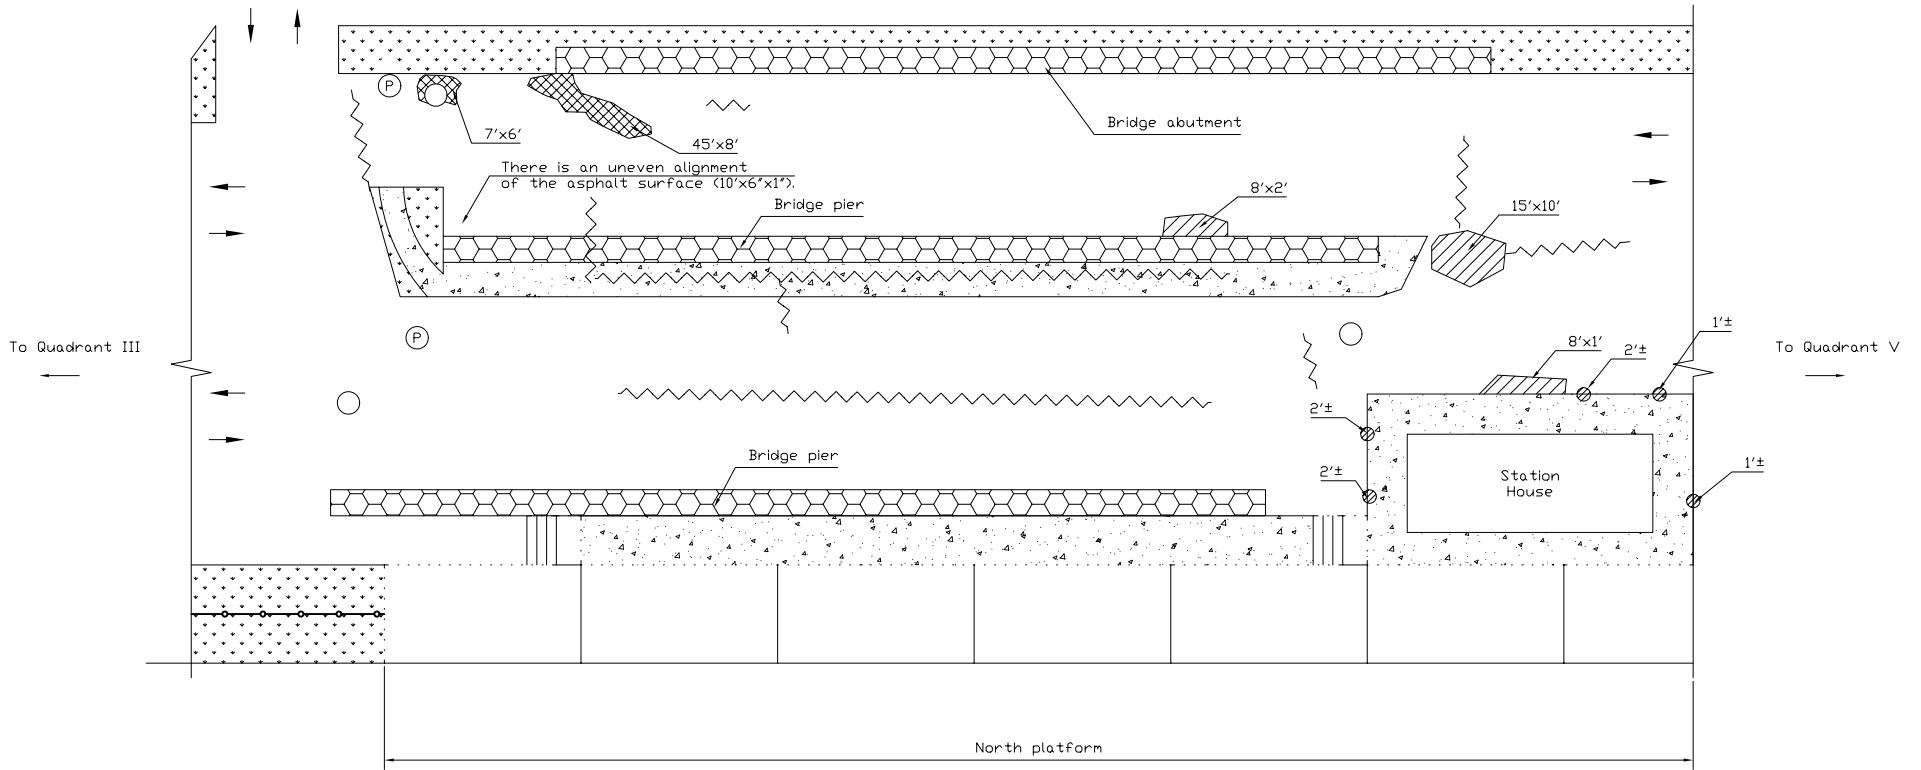
Urbitran Associates, Inc.
Connecticut Dept. of Transportation
Cos Cob Station Quadrant III (Lot 3) Plan
Date: 2/10/02

1. The asphalt surface is cracked 500'± in addition to the map cracking, and the uneven driving surface with cracks.

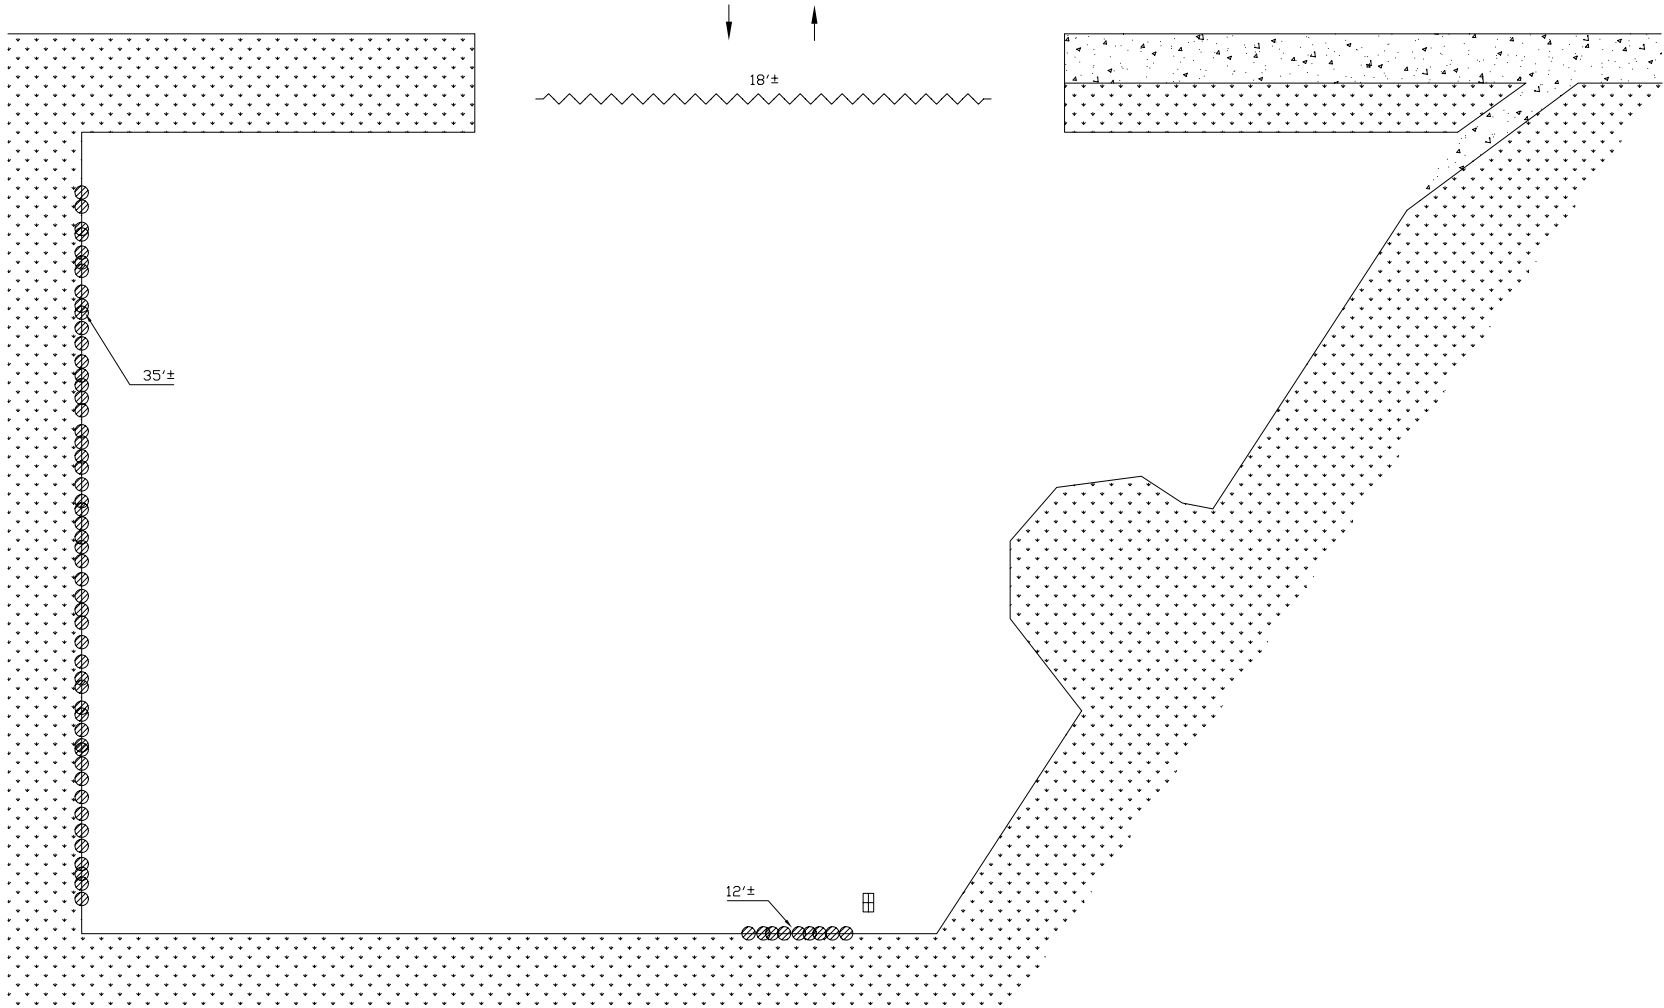
Urbitran Associates, Inc.
Connecticut Dept. of Transportation
Cos Cob Station Quadrant V (Lot 3) Plan
Date: 2/10/02

1. The asphalt surface is cracked 500'± in addition to the map cracking, and the uneven driving surface with cracks.
2. The concrete curb below the platform is spalled (240'±).

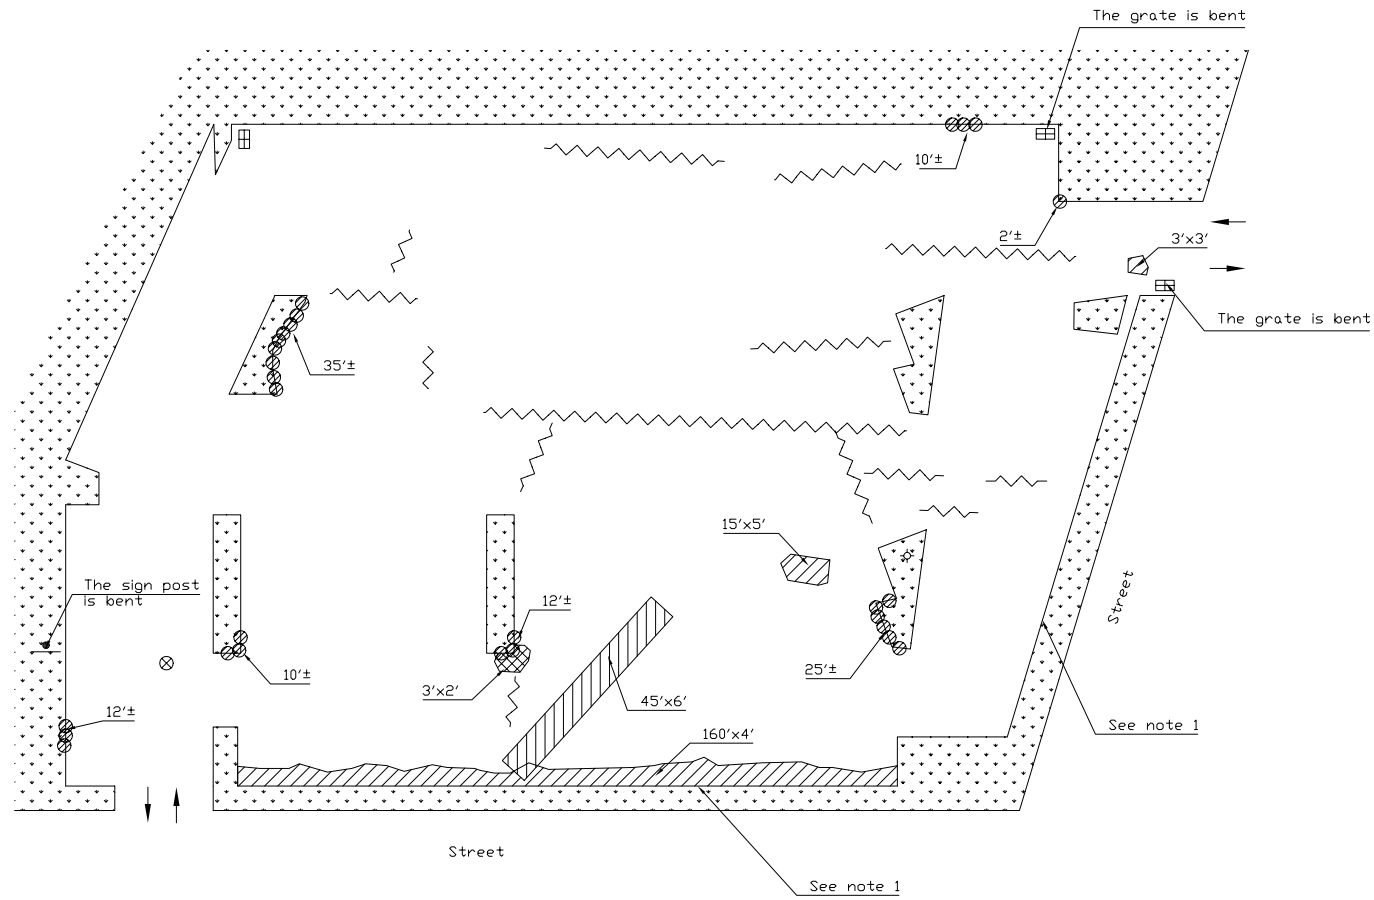
Urbitran Associates, Inc.
Connecticut Dept. of Transportation
Cos Cob Station Quadrant VII (Lot 2) Plan
Date: 2/10/02

1. There are ten areas (4'x4' each) that are missing asphalt.

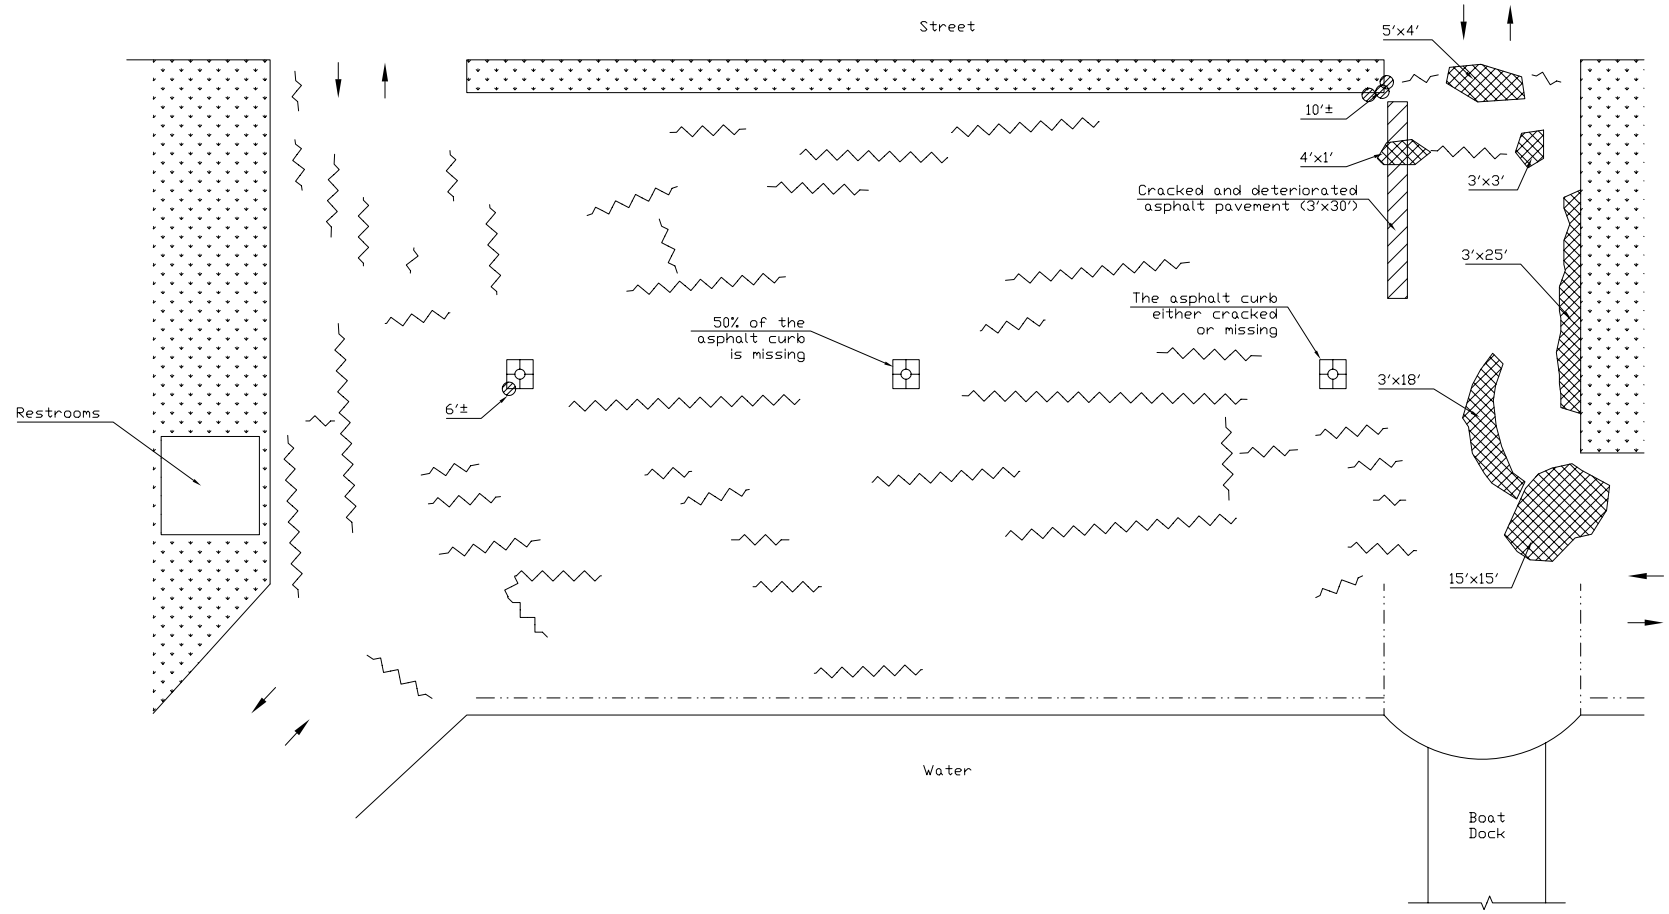
Urbitran Associates, Inc.
Connecticut Dept. of Transportation
Cos Cob Station Quadrant VIII (Lot 1B) Plan
Date: 2/10/02

- NOTES:
1. The curb is cracked, spalled, or missing (240'±).
 2. The asphalt pavement is cracked 500'± in addition to the map cracking, and uneven driving surface with cracks.

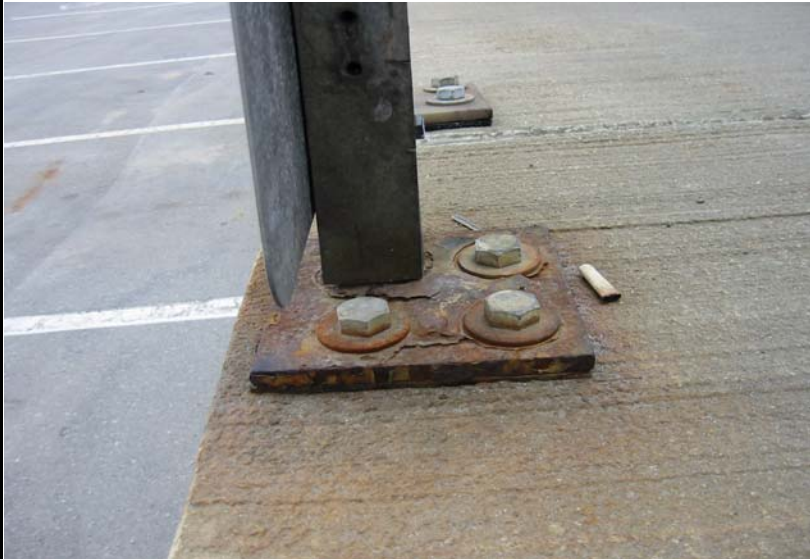
PHOTO NO. 24

Location: Span V of the south platform

Description: Typical rusted and deteriorated railing base plate

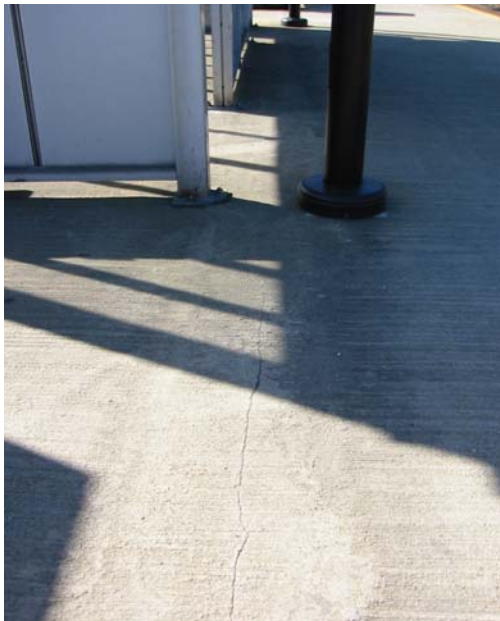
Description: Concrete crack

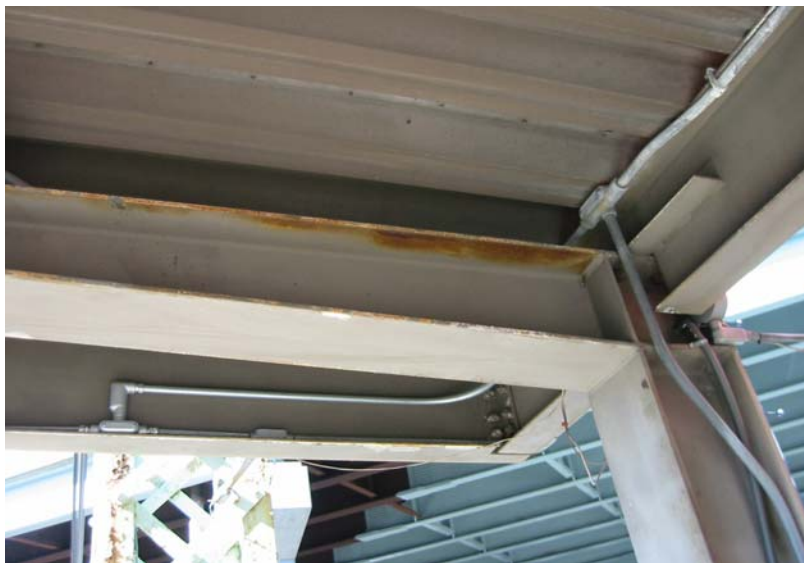
PHOTO NO. 26

Location: Span VI of the north platform

Description: Typical rusted canopy member

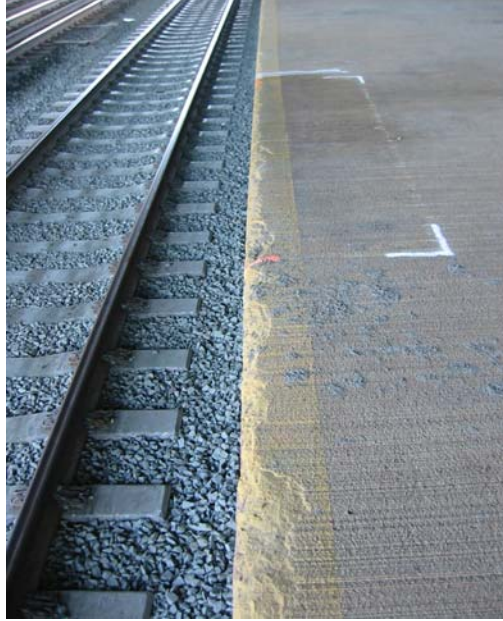
Description: Typical spalled edge of the platform

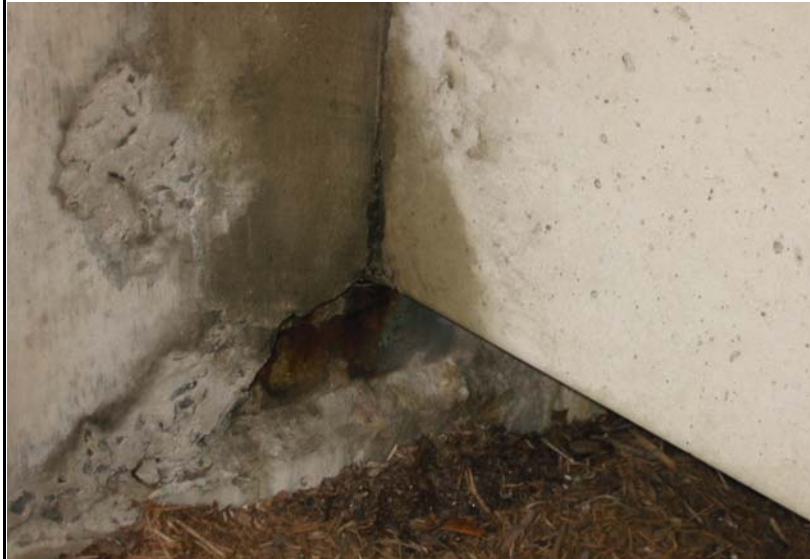
PHOTO NO. 28

Location: West of Span VIII of the south platform

Description: Spalled concrete with exposed steel

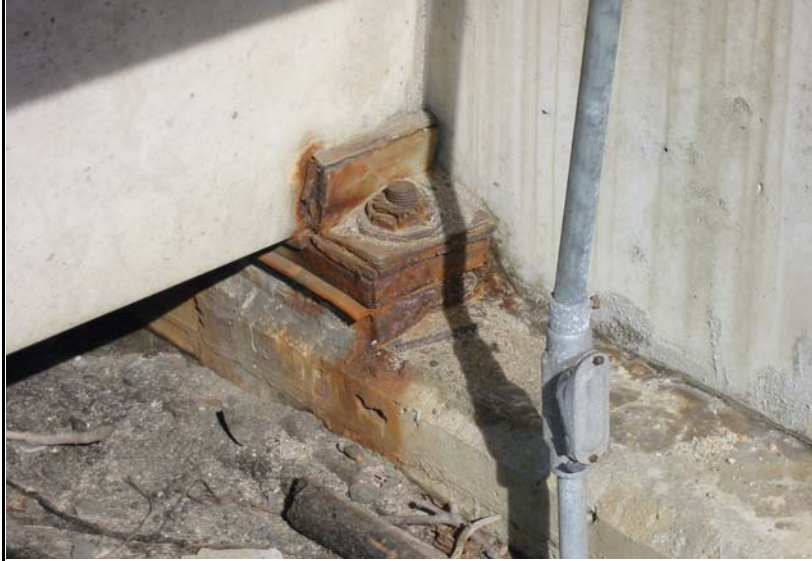
Description: Typical rusted and deteriorated base plate for the double tee

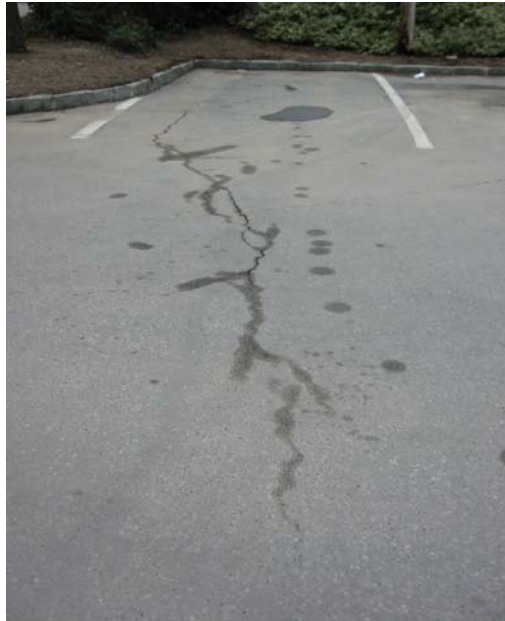
PHOTO NO. 30

Location: Middle of Quad I

Description: Typical asphalt crack

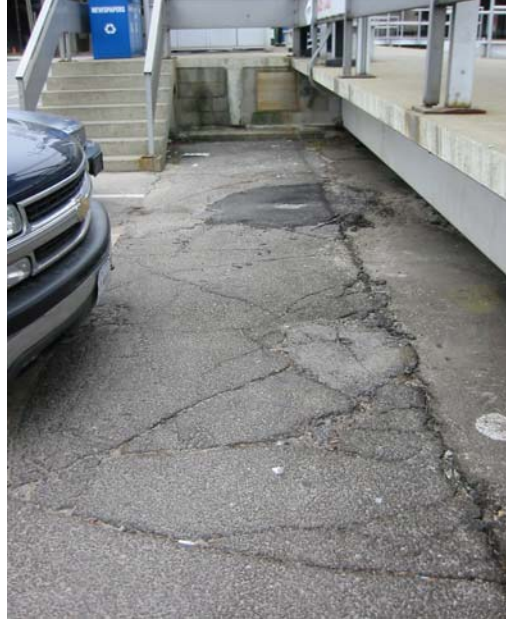
Description: _____
The asphalt sidewalk
is cracked with an
uneven walking surface

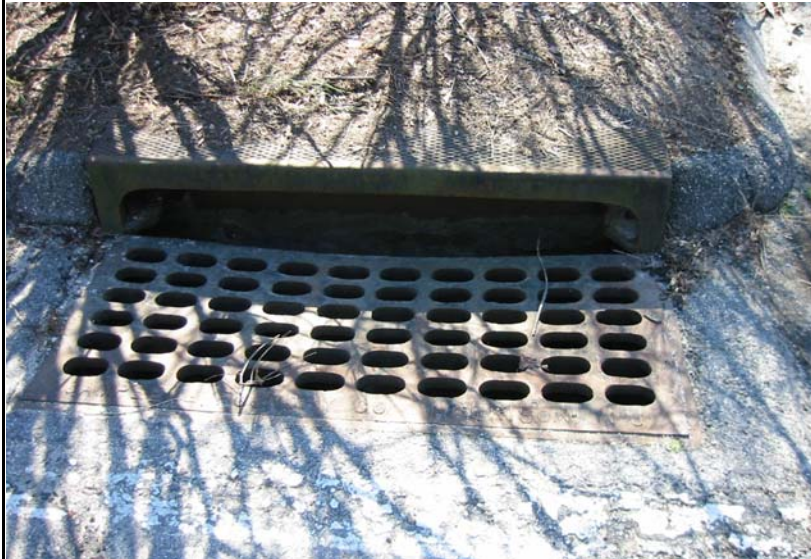
PHOTO NO. 32

Location: _____
Northeast corner of
Quad VIII

Description: _____
The grate of the drain
is bent

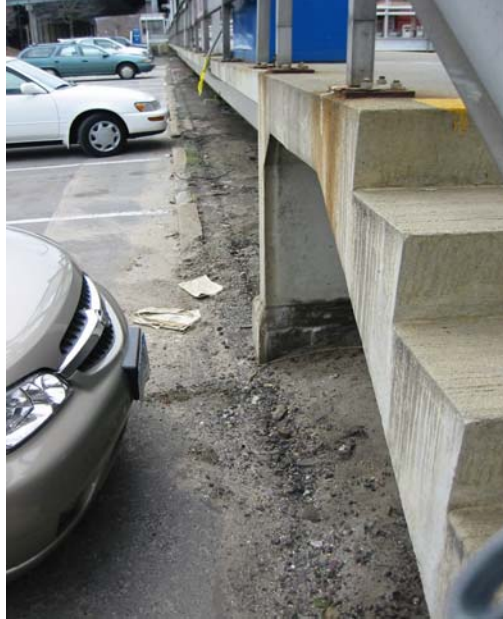
Description: _____
Missing and spalled
concrete curb

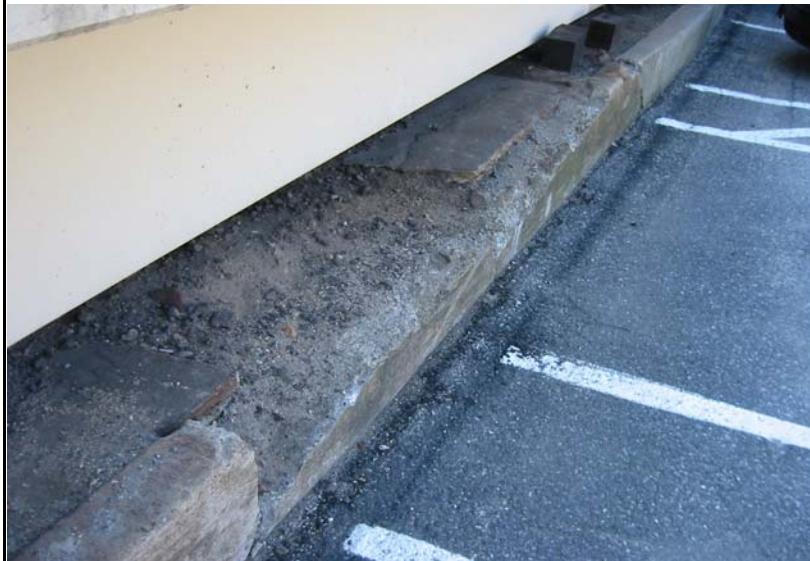
PHOTO NO. 34

Location: _____
North side of Quad I

Description: _____
Typical spalled
concrete curb

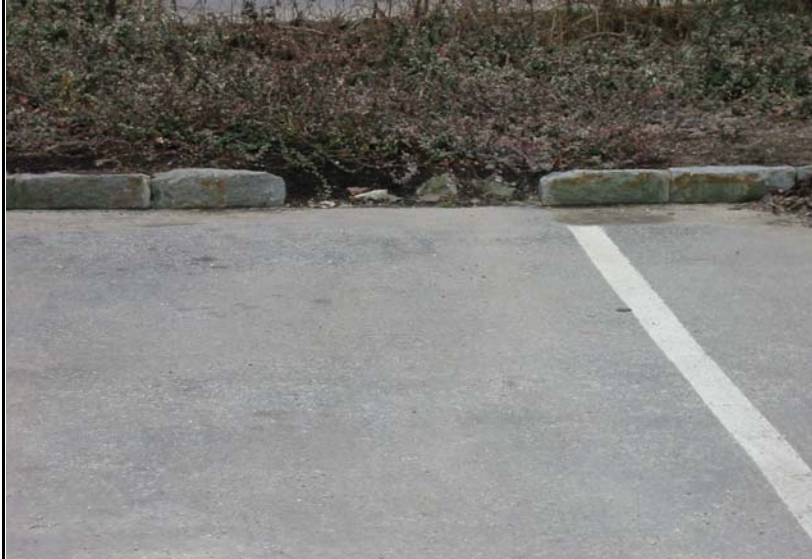
Description: _____
Missing block curb

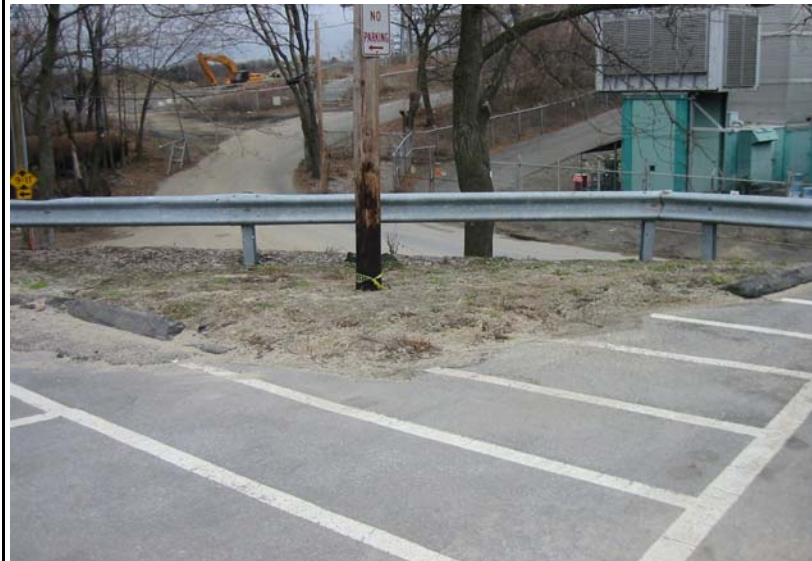
PHOTO NO. 36

Location: _____
South side of Quad I

Description: _____
Missing asphalt curb

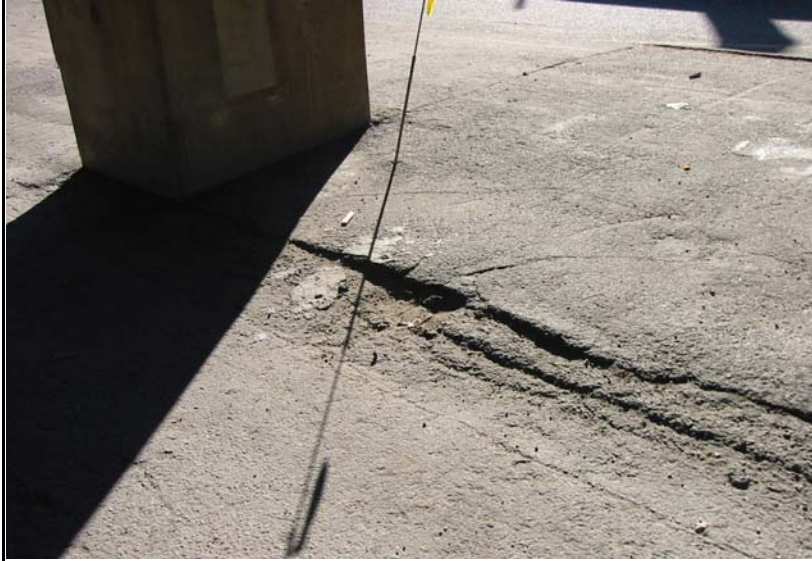
Description: Uneven alignment of the asphalt pavement

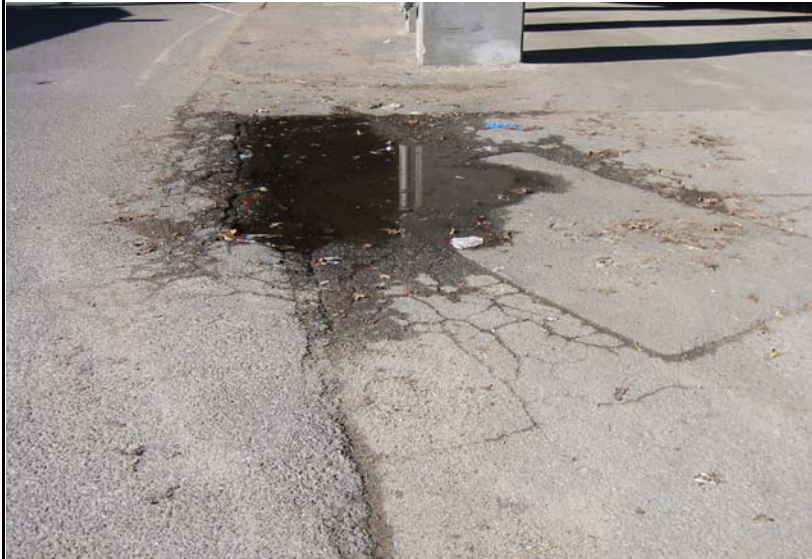
PHOTO NO. 38

Location: West side of Quad IV

Description: Typical ponding of water and map cracking

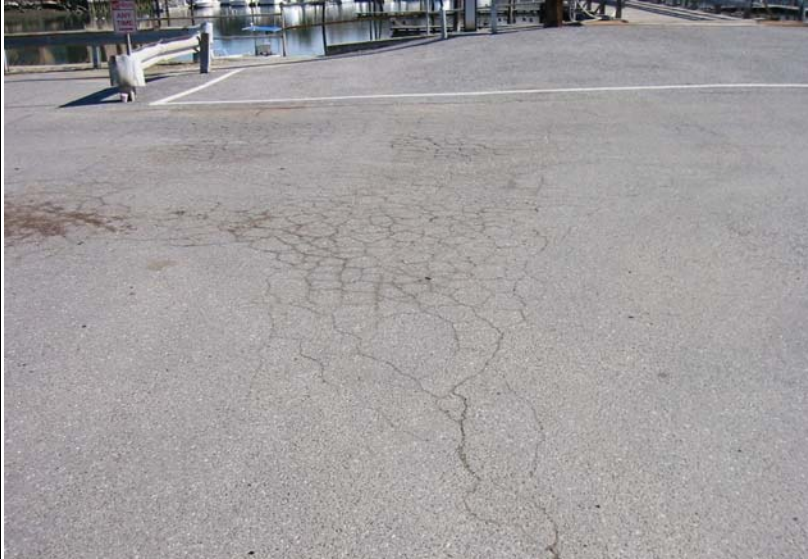
Description: _____
Typical map cracking

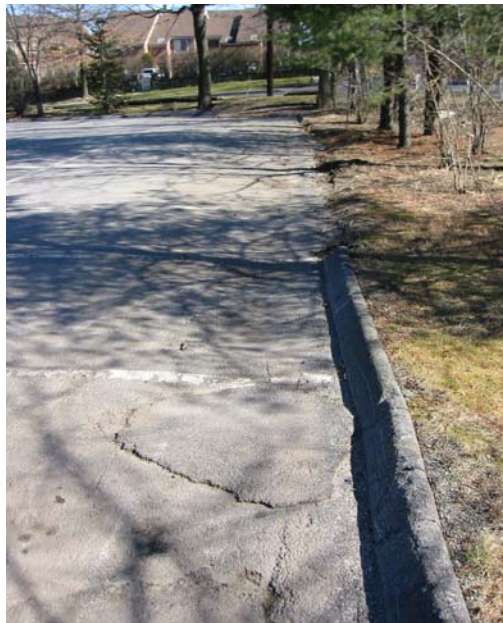
PHOTO NO. 40

Location: _____
South side of Quad VIII

Description: _____
Typical uneven driving surface with cracks

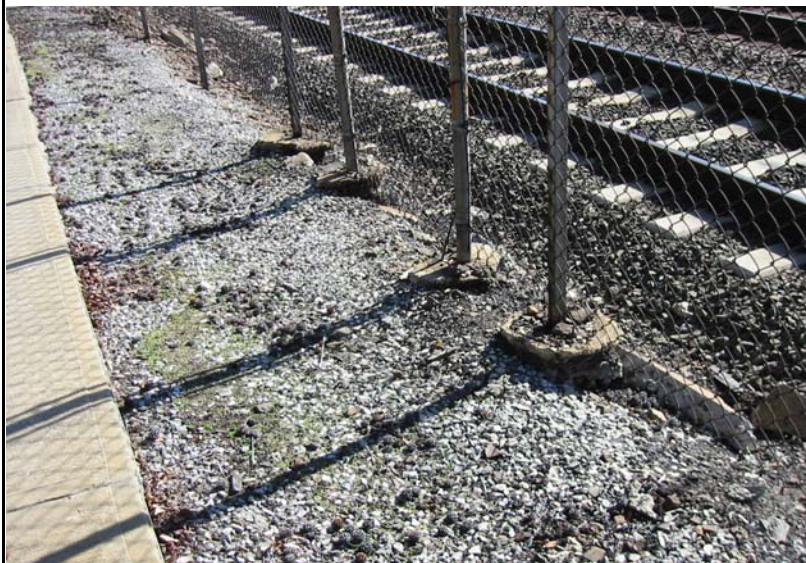
Description: The concrete footings for the fence are exposed

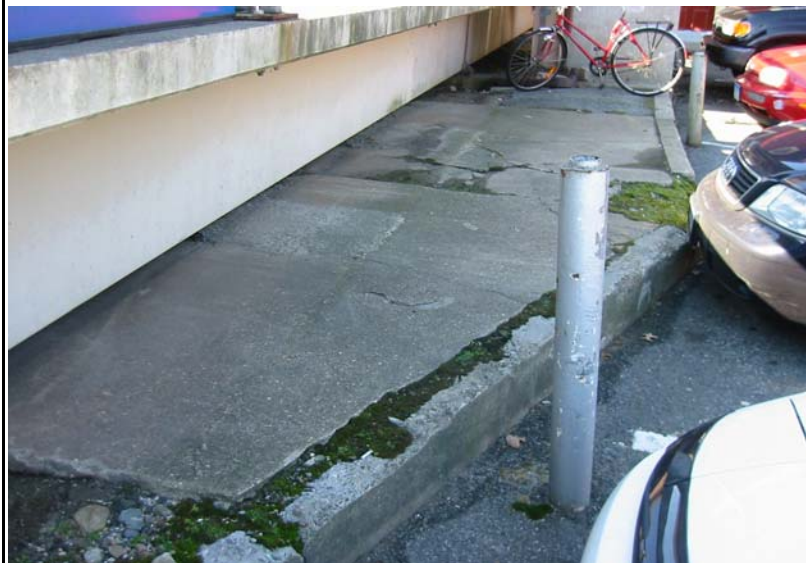
PHOTO NO. 42

Location: South side of Quad V

Description: The concrete sidewalk and curb is spalled and cracked with vegetation growth

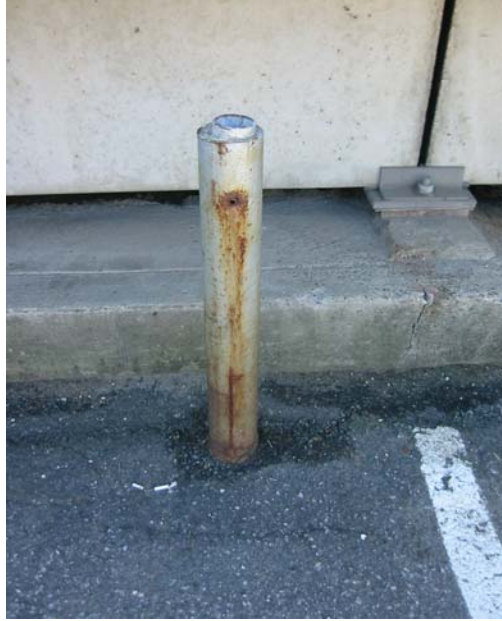
Description: _____
Typical abandoned
post which is rusted

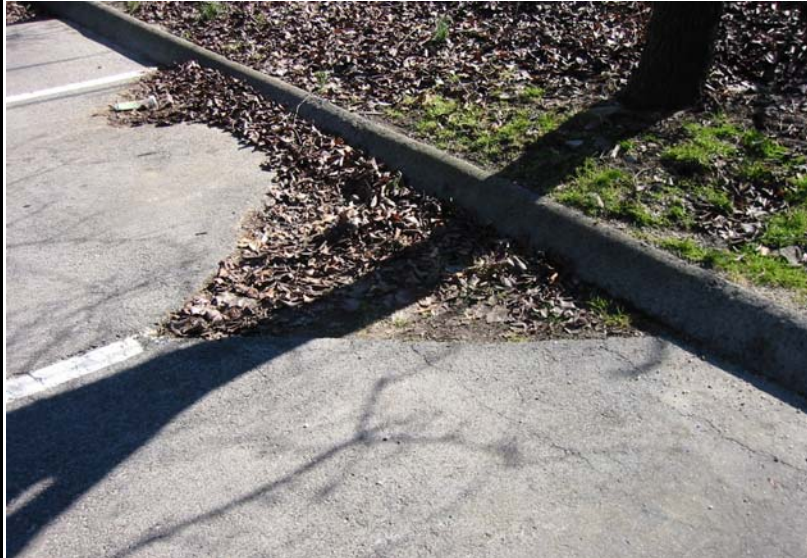
PHOTO NO. 44

Location: _____
North side of Quad VII

Description: _____
An isolated area where
the asphalt is missing

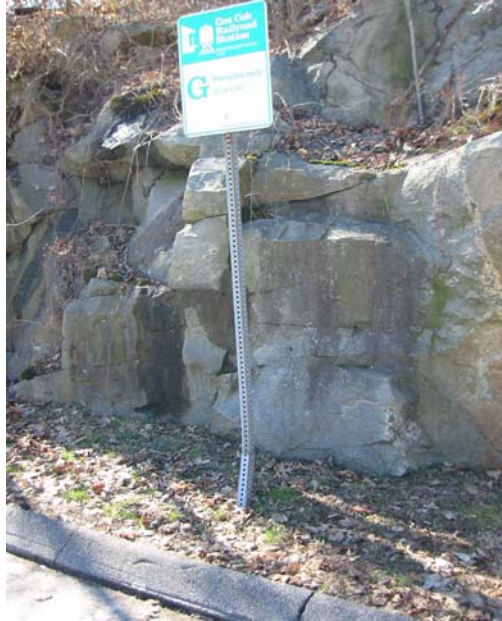
Description: _____
Bent sign post

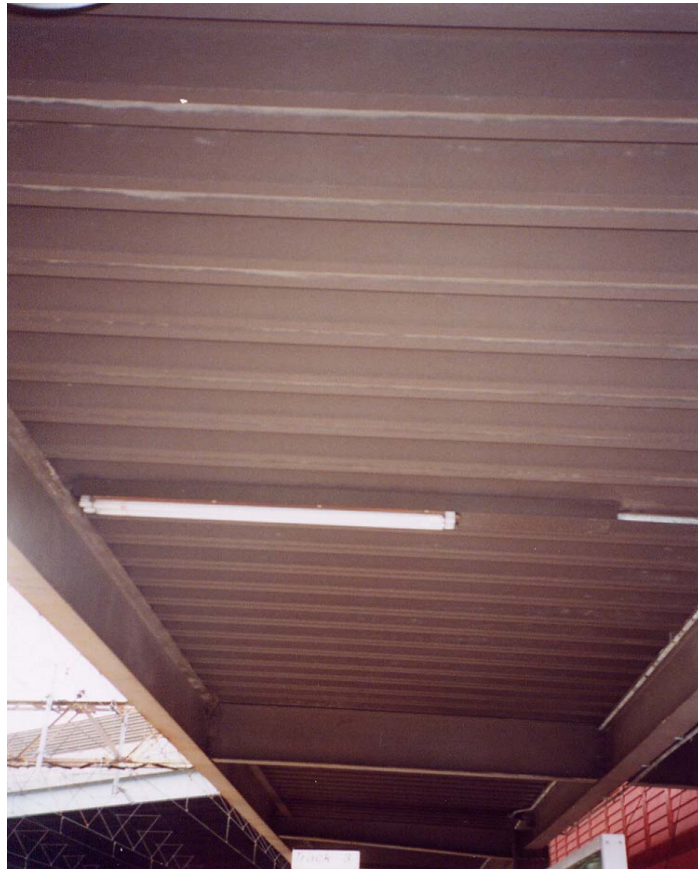
All the platform canopy light fixtures are missing their lenses. This exposes the fixtures to conditions unexpected by the manufacturer and will lead to premature failure. Considering the exposure to the elements and the apparent age of the canopy fixtures, we recommend replacement.

Description:
platform canopy
lighting

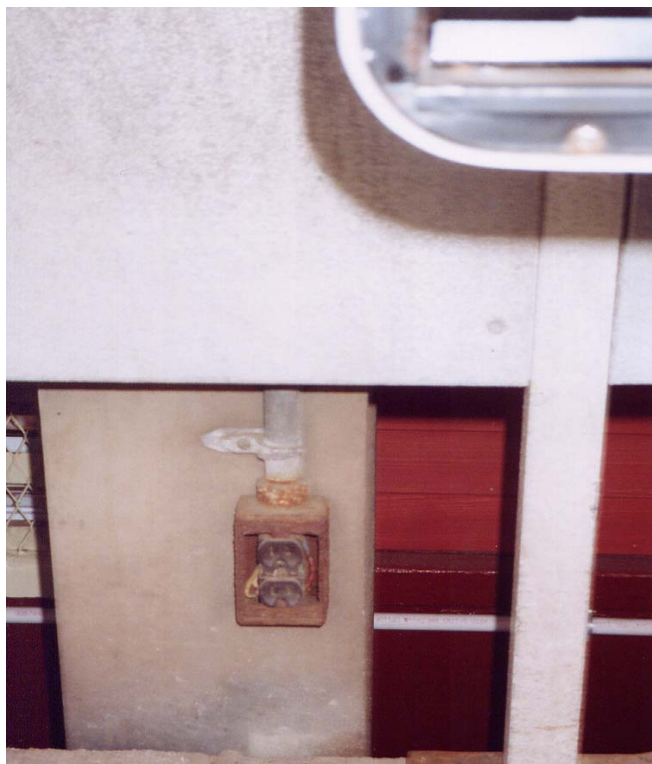
PHOTO NO. 51

There are several GFCI receptacles located on the platforms, but there are also a few non-GFCI receptacles. These non-GFCI receptacles are missing their covers and should be considered a public safety hazard. GFCI receptacles with new covers should replace the existing non-GFCI receptacles that do not meet the NEC requirements.

Location:
platform

Description:
a typical platform
receptacle

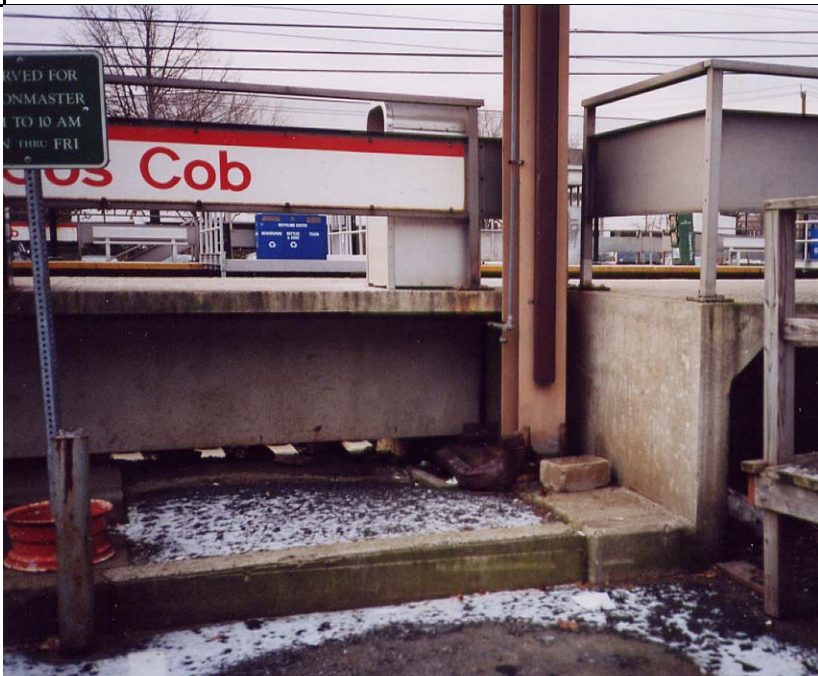
PHOTO NO. 53

There is one building downspout near the post office box which needs repair. There is one broken platform downspout. All the other gutters and downspouts are in good repair.

Description:
platform
downspout
lower part
missing
