CONNECTICUT
DEPARTMENT
OF
TRANSPORTATION

CONDITION INSPECTION
FOR THE
FAIRFIELD STATION

**CONN. DEPT OF TRANSPORTATION
STATION INSPECTION**

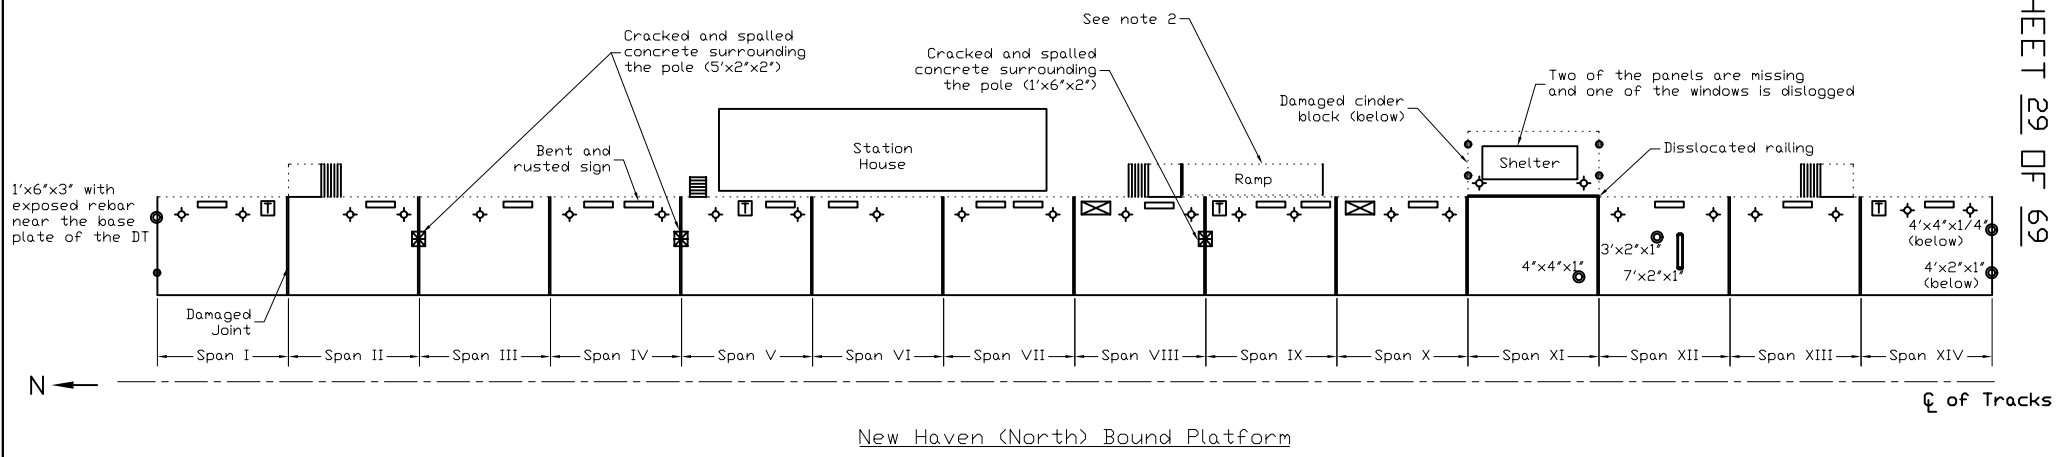
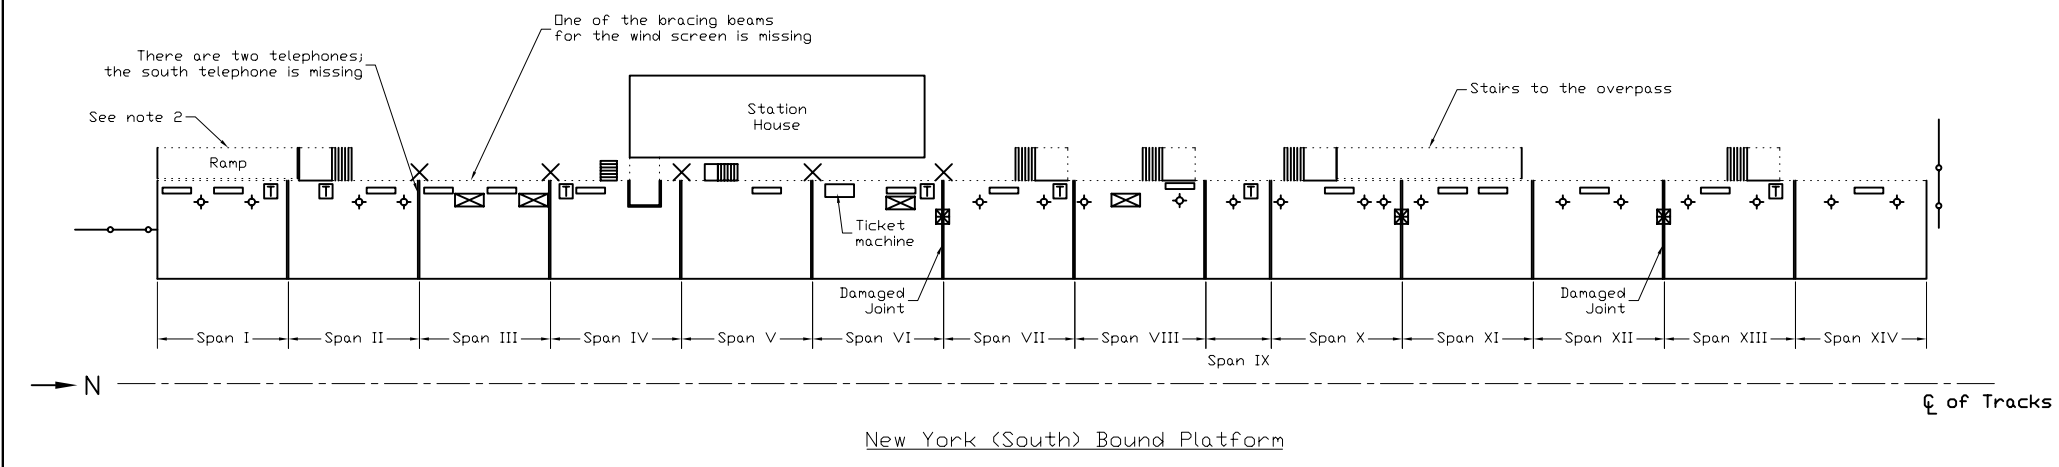
New Haven (North) Bound Platform

- NOTES:
1. The railings on the New Haven Bound and New York Bound platforms are bent throughout the length of the platform.
 2. The railing base plates for the ramps on the New York bound and New Haven bound platforms are rusted (12 plates per ramp).

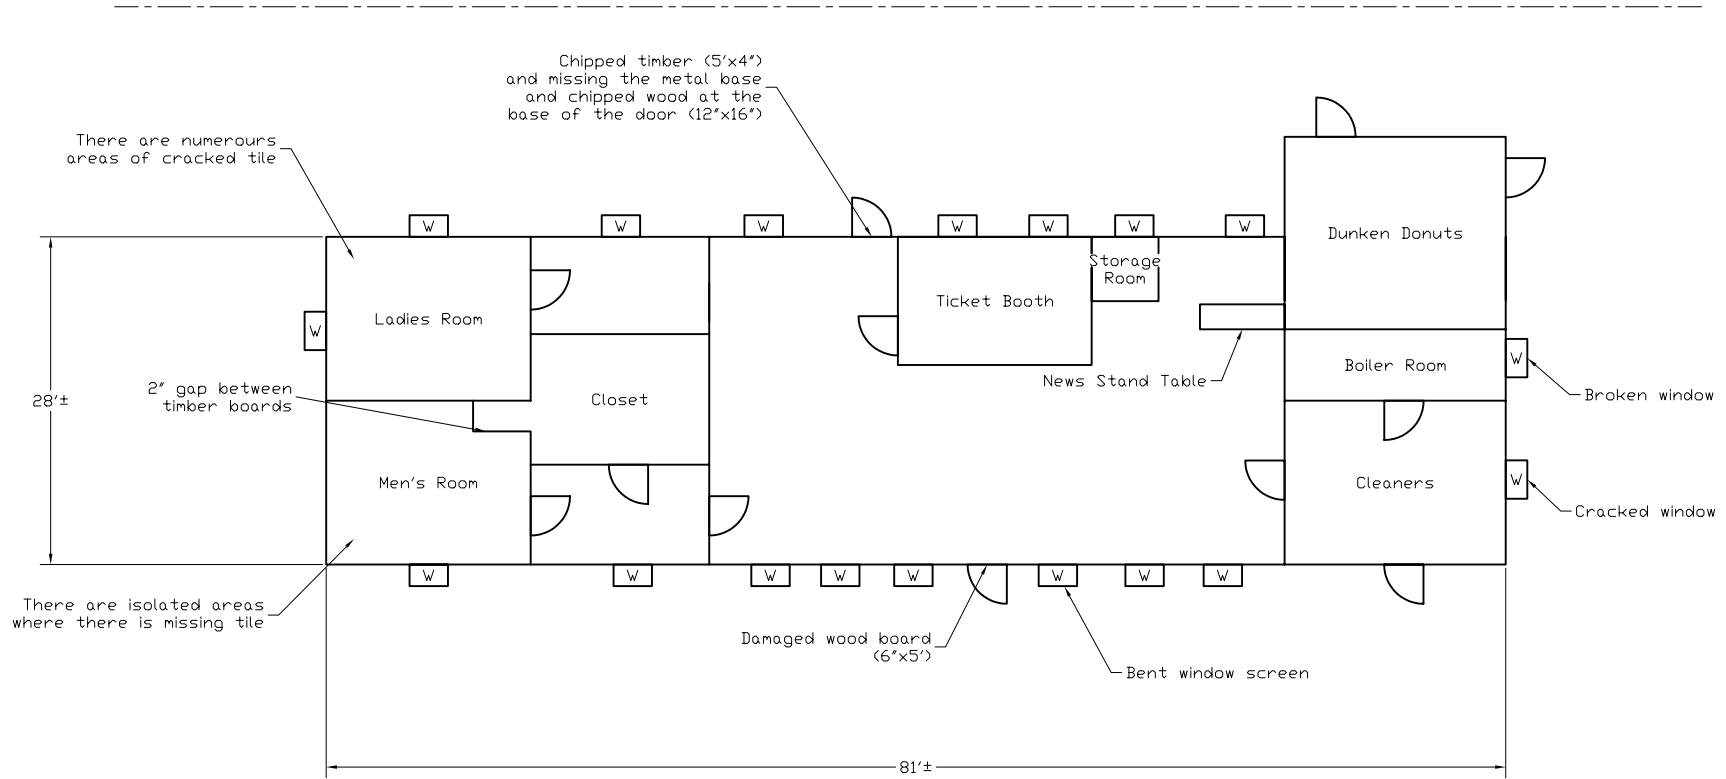
Urbitran Associates, Inc.
Connecticut Dept. of Transportation
New York Bound Station House Plan
Date: 7/16/02

1. Missing roofing material (1'x42') along the west side.
2. Missing roof board (1'x6') along the west side.
3. As told by the station building maintenance, they are going to fix the roofing; Maybe they will install new gutters.
4. Minor damage to the timber molding with chipped paint (17'x2') along the south elevation.
5. The west and east side windows are missing screws that attach the window screen and window frame.

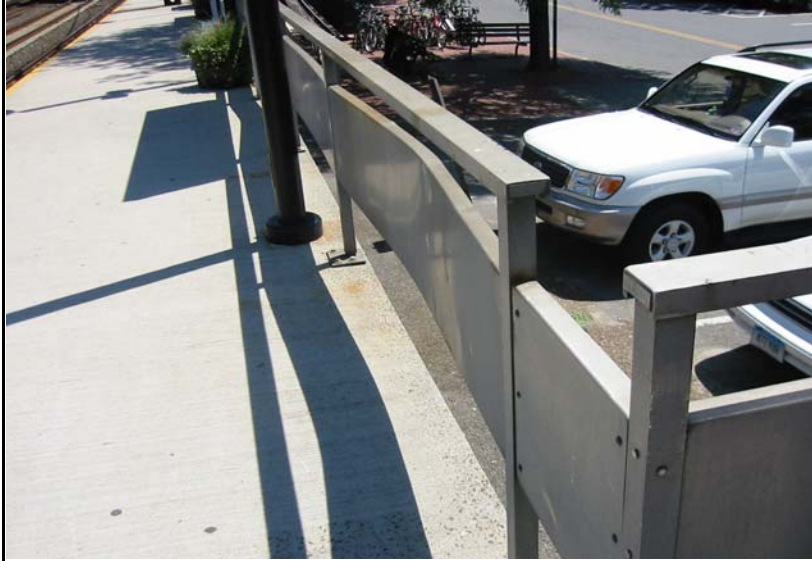
Description: _____
Typical bent railing for
the NH and NY bound
platforms

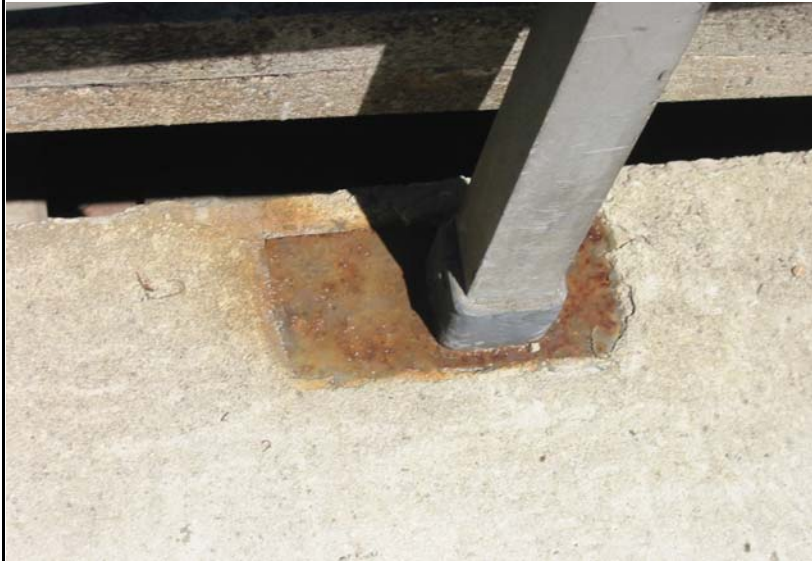
PHOTO NO. 20

Description: _____
Typical rusted railing
base plate on the ramp
of the NH and NY bound
platforms
(12 each ramp)

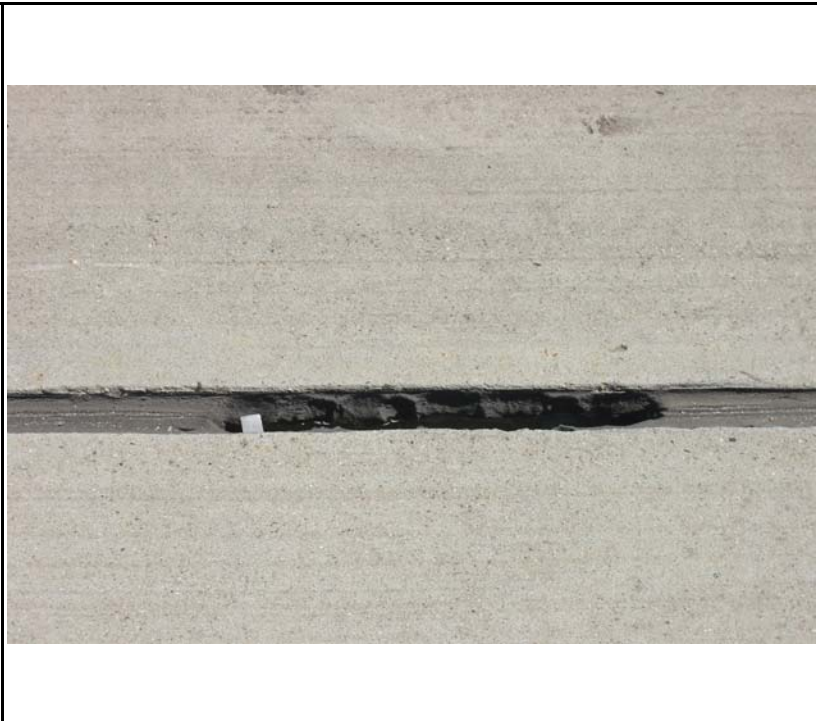
Description: Missing joint filler material in Span I of the NH bound platform; similar damage on the NY bound platform

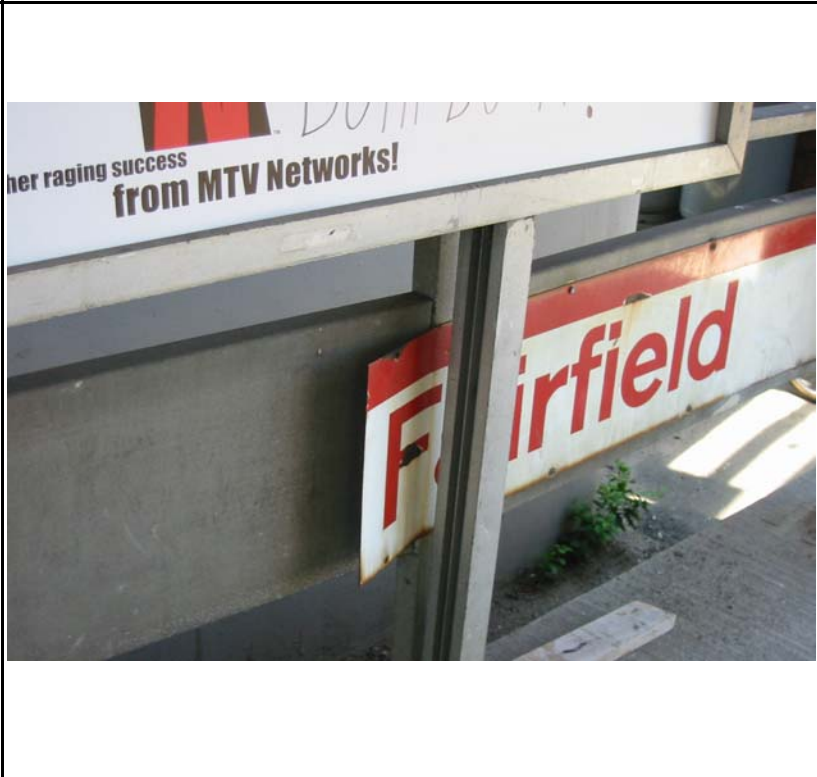
PHOTO NO. 22

Description: Bent and rusted sign

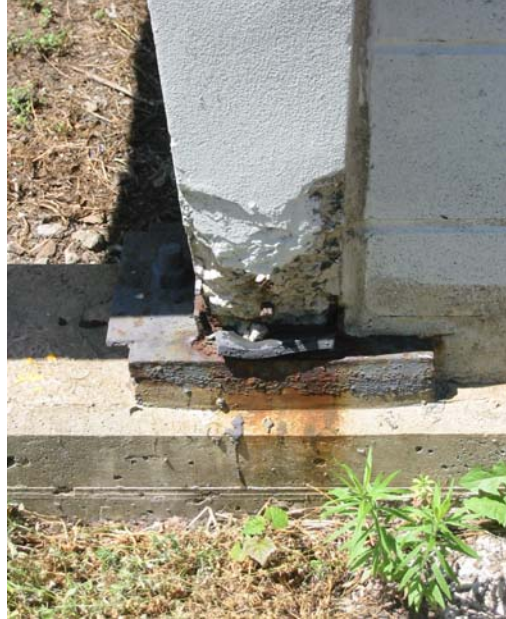
Description: _____
The base of the double
tee is spalled with
exposed rebar
(1'x6"x3") and the base
plate is rusted

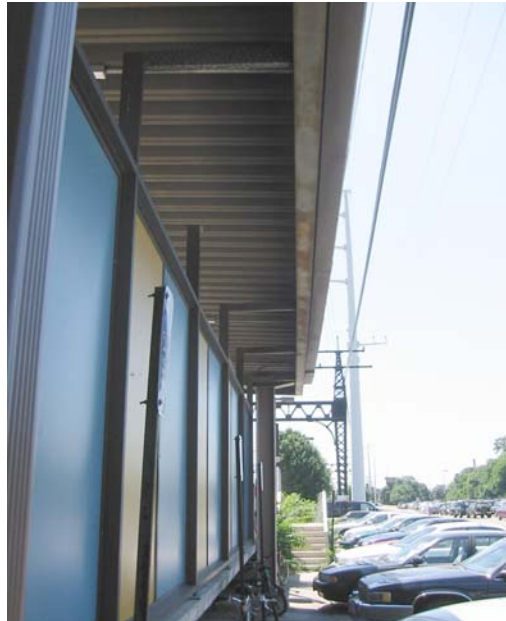
PHOTO NO. 24

Description: _____
The wind shield is
missing one of the
bracing beam

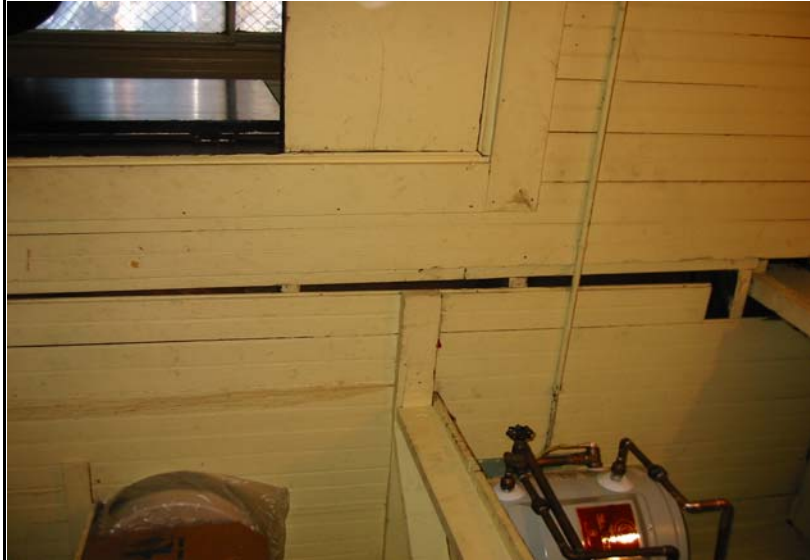
Description: 2"-4" gap between wood panels

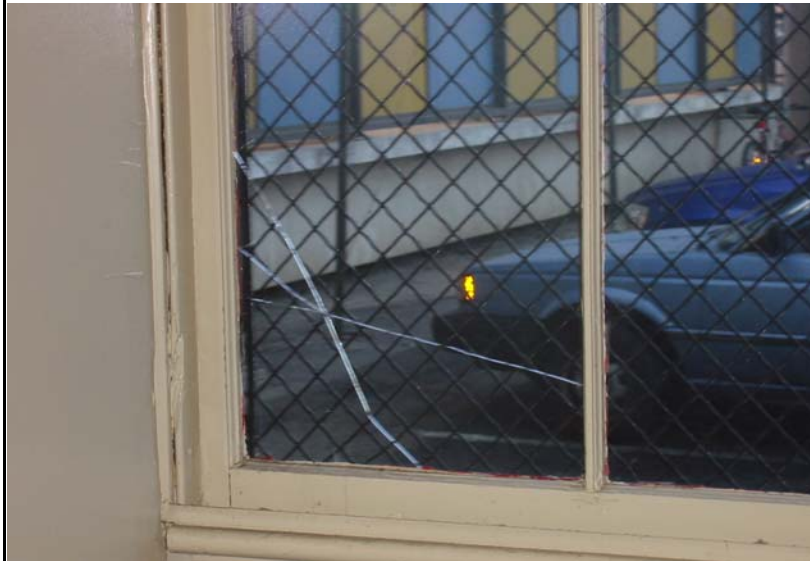
PHOTO NO. 26

Description: Cracked window

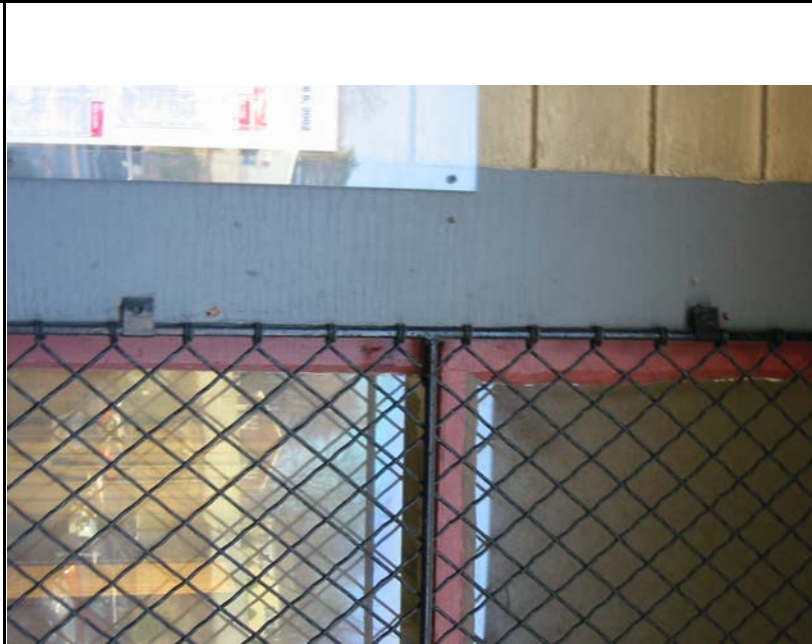
Description: Missing screws attach-
ing the window screen to
the window frame;
typical for all windows
on the west and east
elevations

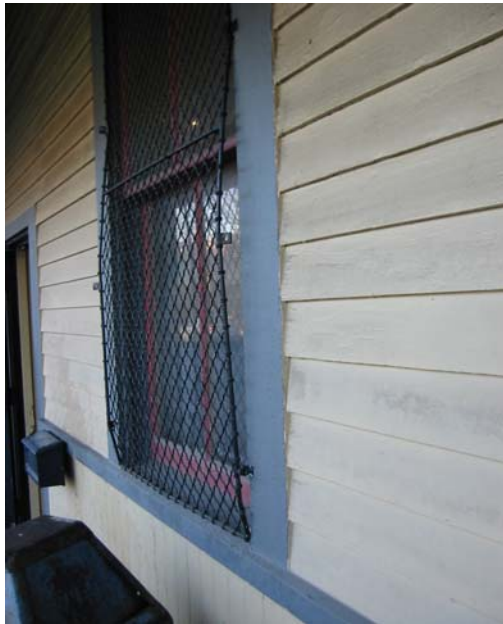
PHOTO NO. 28

Description: Bent screen on the
window south of the
west door

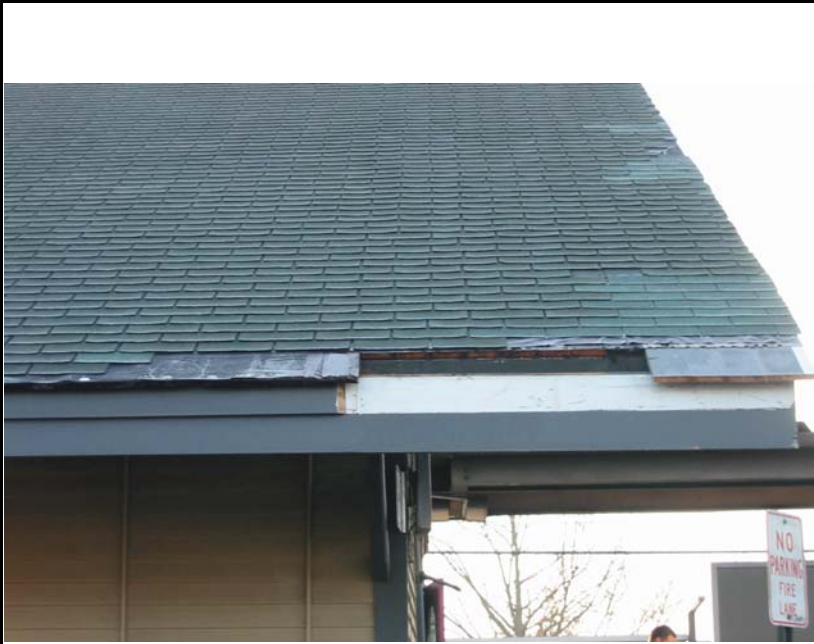
Description:
Missing roof material
on the southwest corner
of the NY bound station
house

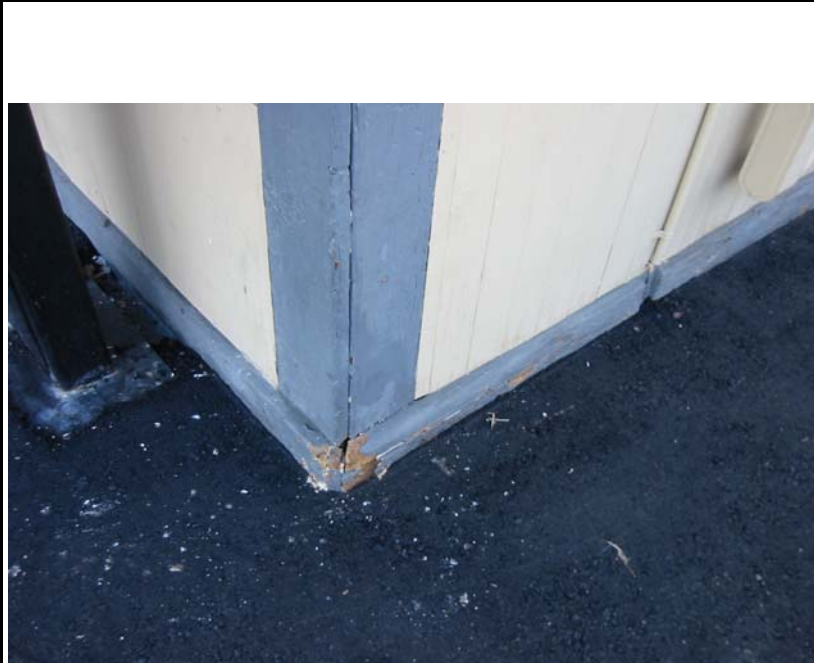
PHOTO NO. 30

Description:
Deteriorated timber at
the base of the southwest
corner of the NY bound
station house

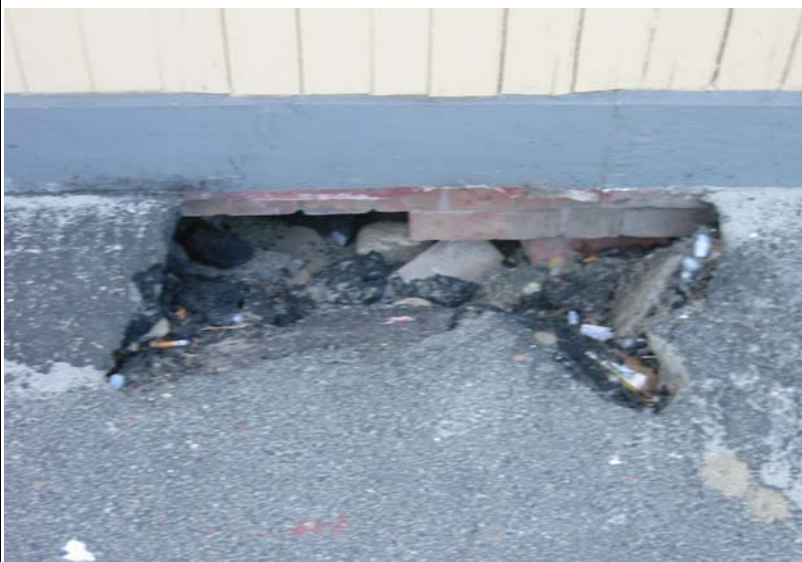
Description: There is a hole in the asphalt adjacent to the station house

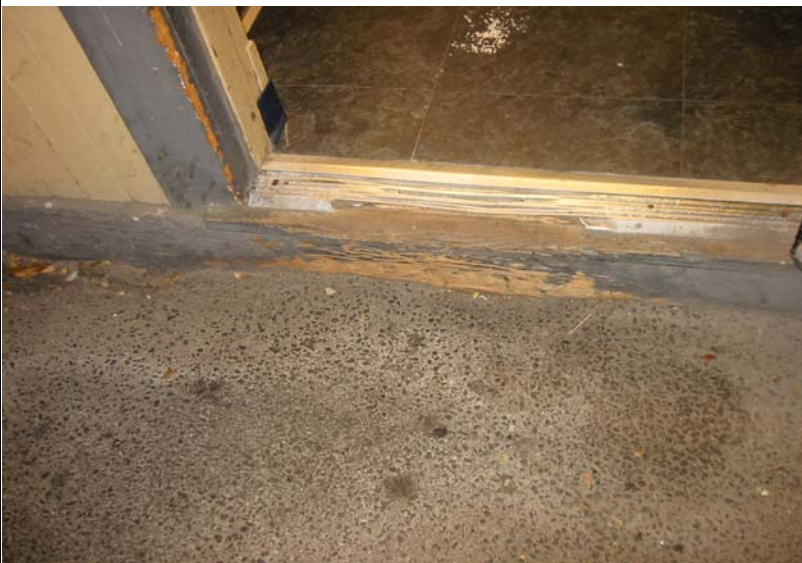
PHOTO NO. 32

Description: Deteriorated timber, and damaged metal base at the base of the east door

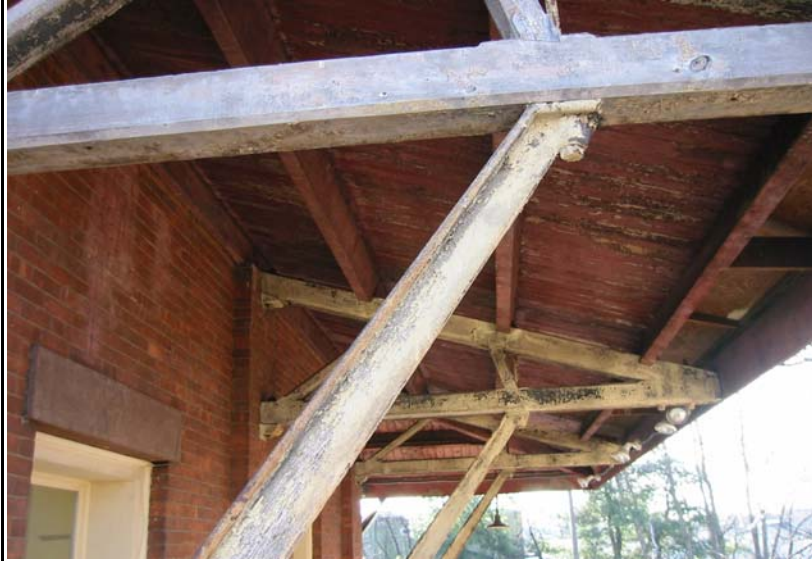
Description: Rust stains on the south side overhang of the NH bound station house

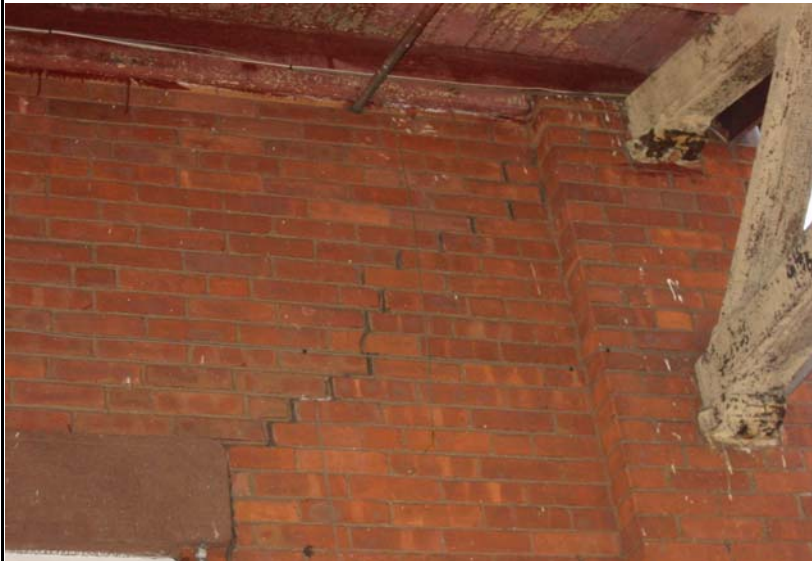
PHOTO NO. 34

Description: Cracked brick that extends from the window to the top northwest corner

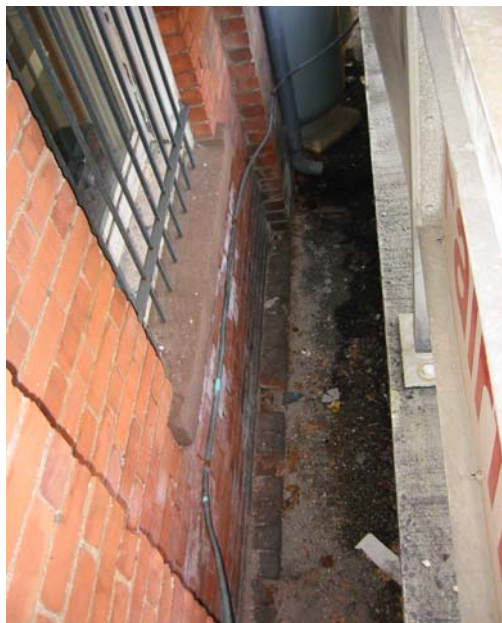
Description: Typical missing bricks at the base of the NH bound station house

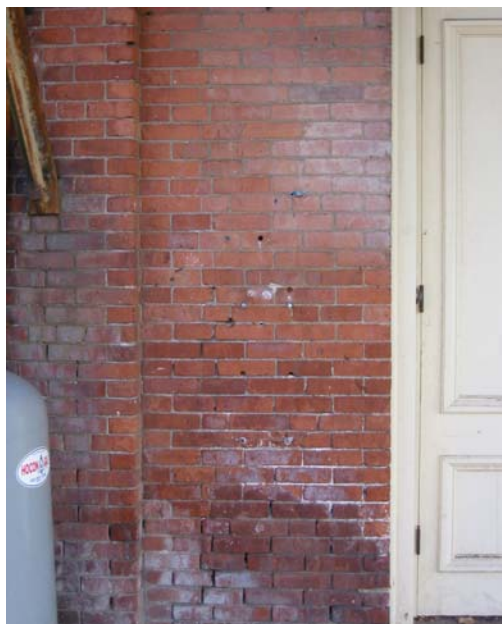
PHOTO NO. 36

Description: Holes, cracks, missing mortar, and broken brick on the west side of the NH station house

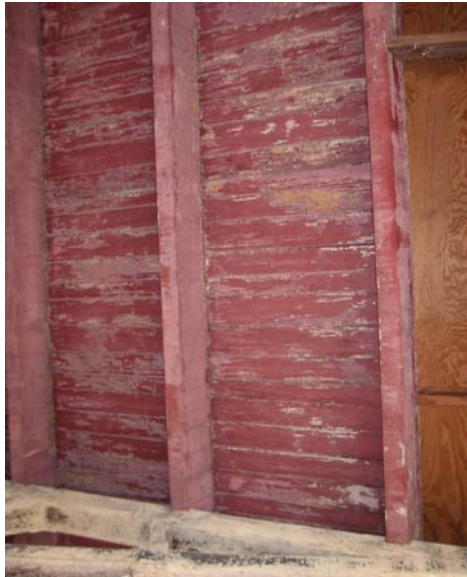
Description: Deteriorated timber on the south side overhang

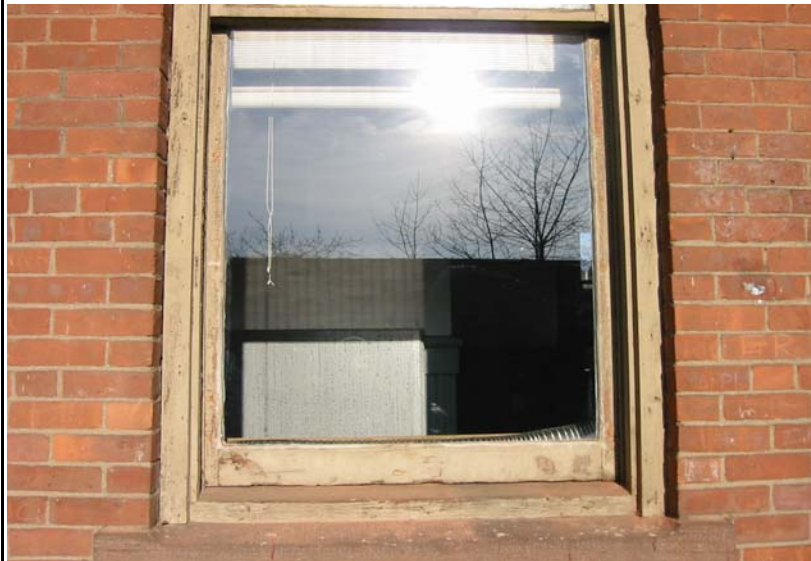
PHOTO NO. 38

Description: Deteriorated timber window frame; typical for all the windows

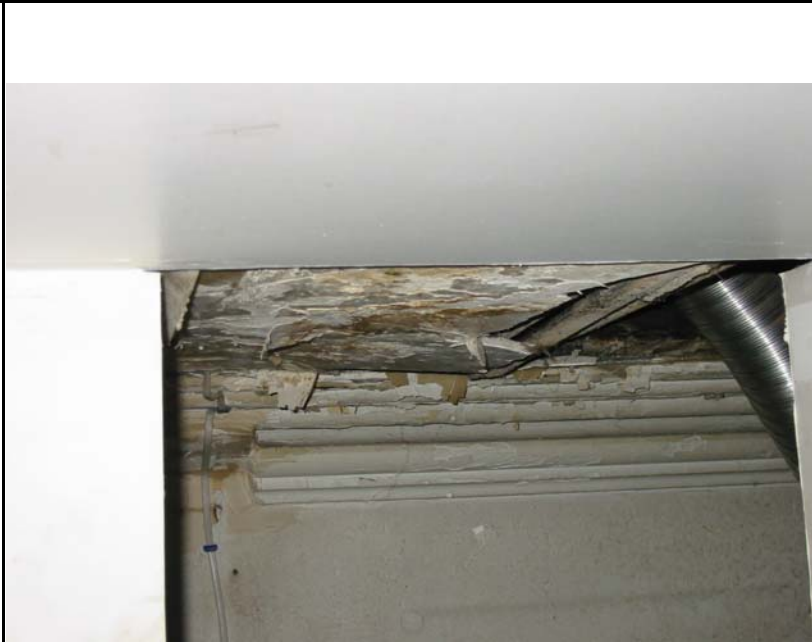
Description: Unfinished ceiling in the pizza shop

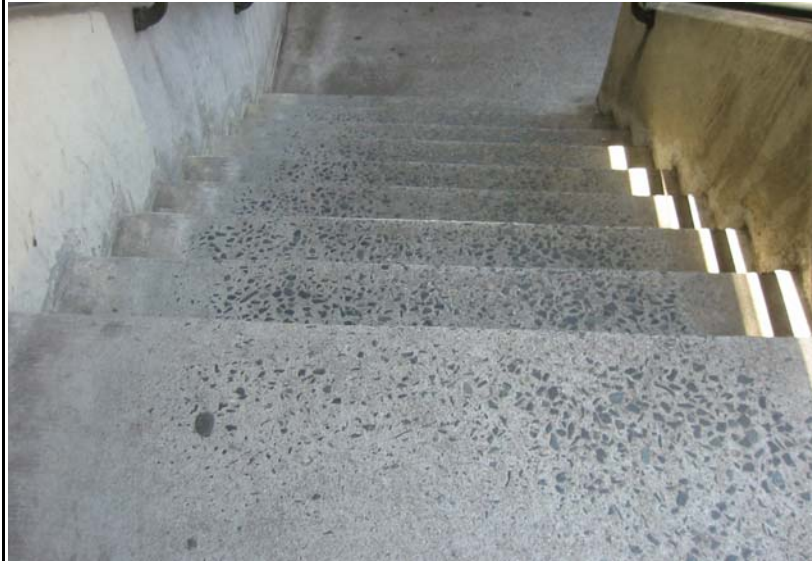
PHOTO NO. 40

Description: Typical scoured concrete

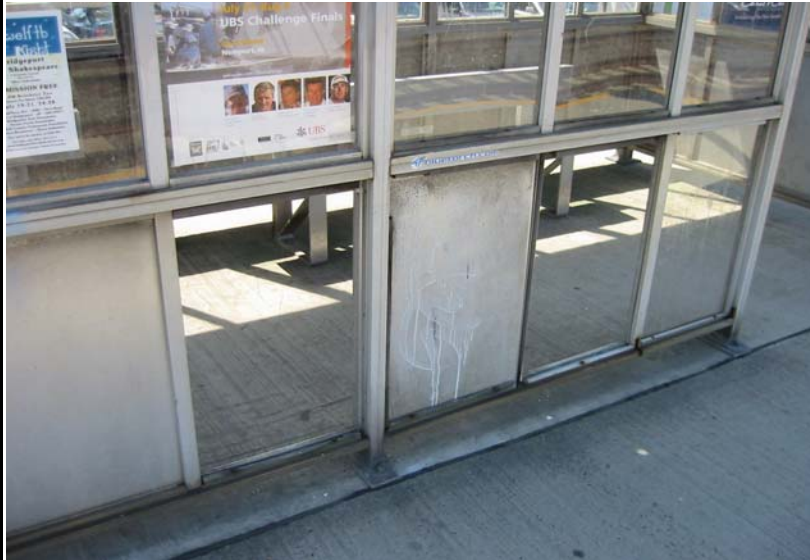
Description:
The shelter is missing
two panels

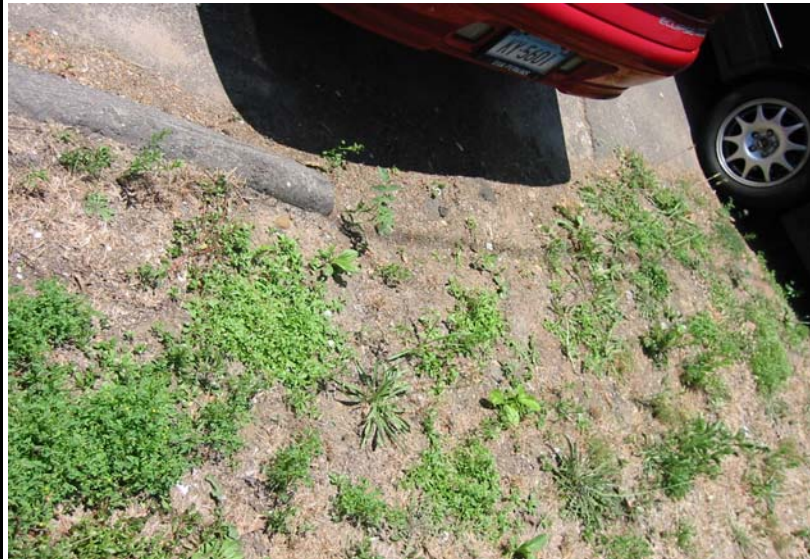
PHOTO NO. 42

Description:
Broken and/or missing
asphalt curb

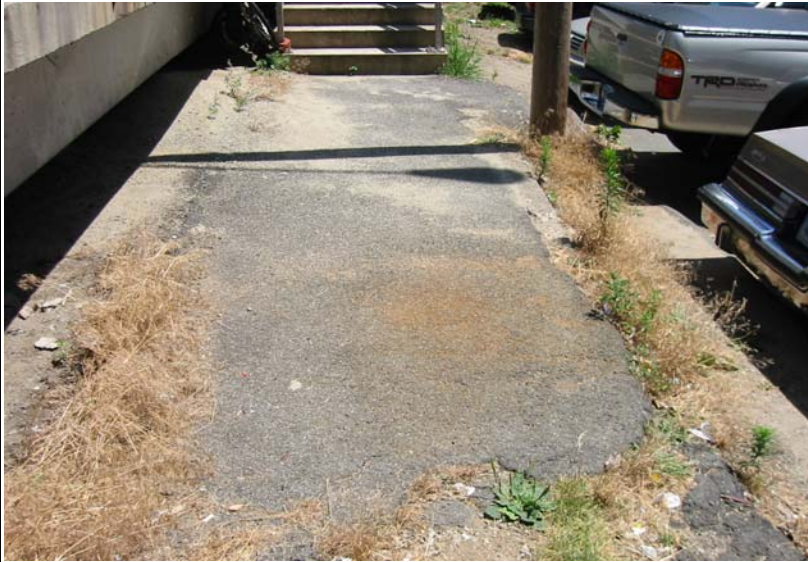
Description:
uneven asphalt sidewalk
with vegetation growth

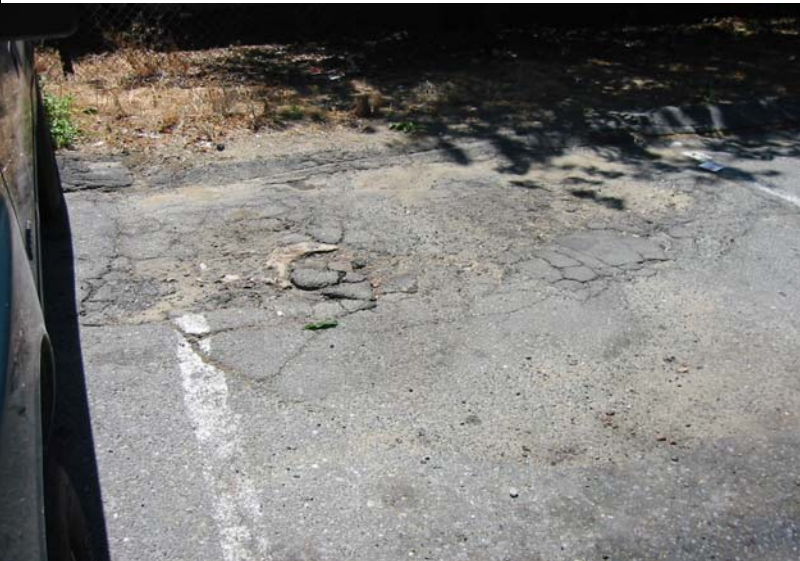
PHOTO NO. 44

Description:
Uneven driving surface
and cracked asphalt
(5'x10')

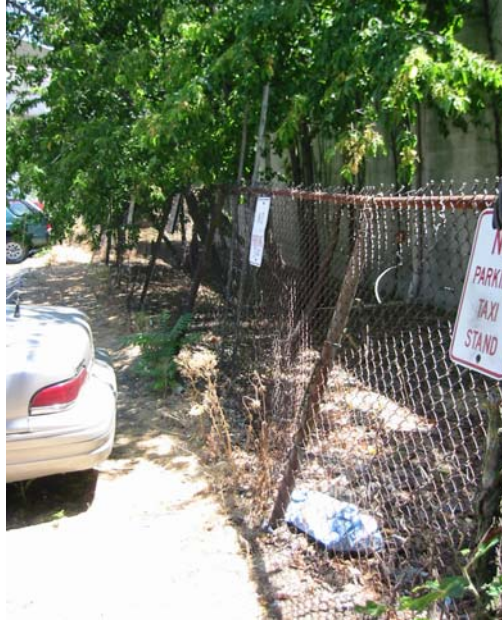
Description: Typical rusted bent fence

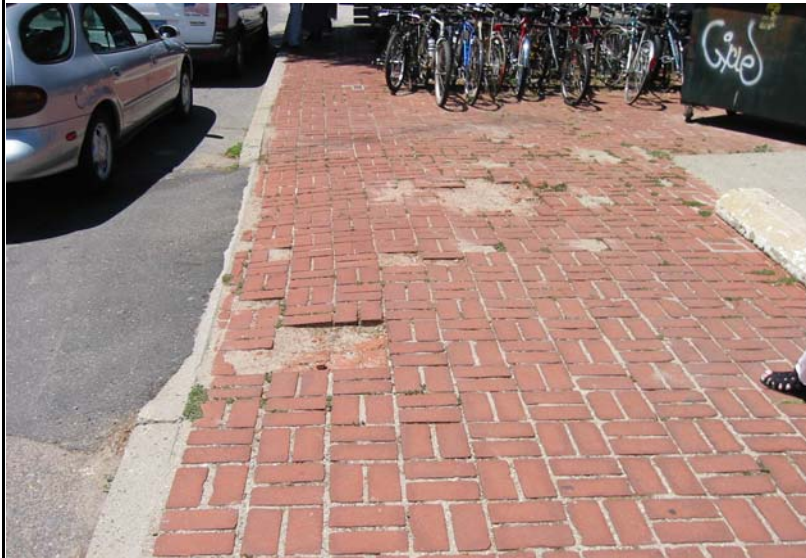
PHOTO NO. 46

Description: Brick sidewalk with missing or cracked bricks (15'x7')

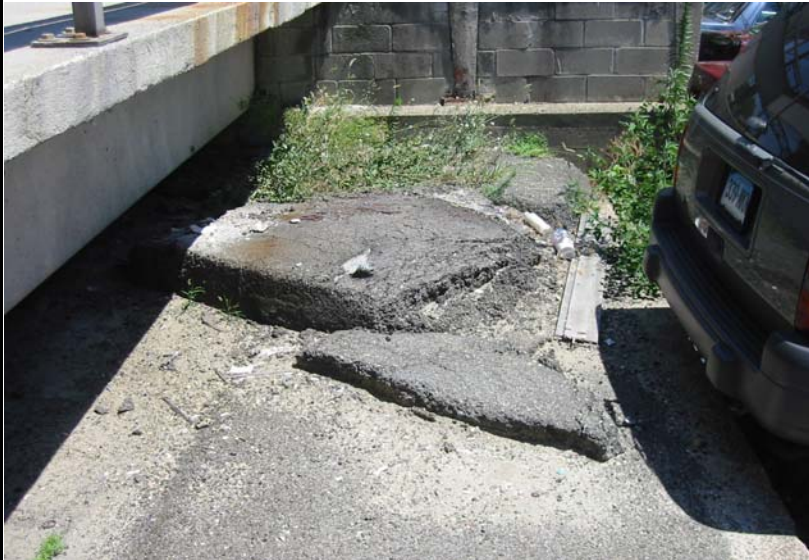
Description: _____
damaged asphalt
sidewalk with vegetation
(15'x5')

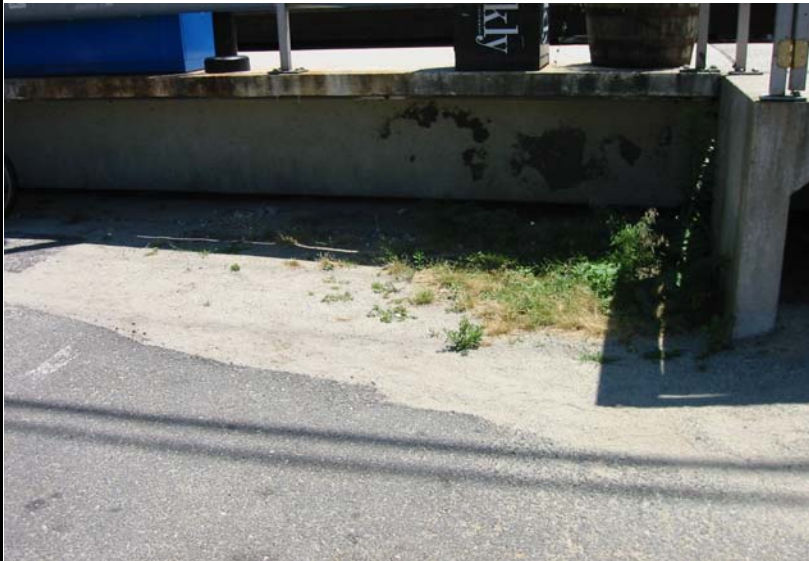
PHOTO NO. 48

Description: _____
Dirt and vegetation

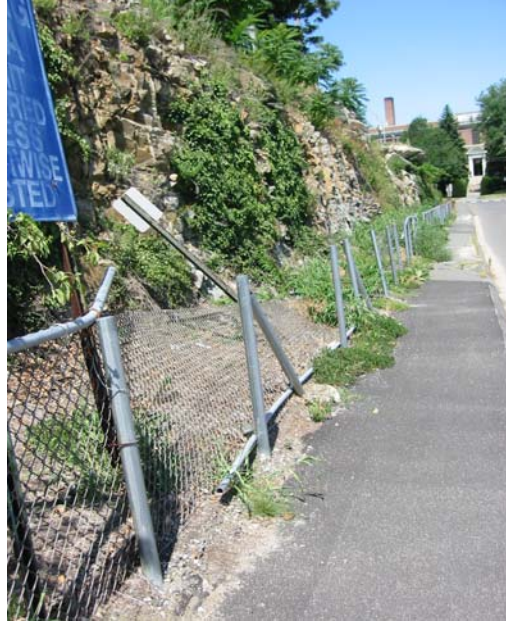
Description: _____
Damaged fence and
leaning sign

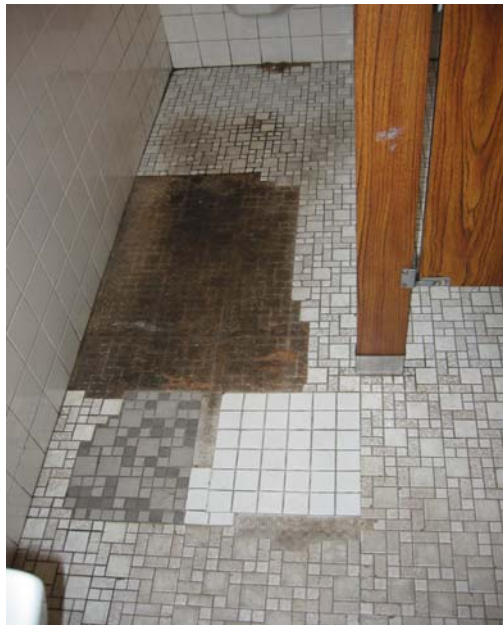
PHOTO NO. 50

Description: _____
Missing tile

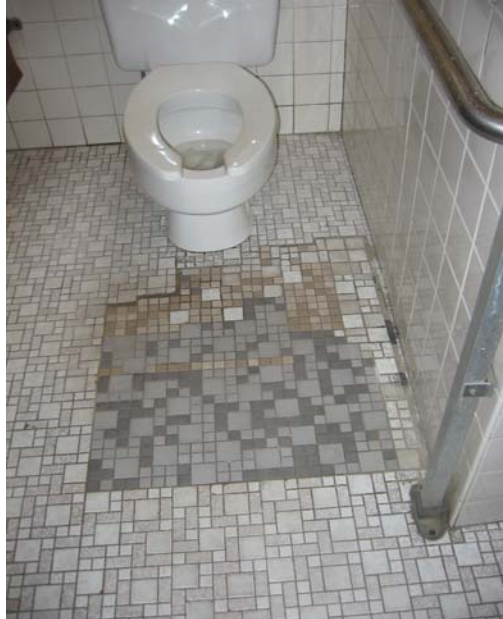
Description: _____
Missing tile

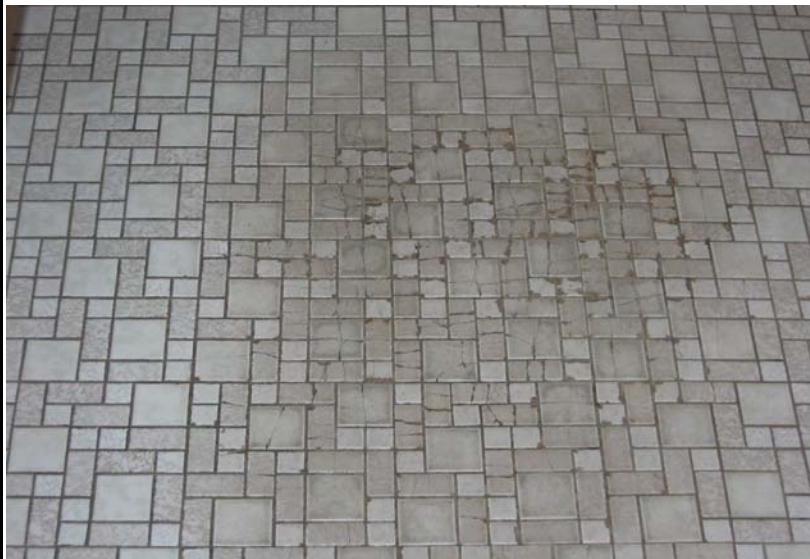
PHOTO NO. 52

Description: _____
Cracked tile

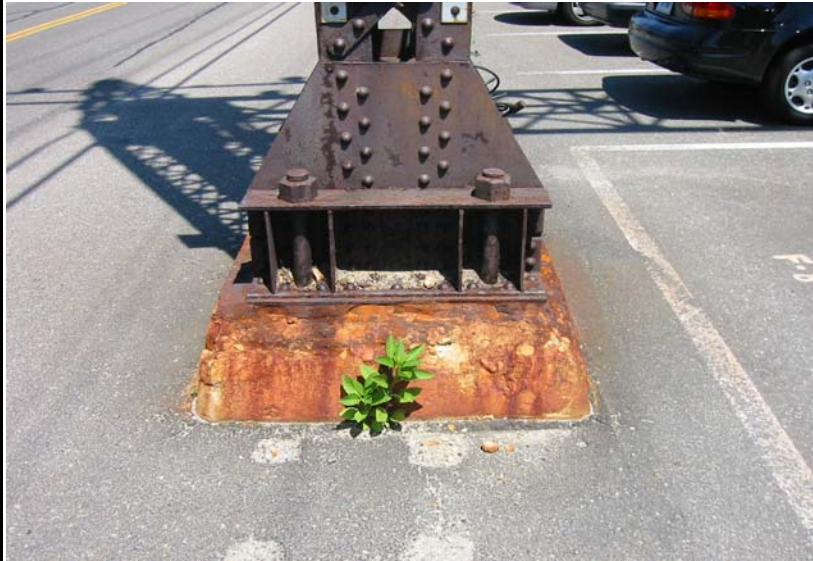
Description: _____
Typical spalled concrete
footing with rust stains

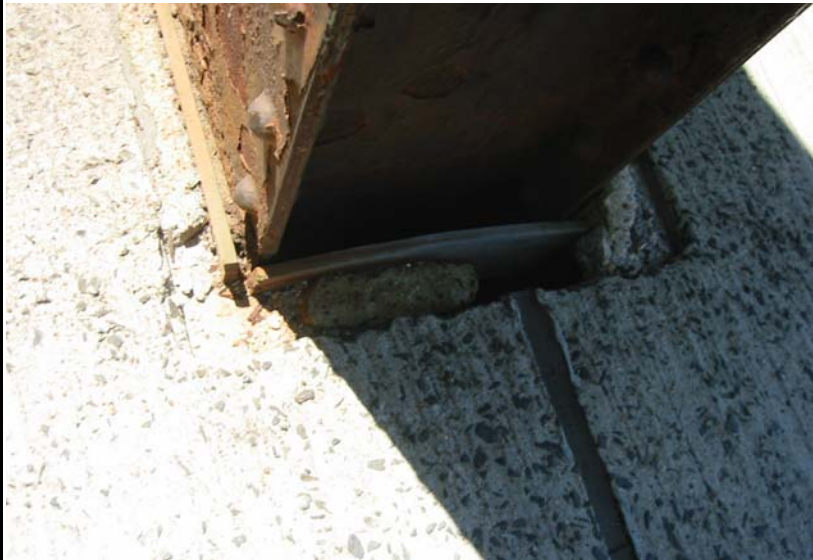
PHOTO NO. 54

Description: _____
Typical spalled, cracked,
and missing concrete
adjacent to the train's
power line pole

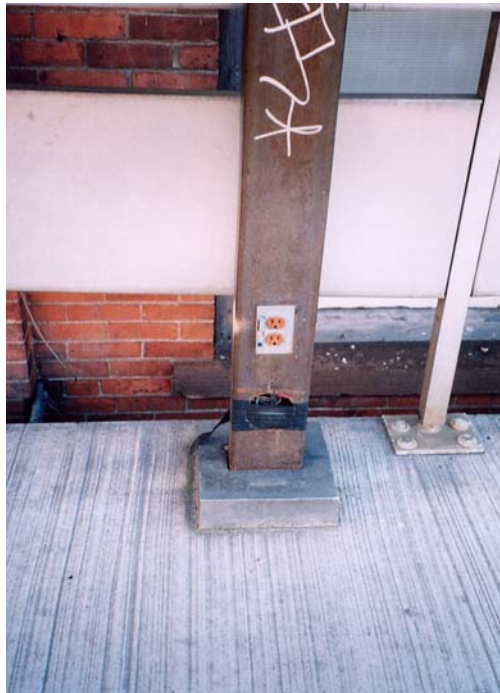
The northbound platform exceeds the minimum maintained light level per IESNA recommended practice while the southbound platform is slightly below the recommended 5 foot-candles. Luminaires and poles on both platforms have serious deterioration and should be replaced.

Description:
close-up of the
light pole base

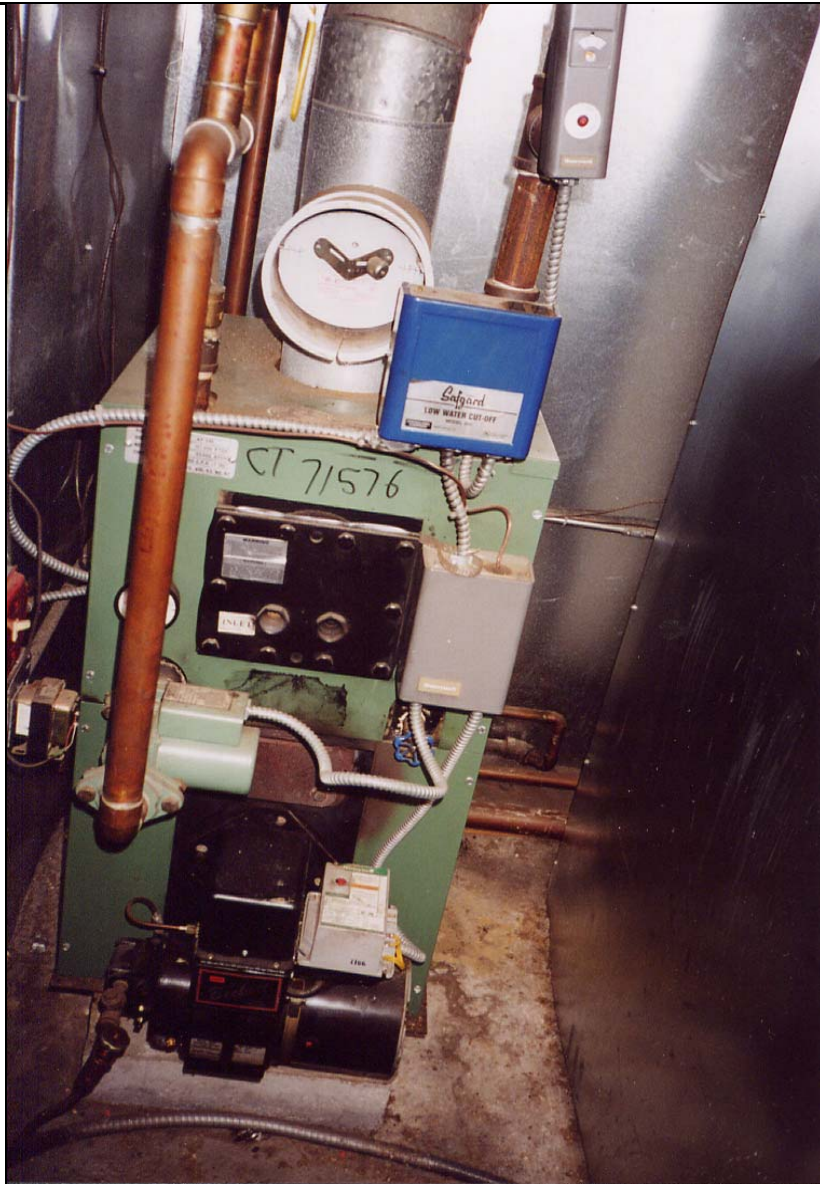
The heating for the main building with the ticket counter is provided by a hot water, oil fired boiler, and old fashion cast iron radiators. The estimated life left in the boiler is 8-10 years. The system is not up to current code. The boiler is in a confined space and requires combustion openings, in accordance with the BOCA International Mechanical Code. The boiler pipes are not insulated and it is recommended that they be insulated. The system does not have an expansion tank or a floor drain. It is recommended that the heating system be brought up to code. The system is working well and is in good condition. The outdoor combustion air openings are not in accordance with the code.

Description:
Oiled Fired Boiler
with Hot Water
for Heating
