CONNECTICUT  
DEPARTMENT  
OF  
TRANSPORTATION

CONDITION INSPECTION  
FOR THE  
NAUGATUCK STATION

**CONN. DEPT OF TRANSPORTATION  
STATION INSPECTION**

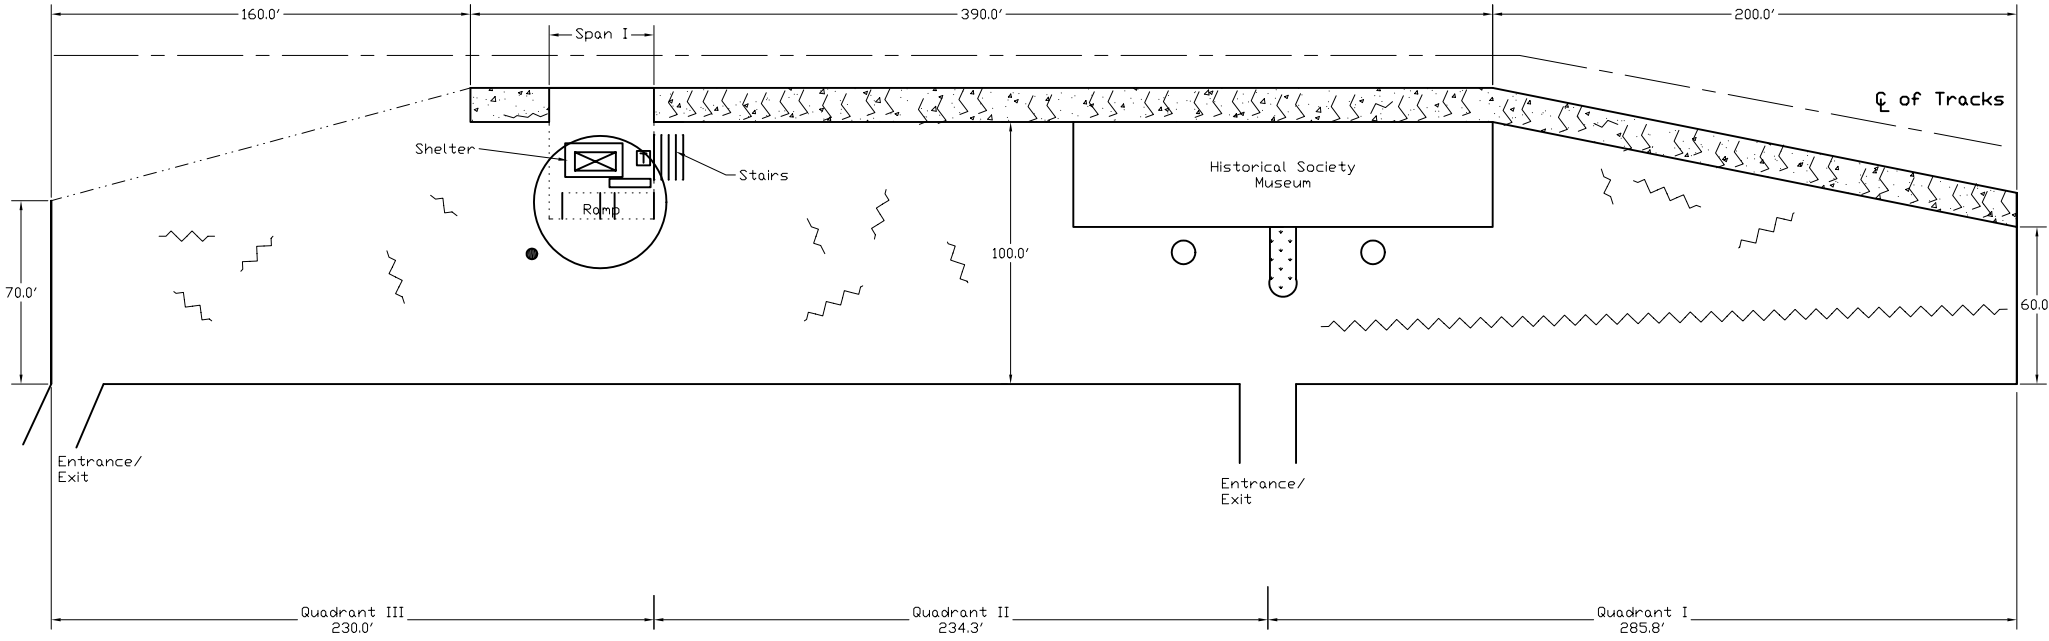
- NOTES:
1. The asphalt sidewalk contains numerous cracks and uneven settlement.
  2. The asphalt surface in Quad I exhibits numerous cracks and an uneven driving surface.
  3. The asphalt surface in Quad II and III exhibits numerous cracks.

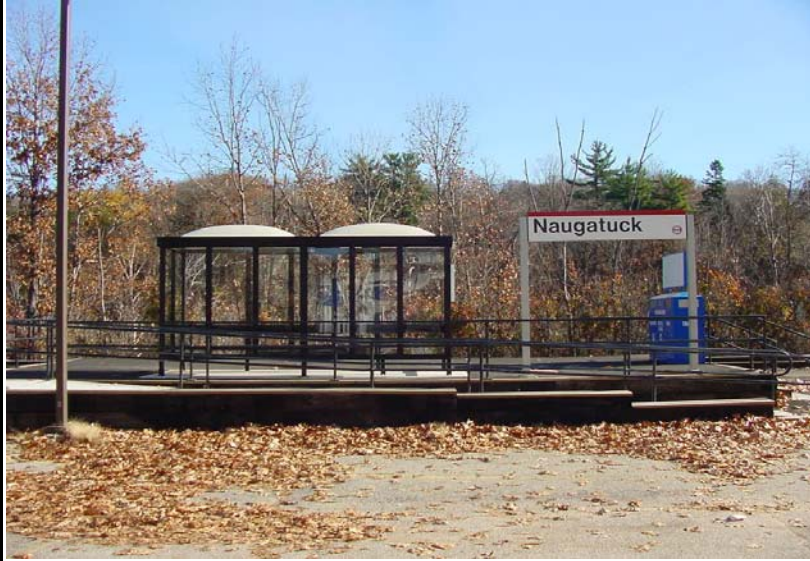
PHOTO NO. 1

Description:  
General view of the platform

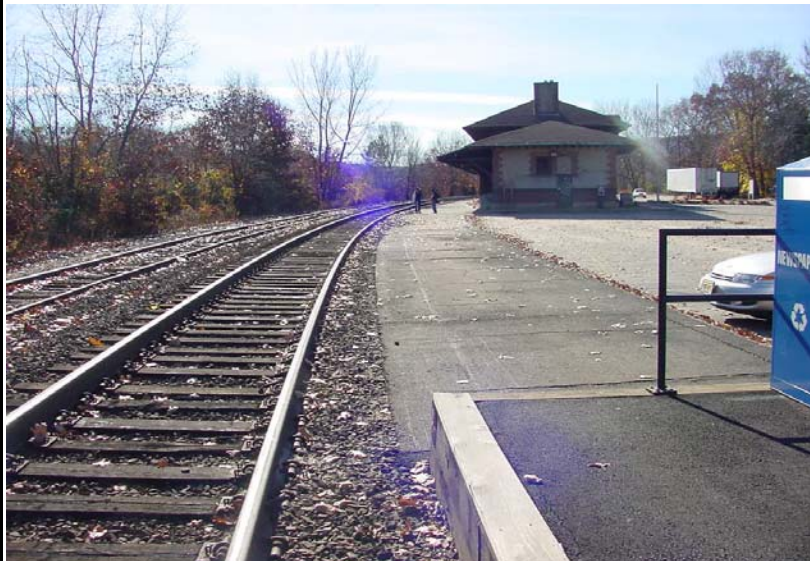
PHOTO NO. 2

Description:  
General view of the asphalt sidewalk in Quad I and II

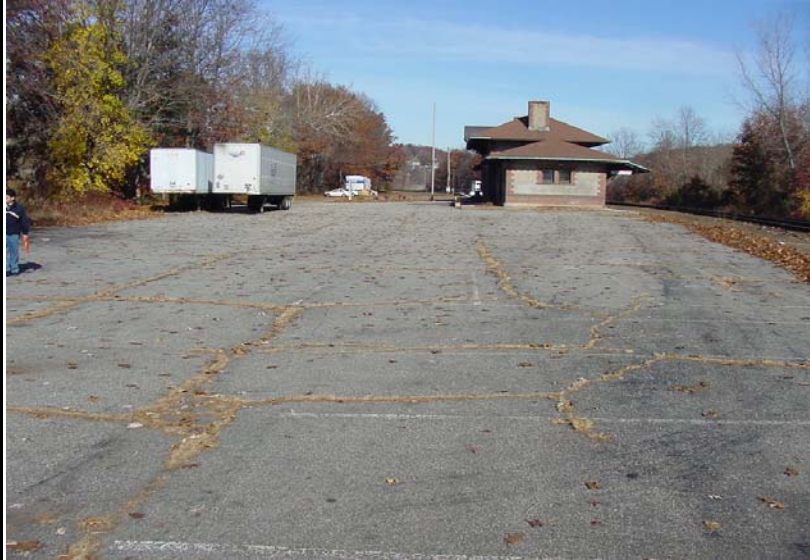
PHOTO NO. 3

Description: \_\_\_\_\_  
General view of the  
parking lot  
Note the cracks with  
vegetation growth

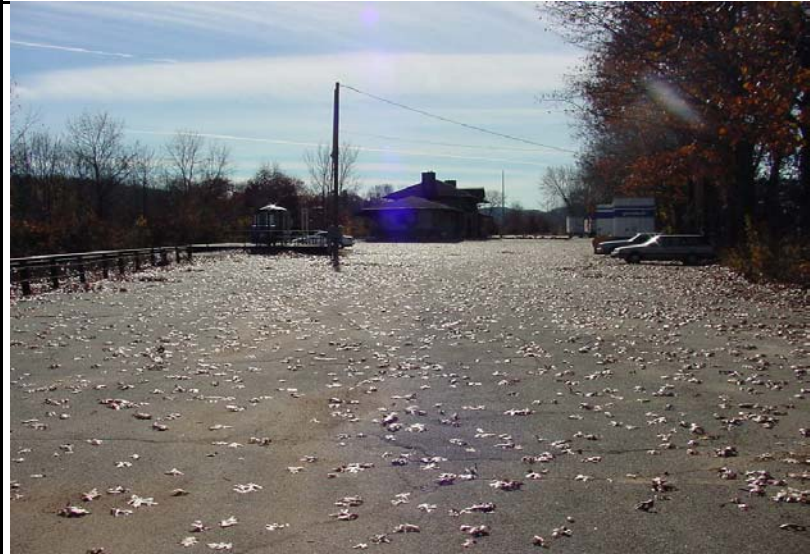
PHOTO NO. 4

Description: \_\_\_\_\_  
General view of the  
parking lot

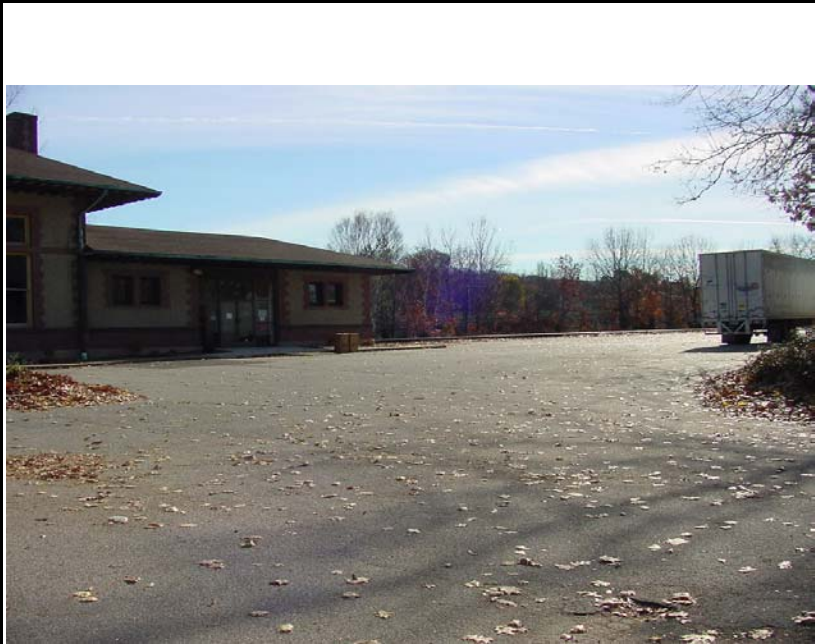
PHOTO NO. 5

Description: \_\_\_\_\_  
General view of the  
parking lot

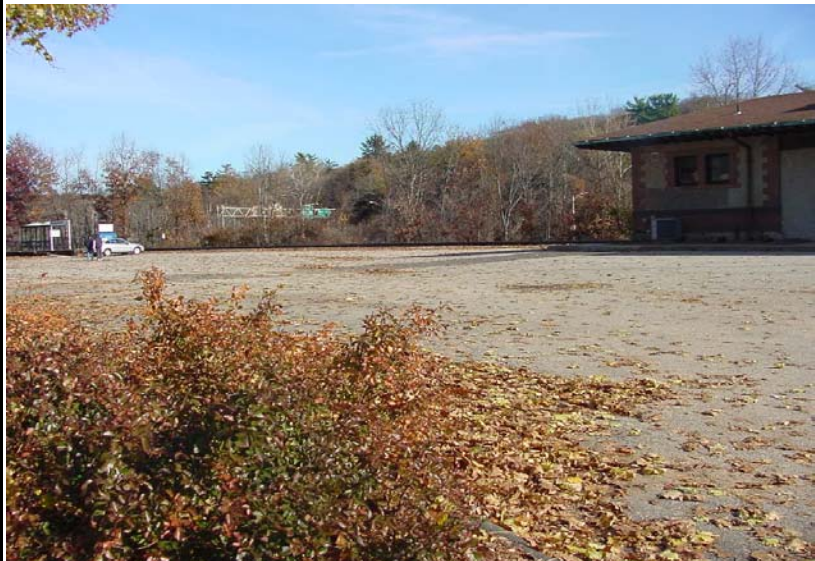
PHOTO NO. 6

Description: \_\_\_\_\_  
General view of the  
parking lot

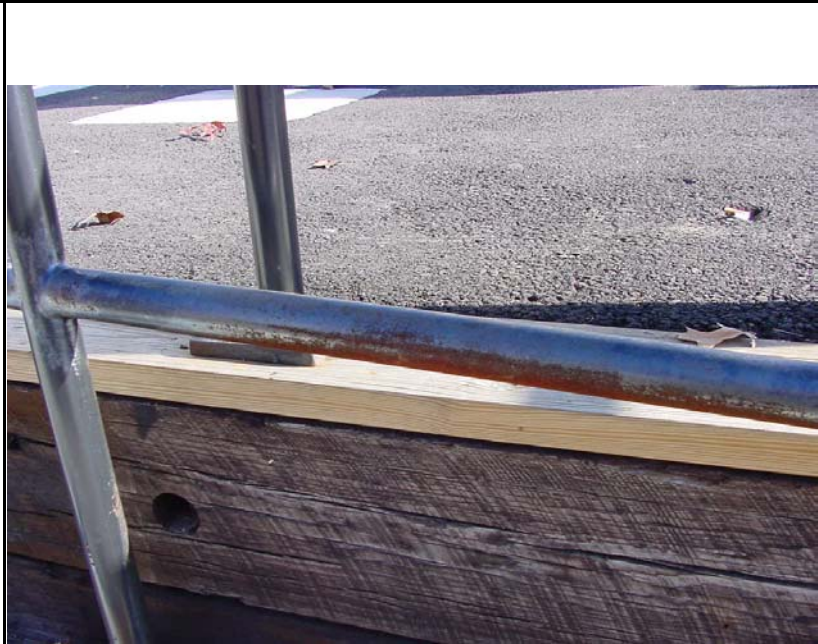
PHOTO NO. 7

Description: The railing is corroded throughout

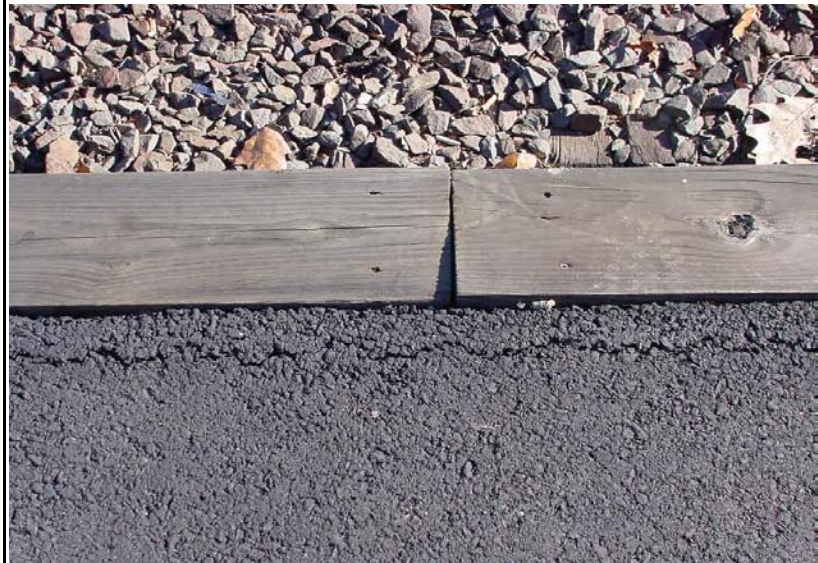
PHOTO NO. 8

Description: The east side of the platform is uneven by approximately 1" which is a tripping hazard

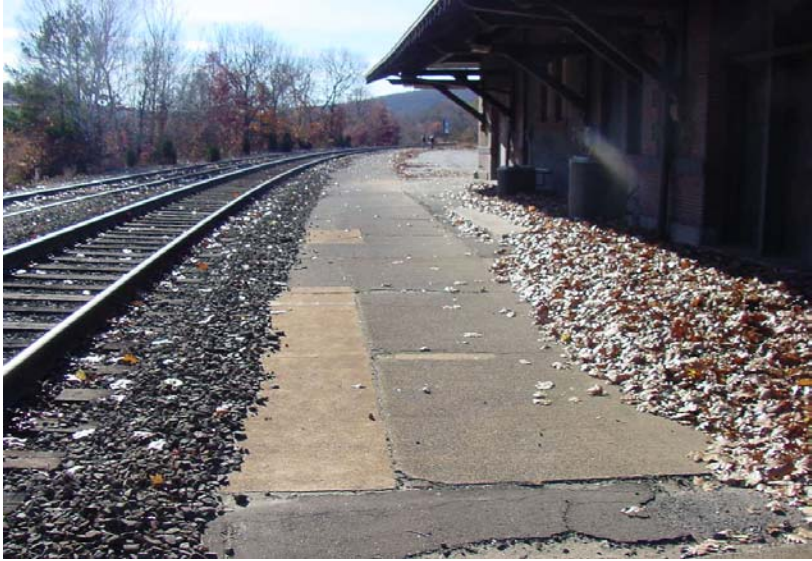
PHOTO NO. 9

Description: Typical cracks and uneven surface along the asphalt sidewalk

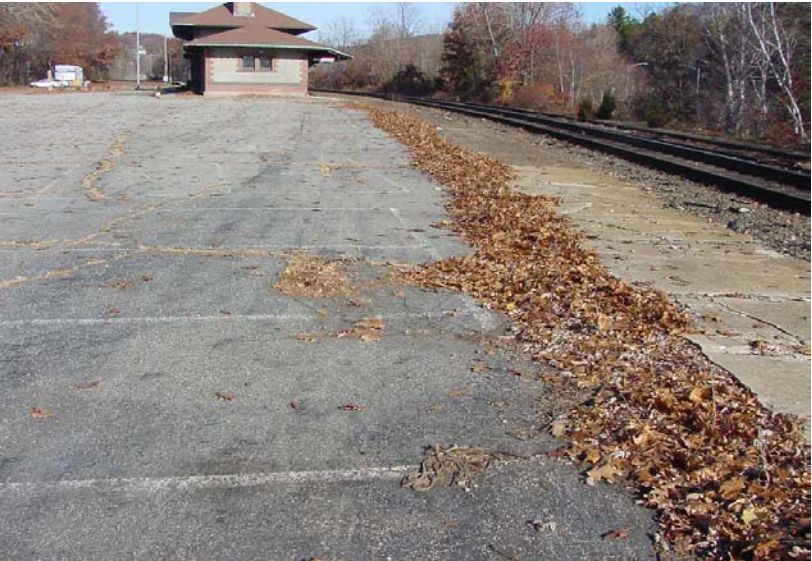
PHOTO NO. 10

Description: Striping is faded; asphalt surface is cracked with vegetation growing thru the cracks; note accumulation of leaves

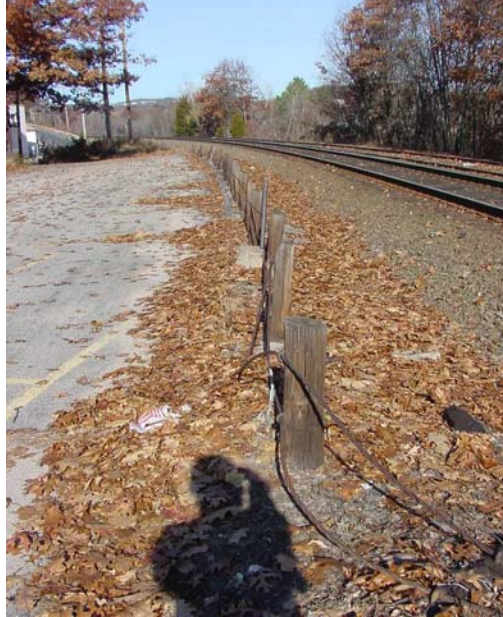
PHOTO NO. 11

Description: \_\_\_\_\_  
The guard rail in Quad III  
is not plumb

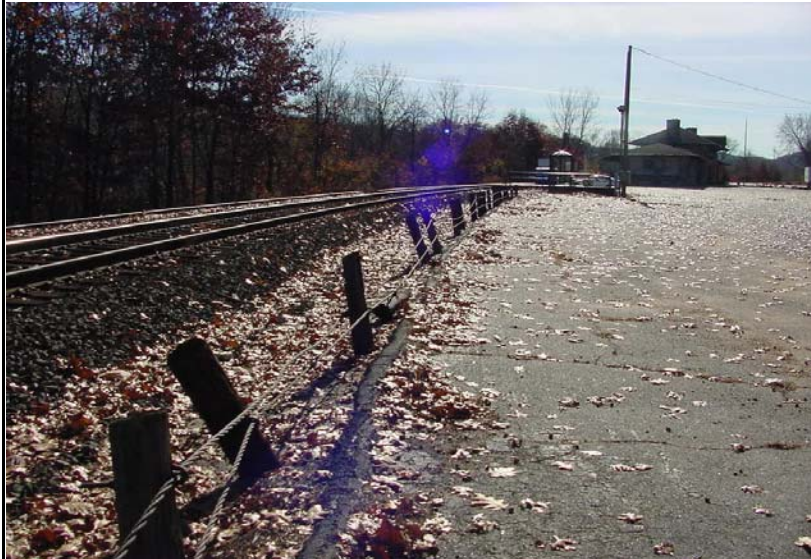
PHOTO NO. 12

Description: \_\_\_\_\_  
The guard rail in Quad III  
is not plumb

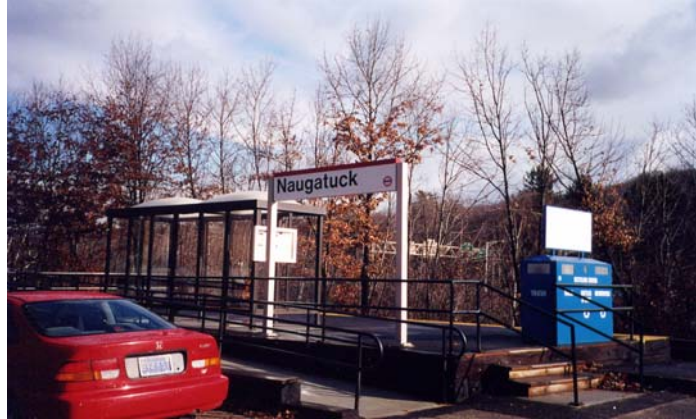
PHOTO NO. 13

Description:  
overall picture  
of the entire  
platform

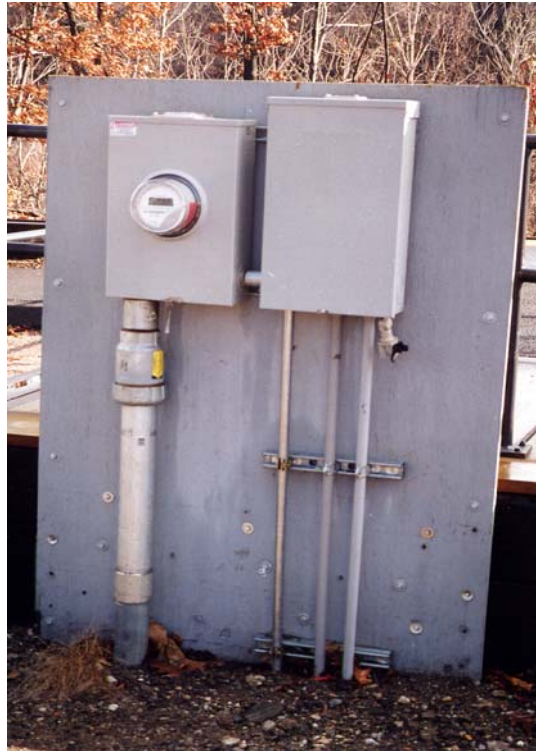
PHOTO NO. 14

The electrical service supplies power to a panelboard via a meter for this platform power source. Since the panelboard is not locked, we recommend that a padlock be placed on it to allow only authorized personnel to gain access. The panelboard is well preserved in the enclosure and will adequately serve the platform power needs for the near future. There are no receptacles or lights on the platform. There is a light pole adjacent to the platform with two metal halide fixtures on it. One of these fixtures is aimed at the platform and provides luminance to the general area around the pole. However, the floodlight provides an average of only 2.4 foot-candles to the platform, which is less than the minimum as recommended by the IESNA. We recommend that additional luminaires be installed to increase the average light level to be at least the minimum of 5 foot-candles as recommended by the IESNA.

Description:  
electrical service  
enclosure

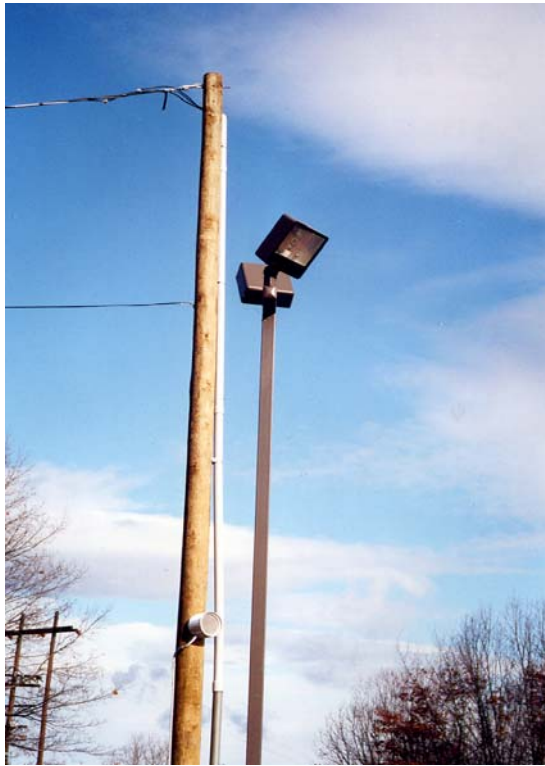
PHOTO NO. 15

Description:  
parking lot/platform  
lighting and  
speaker

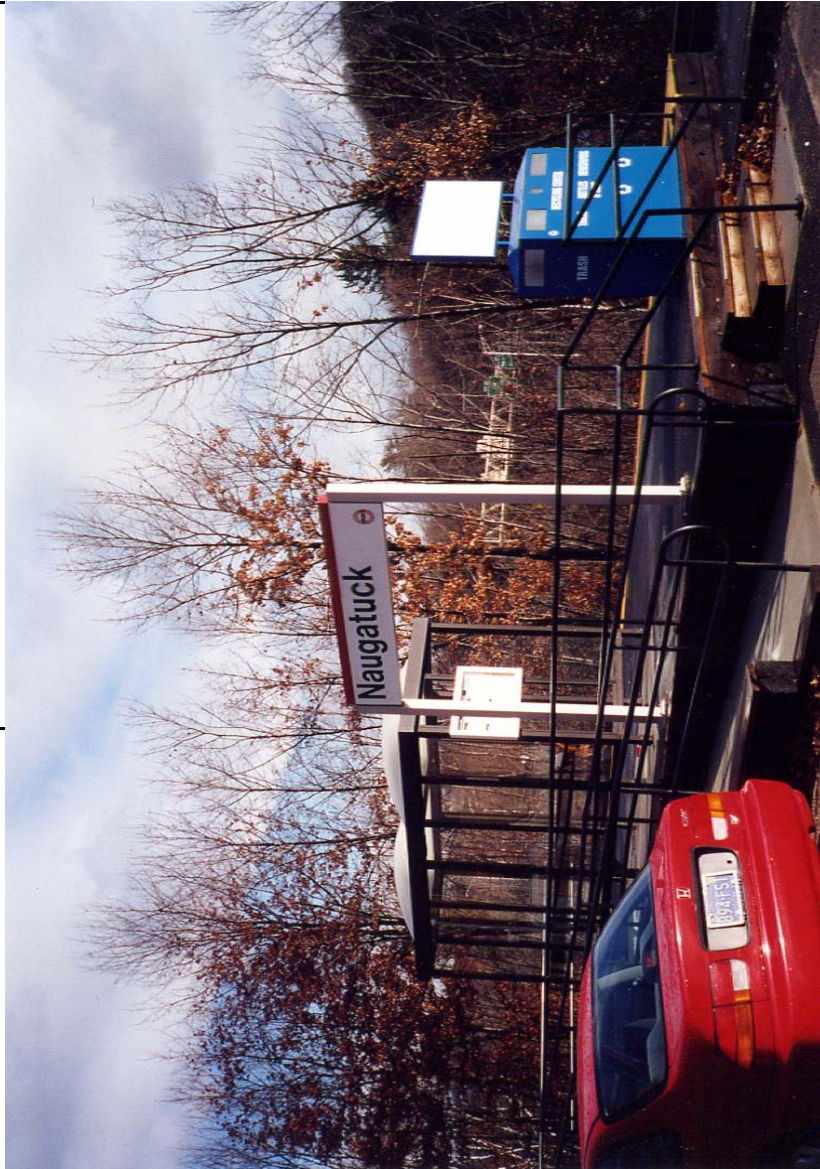
PHOTO NO. 16

There are two small shelters with plastic curbed roofs. There are no gutters or downspouts.  
There is no maintenance required.

Description:  
Platform shelter
