CONNECTICUT
DEPARTMENT
OF
TRANSPORTATION

CONDITION INSPECTION
FOR THE
RIVERSIDE STATION

**CONN. DEPT OF TRANSPORTATION
STATION INSPECTION**

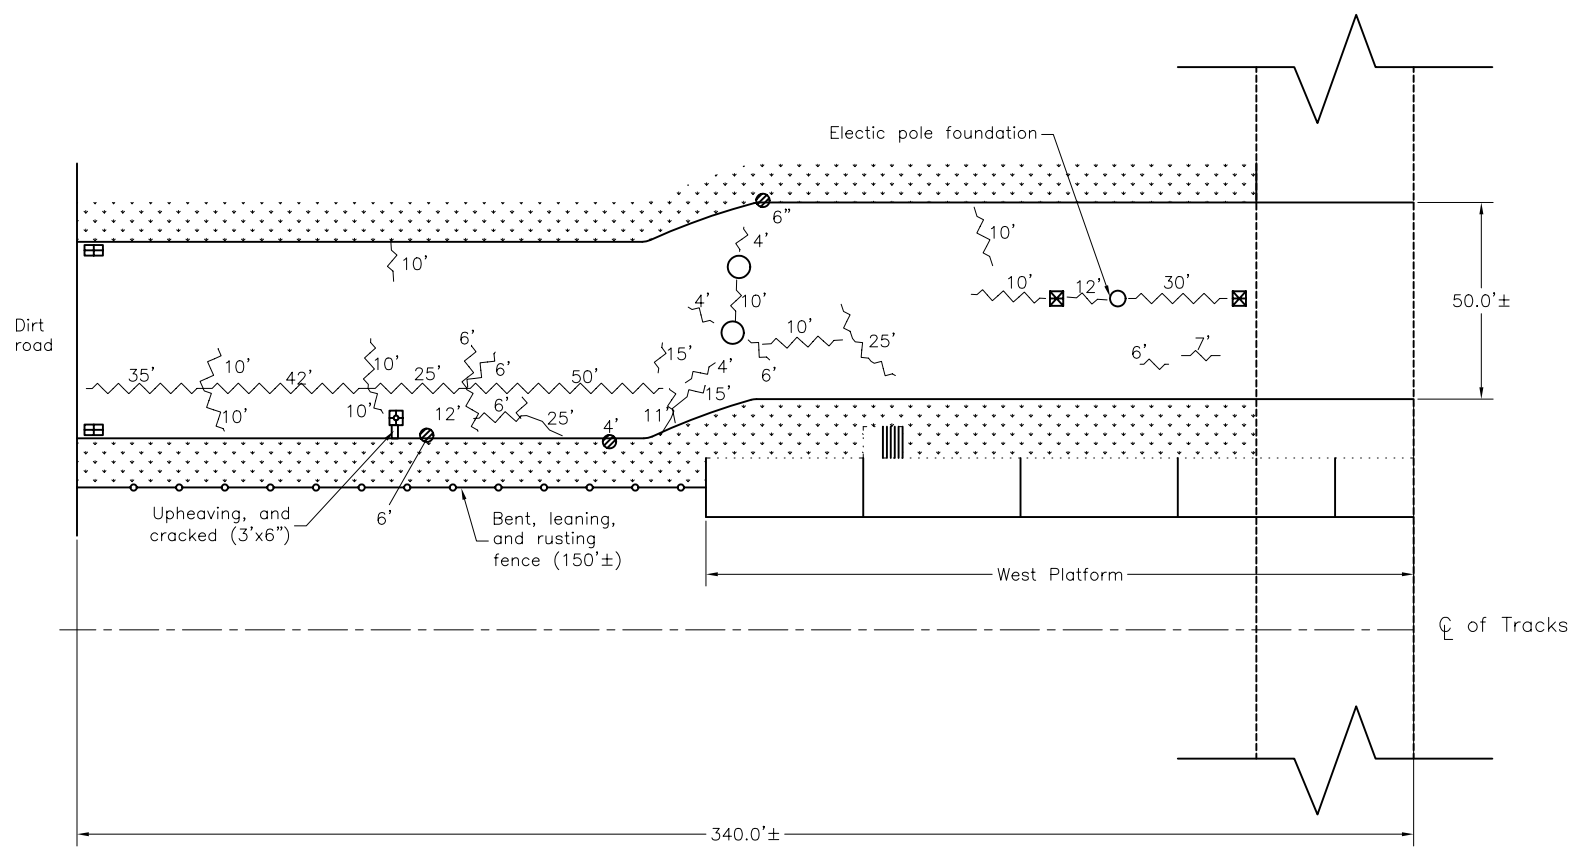
Urbitran Associates, Inc.
Connecticut Dept. of Transportation
Riverside Station Quadrant IV Plan
Date: 3/5/02

NOTES:
 1. The east side curb is cracked in multiple locations (total of 30'±)

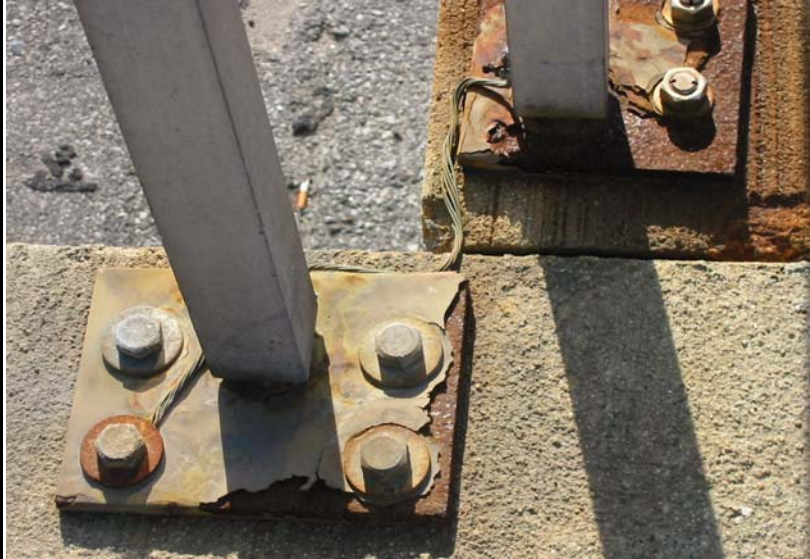
Description: _____
The railing base plates
are rusted and
deteriorated

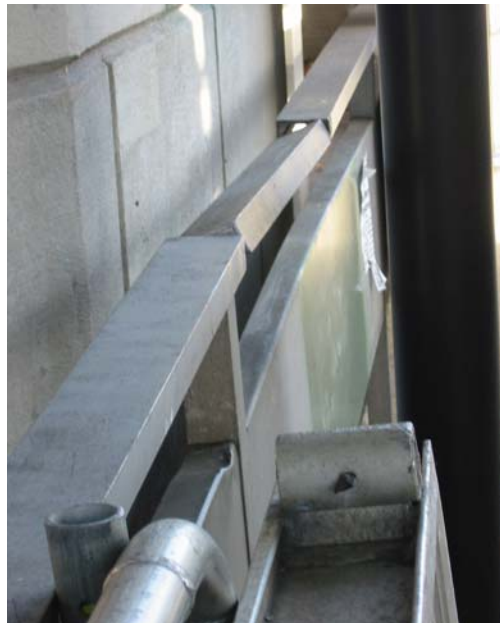
PHOTO NO. 22

Location: _____
Span V of the west
platform

Description: _____
Broken handrail

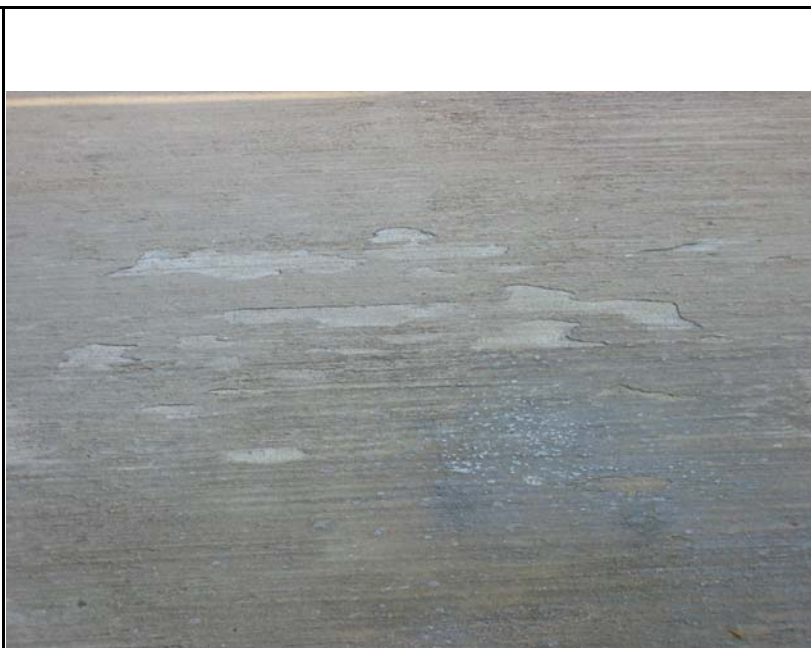
Description: _____
10% of the concrete
surface is scaled

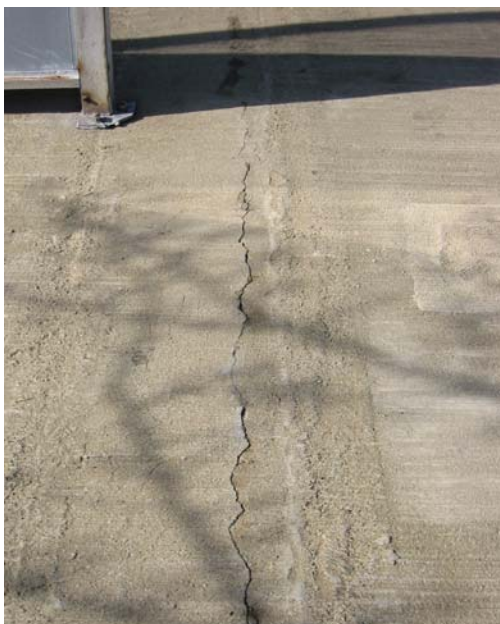
PHOTO NO. 24

Location: _____
Span XI of the east
platform

Description: _____
40' crack

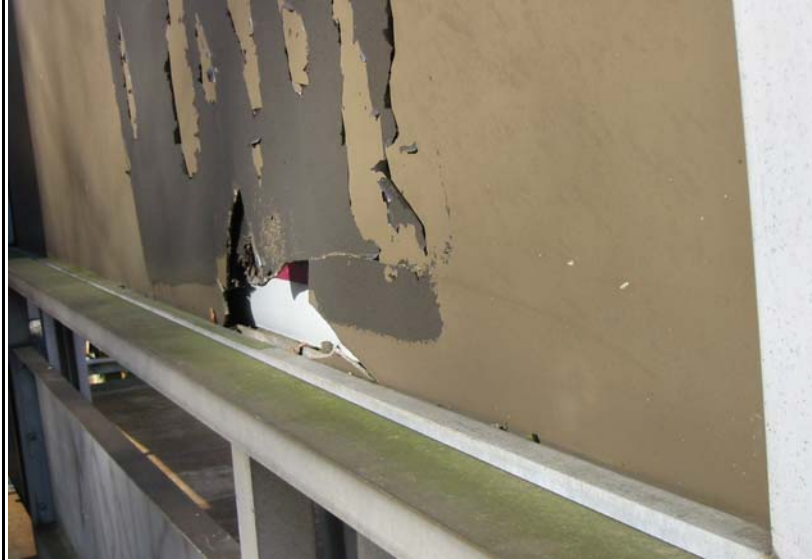
Description: _____
The back of the sign is
cracked and damaged

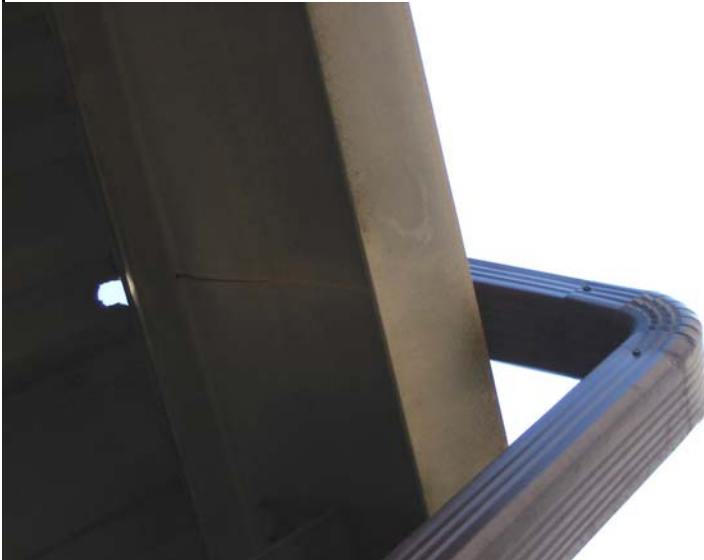
PHOTO NO. 26

1. The canopy roof (metal decking) in Spans IX–XIII are rusted, deteriorated and contain holes.
2. The base plates for the double tees are typically rusted.

Location: _____
Span XIII of the west
platform

Description: _____
There is an isolated
area where there is
a hole in the canopy

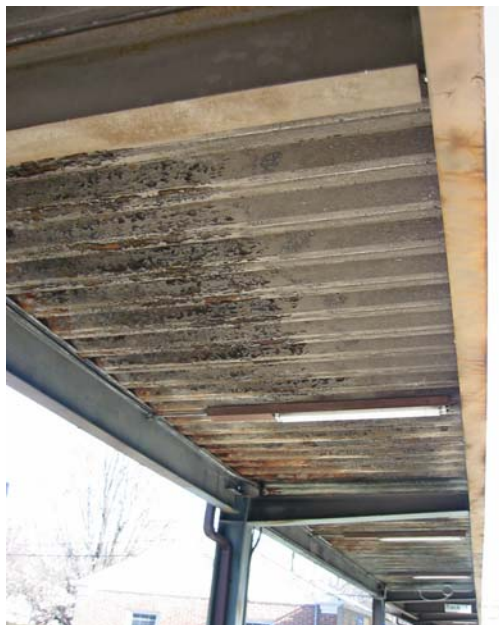
Additional Notes
 Platform roof rusted needs repair

Description: _____
The canopy is
corroded, rusted, and
the paint is chipping

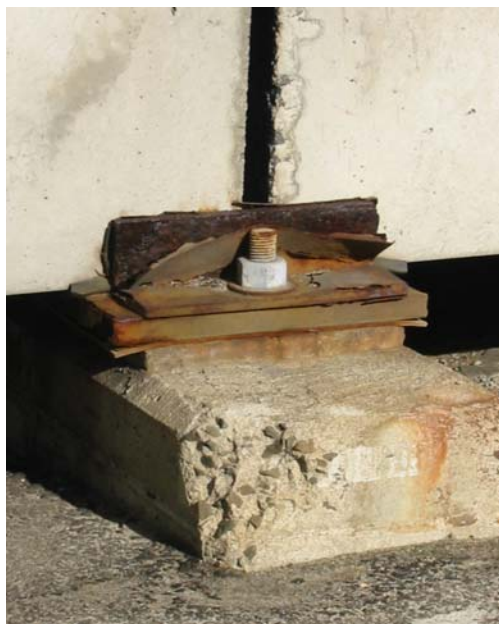
PHOTO NO. 28

Location: _____
East of Span IX of the
east platform

Description: _____
The concrete footing
is spalled (4"x4")
and the base plates
are rusted and
deteriorated

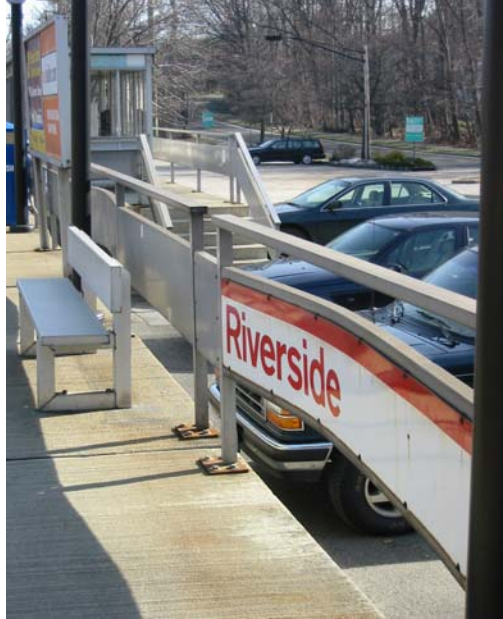
Description: _____
Bent railing

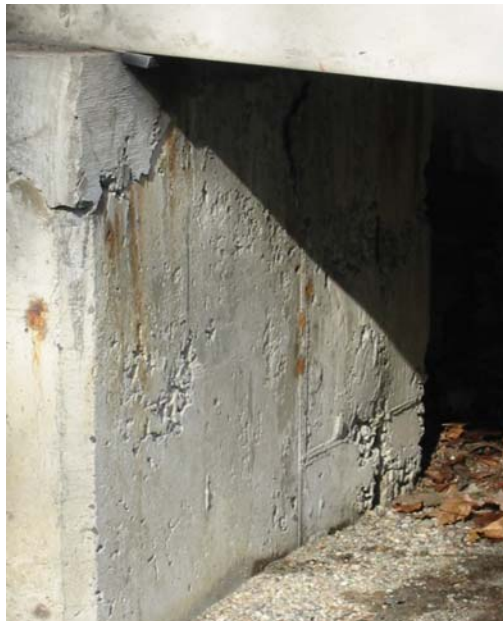
PHOTO NO. 30

Location: _____
East of Span VIII of the
east platform

Description: _____
The concrete pier is
spalled and cracked
(3'x2')

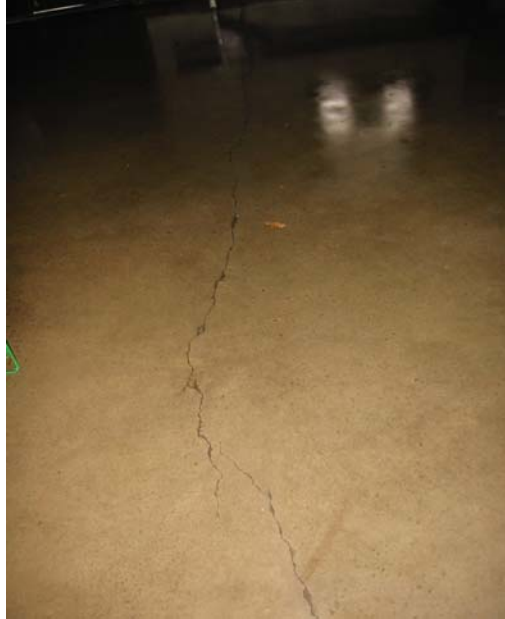
Description: _____
Crack extending from
the east interior wall to
the west interior wall

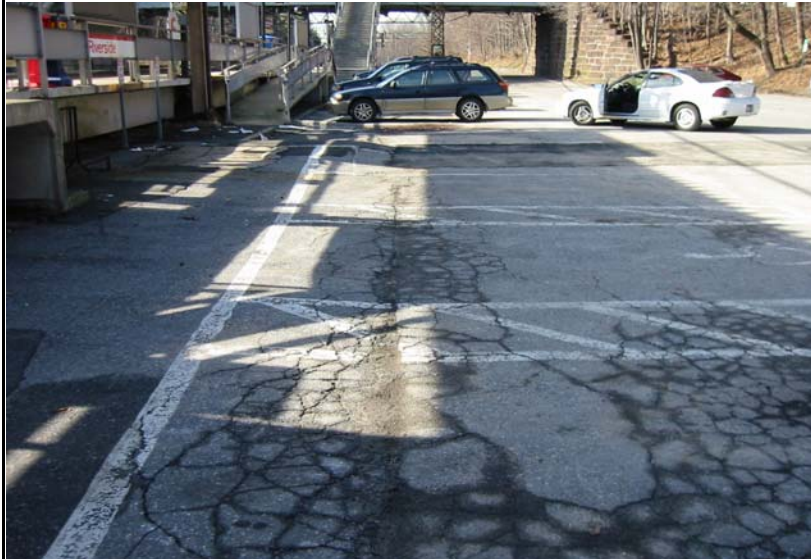
PHOTO NO. 32

Location: _____
East side of Quad IV

Description: _____
Map cracking

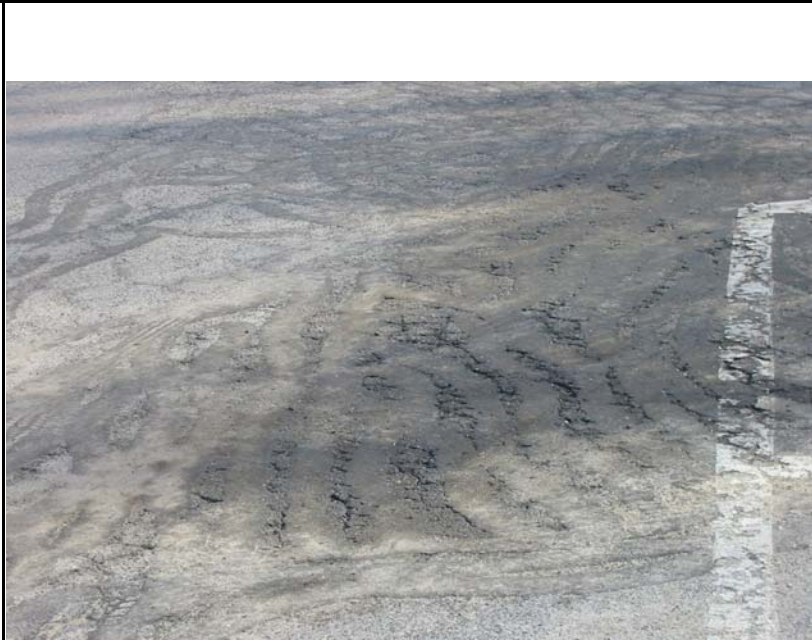
Description: Filled asphalt cracks
which is still cracked

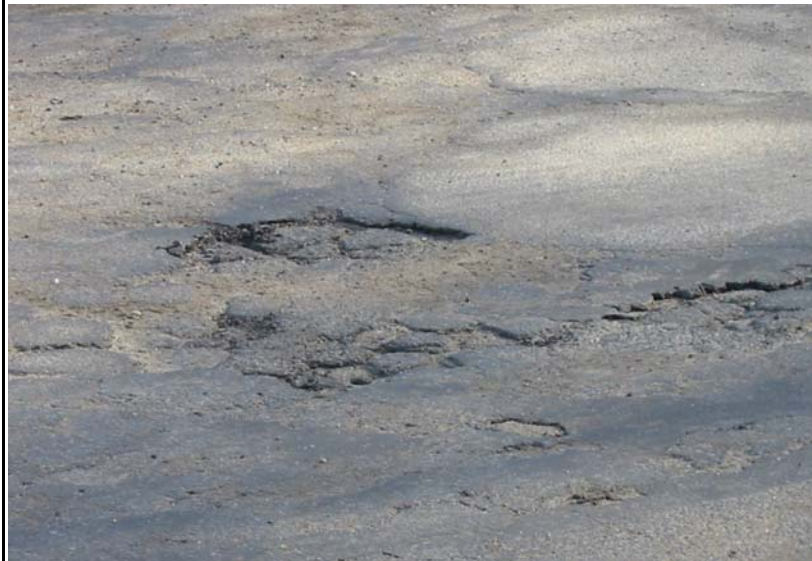
PHOTO NO. 34

Location: Middle of Quad II

Description: Typical spalled asphalt
surface

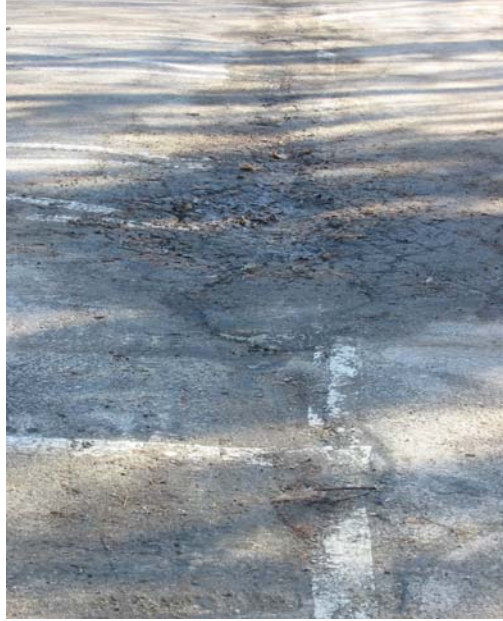
Description: The asphalt pavement is cracked and uneven with potholes (6'x2'x4")

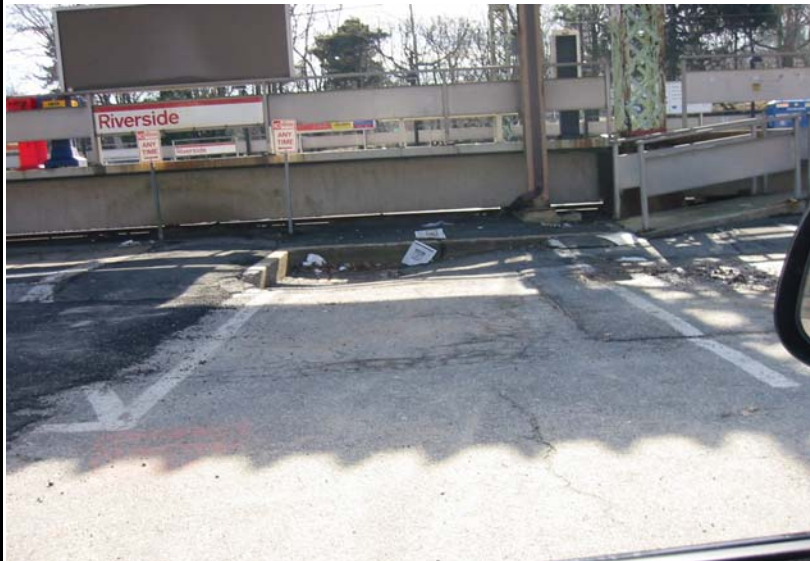
PHOTO NO. 36

Location: South of the station house

Description: The asphalt pavement is cracked with uneven settlement

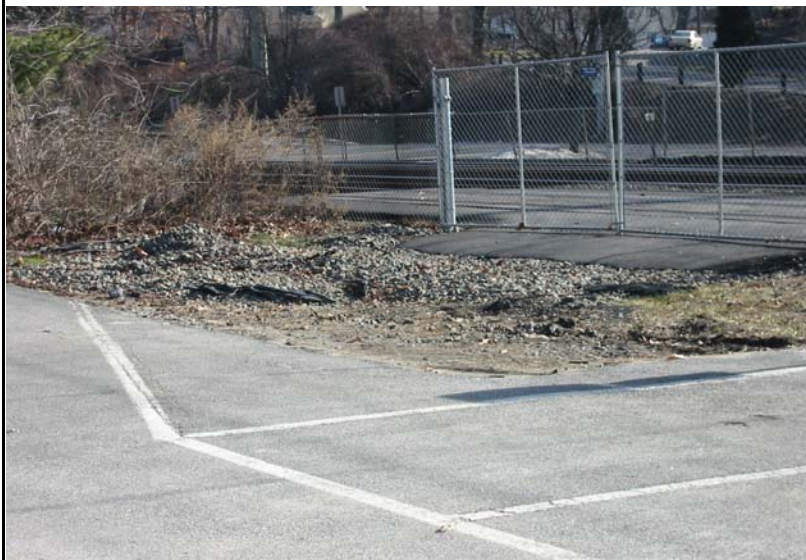
Description: _____
Loose debris; there
is no curb

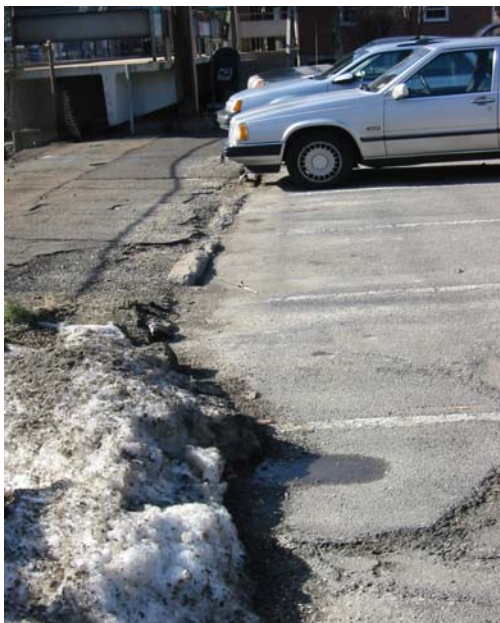
PHOTO NO. 38

Location: _____
Northeast corner of
Quad IV

Description: _____
The asphalt sidewalk
is cracked, and uneven;
the concrete curb is
missing, or spalled

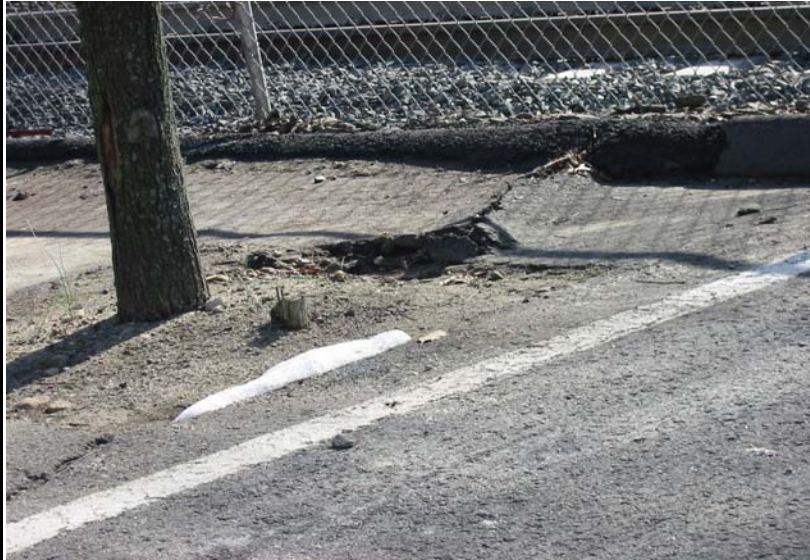
Description: The asphalt pavement is up heaving and cracking due to the roots of the tree (3'x6")

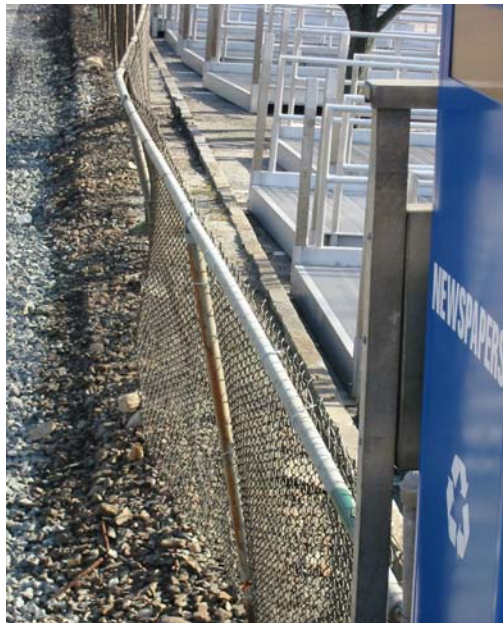
PHOTO NO. 40

Description: The west fence in Quad II is rusted, the chain links and frame are bent and leaning

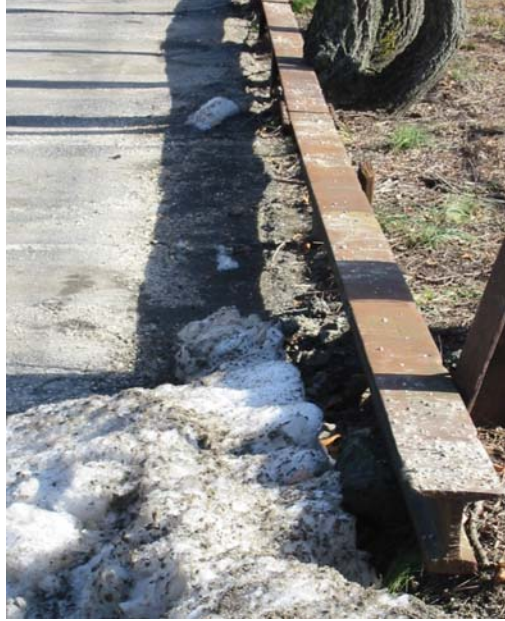
Description: _____
The guardrail is loose

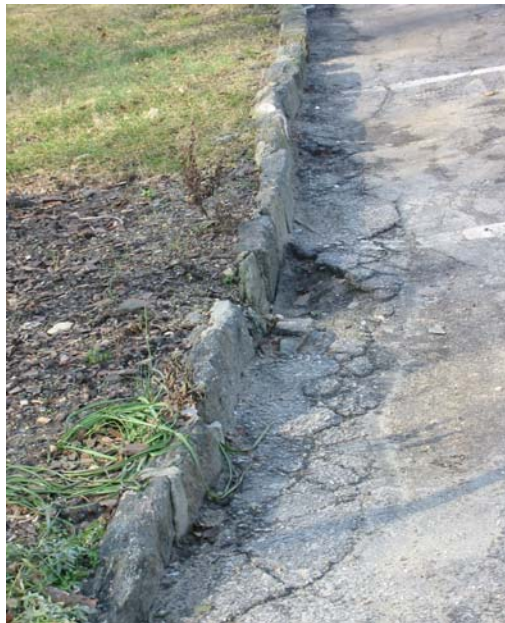
PHOTO NO. 42

Location: _____
East side of Quad II

Description: _____
The curb is spalled and
the asphalt pavement is
cracked with potholes
(14'x1')

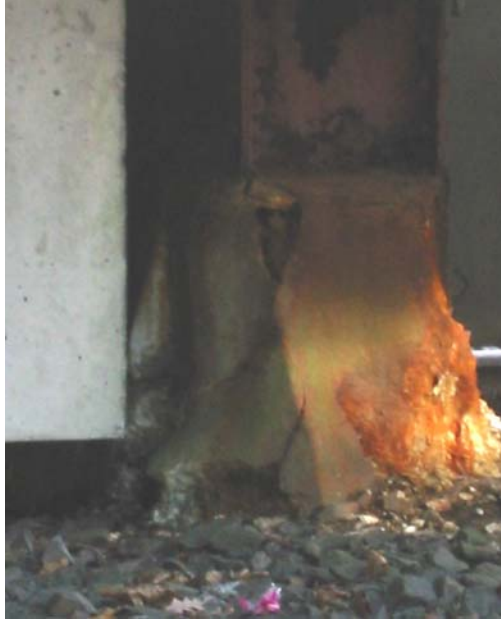
Description: _____
The train power line
footing is spalled,
cracked, deteriorated,
and covered with
rust stains

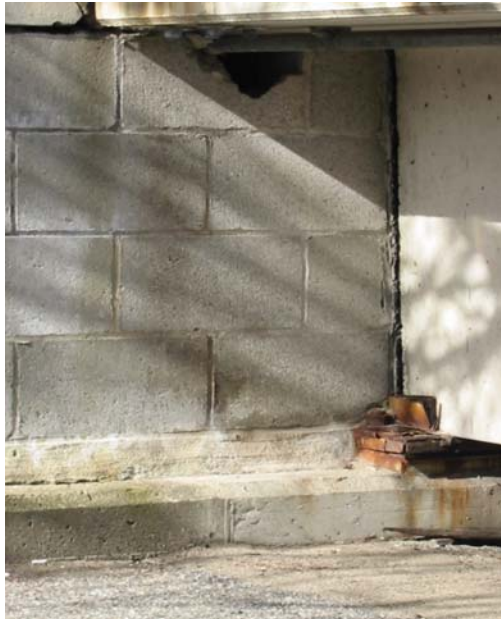
PHOTO NO. 44

Location: _____
North of Span XI of the
east platform

Description: _____
The cinder block
is damaged (6"x6")

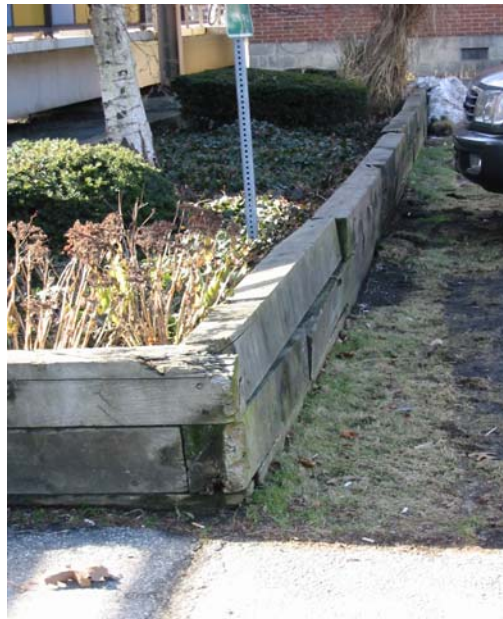
PHOTO NO. 46

Location: _____
North of the station
house in Quad IV

Description: _____
The retaining wall is
leaning

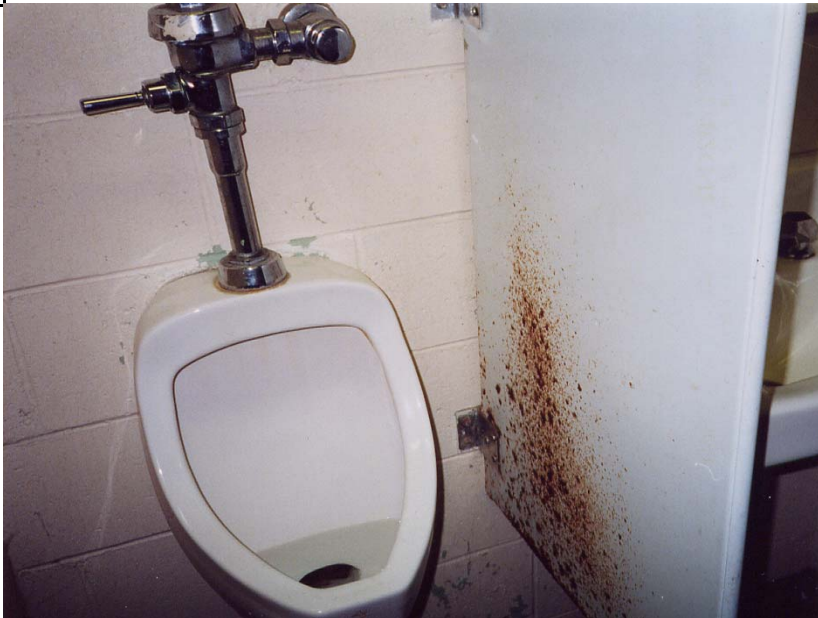
PHOTO NO. 54

1 Urinal - Good Repair
1 Toilet - Good Repair
1 Lavatory - Good Repair
All Handicapped fixtures
Handicapped accessible
No water conservation fixtures
Area conditions acceptable but
dividing short wall is rusted - Deficient,
needs maintenance or replacement

Description:
Men's Room
Urinal in Good
Condition
Partition Rusted

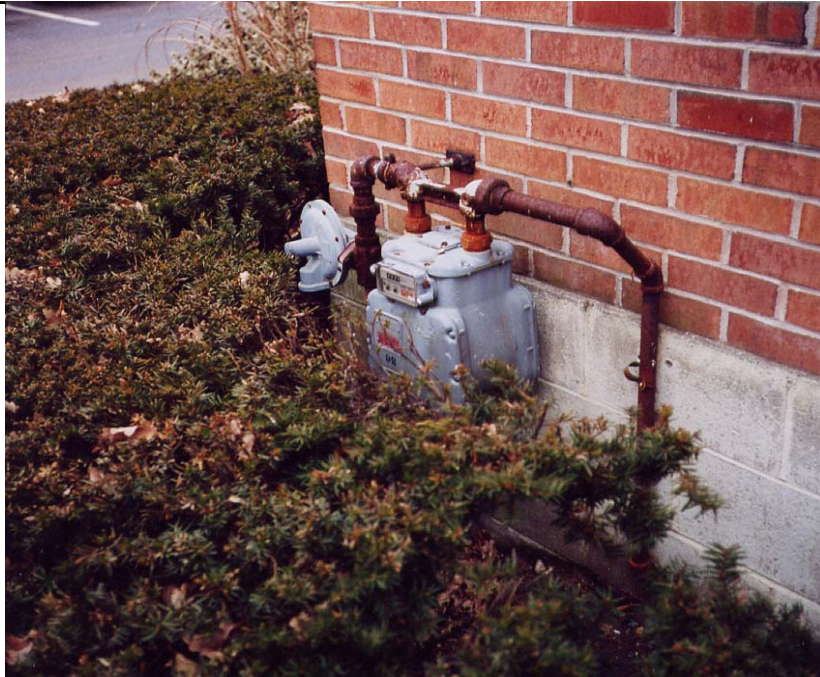
Outside the building the pipes to the gas meter are rusted and in need of maintenance.

Description:
Natural Gas
Meter, Pipe
Rusted Needs
attention
