CONNECTICUT  
DEPARTMENT  
OF  
TRANSPORTATION

CONDITION INSPECTION  
FOR THE  
ROWAYTON STATION

**CONN. DEPT OF TRANSPORTATION  
STATION INSPECTION**

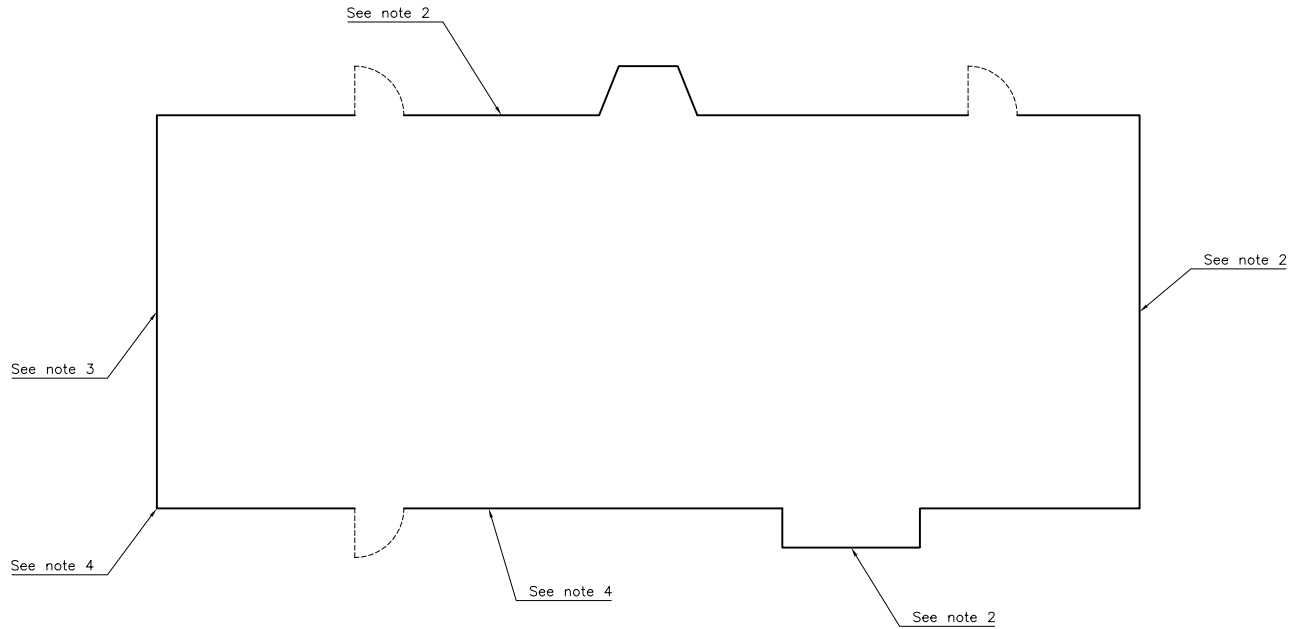
Urbitran Associates, Inc.
Connecticut Dept. of Transportation
Rowayton Station Station House Plan
Date: 12/07/01

1. The roof shingles are starting to uplift.
2. There are isolated areas where the exterior elevation is cracked.
3. There is an isolated area where the gutter is dislocated from the roof.
4. There are isolated areas where the paint is chipped.
5. At the time of inspection we could not get access to the interior of the station house.

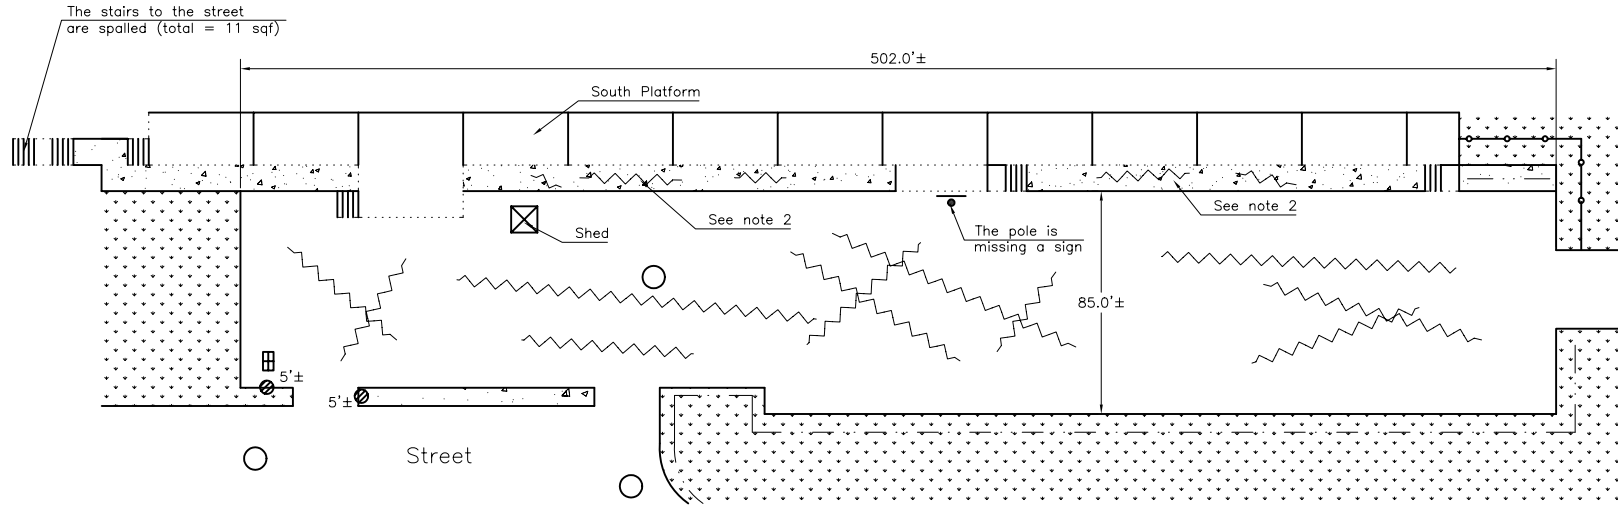
1. The asphalt surface contains numerous cracks with vegetation growth.
2. There are random cracks in the asphalt sidewalk (60'±).

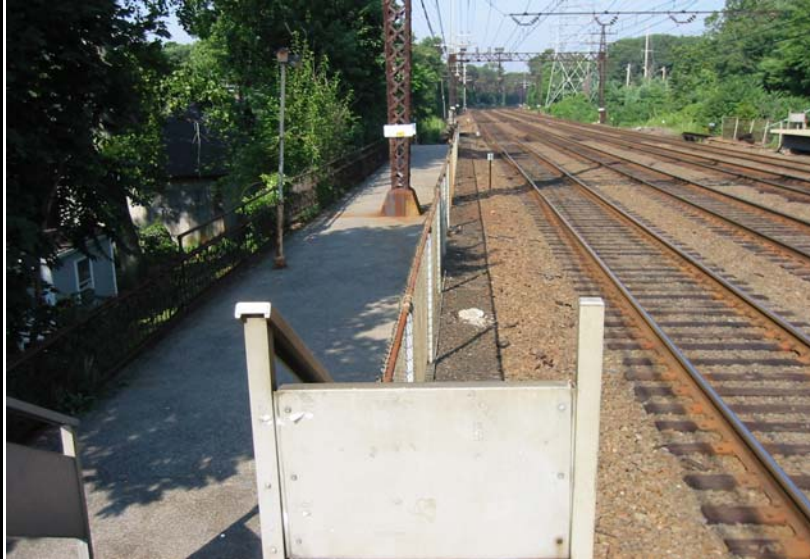
Description: Missing top rail of the railing

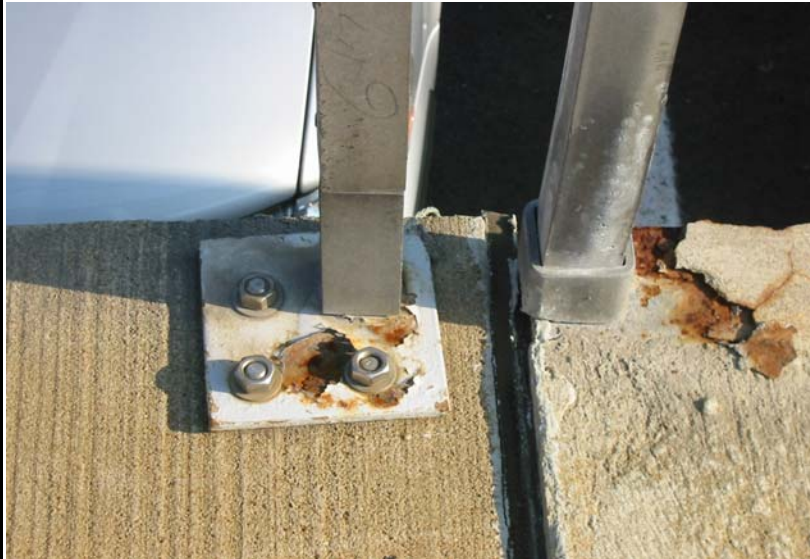
PHOTO NO. 14

Description: Typical rusted base plate

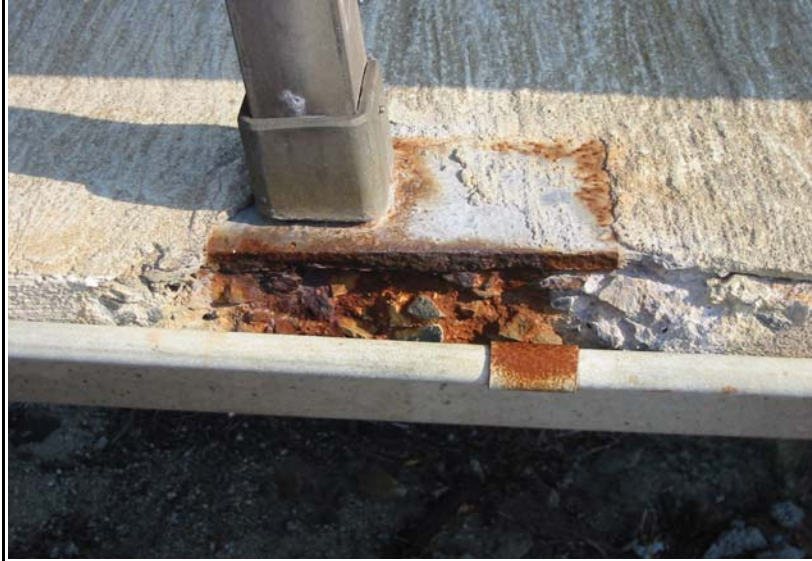
Description: Typical spalled concrete adjacent to the railing base plate

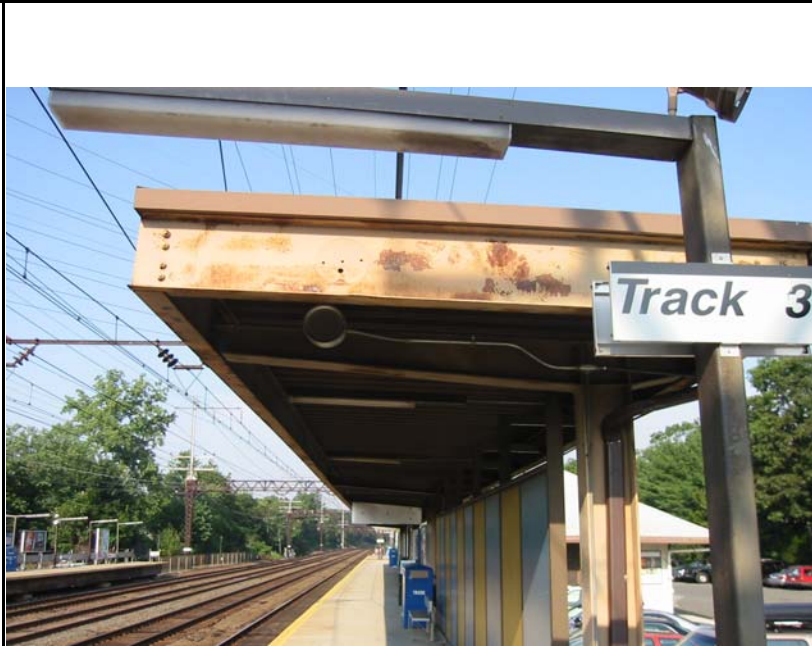
Description: The canopy member contains minor surface rust

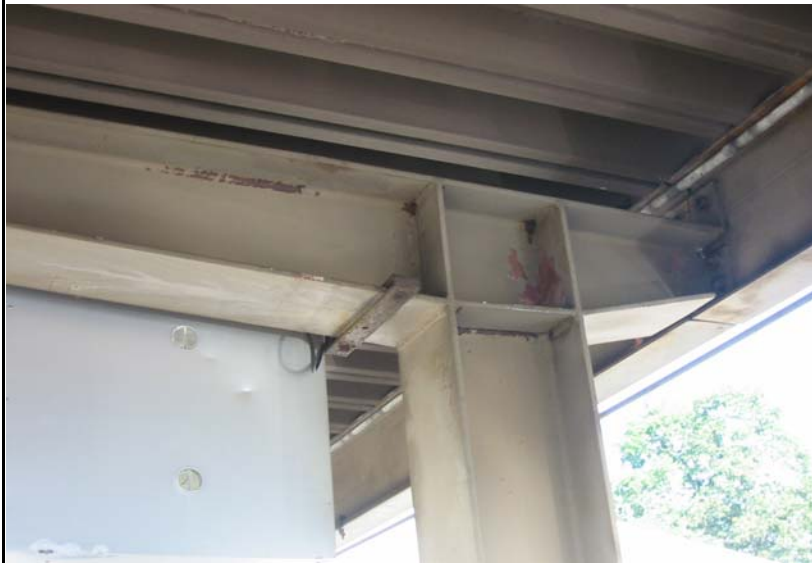
PHOTO NO. 18

Description: The canopy member contains minor surface rust

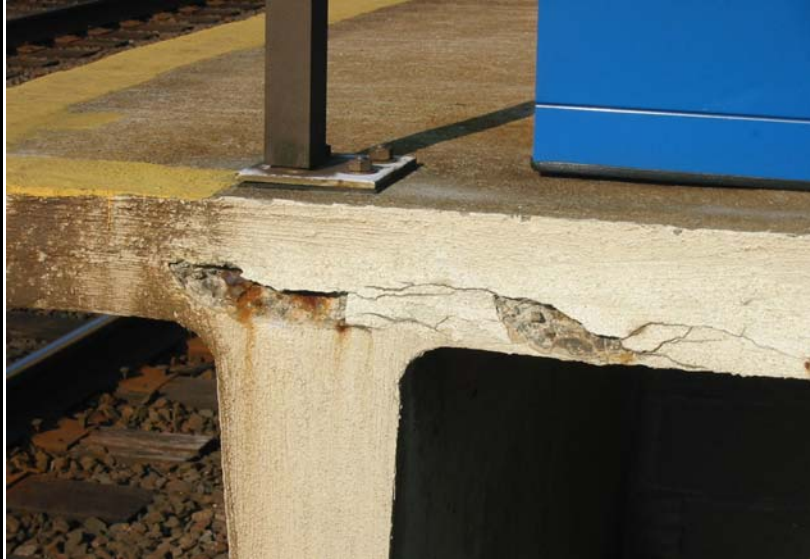
Description: Spalled and cracked double tee flange

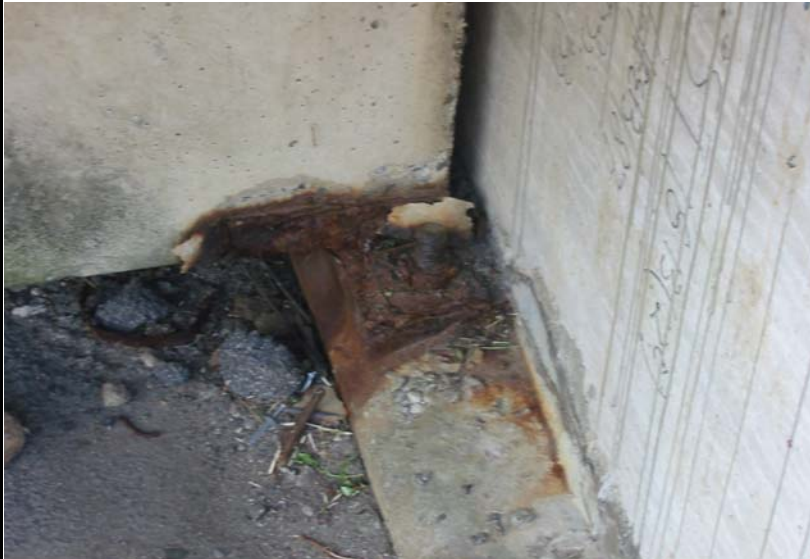
PHOTO NO. 20

Description: Typically the base plate for the double tee is rusted and deteriorated

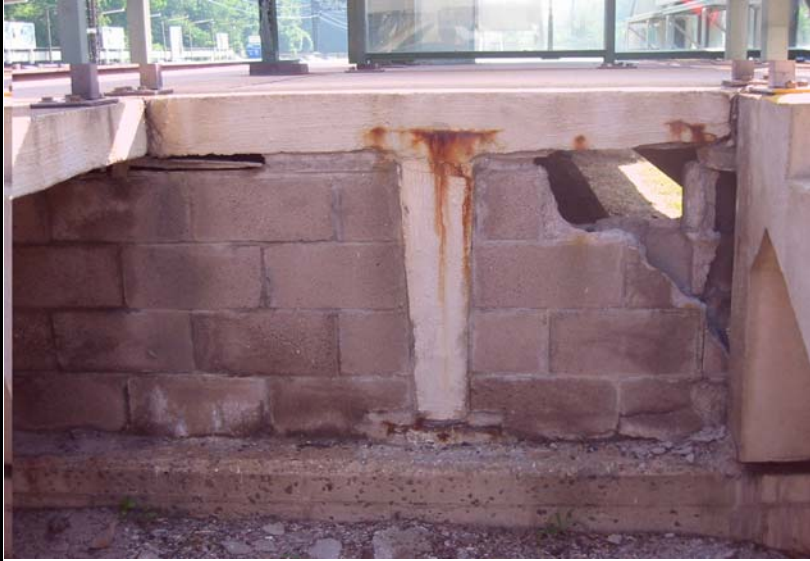
Description: Damaged cinder block façade (3'x3' and 2'x1")

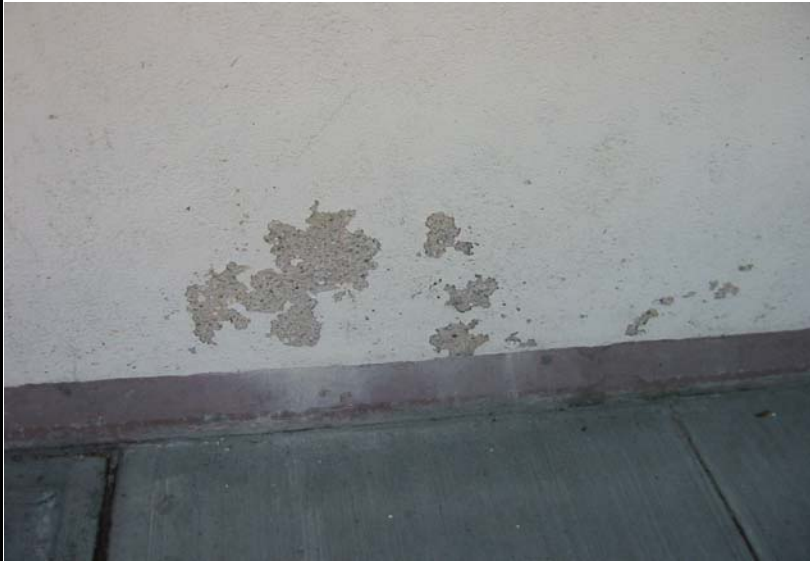
PHOTO NO. 22

Description: Chipped paint on the middle of the exterior north elevation

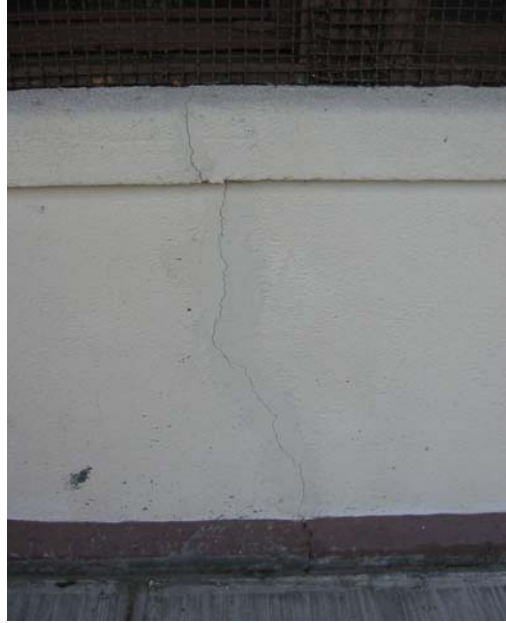
Description: \_\_\_\_\_  
Crack on the middle of  
the exterior east  
elevation

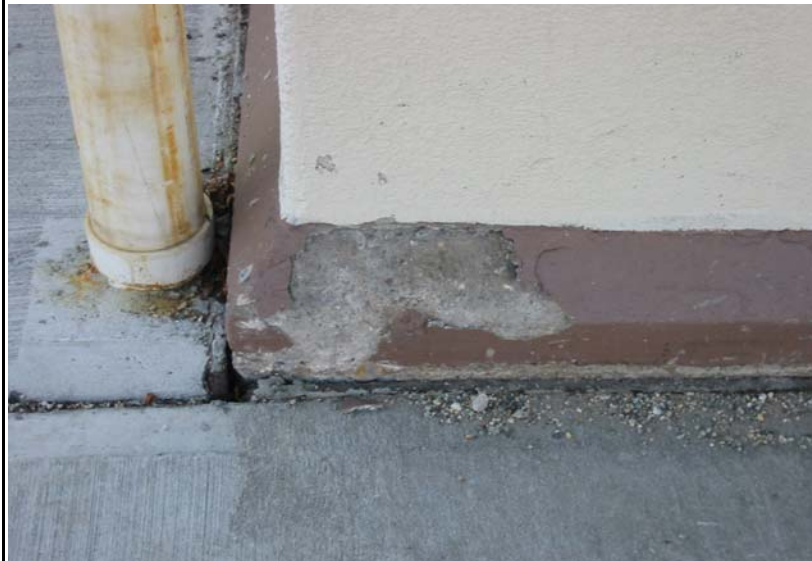
PHOTO NO. 24

Description: \_\_\_\_\_  
Chipped paint on the  
lower exterior north  
elevation

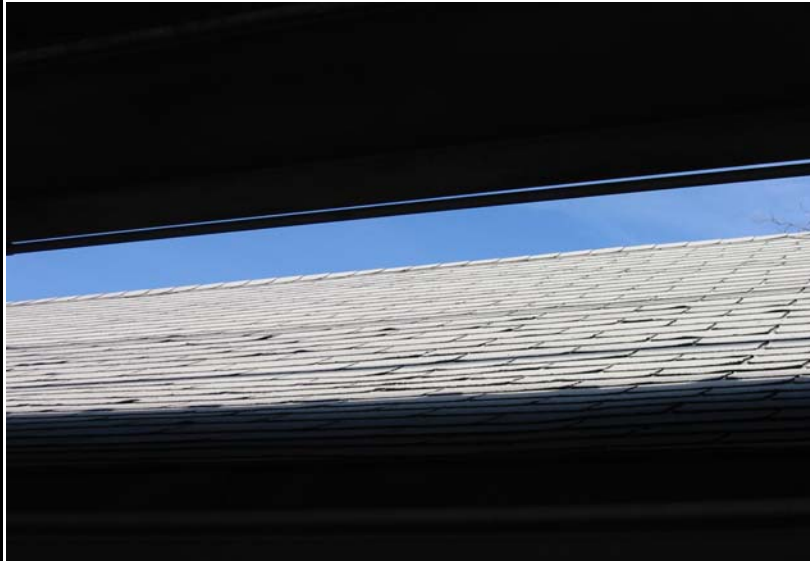
Description: \_\_\_\_\_  
Typically the shingles  
are starting to uplift

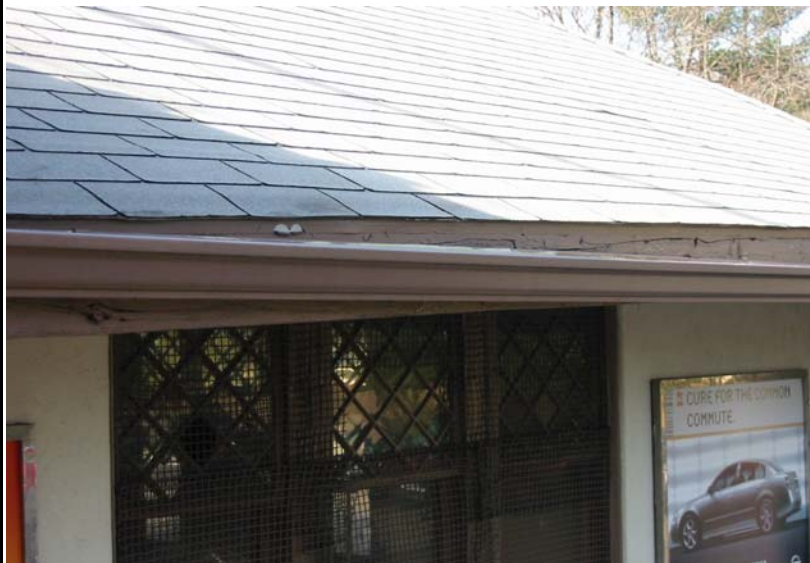
PHOTO NO. 26

Description: \_\_\_\_\_  
The drain is dislocated  
from the roof

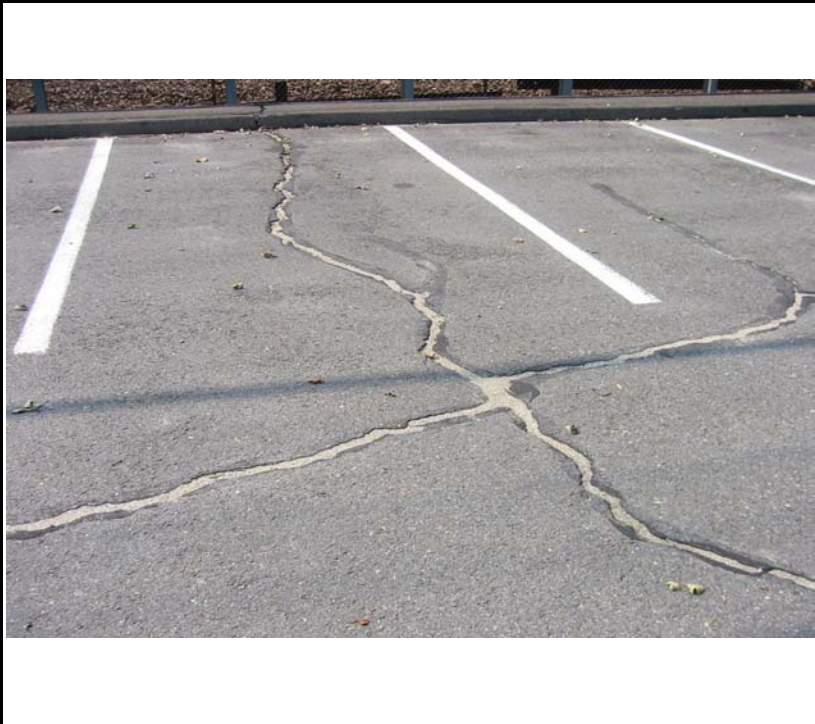
Description: Typical cracks

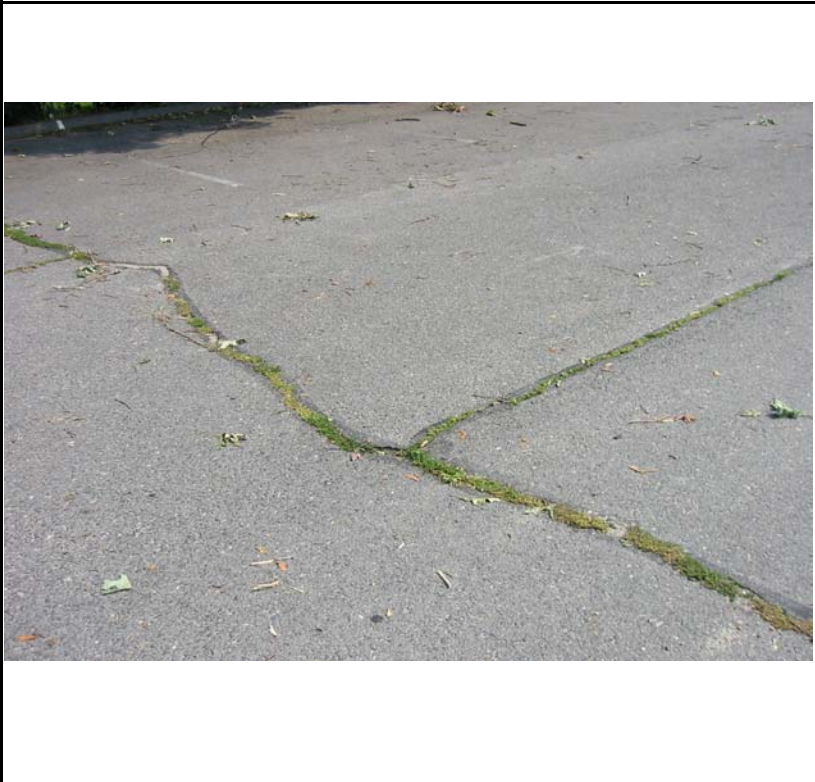
PHOTO NO. 28

1. The asphalt surface in Quadrant II contains numerous cracks with vegetation growth.

Description: Typical crack with vegetation growth

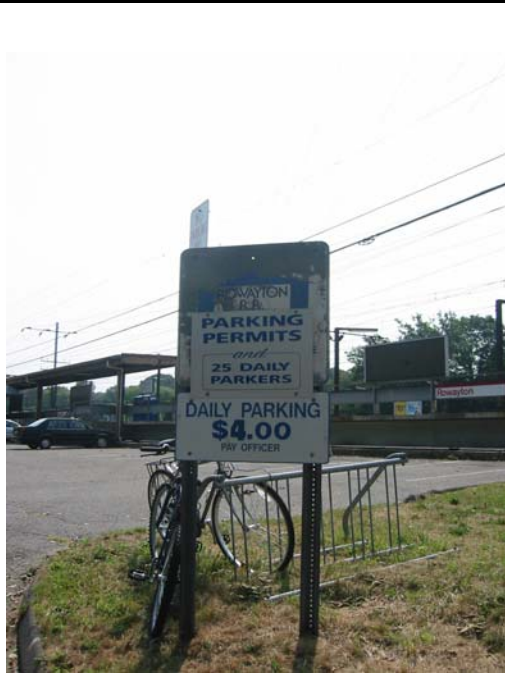
Description:  
Faded paint on the sign

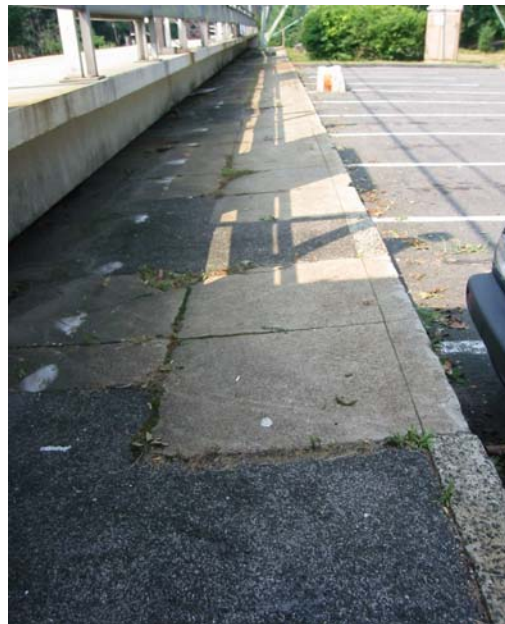
PHOTO NO. 30

Description:  
Typical cracked sidewalk with vegetation growth and an uneven walking surface

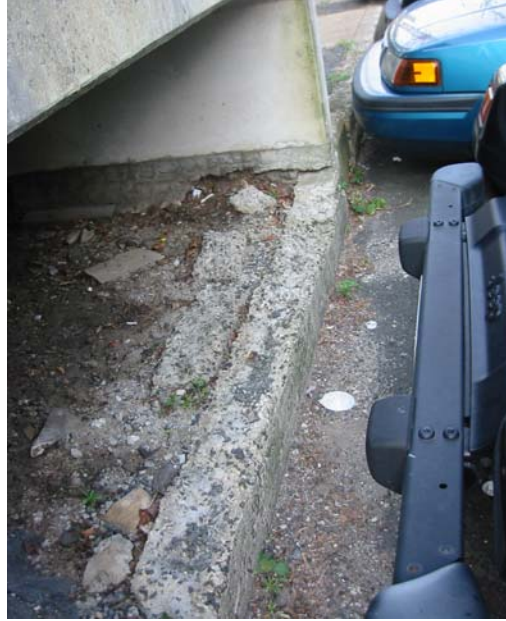
Description: Typical spalled concrete curb

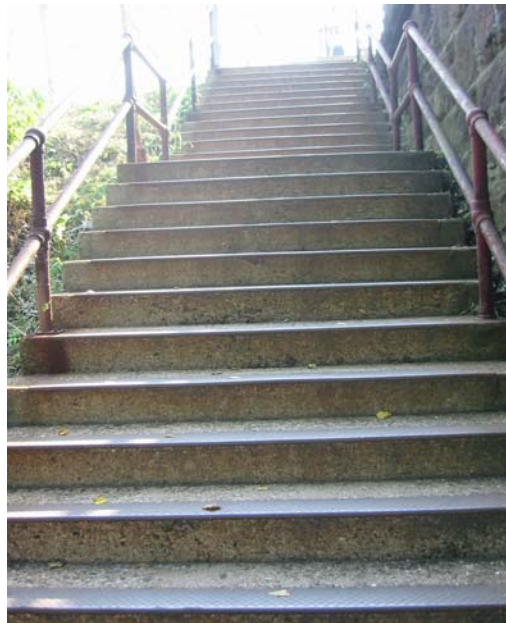
PHOTO NO. 32

Description: The railing is rusted

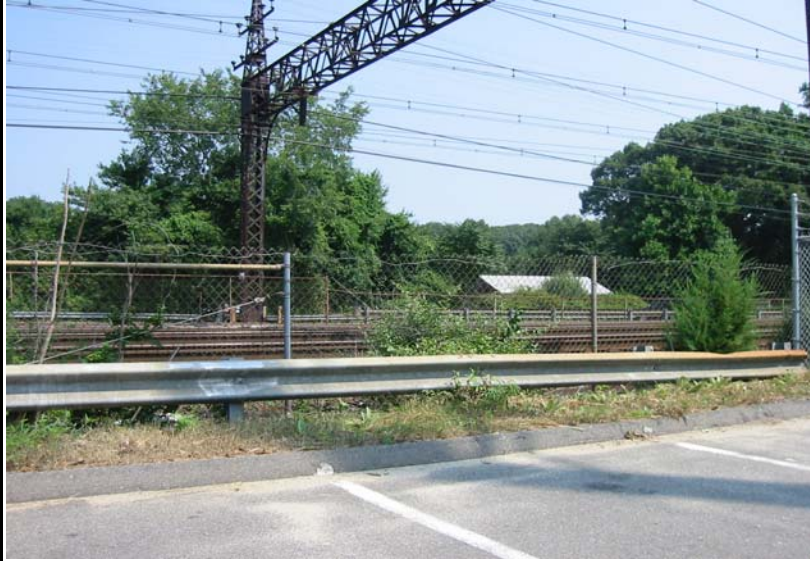
Description: Typical damaged fence

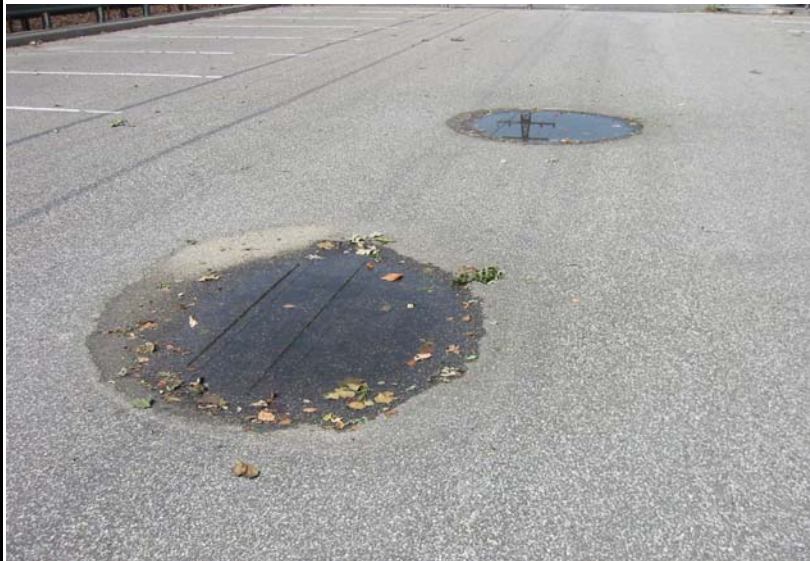
PHOTO NO. 34

Description: Ponding of water was noted in two locations (5'x5' each)

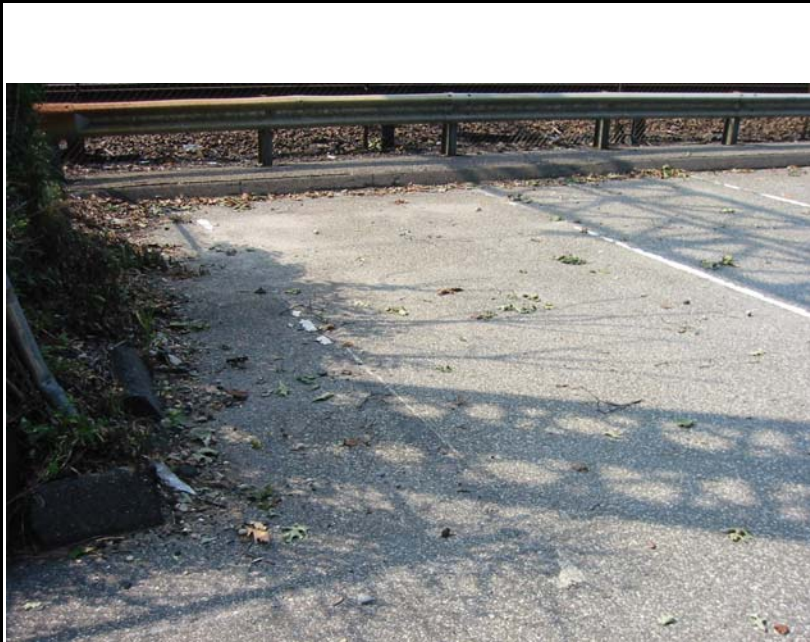
Description:  
Missing asphalt curb  
(3')

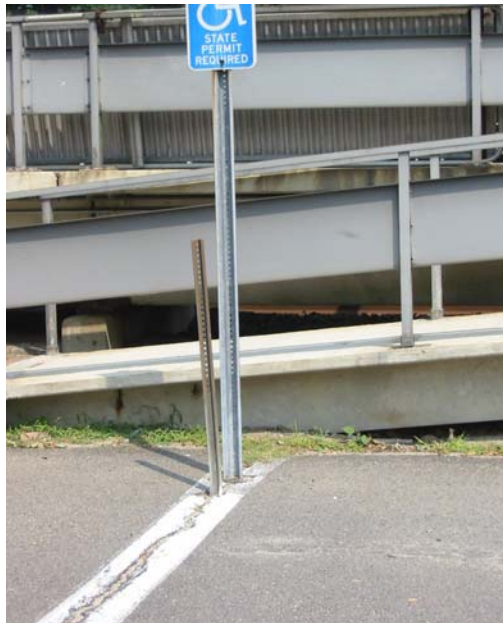
PHOTO NO. 36

Description:  
The pole is missing a  
sign

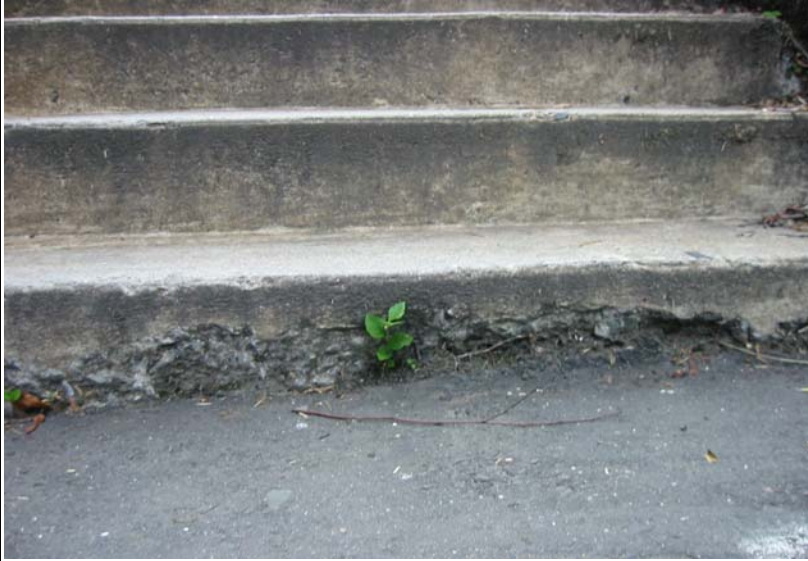
Description: Typical spalled concrete stair

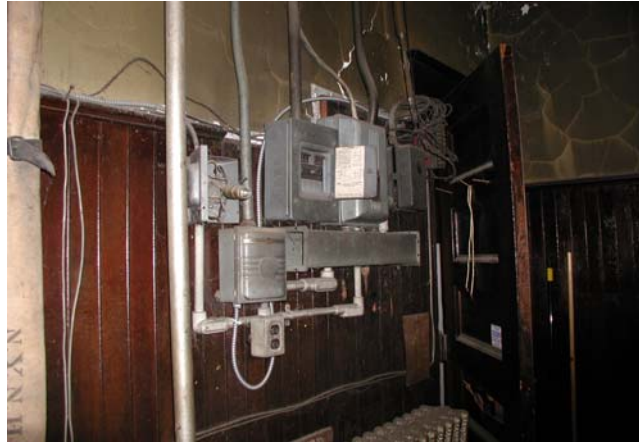
Remarks: The electrical panels in the coffee shop are out dated and should be replaced.  
 \_\_\_\_\_  
 \_\_\_\_\_  
 \_\_\_\_\_

The main electrical panelboard is in good working condition but the remaining two sub-panelboards should be replaced. Both the manufacturers have been out of business for many years and it is questionable if they are operating as designed.

Description:  
Out of date  
service panels

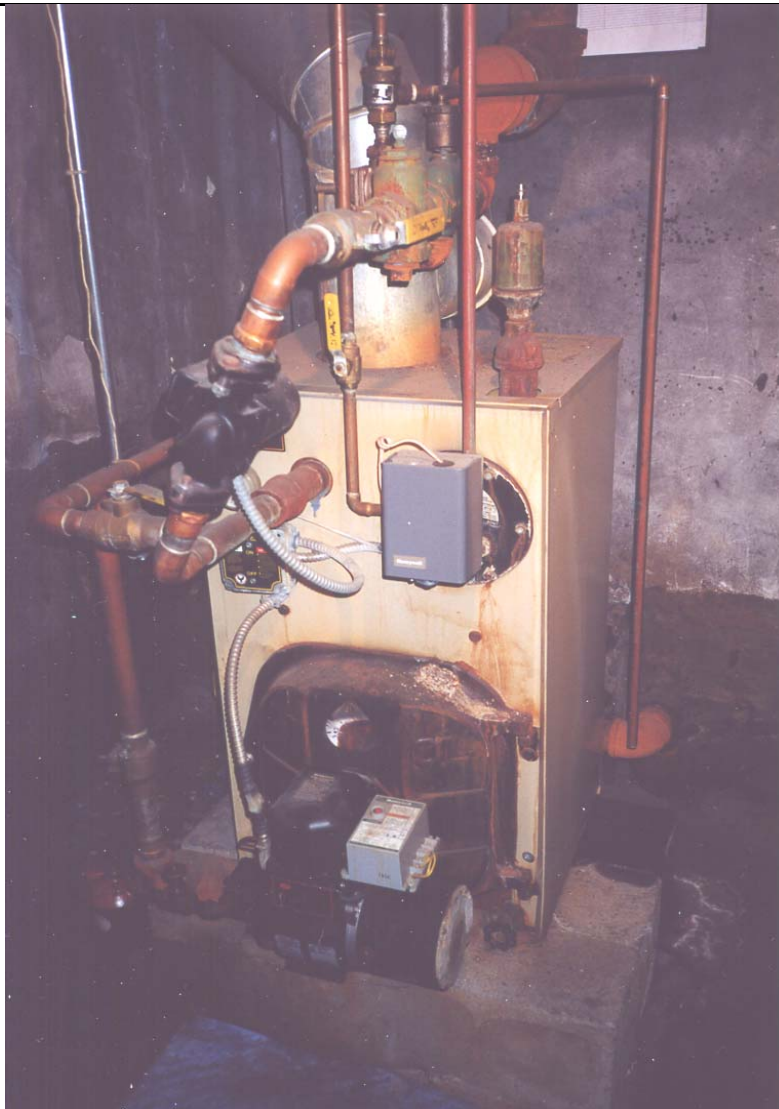
BOILER: Weil McLain, hot water oil burner, Model WT00-4, capacity 151,000 Btu/hr  
Net Rating 131,000 Btu/hr, includes a coil for producing domestic hot water  
At this time the boiler is working but it is deficient because rust and deterioration  
is shown. Pipes are rusted and not insulated. The combustion air openings are not  
in accordance with the Code (BOCA International Mechanical Code).

The station is equipped with an old hot water producing boiler in deficient condition. The boiler uses an oil burner. It is working at this time but it looks more than 25 years old (see picture 51). The life expectancy for such a boiler is 20-25 years. Due to this situation the boiler must be scheduled for replacement. The system does not have an expansion tank or a floor drain which is required by current code. The hot water heating pipes also need replacement. When new piping is installed it shall be insulated. The pipes observed are rusted and have no insulation. A required outside opening for combustion air could not be seen. When a new boiler is installed two such protected (louver & screen) openings must be provided.

Description:  
Old boiler in  
working condition  
Life left 3-5 years

The present old fashion thermostat must also be replaced with a night set back programmable one.
