Individual Station Report

Branchville

July 2003

CONDITION INSPECTION
BRANCHVILLE STATION

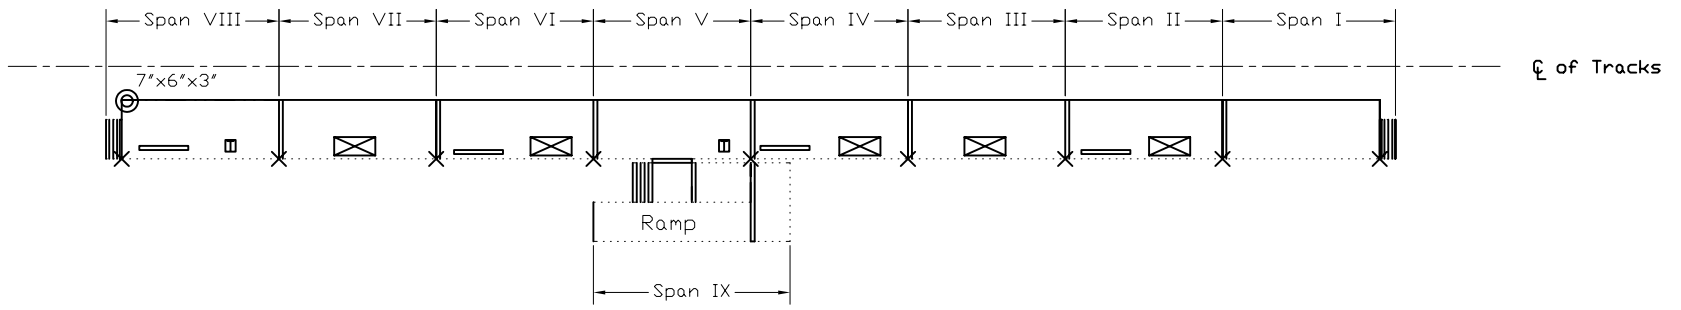
Urbitran Associates, Inc.
Connecticut Dept. of Transportation
Branchville Station Platform Plan
Date: 12-05-01

1. The warning strip paint is fading through out the entire length of the platform

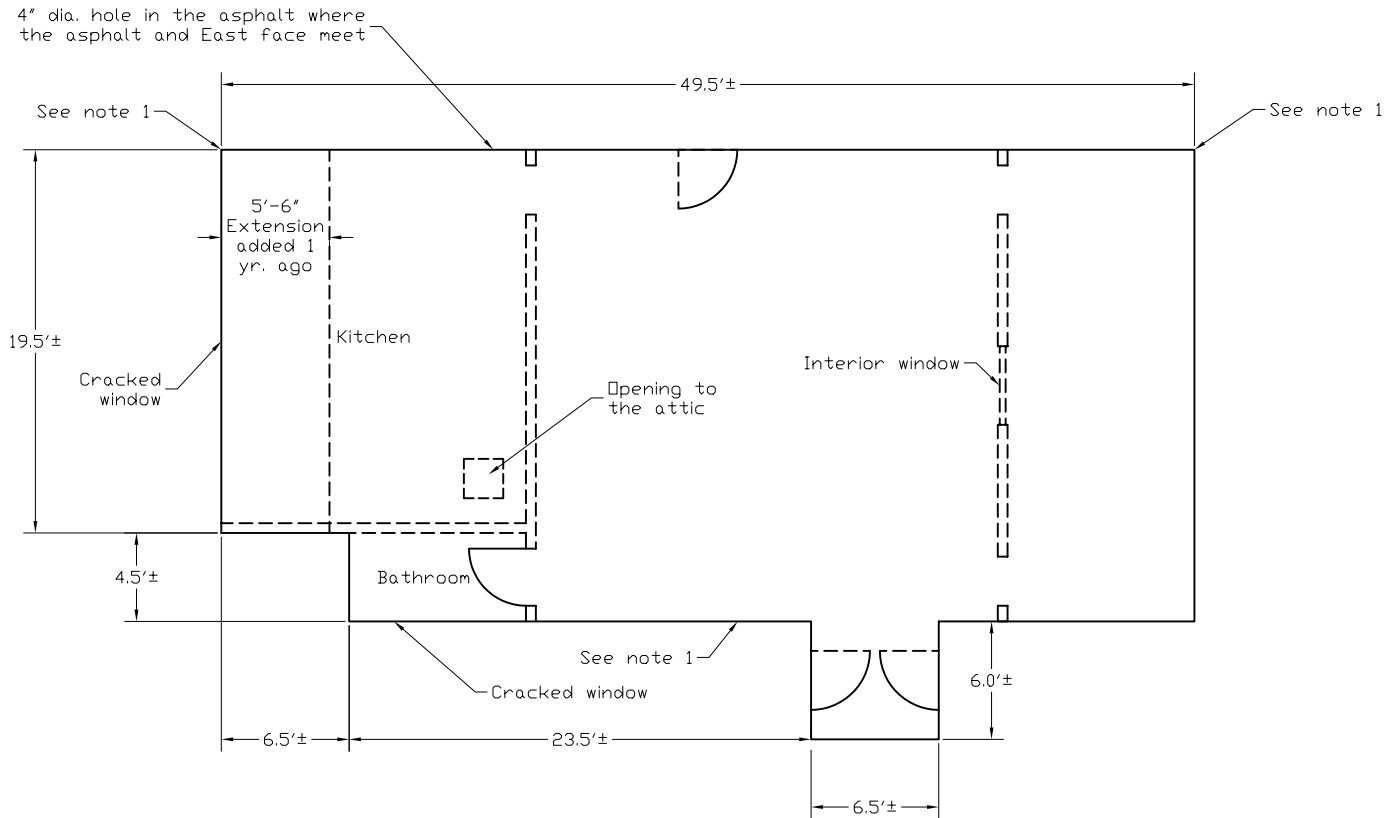
Branchville Station
Station House Plan

1. The roof is damaged in the Northwest corner, Southwest corner, and the middle of the Westside
